Phase I Environmental Site Assessment

Vacant Property
927 Richmond Road and 108 Woodroffe Avenue
Ottawa, Ontario

November 10, 2017

Report: PE1373-1

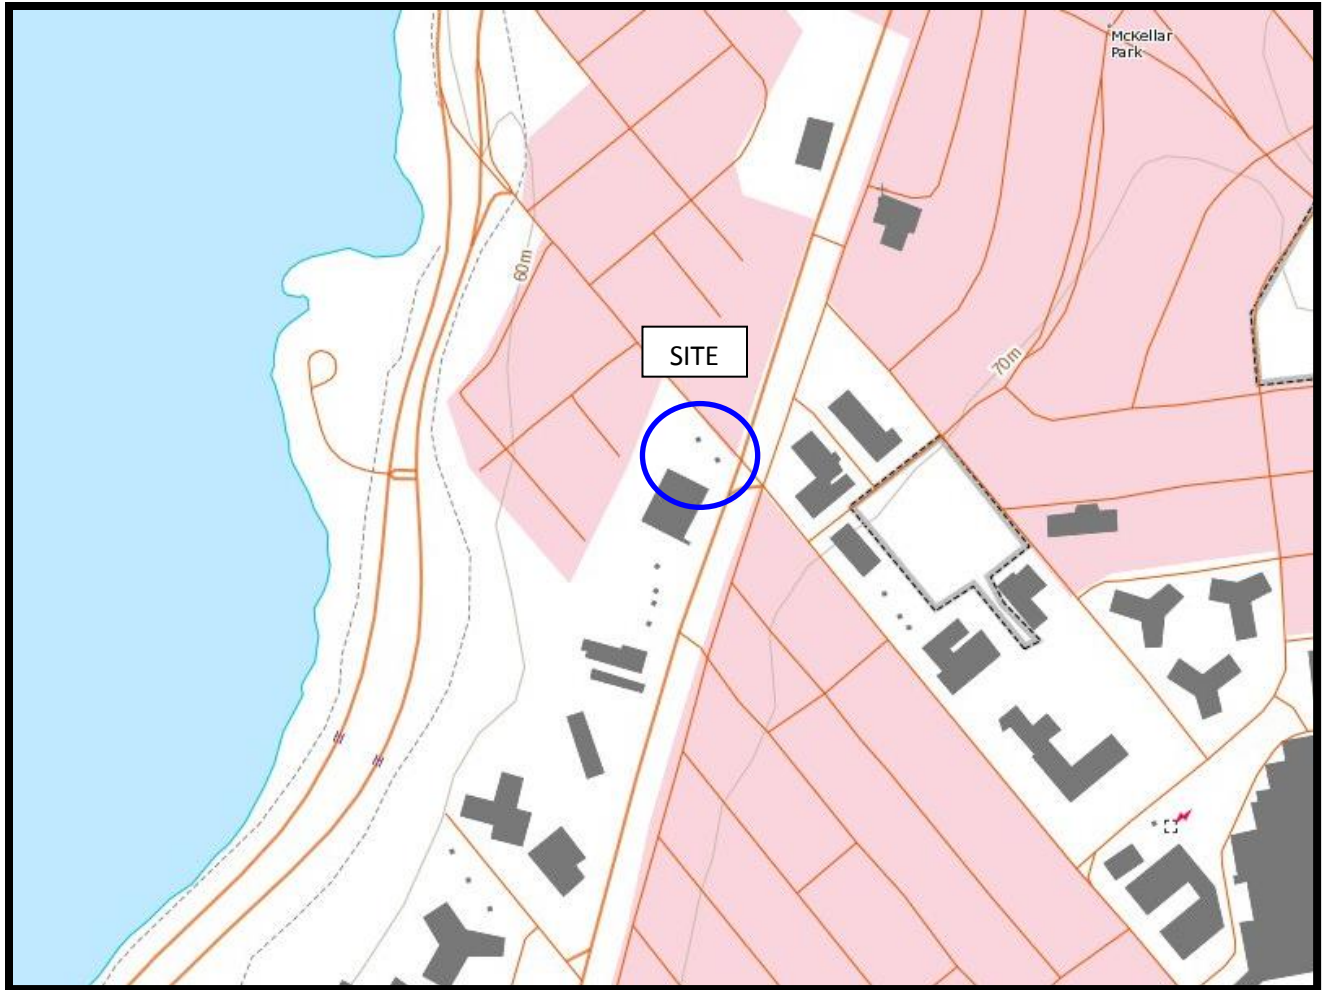
FIGURE 2
TOPOGRAPHIC MAP

Topographic maps were obtained from Natural Resources Canada – The Atlas of Canada website and from the City of Ottawa website. The topographic maps indicate that the regional topography in the general area of the site slopes downward to the north and the Ottawa River, approximately 300 m away. According to the maps, the subject site is located in an area with commercial and other large buildings (along Richmond Road and parts of Woodroffe Avenue) as well as residential areas to the north, south, and further east and west. An illustration of the referenced topographic map is presented on Figure 2 – Topographic Map, appended to this report.

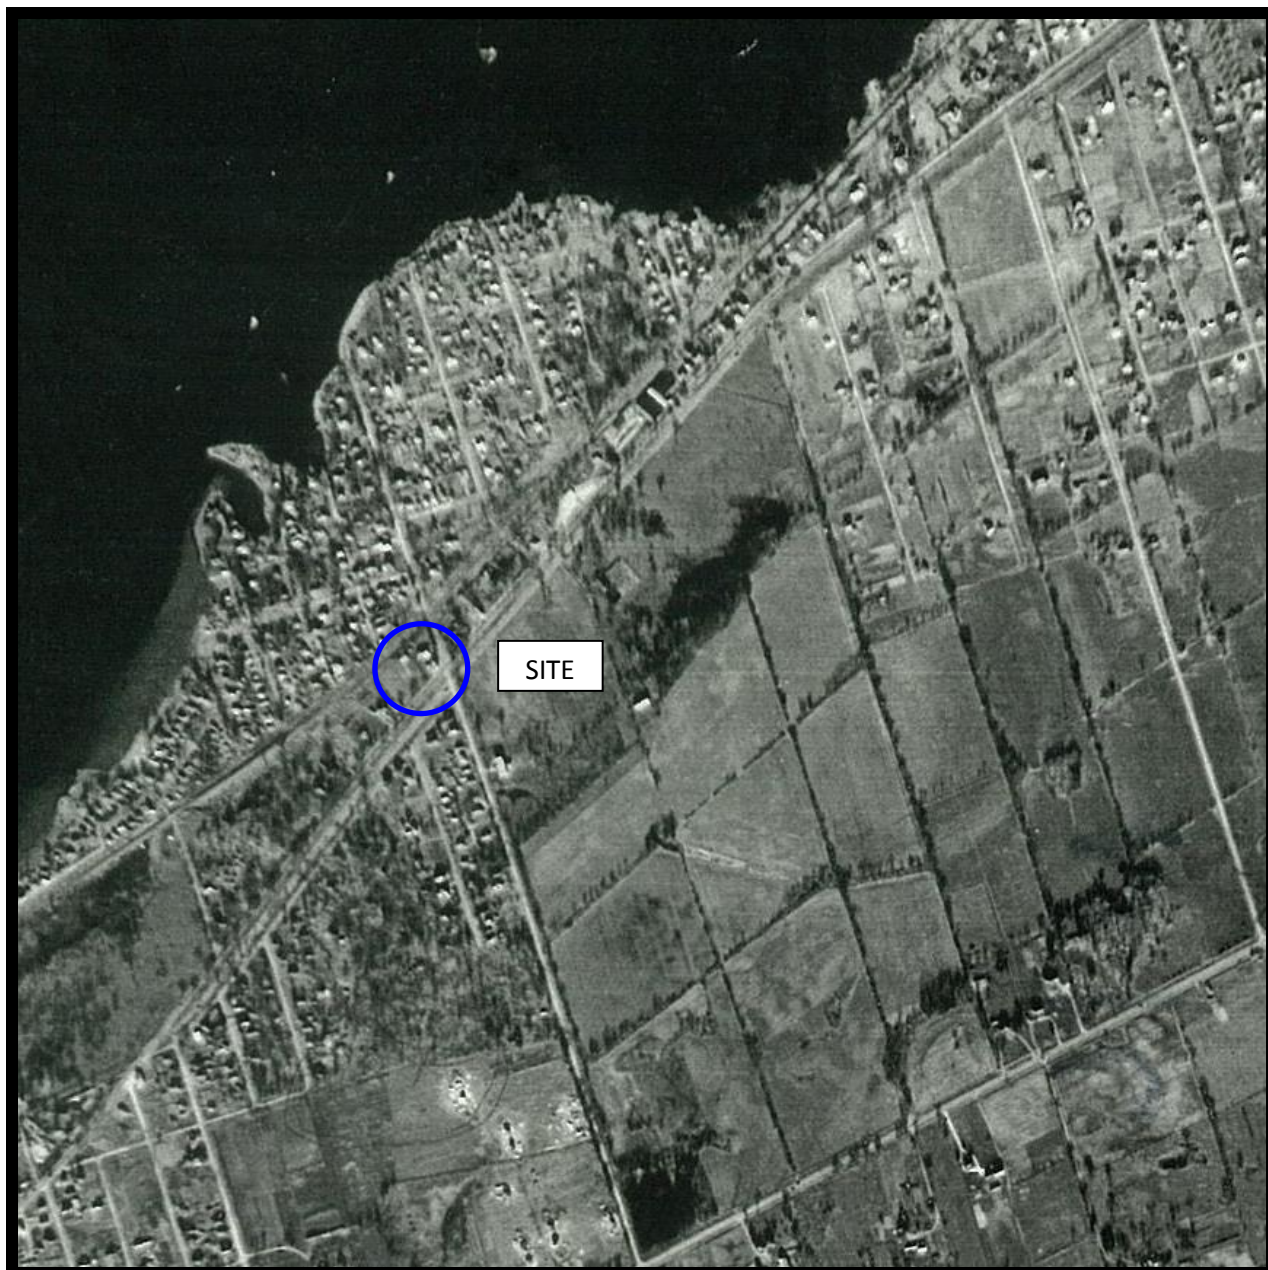
AERIAL PHOTOGRAPH
1945

| 1945 | Three buildings can be seen on the subject property; one dwelling along Richmond Road and another along Woodroffe Avenue. The third building, located in the northwestern corner of the property, appears to be a large shed. The property to the west appears vacant, while properties to the north and south appear to be used for residential purposes. |

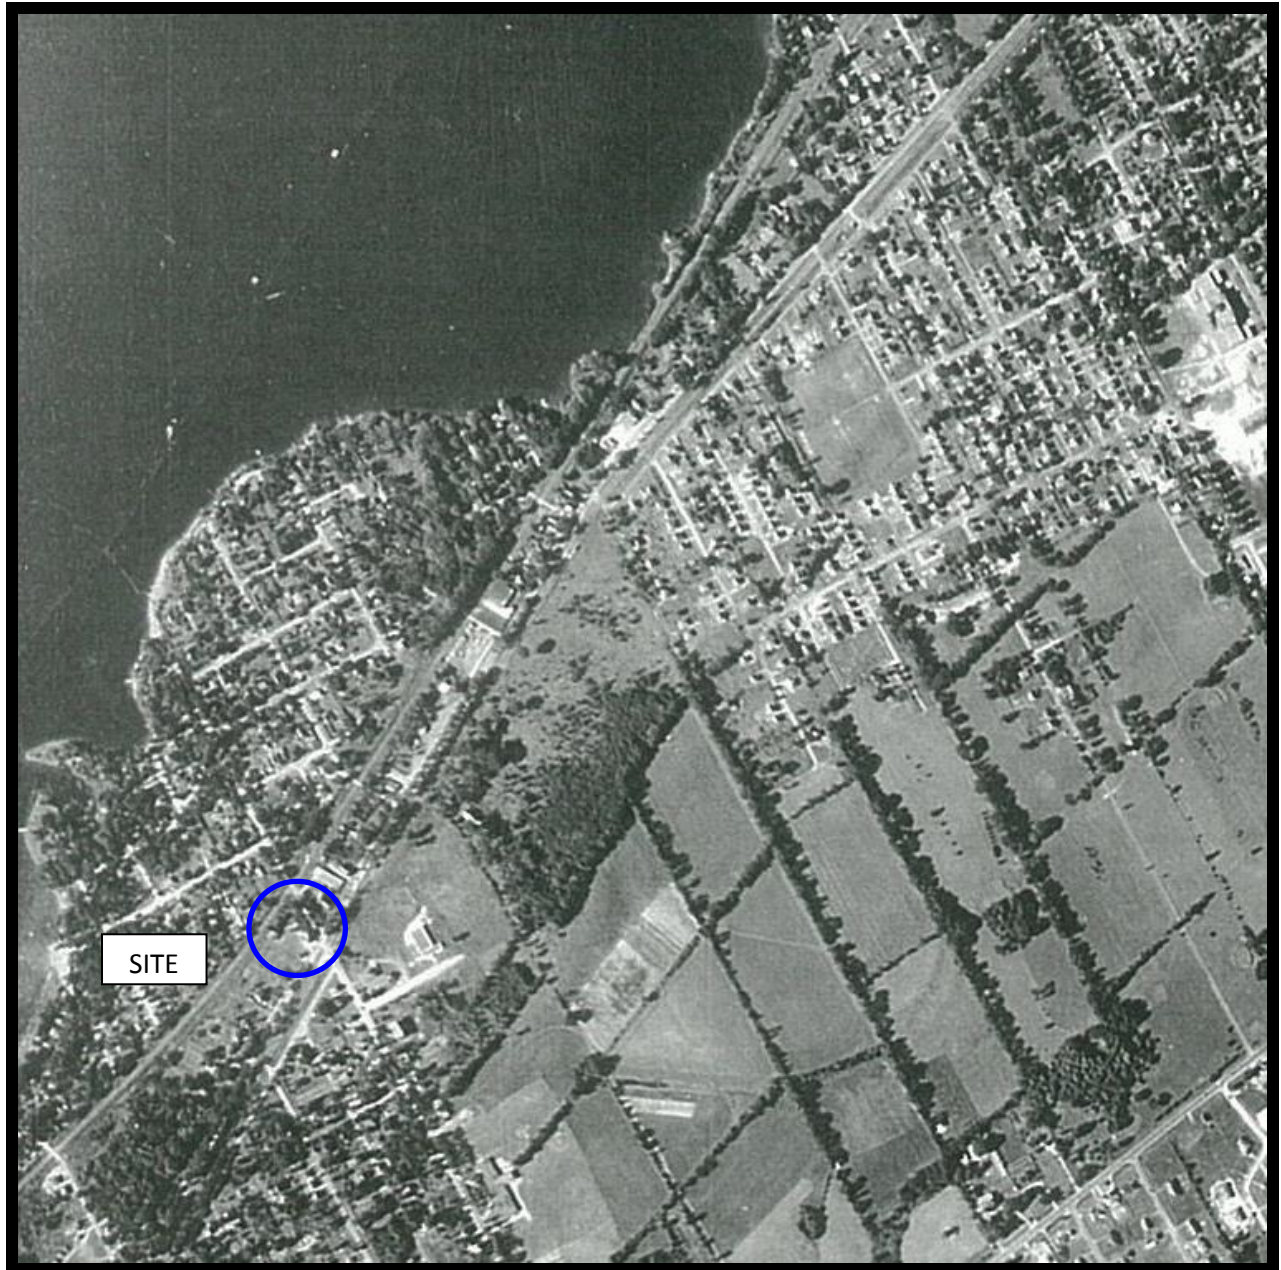
AERIAL PHOTOGRAPH
1952

1952	No significant changes appear to have been made to the subject property. Neighbouring properties to the north continue to be developed with residential dwellings. A commercial building has been constructed to the east of the site.
1976	Due to the poor resolution of the photograph, the subject site cannot be clearly shown. The adjacent property to the west appears to have been developed with a large building, similar to the one present today. The general study area appears to have been further developed with residential and commercial buildings.
1986	The third building on the subject property (formerly in the northwest corner) is no longer present. No other changes were noted on the subject site, or adjacent properties.
1994	The subject and neighbouring properties are relatively unchanged from the previous photo.
2005	The subject and neighbouring properties are relatively unchanged from the previous photo

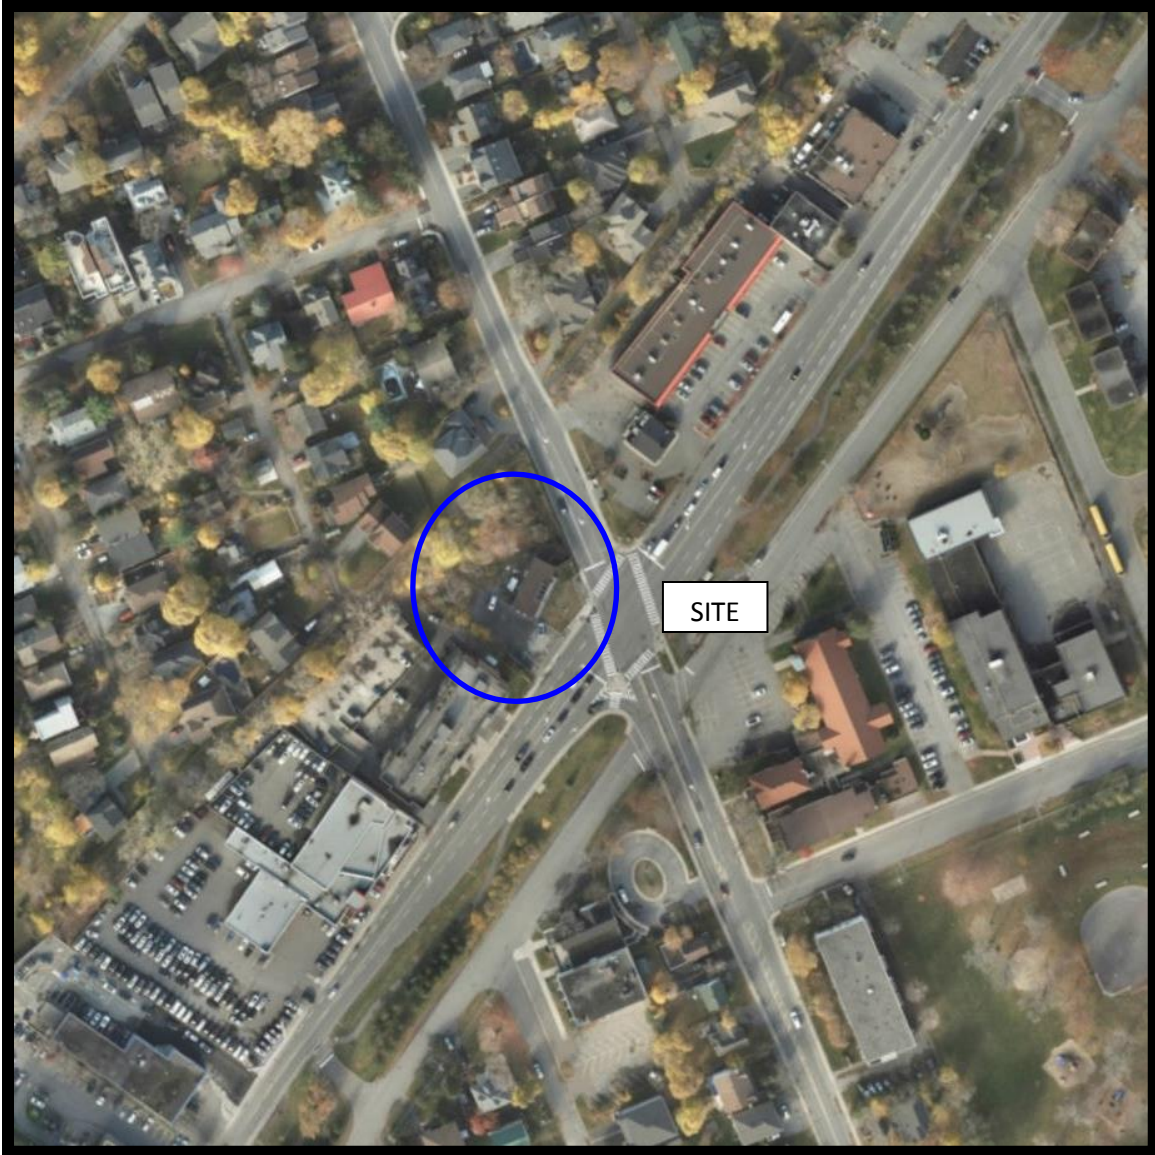
AERIAL PHOTOGRAPH
2015

2015	The former dwellings on the property have been demolished and a temporary showroom trailer has been constructed in the southeast corner of the site. No significant changes have been made to adjacent properties.

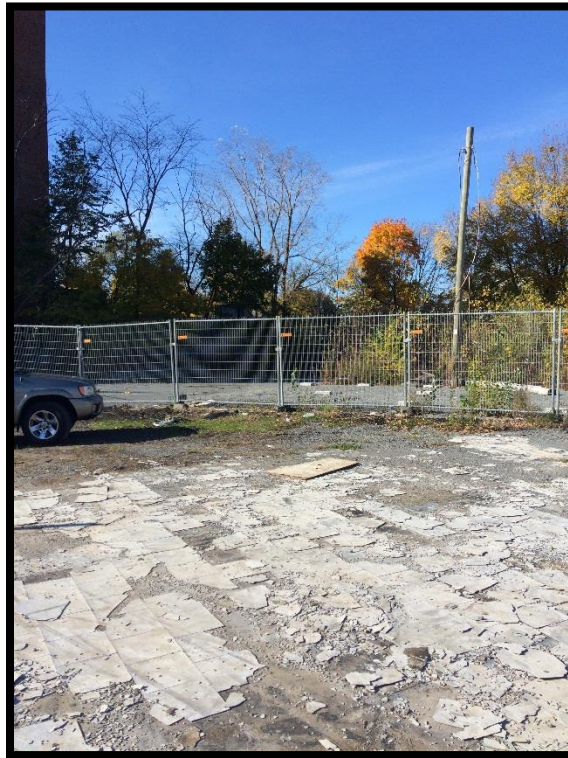
Photograph 1: View of the site, looking northwest from the southwest corner of the property.

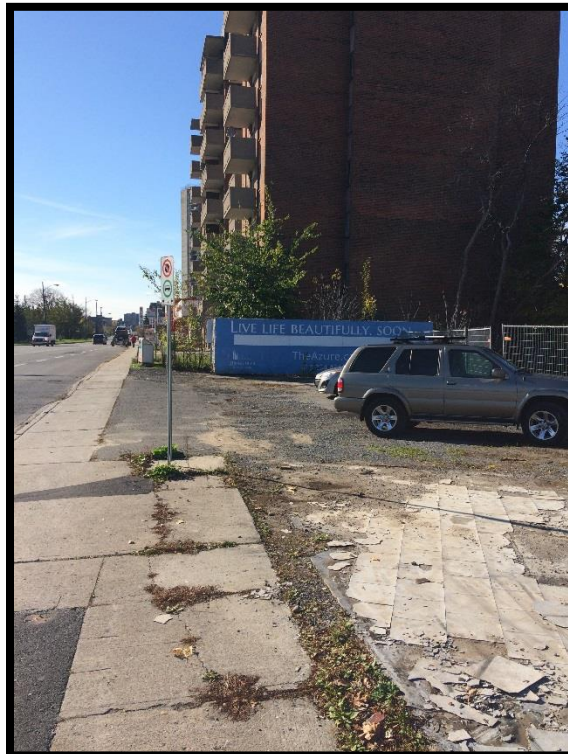
Photograph 2: View of the site, looking west from the east side of the property. The adjacent property to the west is occupied by a residential apartment building (background).

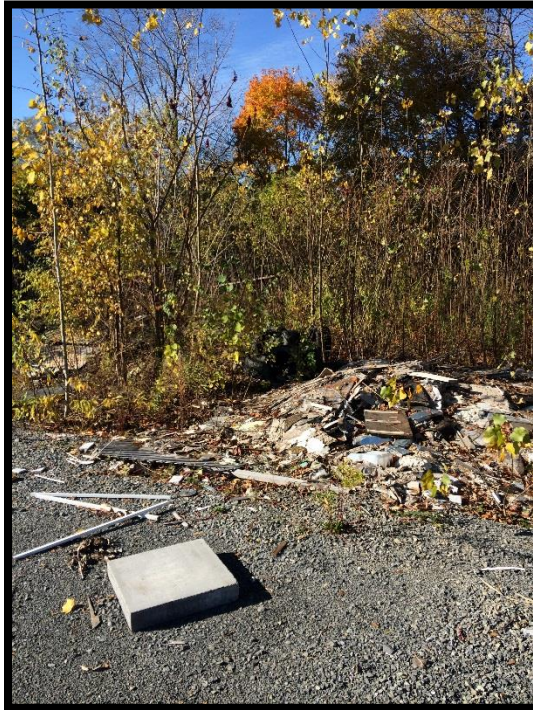
Waste and debris was noted on the subject property. Debris consisted of construction materials such as wood and masonry. Scrap tires were also noted on the property.

Photograph 3: View of the interior of the property, looking north. A pile of debris can be seen in the centre-right of the photo, with a pile of tires immediately behind it. The property is significantly overgrown (background)

All debris located on the property, including tires and used construction materials, must be properly disposed of. Prior to, or in conjunction with, site redevelopment, the metal impacts (above background standards) in the vicinity of borehole BH7 should be further delineated. Any soils exceeding MOECC Table 1 background standards should be disposed of at an approved waste disposal facility. A Toxicity Characteristic Leaching Procedure analysis on a representative soil sample will be required prior to disposal at a waste facility.

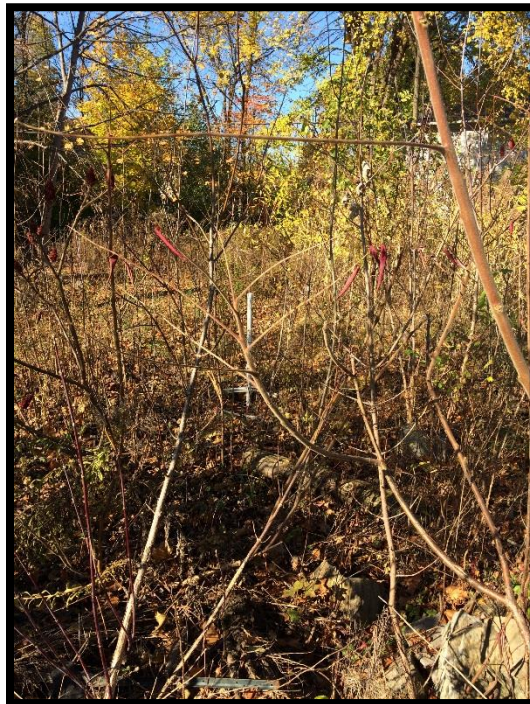
Photograph 4: View of the overgrown portion of the property. A monitoring well (BH6) can be seen within the vegetation.

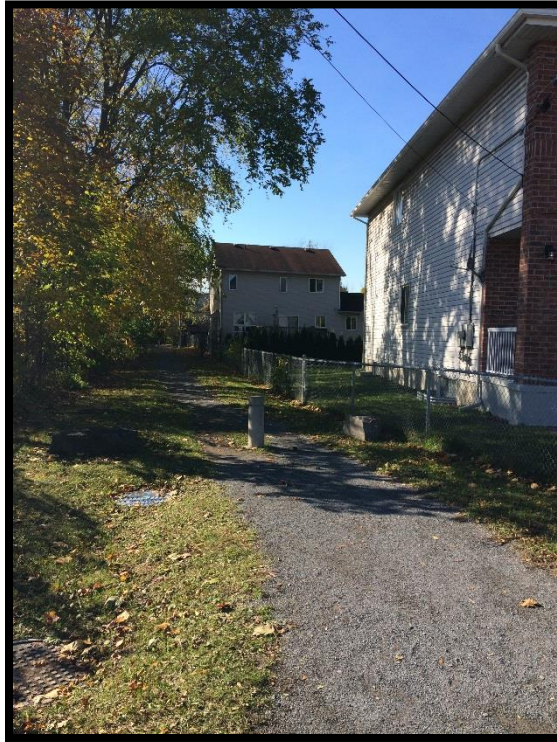
Photograph 5: View of the adjacent bike path immediately north of the site, looking west. A residential dwelling is present on the right of the photo.

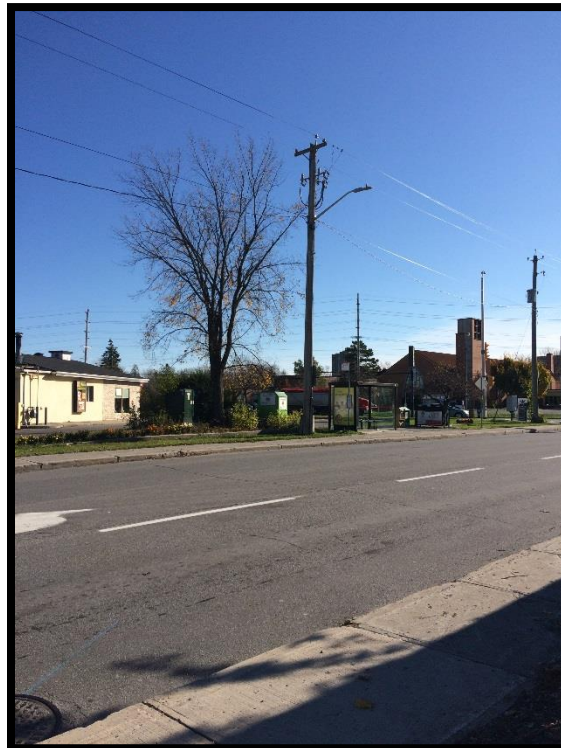
The former retail fuel outlet to the east may have had the potential to impact the subject site, creating an area of potential environmental concern (APEC) on the eastern side of the subject site. This will be discussed further later in the report.

Photograph 6: View of adjacent properties, looking southeast. On the centre-left of the photo is the former retail fuel outlet. In the centre-right is a church.
