# **Mer Bleue Area 10 Urban Expansion Area**

## **Headwaters Report**

**March 2017**

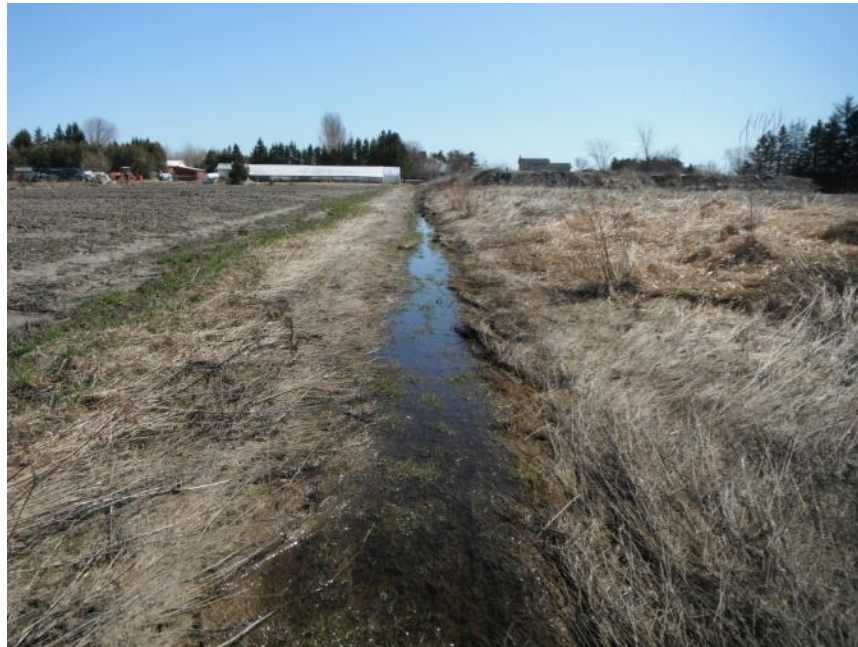
**Photo 1 Drain 1 (Station 4) looking upstream from the downstream end. April 28, 2014**

The substrate was composed of fines. The entire channel was choked with vegetation (purple loosestrife, reed canary grass and pale smartweed). There were no signs of erosion.

The banks were fully vegetated with herbaceous vegetation. Herbaceous vegetation consisted of reed canary grass, common sow-thistle and common milkweed. There was no canopy cover.

During the spring visit in April 2014, the site was shocked for 273 seconds over an area of approximately 56 m<sup>2</sup>. The average wetted width and water depth obtained in April were 1.4 m and 6 cm (range 1-14 cm), respectively. No fish were captured.

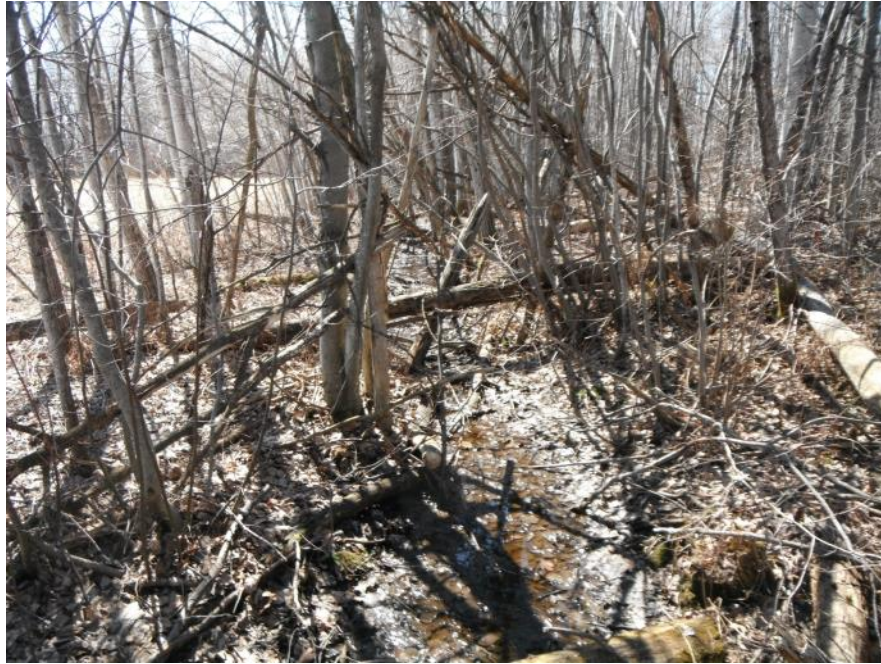
**Photo 3 Drain 2 (Station 5) looking upstream from the downstream end. April 28, 2014**

During the spring visit in April 2014, the site was dipped 60 times as it was too shallow to shock and contained small and large woody debris. The average wetted width and

water depth obtained in April were 1.0 m and 5 cm (range 2-13 cm), respectively. No fish were captured.

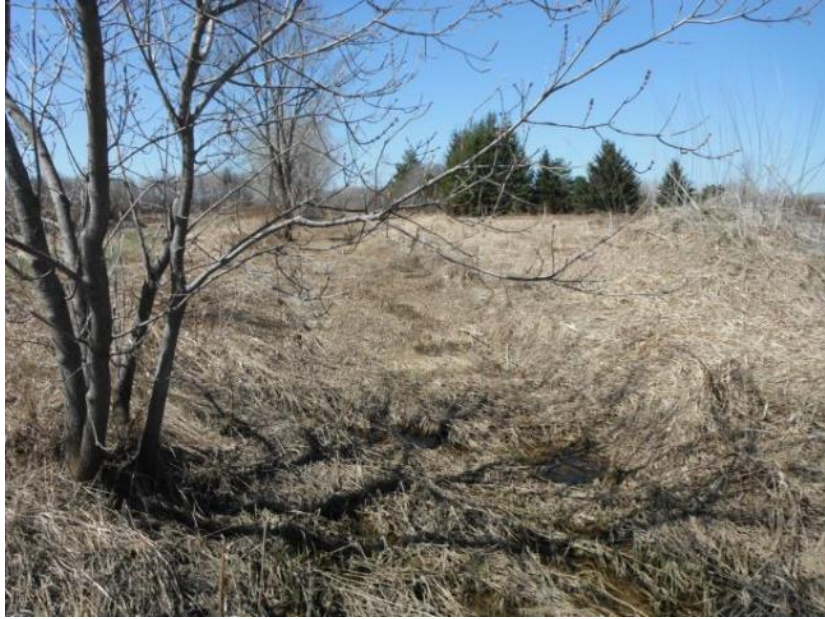
**Photo 5    Drain 3 (Station 6) looking upstream from the downstream end. April 28, 2014**

The substrate was composed of fines. The entire channel was choked with aquatic vegetation (reed canary grass and purple loosestrife). There were no signs of erosion.

The banks were fully vegetated with herbaceous vegetation and poorly vegetated with woody species. Herbaceous vegetation consisted of reed canary grass, New England aster and daisy fleabane. Woody species included American elm and trembling aspen. There was very sparse canopy cover.

During the spring visit in April 2014, the site was dipped 50 times as it was too shallow and was choked with remnant vegetation to shock. The average wetted width and water depth obtained in April were 2.0 m and 10 cm (range 6-25 cm), respectively. No fish were captured.

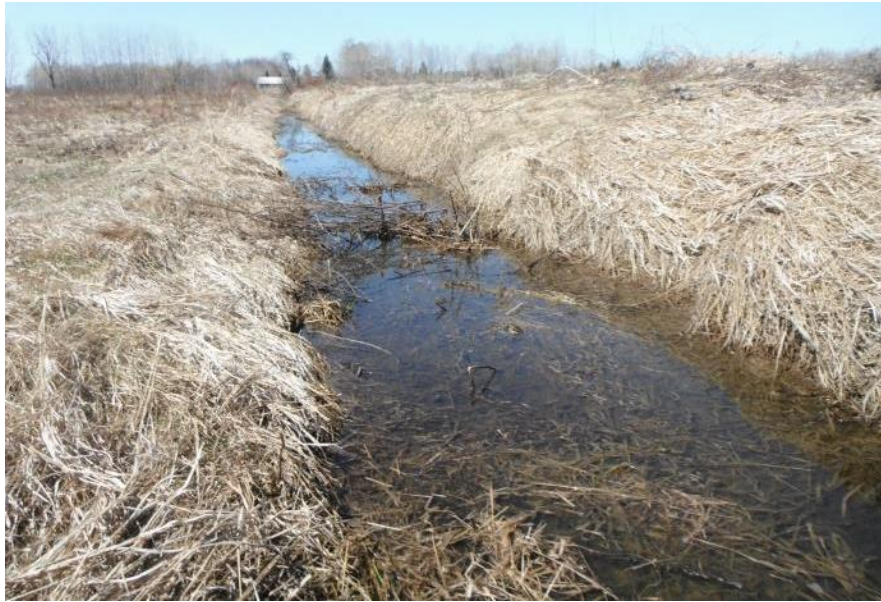
**Photo 7    Drain 4 (Station 7) looking upstream from the downstream end. April 28, 2014**

The substrate was composed of fines. The entire channel was heavily choked with vegetation (reed canary grass and purple loosestrife). There were no signs of erosion.

The banks were completely vegetated with herbaceous vegetation and poorly vegetated with woody species. Herbaceous vegetation consisted of reed canary grass, daisy fleabane and purple loosestrife. Woody species included common buckthorn. There was no canopy cover.

During the spring visit in April 2014, the site was shocked for 299 seconds over an area of approximately 52 m<sup>2</sup>. The average wetted width and water depth obtained in April were 1.3 m and 8 cm (range 4-14 cm), respectively. No fish were captured.

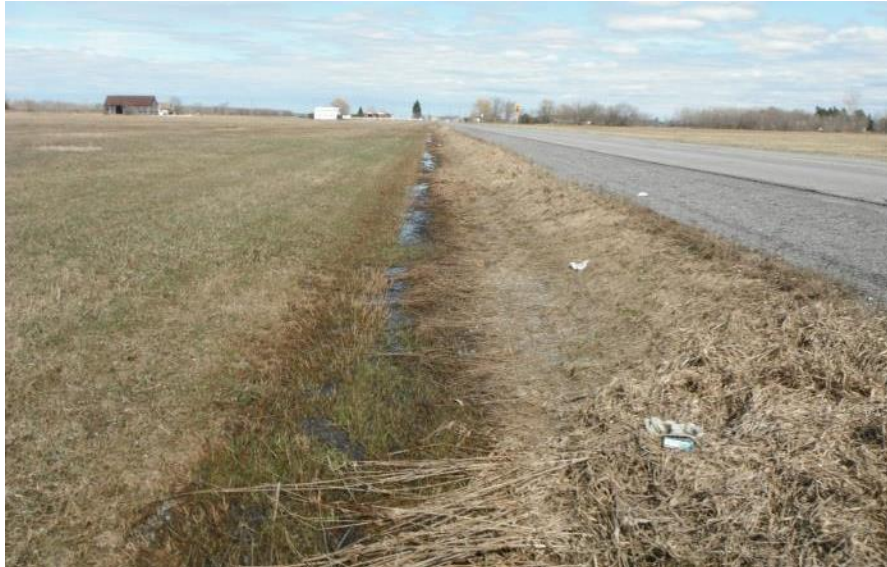
**Photo 9 Drain 6 (Station 8) looking upstream from the downstream end. April 28, 2014**

The substrate was composed of fines. The entire channel was choked with vegetation (reed canary grass, and purple loosestrife). There were no signs of erosion.

The banks were fully vegetated with herbaceous vegetation. Herbaceous vegetation consisted of grass species, common sow-thistle and purple loosestrife. There was no canopy cover.

During the spring visit in April 2014, the site was dipped 60 times as it was too shallow to shock. The average wetted width and water depth obtained in April were 1.3 m and 5 cm (range 3-12 cm), respectively. No fish were captured.

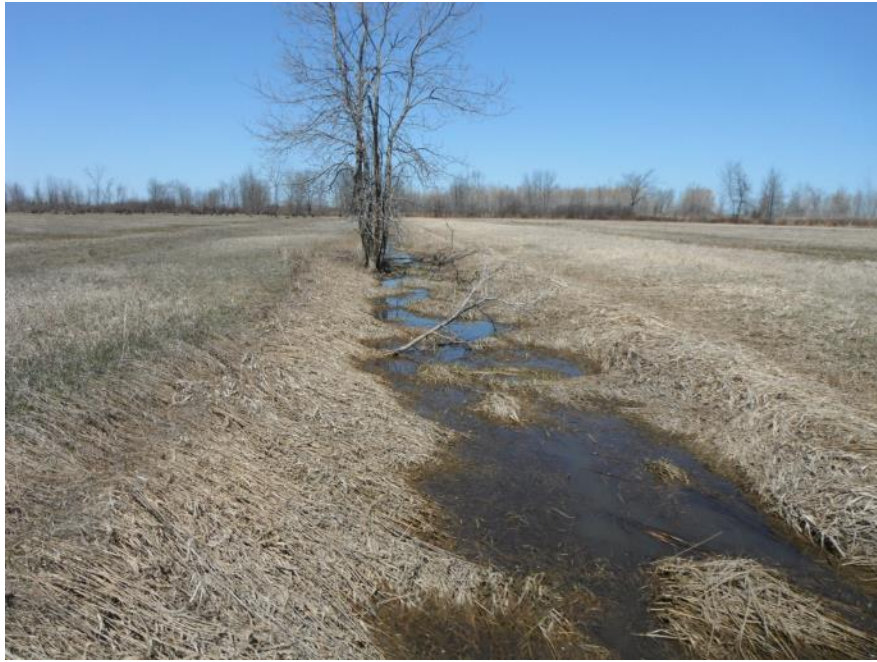
**Photo 10 Drain 7 (Station 9) looking upstream from the downstream end. April 28, 2014**

The substrate was composed of fines. The in-stream cover consisted of aquatic vegetation (reed canary grass, narrow-leaved cattail, and purple loosestrife). There were no signs of erosion.

The banks were fully vegetated with herbaceous vegetation, and very poorly with woody species. Herbaceous vegetation consisted of reed canary grass, timothy and common sow-thistle. Woody vegetation included green ash. There was no canopy cover.

During the spring visit in April 2014, the site was shocked for 328 seconds over an area of approximately 80 m<sup>2</sup>. The average wetted width and water depth obtained in April were 2.0 m and 10 cm (range 7-22 cm), respectively. No fish were captured.

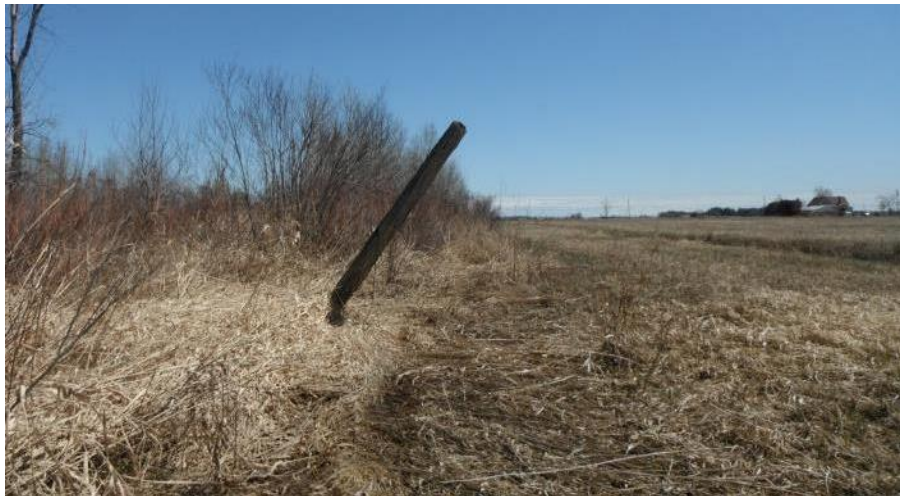
**Photo 12 Drain 8 (Station 10) looking upstream from the downstream end.  
April 28, 2014**

The substrate was composed of fines. The channel was heavily choked with vegetation (purple loosestrife, narrow-leaved cattail, and reed canary grass). There were no signs of erosion.

The banks were fully vegetated herbaceous vegetation and very poorly vegetated with woody species. Herbaceous vegetation consisted of New England aster, timothy and brome species. Woody species included slender willow, grey birch and trembling aspen. There was scarce canopy cover.

During the spring visit in April 2014, the site was dipped 10 times as it was too shallow to shock and was choked with vegetation. The average wetted width and water depth obtained in April were 0.7 m and 2 cm (range 1-6 cm), respectively. No fish were captured.

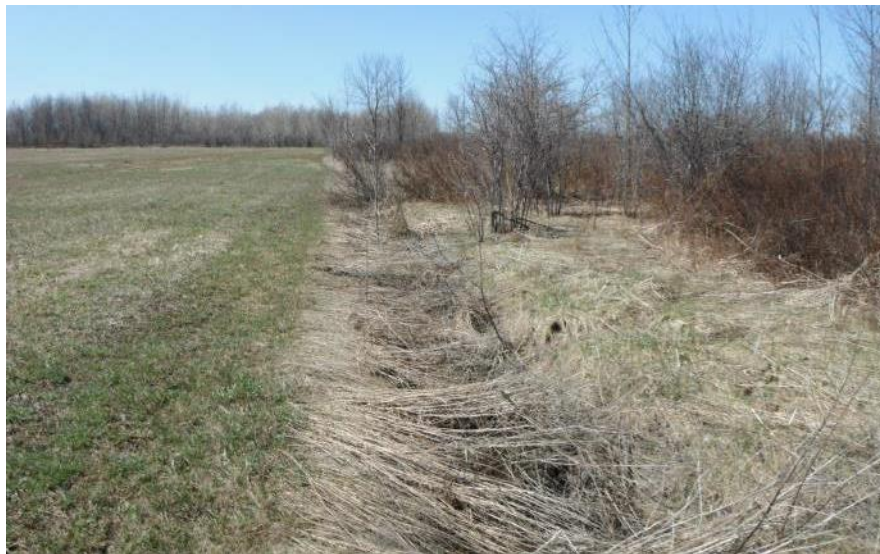
**Photo 13 Drain 9 (Station 11) looking upstream from the downstream end.  
April 28, 2014**

The substrate was composed of fines. The channel was entirely choked with aquatic vegetation (reed canary grass, black bulrush, and purple loosestrife). There were no signs of erosion.

The banks were fully vegetated with herbaceous vegetation and very poorly vegetated with woody species. Herbaceous vegetation consisted of common ragweed, reed canary grass and timothy. Woody species included green ash and American elm. There was no canopy cover.

During the spring visit in April 2014, the site was dipped 10 times as it was too shallow to shock and was choked with vegetation. The average wetted width and water depth obtained in April were 0.9 m and 4 cm (range 2-8 cm), respectively. No fish were captured.

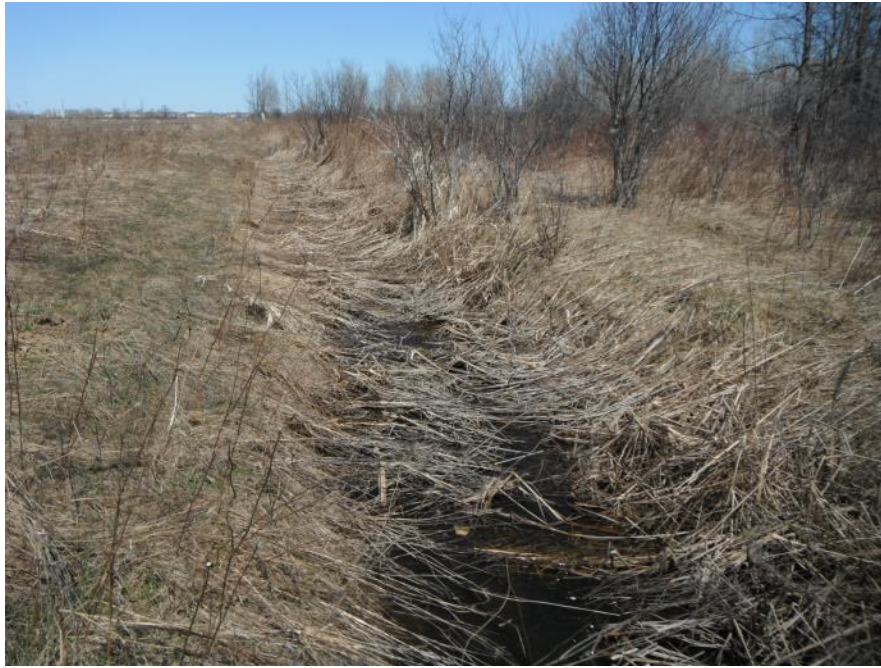
**Photo 15 Drain 10 (Station 12) looking upstream from the downstream end.  
April 28, 2014**

The substrate was composed of fines. The channel was entirely vegetated with purple loosestrife, reed canary grass, and narrow-leaved cattail. There were no signs of erosion.

The banks were fully vegetated with herbaceous vegetation and very poorly vegetated with woody species. Herbaceous vegetation consisted of Canada goldenrod, wild carrot and timothy. Woody species included common buckthorn. There was no canopy cover.

During the spring visit in April 2014, the site was shocked for 416 seconds over an area of approximately 84 m<sup>2</sup>. The average wetted width and water depth obtained in April were 2.1 m and 11 cm (range 4-20 cm), respectively. No fish were captured

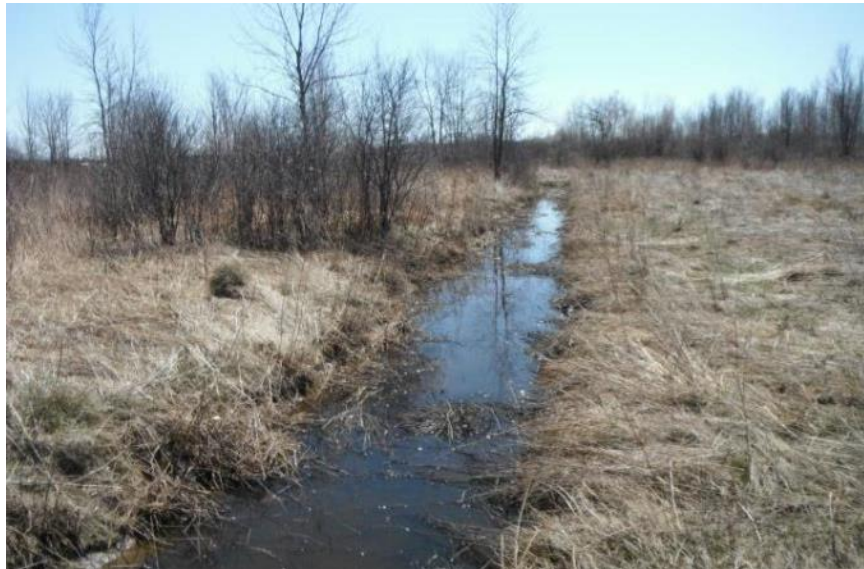
**Photo 17 Drain 11 (Station 13) looking upstream from the downstream end.  
April 28, 2014**

The substrate was composed of fines. The channel was choked by aquatic vegetation (purple loosestrife, narrow-leaved cattail, and reed canary grass). There were no signs of erosion.

The banks were fully vegetated with herbaceous vegetation and moderately vegetated with woody species. Herbaceous vegetation consisted of purple loosestrife, late goldenrod and black bulrush. Woody species included pussy willow, common buckthorn and slender willow. There was poor canopy cover.

During the spring visit in April 2014, the site was dipped 50 times as it was too shallow to shock and was choked with vegetation. The average wetted width and water depth obtained in April were 1.2 m and 6 cm (range 2-15 cm), respectively. No fish were captured.

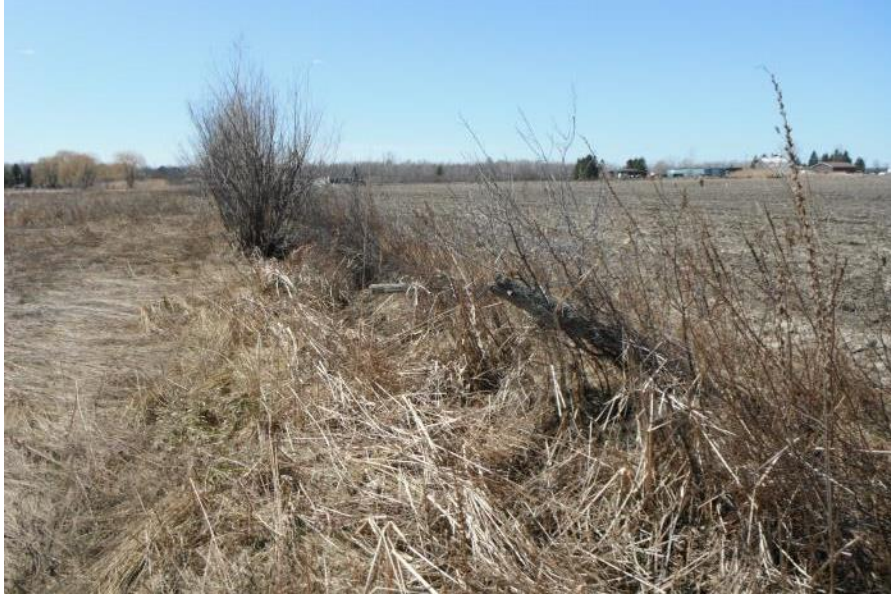
**Photo 19 Drain 12 (Station 14) looking upstream from the downstream end.  
April 28, 2014**

The substrate was composed of fines. The channel was entirely choked by aquatic vegetation (purple loosestrife, broad-leaved cattail, and reed canary grass). There were no signs of erosion.

The banks were fully vegetated herbaceous vegetation and poorly vegetated with woody species. Herbaceous vegetation consisted of purple loosestrife, Canada goldenrod and wild carrot. Woody species included pussy willow and common buckthorn. There was no canopy cover.

The site was dry during the visit in spring 2014; therefore no fish sampling was completed.

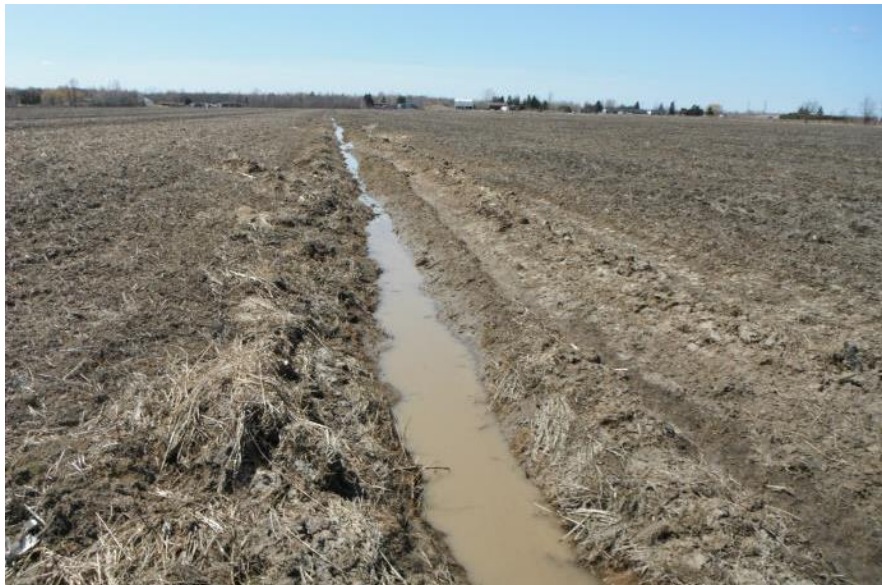
**Photo 21 Drain 13 (Station 15) looking upstream from the downstream end.  
April 28, 2014**

The substrate was composed of fines. The entire channel was heavily vegetated with reed canary grass, broad-leaved cattail, and purple loosestrife. There were no signs of erosion.

The banks were fully vegetated with herbaceous vegetation. Herbaceous vegetation consisted of common ragweed, common sow-thistle and reed canary grass. There was no canopy cover.

During the spring visit in April 2014, the site was shocked for 264 seconds over an area of approximately 24 m<sup>2</sup>. The average wetted width and water depth obtained in April were 0.6 m and 7 cm (range 3-19 cm), respectively. No fish were captured

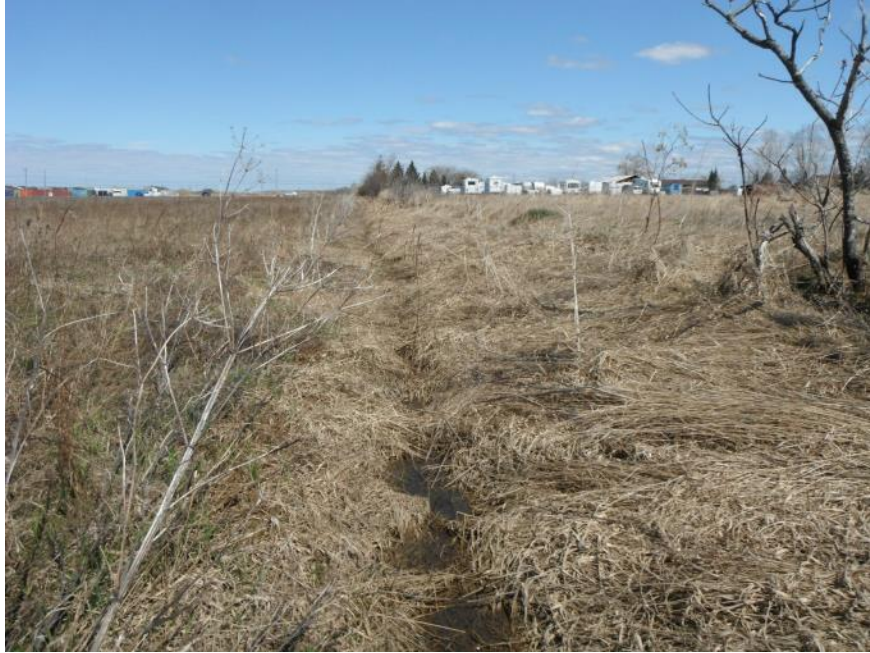
**Photo 23 Drain 14 (Station 16) looking downstream from the upstream end.  
April 28, 2014**

The substrate was composed of fines. The entire channel was fully vegetated (reed canary grass and purple loosestrife). There were no signs of erosion.

The banks were fully vegetated with herbaceous vegetation and poorly vegetated with woody species. Herbaceous vegetation consisted of common ragweed, wild carrot and grass species. Woody species included staghorn sumac, Manitoba maple and white spruce. There was no canopy cover.

During the spring visit in April 2014, the site was dipped 10 times as it was too narrow and shallow to shock. The average wetted width and water depth obtained in April were 0.4 m and 3 cm (range 1-6 cm), respectively. No fish were captured.

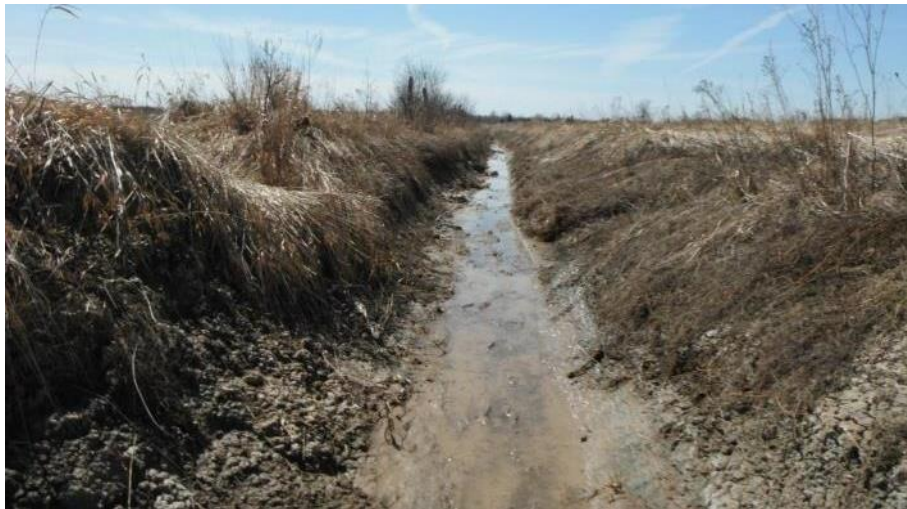
**Photo 25 Drain 15 (Station 17) looking upstream from the downstream end.  
April 28, 2014**

The banks were fully vegetated with herbaceous vegetation, and poorly vegetated with woody species. Herbaceous vegetation consisted of reed canary grass, common sow-thistle and wild carrot. Woody species included common buckthorn and pussy willow. There was no canopy cover.

During the spring visit in April 2014, the site was spot shocked for 154 seconds as it was too shallow to shock in areas. The average wetted width and water depth obtained in April were 0.4 m and 1 cm (range 1-2 cm), respectively. No fish were captured.

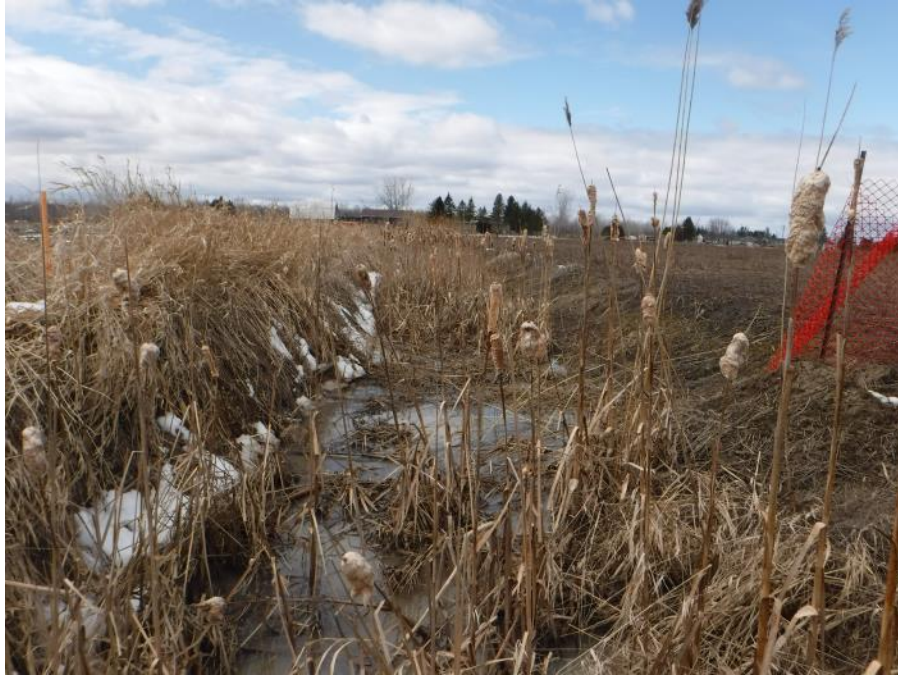
**Photo 29 Drain 18 (Station 26) looking downstream from the upstream. April 12, 2016**

The top of banks were fully vegetated with herbaceous vegetation. Herbaceous vegetation consisted of wheat. There was no canopy cover. The banks were only partially vegetated along their sides resulting in erosion from rain events.

This drain was not sampled for fish as it was dry.
