Phase I Environmental Site Assessment

99 Fifth Avenue
Ottawa, Ontario

October 6, 2017

Report: PE4087-1

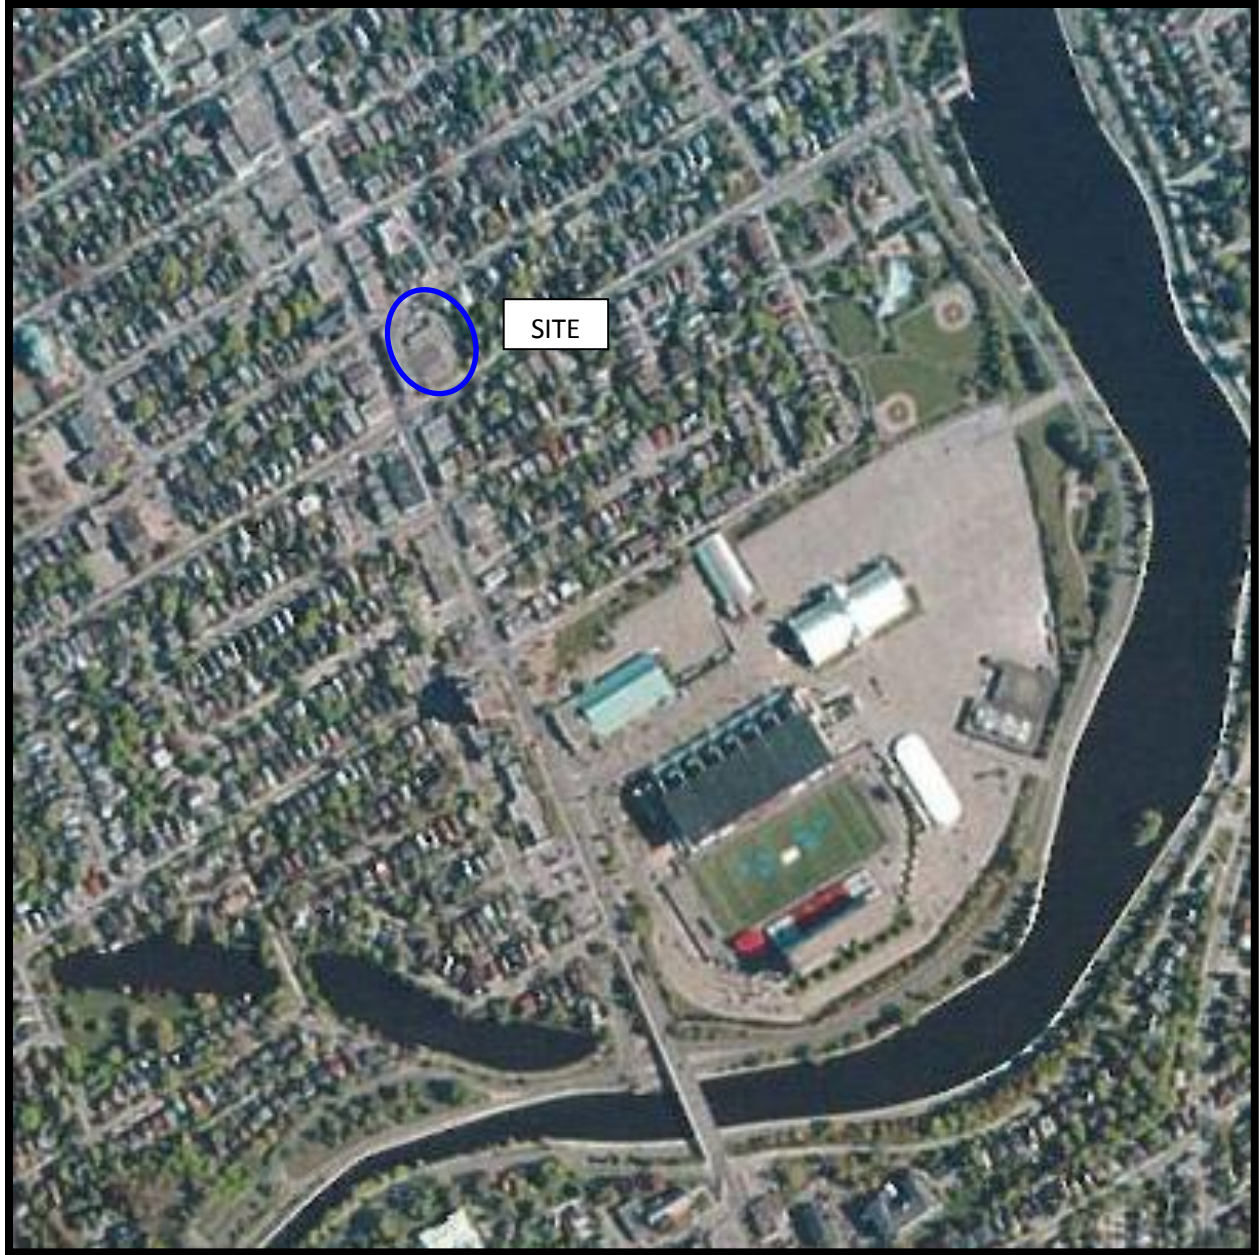
| 2002 | No significant changes were observed on the subject site or neighbouring properties. The property to the southwest no longer appears to be used as a retail fuel outlet. |

AERIAL PHOTOGRAPH
2002

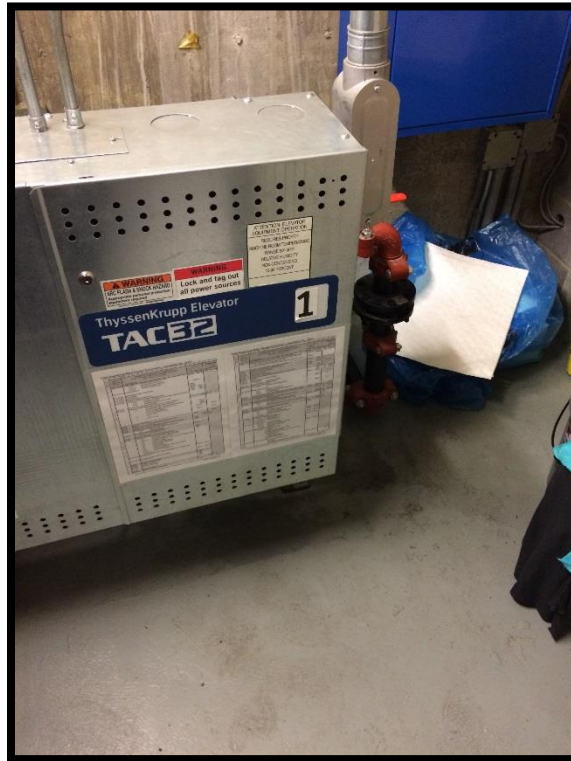
Photograph 7: Elevator control unit. No staining was noted.

No underground or aboveground storage tanks were noted on the property with the exception of a smaller tank used to hold the elevator's hydraulic fluid. The tank was located in the elevator control room located in the basement of the building. The tank appeared to be relatively new, and did not show signs of leaking.
