**Phase One Environmental
Site Assessment
Hillside Vista Walk Up Condominiums
(Blocks 1-5),
St, Joseph Boulevard and Tenth Line
Road, Ottawa, Ontario**

Phase One Environmental Site Assessment

Hillside Vista Walk Up Condominiums (Blocks 1-5),

St, Joseph Boulevard and Tenth Line Road, Ottawa, Ontario

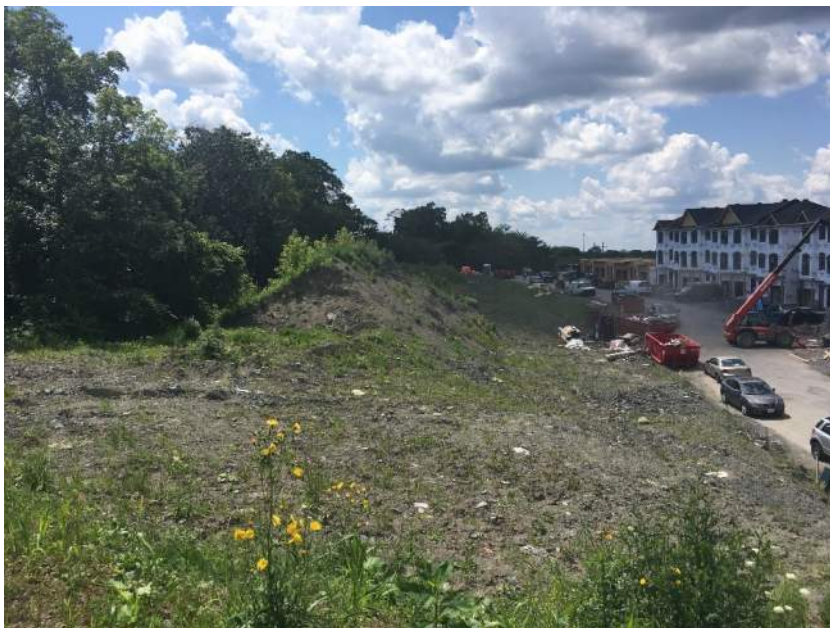
Photograph No. 1

Large amounts of fill were observed across the Site. The fill was observed to contain large boulders, gravel, soils and construction debris (concrete and rebar). The Site is similar in elevation to the property to the north however is approximately 6 m lower in elevation, when compared to the property to the south which is residential. The Site slopes slightly downwards towards the north. Significant amounts of fill materials were observed at the Site which represent an APEC (APEC 1).

View of Site facing west. Large fill piles can be seen among the length of the Site.

Notable amounts of fill material were observed at the Site. Based on the unknown quality of the fill and observation of construction debris within the fill, this represents an APEC (APEC 1).

The large amounts of fill materials were observed at the Site and represents an APEC (APEC 1).

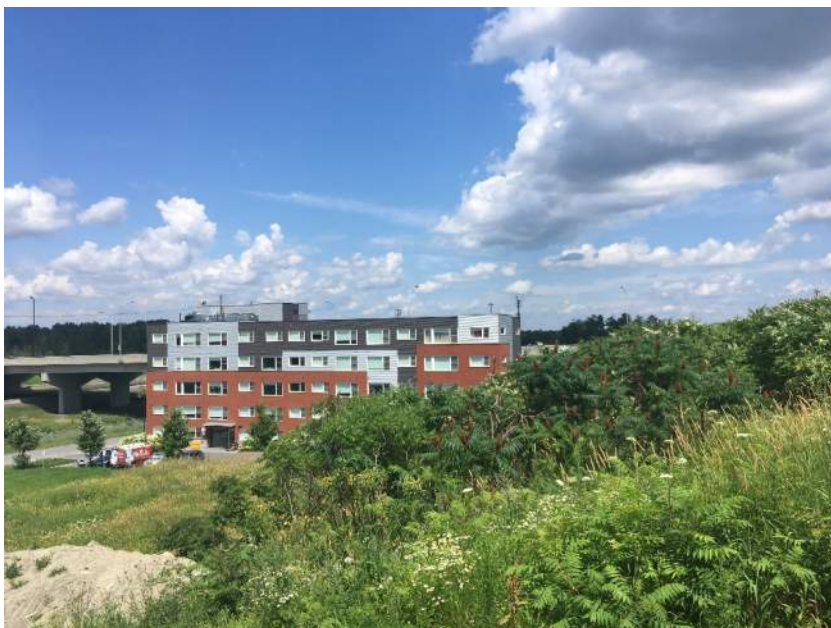
Photograph No. 2

A view of Site facing east.

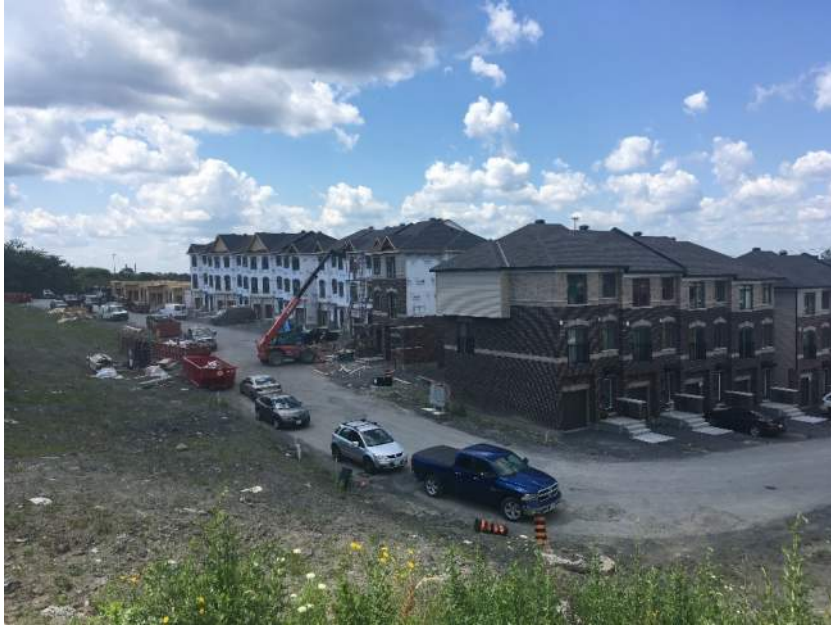
Photograph No. 3

View of the residential development to the north of the Site.

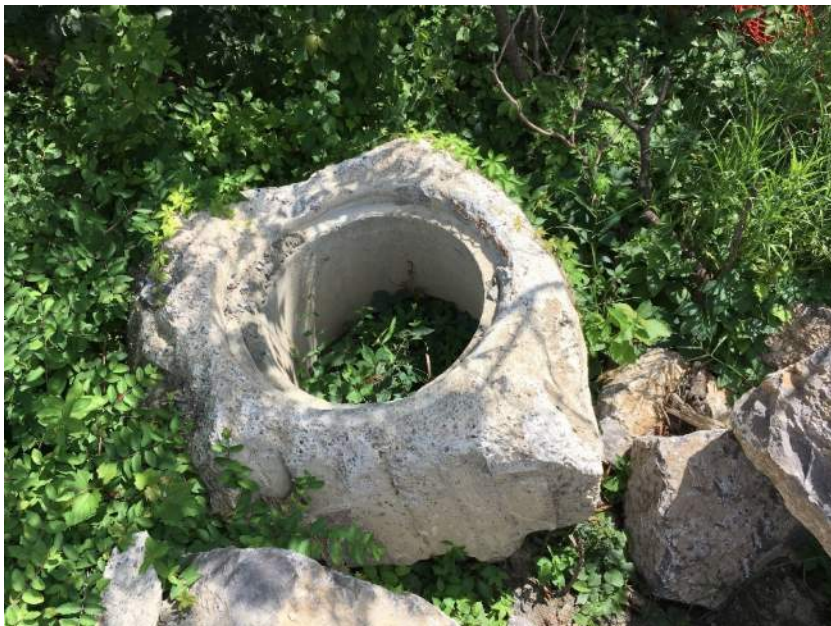
Photograph No. 4

No unidentified substances were observed on the Site at the time of the site visit. Concrete and other construction related debris was observed within the fill piles located on the Site.

Representative view of construction debris within fill piles.

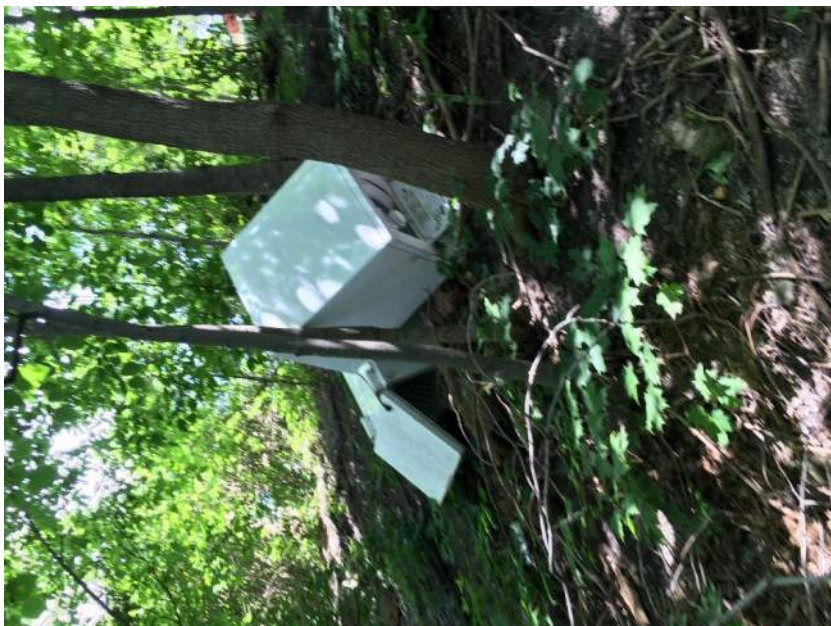
Photograph No. 5

View of old freezer and washing machine located in adjacent property to the north of the Site.

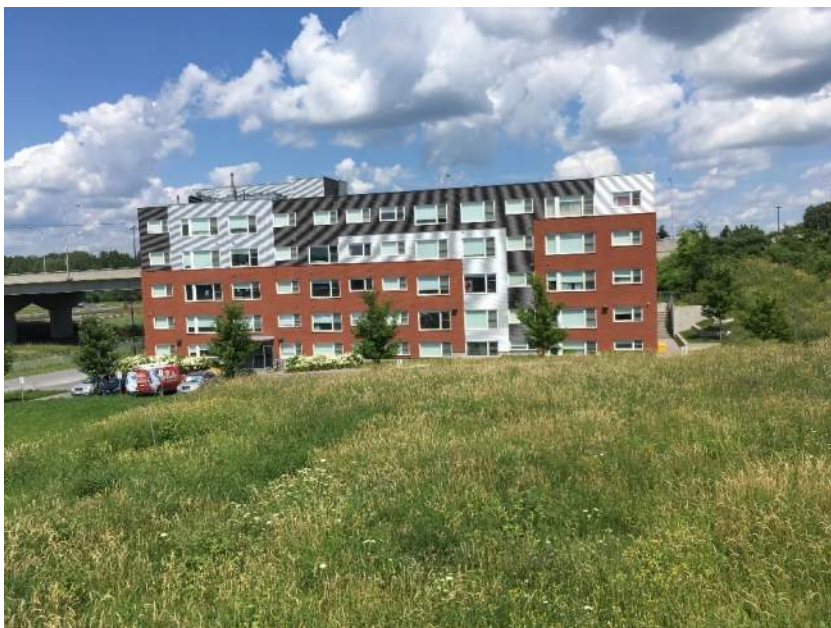
Photograph No. 6

View of multi-tenant residential structure located directly adjacent to the eastern boundary of the Site.

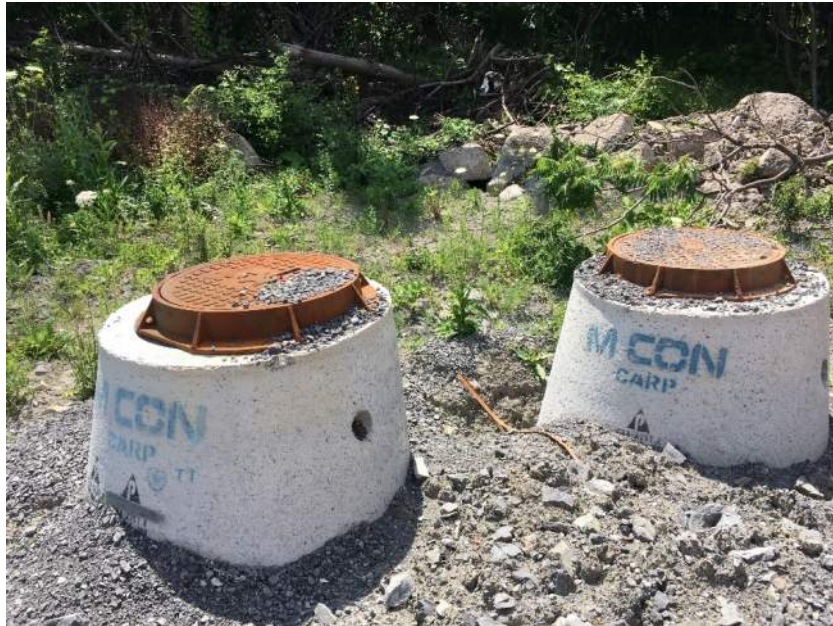
Photograph No. 7

Storm water sewers were observed to be present at the southern and western extents of the Site. As the Site is vacant, it is not currently serviced.

Representative view of storm water sewer located on the Site.
