**Phase I Environmental Site Assessment
Update**

151 Chapel Street
Ottawa, Ontario

Report: PE2930-LET.04

Subject: **Phase I - Environmental Site Assessment Update**
Vacant Lot – 151 Chapel Street
Ottawa, Ontario

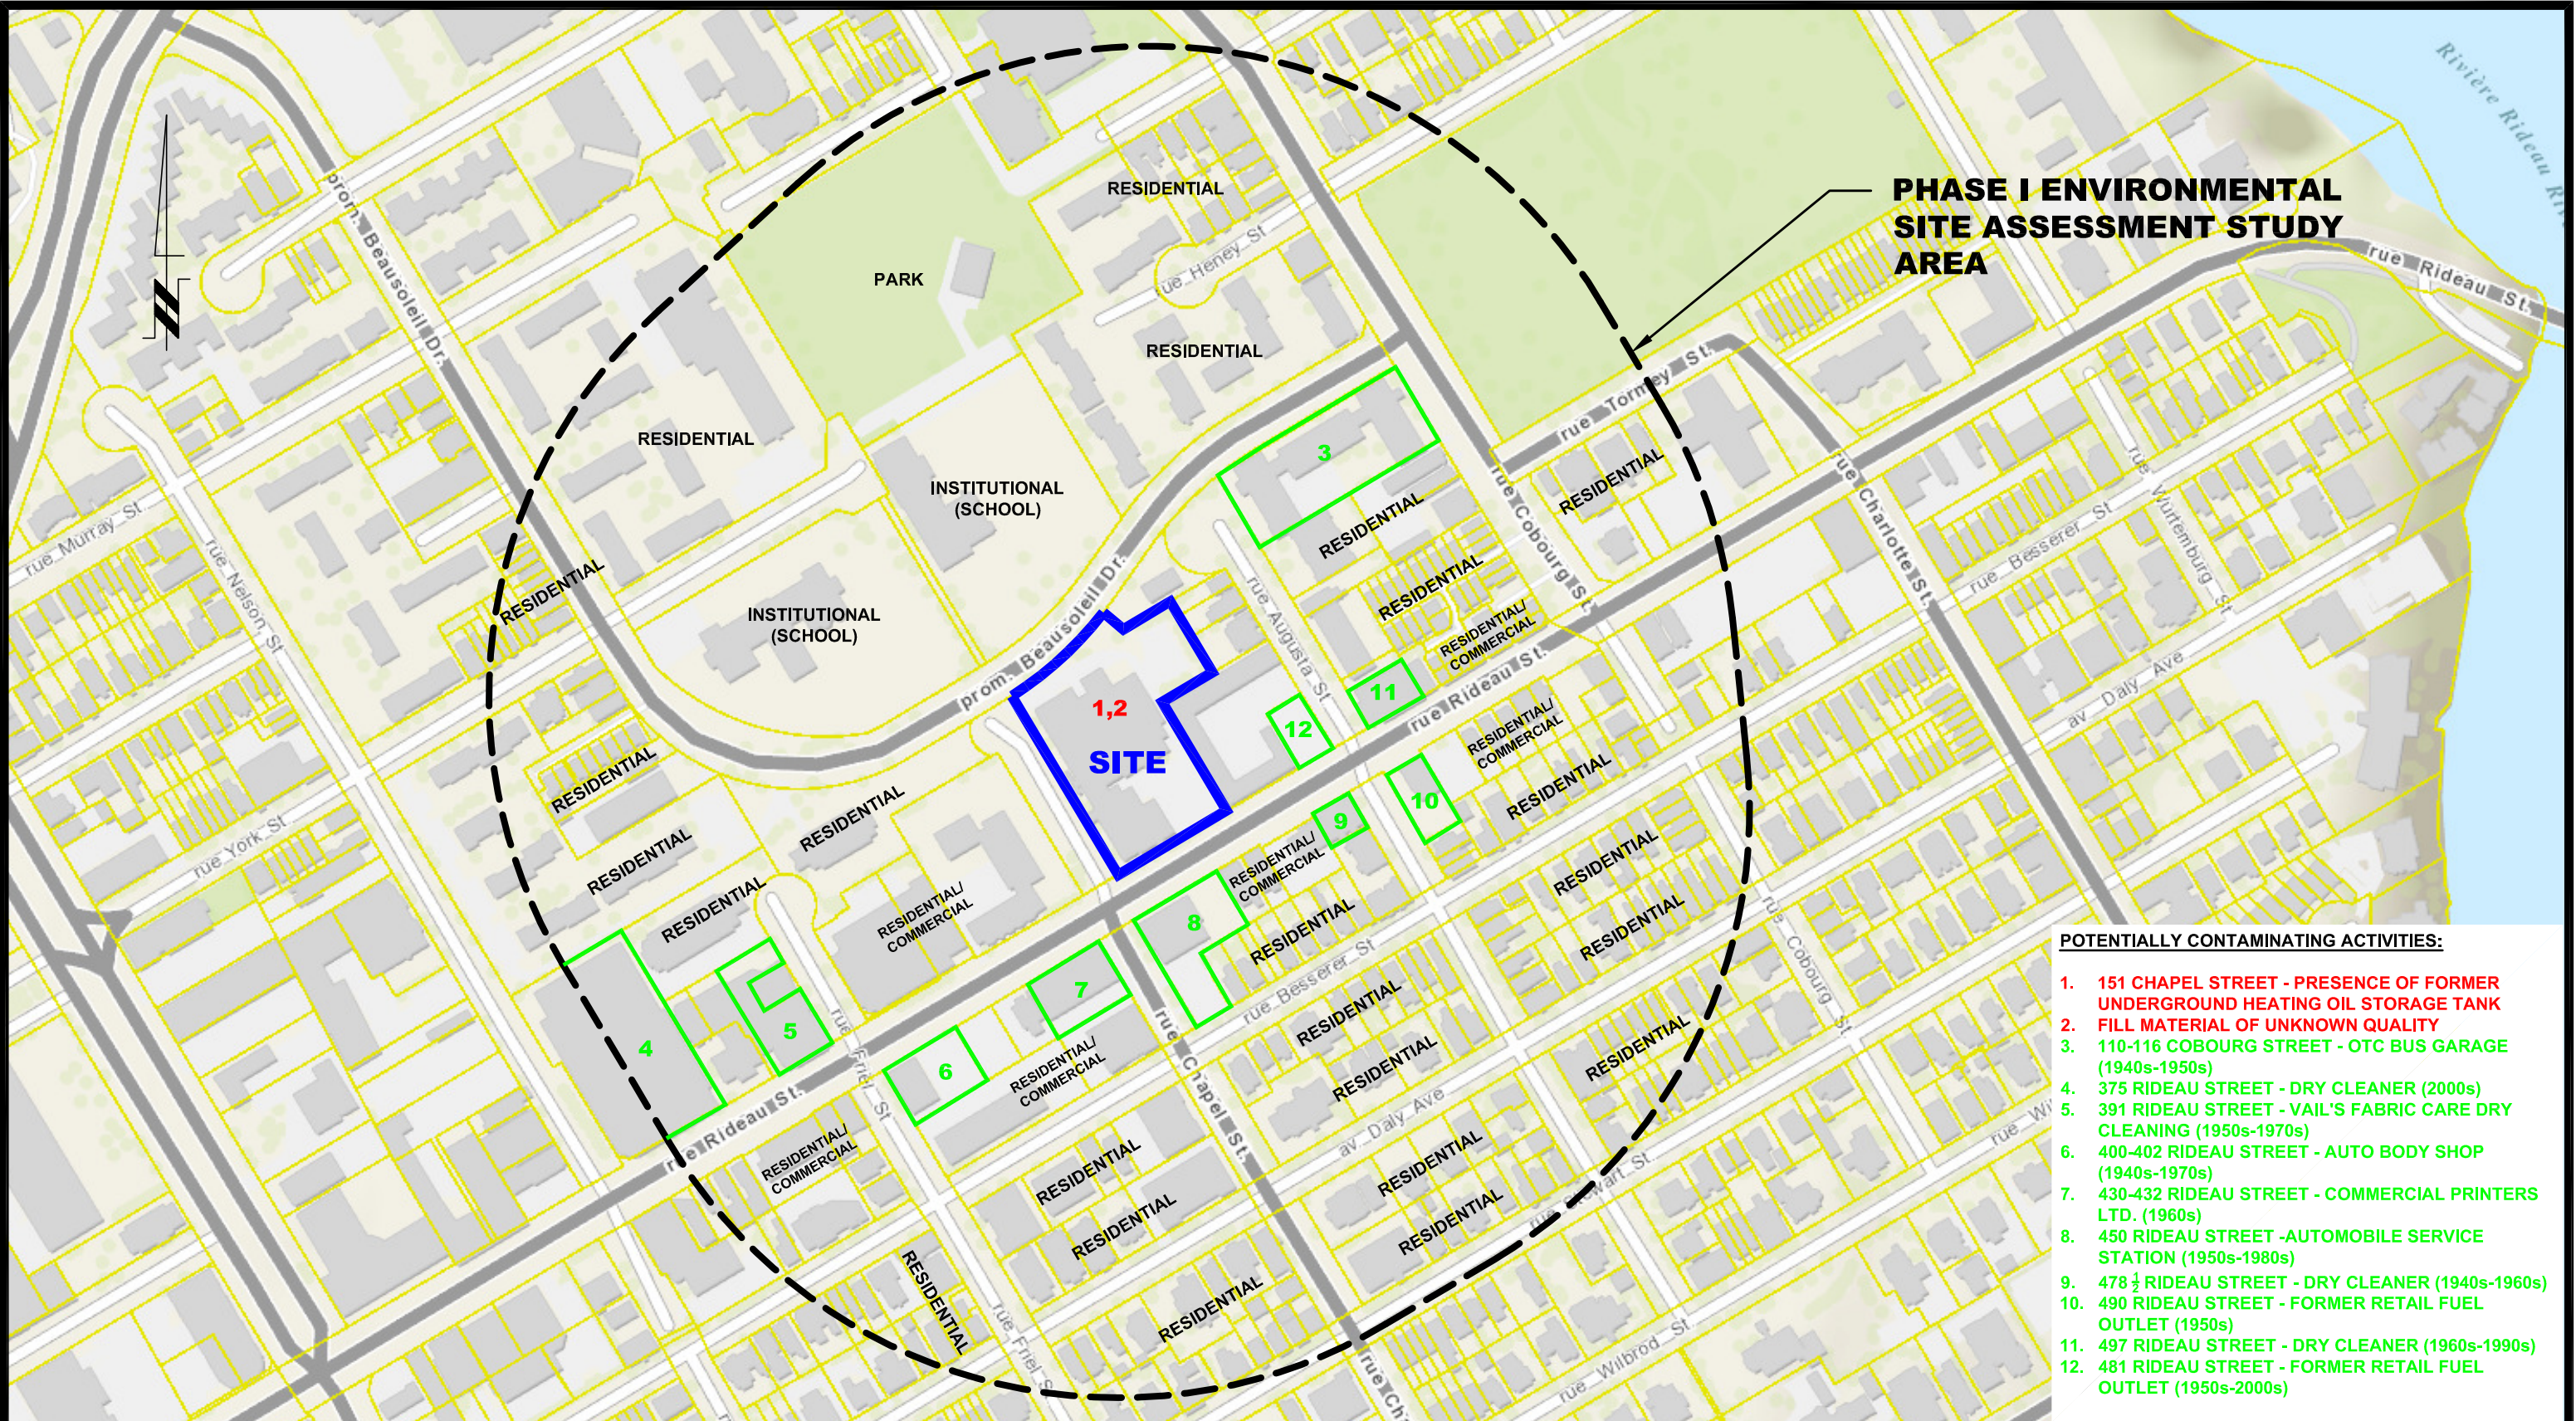
- POTENTIALLY CONTAMINATING ACTIVITIES:**
- 1. 151 CHAPEL STREET - PRESENCE OF FORMER UNDERGROUND HEATING OIL STORAGE TANK
 - 2. FILL MATERIAL OF UNKNOWN QUALITY
 - 3. 110-116 COBOURG STREET - OTC BUS GARAGE (1940s-1950s)
 - 4. 375 RIDEAU STREET - DRY CLEANER (2000s)
 - 5. 391 RIDEAU STREET - VAIL'S FABRIC CARE DRY CLEANING (1950s-1970s)
 - 6. 400-402 RIDEAU STREET - AUTO BODY SHOP (1940s-1970s)
 - 7. 430-432 RIDEAU STREET - COMMERCIAL PRINTERS LTD. (1960s)
 - 8. 450 RIDEAU STREET -AUTOMOBILE SERVICE STATION (1950s-1980s)
 - 9. 478 ½ RIDEAU STREET - DRY CLEANER (1940s-1960s)
 - 10. 490 RIDEAU STREET - FORMER RETAIL FUEL OUTLET (1950s)
 - 11. 497 RIDEAU STREET - DRY CLEANER (1960s-1990s)
 - 12. 481 RIDEAU STREET - FORMER RETAIL FUEL OUTLET (1950s-2000s)

There were no unidentified substances or stained snow observed on the subject site. The surrounding properties were also observed during the site visit and are shown on Drawing PE2930-11 – Surrounding Land Use Plan.

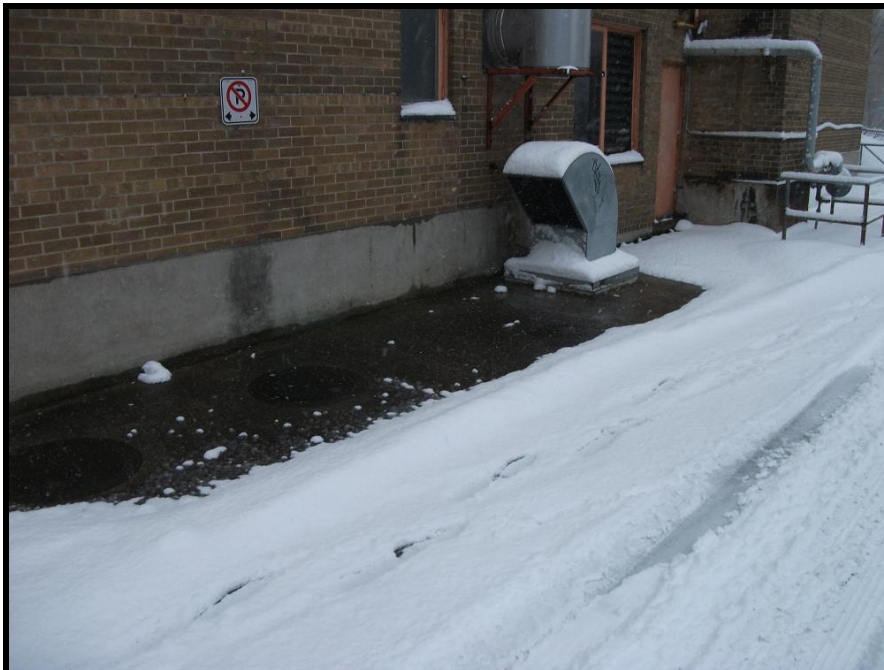
Photograph 2: Facing southwest, towards chimney and boiler room door, in approximate location of former tank.

The information obtained in this interview is consistent with site information obtained from other sources and is considered to be valid. It is noted that based on the results of the MOE FOI search, the tank may have been removed in 2001 at the time of the MOE Occurrence Report, although it is possible that the tank was drained in 2001 and removed later.
