## **1158 Second Line Road, Ottawa, Ontario**

### **Environmental Impact Assessment and Tree Conservation Report**

**CJB Environnement inc.**

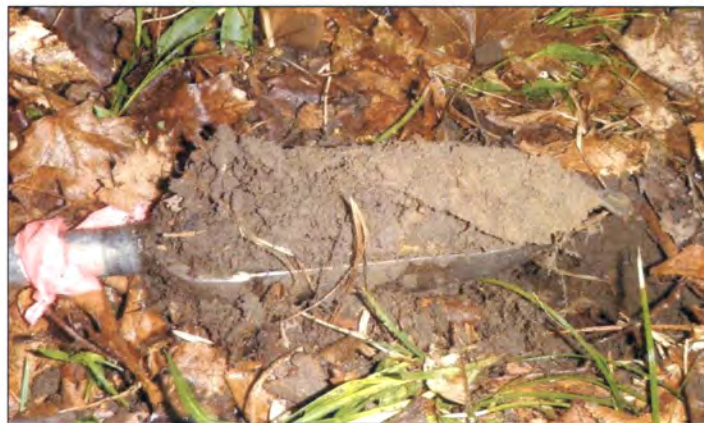
Photo 1

Using a soil auger, we executed one soil sampling on the vegetation plot #1 (SMH side, Figure 1). We observed a thin organic soil layer (< 1 cm) overlying a thicker sandy soil horizon (> 17 cm). This soil composition combined with the absence of mottle (i.e. spots of various colors or shades, often rusty brown) suggests that the site has relatively good drainage (Photo 1).

Soil sample (vegetation plot #1, Figure 1)

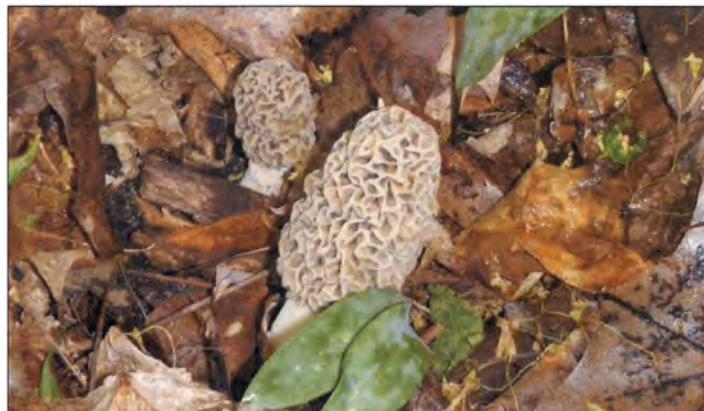
Photo 2

The finding of a colony of white morels (*Morchella esculenta*) on the site suggests that the soil is slightly alkaline (Photo 2).

White morel (*Morchella esculenta*)

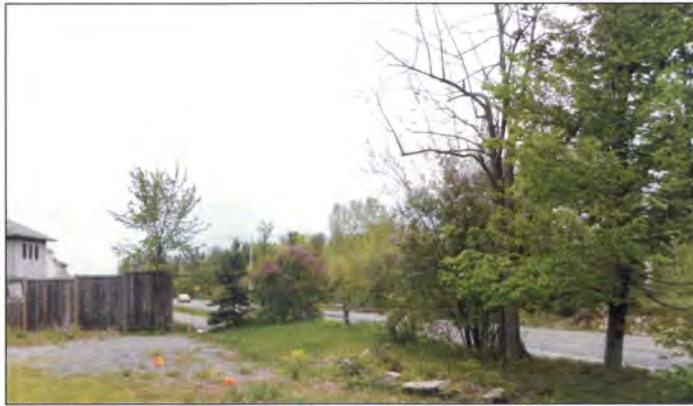
Photo 3

The first vegetation community is a typical residential lawn (grasses and forbs) of 0.11 ha containing a few isolated trees and shrubs. We observed a few common lilacs (*Syringa vulgaris*) and sugar maples (*Acer saccharum*) (Photo 3).

The edge of the residential lawn (Second Line Road behind)

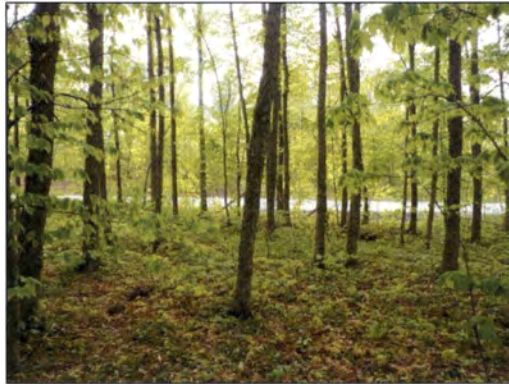
**Forest plot #1, southwest view  
Photo 4**

As its name suggests, the second vegetation community is a forest stand of 0.485 hectare largely dominated by native species such as the eastern hop-hornbeam (*Ostrya virginiana*) commonly known as Ironwood, and sugar maple (*A. saccharum*). American beech (*Fagus grandifolia*) and northern red oak (*Quercus rubra*) were also observed in this forest plot (Photo 4, 5, 6 and 7). Exploring this forest community, we also observed few individuals of bitternut hickory (*Carya cordiformis*) and white ash (*Fraxinus americana*). The complete statistical details (density and number of stem per hectare) of the forest plot #1 are in Table 1. According to Lee (2008), the abundance of ironwood suggests the presence of a highly managed forest or historically grazed site. Photo 6 suggests a certain level of forest management as brushwood, fallen dead branches and twigs are windrowed. In the North Kanata Environmental Management Plan (CH2Mhill Canada 2001), this forest underwent extensive logging. Consequently, trees are not over the range of 50 to 65 years old. The health condition of this forest stratum is generally good. A few individuals had dead branches or had ecological injuries probably caused by fungi, insect or woodpeckers looking for food (Photo 8 and 9). Some trees reach approximately 20 meters high. Table 1 and Photo 4 to 7 show, however, that the stand has many small trees.

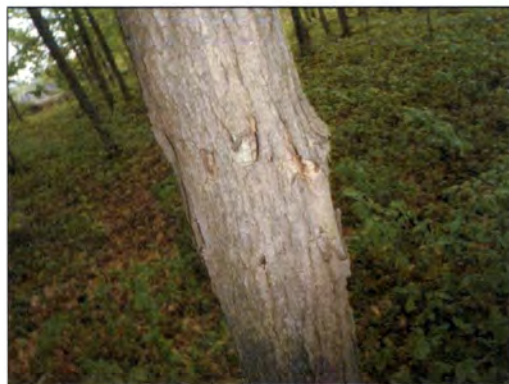
**Sugar maple, injured  
Photo 8**

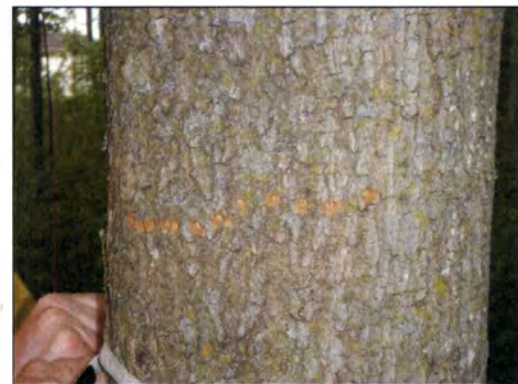
**Sugar maple, woodpecker injury  
Photo 9**

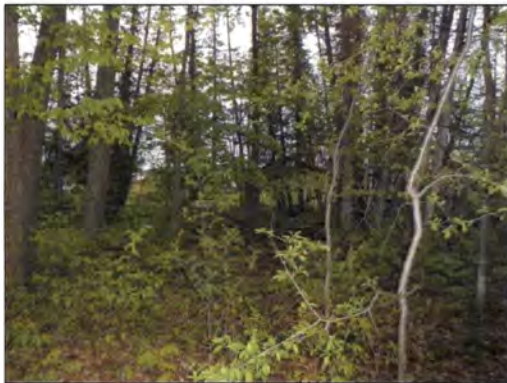
**Photo 10**

The third vegetation community is a forest stand of 0.467 hectares largely dominated by native sugar maple (*A. saccharum*) followed by secondary species such as the eastern hop-hornbeam (*O. virginiana*), basswood (*T. americana*), burr oak (*Quercus macrocarpa*), white ash, (*F. americana*), bitternut hickory (*Carya cordiformis*) and the northern red oak (*Q. rubra*). American beech (*Fagus grandifolia*), eastern white cedar (*Thuja occidentalis*), and eastern hop-hornbeam (*O. virginiana*) were also found (Photo 10, 11, 12 and 13). Exploring this forest community, we also observed a few white elms (*Ulmus americana*). The complete statistical details (density and number of stem per hectare) of forest plot #2 are given in Table 2. Photo 14 suggests a certain level of forest management in this forest segment as brushwood, fallen dead branches and twigs are windrowed. As mentioned earlier, CH2Mhill Canada (2001) suggests that this forest section underwent extensive logging. Consequently, trees are not over the range of 50 to 65 years old. The health condition of this forest stratum is not as good as the FODM5-9. Half of the individuals in the plot were not in good condition. These individuals were dead or had dead branches or had injuries probably caused by fungi, insects or birds such as woodpeckers (Photo 15). The tallest trees are approximately 18 meters high. Table 2 and Photo 10 to 13 show, however, that the stand has many small trees.

**Forest plot #2, northwest view**

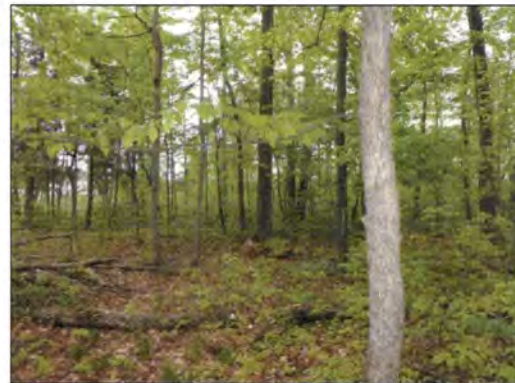
**Photo 11**

**Forest plot #2, southeast view**

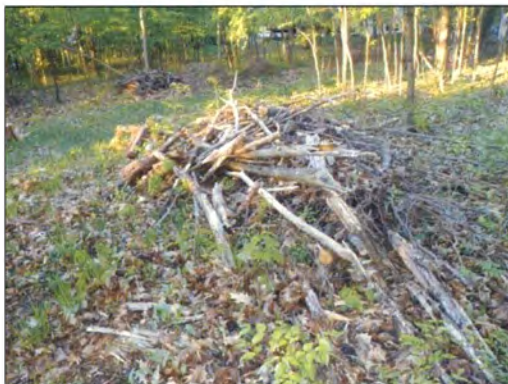
**Windrow**  
**Photo 14**

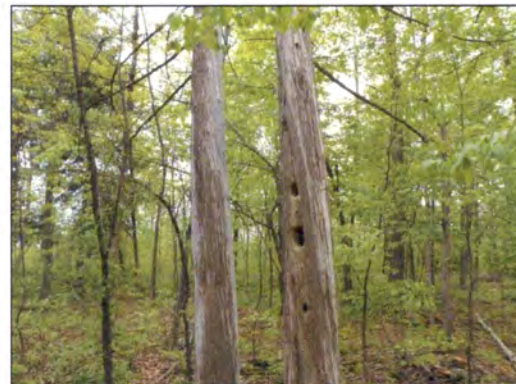
**Snag of eastern white cedar**  
**Photo 15**

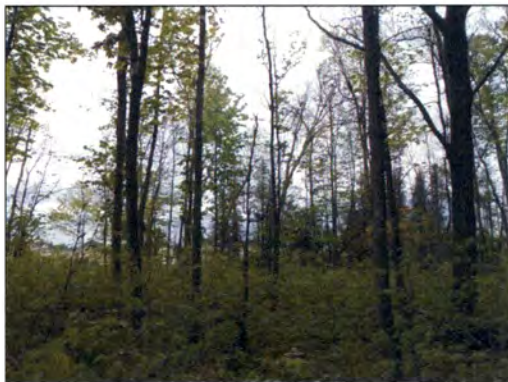
**Forest dieback**  
**Photo 16**

A small portion of this vegetation community (0.14 ha) was in very bad condition. This stand is located at the northern section of the study site (Figure 1). Indeed, this forest section has several snags (i.e. standing leafless trees) probably caused by a significant natural stress agent (e.g.: lack of water, insects, fungi, etc.) (Photo 18). We were not able to identify the cause of this forest dieback. We observed, however, dying sugar maple, white ash, and some aspen (*Populus* spp.). The forest regeneration of this section was well established with the Eastern hop-hornbeam (*O. virginiana*) dominating the vegetation cover (60%) followed by the white ash (25%), the European buckthorn (*Rhamnus cathartica*) (5%), and minor species such as the bitternut hickory (*Carya cordiformis*) and the black cherry (*Prunus serotina*).

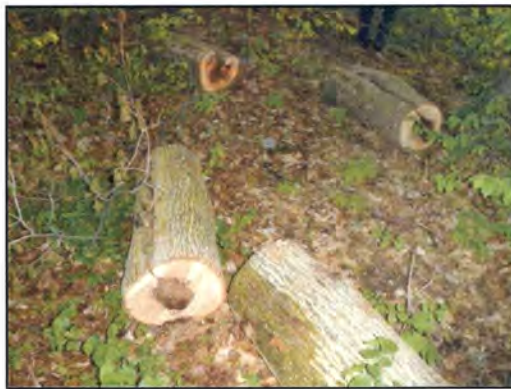
We also observed isolated non vigorous and snags of white ash on the property. Some of these snags were cut (Photo 17) while others were still standing (Photo 18). The cause of their death is unconfirmed.

Snag of white ash cedar cut down  
Photo 17

1. All ash species found on the site should be cut immediately in order to avoid the study site becoming a possible source of infestation by the emerald ash borer;

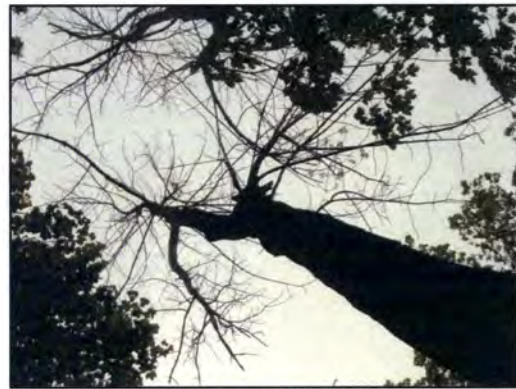
Snag of white ash standing  
Photo 18

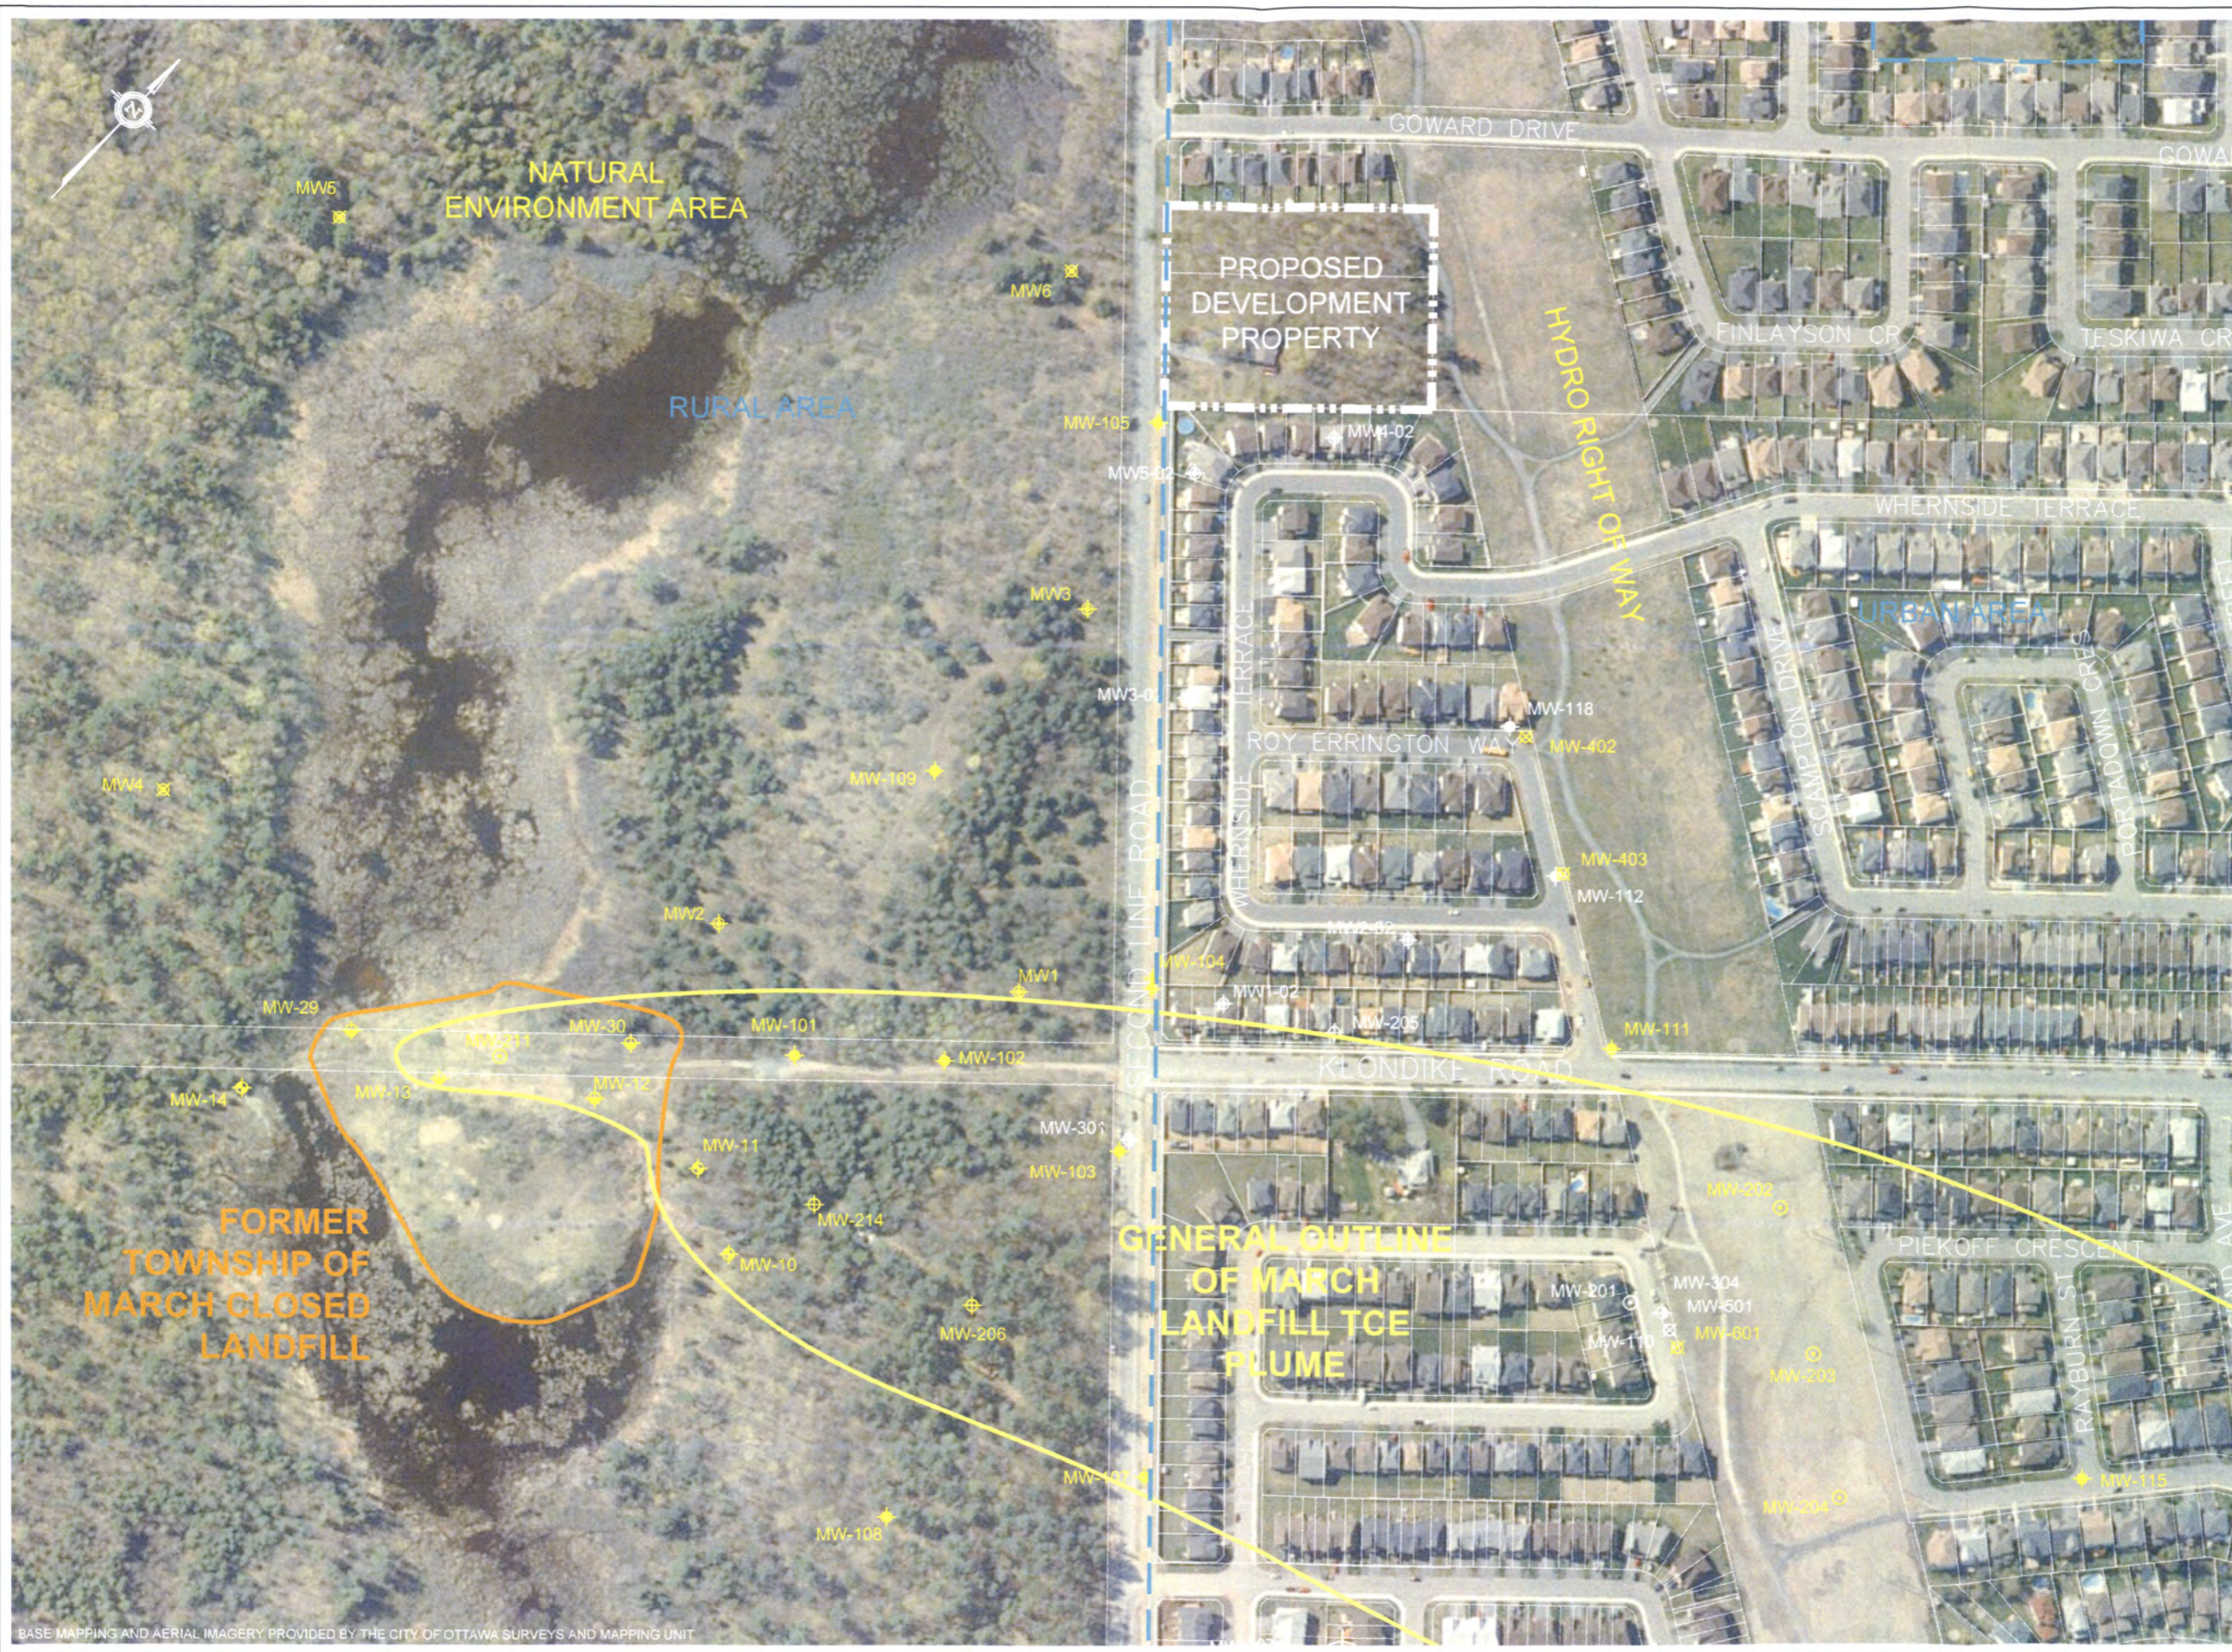
Attachment (1)  
Figure 1 – Site Plan

Groundwater in the vicinity of March Landfill has been impacted by PHC, PAH and VOC, the latter consisting primarily of TCE and related degradation products. Impacts by PHC and PAH are confined to the immediate area of the landfill. TCE groundwater impacts extend beyond the landfill and have been delineated over a distance of 1.5 kilometres and a maximum width of approximately 350 metres migrating in the sandstone bedrock. The TCE plume has been the subject of continuous monitoring since 2000. The migration of the TCE plume has been well documented in annual reports prepared by AMEC on behalf of the City of Ottawa. These data indicate the TCE plume to be migrating to the east-northeast.
