## **Phase I Environmental Site Assessment**

879 River Road  
Ottawa, Ontario

**January 24, 2018**

Report: PE4201-1

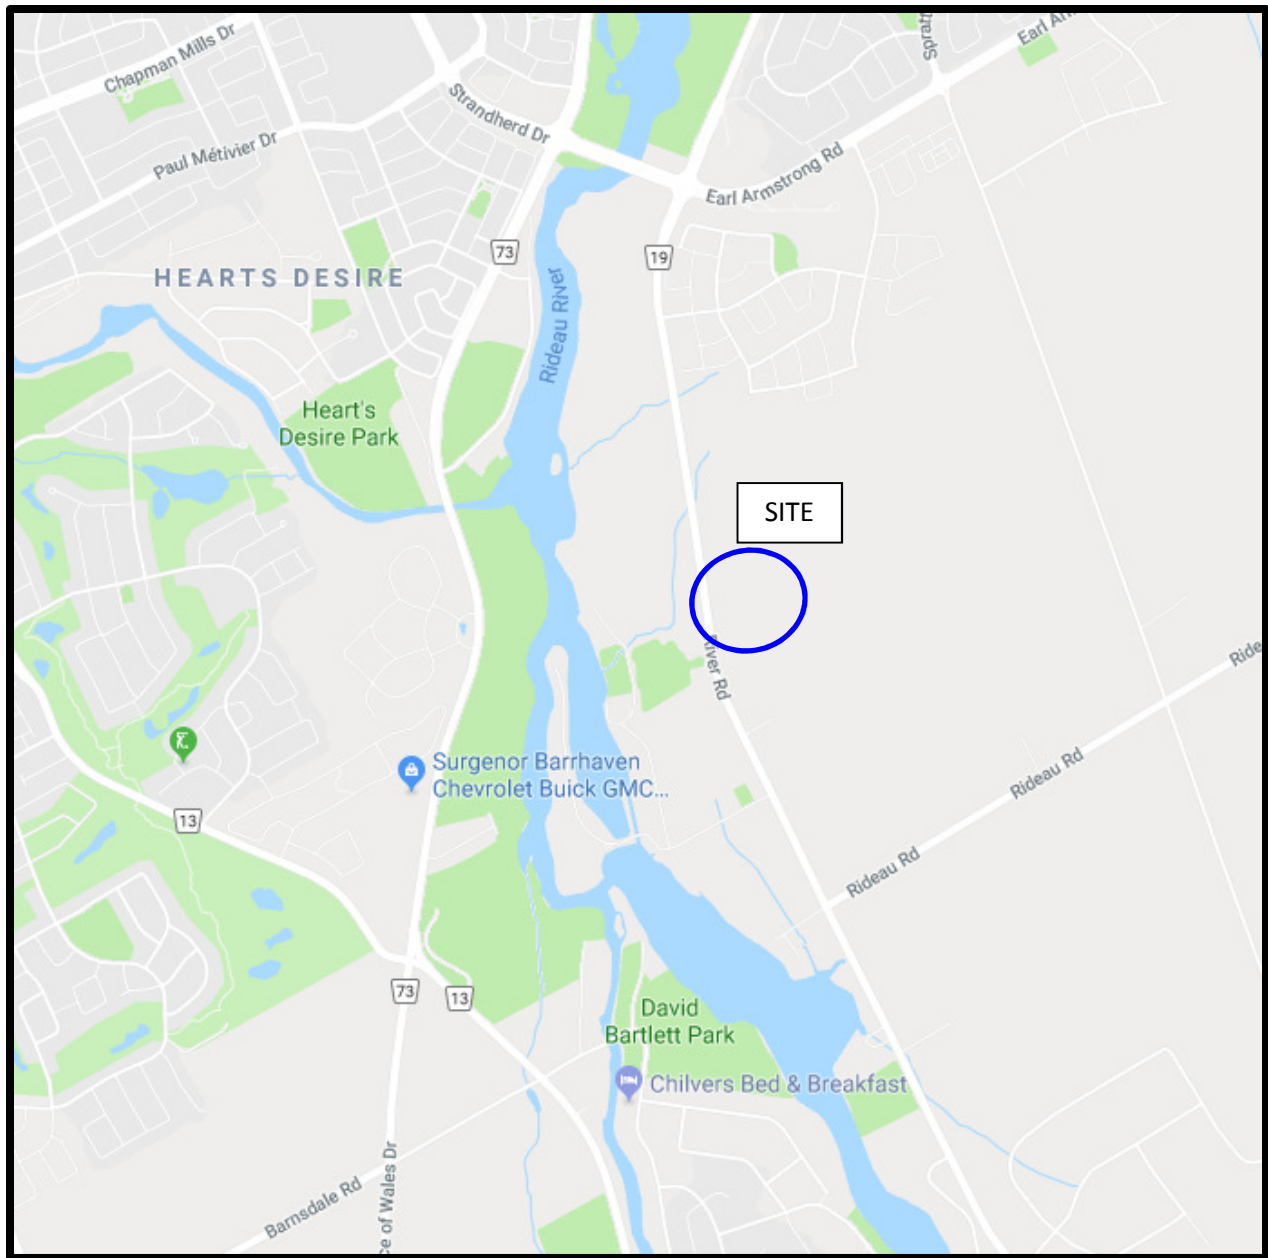
FIGURE 1  
KEY PLAN

Address:	879 River Road, City of Ottawa.
Legal Description:	Part of Lot 23, Broken Front Concession (Rideau Front), Geographic Township of Gloucester, City of Ottawa.
Location:	The subject site is located on the east side of River Road, between Rideau Road and Summerhill Street. The subject site is shown on Figure 1 - Key Plan following the body of this report.

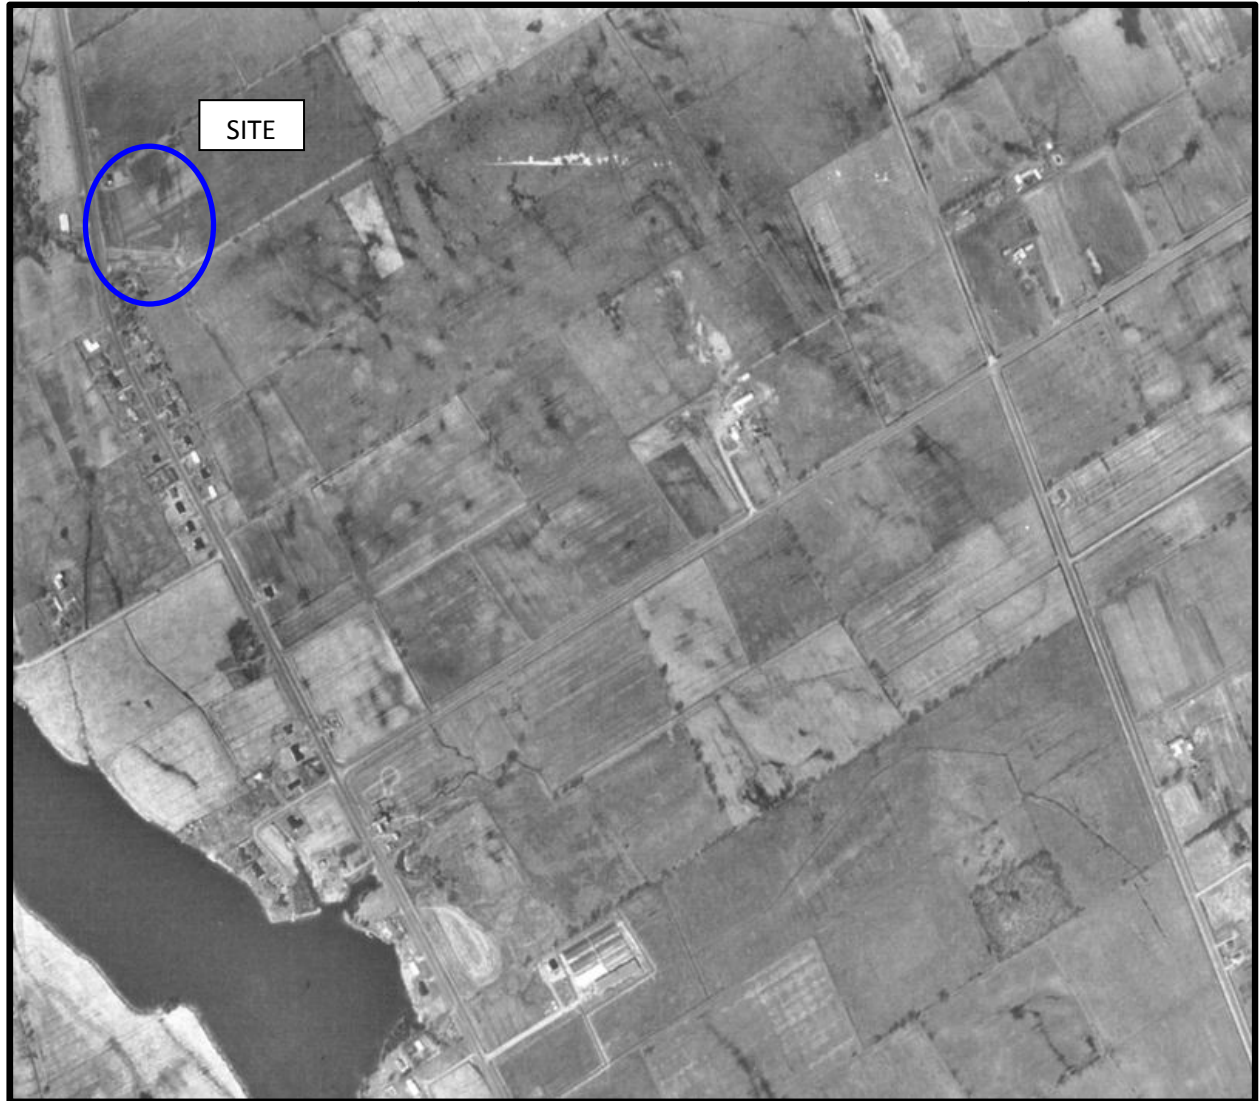
AERIAL PHOTOGRAPH  
1973

| 1973 | No changes appear to have been made to the subject site. The surrounding properties to the north, east, and west do not appear to have changed significantly, although a barn structure is visible to the west, across River Road. Residential dwellings have been constructed to the south of the subject property, on either side of River Road. |

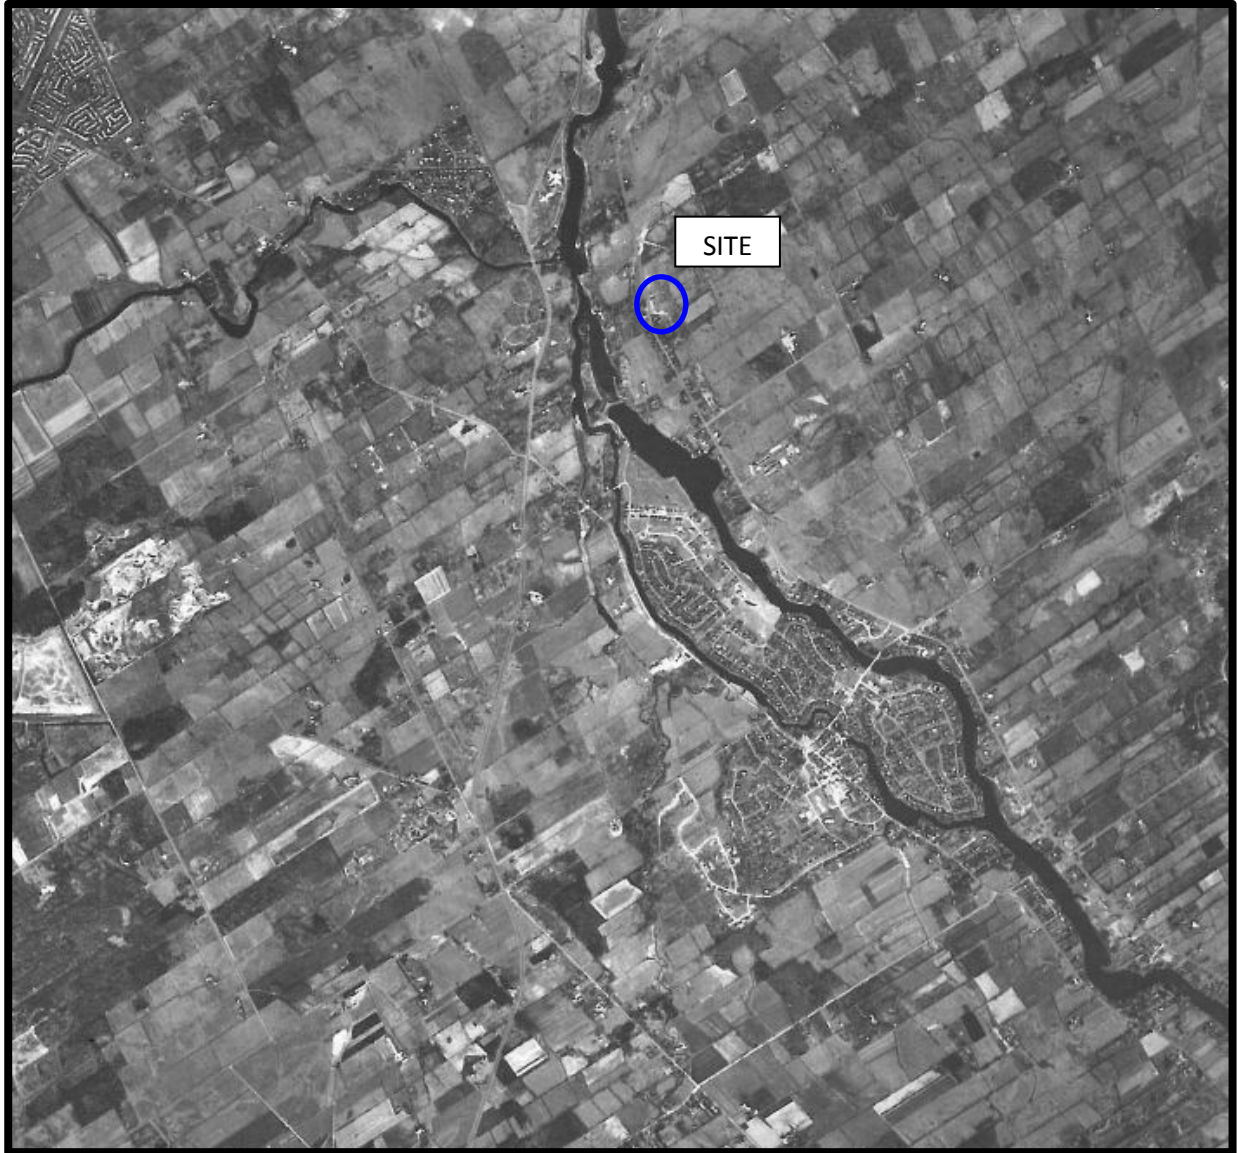
AERIAL PHOTOGRAPH  
1983

| 1983 | (Poor scale) The ground surface of the western side of the subject site appears to have been disturbed. No significant changes appear to have been made to surrounding properties. |

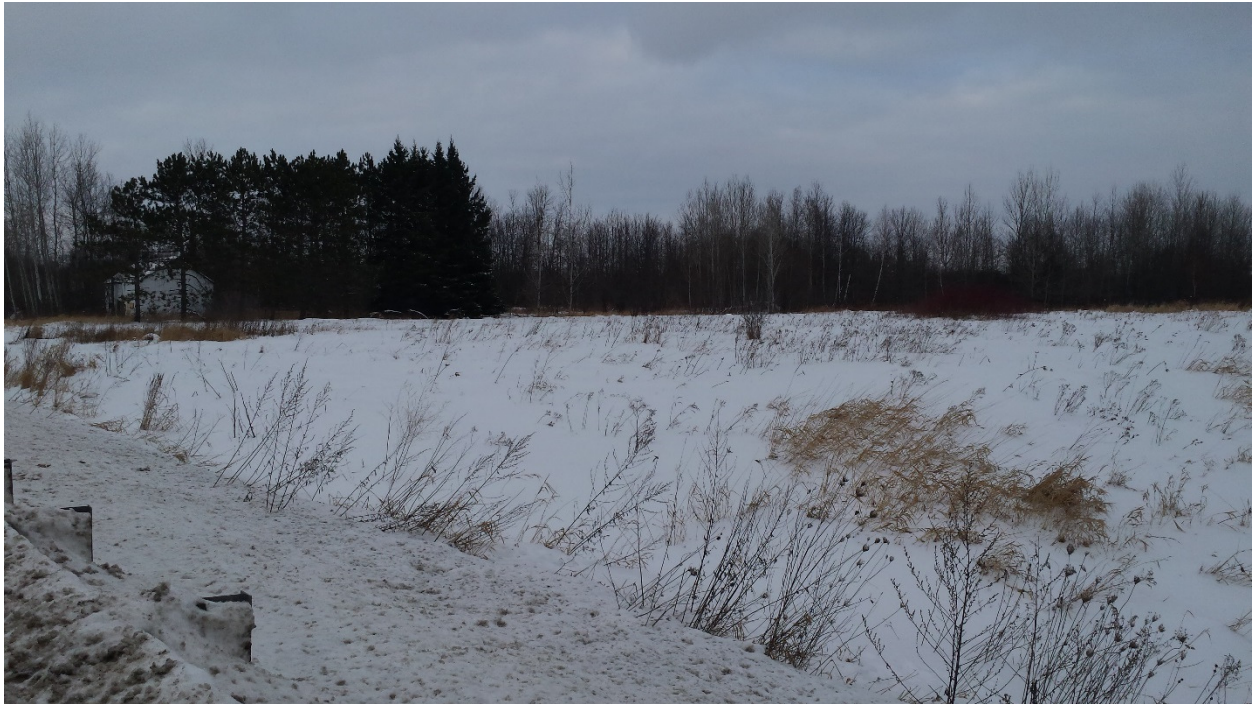
Photograph 1: View of the subject site from River Road, looking northeast. The barn on the subject site is visible at left.

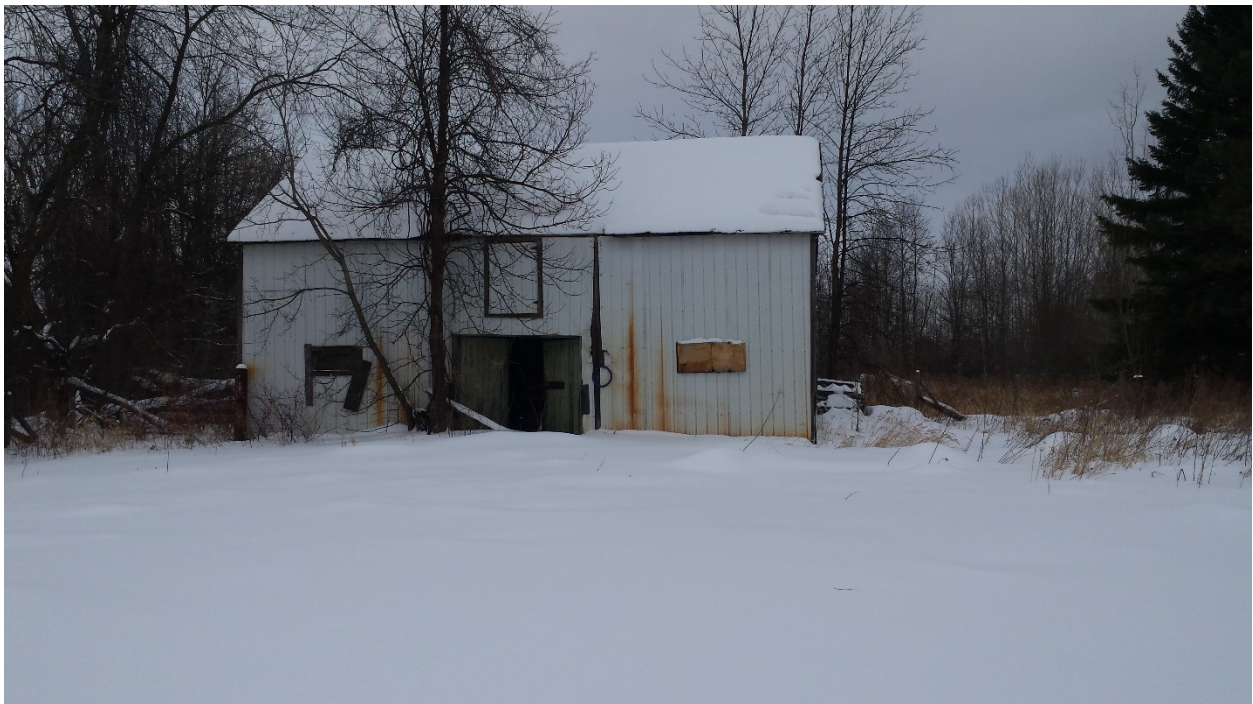
There is one barn structure on the subject site. No other buildings or structures are present on the subject site. The barn is constructed of wood and metal siding, and has a sloped roof. The barn interior contained lumber, other old building supplies, empty containers and bags, and a push lawn mower. No concerns were identified in the interior of the barn.

Photograph 2: View of the barn in the northwest corner of the subject site, looking east.

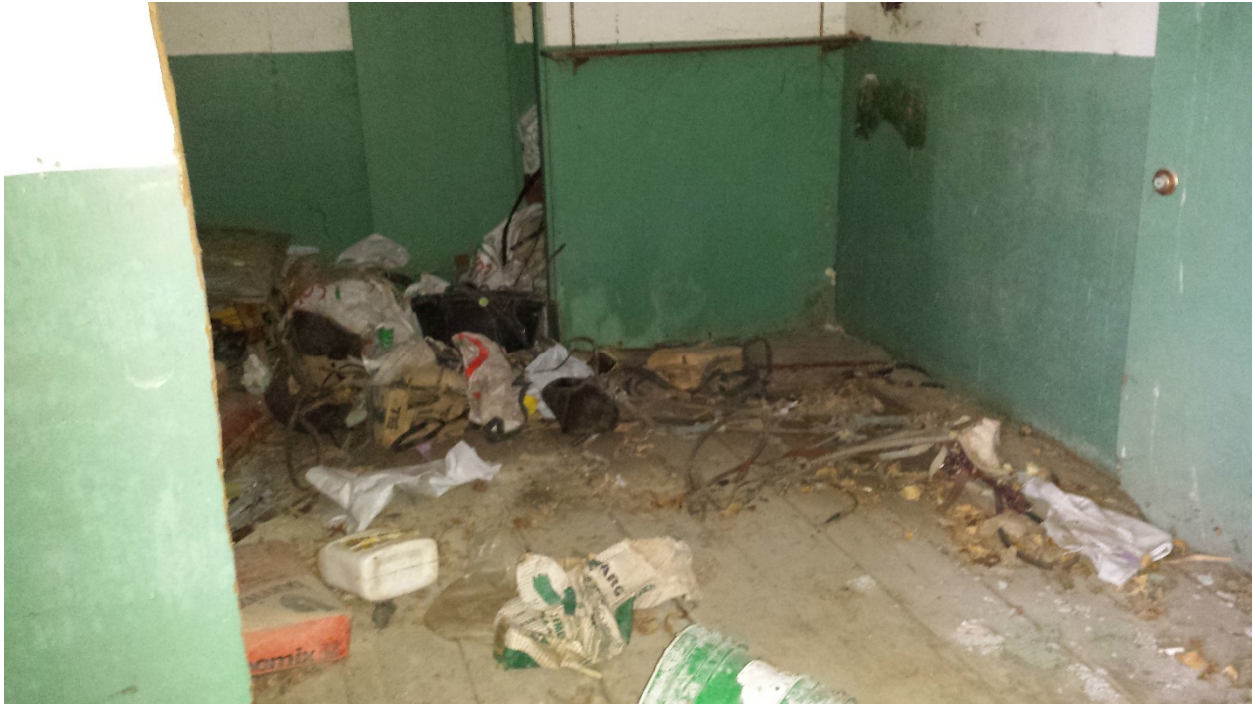
Photograph 3: Interior view of the barn structure.

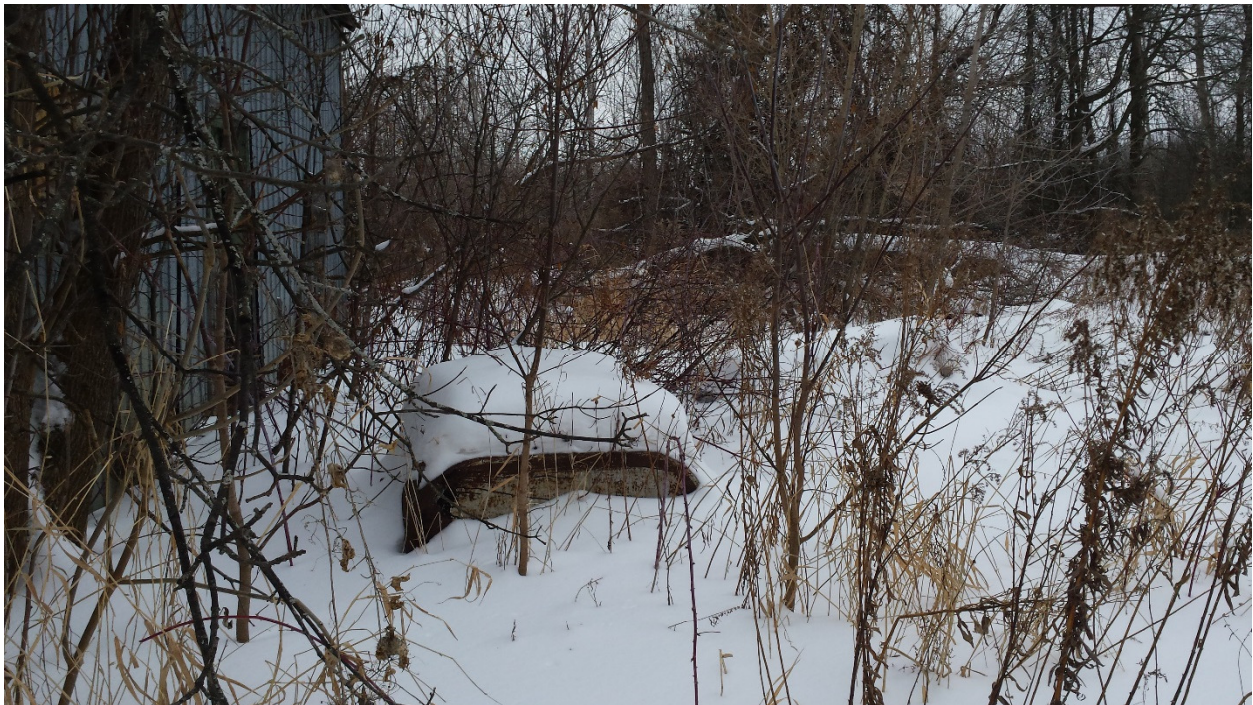
One unused storage tank was observed at the rear of the barn structure. Due to the snow coverage on the site, it was not possible to observe the ground surface in the area of the tank. However, the tank appeared to be empty and to have been discarded at the location, rather than to have been in use at the location. Furthermore, a borehole from the geotechnical program was placed beside the tank and no indication of any contamination was observed. The presence of this fuel tank is not considered to pose an environmental concern, and is not considered to be a potentially contaminating activity.

Photograph 4: View of the fuel storage tank at the rear of the barn structure.
