99 FIFTH AVENUE PROPOSED REDEVELOPMENT
HERITAGE CONSIDERATIONS REVIEW

The proponent proposes a redevelopment at the rear of the 99 Fifth Avenue property. The purpose of this Heritage Considerations Review is to observe the potential impact of the proposed development on the older commercial buildings located at 819-843 Bank Street, at the early stage of concept design development (zoning amendment application). It also includes a historical overview highlighting the role of the building within its surroundings and a brief summary of the building's perceived heritage value. The heritage observations are exclusively limited to potential measures intended to enhance the responsiveness of the proposed development relative to the existing street frontage (819-843 Bank Street); it does not consider the impact on the broader neighbourhood. At the time of this report's preparation, the street frontage possesses no OHA Part IV designation, however the buildings are identified on the City of Ottawa Heritage Registry. In addition, the subject property is located within a context that is not within a heritage conservation district designated under OHA Part V.

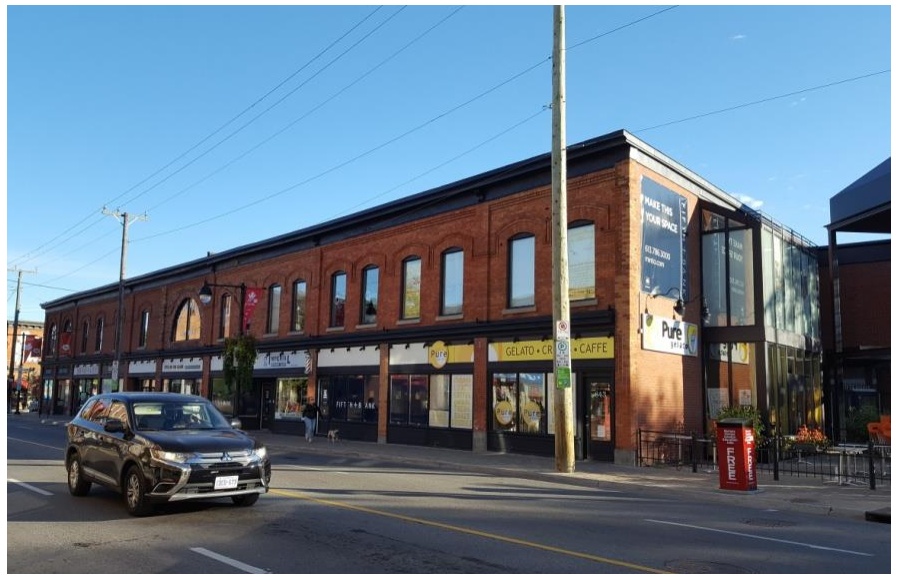
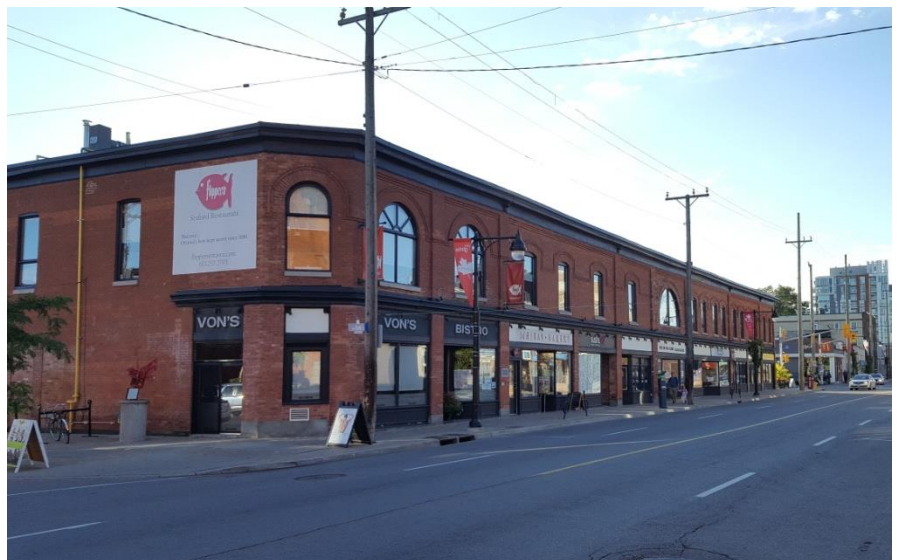
819-843 BANK STREET:

MIDDLE Looking north-east towards the Bank Street front of the pre-existing 1896-1909 buildings within the subject block.

BOTTOM Looking south-east along the Bank Street frontage of the subject property.

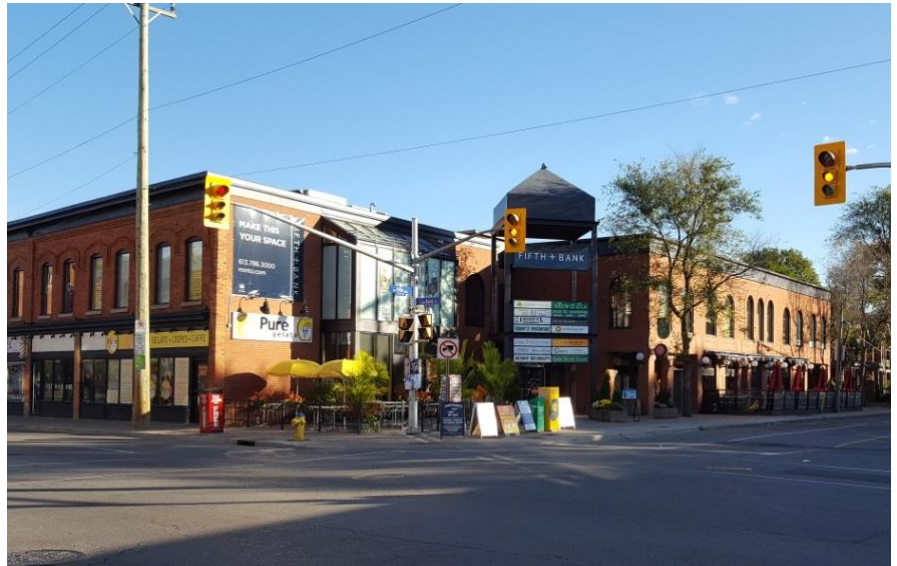
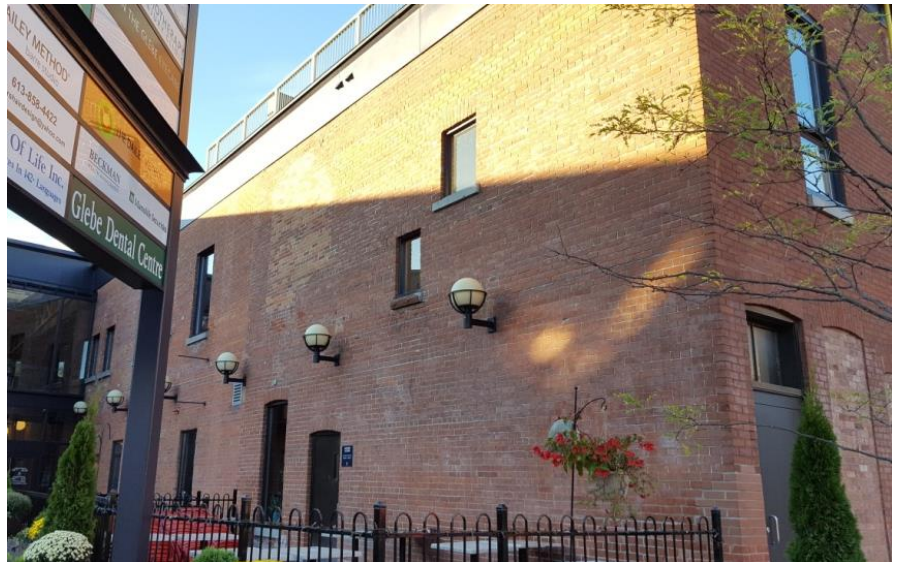
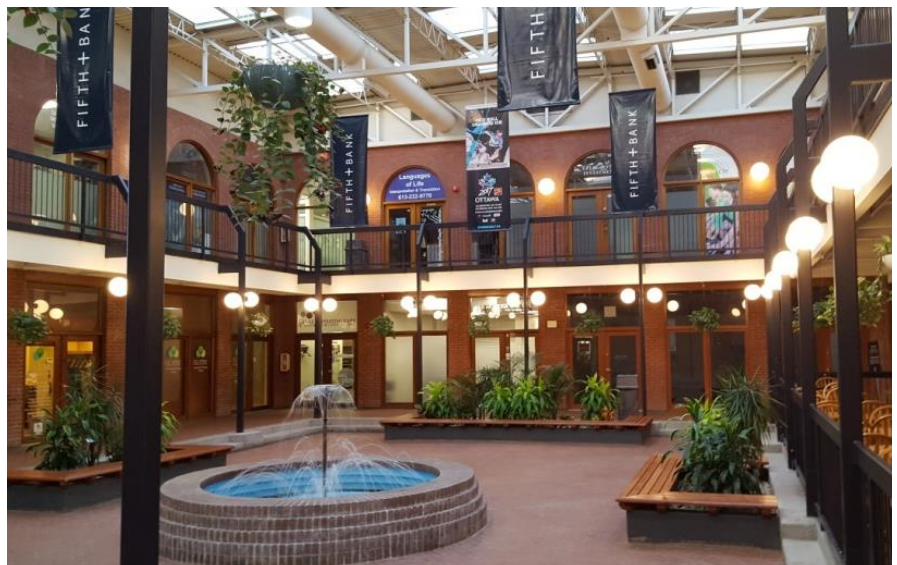
819-843 BANK STREET:

TOP Highlighting the corner of Bank Street and Fifth Avenue and the relationship between the early 20th c. buildings and 1980s addition (centre & right).

MIDDLE Highlighting the exposed rear of the northern portion of the street-fronting buildings (from 4th Avenue).

BOTTOM Interior courtyard is part of the 1980s renovation/ addition (all 1980s buildings shown).

The proposed development includes the removal of the existing 1980s rear addition and interior courtyard. This removal will require the brickwork along the rear of the historic buildings to revert back to exterior exposure across central portion of this elevation. As part of this work, existing openings will be replaced with windows or infilled with brick as required by the adjacent new use. The balance of the rear elevation at the north and south extents will be directly abutted by the proposed development. The portion of the rear elevation that will become exterior will front onto a proposed outdoor amenity space. Refer to the included floor plans below (ground and second floors) to better understand the placement of the proposed development relative to existing, along the rear elevation.

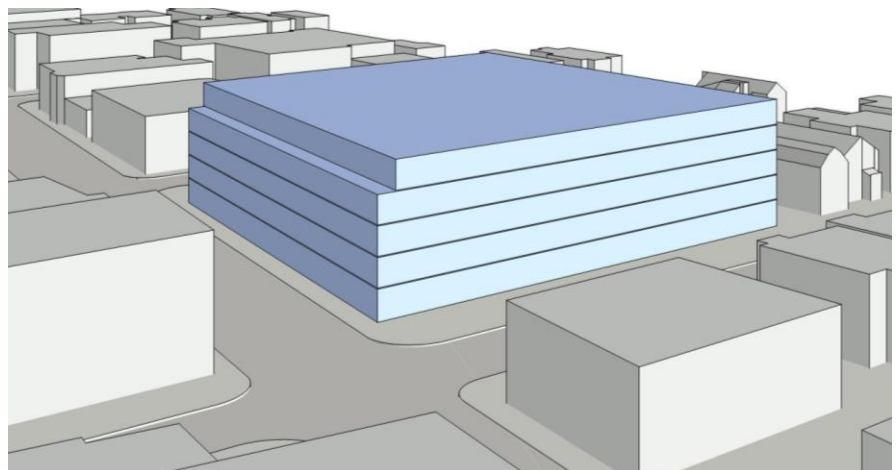
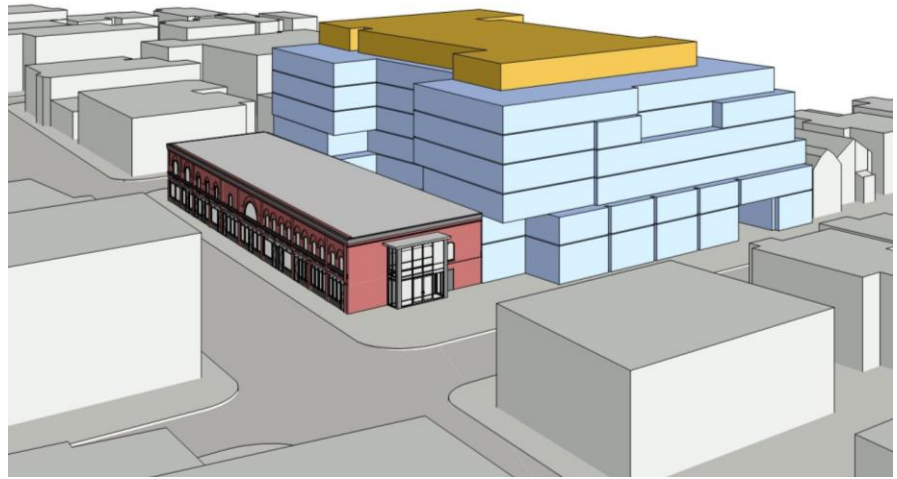
BOTTOM Aerial perspective showing the 5-storey “as-of-right” development (156,000 sq.ft.) approach. TACT Architecture

TOP Aerial perspective showing the Proposed Massing and Articulation of As of Right and Redistribution Development Potential (7 Stories) approach. *TACT Architecture*

As part of the early design concept development from the proponent’s proposal, the allowable development potential was reviewed. This option included redeveloping the entire parcel of land including the removal of the street-fronting buildings, which would be allowed “As-of-Right.”

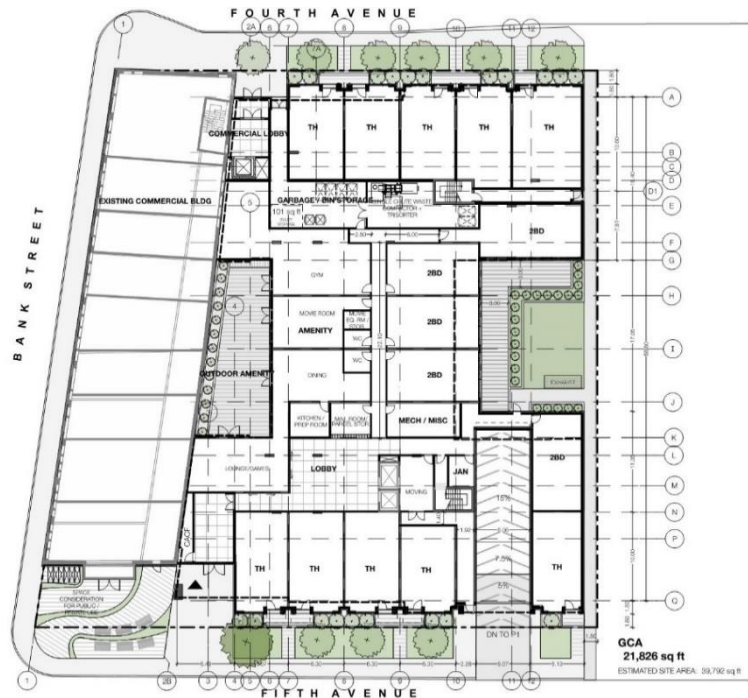
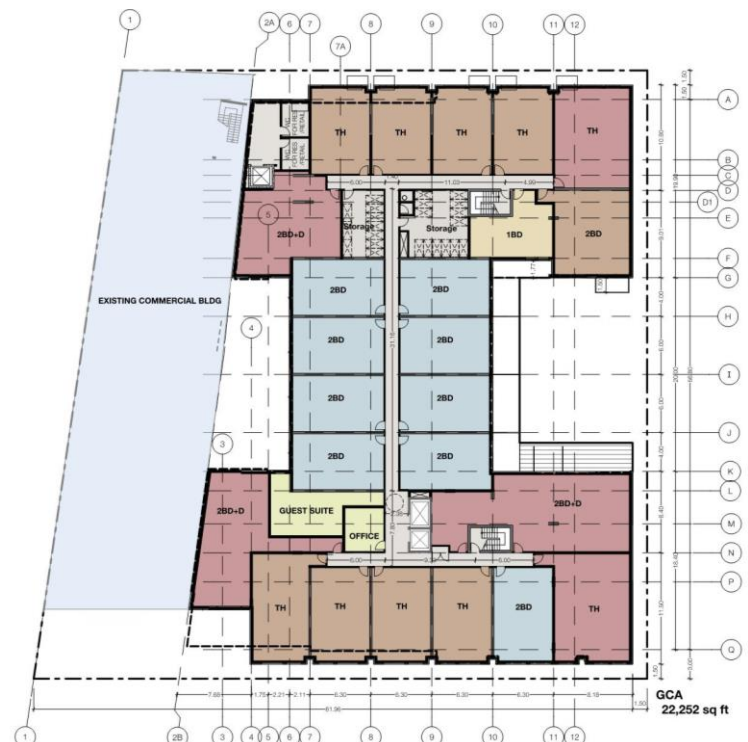
TOP Ground floor plan showing the position of the retained building and new portion. *TACT Architecture*

BOTTOM Second floor plan showing the position of the retained building and new portion. *TACT Architecture*

In order to provide access to the upper floor of the existing Bank Street frontage, a new elevator is planned at the north end of the proposed building, along with a dedicated commercial lobby. Based on the provided plans, the elevator is separate from the existing structure, a good conservation strategy.

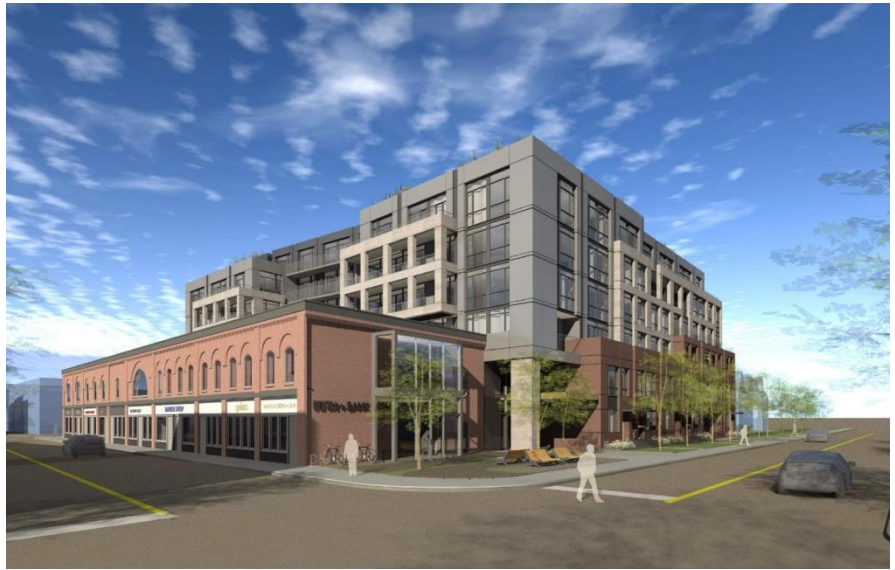
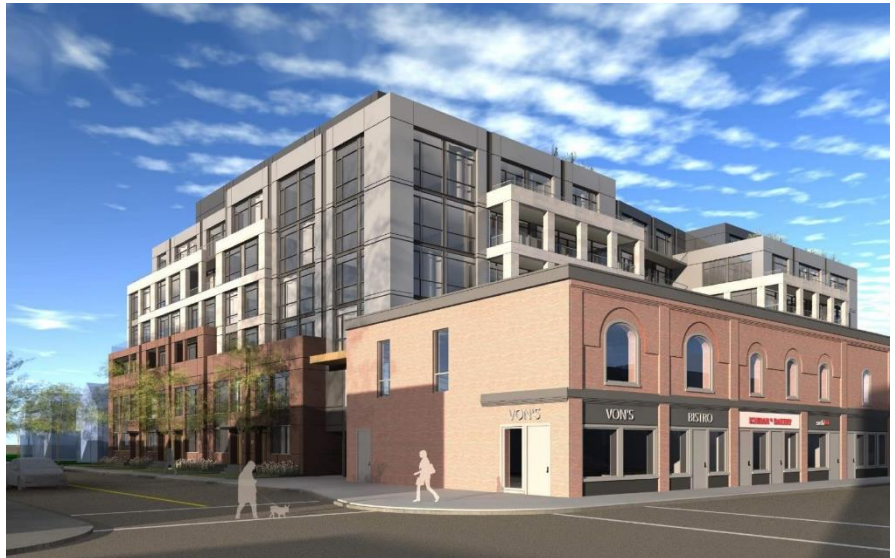
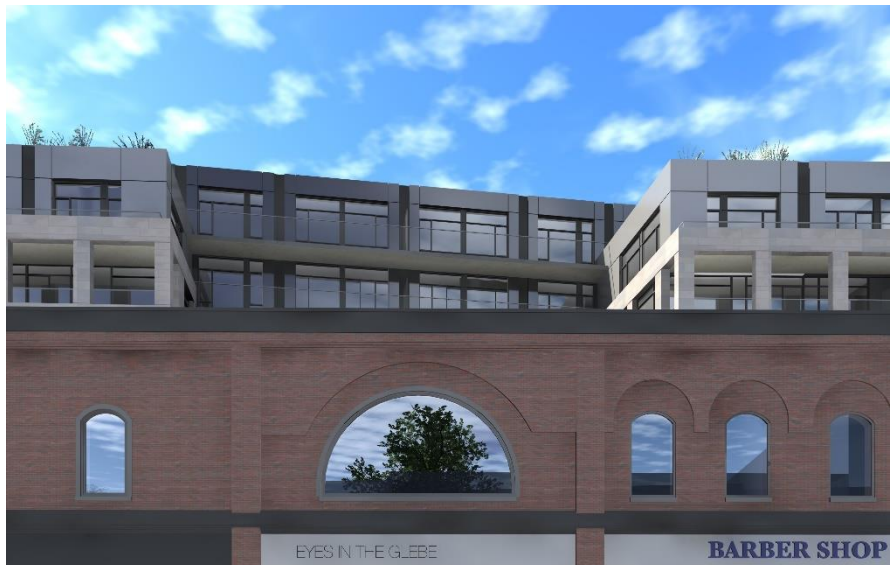
TOP Looking northeast at the corner of Bank Street and Fifth Avenue. *TACT Architecture*

MIDDLE Looking southeast at the corner of Bank Street and Fourth Avenue. Traditional residential homes on 4th are shown at left. *TACT Architecture*

BOTTOM Looking towards the proposed development from the west side of Bank Street. *TACT Architecture*

1. Portions of the upper two-three storeys appear to be visible from within the immediate context of the development. The visibility of additional floors is highest at the corners of Fourth and Fifth Avenues. However, as a viewer moves away from the proposed development, the visibility diminishes due to the distance of the 7-storey mass back from Bank Street. It should be noted that the reduction in height and quieting of the architecture of the west elevation featured within the current proposal have enhanced the relationship between the proposed development and the heritage register-listed frontage.

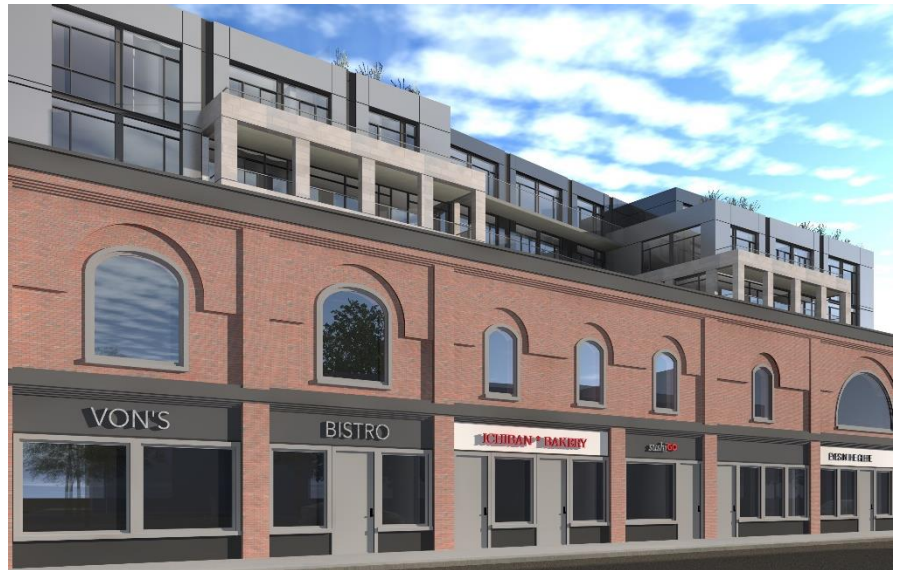
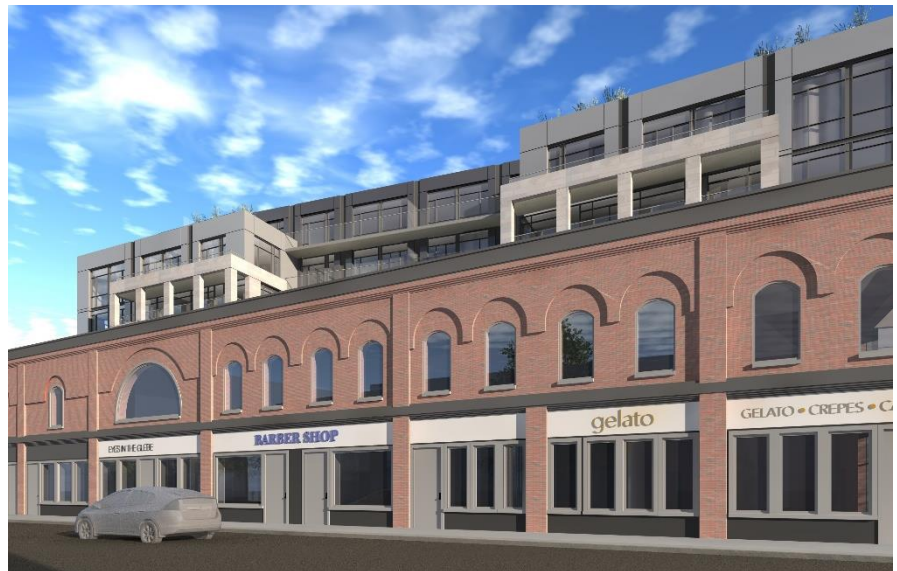
TOP View of the proposed development behind the heritage register-listed frontage looking southeast on Bank Street. *TACT Architecture*

BOTTOM View of the proposed development behind the heritage register-listed frontage looking northeast on Bank Street. *TACT Architecture*

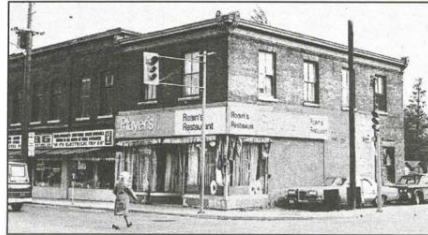
841 - 845 Bank Street in 1974

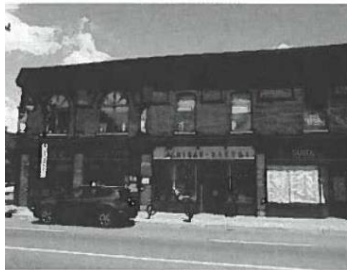
819-843, rue Bank St

Large red brick commercial building ample display space on ground floor. Brick pilasters, round arch windows, projecting cornice, brick stringcourse and voussoirs enhance facade.
