**Phase I Environmental Site Assessment**

Vacant Property  
Quinn's Point – Stage 2  
Ottawa, Ontario

Minto Communities Inc.

Report: PE4246-1

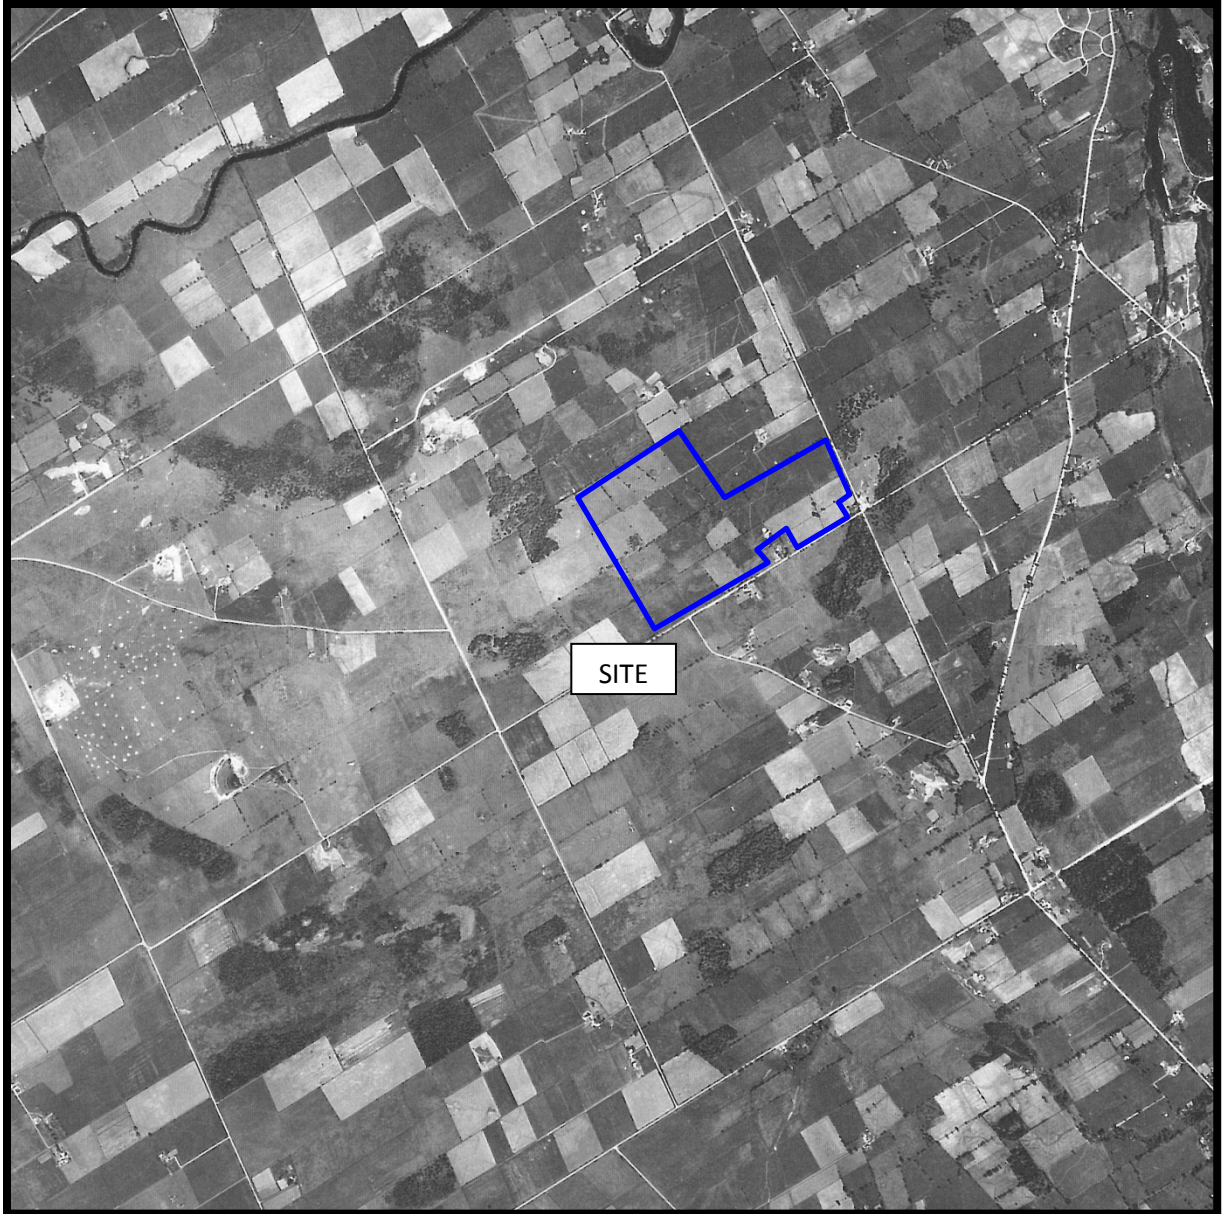
AERIAL PHOTOGRAPH  
1959

| 1959 | The subject property is vacant agricultural fields. A barn appears to be present on the south part of the site, to the north of a farmstead addressed 3818 Barnsdale Road. Surrounding properties are agricultural fields and farmsteads, with Greenbank Road visible to the east and Barnsdale Road to the south. |

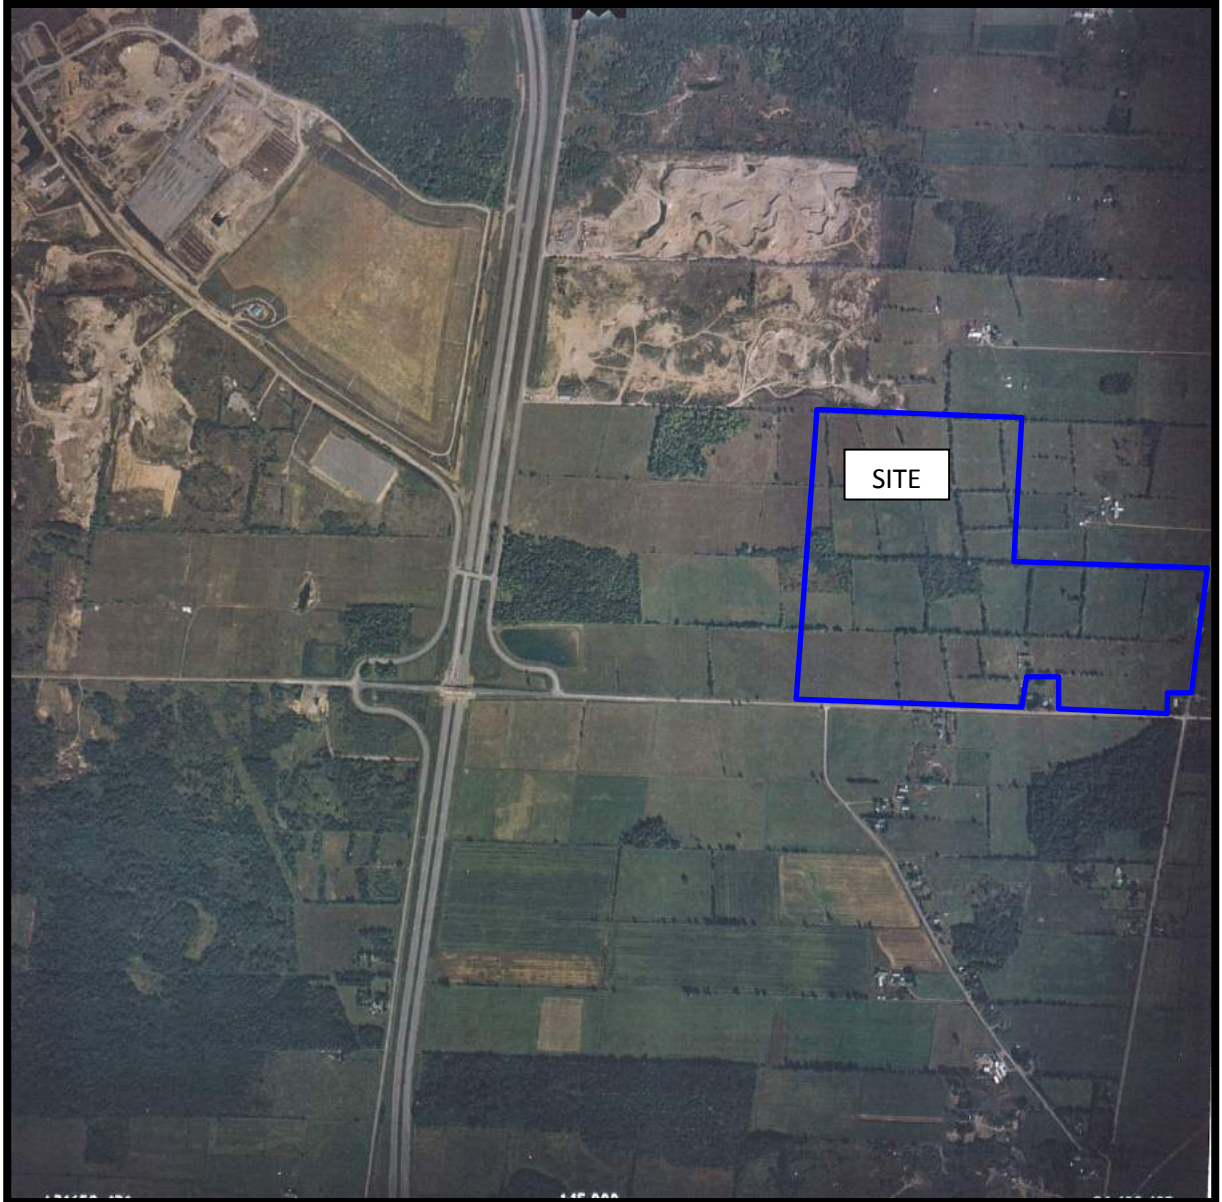
AERIAL PHOTOGRAPH  
1993

| 1993 | No significant changes have been made to the subject property or surrounding lands. |

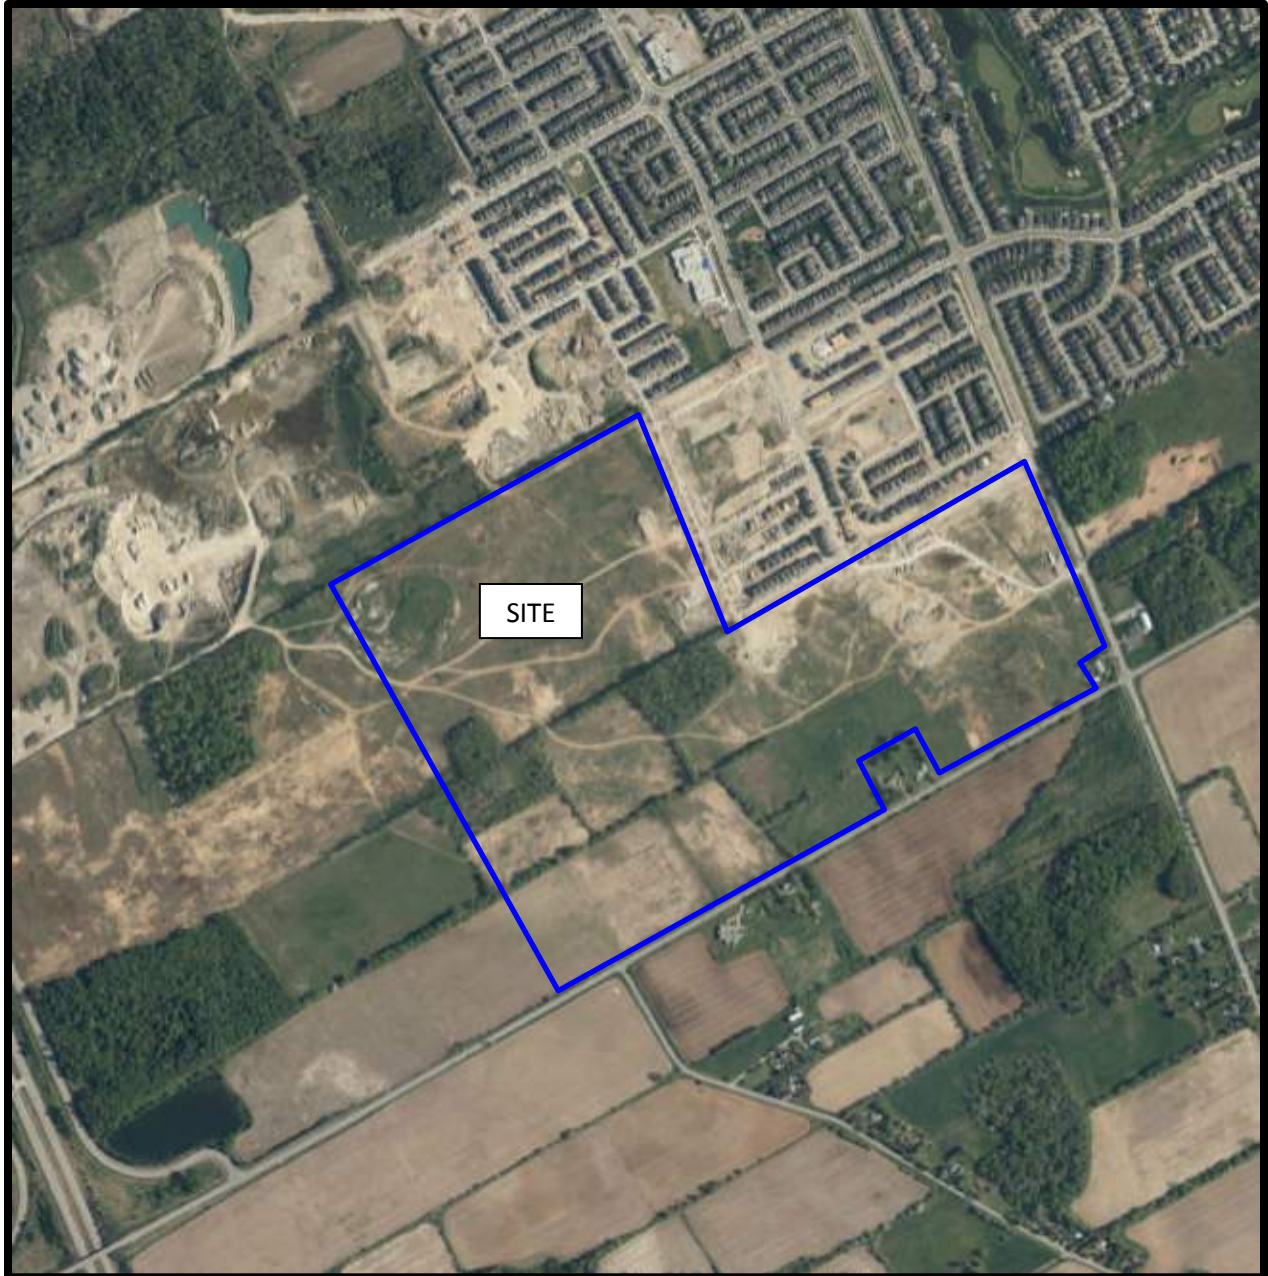
AERIAL PHOTOGRAPH  
2017

| 2017 | (City of Ottawa website) Some construction access roads and disturbed areas are present on the east side of the subject property, as well as storage containers and construction equipment. The adjacent lands to the northeast have been developed with residential roadways and dwellings. |

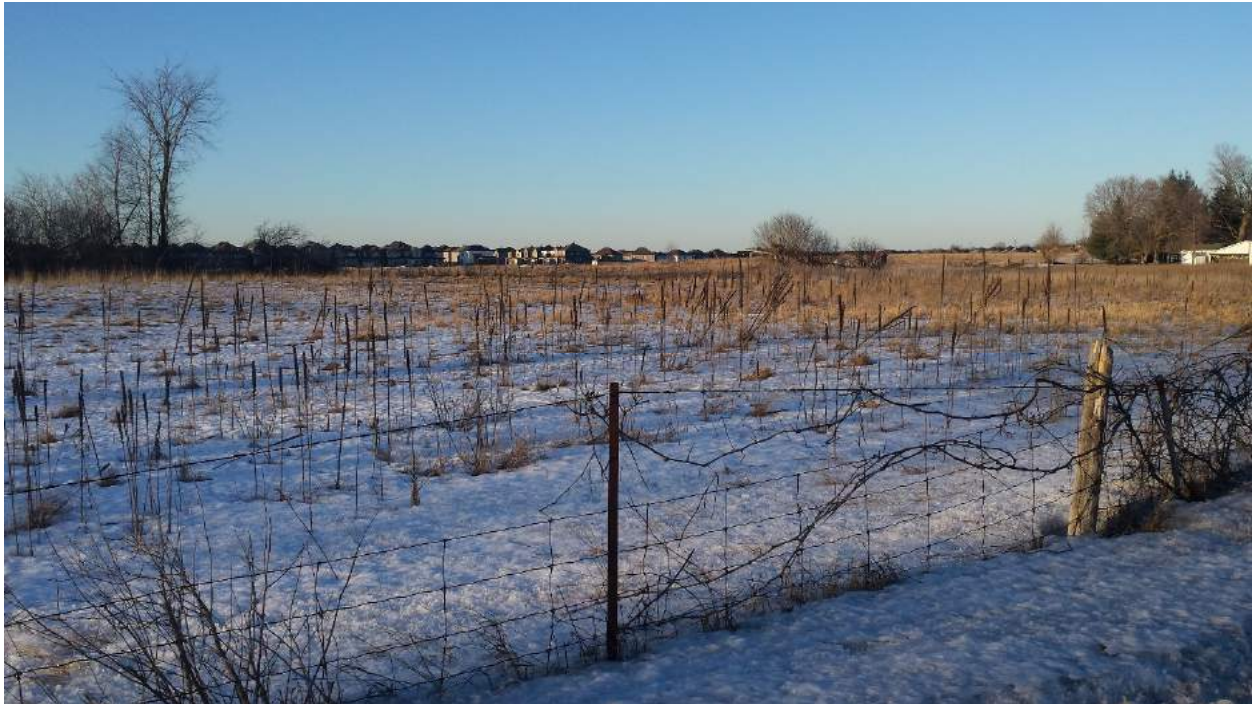
Photograph 1: View of the south side of the subject property, looking north from Barnsdale Road.

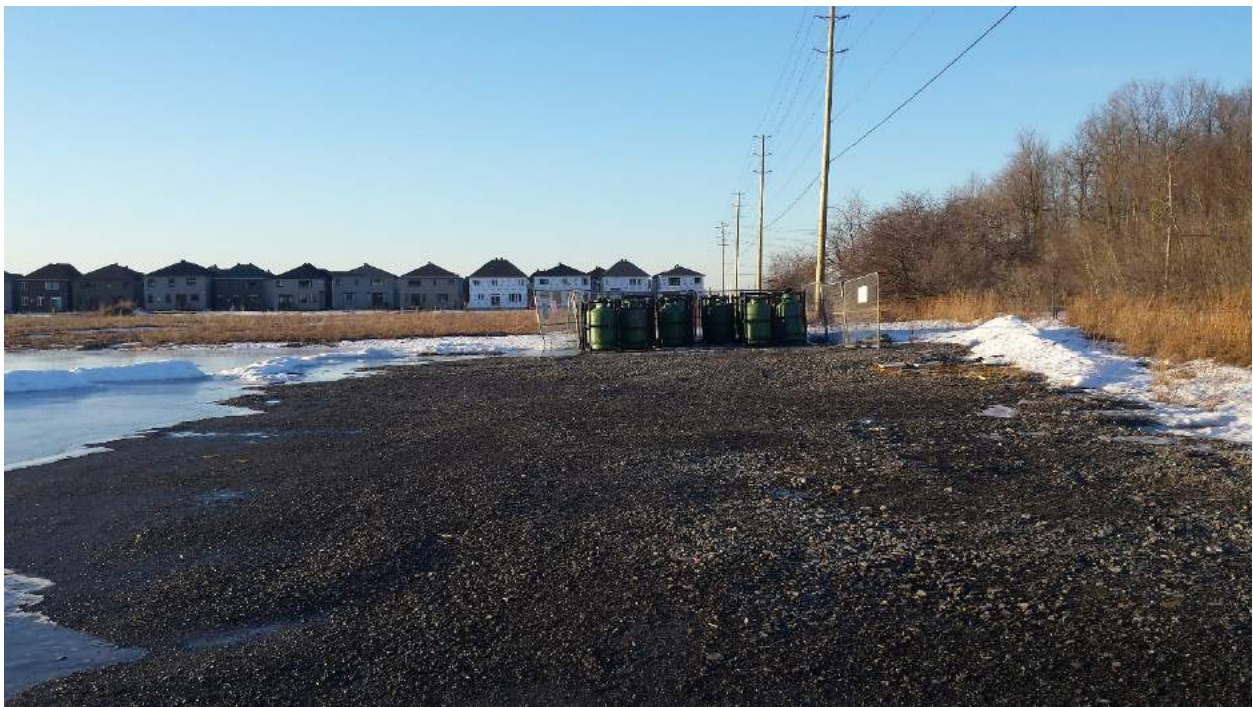
Construction materials were present on the subject site at the time of the site visit, including used propane tanks. No hazardous waste materials were identified.

Photograph 2: View of propane tank storage area on the east side of the subject site, near Greenbank Road.

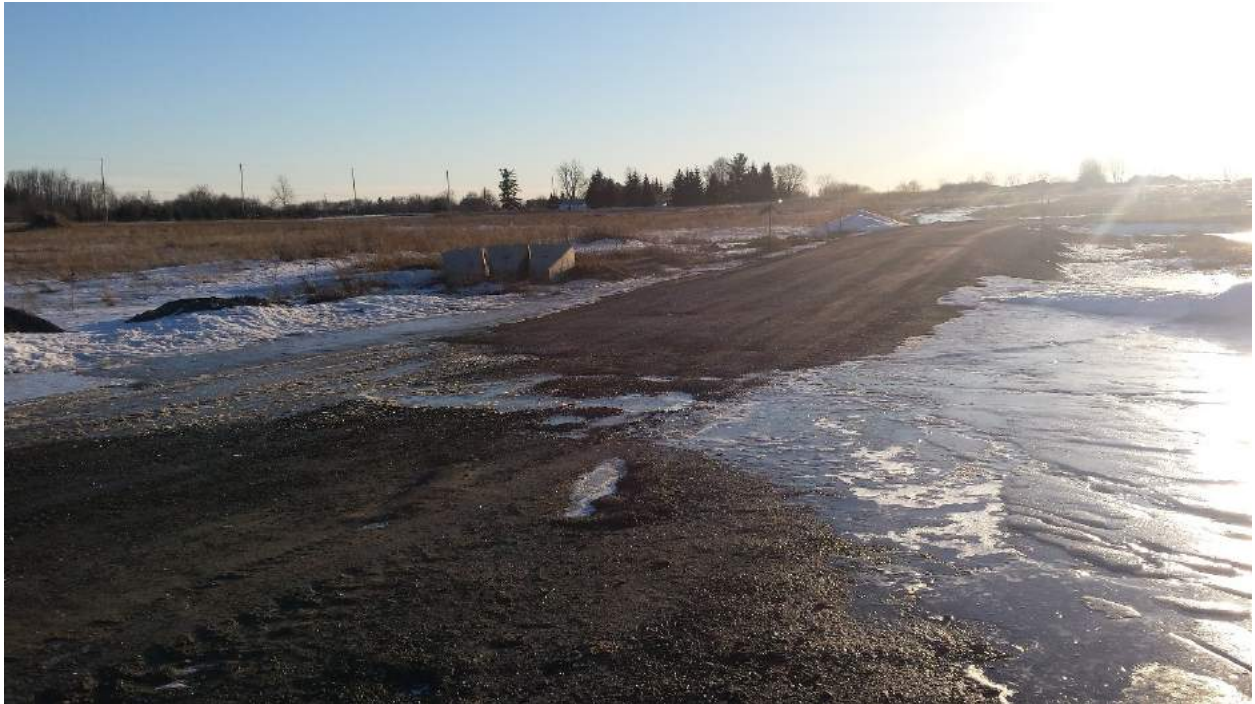
Photograph 3: View of the central part of the subject property, looking west.

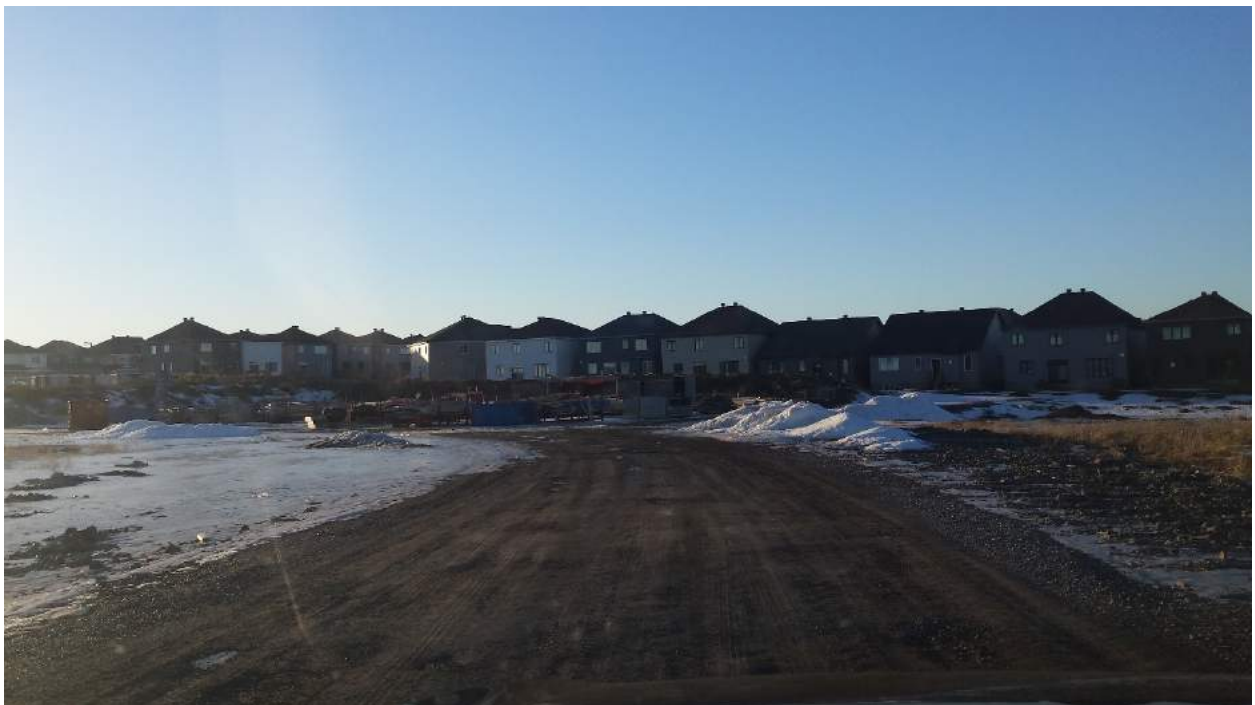
The subject site is a vacant lot of land. No buildings or permanent structures exist on the subject property. A site office trailer is present to the south of Guinness Crescent, as well as some storage containers and construction materials related to the Phase I development of Quinn's Point. A depiction of the subject site is shown on Drawing PE4246-1 – Site Plan, in the Figures section of this report.

Photograph 4: Construction site office and storage area south of Russet Terrace, looking north.

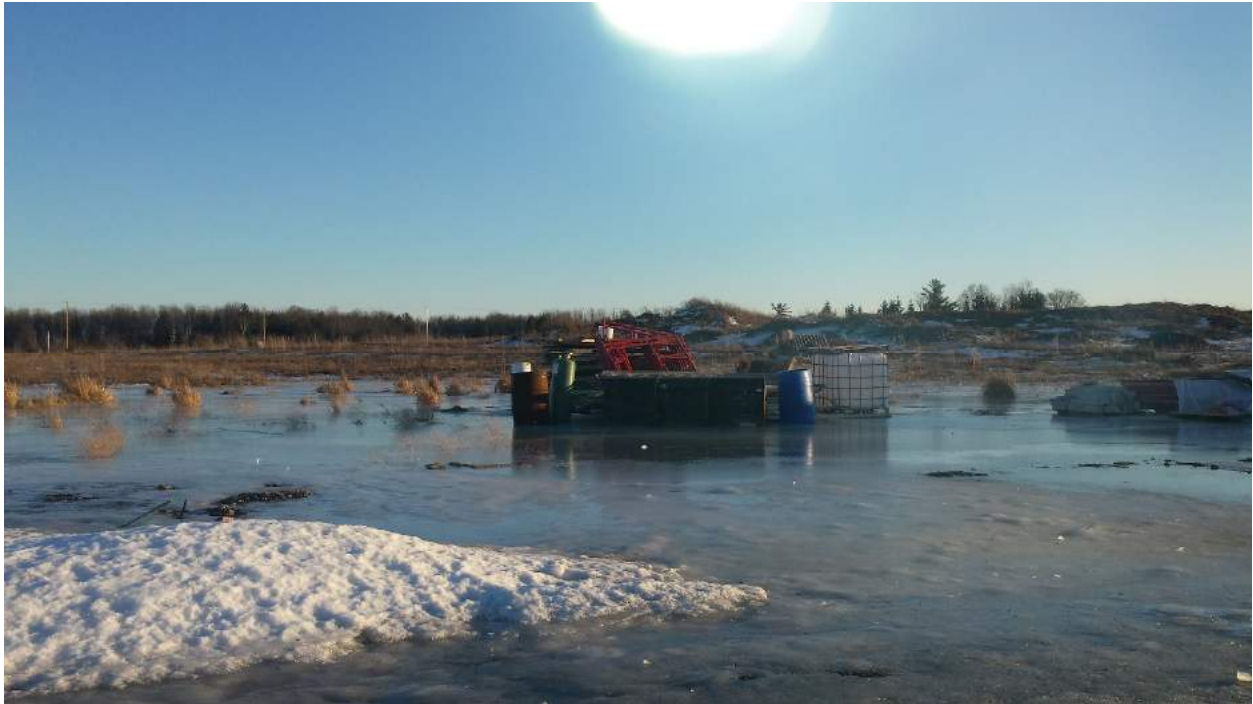
Photograph 5: View of the central part of the subject property, looking southwest.

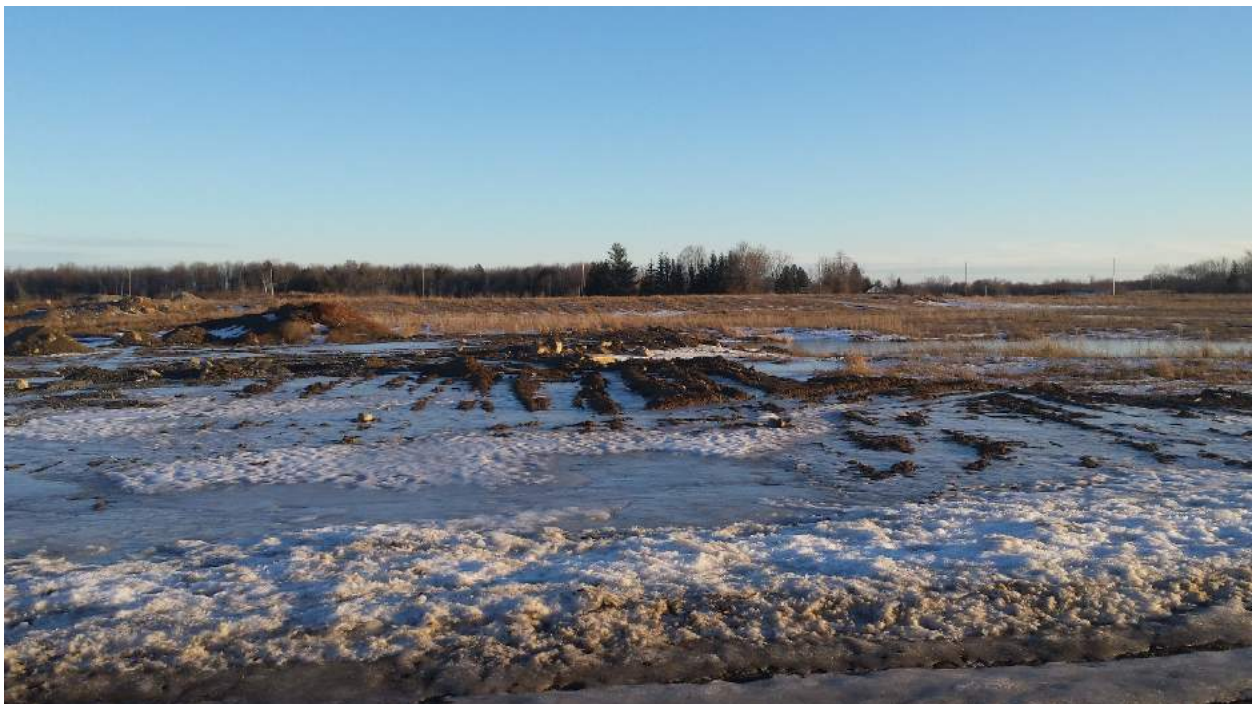
Photograph 6: View of the central part of the subject site, looking south from the construction storage area.

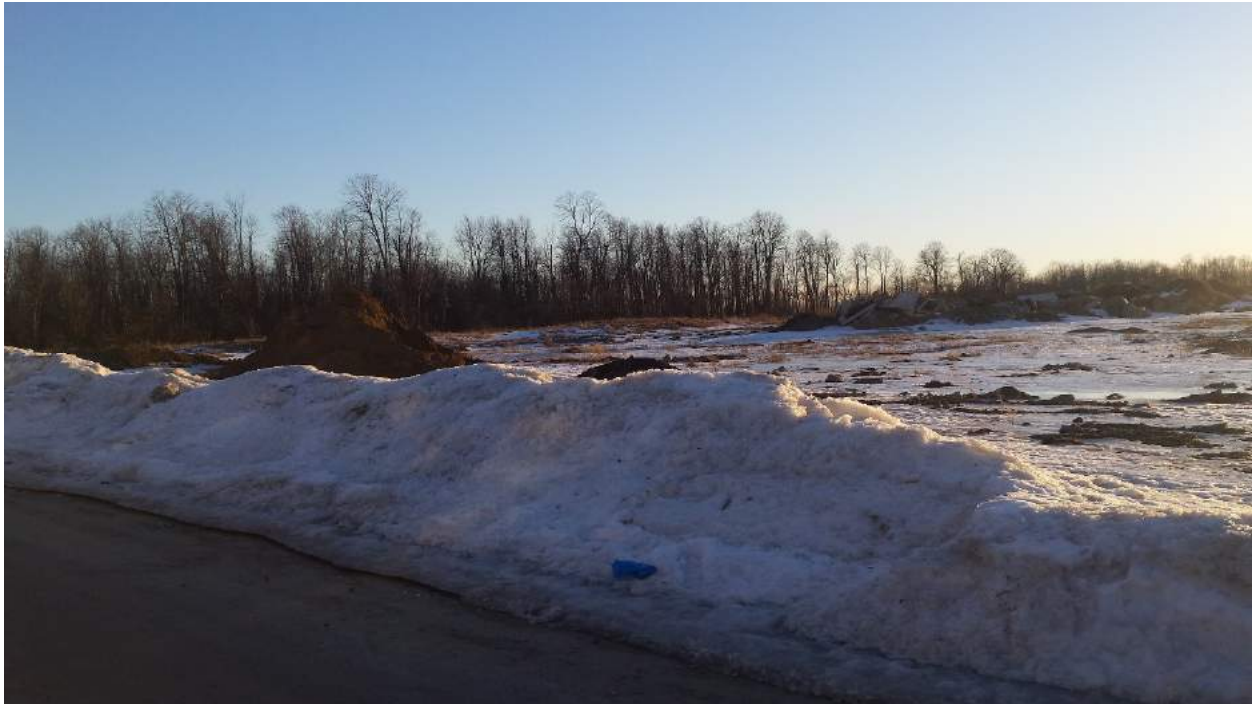
Photograph 7: North part of the subject site, looking south from Alex Polowin Avenue.

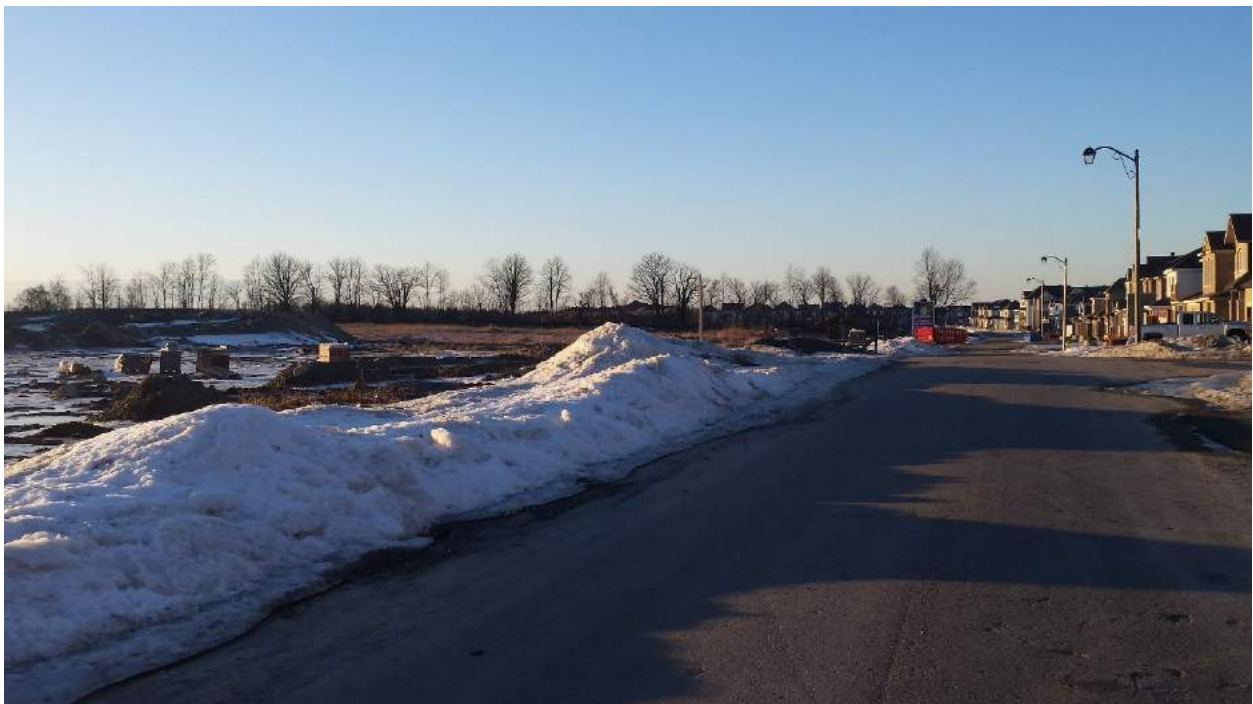
Photograph 8: North part of the subject site, looking north from Alex Polowin Avenue.
