Phase I Environmental Site Assessment

Vacant Property
The Meadows – Borrisokane Road
Ottawa, Ontario

March 8, 2018

Report: PE0190-3

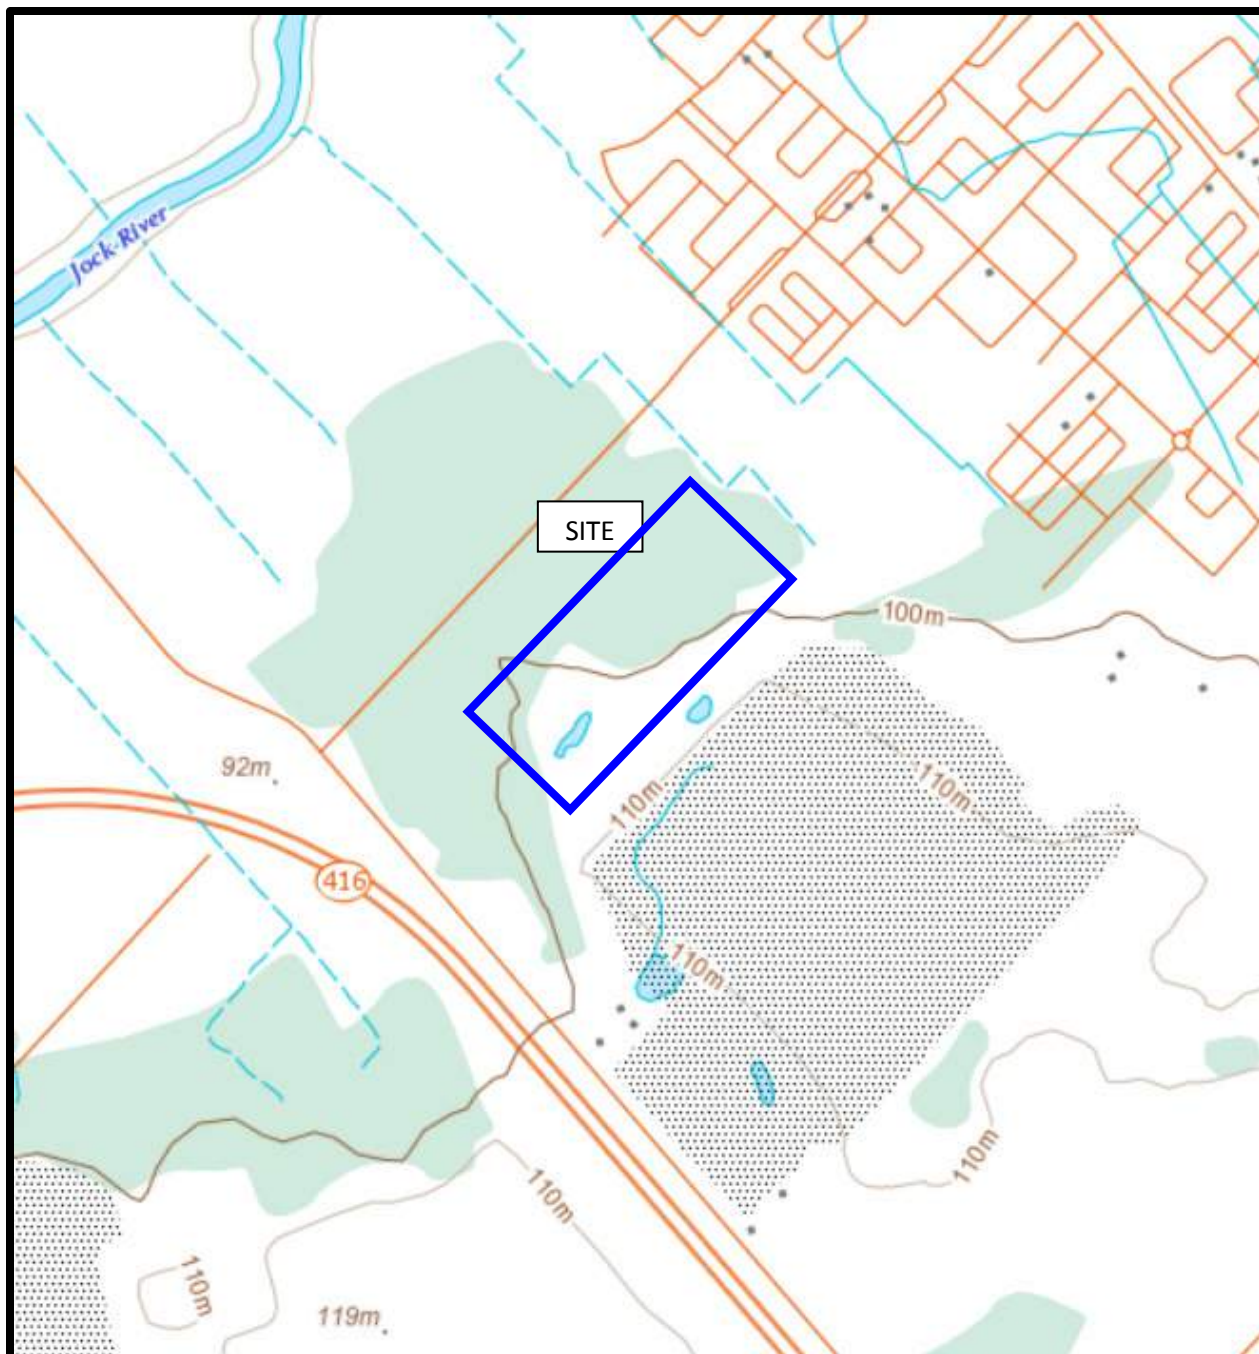
FIGURE 2
TOPOGRAPHIC MAP

Topographic information was obtained from Natural Resources Canada – The Atlas of Canada website. The topographic maps indicate that the elevation of the subject site is approximately 96 m above sea level. The regional topography in the general area of the site slopes downward to the north, towards the Jock River. An illustration of the referenced topographic map is presented on Figure 2 – Topographic Map, appended to this report.

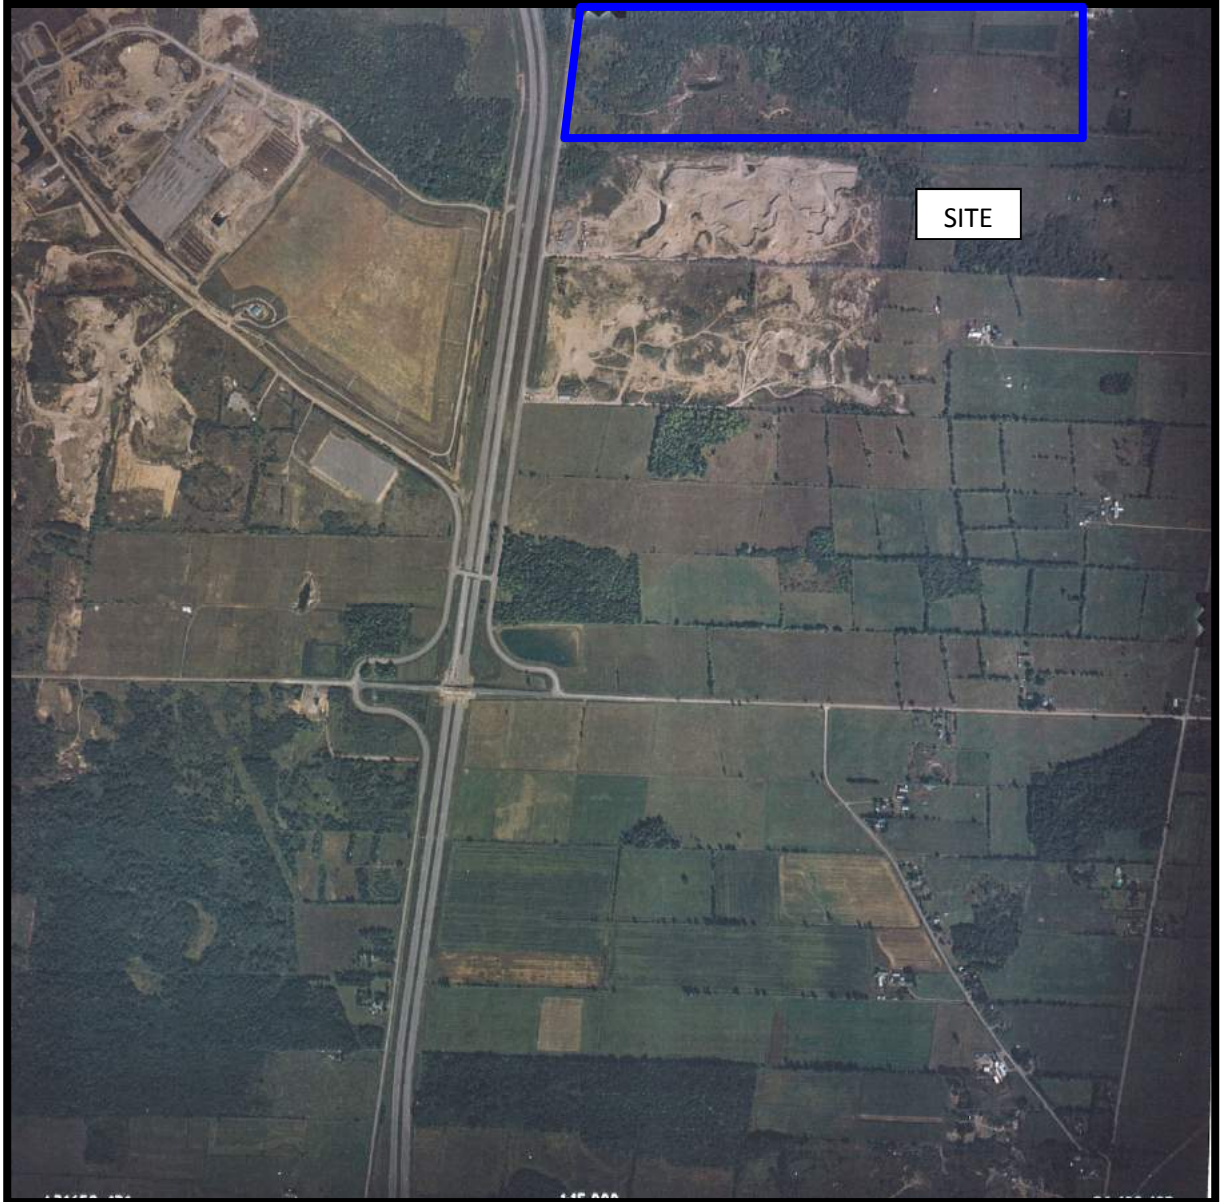
AERIAL PHOTOGRAPH
1993

| 1993 | The subject site does not appear to be in use. Some of the previously clear land is tree covered, with some agricultural fields on the eastern side of the site. Highway 416 has been constructed to the west of Cedarview Road / Borrisokane Road. No other significant changes have been made to the surrounding properties. |

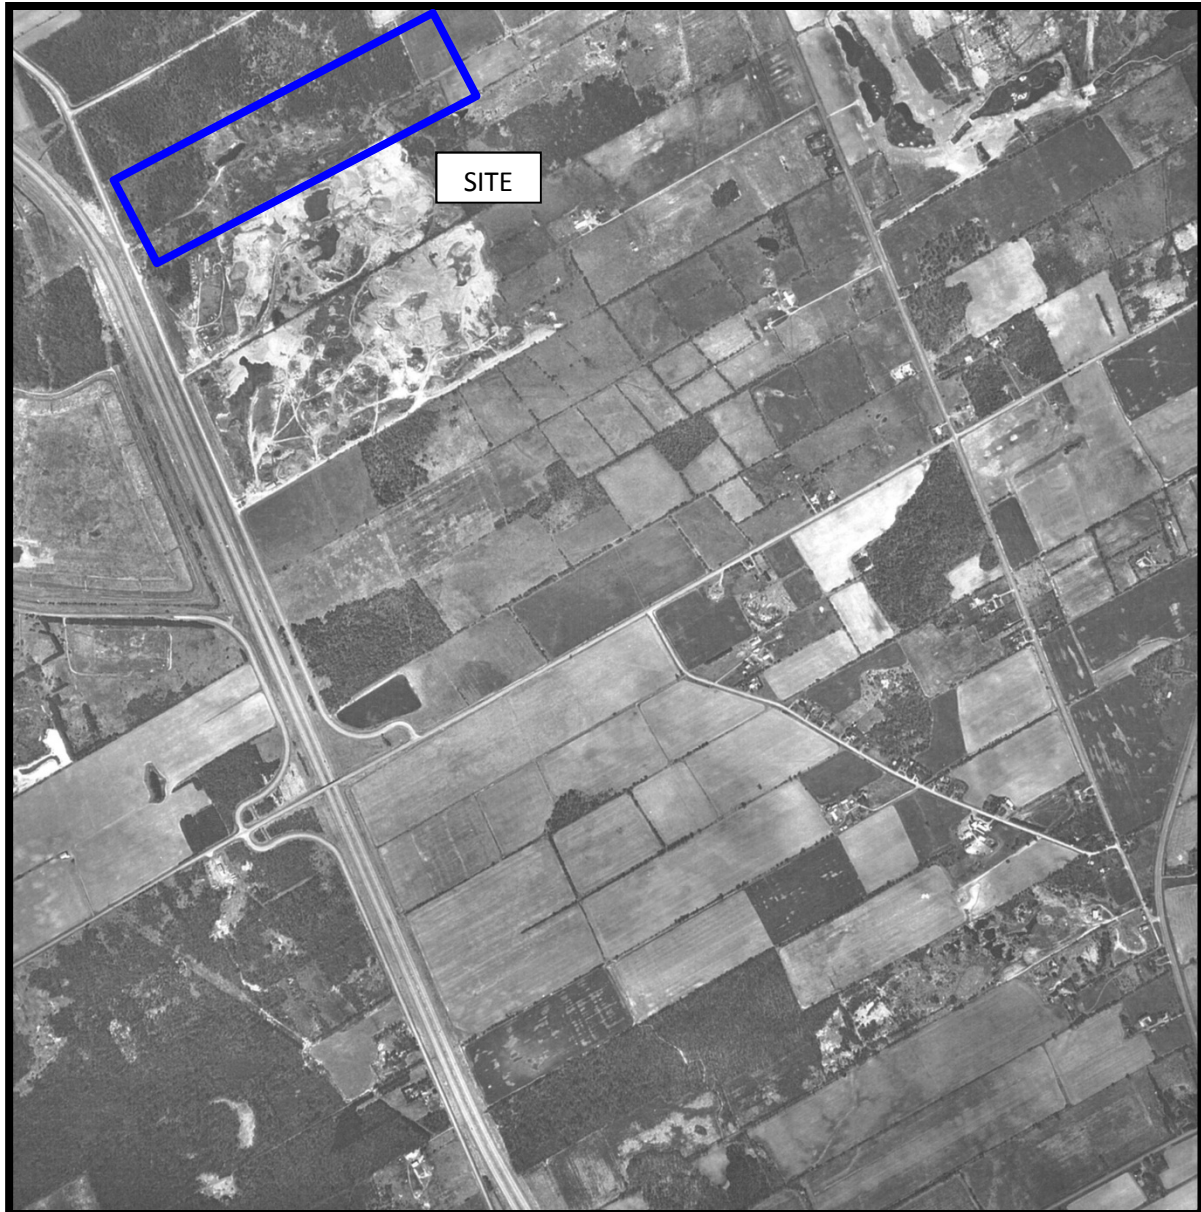
AERIAL PHOTOGRAPH
2001

| 2001 | Part of the subject site previously developed as an aggregate site appears to contain water. Some of the formerly agricultural fields in the eastern part of the site are unused and partly tree covered. The property to the south continues to be occupied by a quarry. |

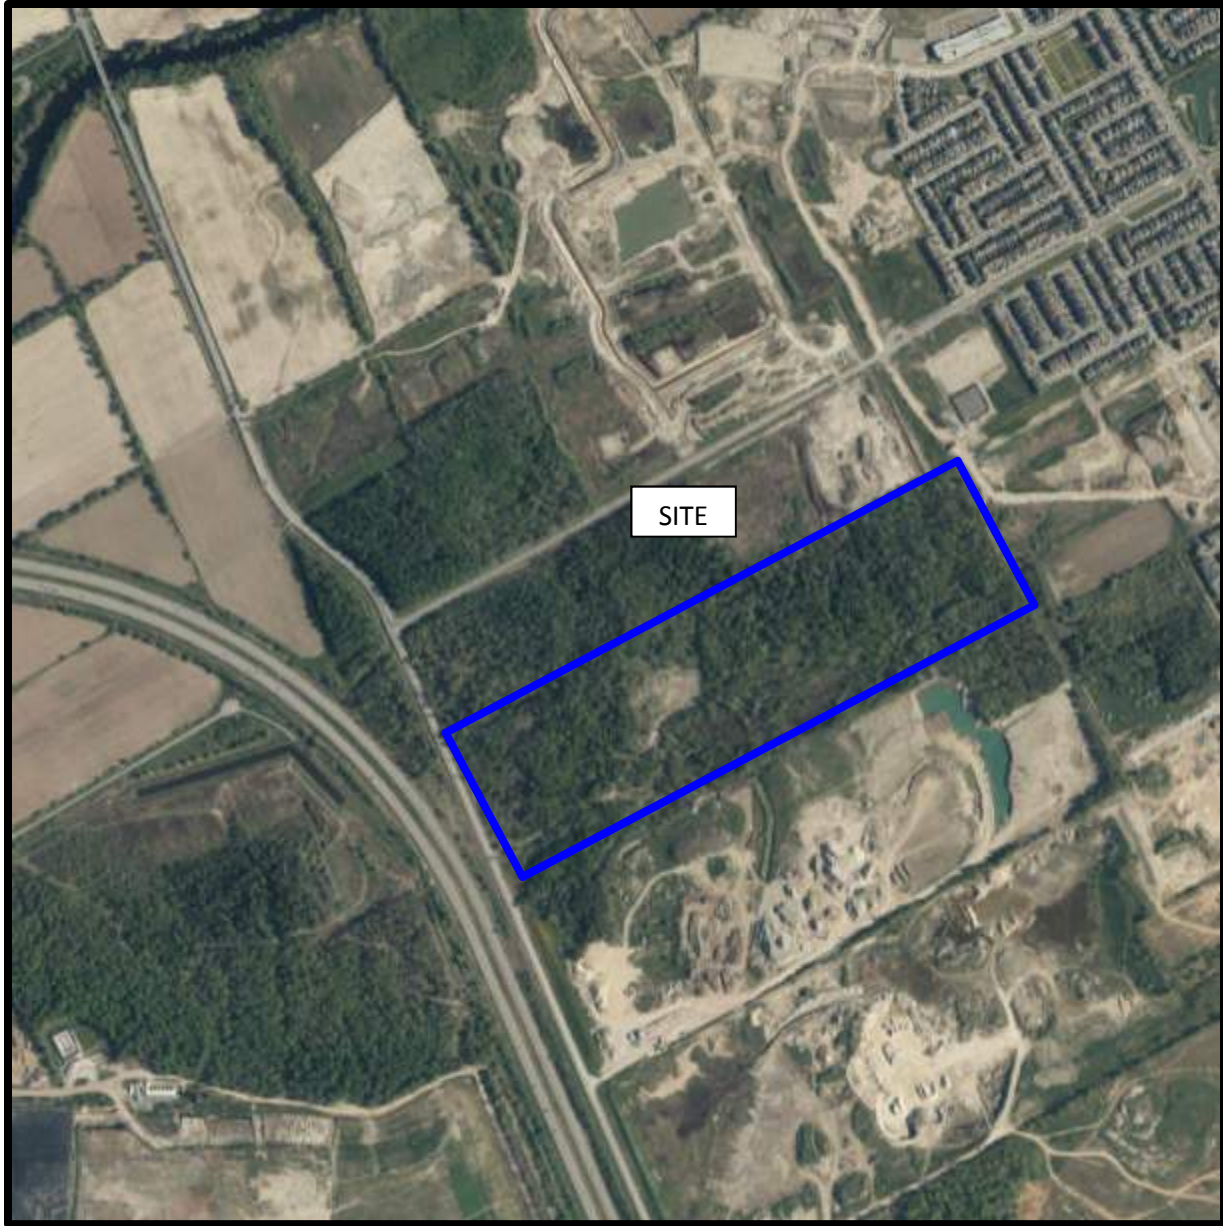
AERIAL PHOTOGRAPH
2017

| 2017 | (City of Ottawa website) The majority of the site is tree covered. Residential developments are present further to the northeast, on roadways including River Mist Road and Cambrian Road. |

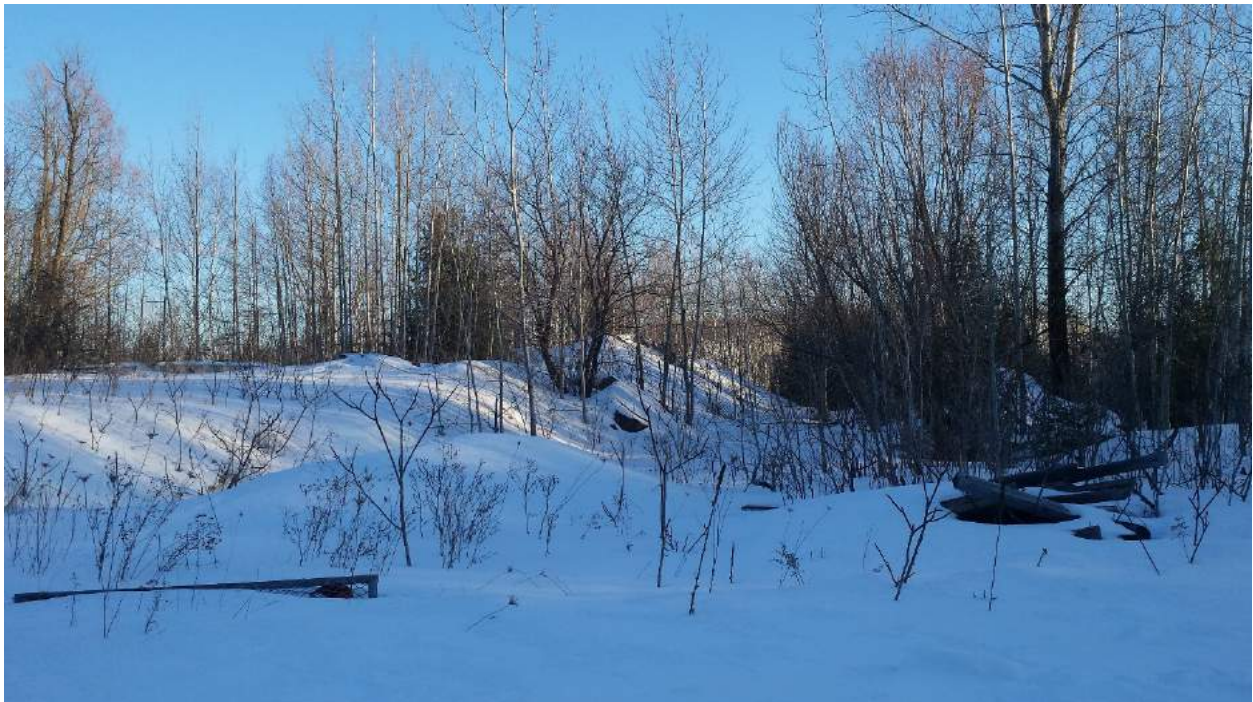
The lands on either side of the access roadways on the site were observed to be occupied by occasional waste items/debris, including: building materials, furniture, and plastic and metal barrels.

Photograph 2: Some construction debris, with Costello aggregate pit property behind, near the western boundary of the subject property.

It is recommended that all discarded/waste items be properly disposed of during the future development of the land.

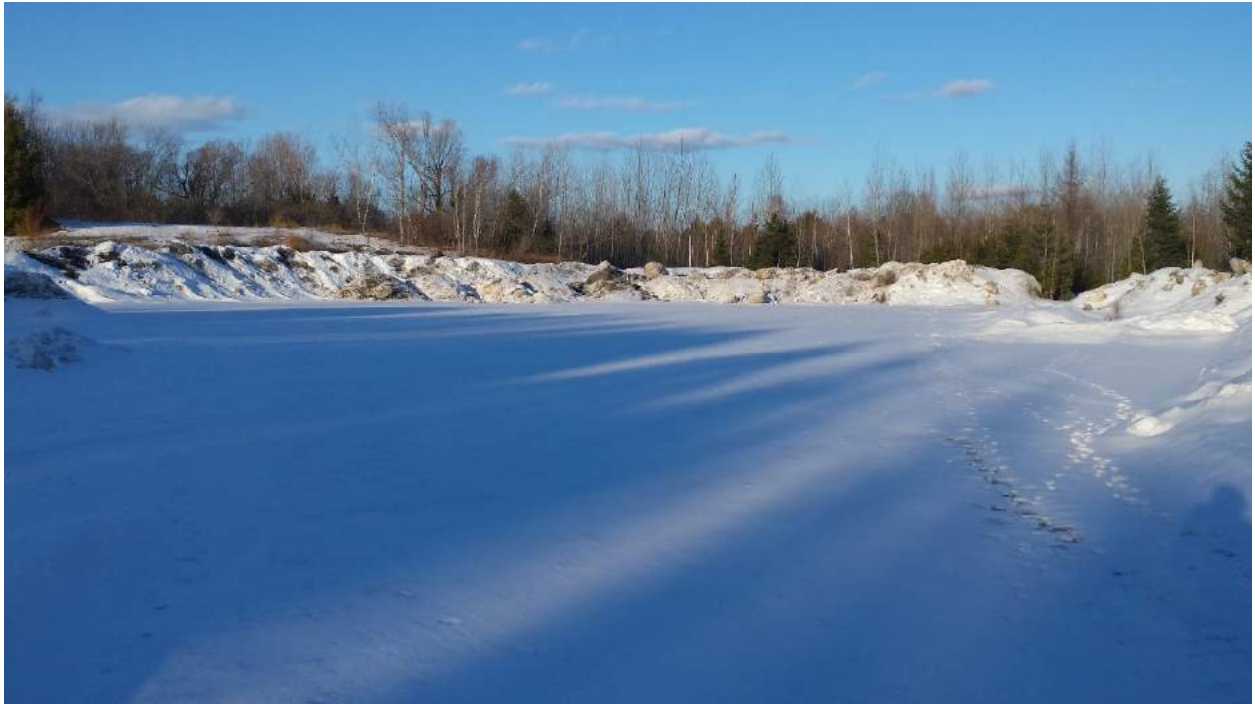
Photograph 3: Open space near the western side of the subject property; former aggregate extraction pit.

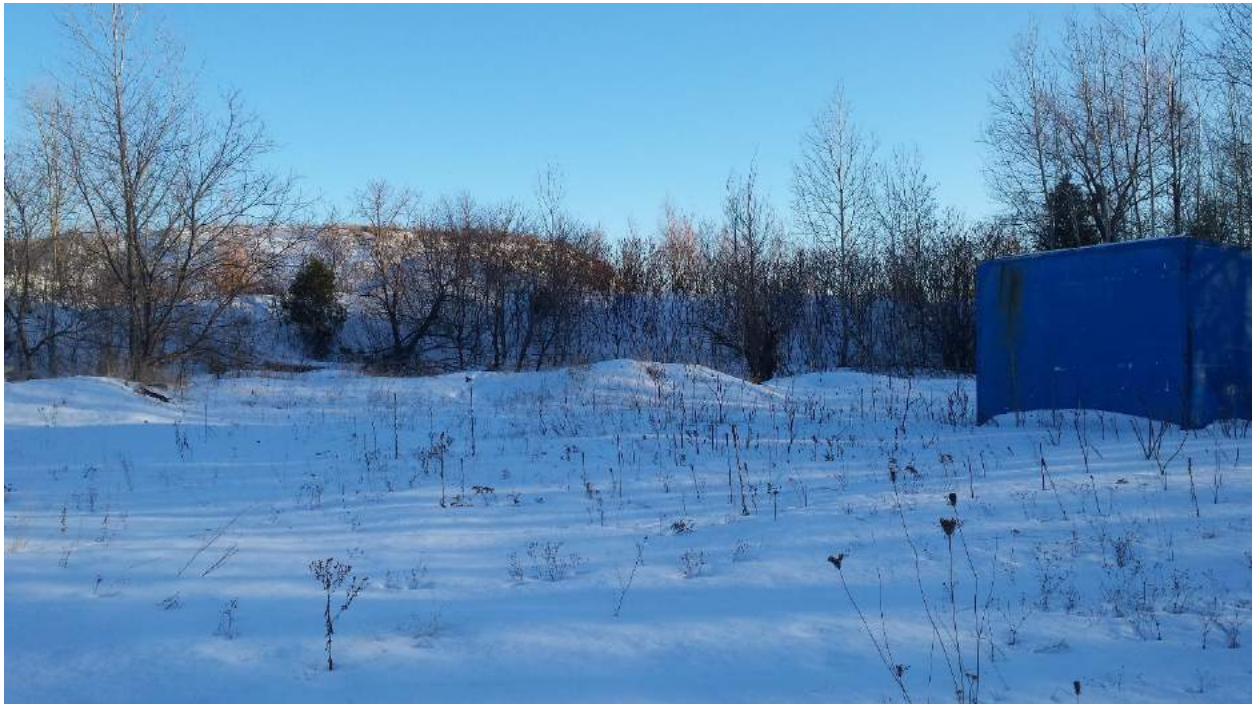
Photograph 4: Storage container with unknown contents near former aggregate pit.
