**ENVIRONMENTAL IMPACT STATEMENT
and
TREE CONSERVATION REPORT**

PROPOSED MIXED USE DEVELOPMENT

**KANATA WEST LANDS
CITY of OTTAWA**

Revised May, 2018

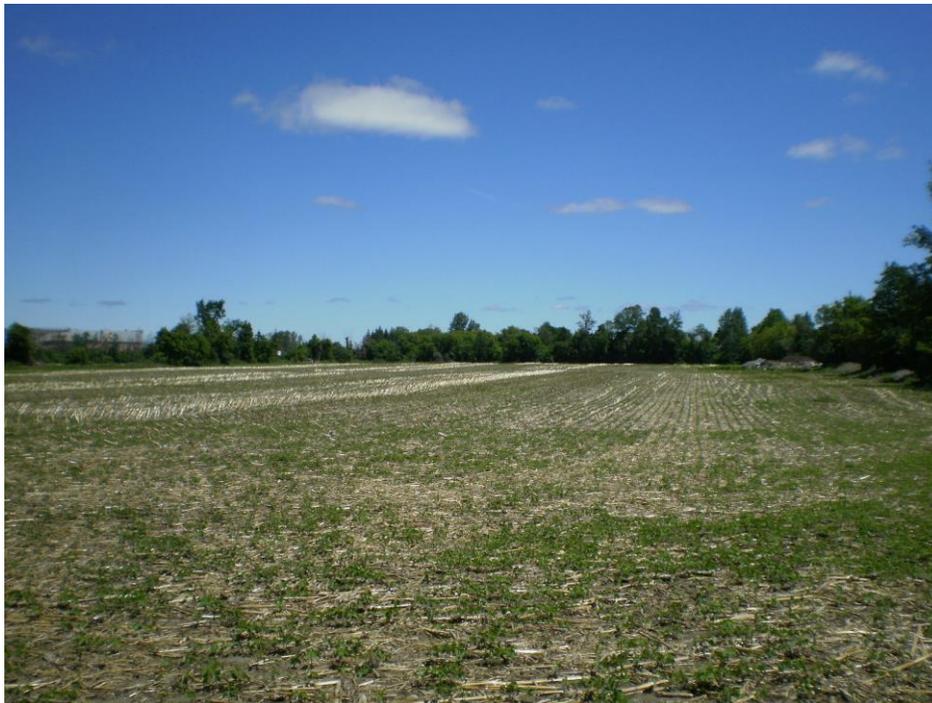
Photo 1 – Soybean fields dominate the east portion of the site. This is the south field with view looking east to cultural woodlands owned by others to the west of Huntmar Drive (June 10th, 2016)

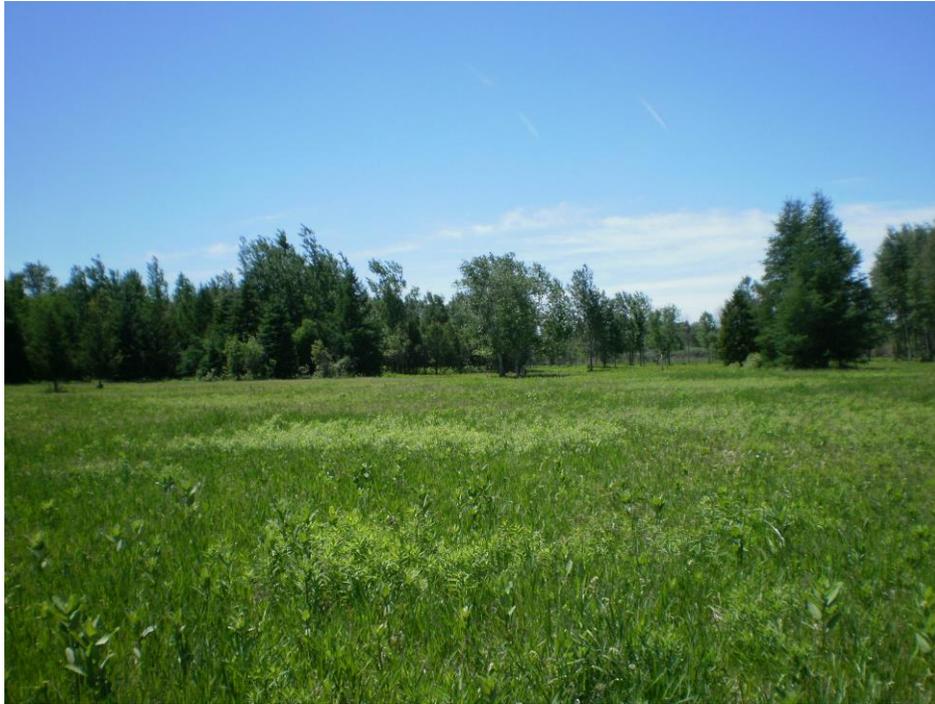
*Photo 2 – Cultural meadow habitat in the central-west portion of the site.
View looking west from central point of meadow (June 10th, 2016)*

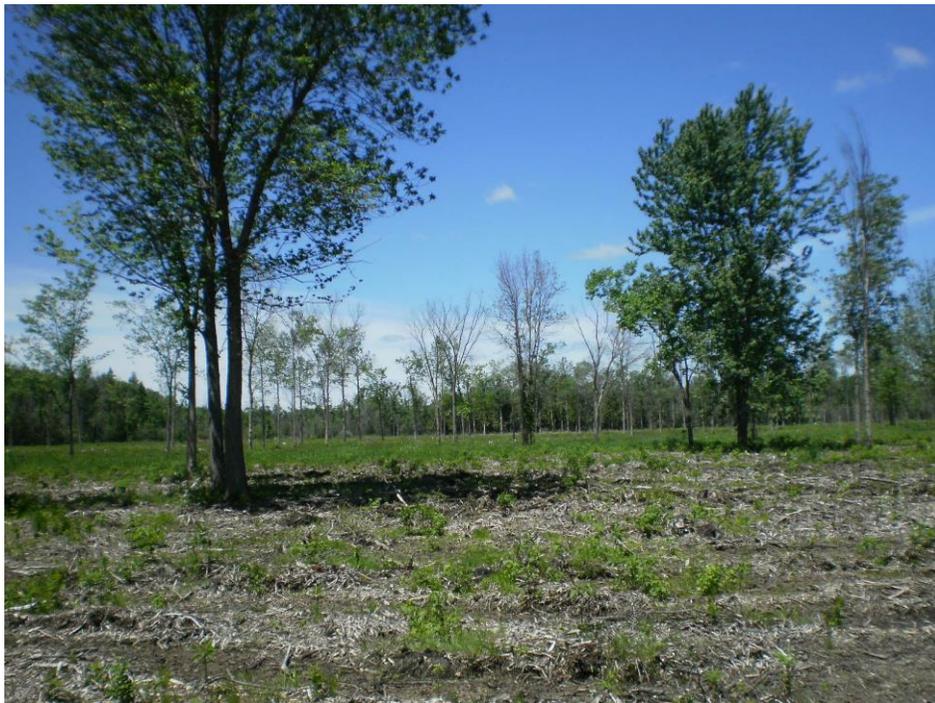
Photo 3 – Recently cut area in the central west portion of the site to the west of the meadow habitat. View looking north from the south edge of the cutting (June 10th, 2016)

As shown on Map 1 many areas of the north portion of the site have been recently cleared of most trees and the areas grubbed (Photos 3, 4 and 5). No areas of ponding were observed in these cleared areas during the spring or summer 2016 field surveys. Based on Paterson (2018) the cleared area in the northwest portion of the site contains a topsoil layer zone overlying a silty clay layer and glacial till deposits.

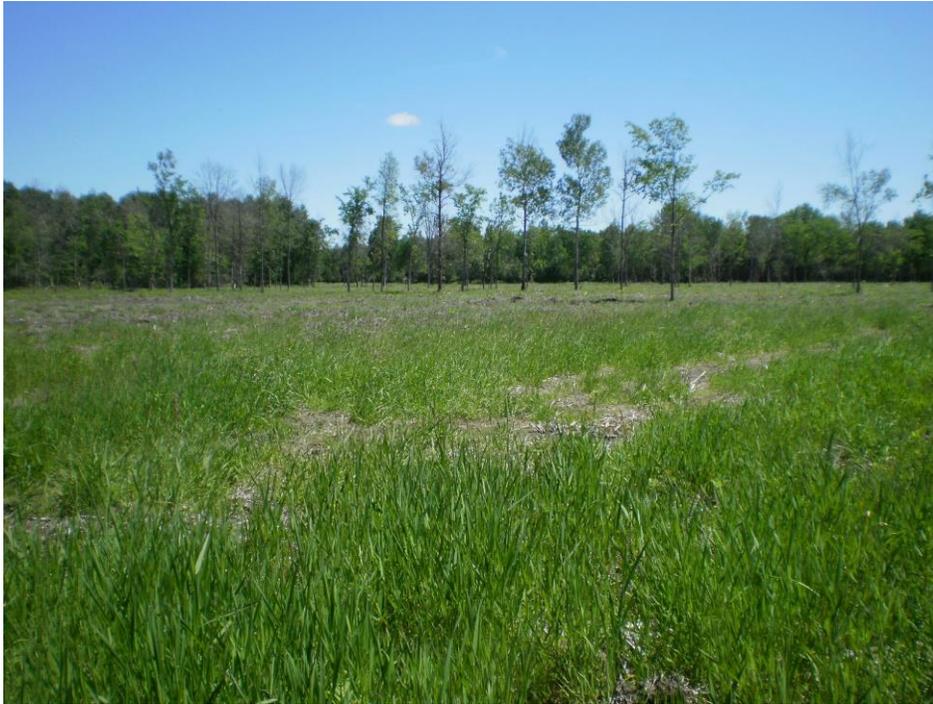
Photo 4 – Another area of tree cutting - this is in the northwest portion of the site, looking southeast from the northwest site boundary (June 10th, 2016)

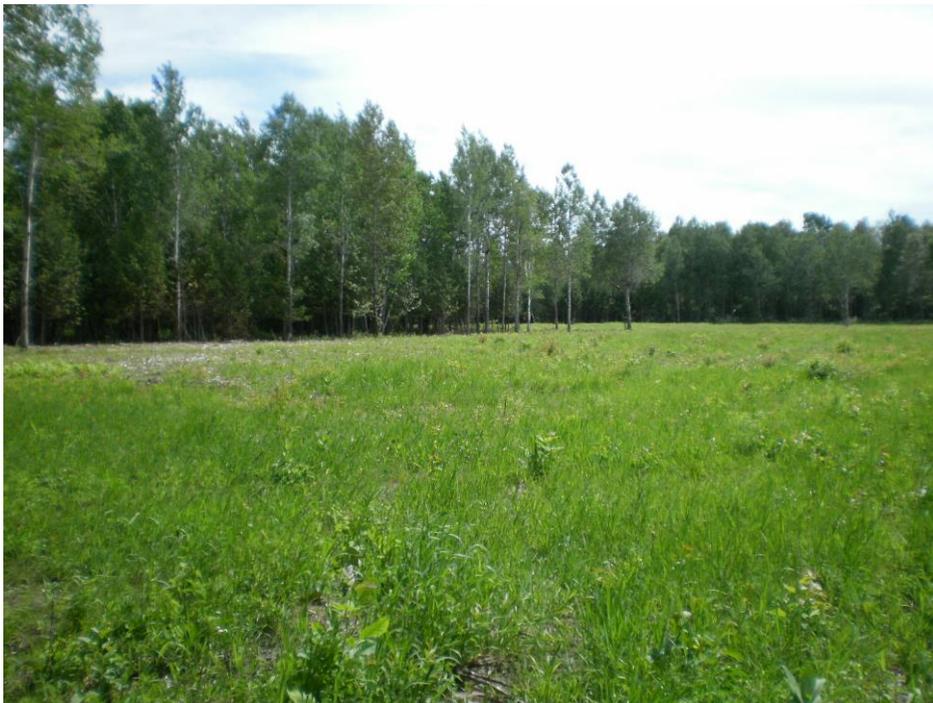
Photo 5 – Area of tree cutting in the north-central portion of the site. View looking southwest (June 10th, 2016)

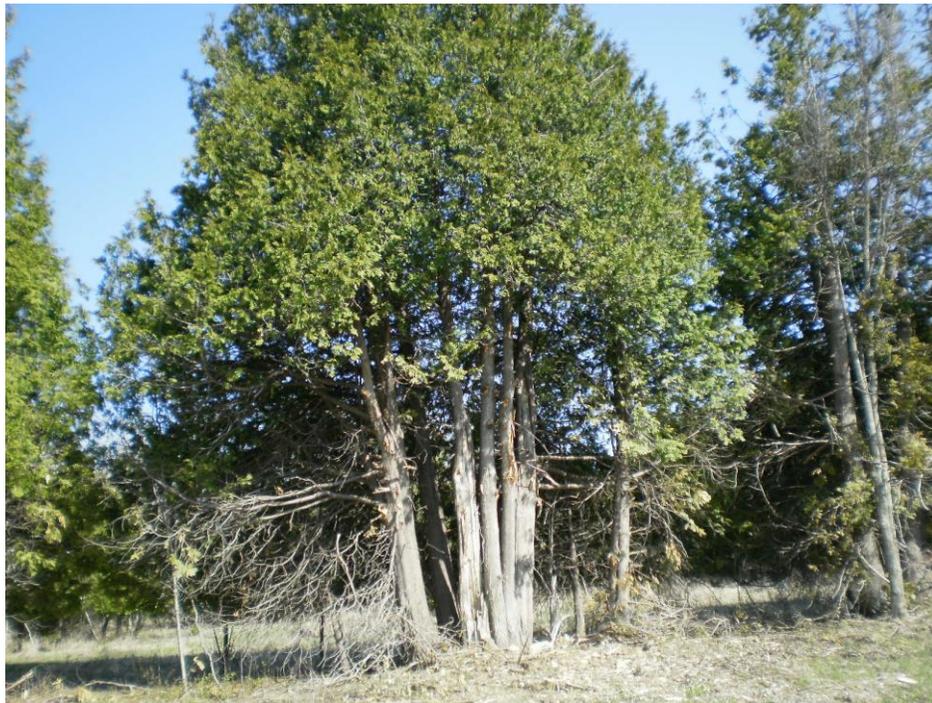
Photo 6 - White cedar in the short coniferous hedgerow in the north-central portion of the site

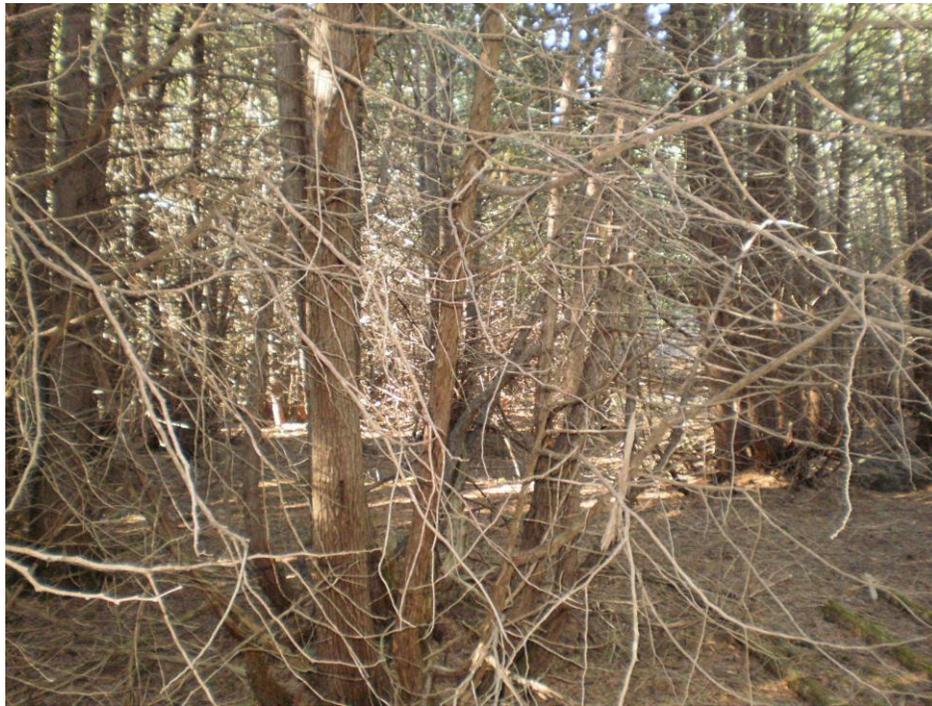
Photo 7 - Dense cedar forest in the northeast portion of the site with very limited understory and ground cover (May 11th, 2016)

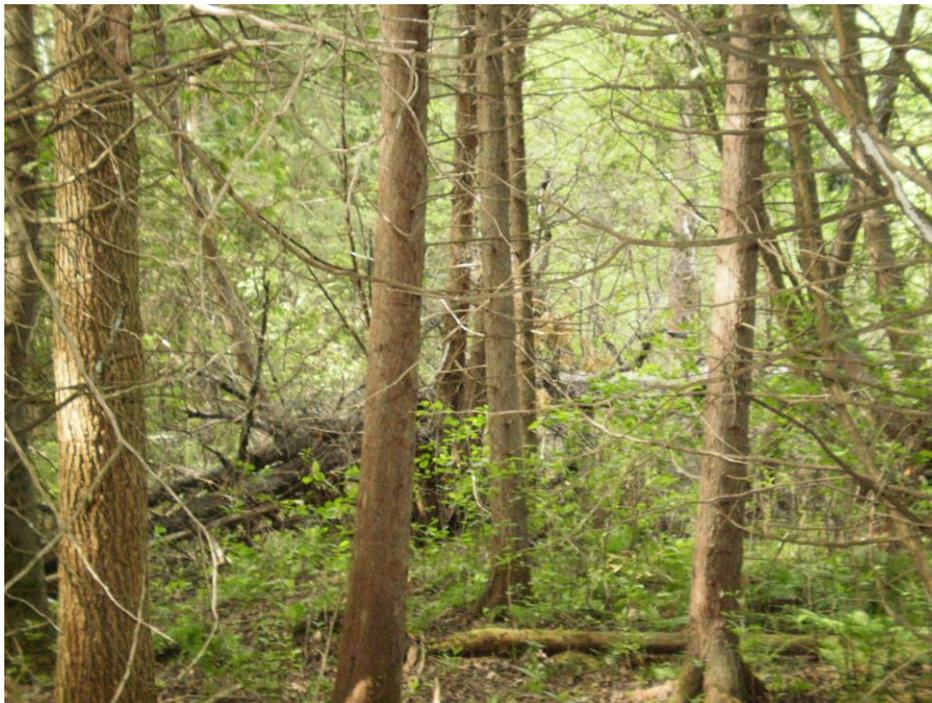
Photo 8 - Some wind throw in the cedar coniferous forest in the south-central portion of the site (June 10th, 2016)

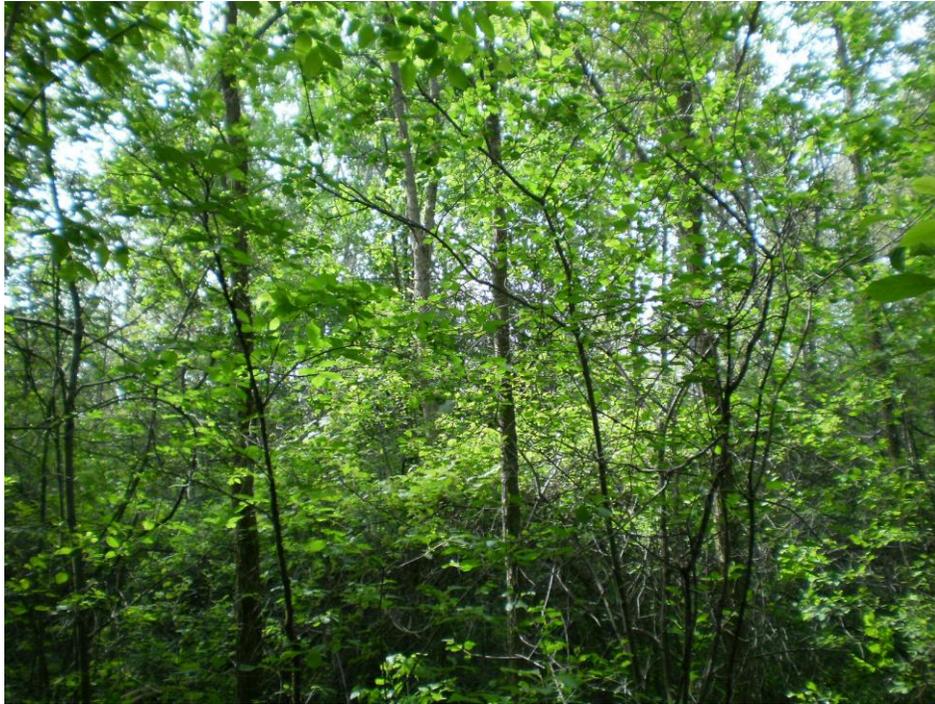
Photo 9 - Mixed forest in the southwest portion of the site

Small pockets of mixed forest are also in the west portion (Photo 9) and east edge of the site. White cedar up to 32cm dbh and trembling aspen up to 40cm dbh are the dominant tree species, with white birch, white ash, sugar maple, balsam poplar, white spruce, bur oak, white elm and green ash also present. A 60cm dbh white spruce is along the southwest edge of the site, likely within a former hedgerow that is now part of the forest habitat. Greater wind throw was noted in the southwest representation of the upland mixed forest. Glossy buckthorn is again abundant in many areas of the understory, with red-osier dogwood and nannyberry also present. Sensitive fern, lady fern, poison ivy, thicket creeper, wild grape, Canada goldenrod, cow vetch, Canada mayflower, Philadelphia fleabane, ox-eye daisy, common dandelion and narrow-leaved goldenrod are typical of the ground flora. Grape and creeper coverage is extensive on the lower branches of many of the trees.

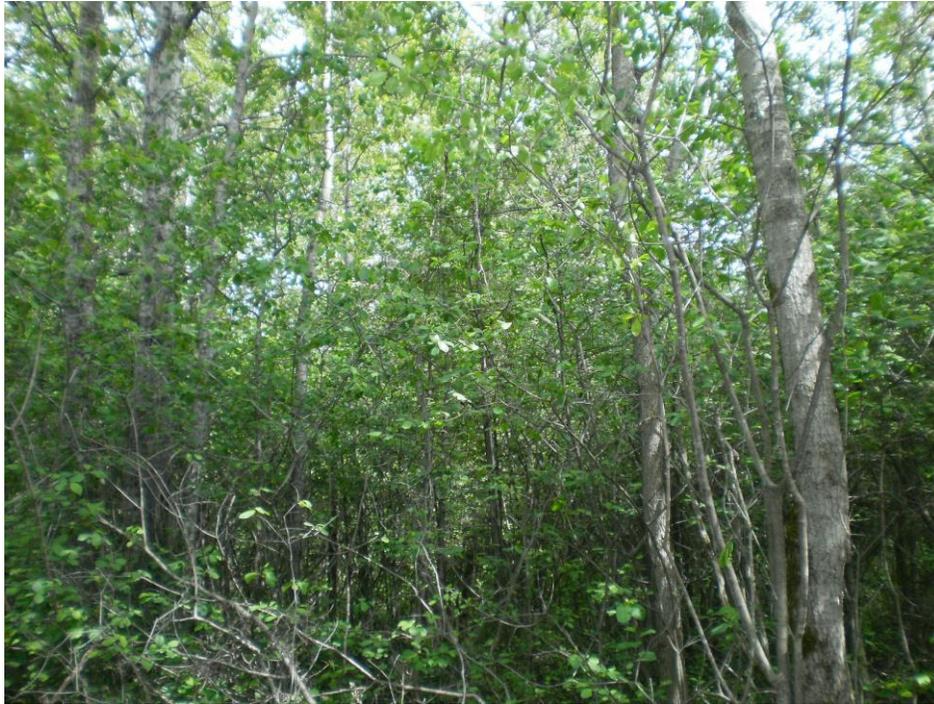
Photo 11 - Poplar deciduous forest in the northeast portion of the site (June 10th, 2016)

This community, scattered in relatively small pockets throughout the central and west portions of the site, is dominated by trembling aspen and balsam poplar up to 48cm dbh and 33cm dbh, respectively (Photos 10 and 11, vegetation community 6 on Map 1). The largest trees seen in this community were white birch and white ash up to 38cm dbh. Green ash, crack willow, basswood, sugar maple, bur oak, white cedar and white elm are also present. Some of the elm were in poor condition with very little leaf-out. Wild grape coverage was thick on many of the trees. Glossy buckthorn or common buckthorn are dominant in portions of the understorey, with prickly gooseberry, tartarian honeysuckle, gray dogwood and regenerating ash and poplar stems also common. Canada goldenrod, tall goldenrod, poison ivy, wild grape, thicket creeper, cow vetch, bugleweed, common dandelion, yellow wood sorrel, white bedstraw, common strawberry, spotted jewelweed, white bedstraw, herb robert, field horsetail, Philadelphia fleabane, daisy fleabane, white snakeroot, thicket creeper, yellow violet, blue violet, tall buttercup, Pennsylvania sedge, eastern bracken, sensitive fern and lady fern are representative of the ground flora generally dominated by non-native and/or invasive species.

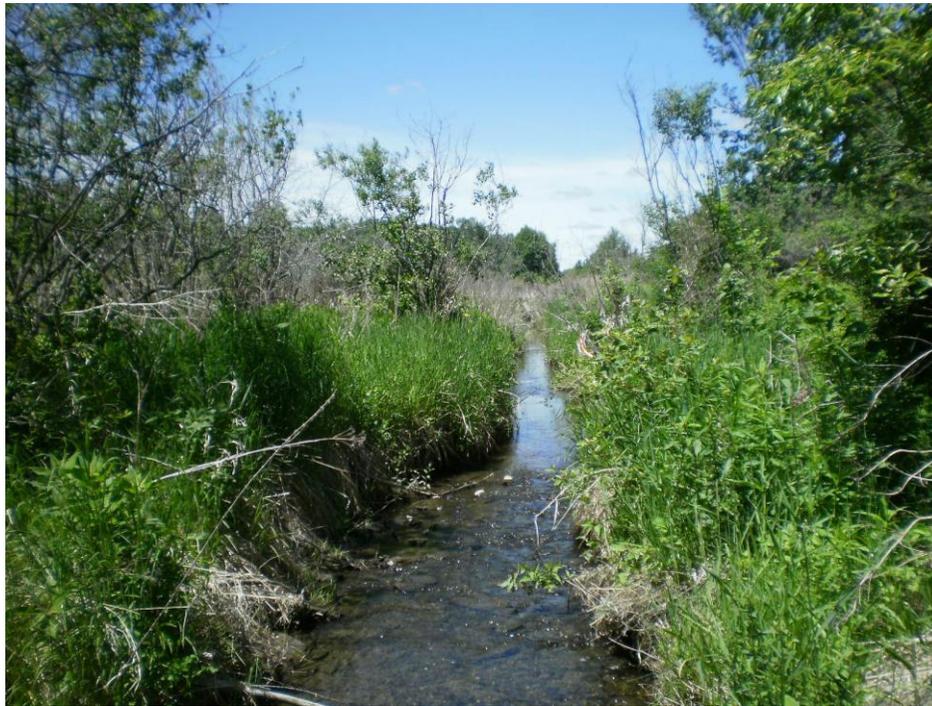
Photo 12 - Feedmill Creek along the unopened road allowance immediately west of the site. View looking north from west of the west-central property edge (June 10th, 2016)

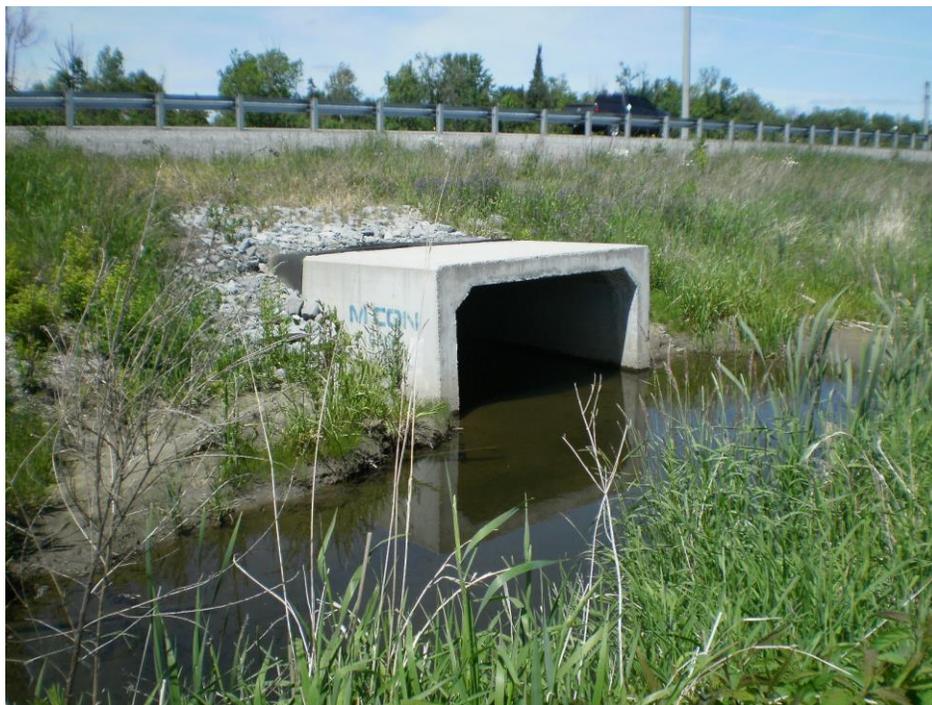
Photo 13 - Feedmill Creek as it enters the box culvert under Highway 417 north of the MTO lands. View looking downstream, northeast (June 10th, 2016)

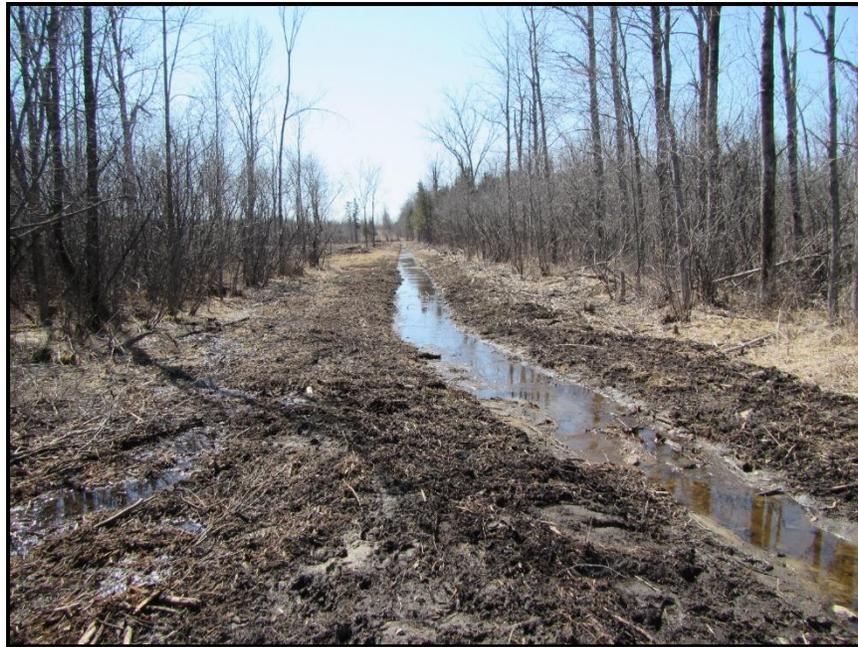
Photo 16 - Realigned northwest swale along the north edge of the site. View looking west, with section of remaining trees to the left, south, and MTO lands to the right, north (April 15th, 2016)

The channel in the northwest portion of the site (sampling sites 5, 6 and 7 on Map 2) is referred to as the 'northwest swale' on Map 1, and is tributary to Feedmill Creek. This swale has been realigned to run along the north site boundary before turning 90 degrees to the north as the swale enters MTO land (Photos 16 and 17). The swale had very limited flowing water (less than 5cm on April 15th and by April 29th there was no longer continuous flow through the channel, with no water observed in the vicinity of the culvert at the 417. By May 6th the entire channel was dry and was also dry on May 20th and June 10th. This feature also does not provide suitable turtle habitat and is only ephemerally wet in the very early spring, with not enough water for fish sampling on April 15th. Thus the northwest swale is also not considered to provide direct fish habitat.

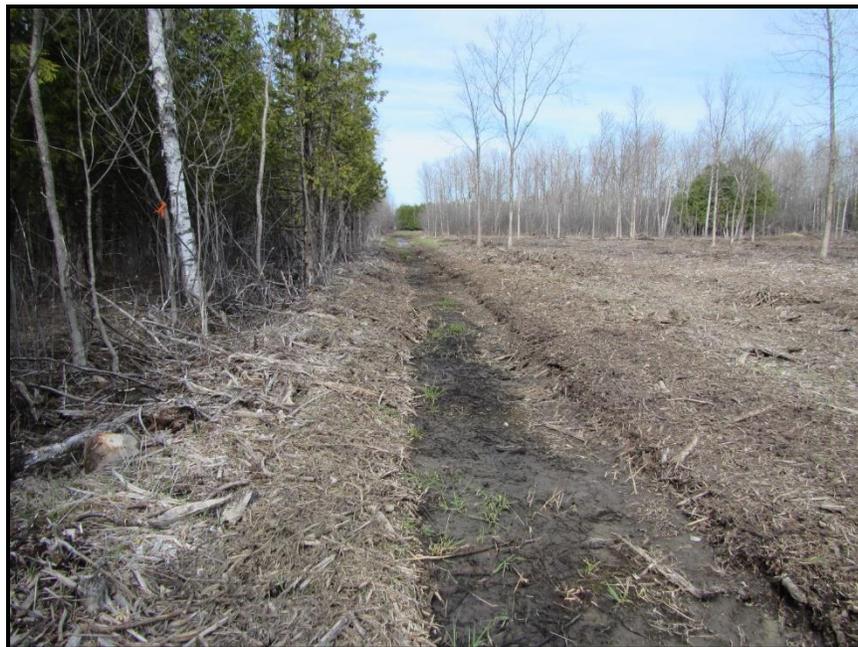
Photo 17 – Realigned dry northwest swale (April 29th, 2016) along the north edge of the site. View looking east, with areas of tree cutting to the right, south, and MTO lands to the left, north

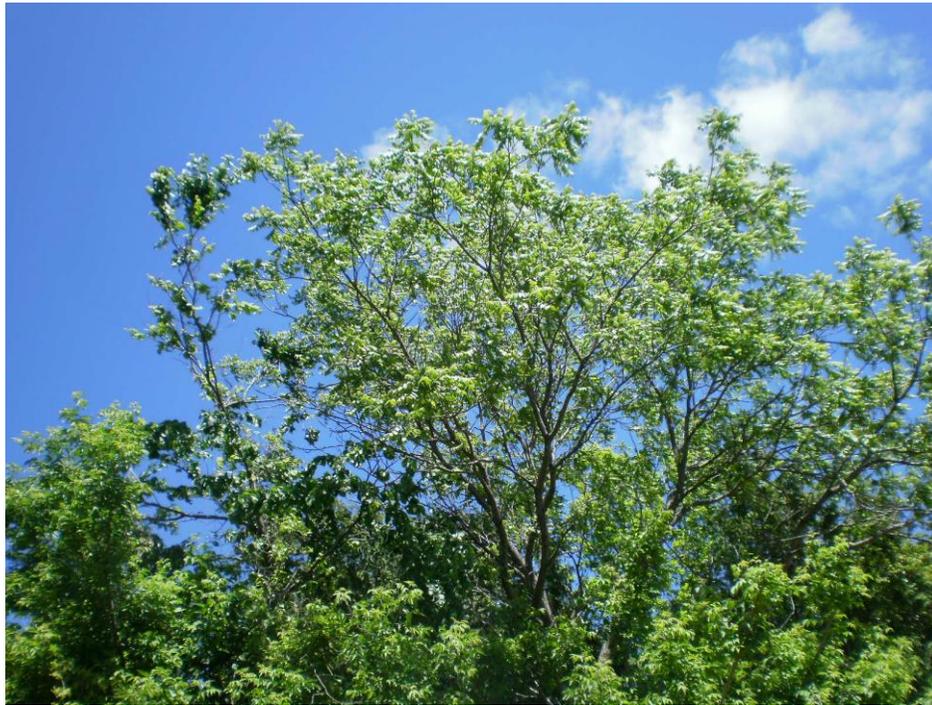
Photo 18 - 35cm dbh butternut in deciduous hedgerow in the south-central portion of the site was assessed as a healthy Category 2 tree

Other than butternut none of these Species at Risk were observed during the field surveys. Specific targeted surveys for Blanding's turtle, eastern whip-poor-will, bobolink and eastern meadowlark found no presence of these species. A 35cm dbh butternut was observed in the southwest portion of the site (Photo 18, a healthy Category 2 butternut). Thirty-one butternuts were assessed by Shaun St. Pierre, a certified Butternut Health Assessor (#281), on July 4th and 16th, 2016. About half of the butternuts (14 of 31) were assessed as unhealthy (Category 1). Sixteen butternuts were assessed as healthy Category 2 butternuts. Fourteen of these Category 2 butternuts were saplings (2cm dbh or less). One 35cm dbh Category 3 butternut was identified along the southwest site boundary. A Category 3 butternut is defined as a healthy tree of at least 20cm dbh within forty metres of an unhealthy butternut. The Category 1 butternuts do not require protection going forward as it has been thirty days since the butternut health assessment report was submitted to MNRF. Any butternuts assessed as healthy are to be protected with the setback until their removal has been compensated for through the on-line registry process or a MNRF permit has been issued.
