Phase I Environmental Site Assessment

Vacant Land
Trim Road and Portobello Boulevard
Ottawa, Ontario

January 20, 2018

Report: PE4111-1

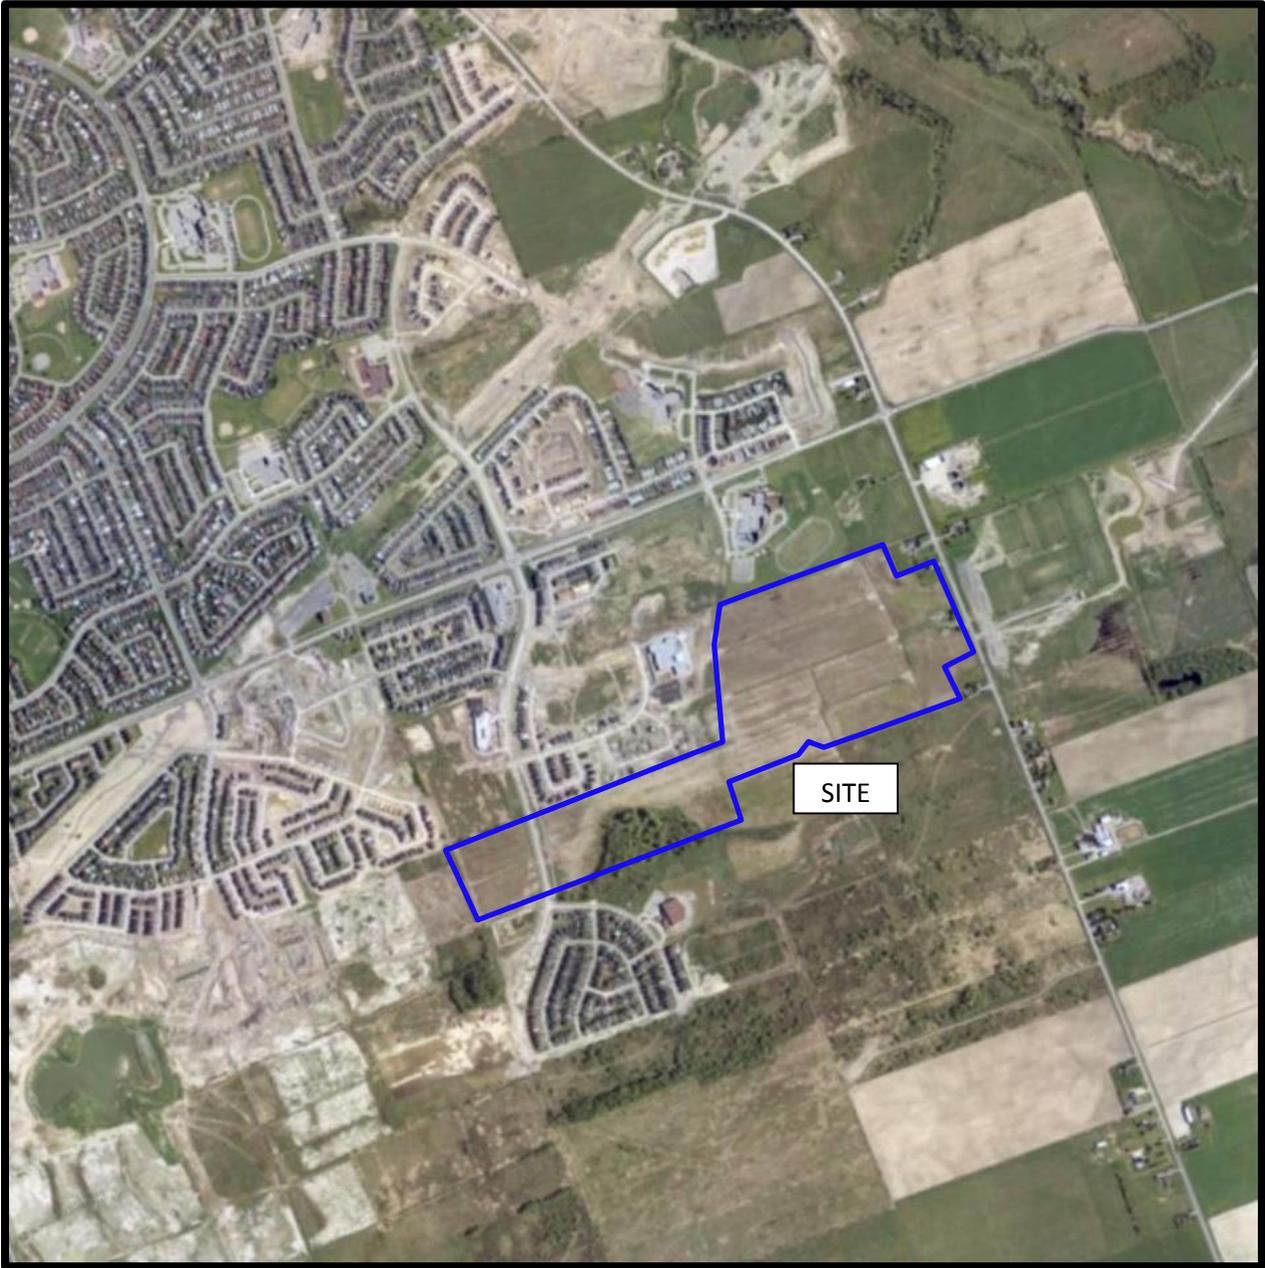
AERIAL PHOTOGRAPH
2002

| 2002 | (City of Ottawa website) The structures on the subject site have been demolished. A pile of rubble is visible on the subject site in the former location of the structures. Several residential developments have been constructed north and south of the subject site. Two (2) schools have been constructed north of the subject site. Soil grading (for soccer fields and additional developments) is visible north and west of the subject site, as well as on the east side of |

Trim Road. Additional residential dwellings are being constructed north of the subject site, along Portobello Boulevard and Scala Avenue.

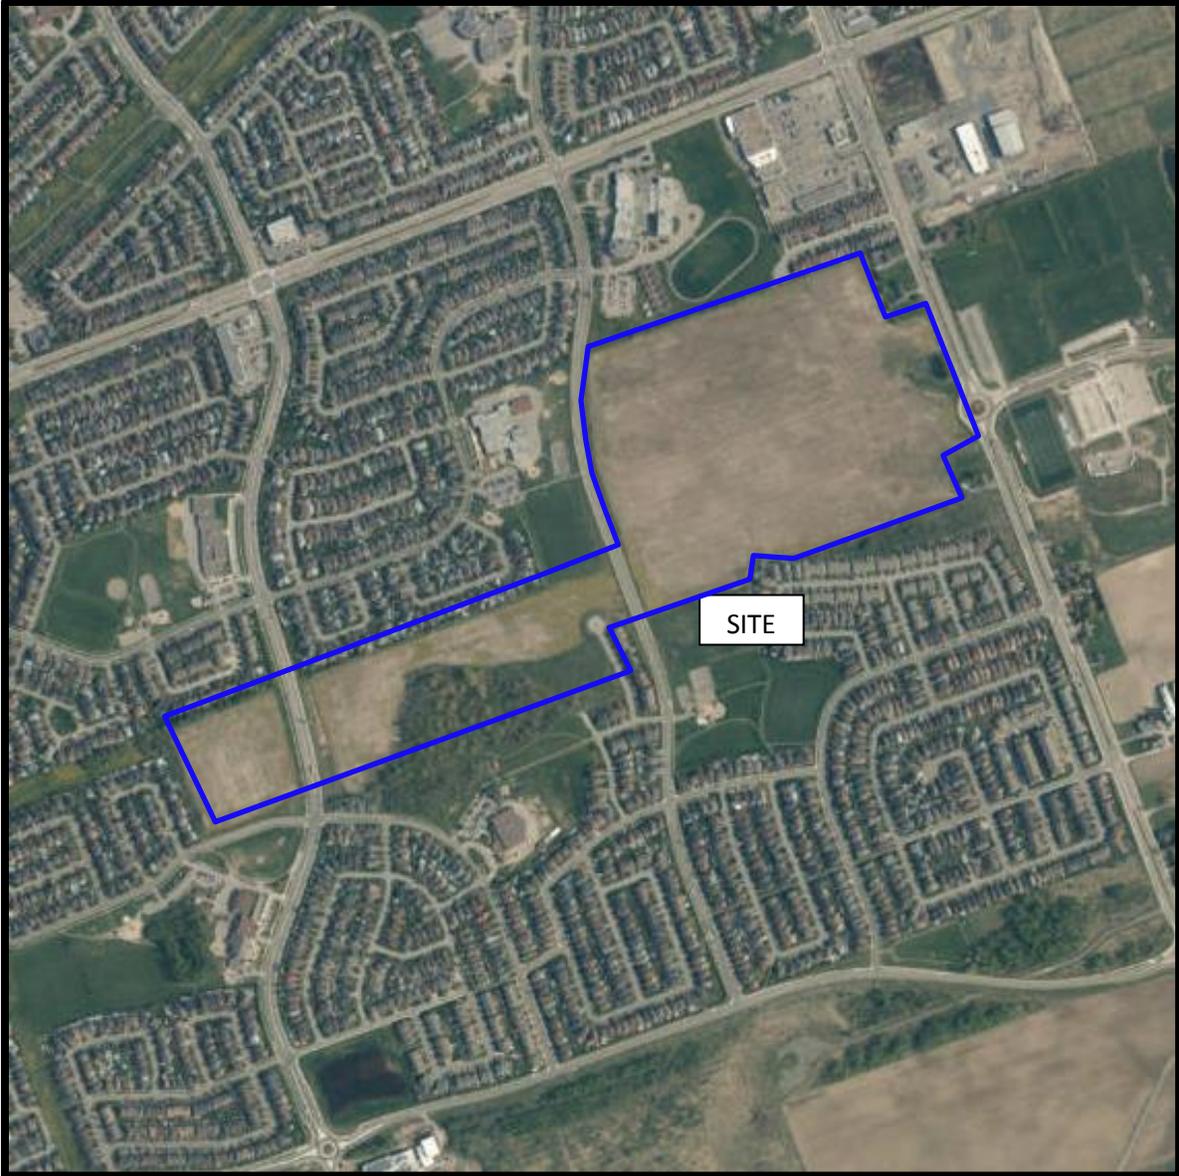
AERIAL PHOTOGRAPH
2017

2017 (City of Ottawa website) The subject site and neighbouring properties appear as they do today. Residential dwellings have been constructed south (north of Montmère Avenue and east of Provence Avenue) and north (along Scala Avenue) of the subject site. The City of Ottawa's Trim Road Garage Depot is visible further to the northeast, on the east side of Trim Road (2035 Trim Road and 5300 Innes Road).

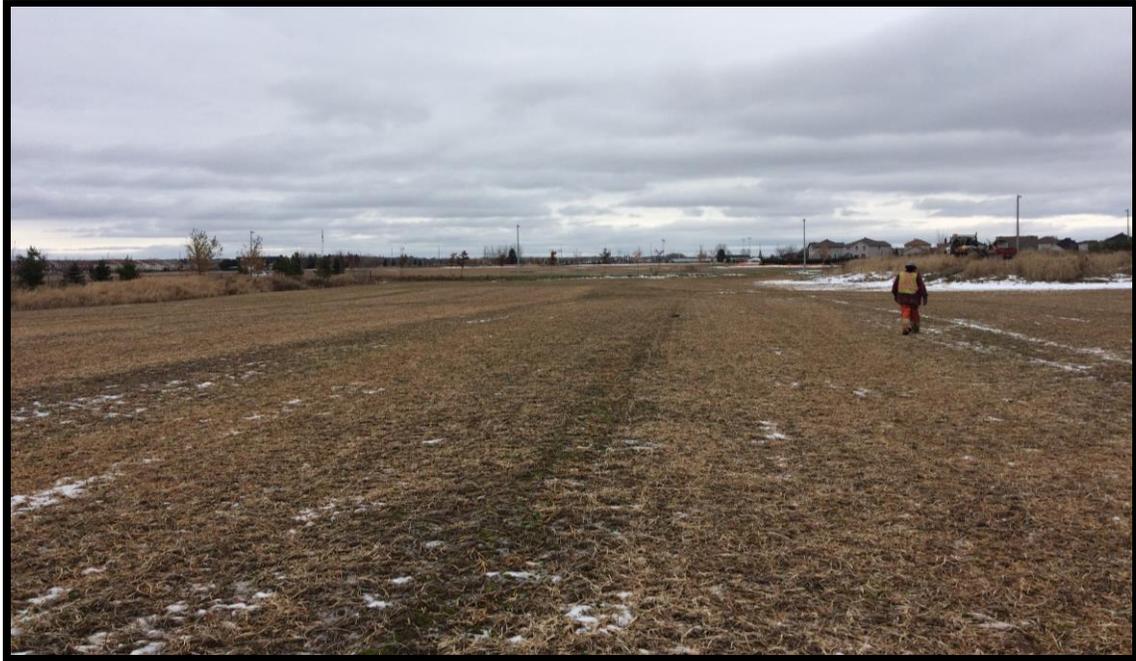
Photograph 1: View of the southwestern portion of the site, facing east. Photograph depicts an agricultural field, the main land cover on the site.

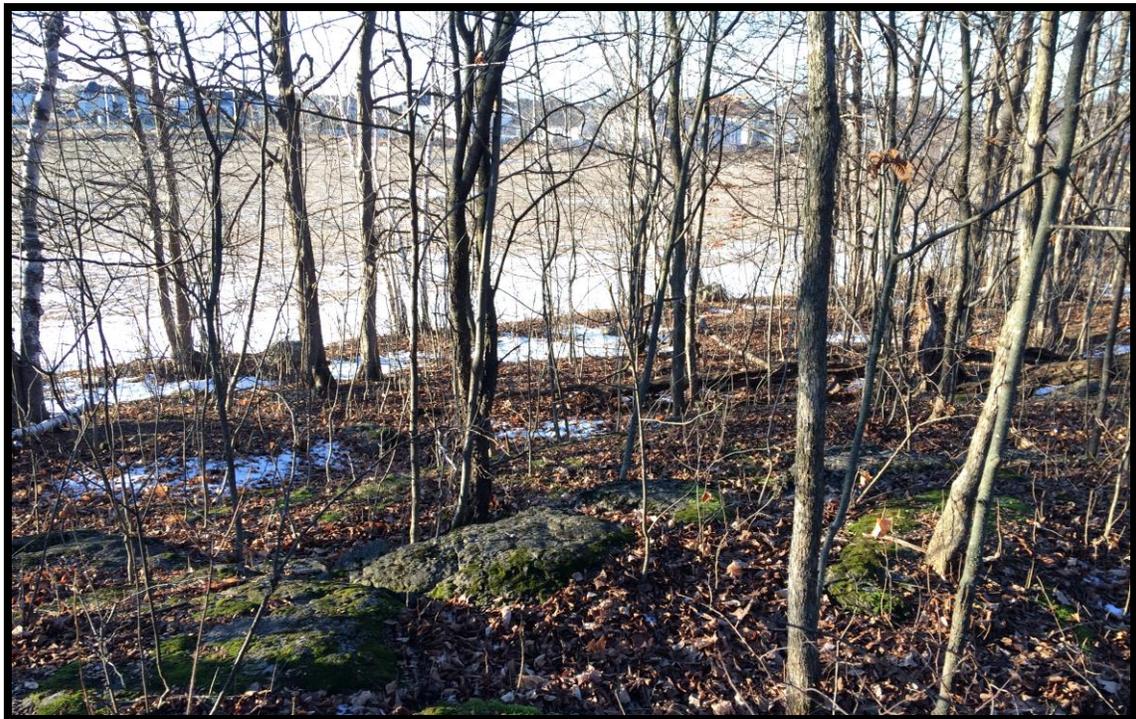
Photograph 2: View of the forested area with outcropping bedrock on the southwest portion of the subject site, facing north.

The subject site is generally flat and undeveloped agriculture land. A small forested ridge with outcropping bedrock is located on the southern portion of the site, north of the Lalande Conservation Park and east of Portobello Boulevard. Drainage consists primarily of infiltration with some sheet flow to catch-basins along adjacent roads. The adjacent properties are generally at grade with the subject site. The site was snow covered at the time of the site visit, however, site photographs were taken by Paterson personnel from the geotechnical department in November, prior to the arrival of snow.

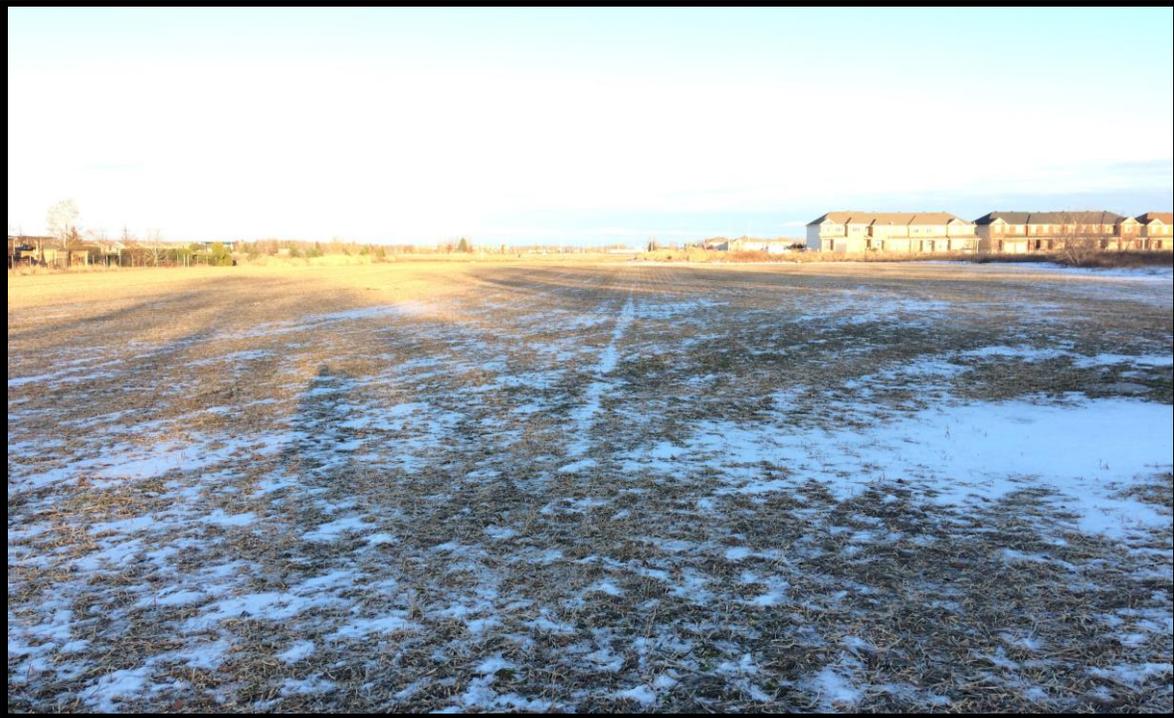
Photograph 3: View of the central portion of the subject site, facing southwest.

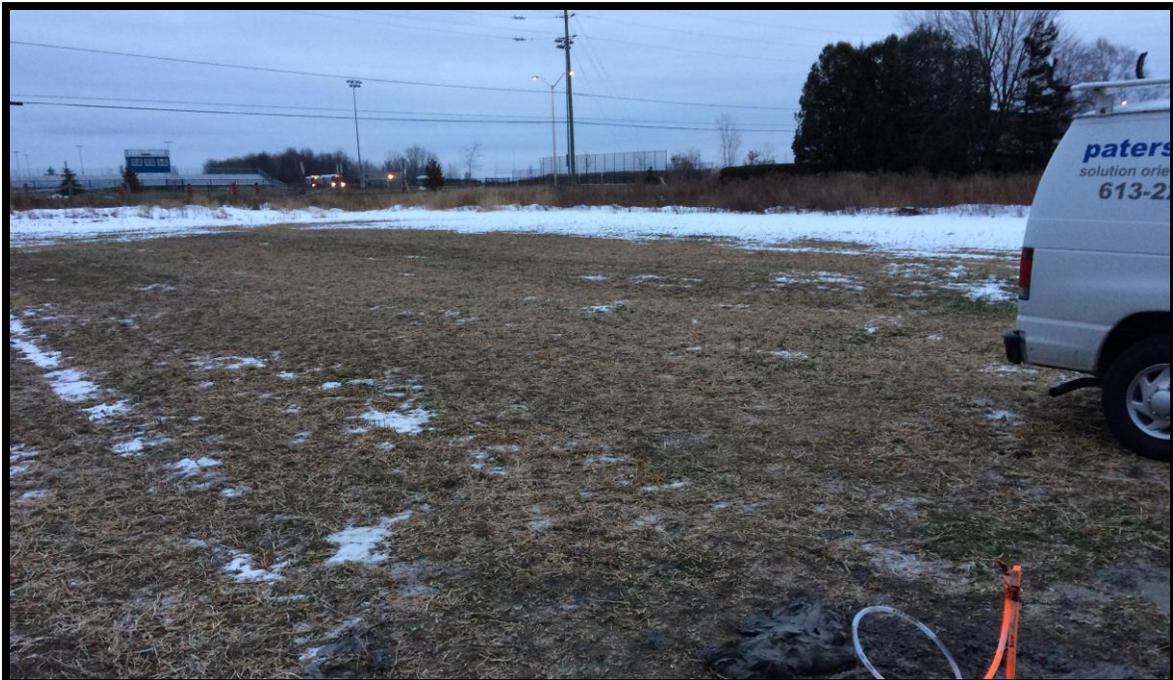
Photograph 4: View of eastern portion of the site, adjacent to Trim Road. Photograph taken facing northeast.
