# Hydrogeology Investigation, Terrain Analysis and Impact Assessment

*Cavanagh Developments, 2596 Carp Road, Ottawa, Ontario*

### **Golder Associates Ltd.**

September 2018

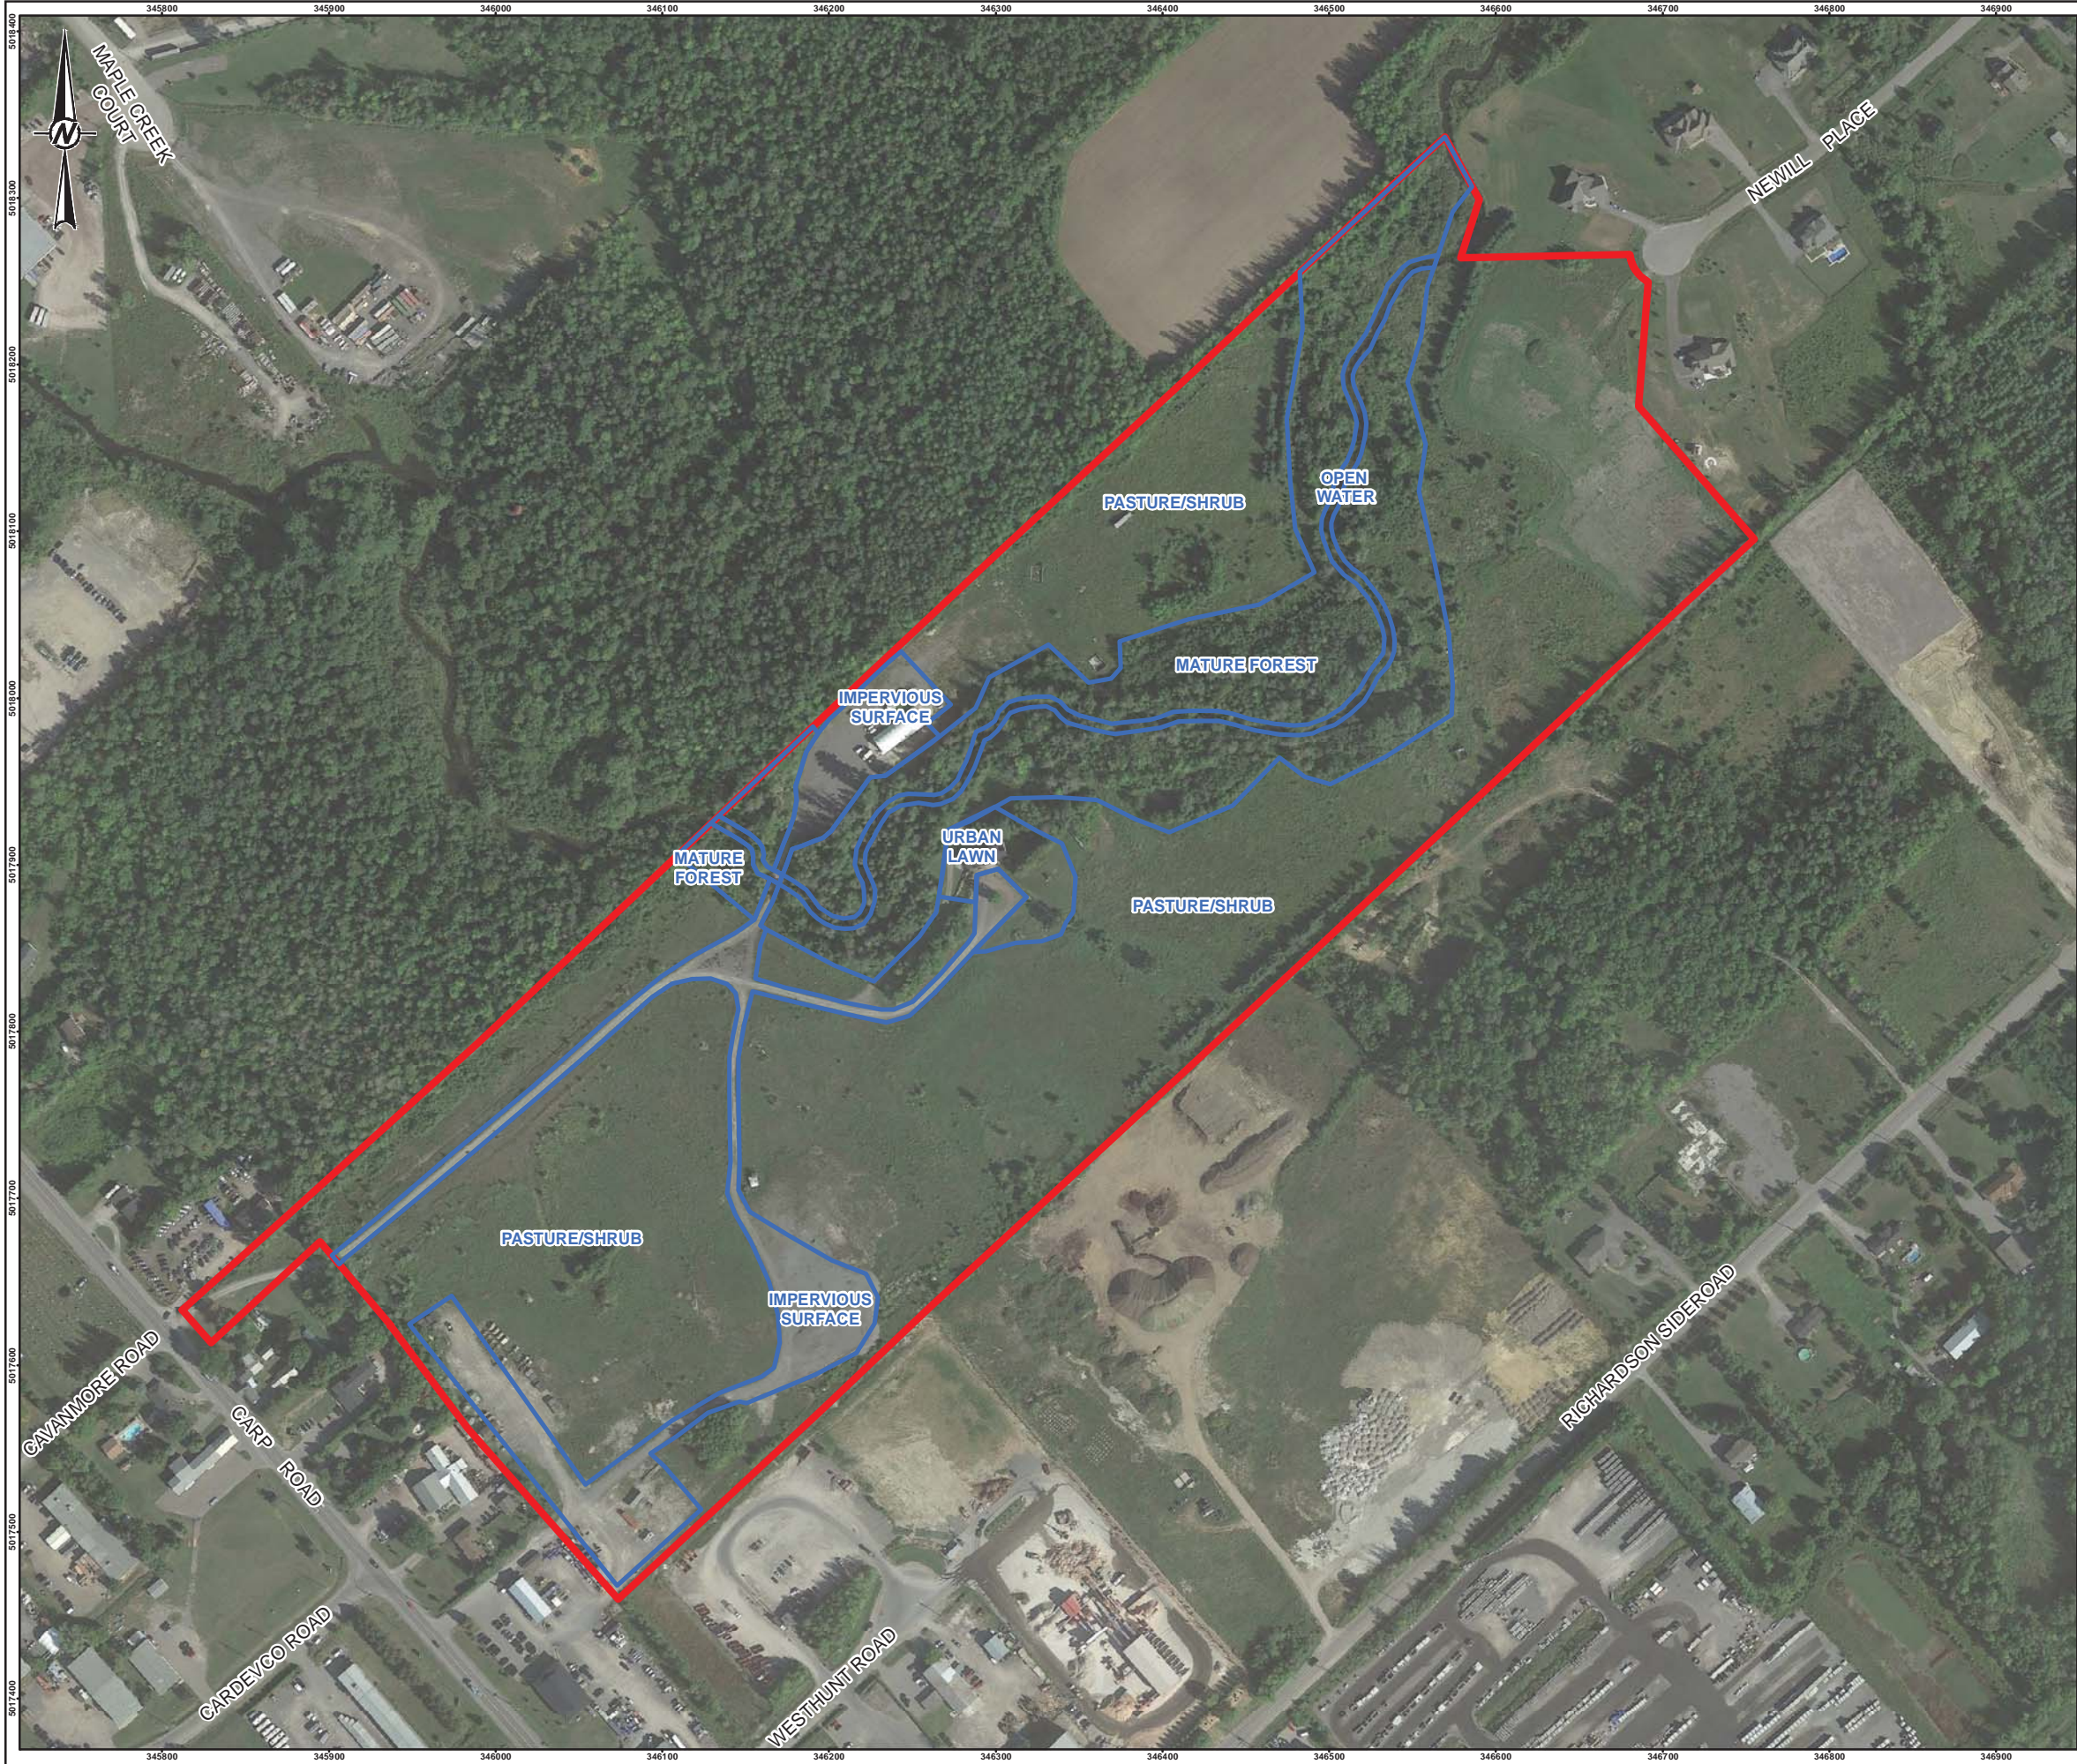
DESIGNED	---
		PREPARED	ABD
		REVIEWED	LEB
		APPROVED	BTB
PROJECT NO.	PHASE	REV.	FIGURE
1543767	2001	0	5

- For the purpose of determining WHC, land use at the Site under existing conditions was identified from Google Earth imagery (dated September 2016) and Golder's Site visits. In keeping with the vegetation cover types described in the MOE Manual (2003), land use was classified as follows (see Figure 5):

- The rest of the Site area was classified as "Pasture/Shrub", based on the presence of tall grasses and shrubs.
- For impervious surfaces, an infiltration factor of zero indicating no infiltration occurring on these surfaces was applied. It was assumed that 20% of precipitation on impervious surfaces would evaporate, while 80% would become runoff (Cuddy et al., 2013).

The following table presents the results of the water balance under pre-development conditions for average annual conditions.

The total estimated average annual pre-development runoff from the site is approximately 45,122 m<sup>3</sup> and the estimated infiltration is approximately 52,182 m<sup>3</sup>.

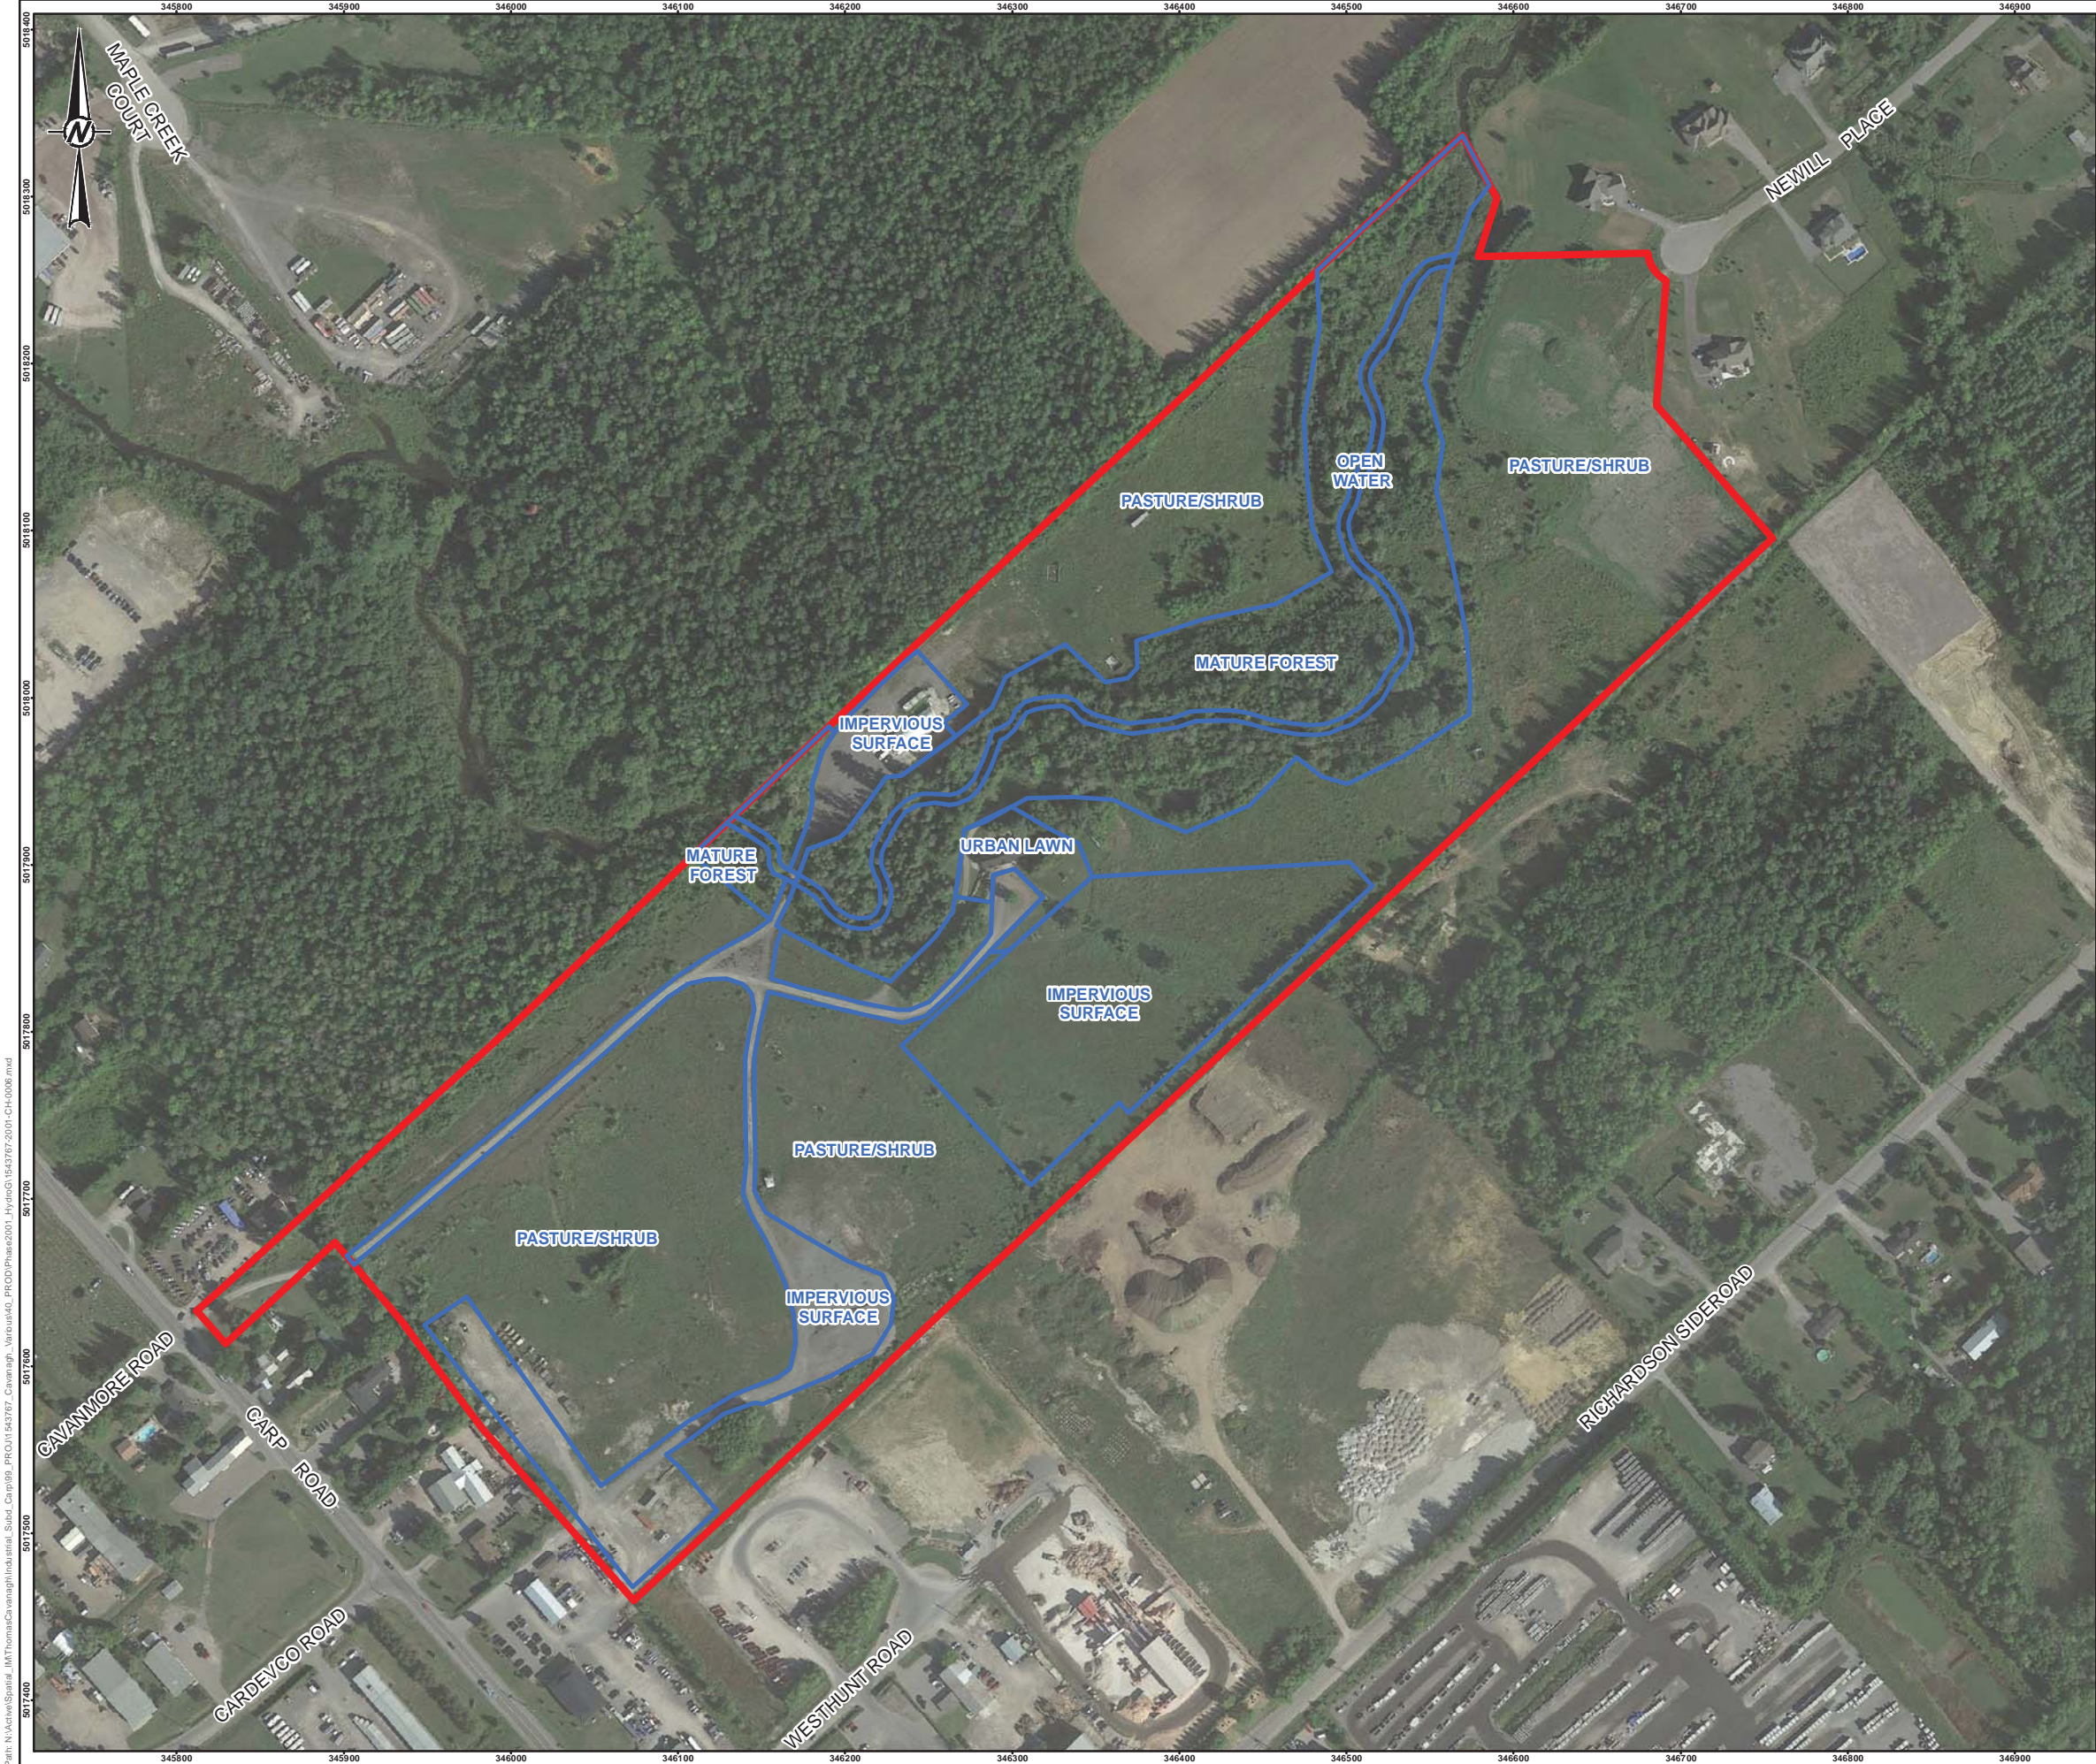
The post-development water balance excludes the LID features (bioretention facilities) proposed for the concrete plant site, which are addressed in the following section. The water balance was completed for the Site under post-development conditions using the same method presented for the pre-development conditions. The assumptions for post-development conditions were the same as described in the previous section for pre-development conditions, with the following exception:

The total estimated average annual post-development runoff from the site is approximately 60,675 m<sup>3</sup> and the estimated infiltration is approximately 47,015 m<sup>3</sup>.

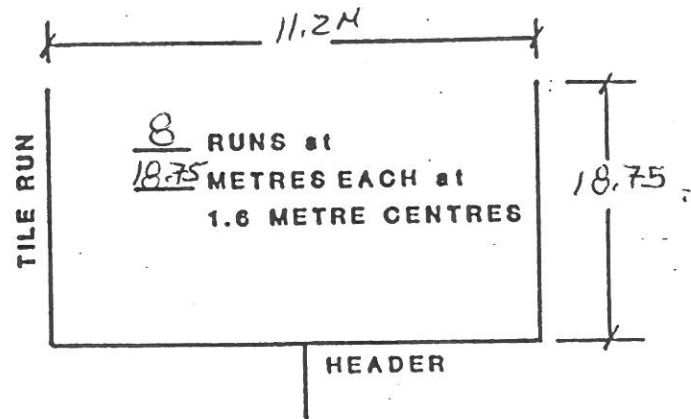
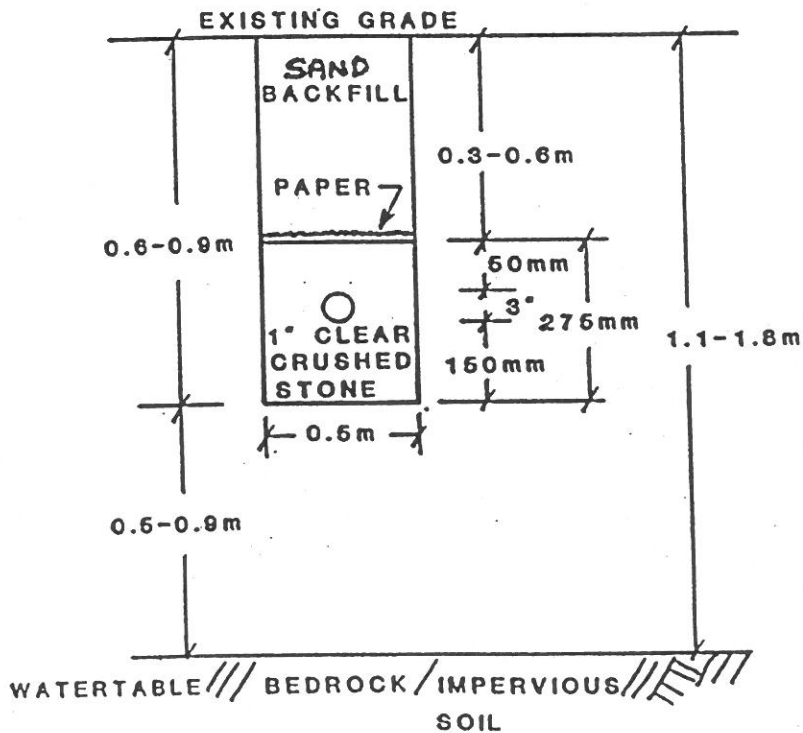
# TYPICAL DRAWING A BURIED BED-ABSORPTION TRENCH METHOD

PLAN

PROFILE
