Phase One Environmental Site Assessment Undeveloped Property

8900 Jeanne d'Arc Boulevard and
100 Inlet Private
Ottawa, Ontario

Brigil Construction Inc.

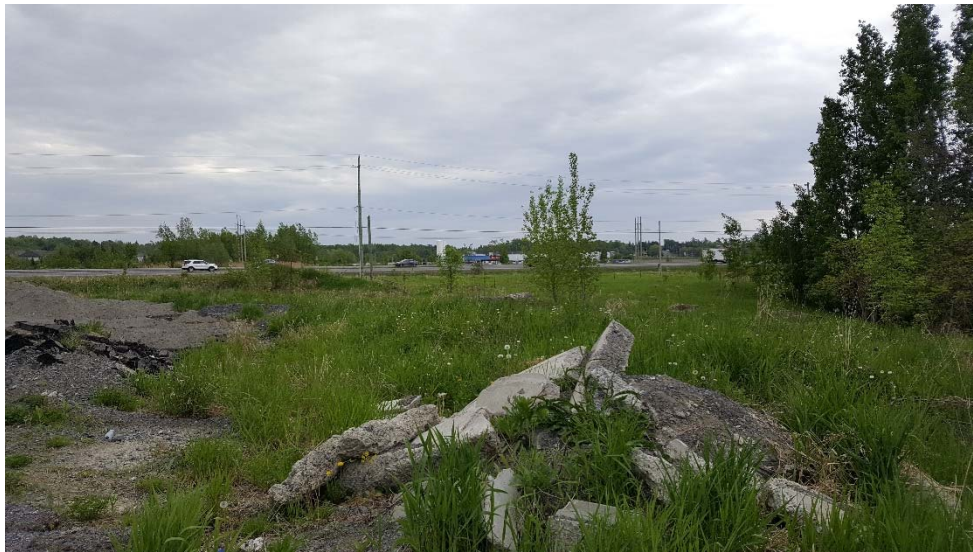
Photo 1 - View of the south portion of the Site facing south. View depicts temporary piles of construction debris and overgrown vegetation.

the concrete construction debris and fill pile was piled at the Site during development of the adjacent properties to the north by the Client. Based on observations and discussion with the Client, the fill consists of stripped topsoil and excavated material from foundations of buildings on the adjacent property to the north, which have been constructed by the Client. The presence of imported fill material is not suspected on the Site.

The Site has surface cover of grass vegetation with the exception of a temporary gravel parking area on the west portion of the Site for undergoing construction activities at the adjacent property to the north. The Site is approximately level with Jeanne d'Arc Boulevard to the west, and Regional Road 174 to the south. A pile of concrete construction debris was observed on the south portion of the Site as well as stockpiled fill material was observed on the east portion of the Site; however, it was suspected that the concrete construction debris and fill pile at the Site as a result of development of the adjacent properties by the Client. It is suspected that the fill was stripped topsoil, and presence of imported fill material is not suspected on the Site; the Client representative confirmed that the fill would be removed as part of Site development.

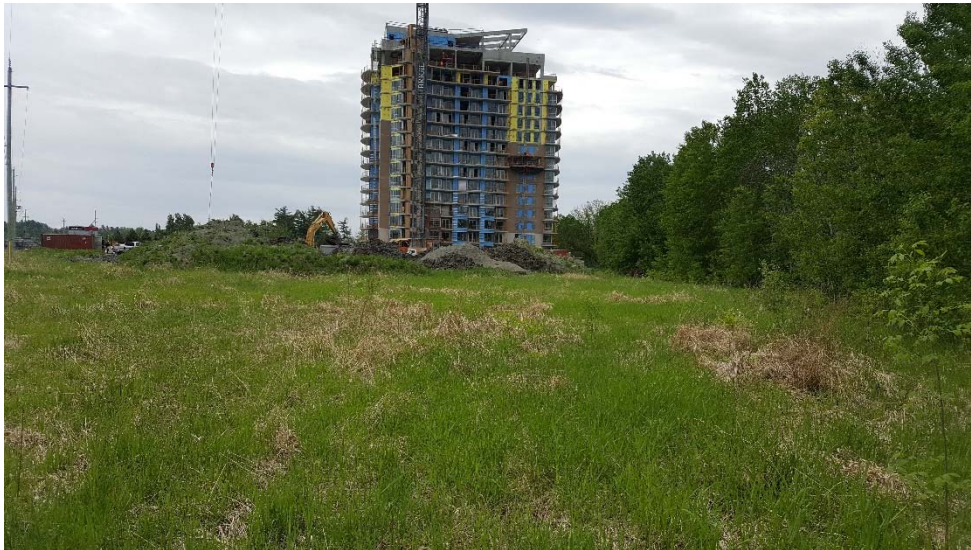
Photo 3 - View of the west portion of the Site facing west. View depicts overgrown vegetation and neighboring properties to the north under construction (residential condos).
