Phase One Environmental Site Assessment

*411, 415, 419, 423, 425 & 431 Ravenhill Avenue, 566, 570 & 576 Byron Avenue,
and 436 & 440 Roosevelt Avenue, Ottawa, Ontario*

1793155-1000

October 2018

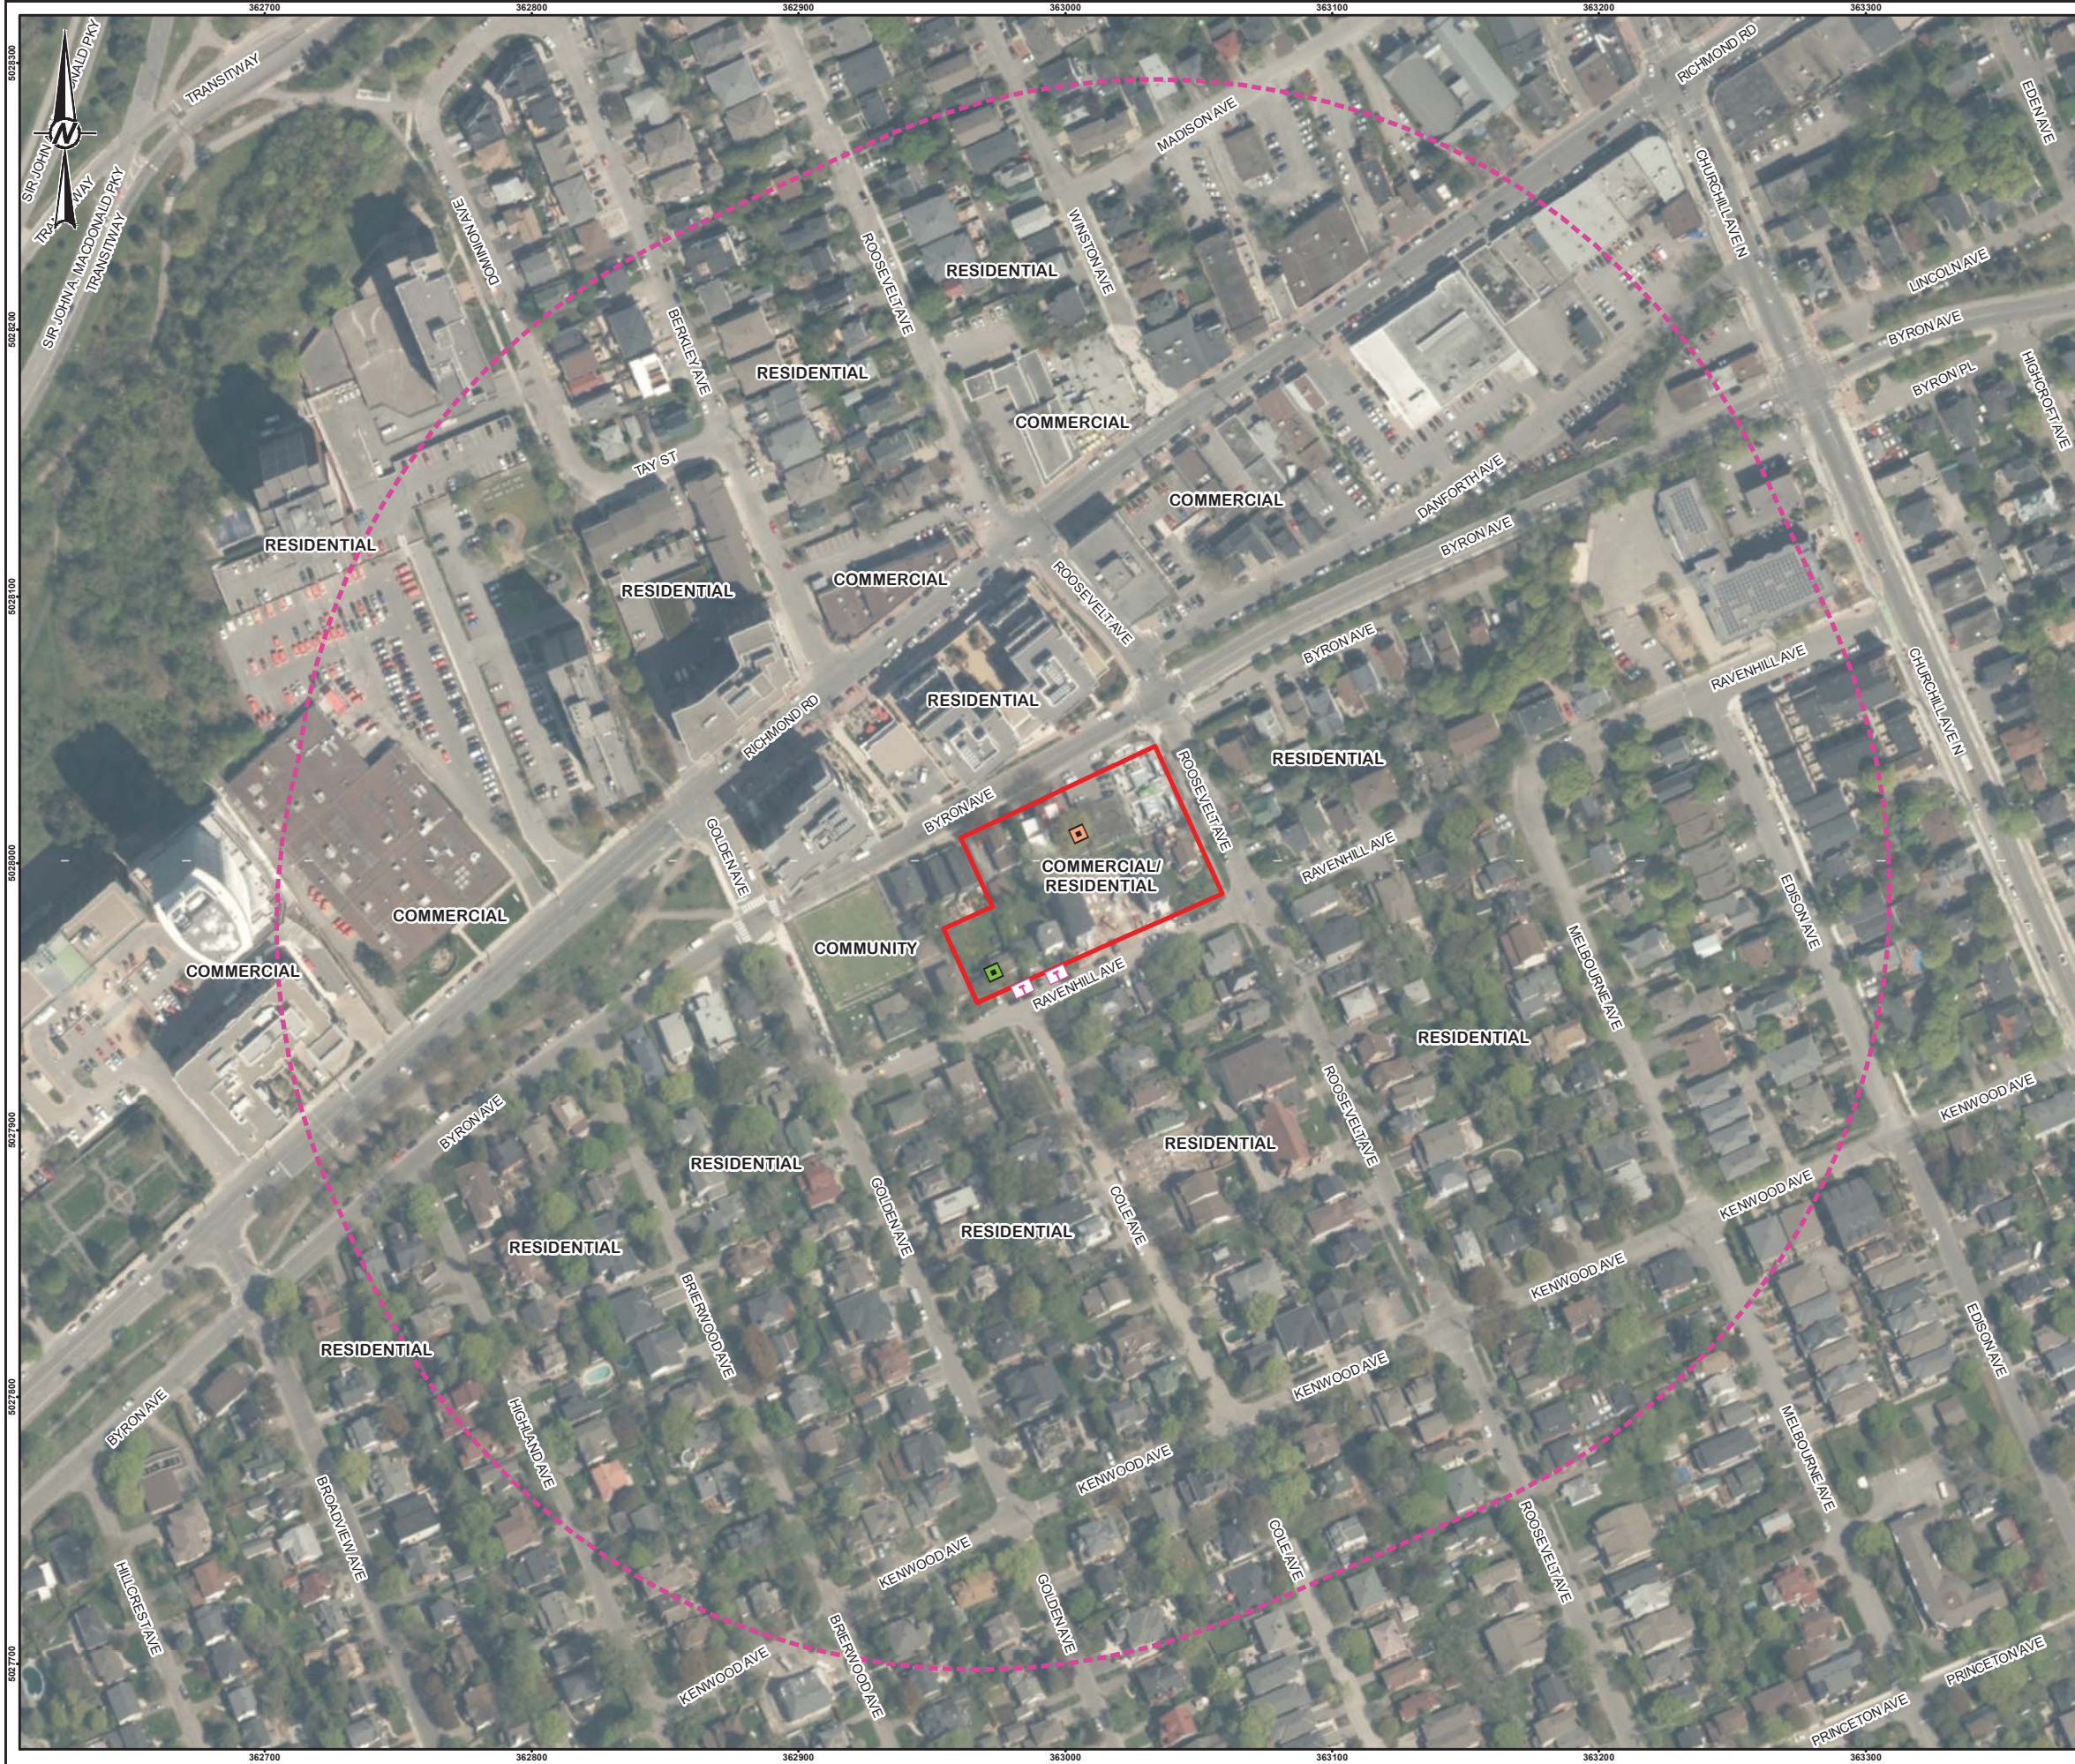
- LEGEND**
- PHASE ONE SITE BOUNDARY
 - PHASE ONE STUDY AREA
 - POLE MOUNTED TRANSFORMER
 - SINGLE WALL NON-METALLIC AST
 - DOUBLE WALL NON-METALLIC AST

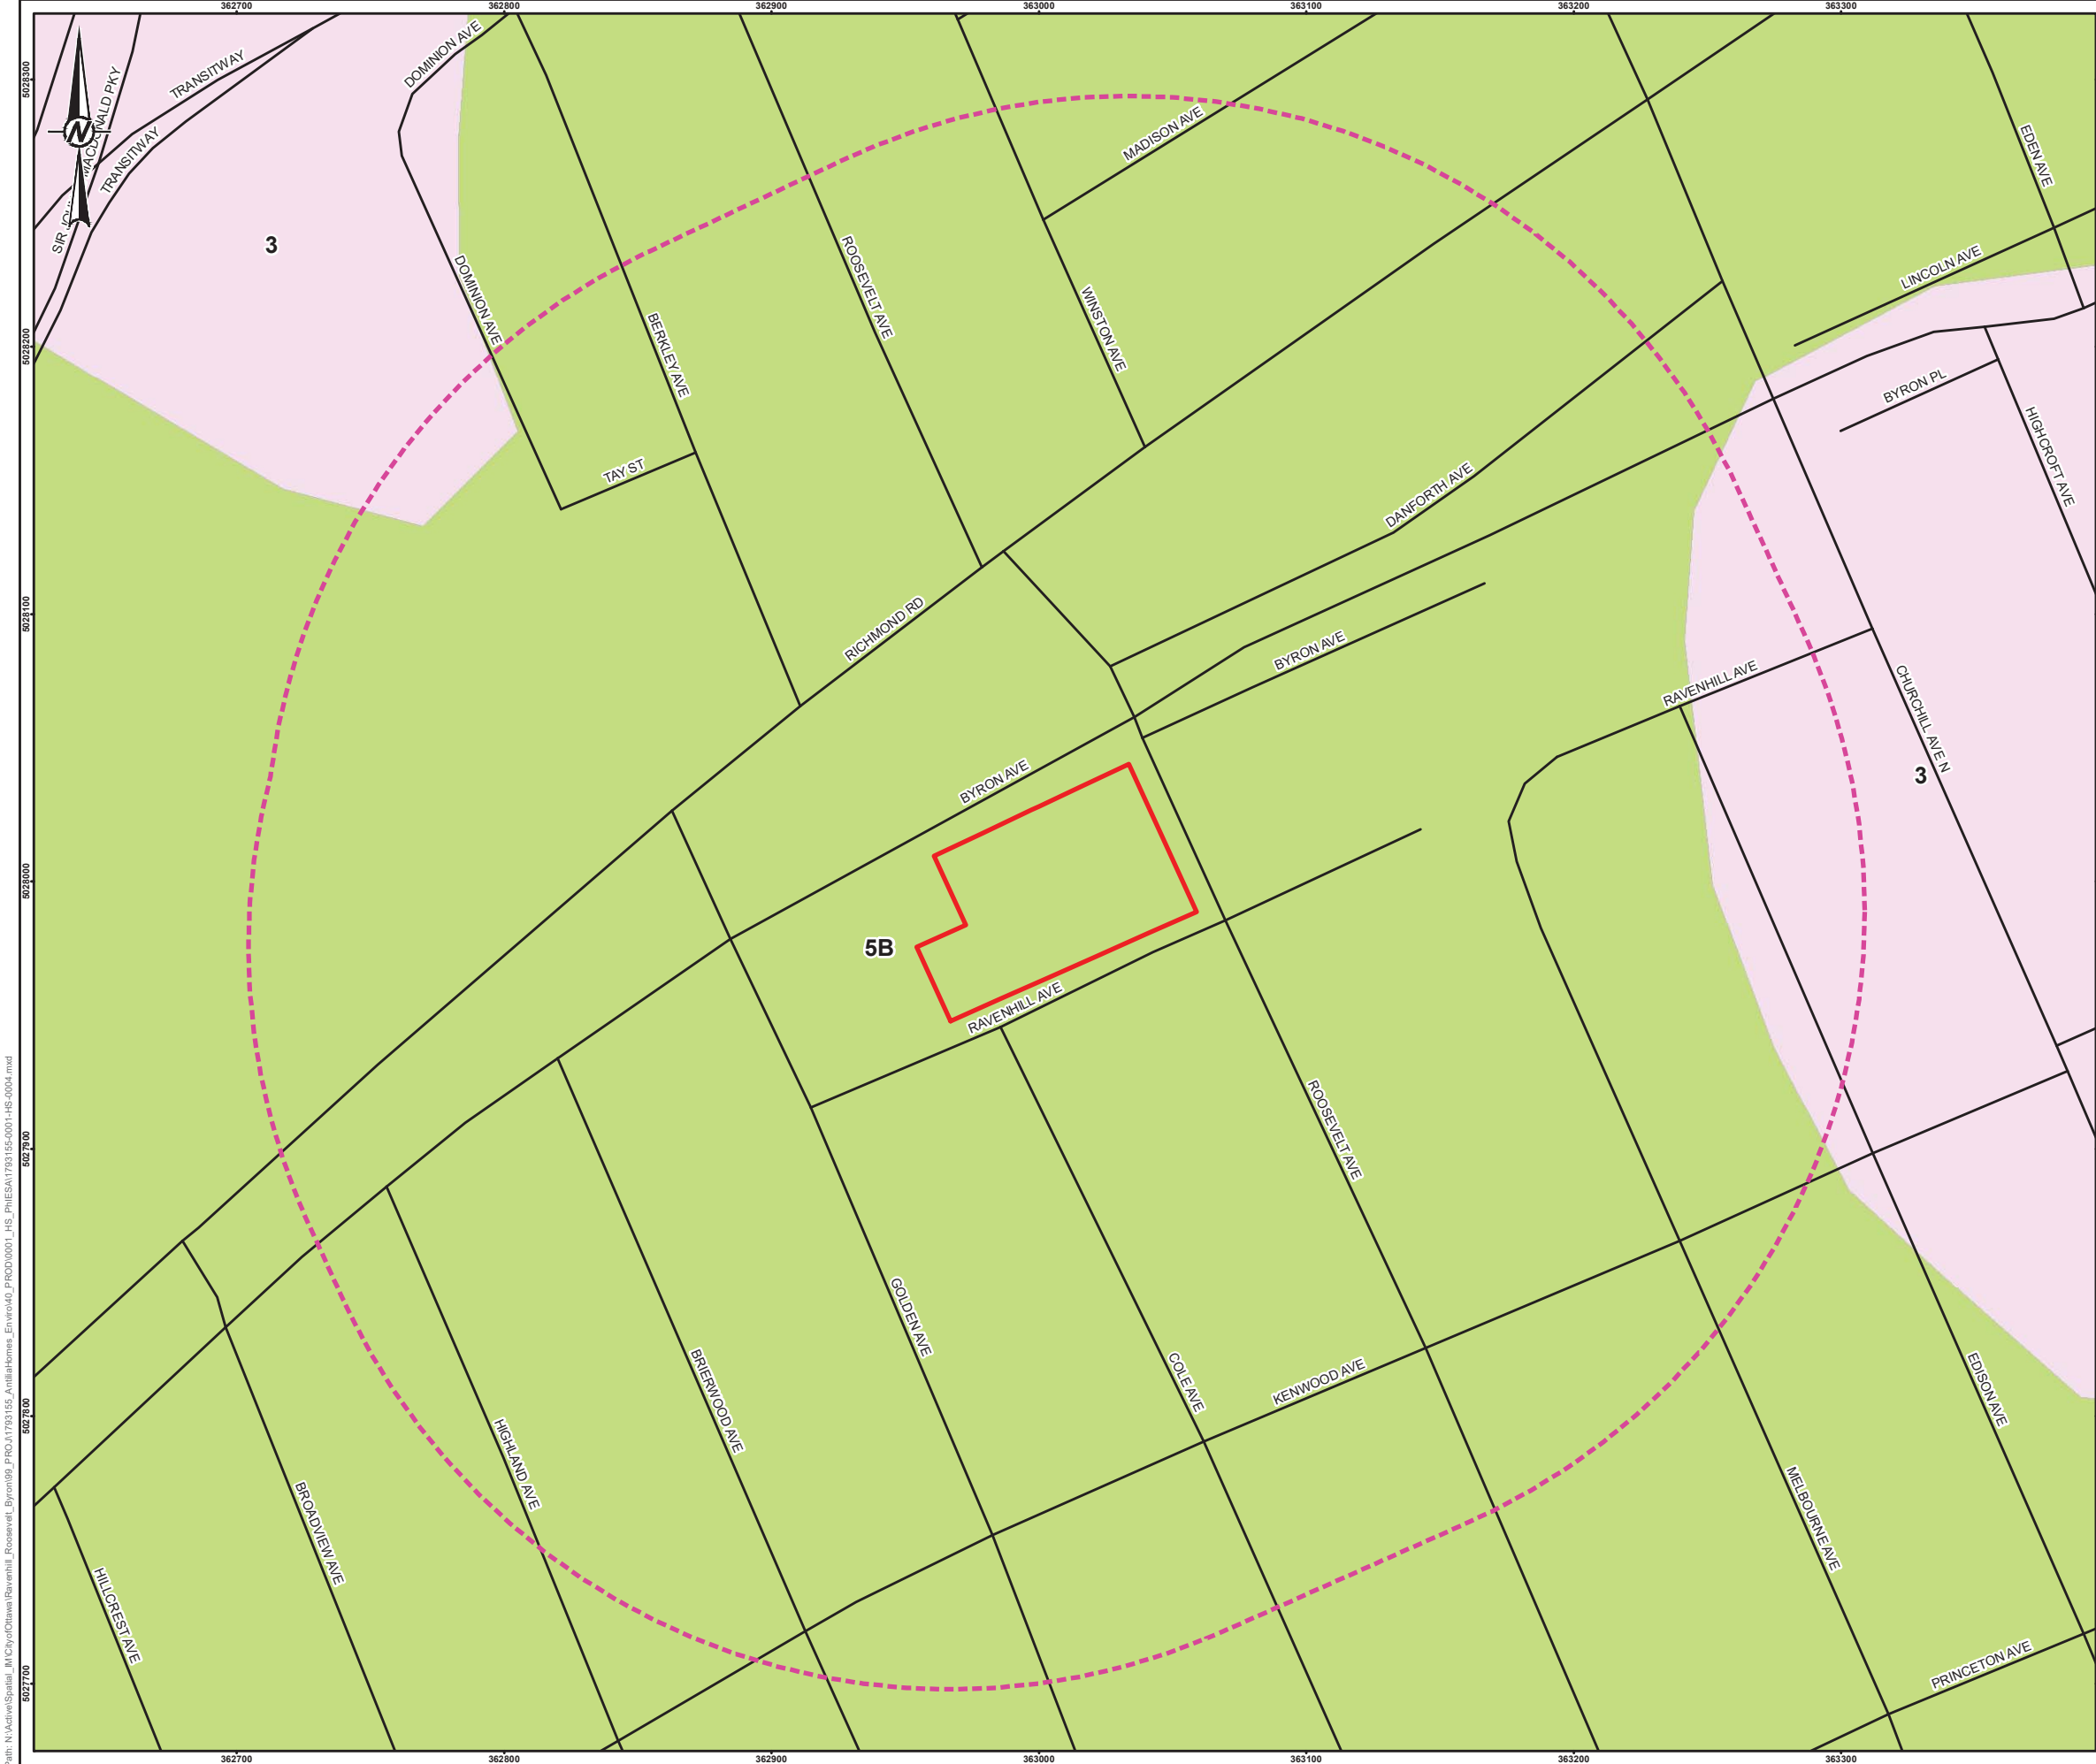
FIGURE
3

The following records were reviewed to identify topographic, geologic and hydrogeological conditions at the Site. A topographic map (Ontario Base Map) showing the Site and the Phase One Study Area and the location of any water bodies is provided in Figure 3. Additional information on Site features, as observed at the time of the Site visit, is provided in Section 6.

Topic	Conditions	Comment / Source
Topography of Site and Surrounding Area	The topography of the Site and surrounding area is sloped to the west.	Site and surrounding area observations and Figure 3 – Topographic Map and Areas of Natural Significance
Overburden Soils	Till: stone-poor, sandy silt to silty sand-textured till on Paleozoic terrain (<5 metres).	Bélanger, J. R. 2008 Urban Geology of the National Capital Area, Geological Survey of Canada, Open File 5311, 1 DVD.
Type of Bedrock	The Site primarily consists of Gull River Formation with limestone, with dolostone beds towards base with central portion consisting of Rockcliffe formation with sandstone, shale, limestone and dolostone.	Armstrong, D.K. and Dodge, J.E.P. 2007. Paleozoic Geology of Southern Ontario; Ontario Geological Survey, Miscellaneous Release – Data 219
Depth to Bedrock	The depth to bedrock is expected to be between 1 and 5 metres below ground surface (mbgs).	2010 Bélanger, J. R., Urban Geology of the National Capital Area, Geological Survey of Canada, Open File D3256, 2001

Inferred Near Surface Groundwater Flow	Local groundwater is anticipated to flow north towards the Ottawa River.	Site and surrounding area observations, Figure 1 – Key Plan and Figure 3 – Topographic Map and Areas of Natural Significance
Site Grade Relative to the Adjoining Properties	The Site appears to follow the topography of the area and inclines below the grade of the surrounding properties east of the Site, above the grade of the surrounding properties west of the Site and is generally at grade with surrounding properties north and south of the Site. During follow-up Site visit, 425 Ravenhill Avenue was excavated below grade for redevelopment purposes, likely multi-tenant residential building.	Site and surrounding area observations and Figure 3 – Topographic Map and Areas of Natural Significance
Depth to Groundwater	Not identified.	N/A

Topic	Conditions	Comment / Source
Nearest Open Water Body	The nearest permanent watercourse is the Ottawa River located approximately 460 m northwest of the Site.	Site observations and Figure 1– Key Plan
Areas of Natural Significance	No areas of natural and scientific interest (ANSI) are known to be located on the Site or on the Phase One Study Area.	Figure 3 (Topographic Map and Areas of Natural Significance)

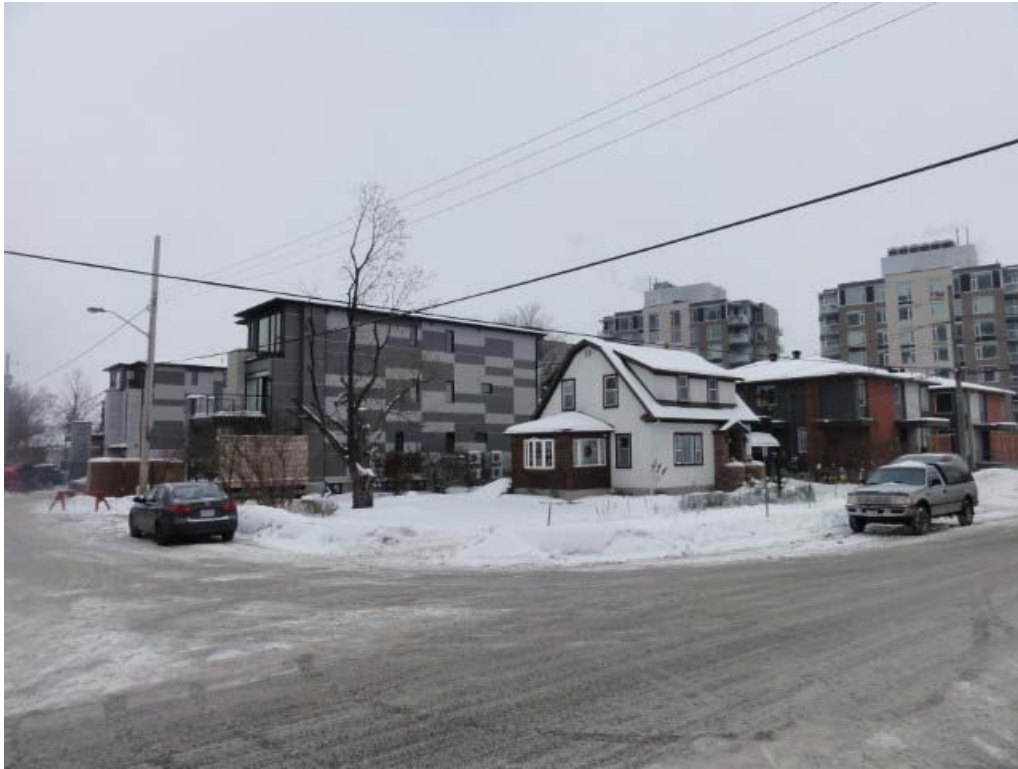
Photo 1: Looking northwest at the Site, elevation of the buildings on Ravenhill Avenue (photo taken Jan 4, 2018).

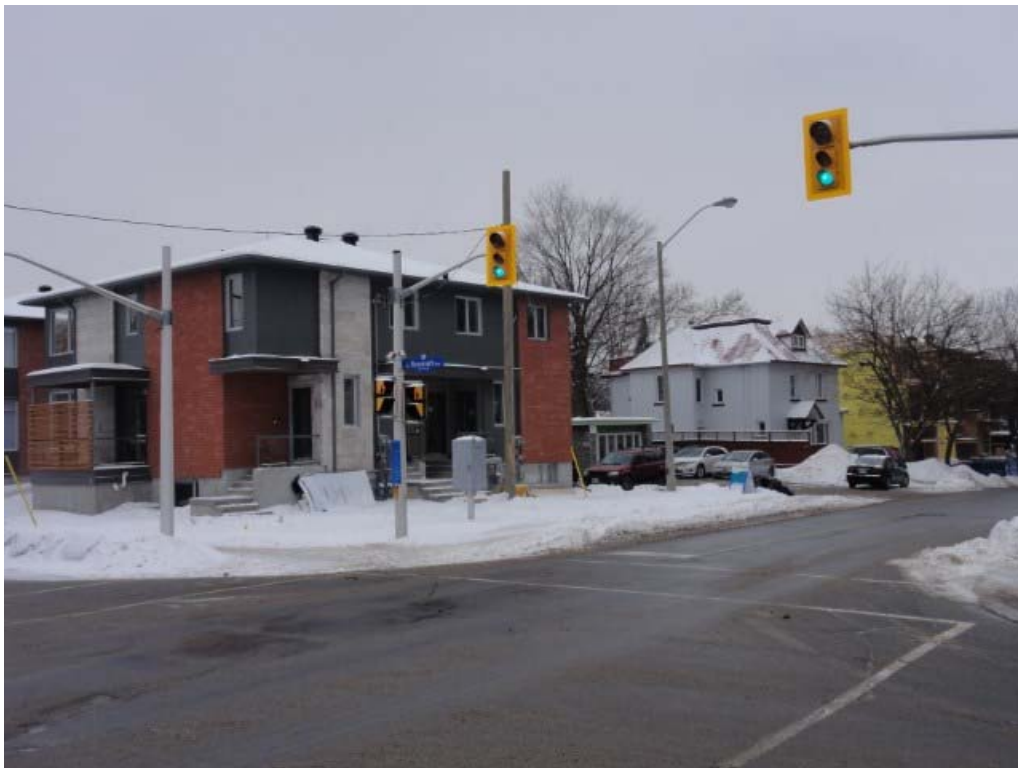
Photo 2: Looking southwest at the Site, elevation of the buildings on Byron Avenue (photo taken Jan 4, 2018).

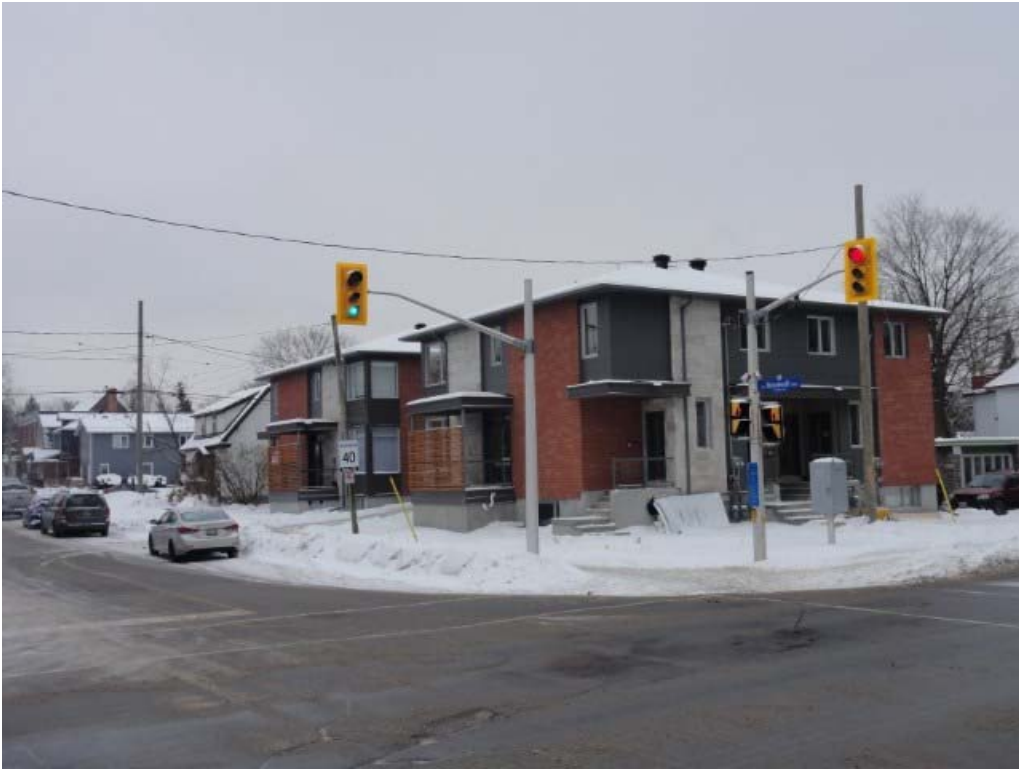
Photo 3: Looking southwest at the Site, elevation of the buildings on Roosevelt Avenue (photo taken Jan 4, 2018).

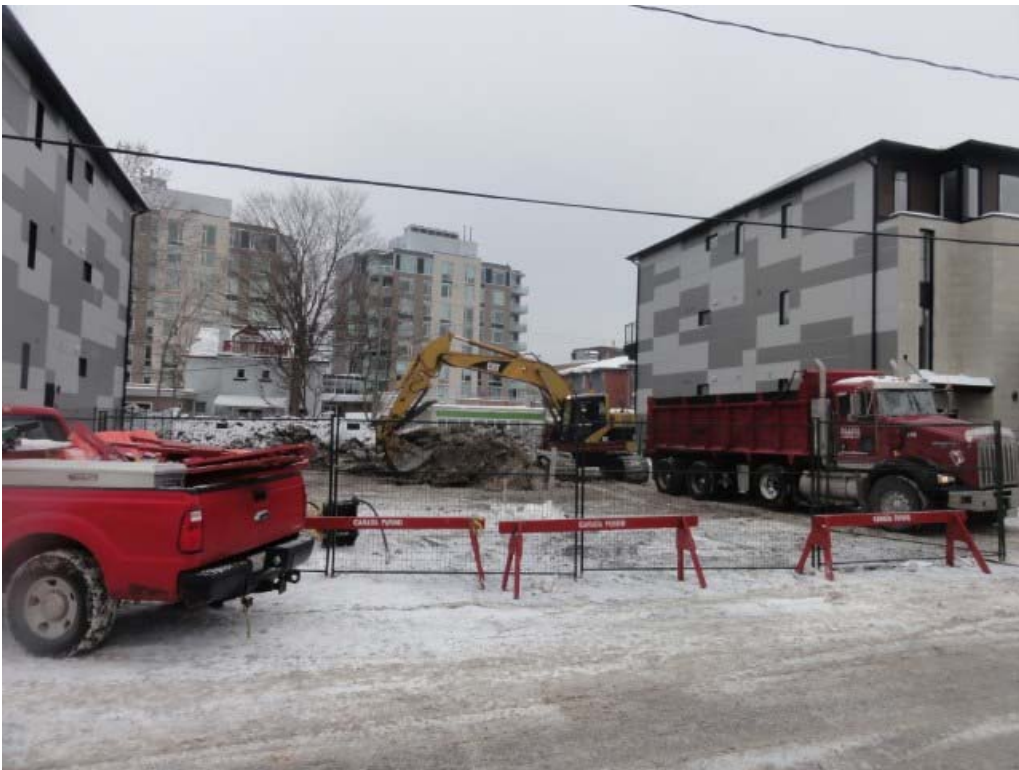
Photo 4: Looking northeast, construction of residential apartments on 415 and 419 Ravenhill Avenue (photo taken Jan 4, 2018).

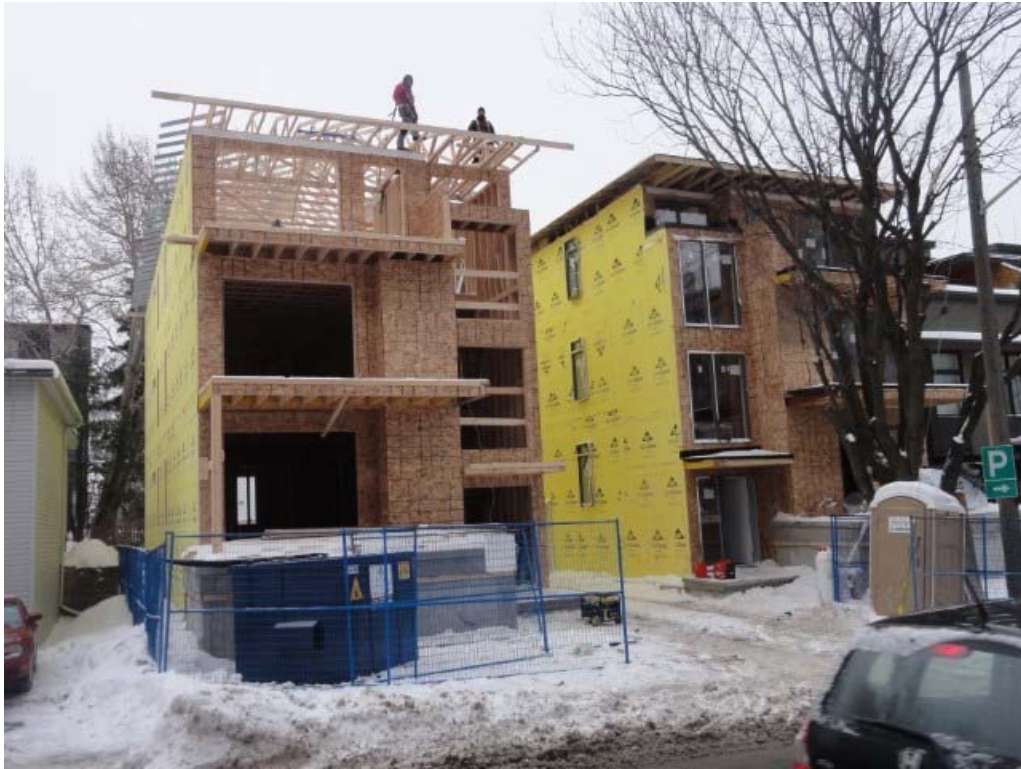
Photo 5: Looking southwest, construction of residential apartments on 574-576 Byron Avenue (photo taken Jan 4, 2018).

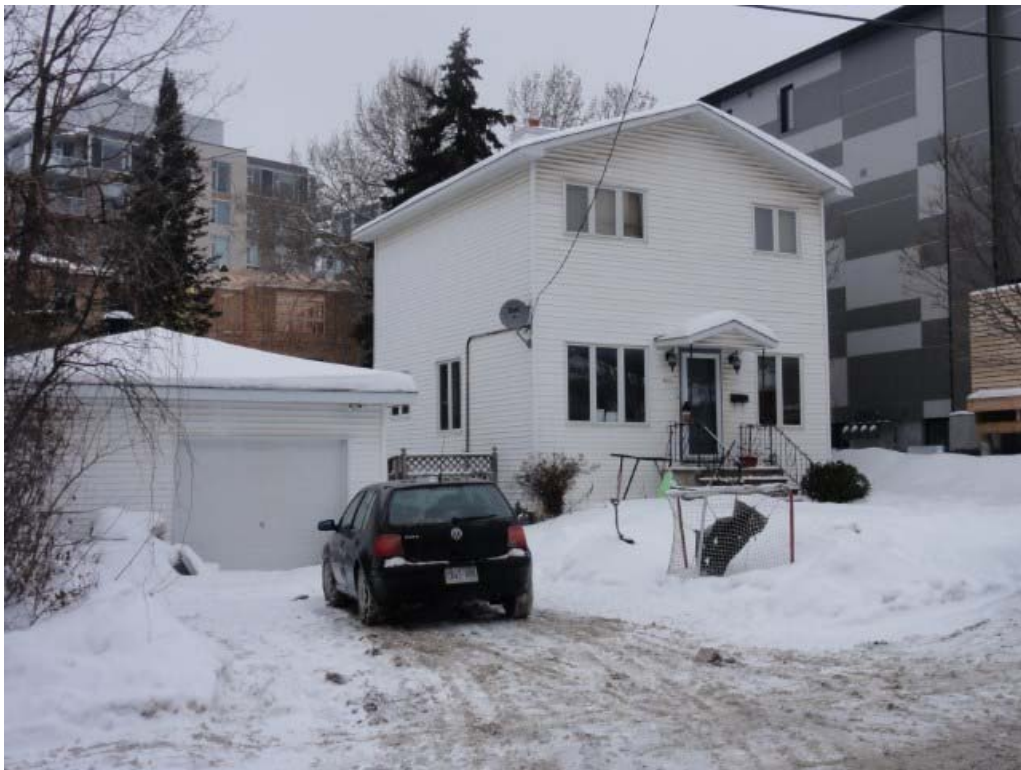
Photo 6: Looking northeast, a typical residential home (425 Ravenhill Avenue) at the Site (photo taken Jan 4, 2018).

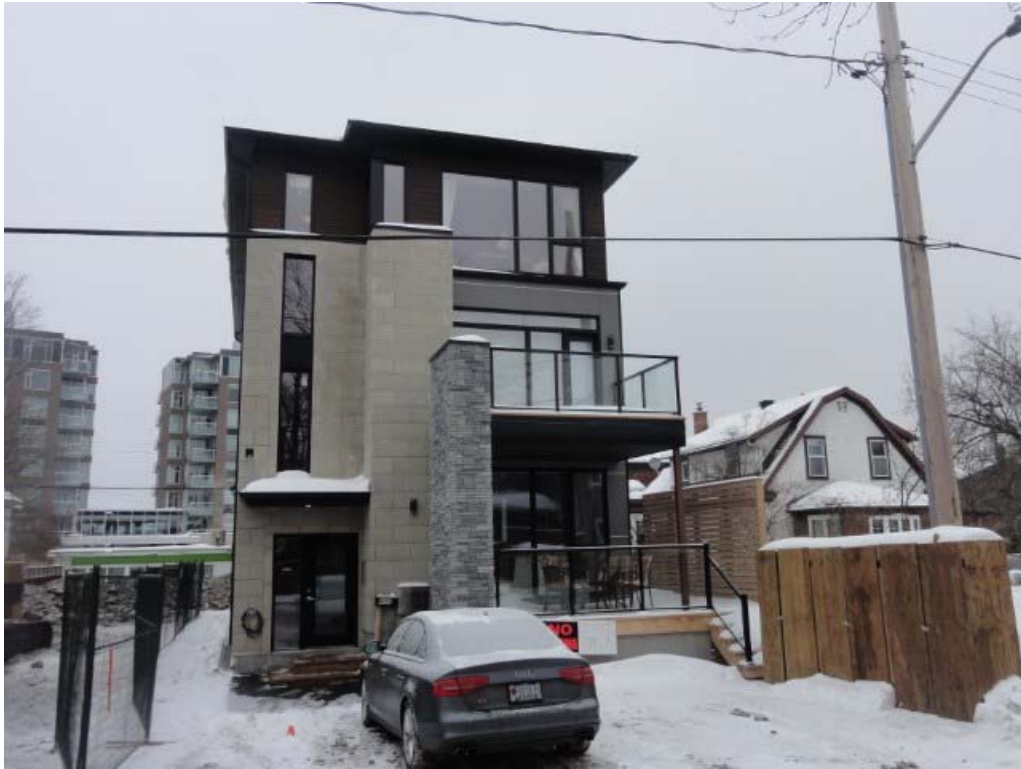
Photo 7: Looking northeast, a typical residential apartment (411 Ravenhill Avenue) at the Site (photo taken Jan 4, 2018).

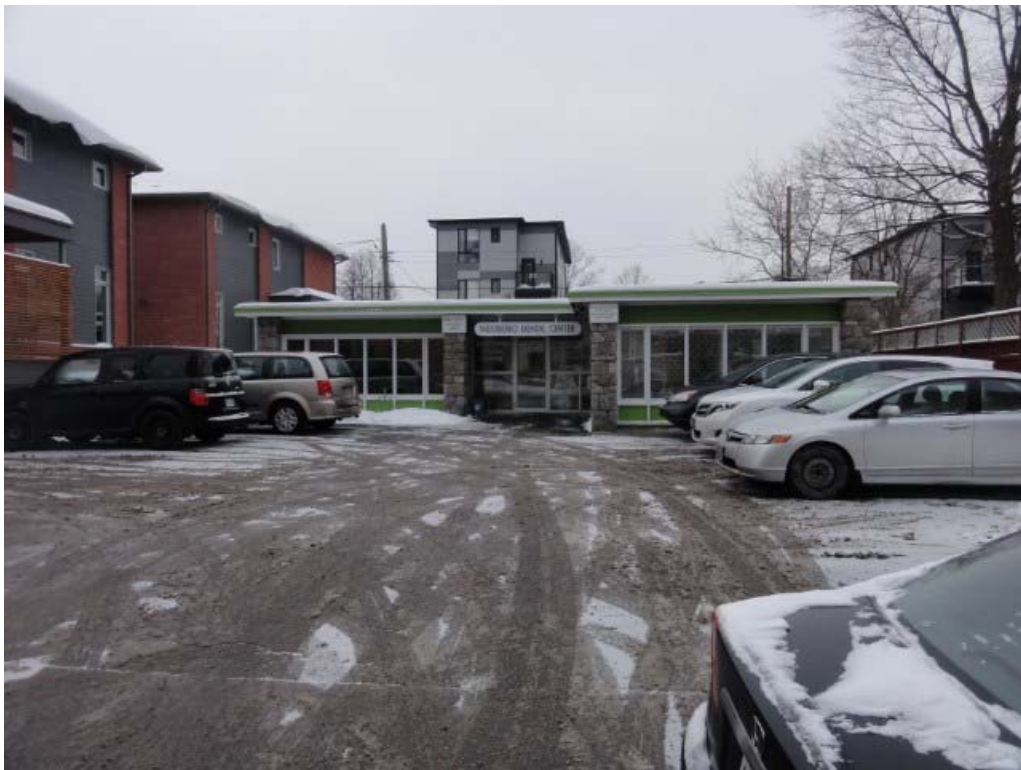
Photo 8: Looking southeast, view of the commercial property (Dental Office) on Site located at 566 Byron Avenue (photo taken Jan 4, 2018).

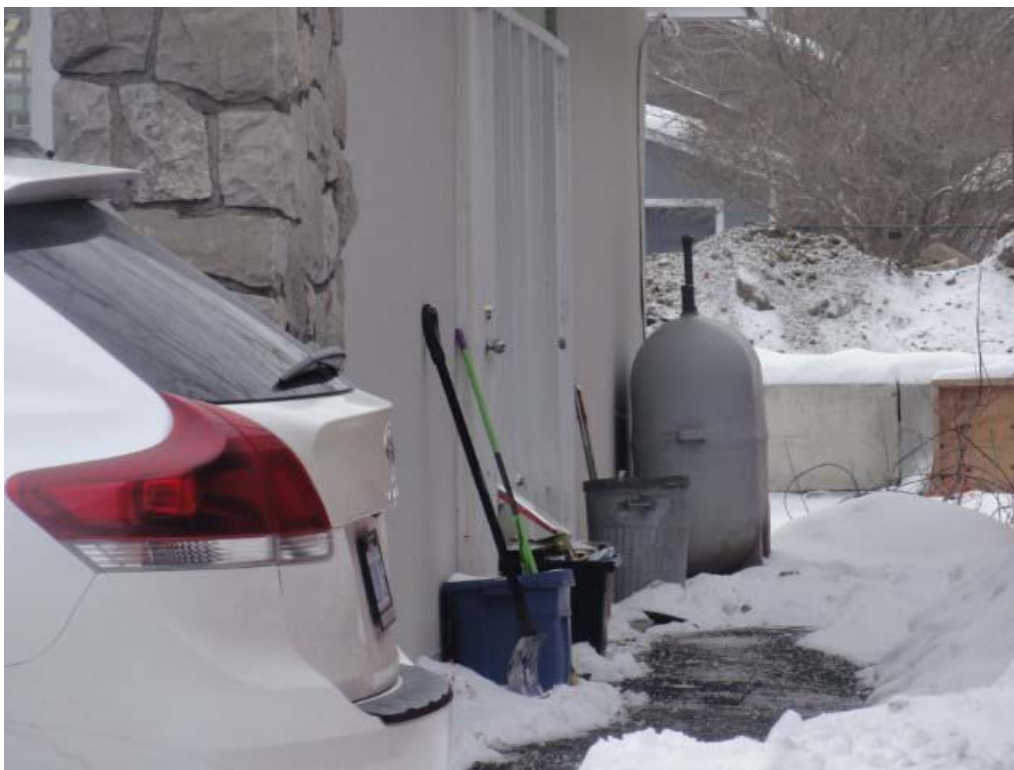
Photo 9: View of the AST located southwest of the Dental Office building on 566 Byron Avenue (photo taken Jan 4, 2018).

During the initial Site visit, a fuel oil AST (909L capacity) was observed on the exterior of the southwest corner of the commercial building on 566 Byron Avenue. The AST was installed in 2014 on a concrete pad and based on limited visual observation, no evidence of stains or spills were observed in the vicinity of the AST; however, observations made during the follow-up Site visit did not indicate any evidence of stains or spills from the AST. In addition, no information about historical spills or leaks from this AST was available. As such, presence of this AST on-Site is considered a PCA; however, for the purposes of city re-zoning application is not considered to represent an APEC on the Site.

- One AST was located on-Site as part of the commercial land use (dentist's office) on 566 Byron Avenue. This AST was installed in 2014 on a concrete pad and based on observations made during the follow-up Site visit did not indicate any evidence of stains or spills from this AST. In addition, no information about historical spills or leaks from this AST was available. As such, presence of this AST on-Site is considered a PCA; however, for the purposes of city re-zoning application is not considered to represent an APEC on the Site.

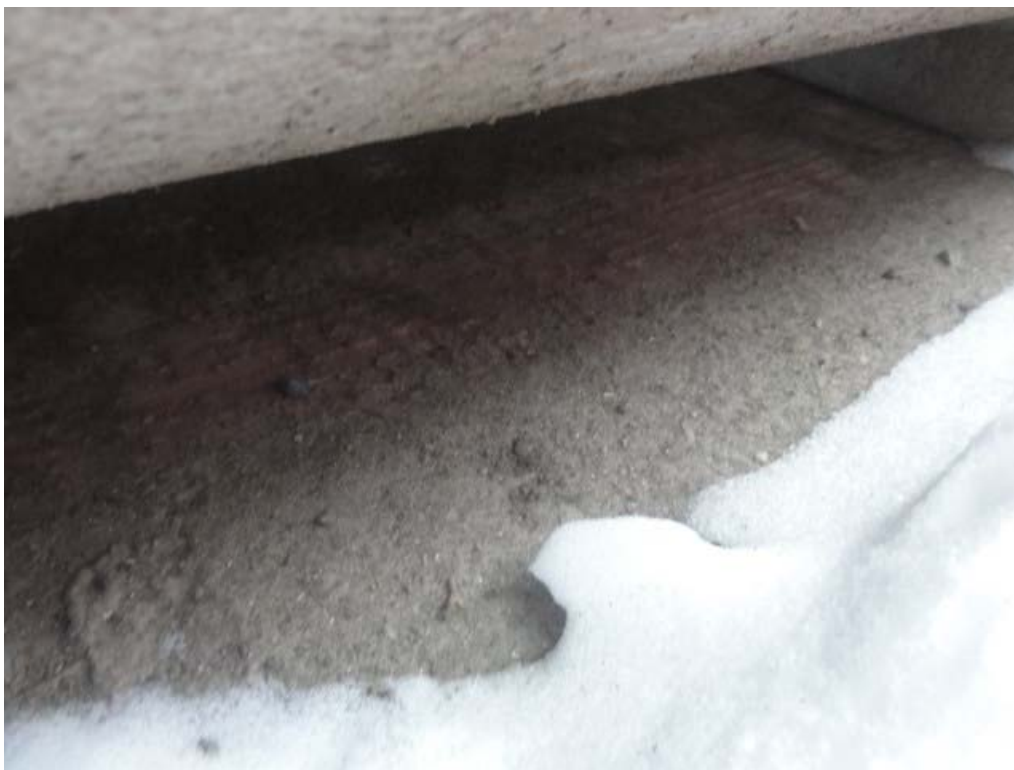
Photo 10: View of the visible portion of the concrete pad underneath AST showing no evidence of stain/spills (photo taken Jan 4, 2018).

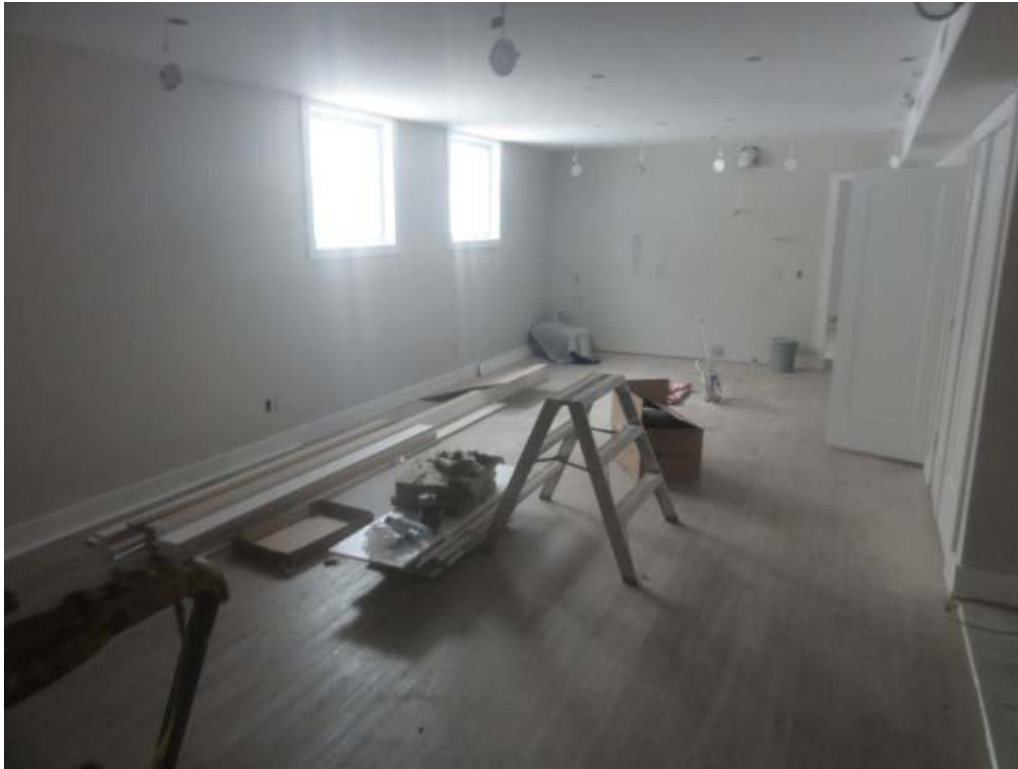
Photo 11: View of the under-construction basement of the ground floor unit in 411 Ravenhill Avenue (photo taken Jan 4, 2018).

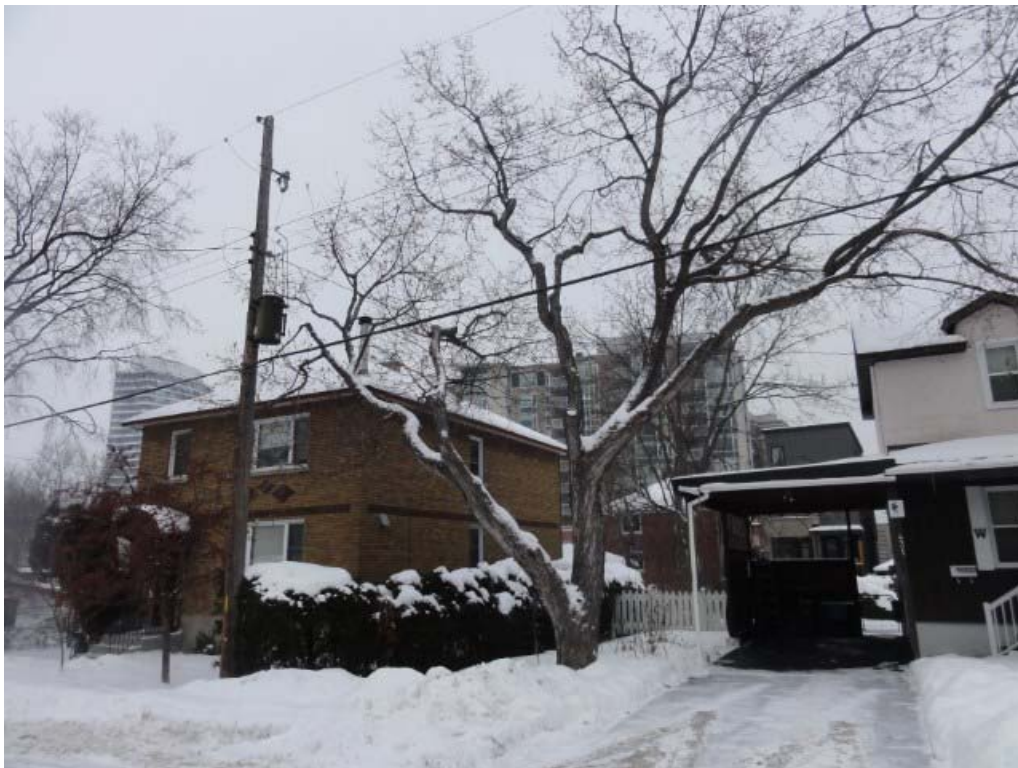
Photo 12: View of an off-site pole mounted transformer to the southwest of the Site (photo taken Jan 4, 2018).

#18. Electricity Generation, Transformation and Power Stations – Two pole-mounted transformers were located southwest of the Site along Ravenhill Avenue. (PCA 10)	Site observations	No evidence of spills or leaks was noted in the area of the transformers at the time of the Site visit. Based on the age (reported as being installed in 2017) of the transformers, they are unlikely to be PCB containing. The presence of relatively new transformers is a PCA that will not result in an APEC on the Site.

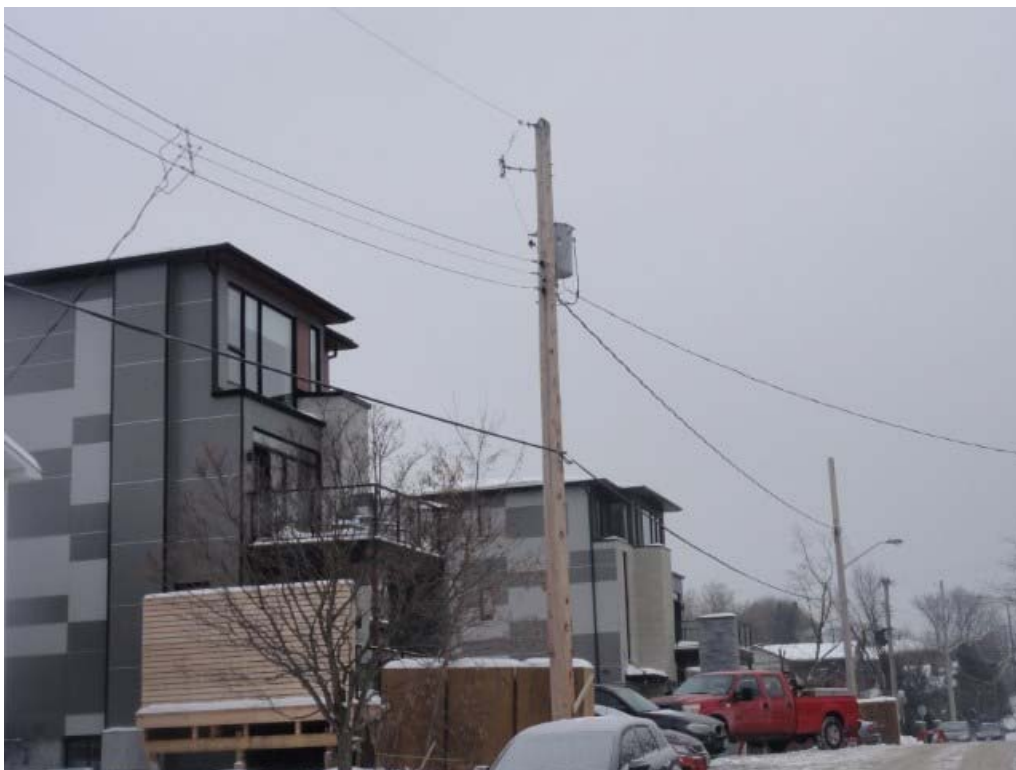
Photo 13: View of a pole mounted transformer on the southwest portion of the Site (photo taken Jan 4, 2018).

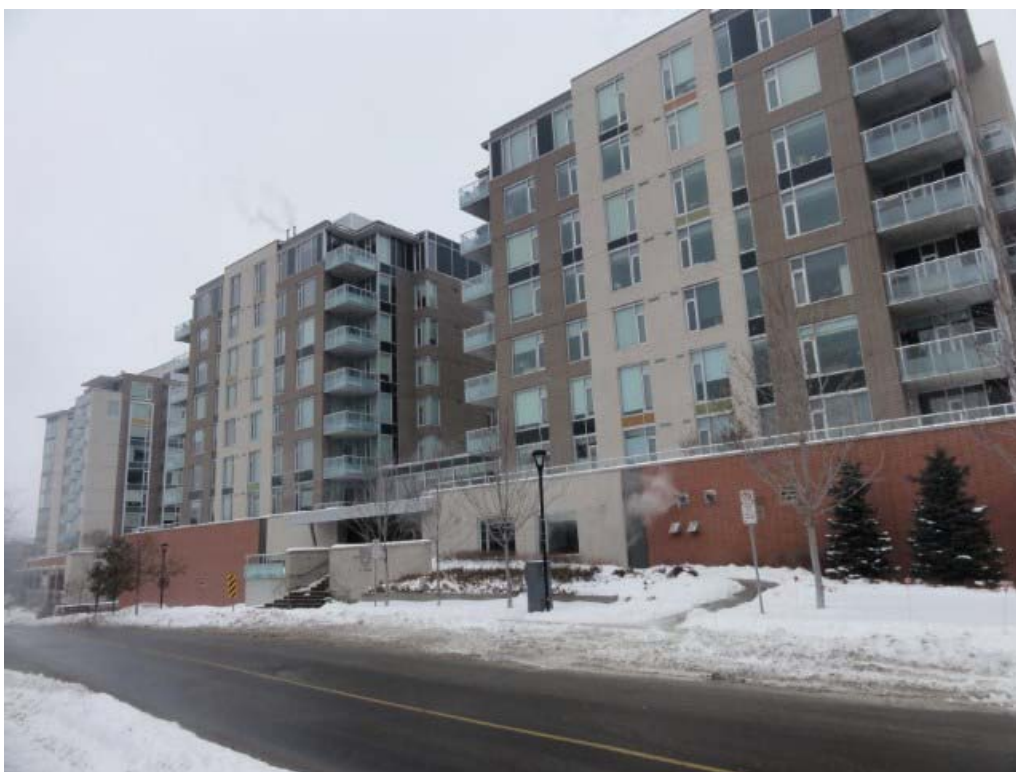
Photo 14: Looking northwest, at the residential apartments north of the Site (across Byron Avenue) (photo taken Jan 4, 2018).

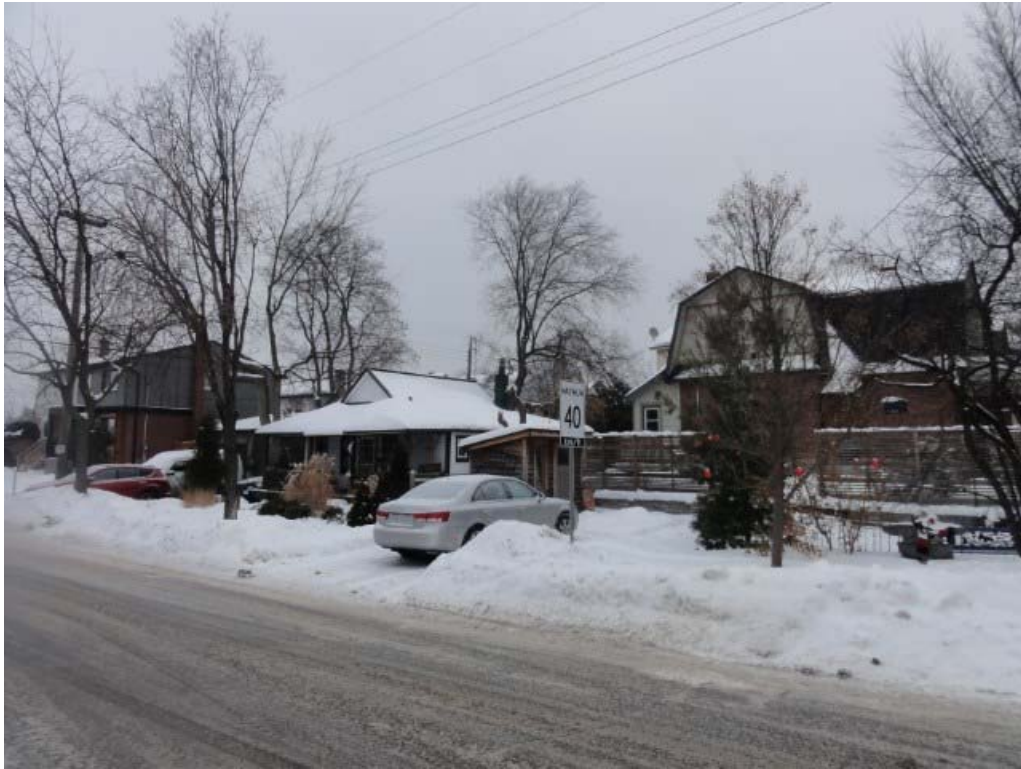
Photo 15: Looking northeast, at the residential properties east of the Site (across Roosevelt Avenue) (photo taken Jan 4, 2018).

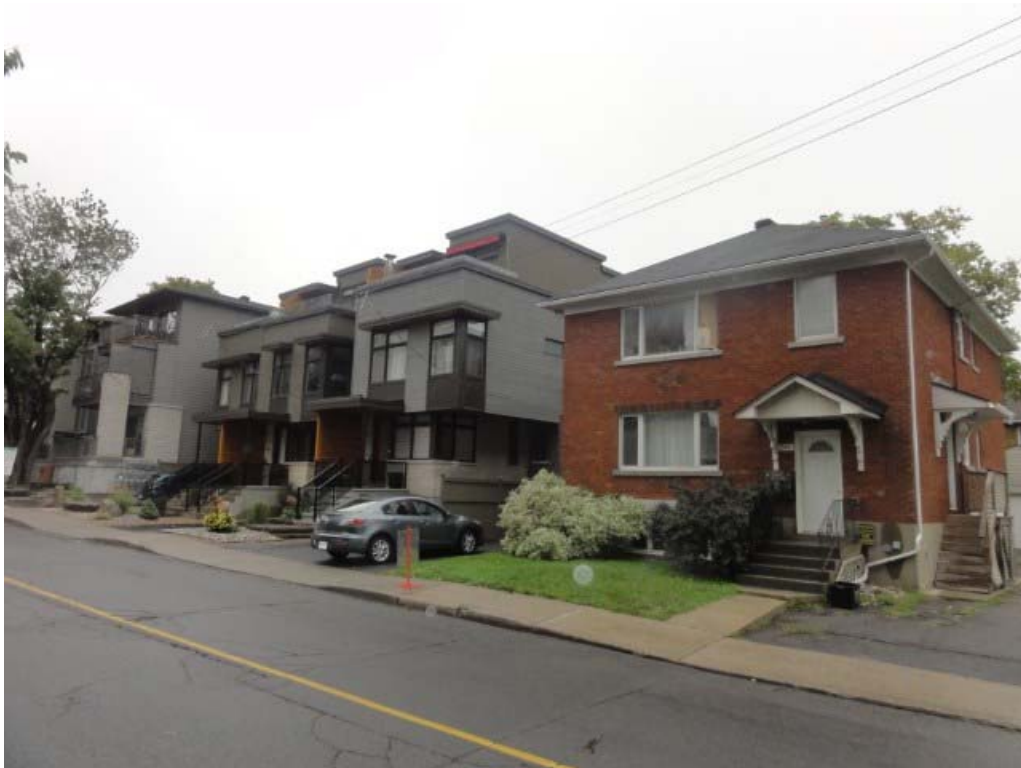
Photo 16: View of multi-tenant residential buildings northwest of the Site (578-586 Byron Avenue), looking southeast (photo taken Sep. 11, 2018).

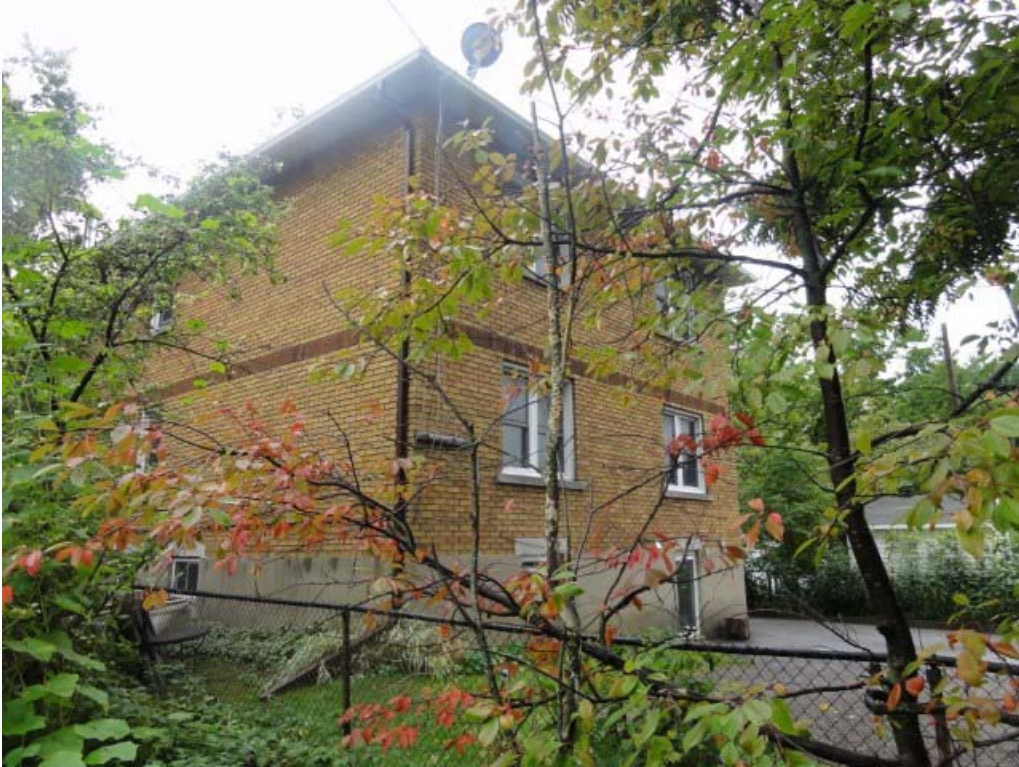
Photo 17: General view of the north and east elevation of the apartment building at 435 Ravenhill Avenue, located adjacent west of the Site (photo taken Sep. 11, 2018).
