Phase One Environmental Site Assessment

*411, 415, 419, 423, 425 & 431 Ravenhill Avenue, 566, 570 & 576 Byron Avenue,
and 436 & 440 Roosevelt Avenue, Ottawa, Ontario*

1793155-1000

October 2018

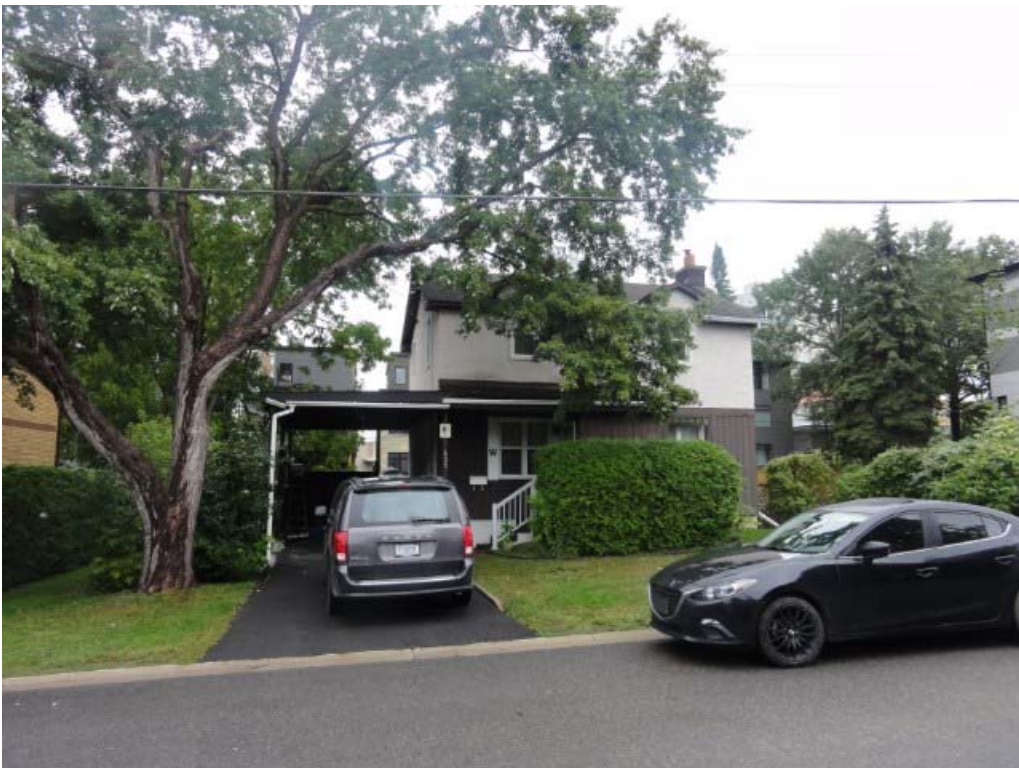
Photo 18: View of the south elevation of the residential home at 431 Ravenhill Avenue, located on the southwest portion of the Site (photo taken Sep. 11, 2018).

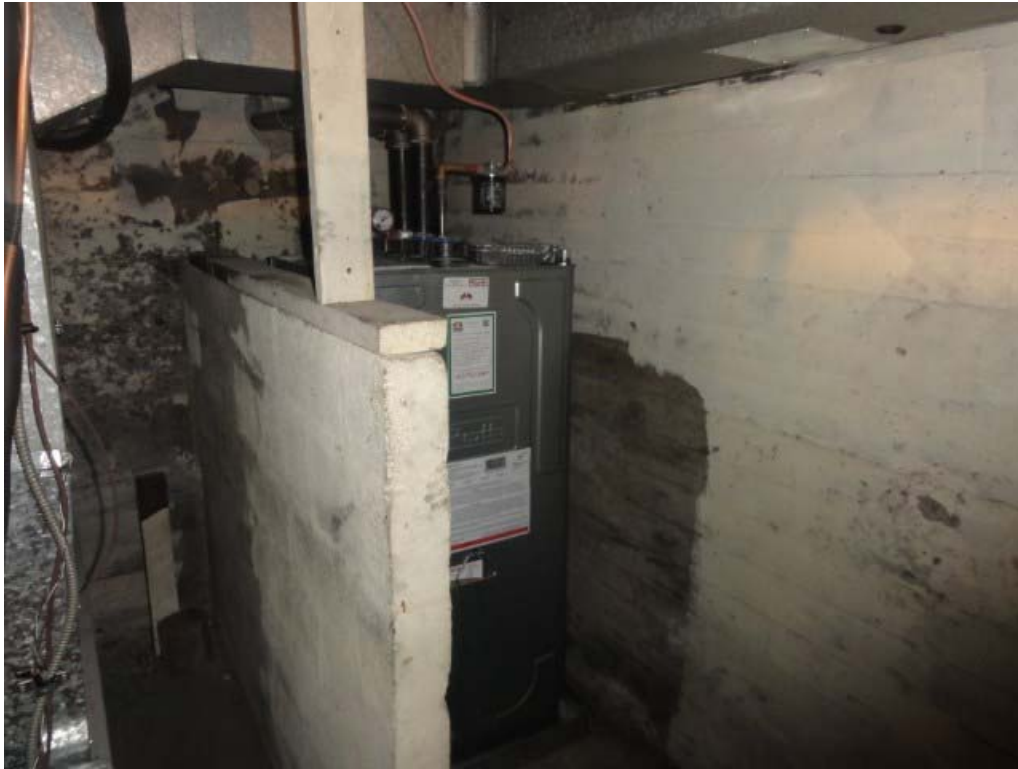
Photo 19: View of the double walled AST for furnace oil storage located in the basement of 431 Ravenhill Avenue (photo taken Sep. 11, 2018).

Another AST (620 L double walled non-metallic tank manufactured in 2017) for furnace oil storage was observed on the concrete basement floor of 431 Ravenhill Avenue. This AST appeared to be in good condition, consisted of a drip-tray and was located on concrete floor in good condition with no cracks in the vicinity of the AST; however, no information about use and/or removal of previous ASTs at this property were available. Although concrete floor near this AST appeared to be in good condition and no evidence of stains or spills were observed anywhere else in the basement of 431 Ravenhill Avenue, there is possibility of potential historical leaks and spills from previous ASTs and hence presence of this AST on-Site is considered a PCA. Since the property addressed 431 Ravenhill Avenue will be redeveloped as a multi-tenant residence, as indicated by the Site Representative, it will require excavation below current basement level which will indicate any impacted soil, if present. In addition, excavation for redevelopment purposes will also remove presence of any impacted soil from the Site. As such, presence of this AST on-Site is a PCA for the Site; however, it is not considered to represent an APEC on the Site.

- During the follow-up Site visit, an AST (620 L double walled non-metallic tank manufactured in 2017) for furnace oil storage was observed on the concrete basement floor of 431 Ravenhill Avenue. Although this AST appeared to be in good condition with no evidence of spills or stains in the vicinity, there is possibility of potential historical leaks and spills from previous ASTs and hence presence of this AST on-Site is considered a PCA. However, this property will be redeveloped as multi-tenant residence which will require excavation below current basement level that will likely indicate any impacted soil, if present. In addition, excavation for redevelopment purposes will also remove presence of any impacted soil from the Site.

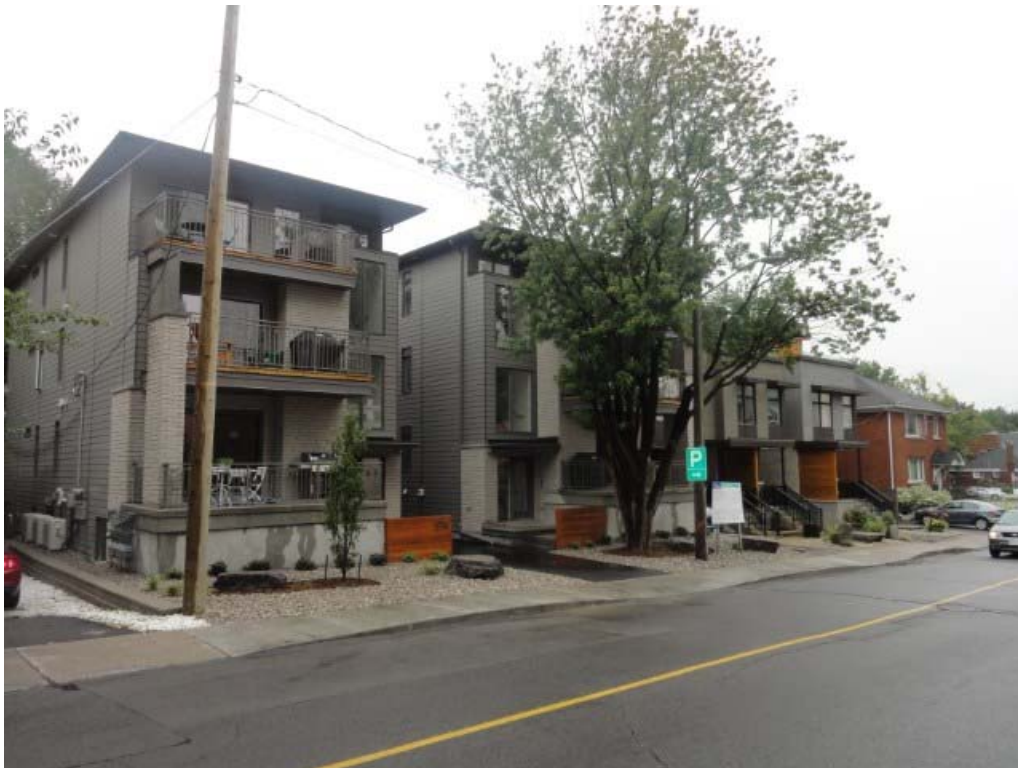
Photo 20: View of multi-tenant residential buildings on the northern portion of the Site (574-576 Byron Avenue), under construction during January site visit (photo taken Sep. 11, 2018).

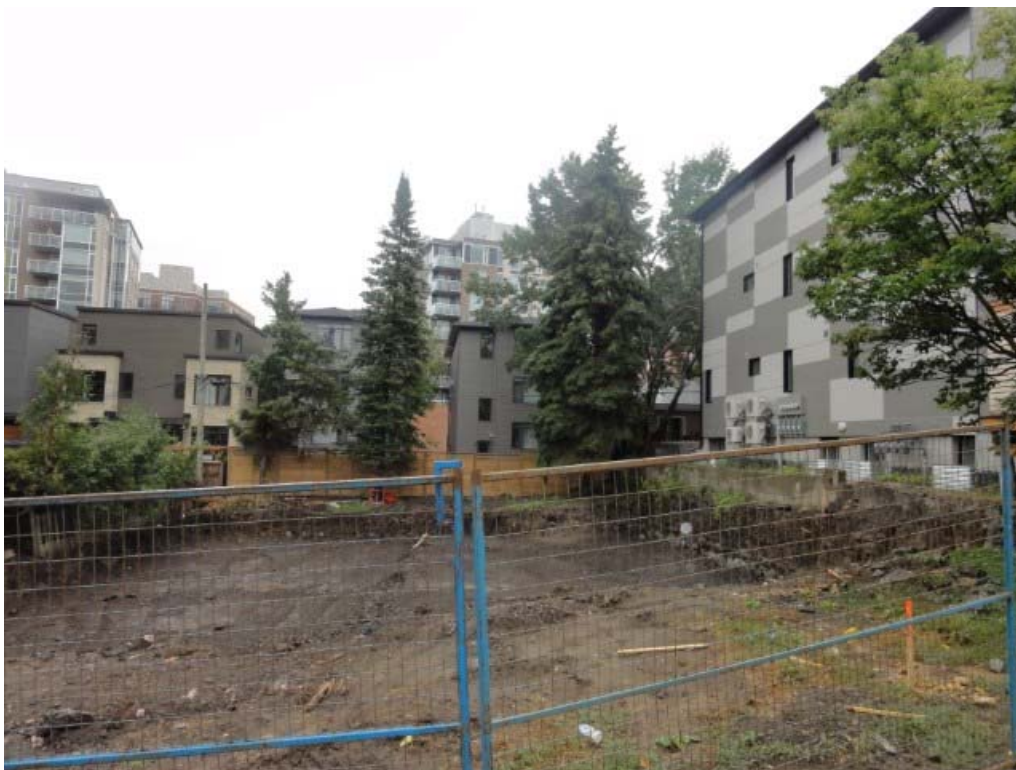
Photo 21: View of excavation at 425 Ravenhill Avenue on southern portion of the Site, previously occupied by a single family residential home (photo taken Sep. 11, 2018).

During the follow-up Site visit, construction of the three properties on the Site (observed during initial Site visit) had been completed. In addition, the single-family home on 425 Ravenhill Avenue had been demolished and the property was excavated a few metres below grade in preparation for redevelopment as a multi-tenant residential building. No evidence of stains or potential issue of concern on the excavation floor or walls were observed.

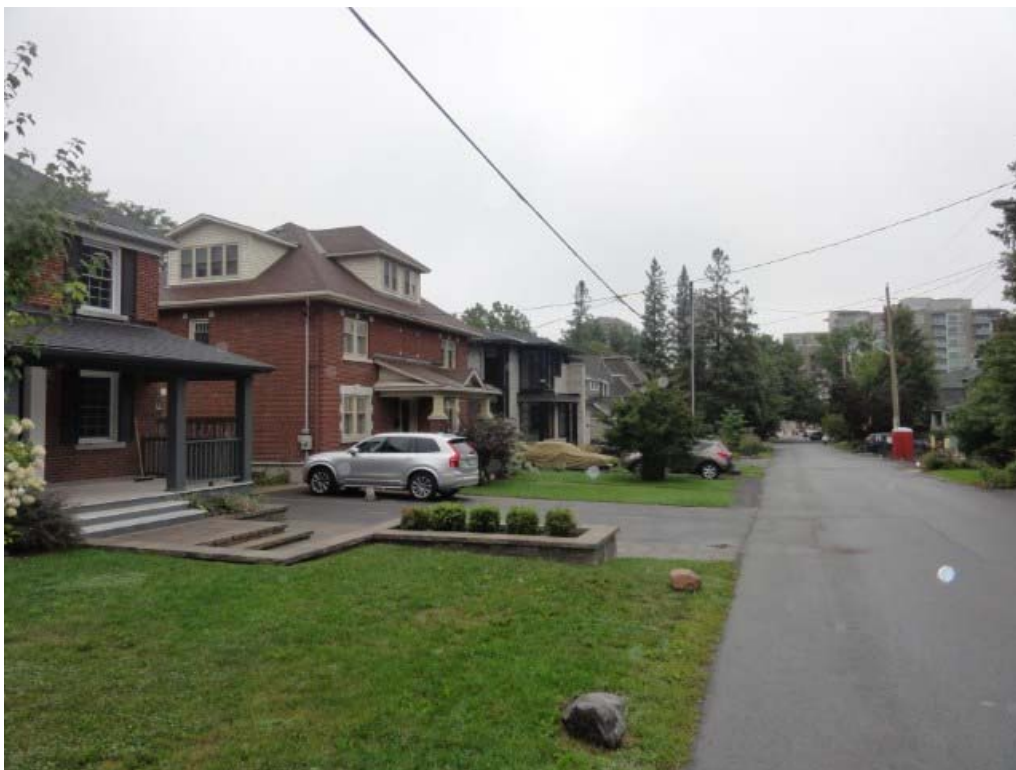
Photo 22: General view of typical residential homes on Golden Avenue, located west of the Site (photo taken Sep. 11, 2018).

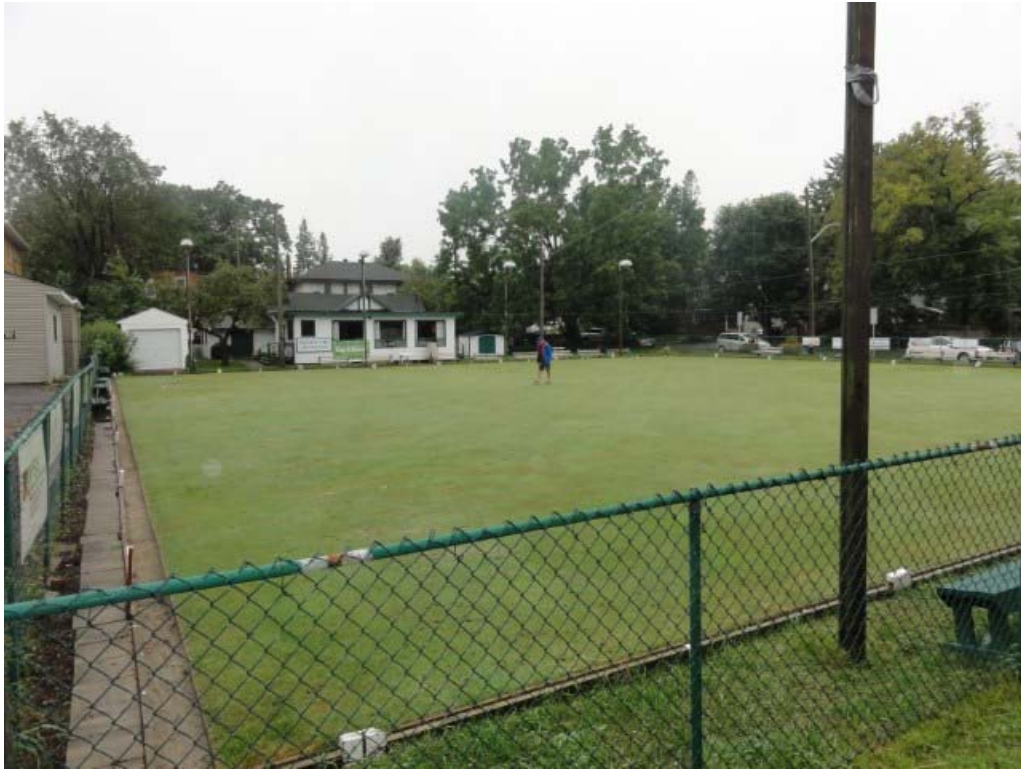
Photo 23 General view of the lawn bowling club at 439 Golden Avenue, located immediately west of the Site (photo taken Sep. 11, 2018).
