Phase I-Environmental Site Assessment

1950 Scott Street, 312 and 314 Clifton Road
Ottawa, Ontario

Prepared For
EBC Inc.

April 5, 2018
Report: PE4239-1

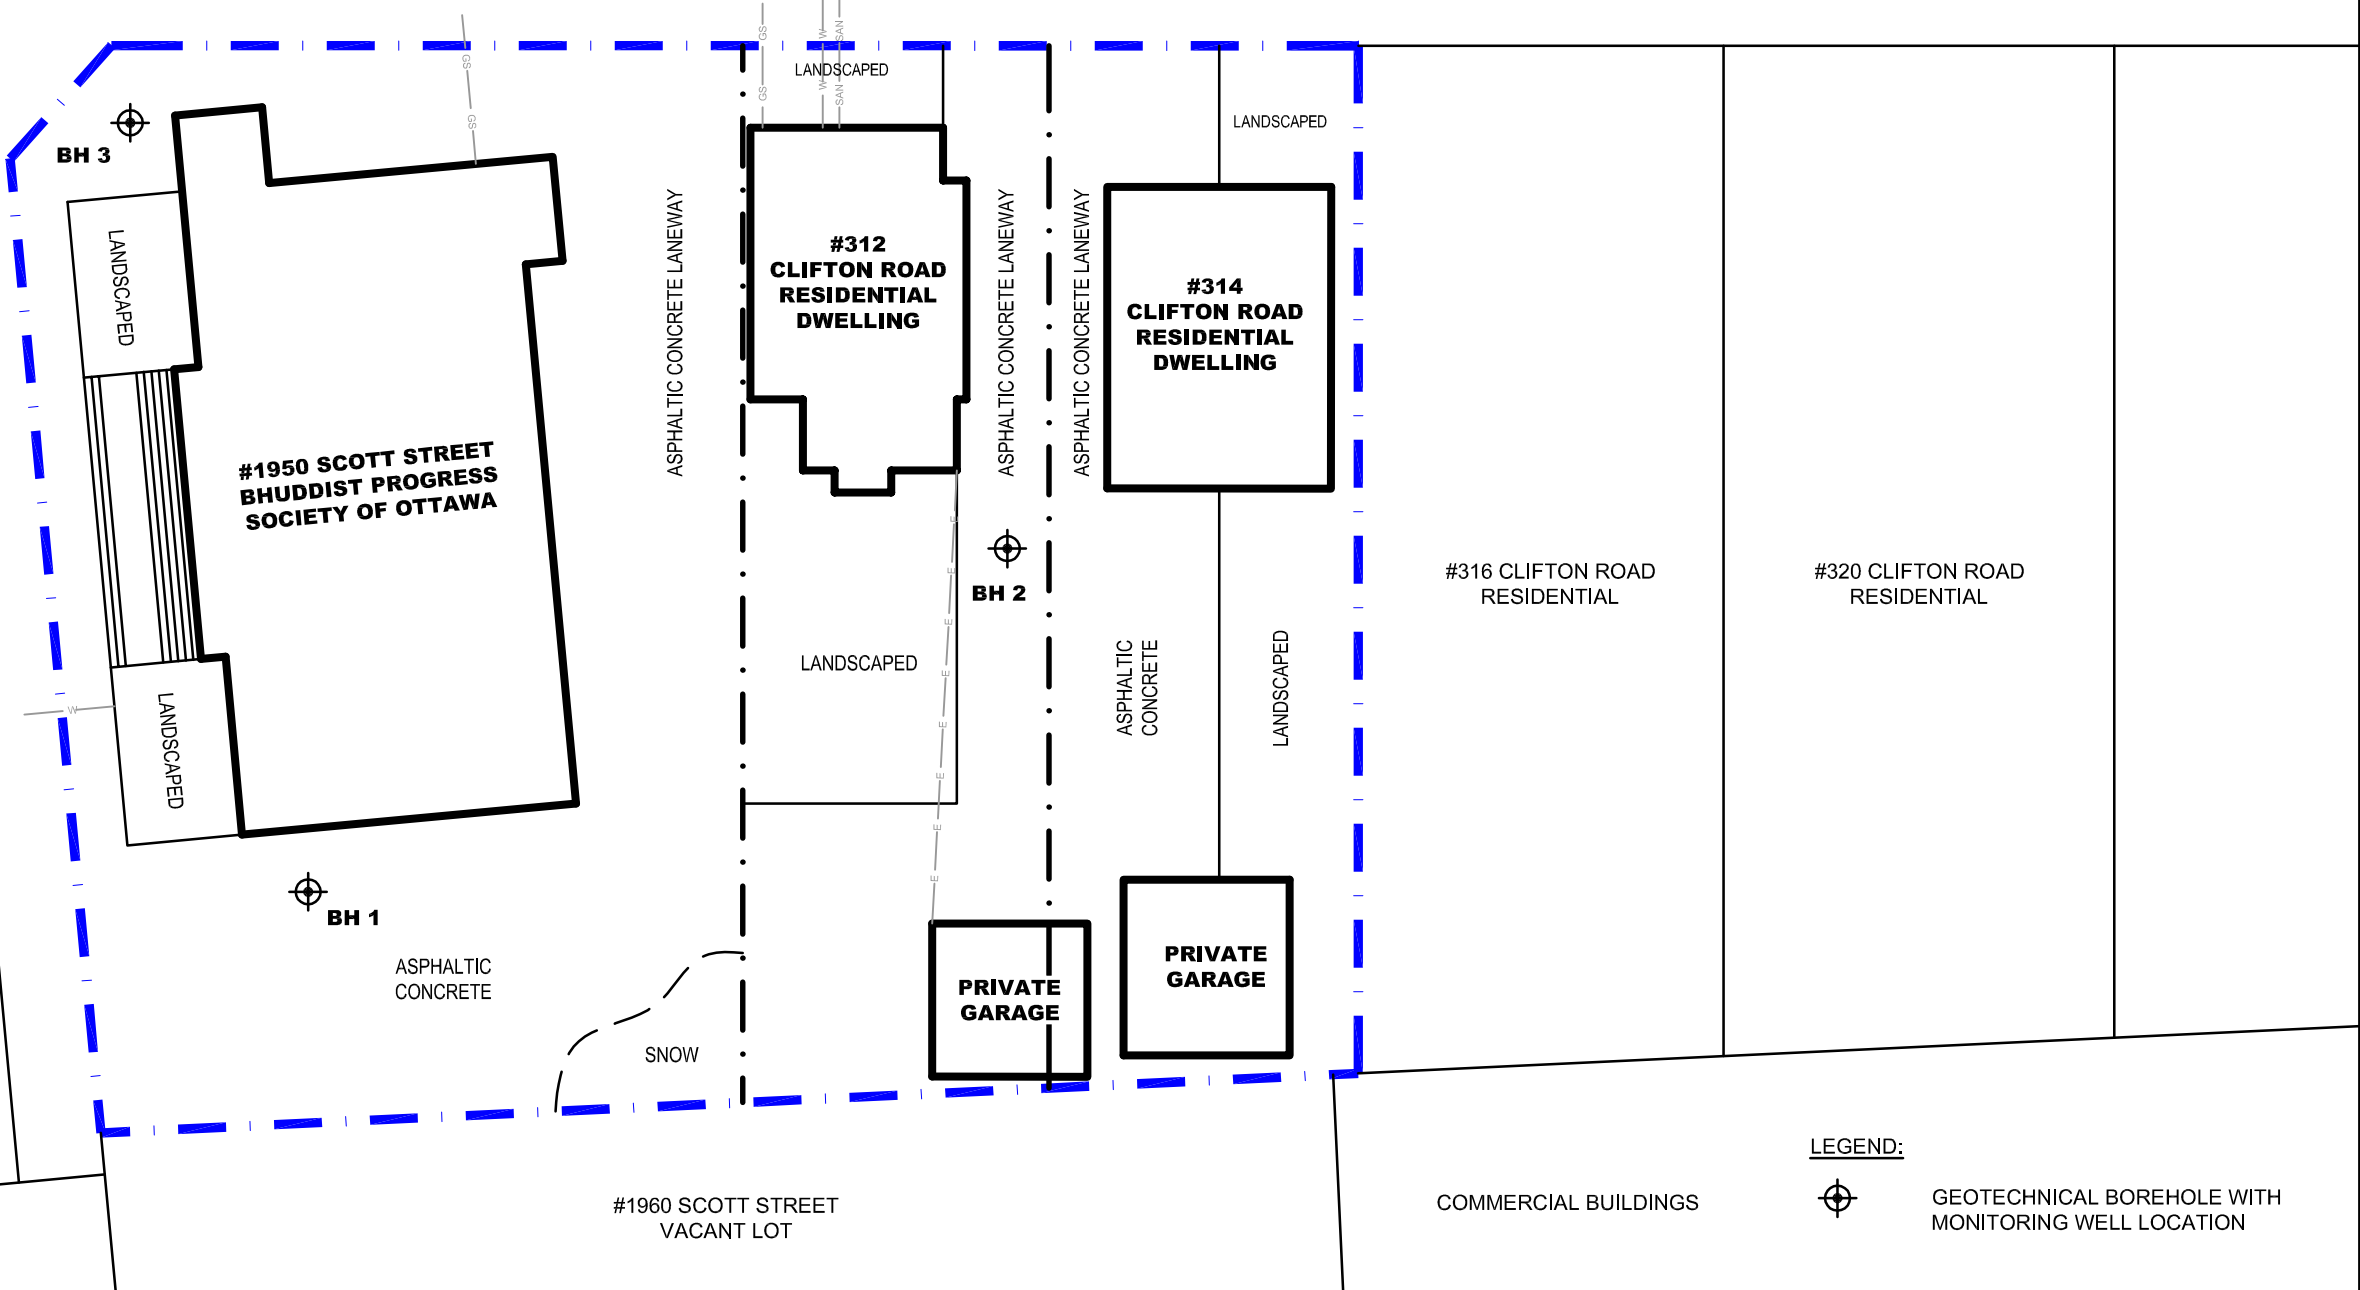
DRAWING PE4239-1 – SITE PLAN

What appeared to be a former coal chute, was observed on the west exterior wall of 1950 Scott Street, near the chimney. The presence of the coal chute and chimney suggest the building was originally heated with coal fired equipment. No exterior aboveground storage tanks (ASTs) or evidence of exterior underground storage tanks (USTs) were observed at the time of the site visit. No spills, staining, stressed vegetation, or visual or olfactory evidence of contamination was noted on the exterior of the subject site during the Phase I site visit.

The above-noted site features are shown on Drawing PE4239-1 - Site Plan.

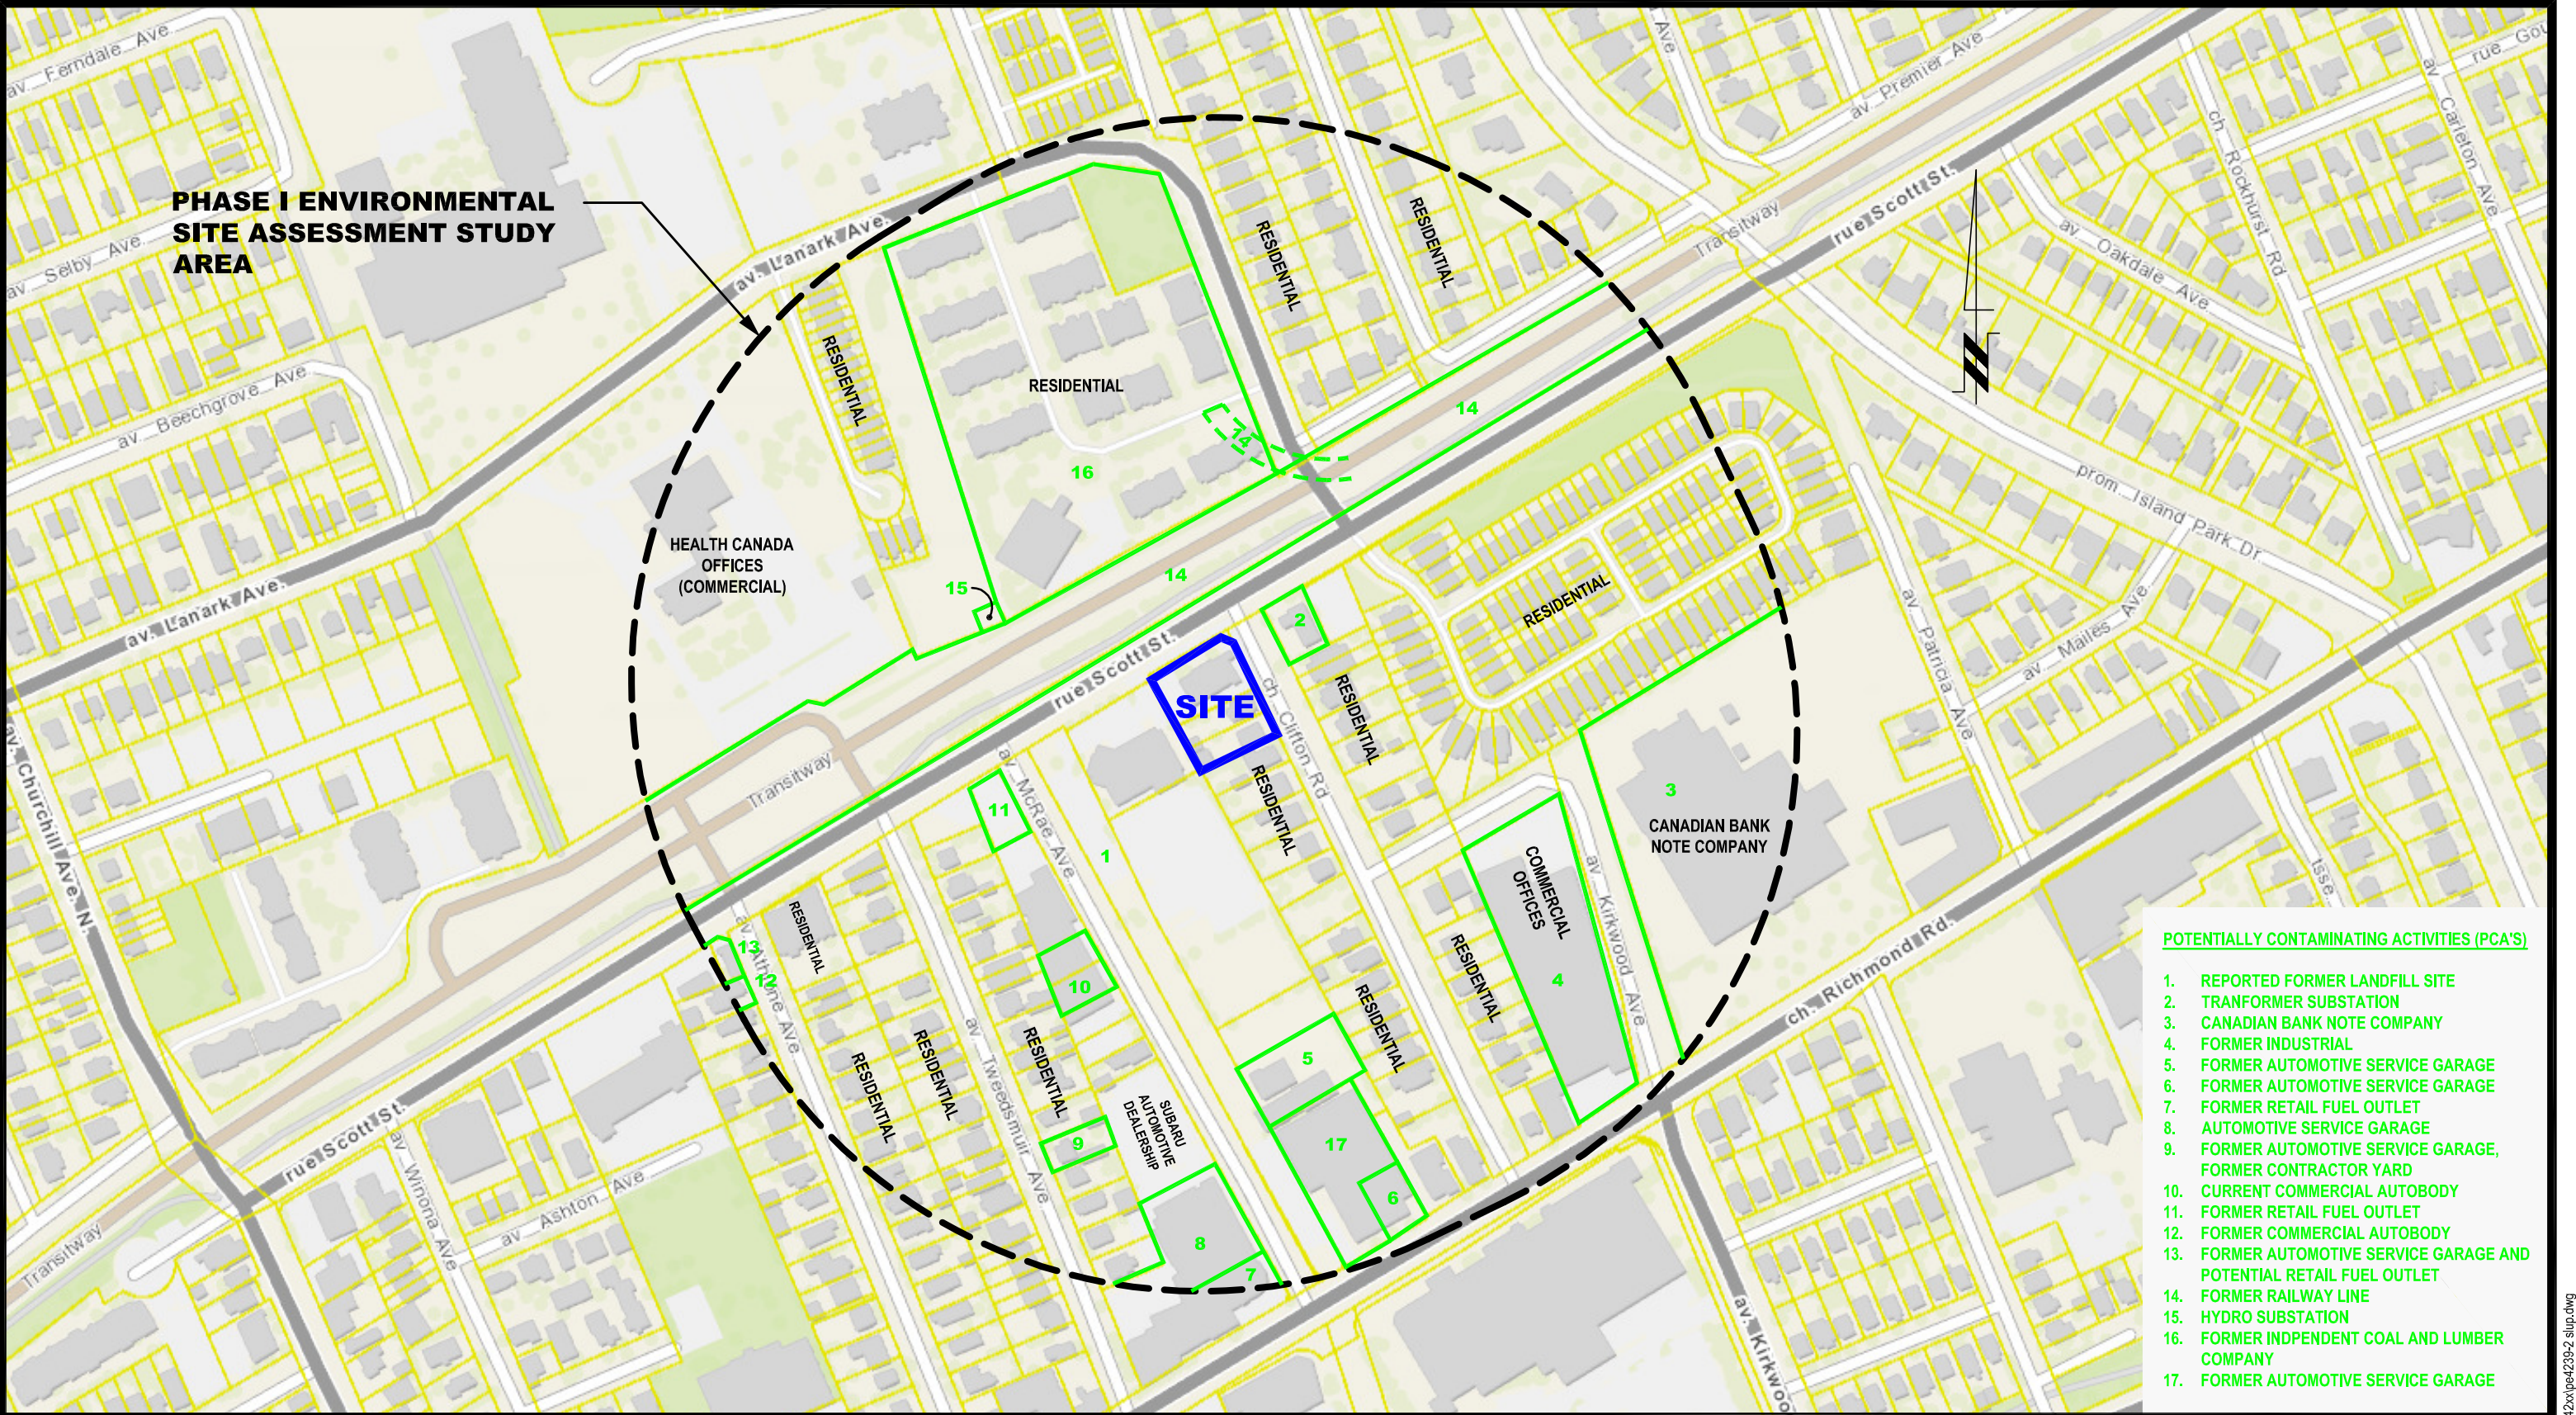
DRAWING PE4239-2 – SURROUNDING LAND USE PLAN

The remaining off-site PCAs noted above are not considered to represent areas of potential environmental concern (APECs) on the Phase I Property based on their separation distances and/or orientations with respect to the subject land. The locations of the aforementioned PCAs, are depicted on Drawing PE4239-2 - Surrounding Land Use Plan.

POTENTIALLY CONTAMINATING ACTIVITIES (PCA'S)

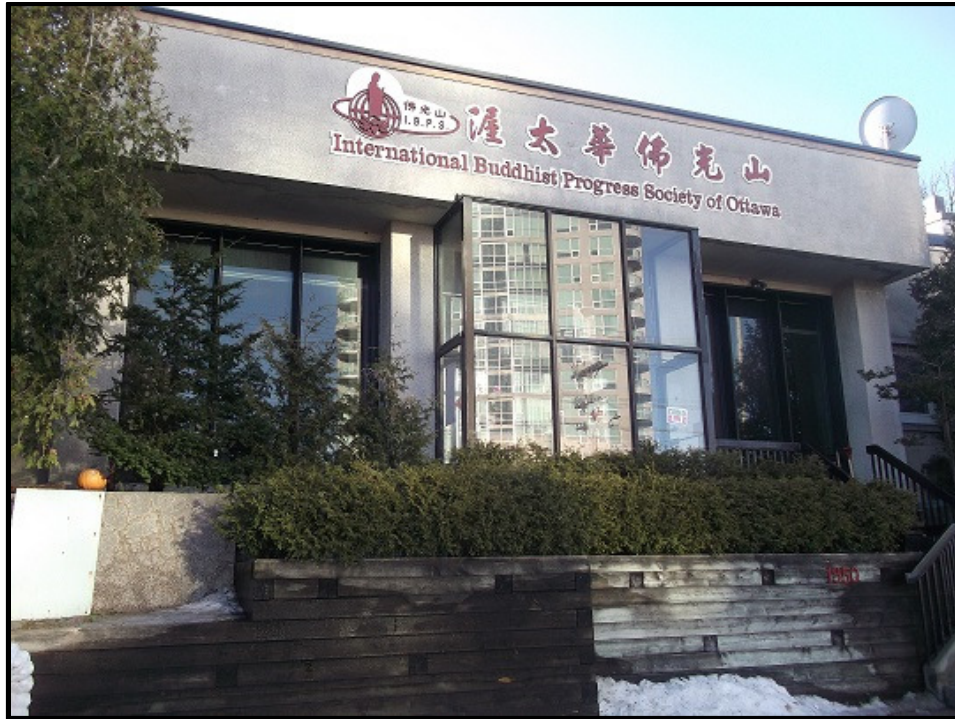
Photograph 1: North face of subject building at 1950 Scott Street, facing southeast.

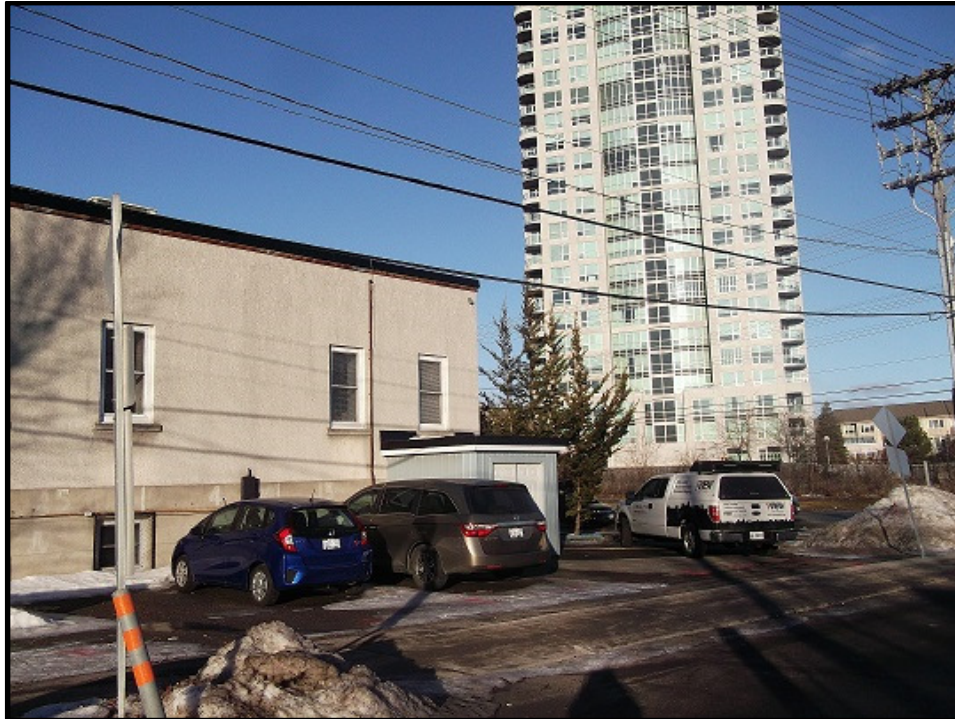
Photograph 2: East face of subject building addressed 1950 Scott Street, facing northwest. Photograph also depicts residential property to the north, across Scott Street.

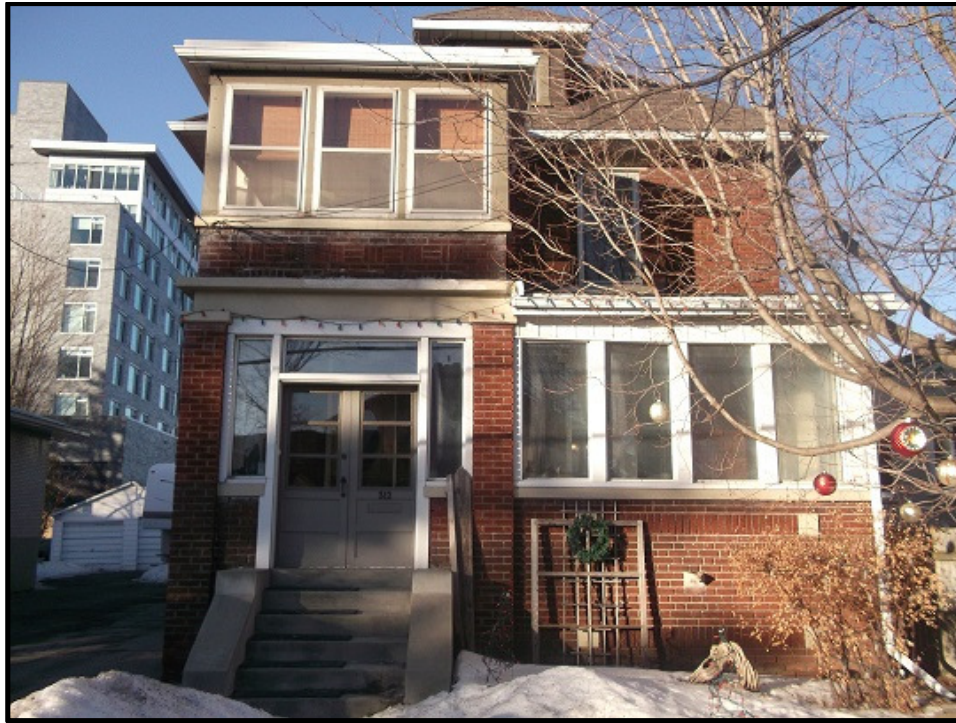
A residential dwelling, private garage and two (2) storage sheds occupy the property addressed 312 Clifton Road. The dwelling is constructed with a stone and mortar foundation and is finished on the exterior with brick and a peaked roof covered with asphaltic shingles. The dwelling is currently heated with natural gas-fired equipment. The private garage is a wood frame structure with a poured slab-on-grade foundation, finished on the exterior with vinyl siding and parging with a peaked roof covered with asphaltic shingles. The storage sheds are temporary metal frame structures. The dwelling and private garage are considered to have been constructed as early as 1928.

Photograph 3: East face of subject building at 312 Clifton Road, facing west.

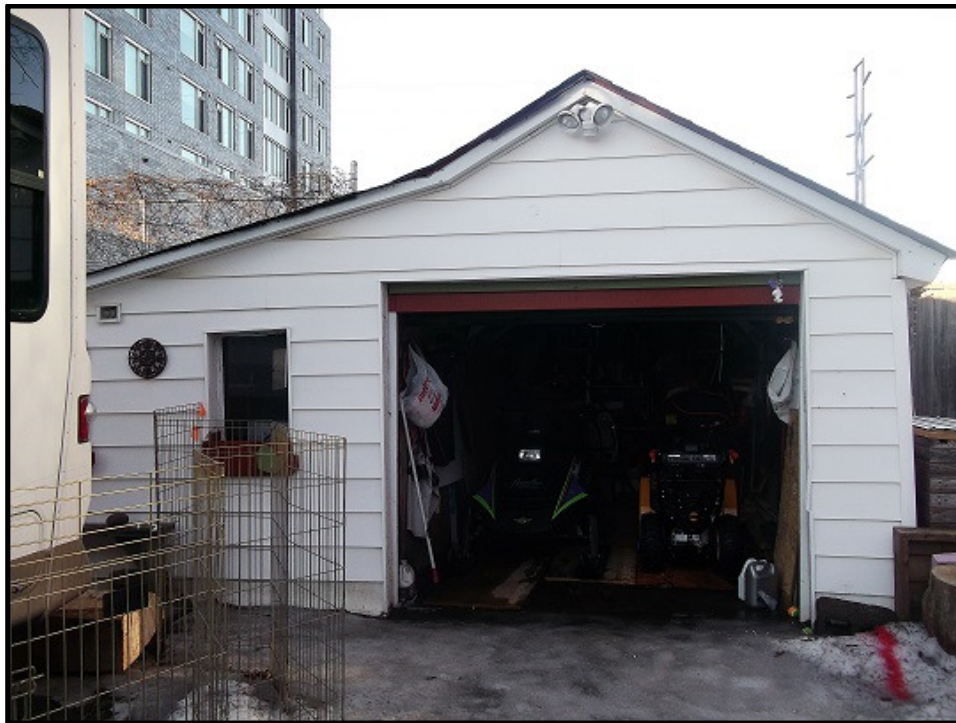
Photograph 4: View of private garage at 312 Clifton Road, facing west. Photograph also illustrates newly constructed residential building (2015) immediately southwest of the Phase I Property.

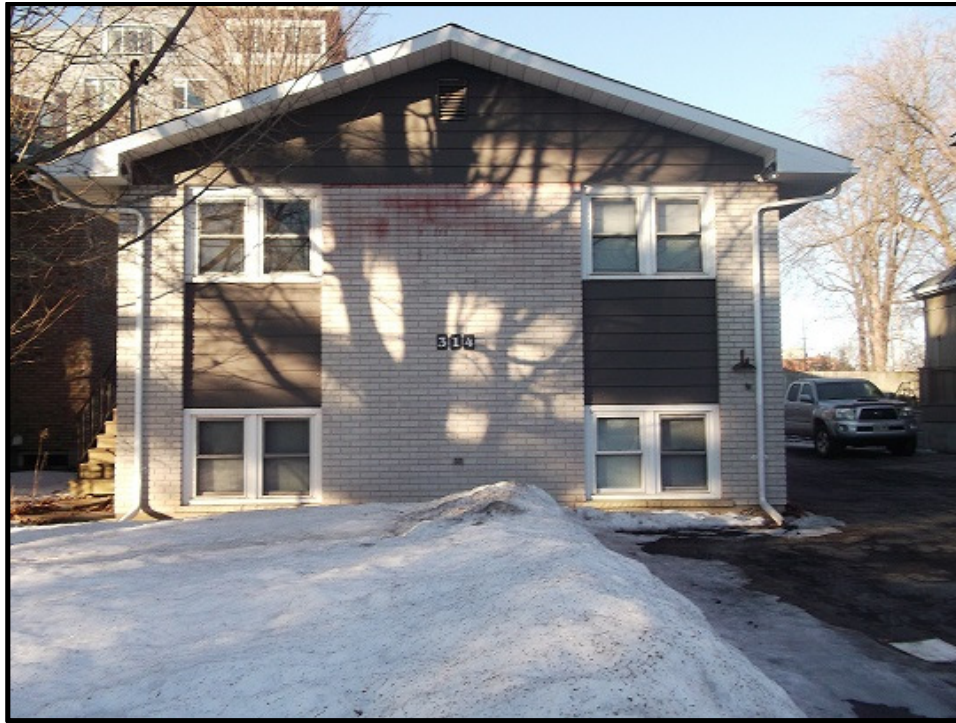
A residential dwelling and private garage occupies 314 Clifton Road. The dwelling is constructed with a poured concrete foundation and is finished on the exterior with brick and a peaked roof covered with asphaltic shingles. The building is currently heated with electricity. The private garage is a wood frame structure with a poured slab-on-grade foundation and finished on the exterior with vinyl siding and a peaked roof covered with asphaltic shingles. Both structures are considered to have been constructed in the 1960's.

Photograph 5: East face of subject building at 314 Clifton Road, facing west.

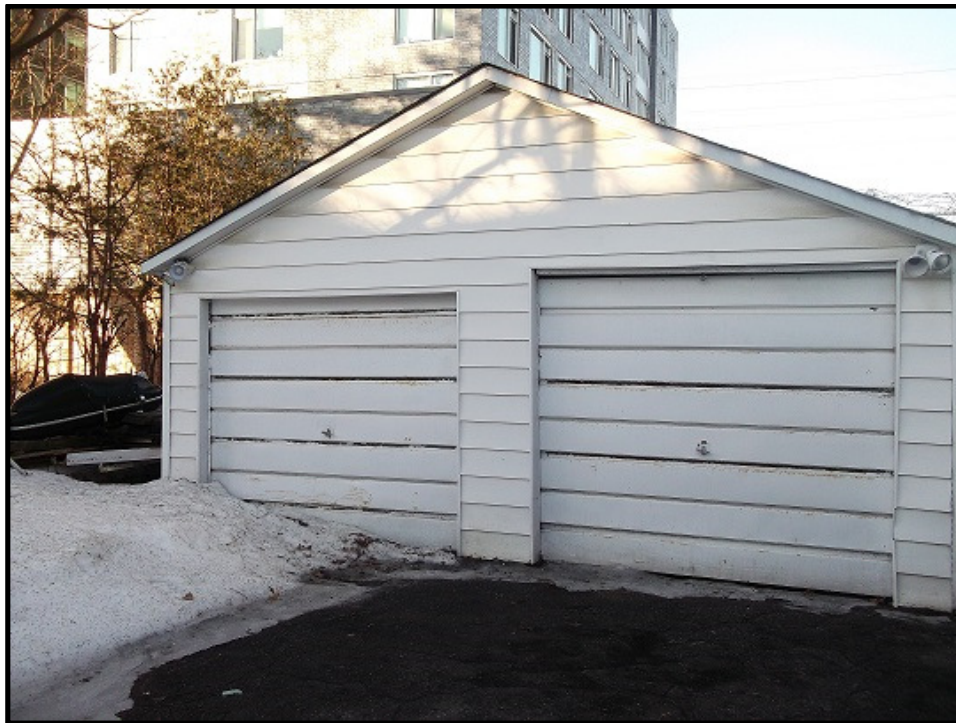
Photograph 6: View of private garage at 314 Clifton Road, facing west.

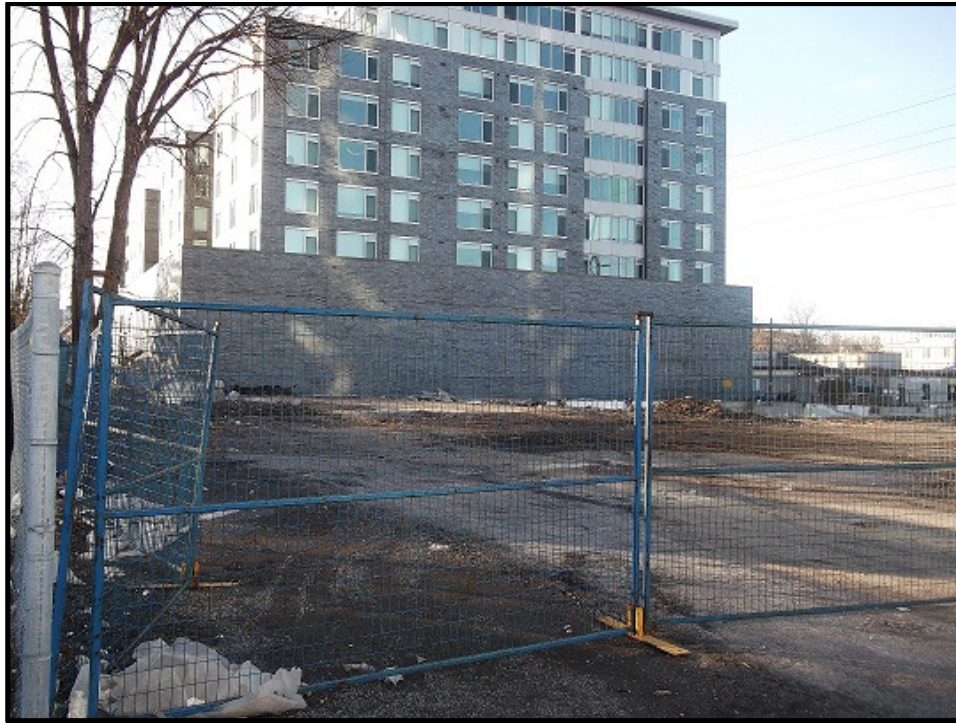
Photograph 7: View of vacant, commercial lot (future residential development) at 1960 Scott Street, adjacent to the west of the Phase I Property, facing southwest.

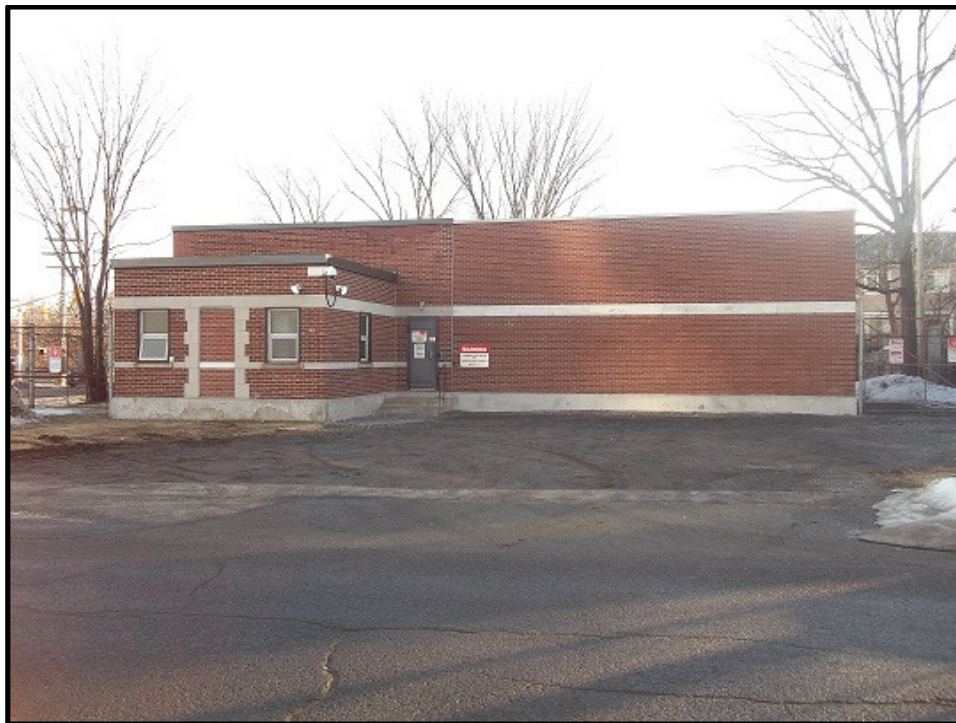
A Hydro Ottawa representative was contacted on March 9, 2018, regarding the transformer sub-station at 305 Clifton Road, east of the Phase I Property. The representative was unaware of any spills or leaks from the on-site transformers.

Photograph 8: View of Hydro transformer sub-station at 305 Clifton Road, facing east.
