**Phase I - Environmental Site Assessment**

966, 968 and 974 Fisher Avenue  
Ottawa, Ontario

February 9, 2017

Report: PE3942-1

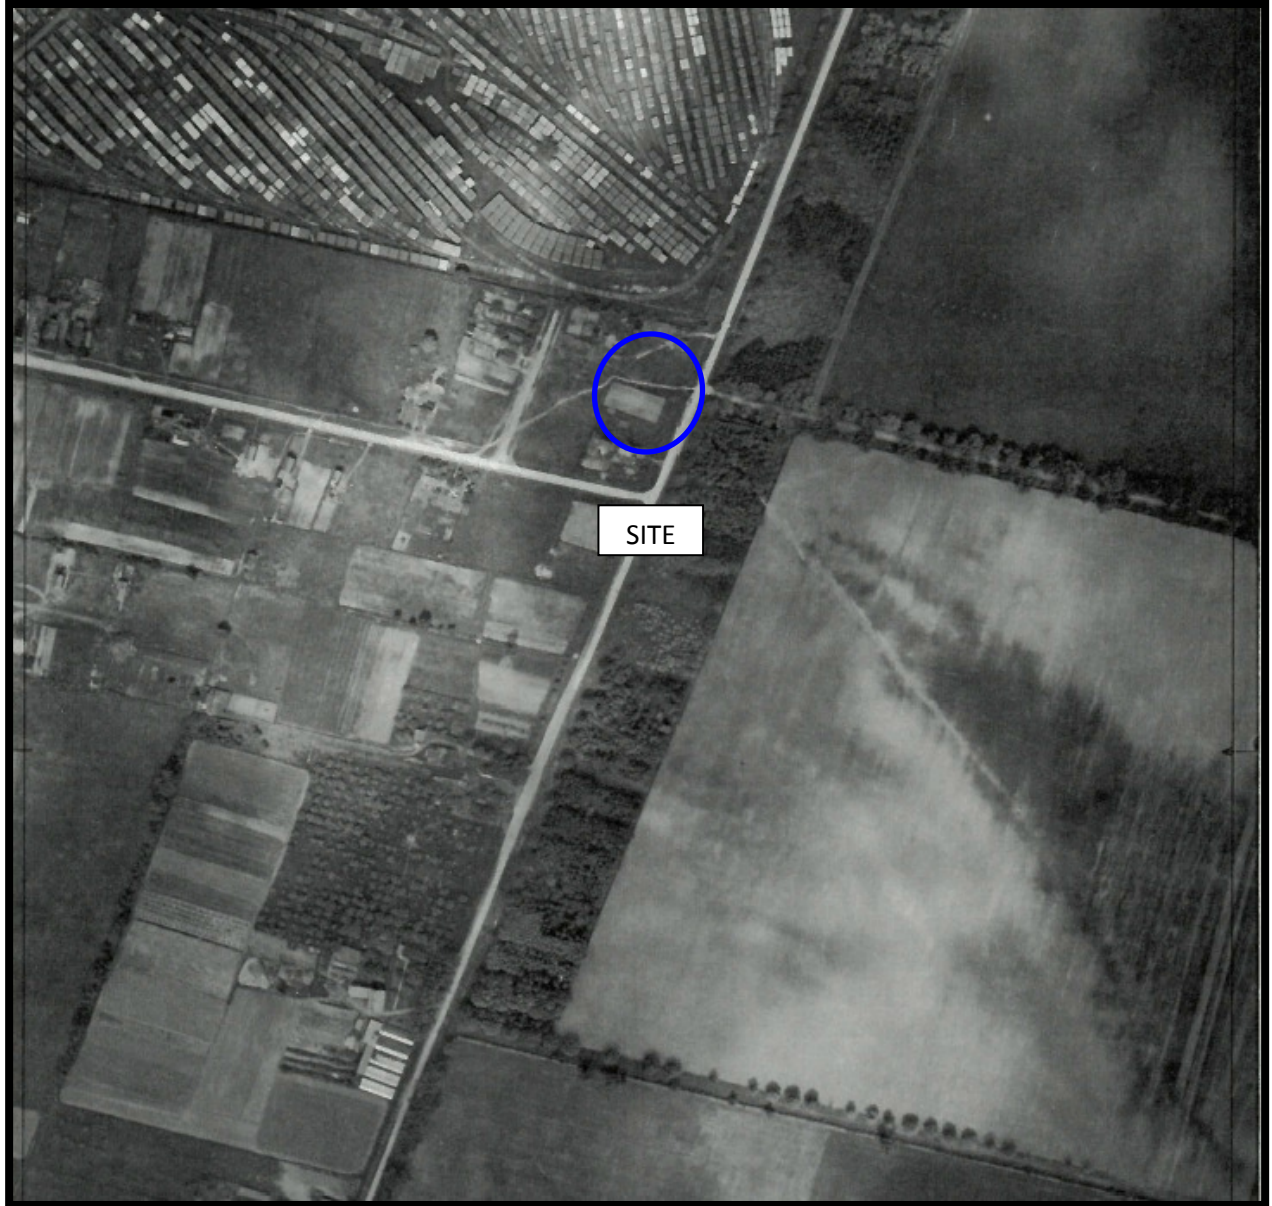
AERIAL PHOTOGRAPH  
1925

| 1925 | The subject site is not developed. Several footpaths traverse the site, and an area cleared of vegetation is present at 974 Fisher Avenue, which may be a garden. The adjacent properties to the north and south are occupied by residential dwellings. The adjacent lands to the east (across Fisher Avenue) and west are vacant. The lands further (20 m) to the north are occupied by a lumber storage yard (stacked lumber) and with occasional railway track. |

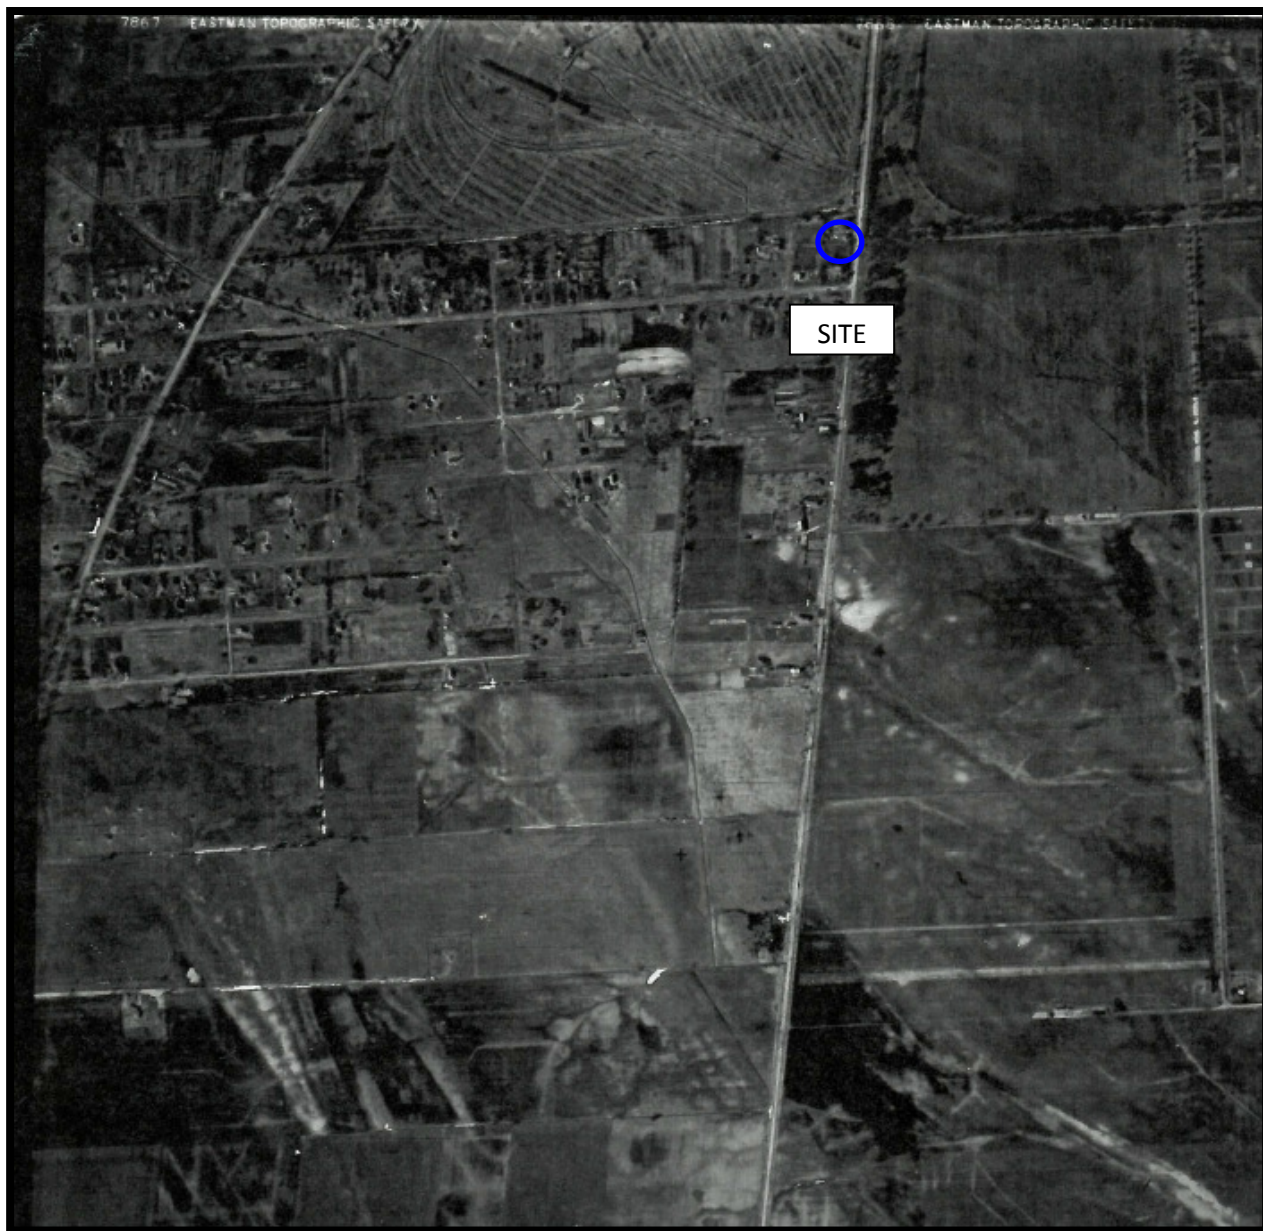
AERIAL PHOTOGRAPH  
1945

| 1945 | <p>Due to the poor scale and quality of this photo, it is not possible to clearly distinguish site features, although the property appears to remain unchanged from the previous photograph.</p> <p>No significant changes appear to have been made to the adjacent properties. Additional residential dwellings have been constructed to the west, along Shillington Avenue. The lumber yard lands to the northwest do not appear to be actively in use, although no redevelopment has occurred.</p> |

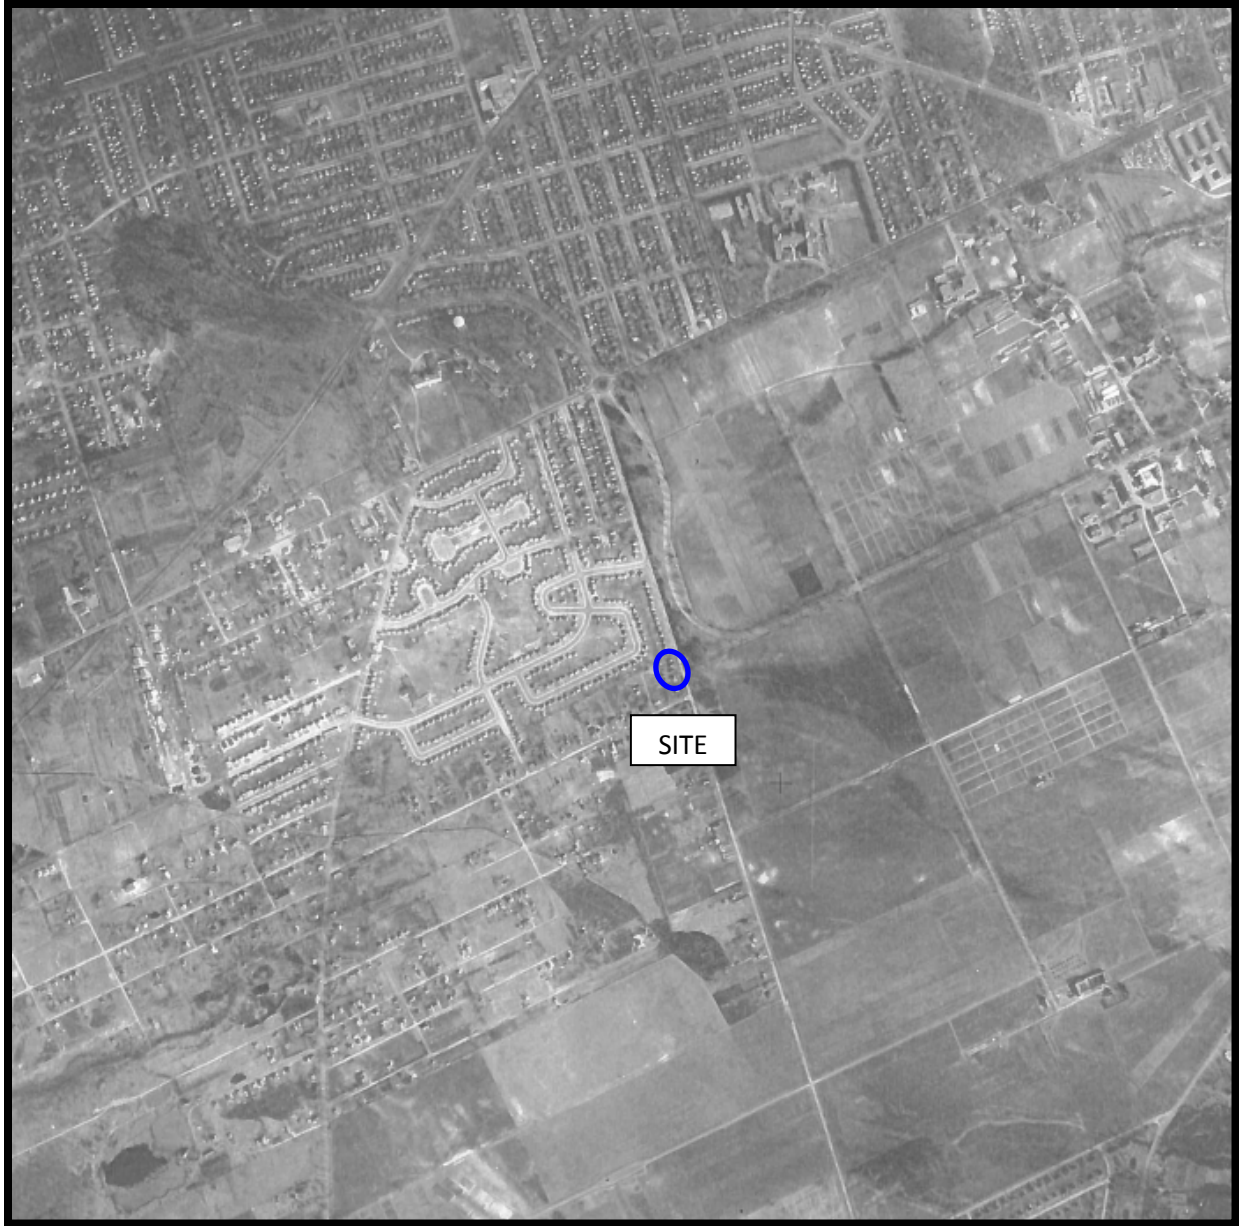
AERIAL PHOTOGRAPH  
1953

| 1953 | The subject site has been developed with three (3) residential dwellings. The neighbouring properties to the north have also been developed with residential dwellings, and the former lumber yard lands to the northwest have been redeveloped with streets and residential dwellings. |

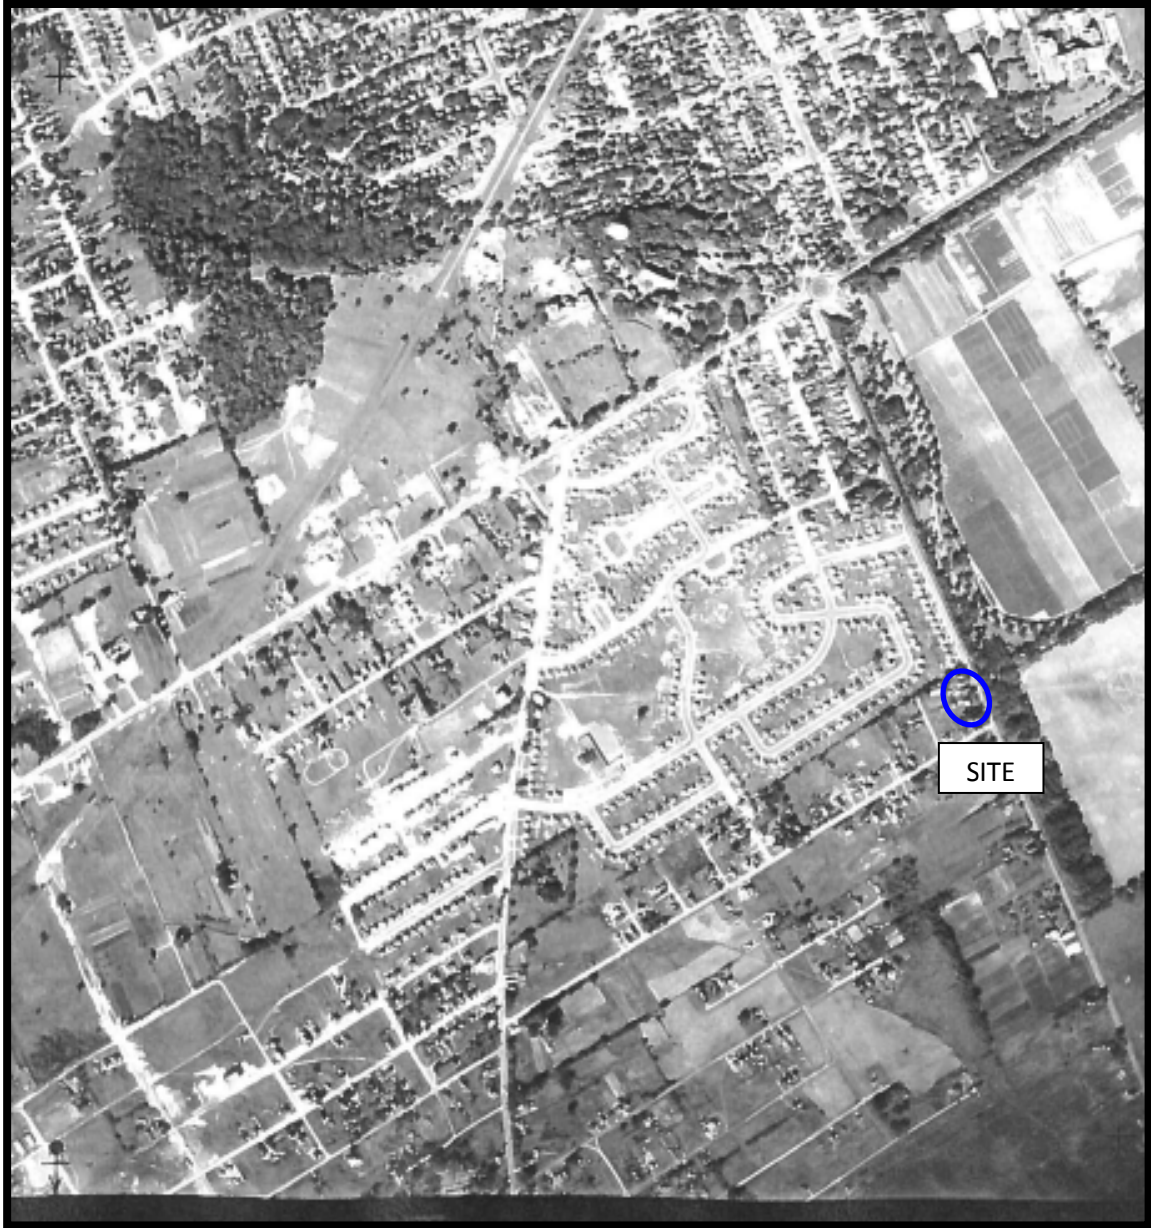
AERIAL PHOTOGRAPH  
1962

| 1962 | No significant changes have been made to the subject site or surrounding properties. |

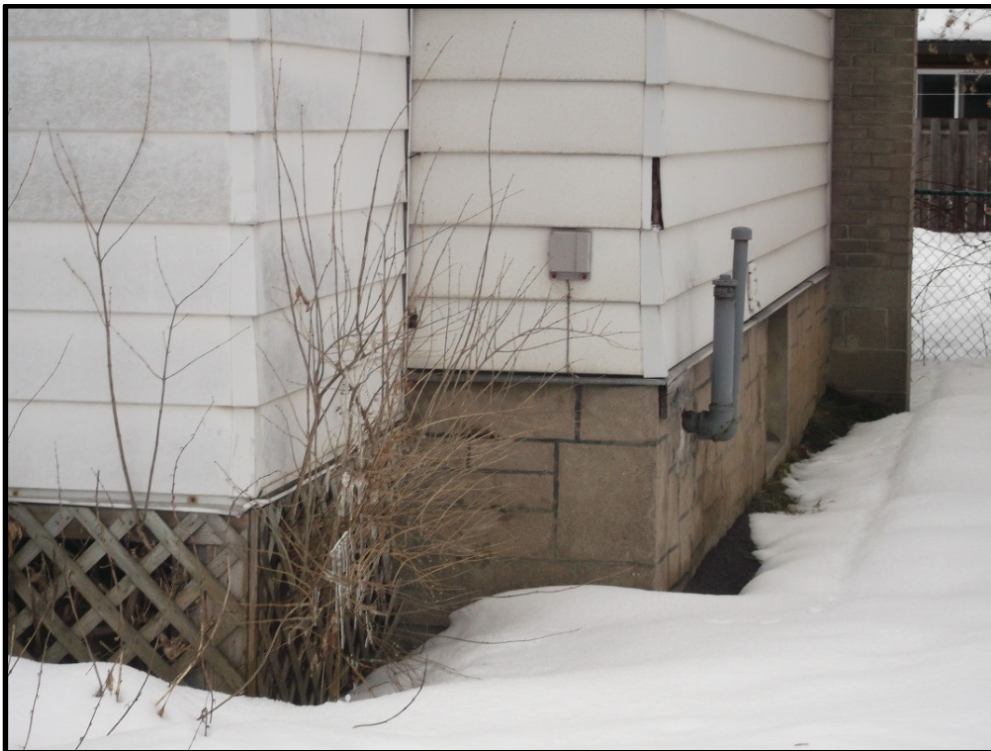
Exterior vent and fill pipes noted at the northeast corner of the residence at 966 Fisher Avenue indicated the presence of an interior aboveground storage tank (AST). No evidence of potential underground storage tanks (USTs) were noted on the exterior of the properties at the time of the site visit. It should be noted that the site was snow covered at the time of the site visit.

Photograph 2: Vent and fill pipes on the northeast corner of 966 Fisher Avenue, looking west.

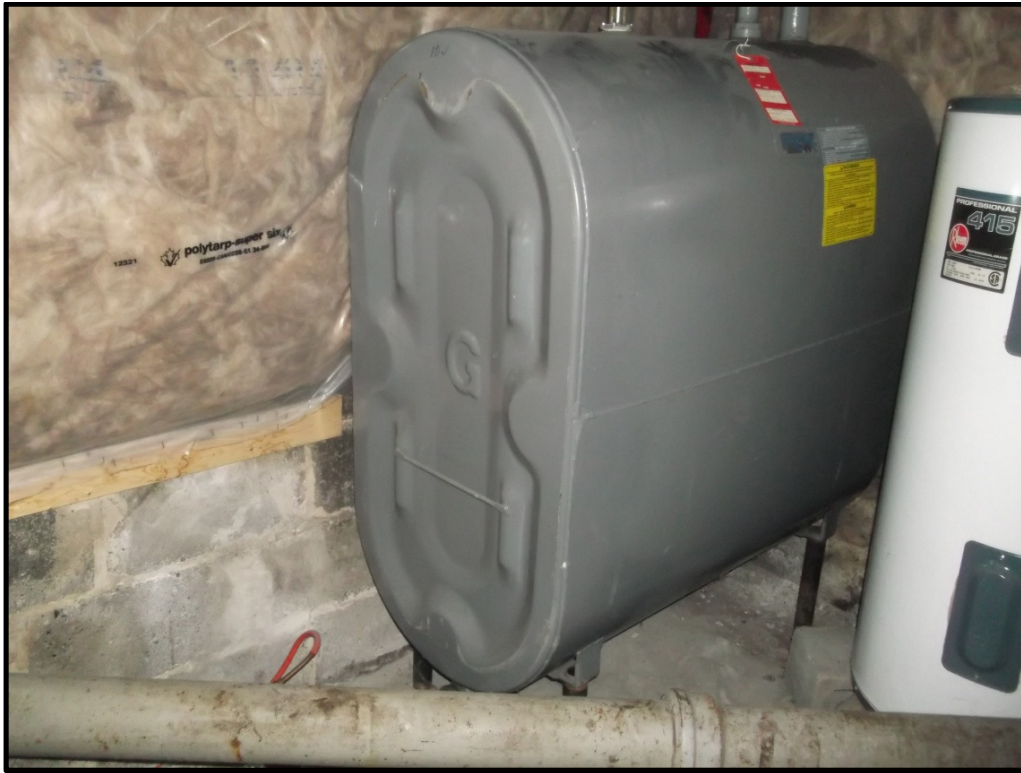
A domestic-sized aboveground storage tank (AST) was present in the basement of the dwelling addressed 966 Fisher Avenue. At the time of the site visit, the AST was three quarters full and in very good condition. According to its tag, the AST was constructed in 2002. No visual or olfactory signs of leakage or staining were noted on or around the AST. The underlying concrete floor slab was in good condition at the time of the site visit.

Photograph 3: Fuel tank and hot water tank in the basement of 966 Fisher Avenue.

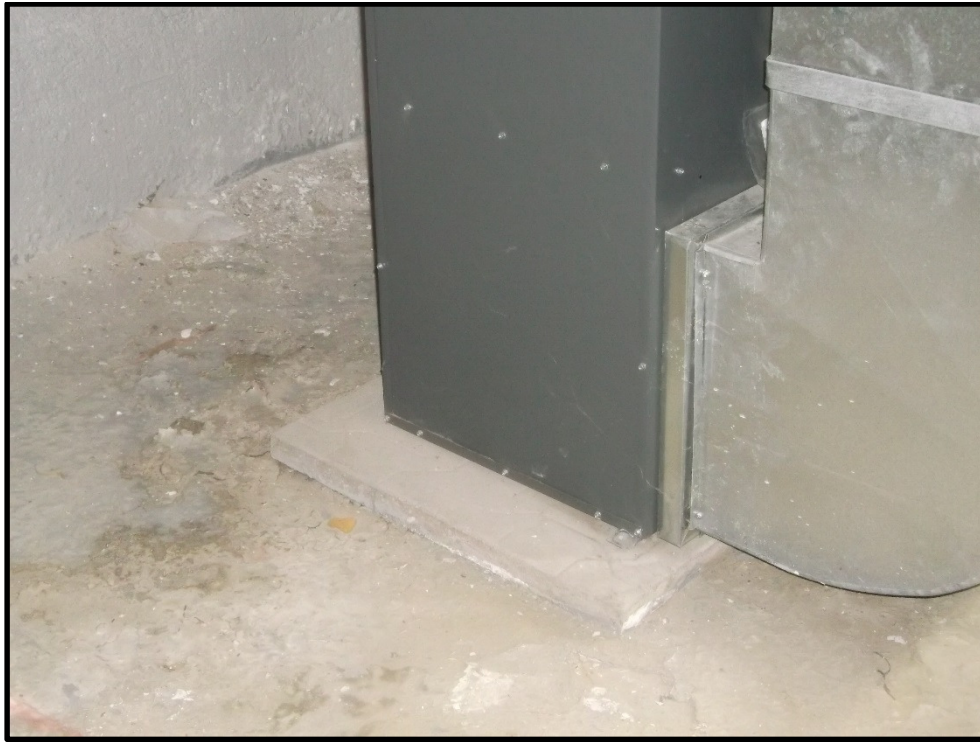
Photograph 7: View of the furnace and floor slab at 968 Fisher Avenue.

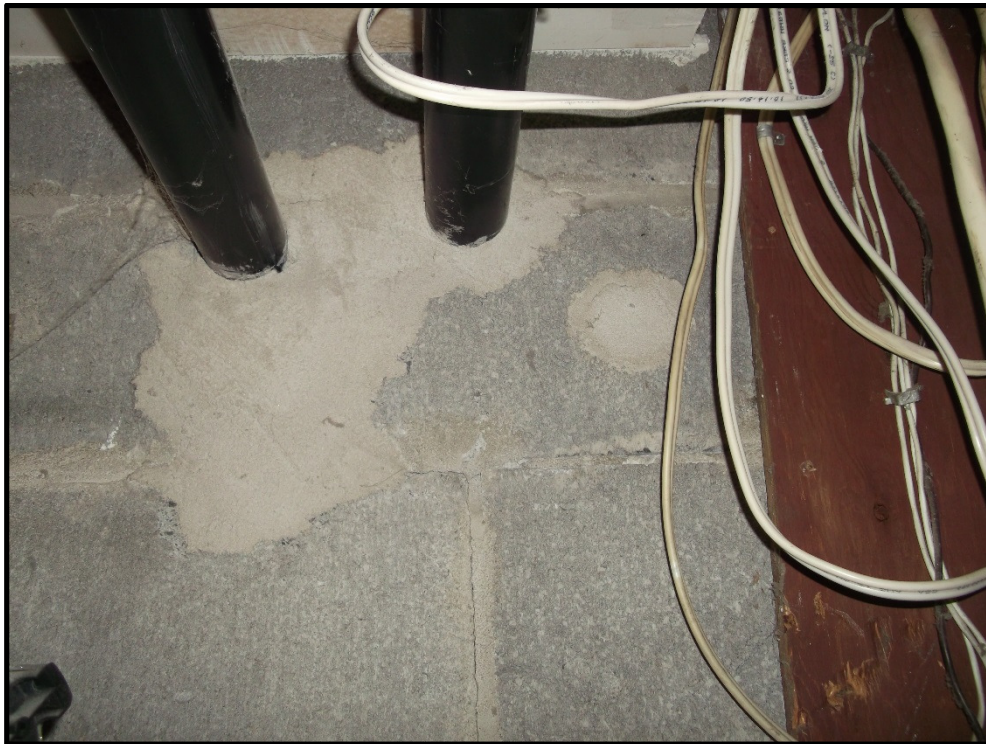
Photograph 10: Possible location of former vent and fill pipes leading to interior AST at 974 Fisher Avenue.

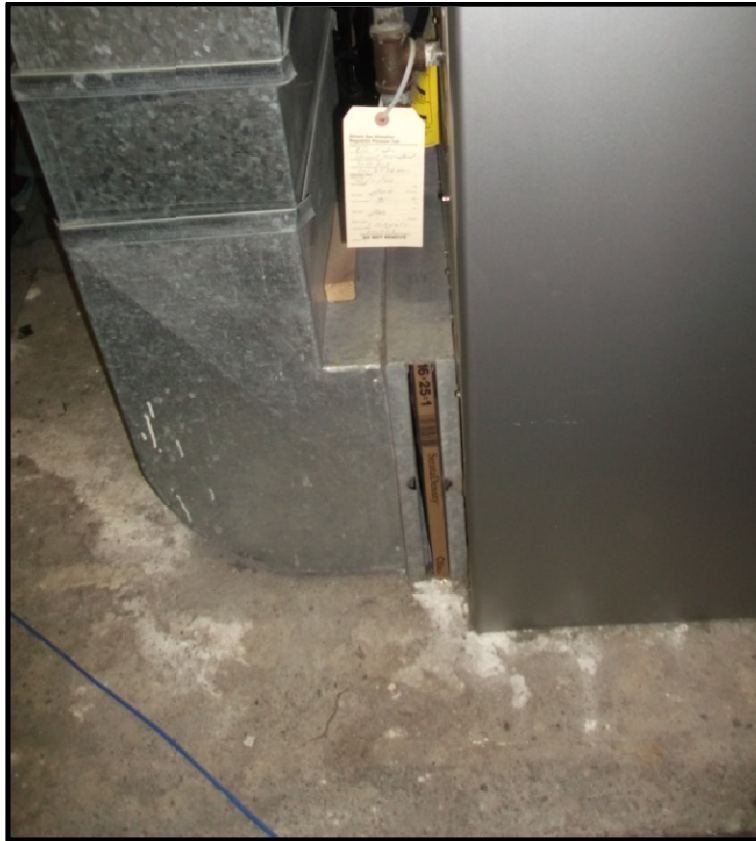
Photograph 11: View of the furnace and concrete floor at 974 Fisher Avenue.
