September 12, 2018

Project No. 1543767

Cavanagh Developments

**ONTARIO REGULATION 153/04 PHASE ONE ENVIRONMENTAL SITE ASSESSMENT UPDATE
2596 CARP ROAD
OTTAWA, ONTARIO**

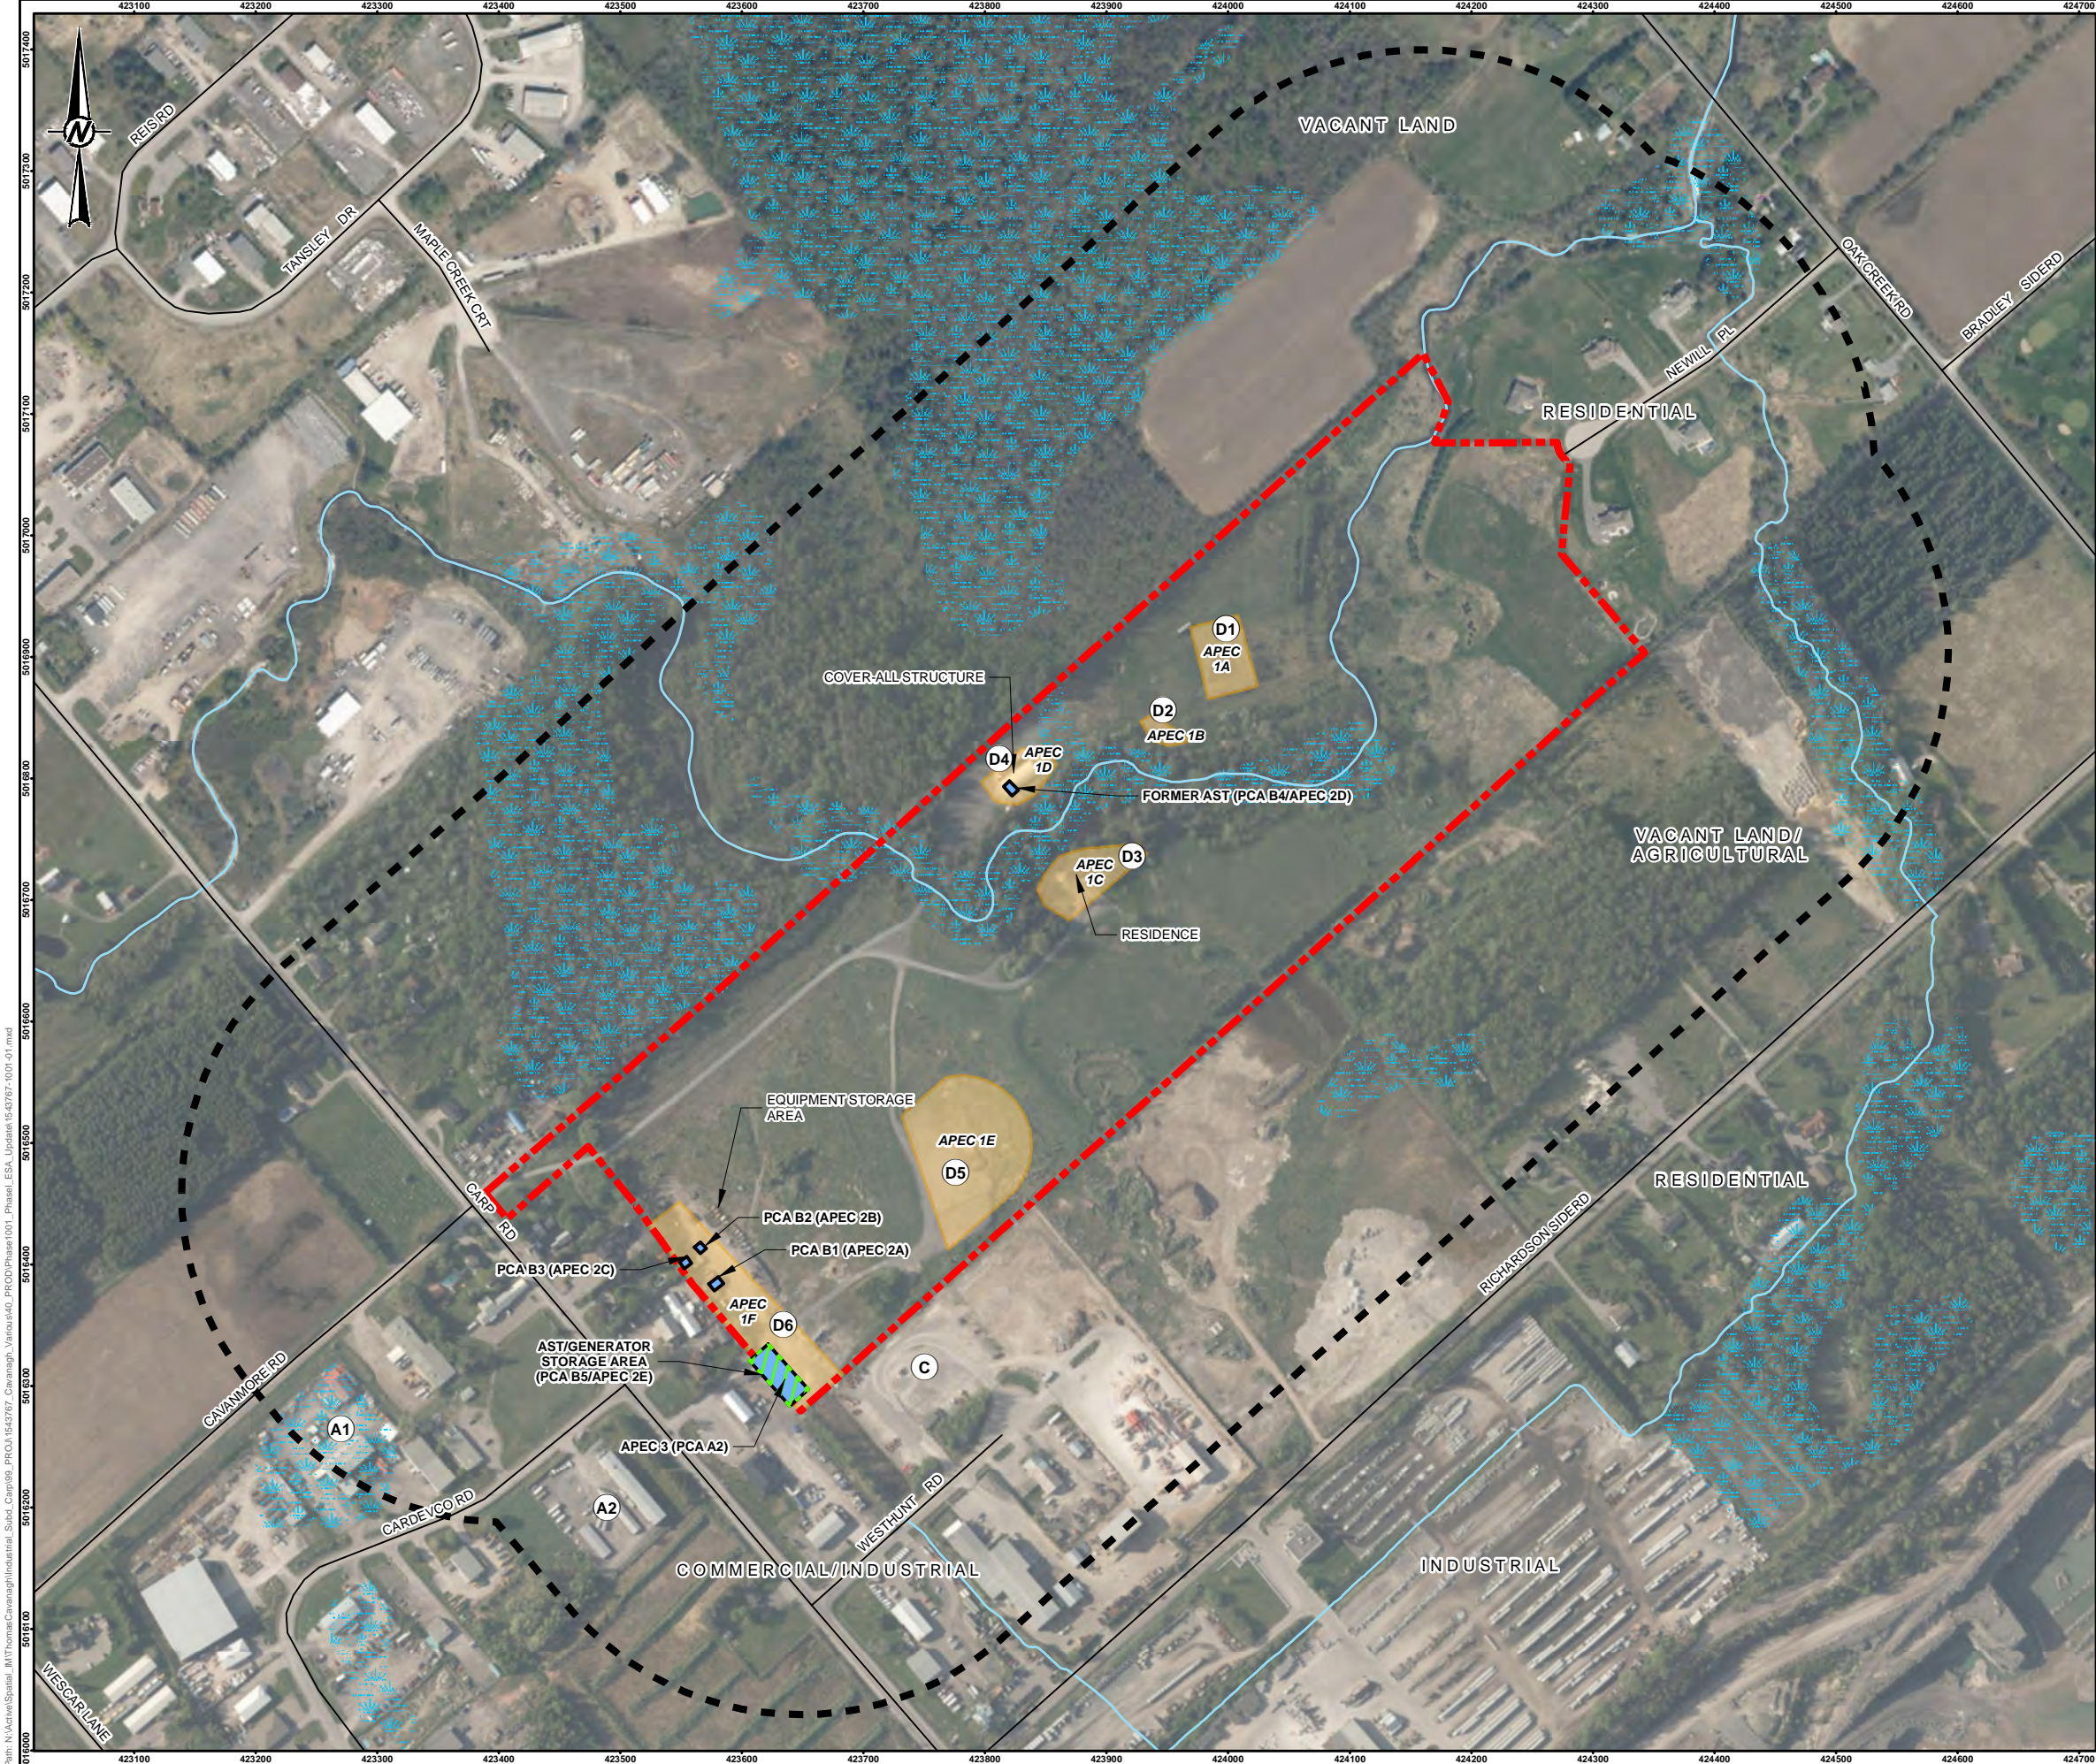
FIGURE
1

APEC 1A TO 1F - IMPORTATION OF FILL OF UNKNOWN QUALITY

APEC 2A TO 2E - GASOLINE AND ASSOCIATED PRODUCTS STORAGE IN FIXED TANKS

APEC 3 - OFF-SITE COMMERCIAL AUTOBODY SHOP

Potential Contaminating Activities ("PCA")			
PCA Location	APEC	Description	PCA# (O.Reg 153/04)
A1	None	Commercial Autobody Shops (Offsite) - Two commercial autobody shops are located southwest of the Site. PCA A1 was not interpreted to represent APECs due to the distance from the Site (>150 m).	10
A2	3		
B1	2A	Gasoline and Associated Products Storage in Fixed Tanks (Onsite) - Currently used diesel/gasoline AST in the Equipment Storage Area	28
B2	2B	Gasoline and Associated Products Storage in Fixed Tanks (Onsite) - Currently used diesel/gasoline AST in the Equipment Storage Area	
B3	2C	Gasoline and Associated Products Storage in Fixed Tanks (Onsite) - Currently used waste oil AST in the Equipment Storage Area	
B4	2D	Gasoline and Associated Products Storage in Fixed Tanks (Onsite) - Former AST adjacent to the Cover-All Structure	
B5	2E	Gasoline and Associated Products Storage in Fixed Tanks (Onsite) - New/used generator ASTs and new generators (not connected and functioning) in the AST/Generator Storage Area	58

C	None	Waste Disposal and Waste Management - The properties at 107 and 111 Westhunt Road are waste transfer/sorting management facilities for dry construction materials for recycling purposes. PCA C was not interpreted to represent an APEC since the waste management/sorting facility is inferred to be located cross-gradient from the Phase One Property based on local topography and contained largely stockpiled lumber and other dry construction materials with absence of liquid waste during the 2016 and 2018 Site Reconnaissance.	
D1	1A	Importation of Fill of Unknown Quality - Potential importation of fill of unknown quality northeast of the Cover-All Structure	
D2	1B	Importation of Fill of Unknown Quality - Potential importation of fill of unknown quality northeast of the Cover-All Structure	
D3	1C	Importation of Fill of Unknown Quality - Potential importation of fill of unknown quality is present near the Residence	30

D4	1D	Importation of Fill of Unknown Quality - Potential importation of fill of unknown quality is present near the Cover-All Structure	
D5	1E	Importation of Fill of Unknown Quality - Potential importation of fill of unknown quality is present northeast of the Equipment Storage Area	
D6	1F	Importation of Fill of Unknown Quality - Potential importation of fill of unknown quality is present at the Equipment Storage and AST/Generator Areas

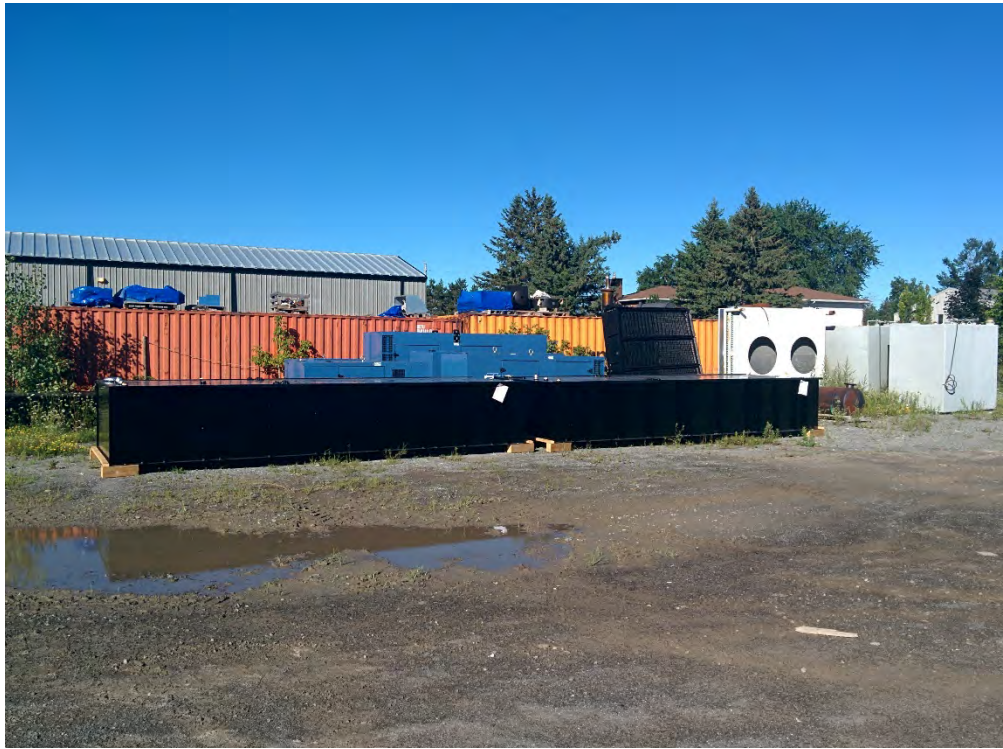
Photo 1: View of the AST/Generator Storage Area occupied by Gal Power Systems Ottawa. Facing southwest.

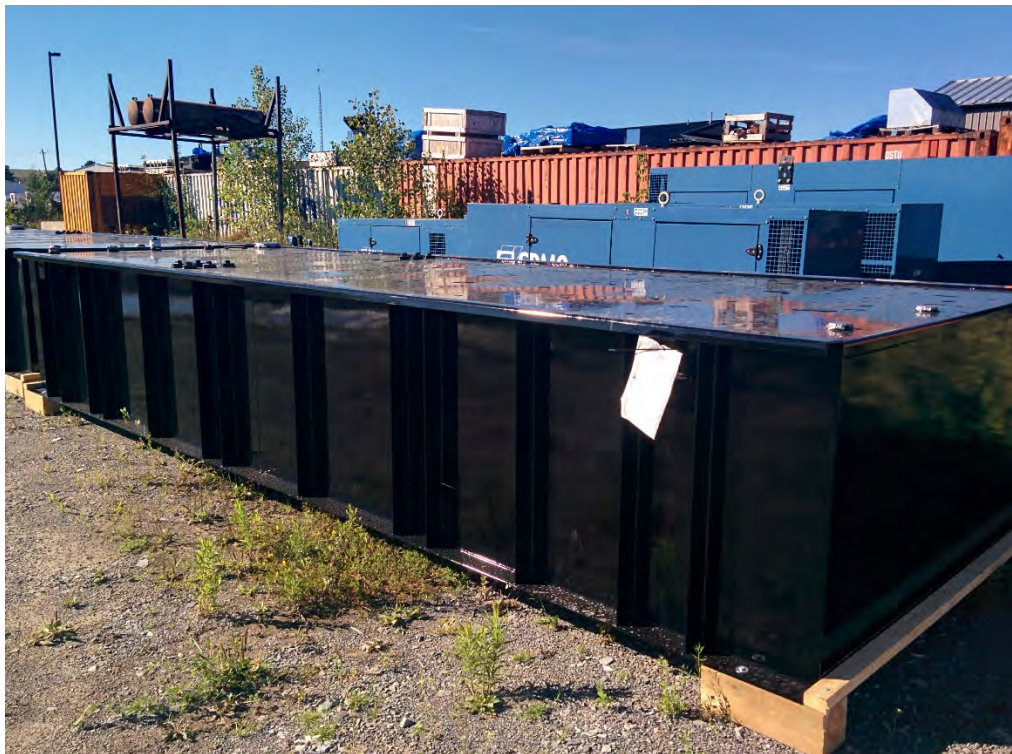
Photo 2: View of the AST/Generator Storage Area occupied by Gal Power Systems Ottawa. No staining/odour observed. Facing southwest.

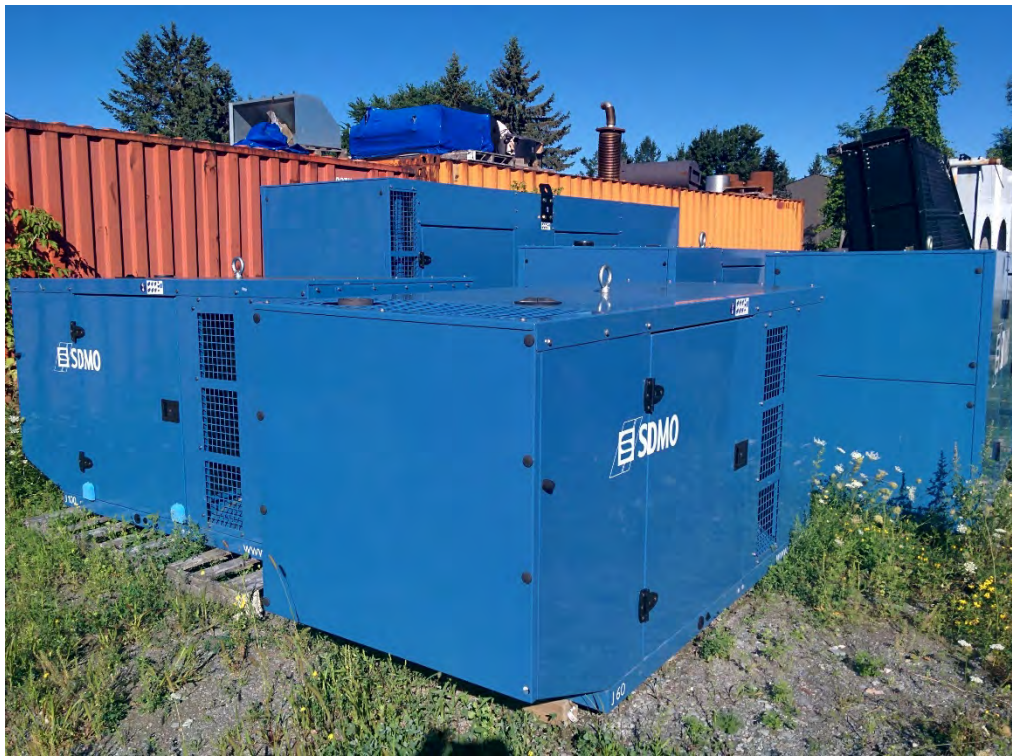
Photo 3: View of new generators in the AST/Generator Storage Area occupied by Gal Power Systems Ottawa. Facing southwest.

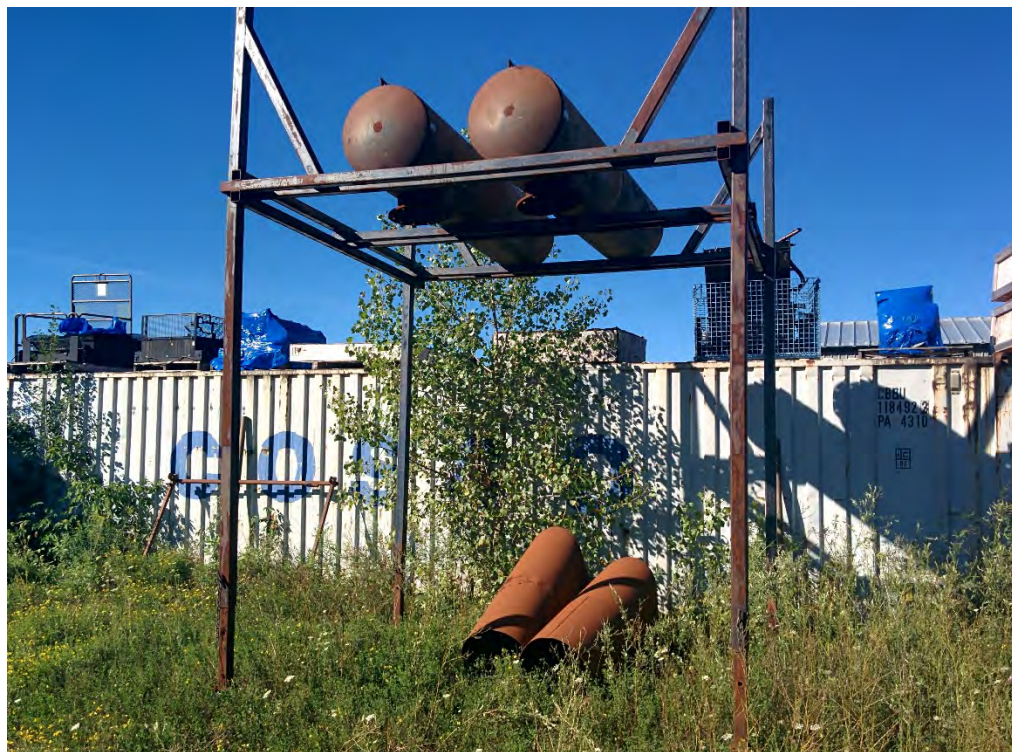
Photo 4: View of used ASTs in the AST/Generator Storage Area occupied by Gal Power Systems Ottawa. No staining/odour observed. Facing southwest.

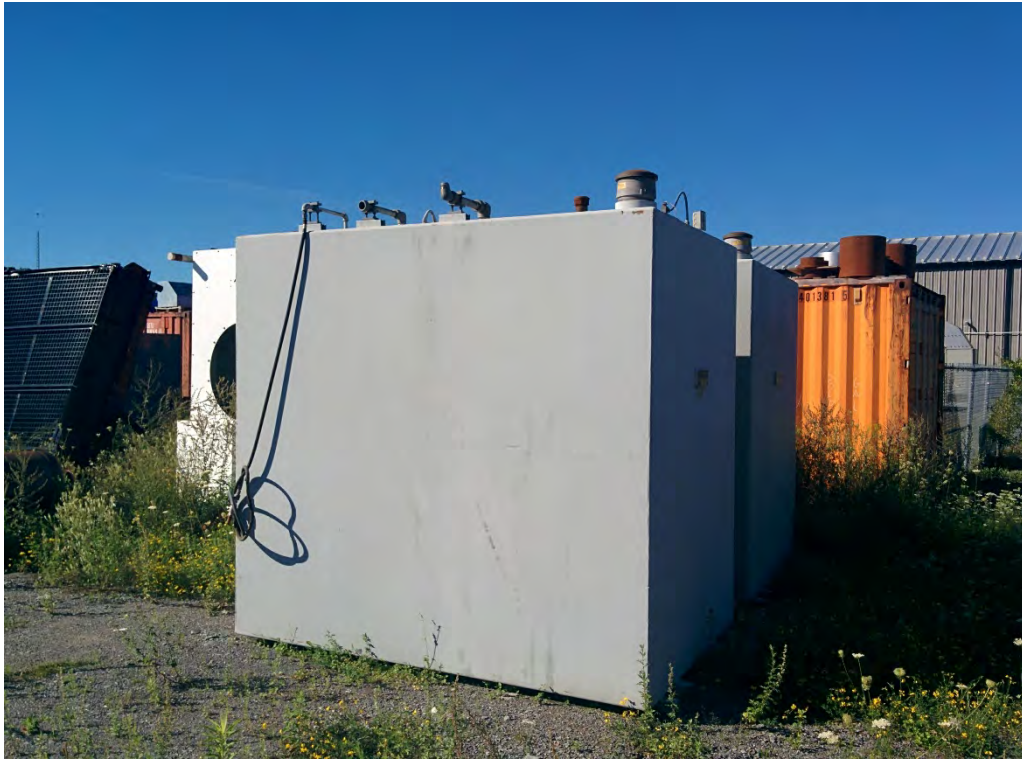
Photo 5: View of new/used ASTs in the AST/Generator Storage Area occupied by Gal Power Systems Ottawa. No staining/odour observed. Facing southwest.

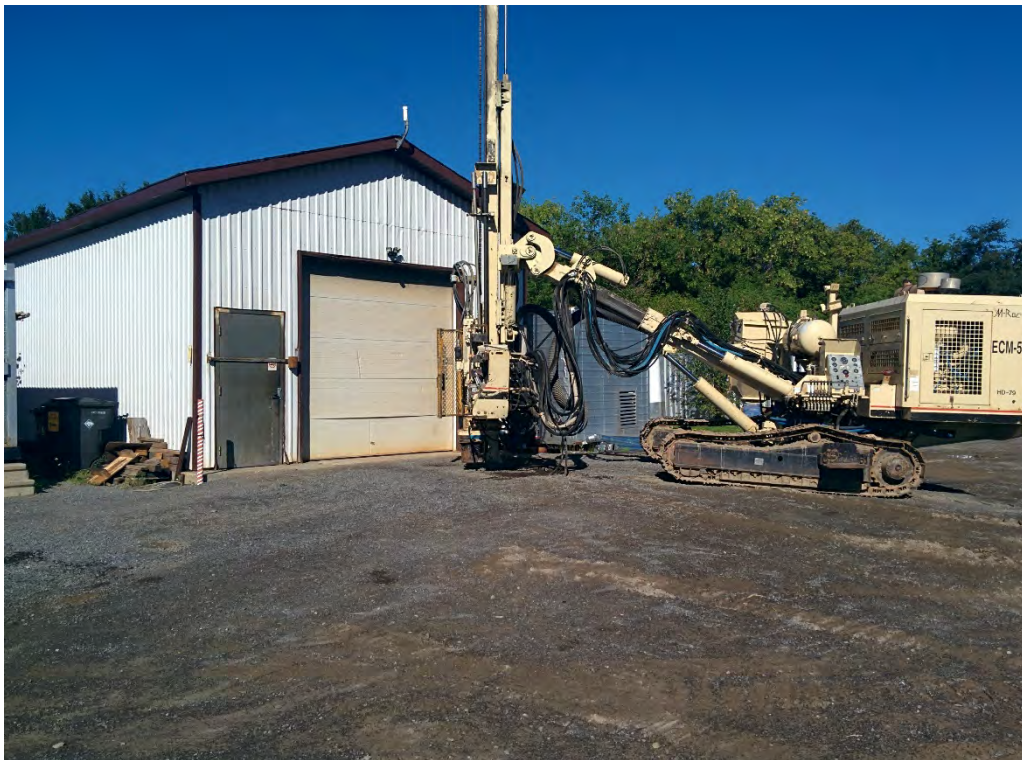
Photo 6: View of the maintenance garage and drilling equipment in the Equipment Storage Area occupied by M-Roc Ltd. Facing southwest.

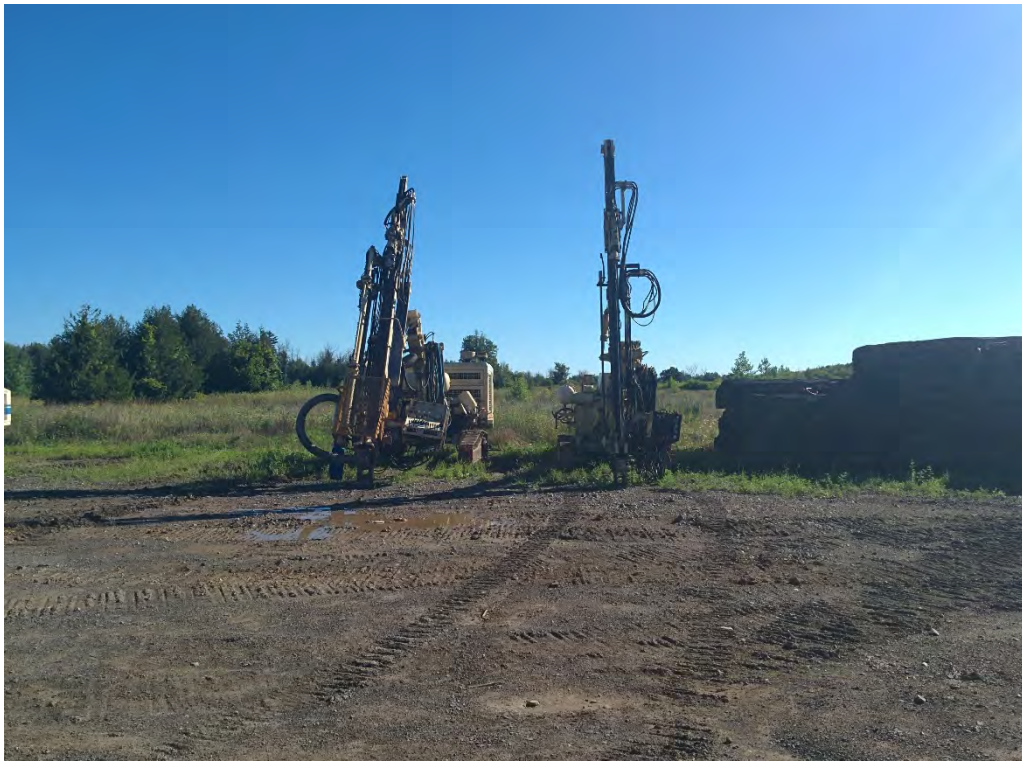
Photo 7: View of stockpiled scrap rubber tires and drilling equipment on the Equipment Storage Area occupied by M-Roc Ltd. Facing northeast.

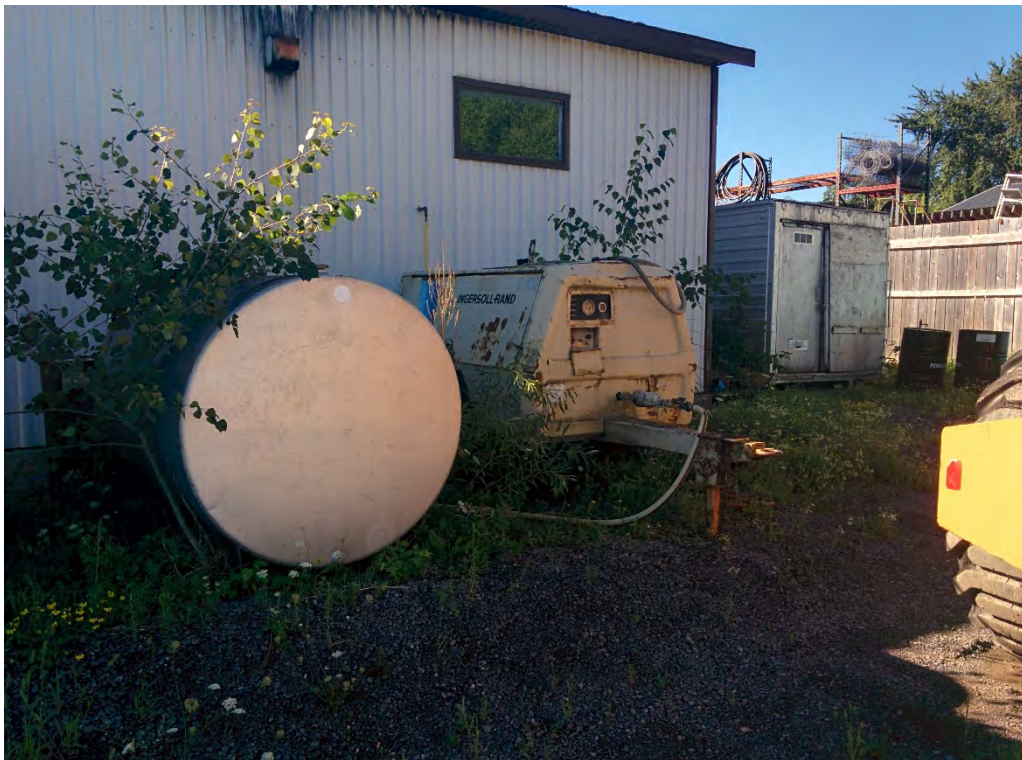
Photo 8: View of an actively used diesel AST (APEC 2A) on the Equipment Storage Area occupied by M-Roc Ltd. Facing south.

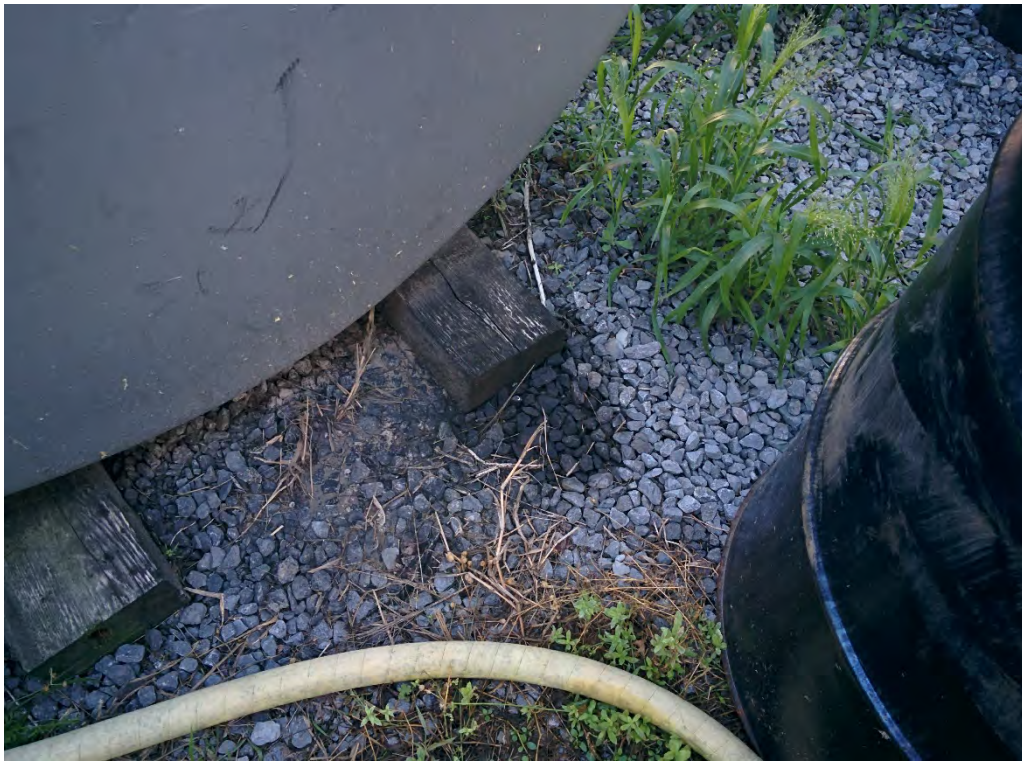
Photo 9: View of an actively used diesel AST (APEC 2A) and slight ground staining on the Equipment Storage Area occupied by M-Roc Ltd. Facing north.

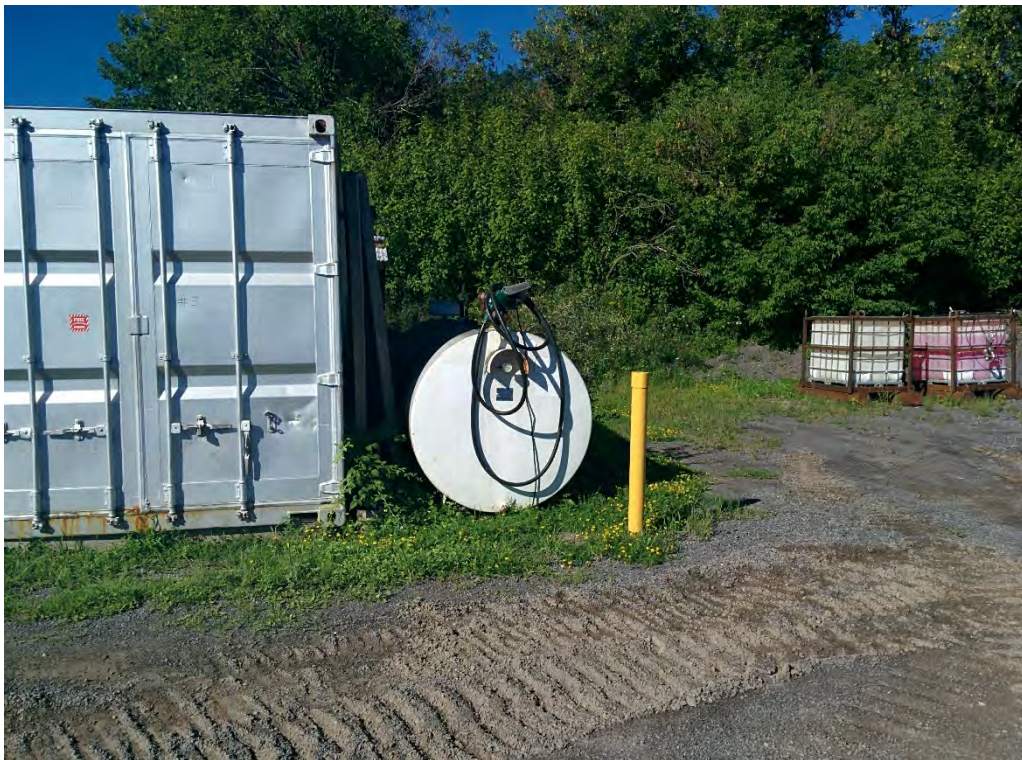
Photo 10: View of an actively used AST (APEC 2B) on the Equipment Storage Area occupied by M-Roc Ltd. No staining/odour observed. Facing southwest.

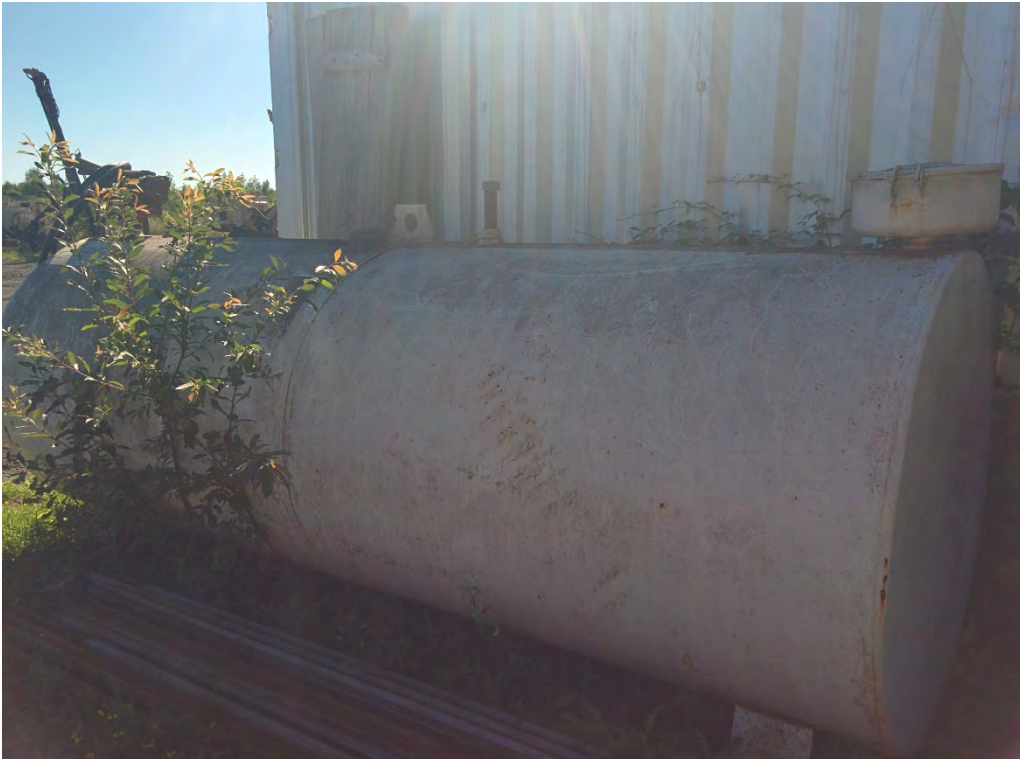
Photo 11: View of an actively used AST (APEC 2B) on the Equipment Storage Area occupied by M-Roc Ltd. No staining/odour observed. Facing northeast.

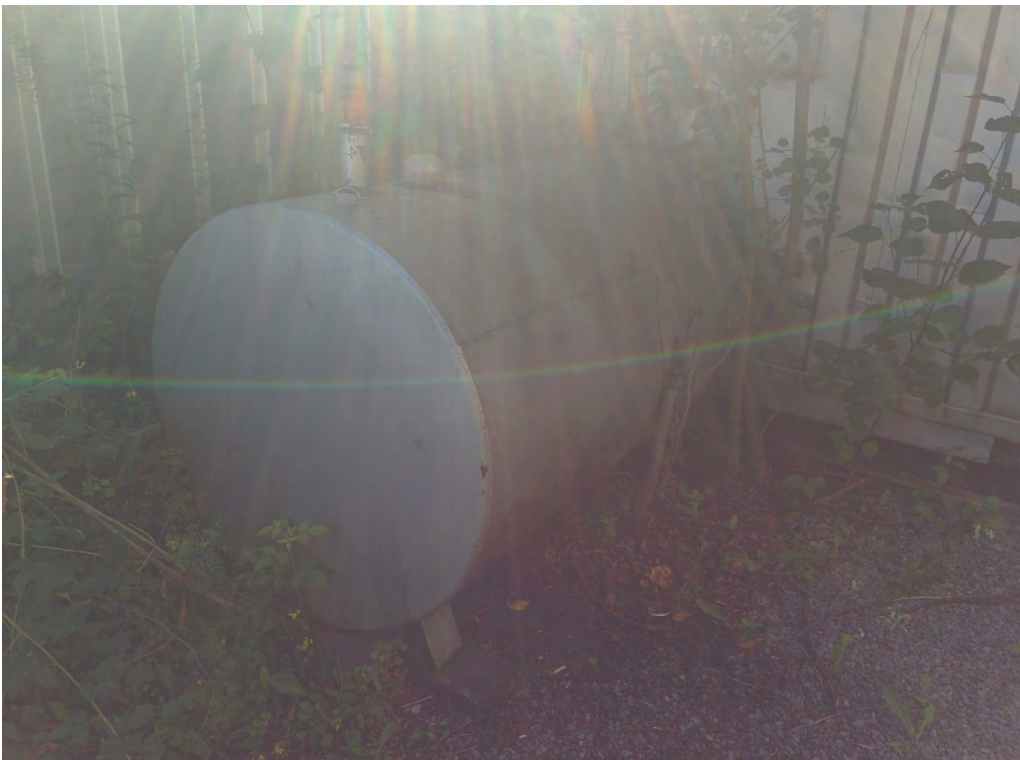
Photo 12: View of an actively used AST (APEC 2C) on the Equipment Storage Area occupied by M-Roc Ltd. Slight staining and odour observed. Facing northeast.

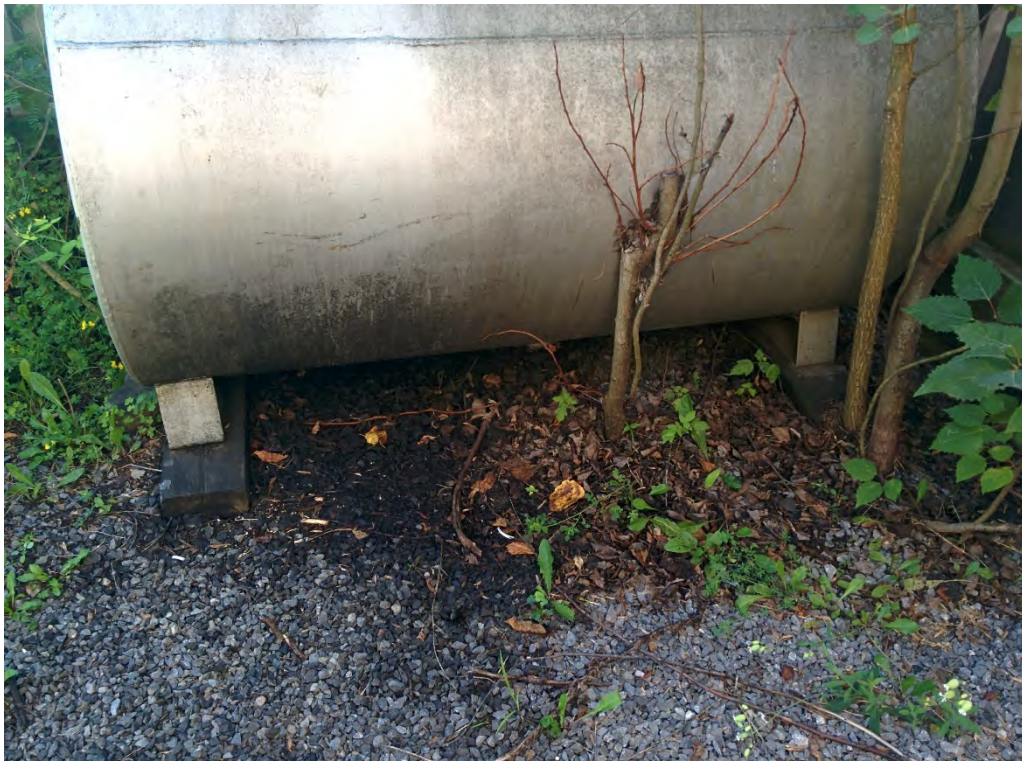
Photo 13: View of an actively used AST (APEC 2C) on the Equipment Storage Area occupied by M-Roc Ltd. Slight staining and odour observed. Facing northeast.

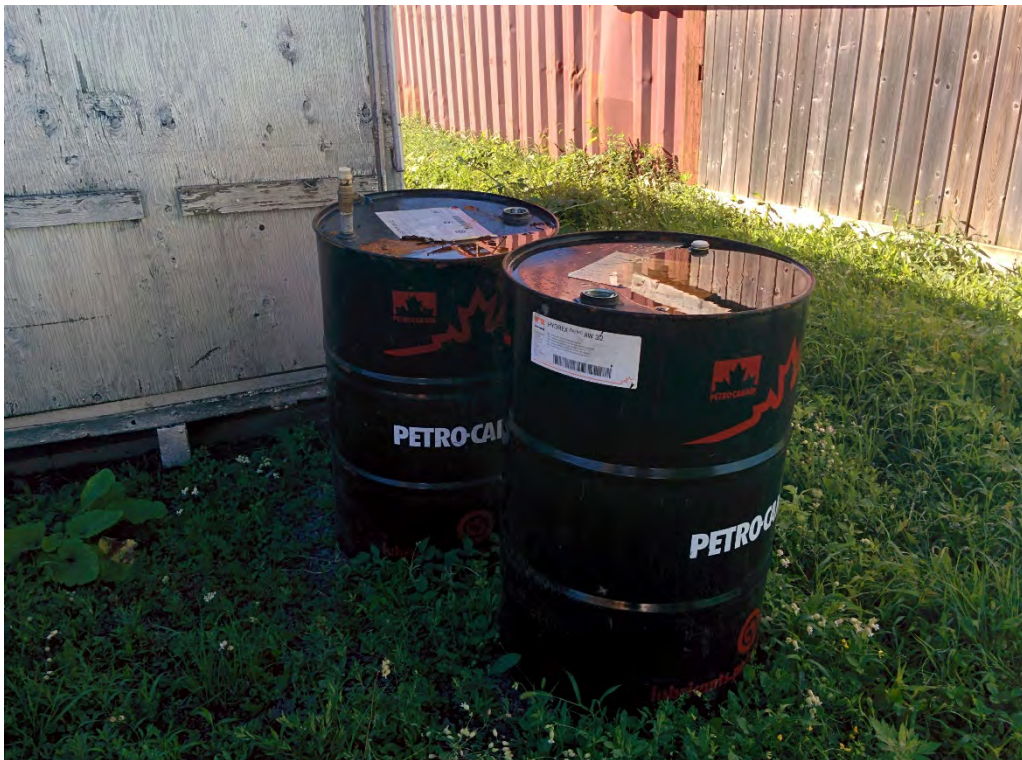
Photo 14: View of hydraulic oil drums on the Equipment Storage Area occupied by M-Roc Ltd. No evidence of contamination. Facing southeast.

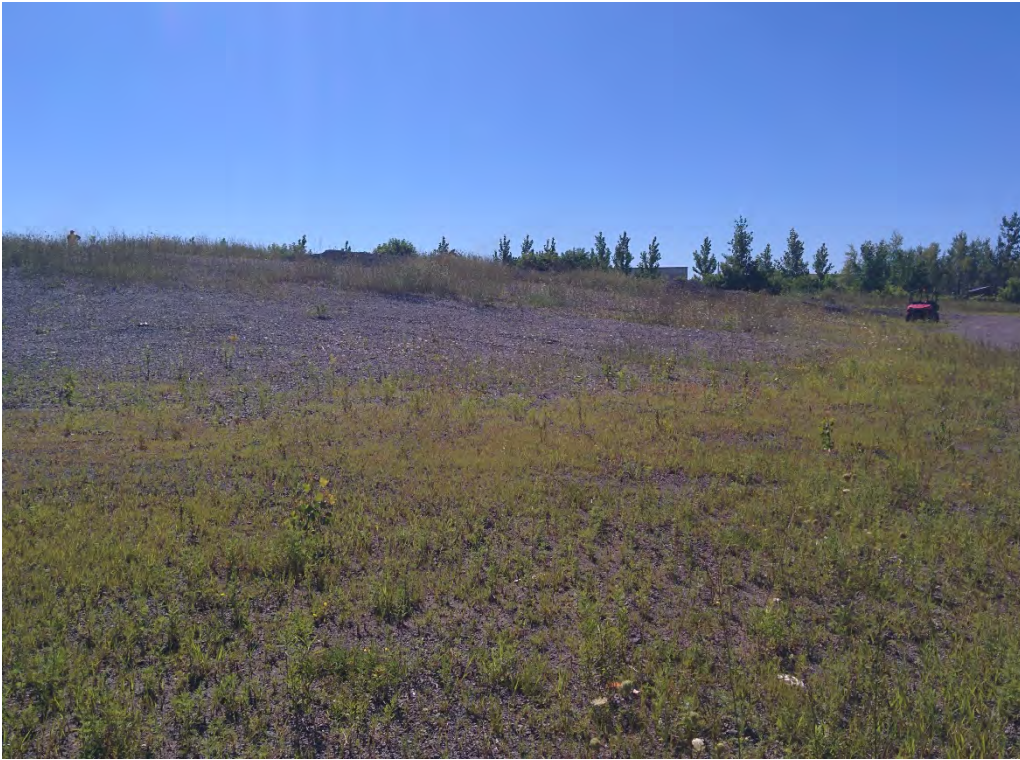
- Areas of imported fill were observed immediately northeast of the AST/Generator Storage Area, as outlined by areas of topographic highs containing coarse granular material (identified as APEC 1E in Figure 1). Aerial photographs from 2004 showed evidence of fill placement in this area. Roof shingles and stockpiled lumber were also identified during the 2018 site visit.

Photo 15: View of imported fill area immediately northeast of the Equipment Storage Area (APEC 1E). The area consists of coarse granular material. Facing southeast.

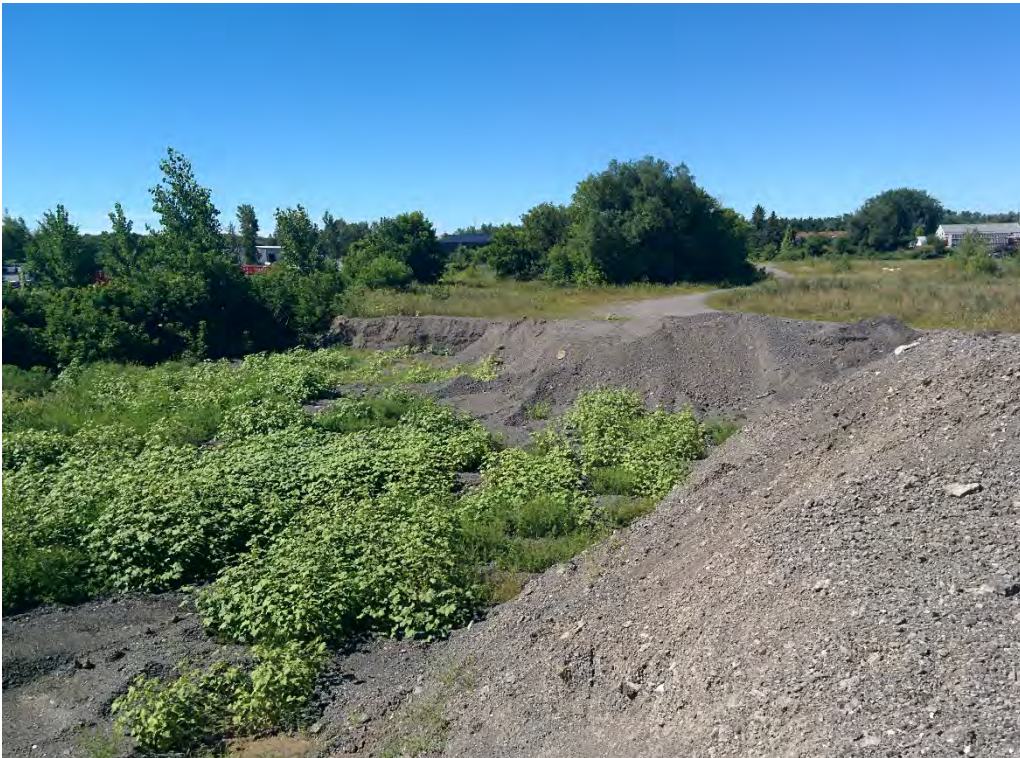
Photo 16: View of imported fill area immediately northeast of the Equipment Storage Area. The area consists of coarse granular material. Facing southeast.

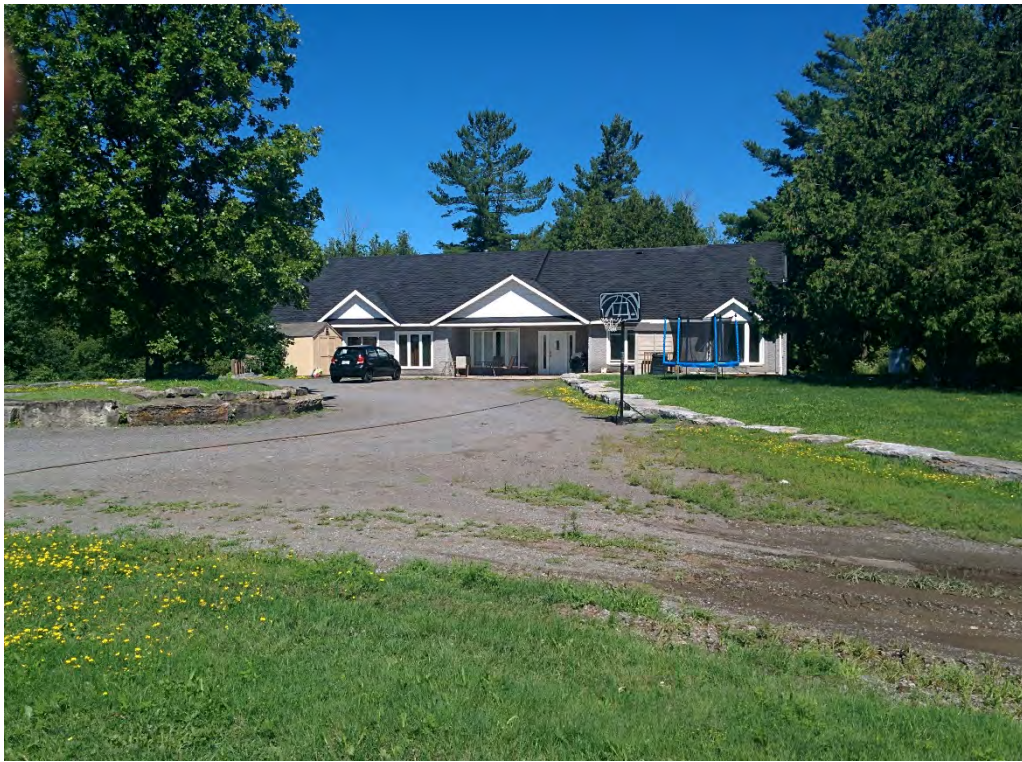
Photo 17: View of the onsite residence, which appears to have remained unchanged from the 2016 Phase One ESA. Facing north.

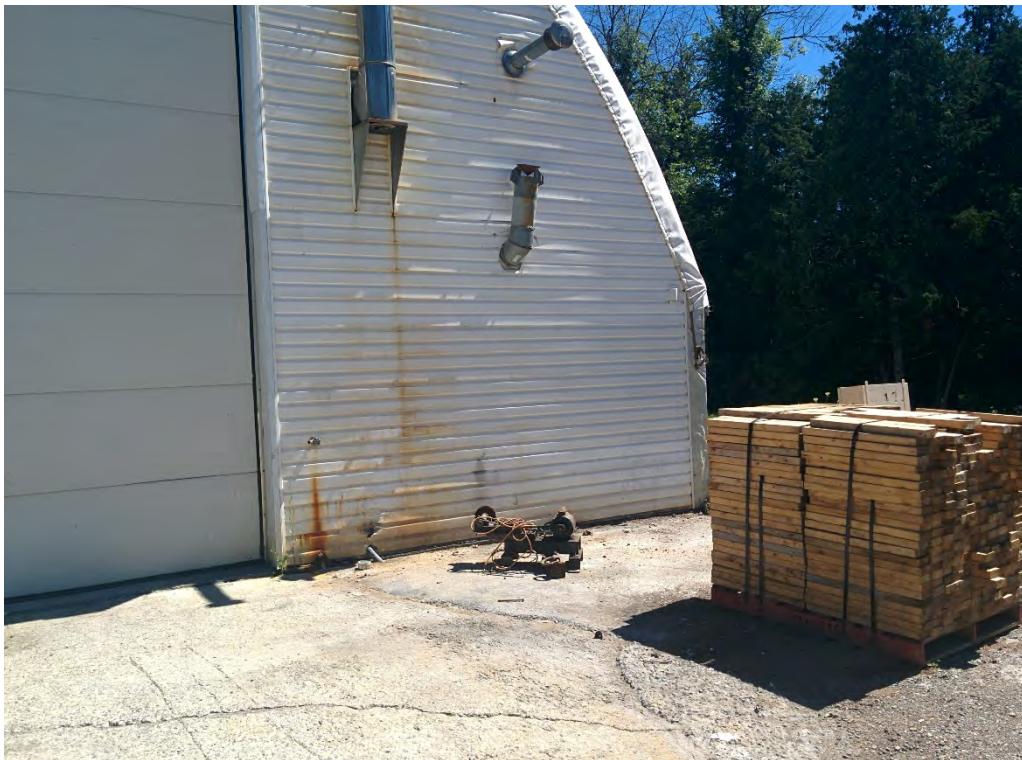
- The area of the property that features a residence appears to have remained unchanged from the 2016 Phase One ESA.
- The AST connected to the west wall of the Cover-All Structure in the 2016 Phase One ESA that featured staining (herein referred to as the Former AST or APEC 2D) was not observed during the 2018 site visit. The Former AST, along with the exterior piping located outside of the Cover-All Structure, appeared to be removed, however the ground featured noticeable staining. The location of the Former AST is shown on Figure 1. The other two (2) ASTs identified in the 2016 Phase One ESA located along the northern site boundary were also not observed during the 2018 site visit.

Photo 18: View of the west wall of Cover-All Structure, where the out-of-service AST (Former AST) was located in the April 2016 site visit. Visible staining was observed. Facing northeast.

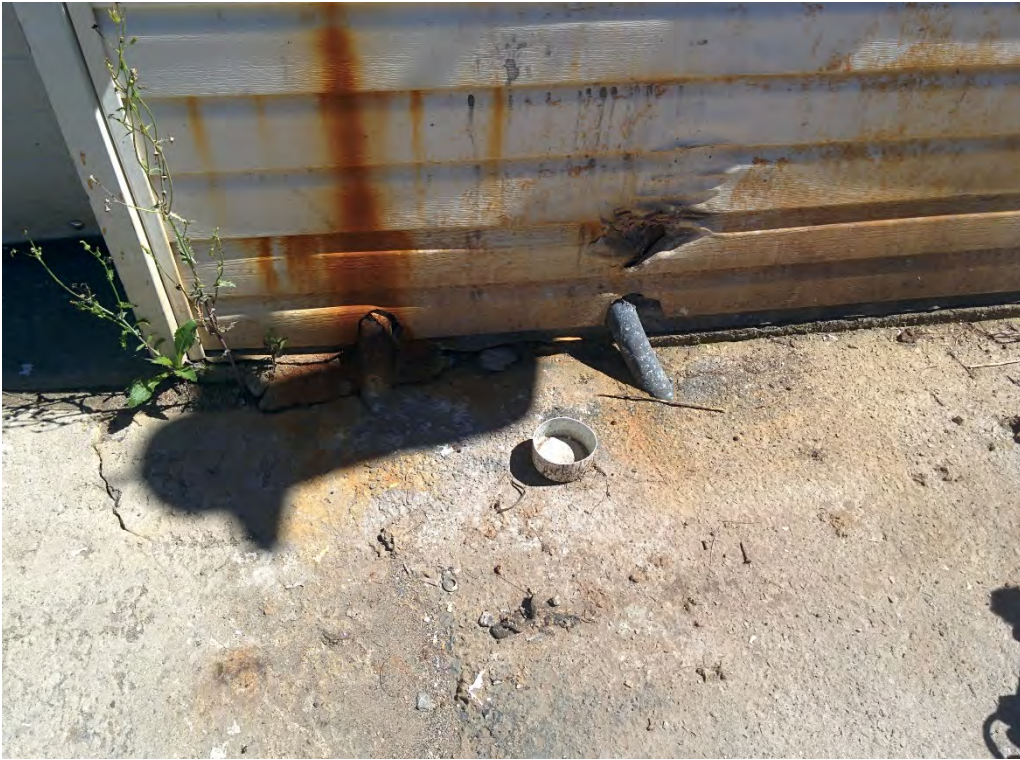
Photo 19: View of the west wall of Cover-All Structure, where the out-of-service AST (Former AST) was located in the April 2016 site visit. Visible staining was observed. Facing northeast.

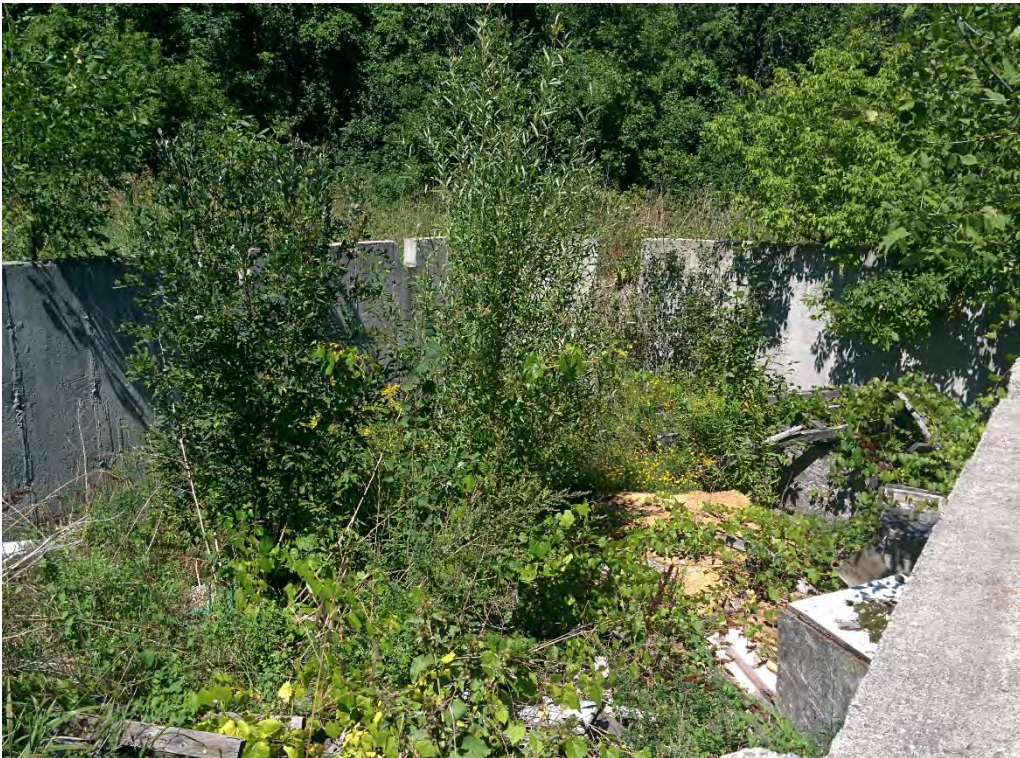
- The two (2) concrete foundations located to the northeast of the Cover-All Structure were observed during the 2018 site visit and appeared to have remained unchanged from the 2016 Phase One ESA.

Photo 20: View of concrete foundation with wood debris identified in the 2016 Phase One ESA.
