**Phase I Environmental Site Assessment**

384 Frank Street  
Ottawa, Ontario

November 28, 2017

Report: PE4140-1

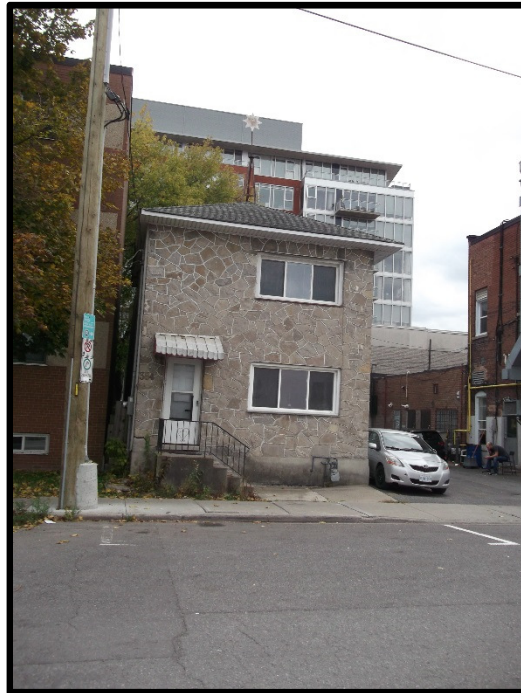
The property at 384 Frank Street is occupied by a two-storey residential dwelling with a full basement level. The structure is constructed with a stone and mortar foundation. The original brick walls on the north, south and west faces of the building have been covered with vinyl siding or stone veneer, while the east wall of the structure is constructed of concrete block. The roof of the structure is covered with asphaltic shingles.

Photograph 1: View of north face of subject structure, facing south.

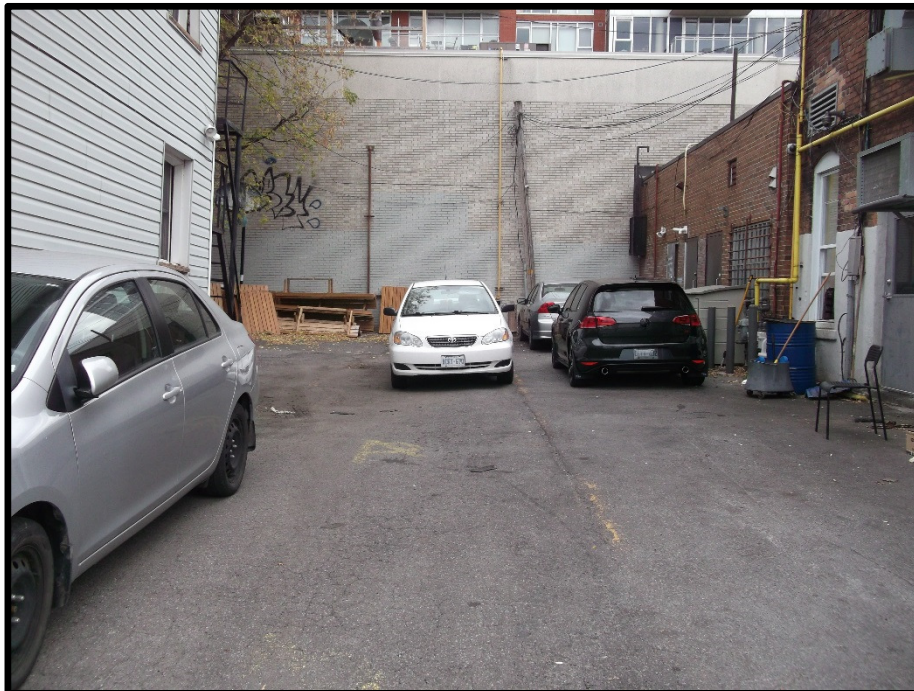
Photograph 2: View of western portion of the Phase I Property, facing south. Photo illustrates west face of subject structure as well as commercial buildings on the adjacent properties to the south and east.

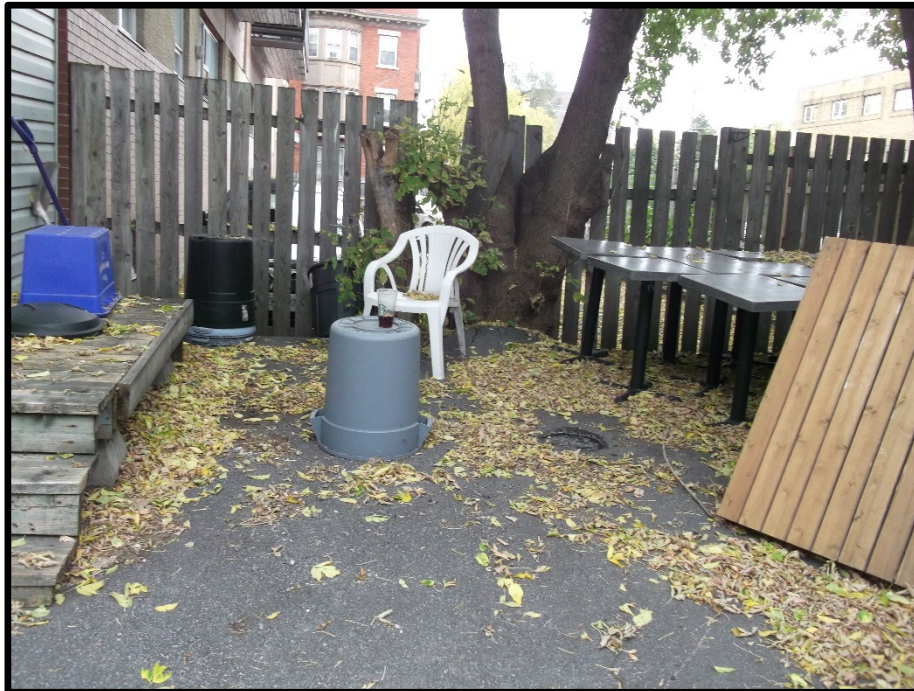
The location of a previous borehole conducted by others, was noted on the exterior of the property, south of the subject structure; otherwise no evidence of recent excavation was observed at the time of the site visit. No evidence of current or former railway or spur lines on the subject land were observed at the time of the site visit. There were no unidentified substances observed on the exterior of the Phase I Property.

Photograph 3: View of southwestern portion of Phase I Property, facing east. Photo illustrates location of previous geotechnical borehole.

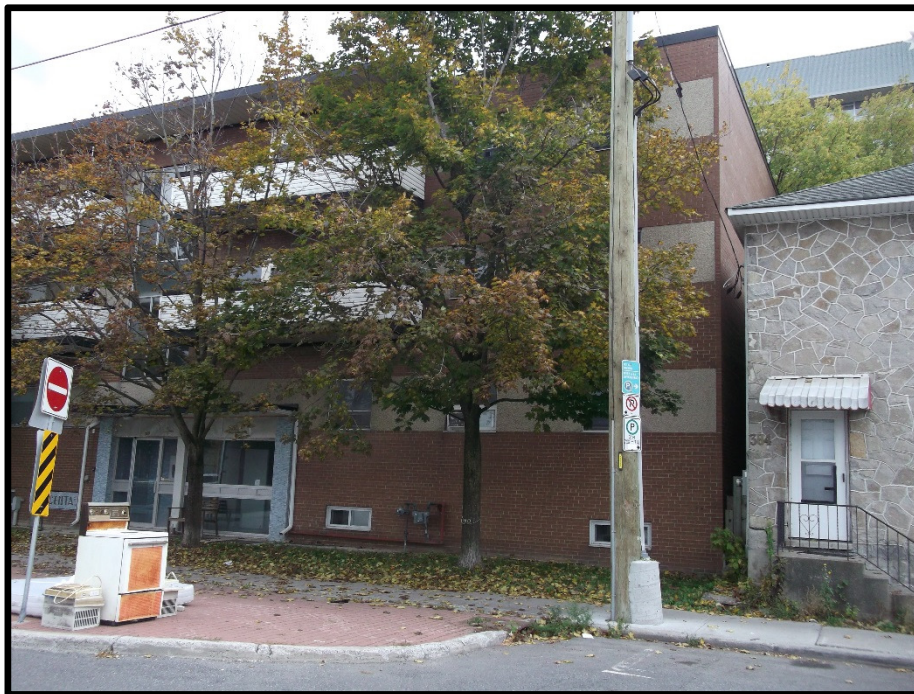
Photograph 4: Photo illustrates residential apartment building adjacent to the east, facing southeast.

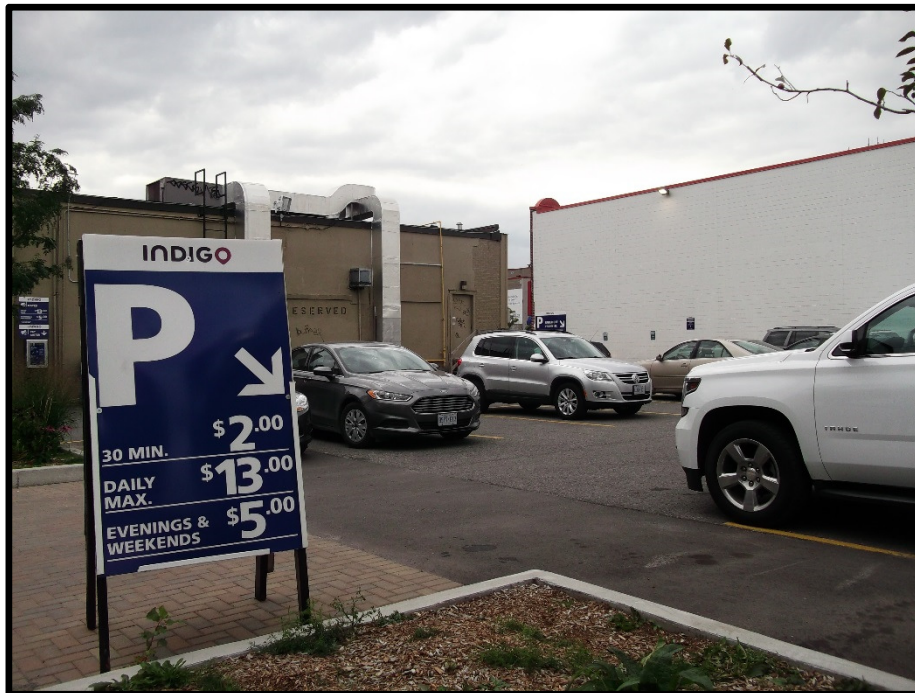
Photograph 5: Photo illustrates commercial parking lot north of the Phase I Property, across Frank Street, facing northwest.

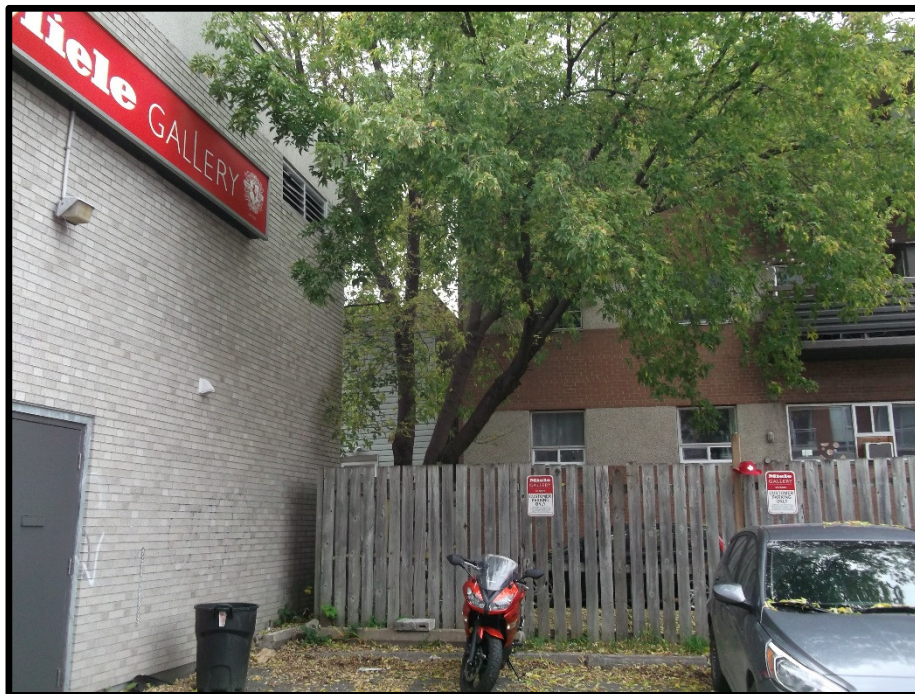
Photograph 6: View of east face of adjacent commercial property to the south and south face of the residential apartment building to the east of the Phase I Property, facing northwest.

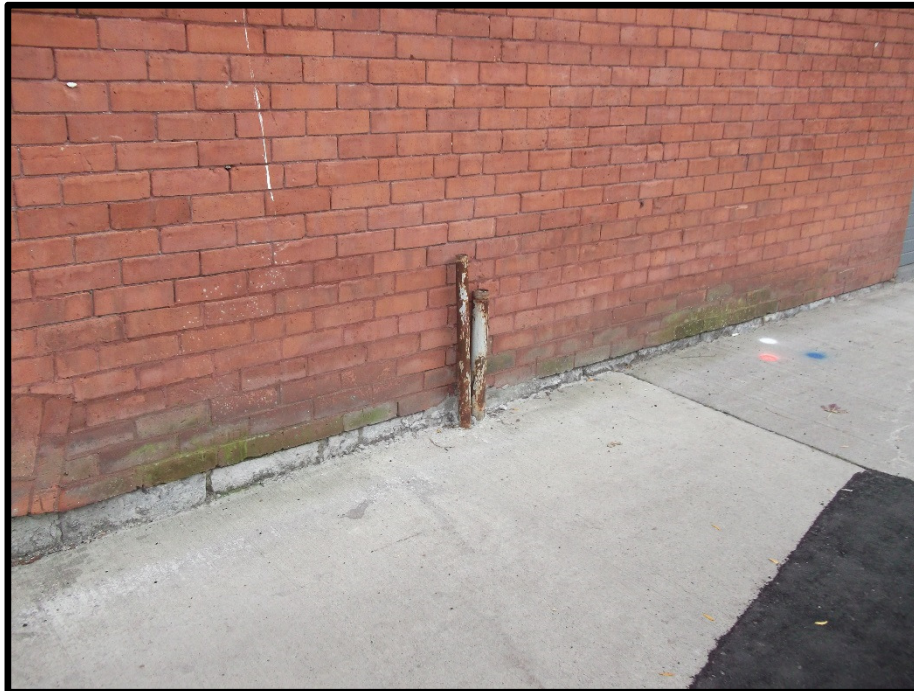
Photograph 7: Photo illustrates vent and fill pipes along the north wall of the commercial building (fronting onto Frank Street) adjacent to the west of the Phase I Property, facing southwest.

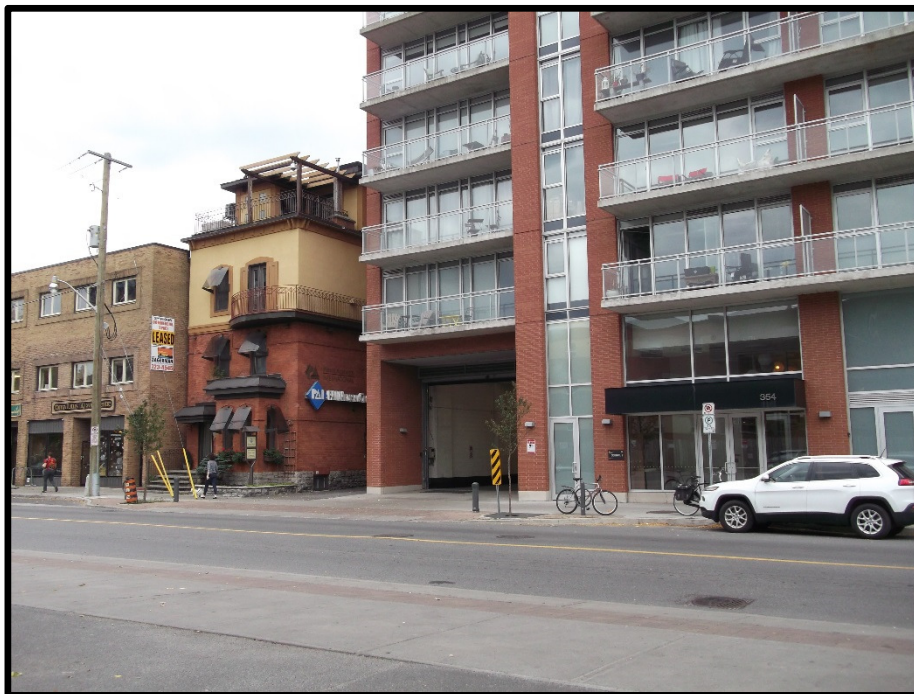
Photograph 8: View of residential and commercial properties one block south of the Phase I Property, along the south side of Gladstone Avenue.
