Phase I-Environmental Site Assessment

471 Terry Fox Drive
Ottawa, Ontario

September 5, 2018

Report: PE4407-1

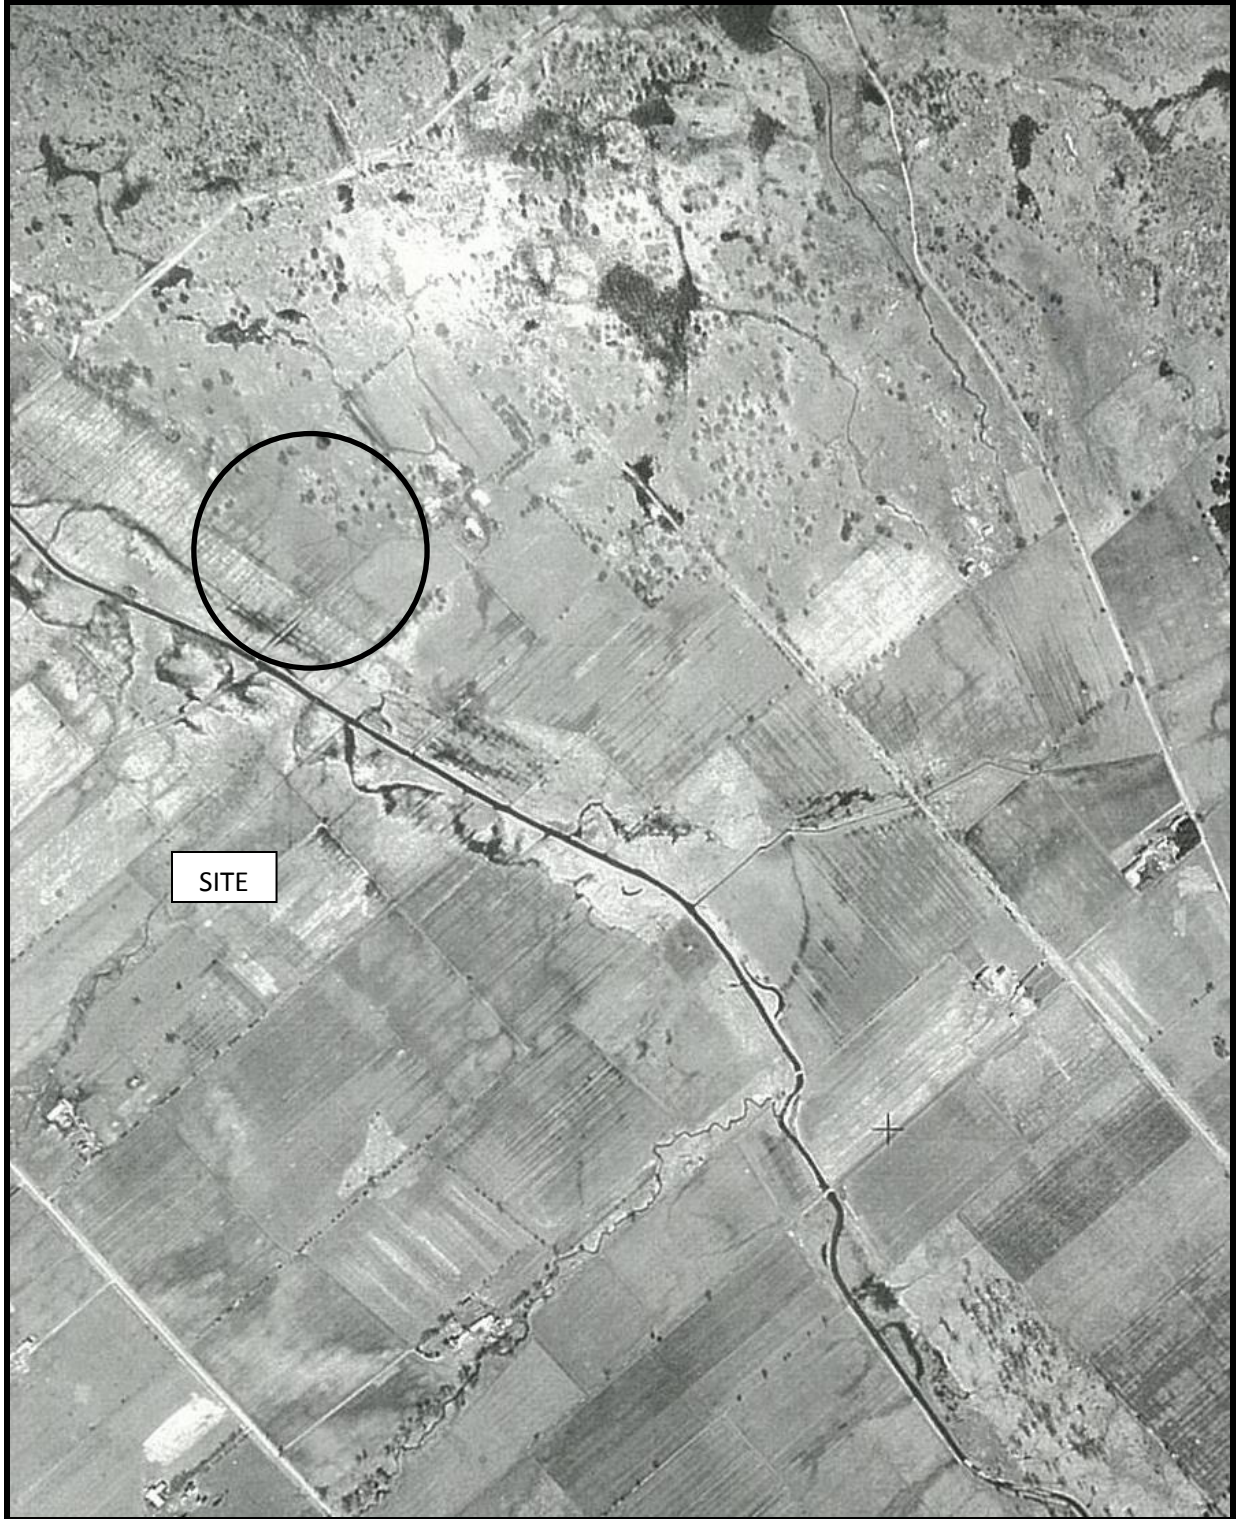
AERIAL PHOTOGRAPH
1947

| 1947 | The subject site is vacant agricultural land. The Carp River is present to the southwest, and Richardson Side Road is present to the north. Terry Fox Drive and Kanata Avenue have not yet been constructed. |

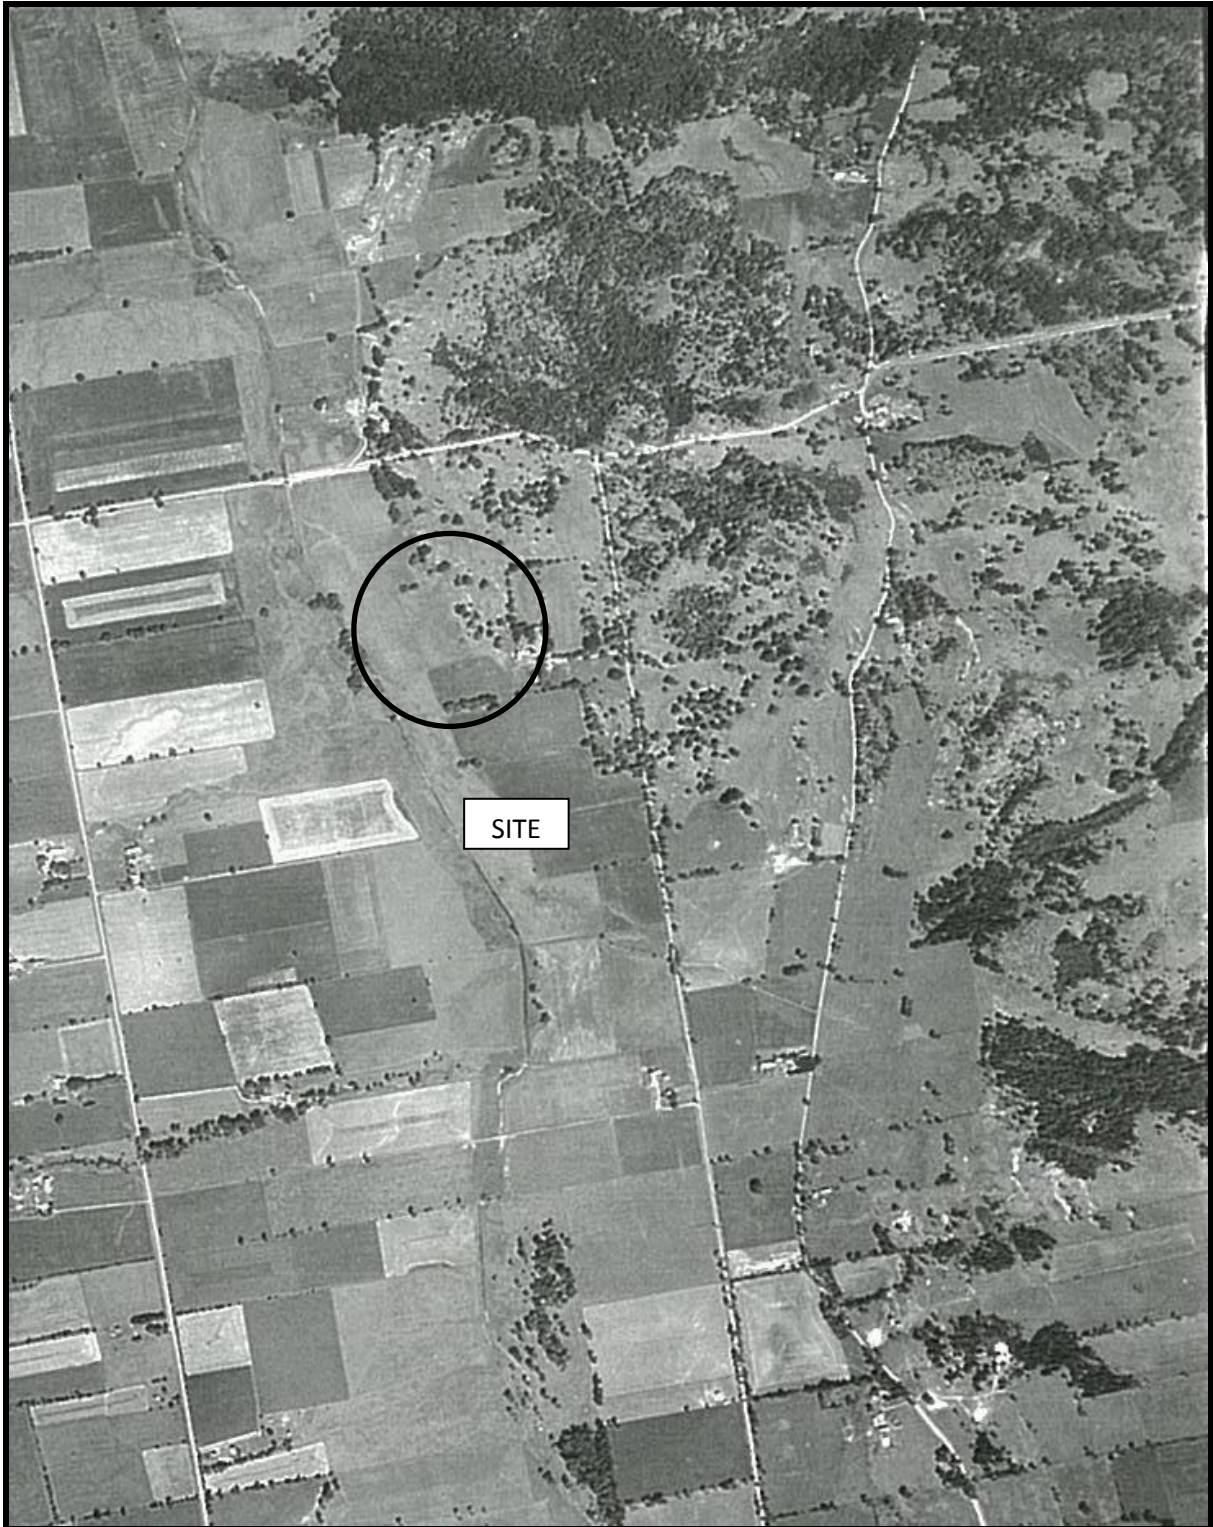
AERIAL PHOTOGRAPH
1959

| 1959 | No significant changes have been made to the subject site or adjacent properties. Increased tree cover is present in the vicinity of the site. |

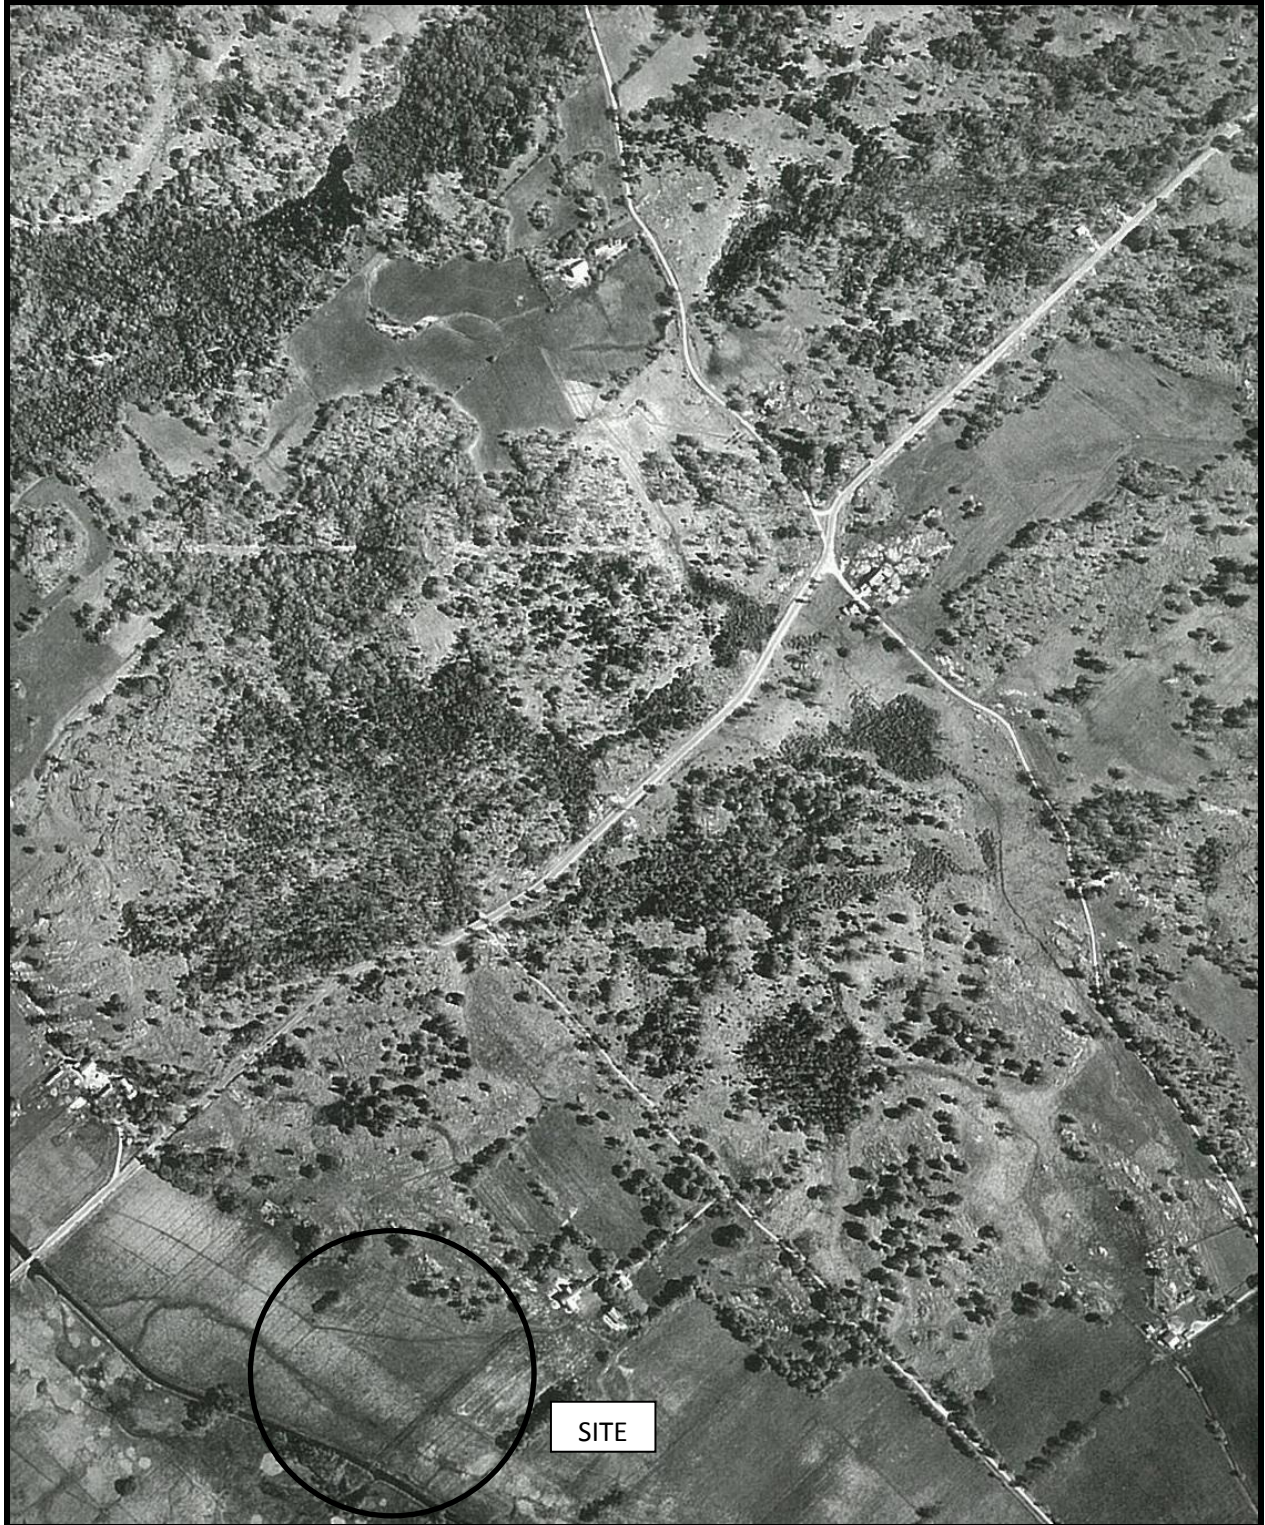
AERIAL PHOTOGRAPH
1963

| 1963 | No significant changes have been made to the subject site or adjacent properties. |

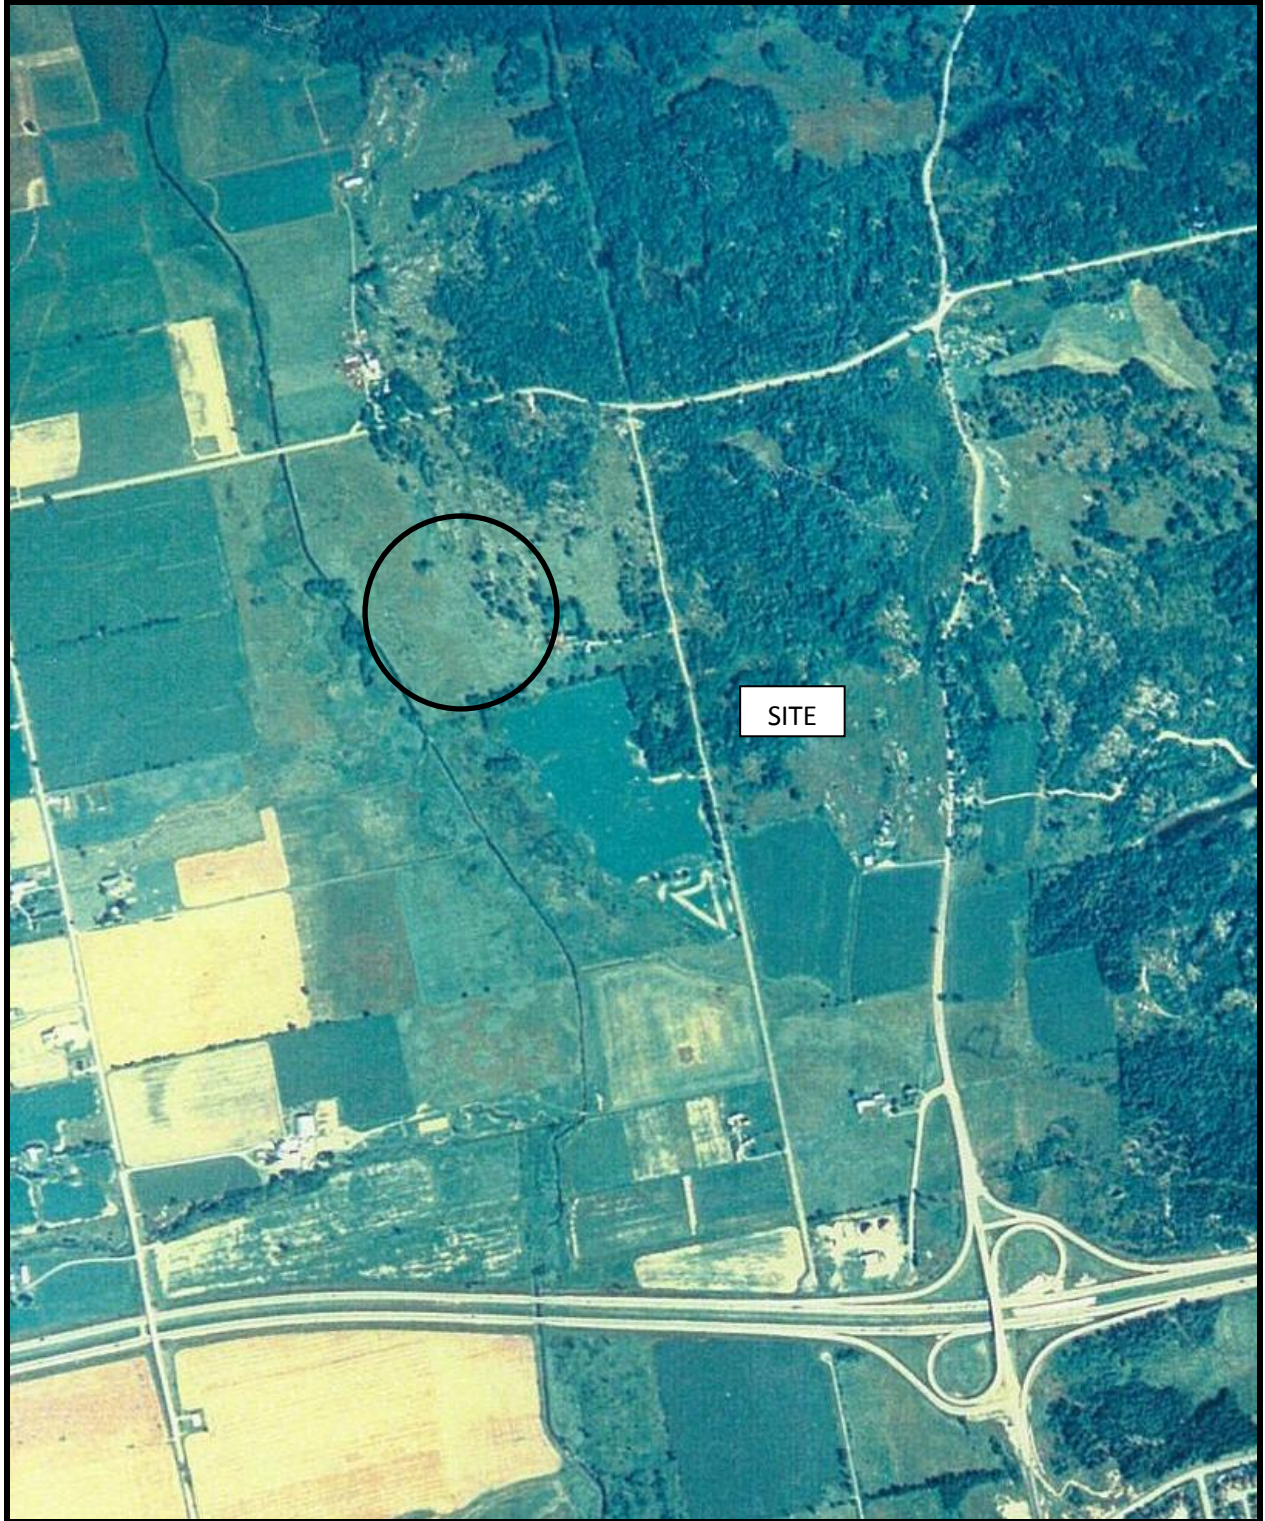
AERIAL PHOTOGRAPH
1987

| 1987 | No significant changes have been made to the subject site. Highway 417 has been constructed further to the south of the subject site. |

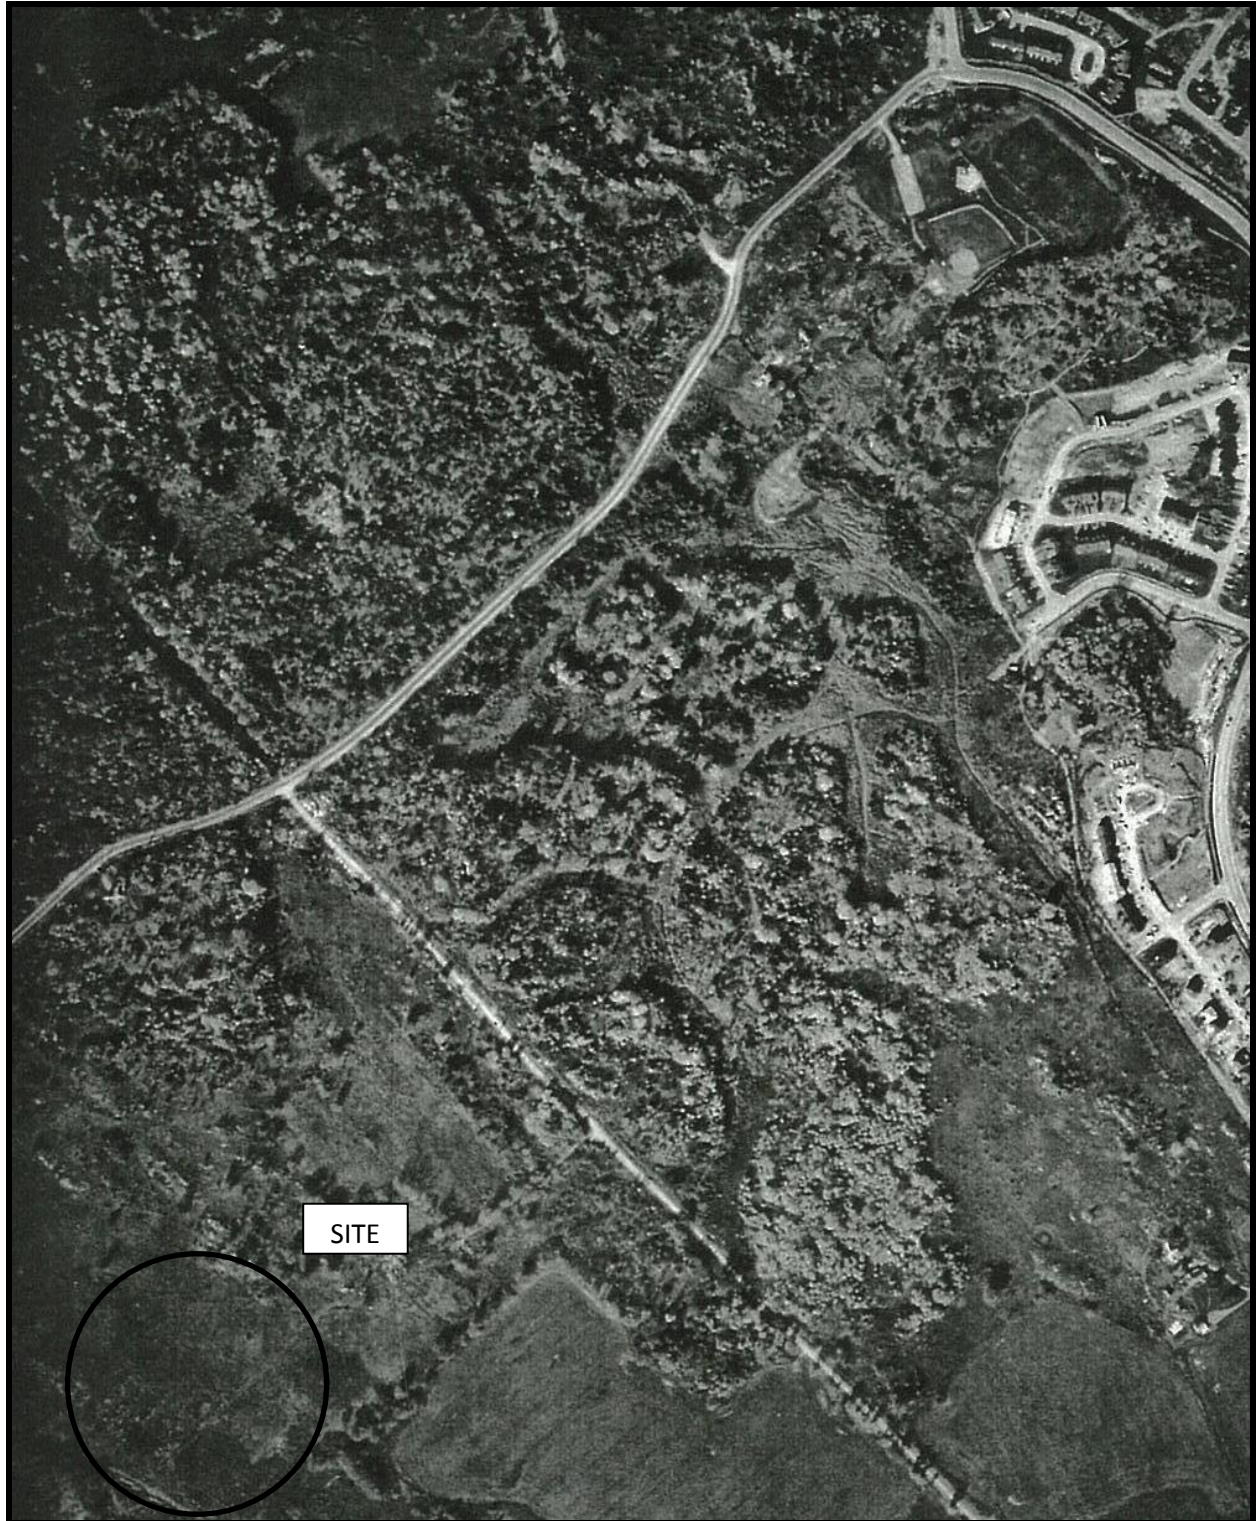
AERIAL PHOTOGRAPH
1994

| 1994 | No significant changes have been made to the subject site. Kanata Avenue has been constructed to the east of the site but has not yet been aligned in its present location in the vicinity of the subject site. Residential development is underway further east of the subject site. Didsbury Road still extends north to Richardson Side Road/Kanata Avenue. |

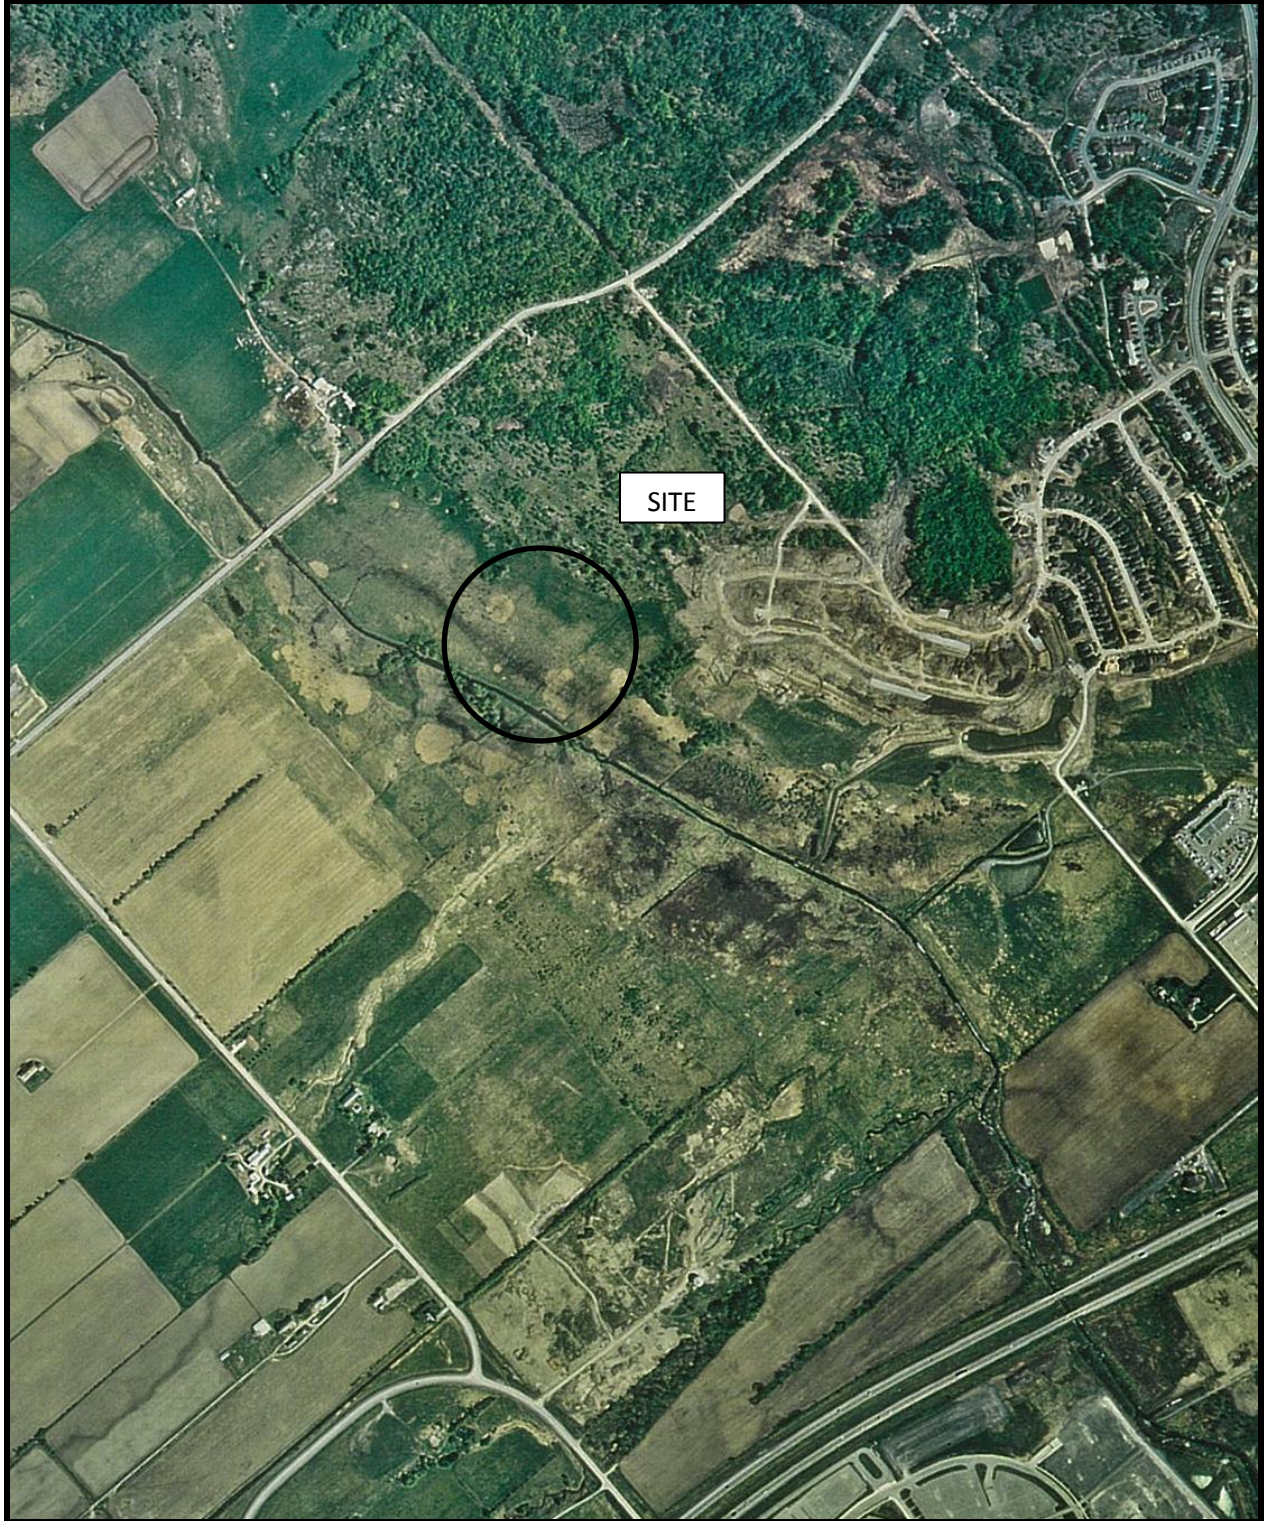
AERIAL PHOTOGRAPH
1999

| 1999 | No significant changes have been made to the subject site or surrounding properties. Residential development continues to the east. |

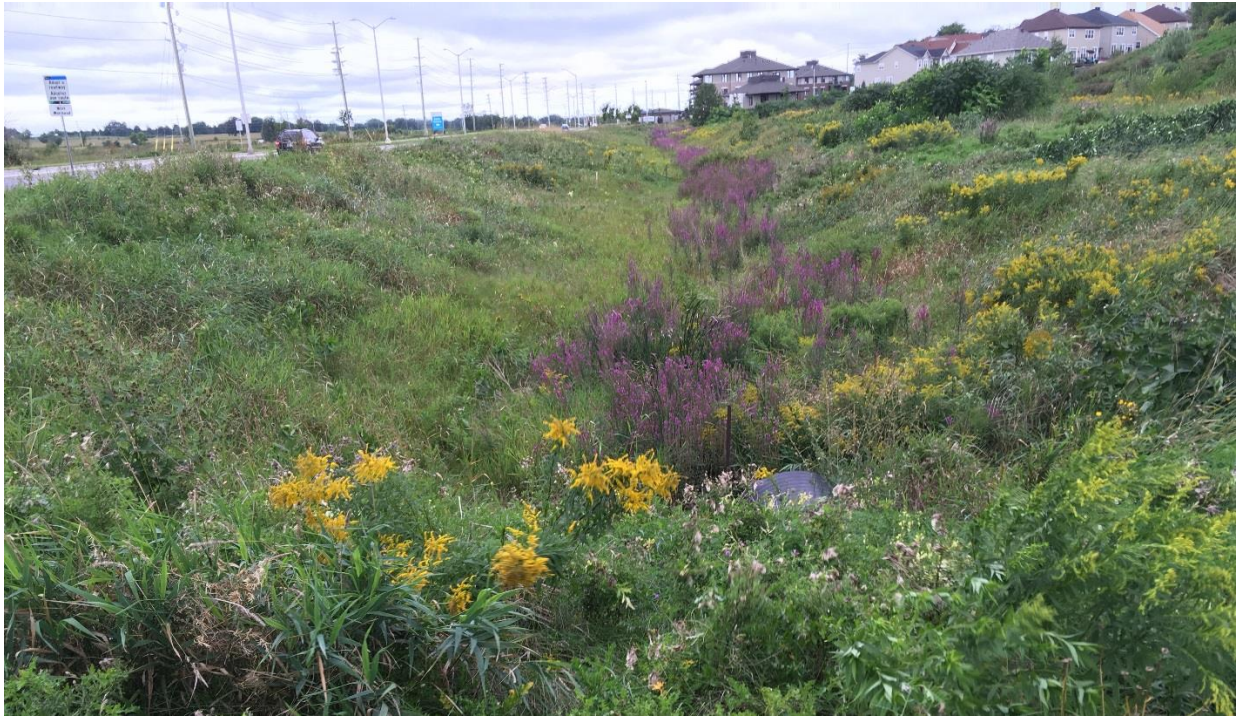
Photograph 1: View of the south west side of the subject property along Terry Fox Drive, looking towards Tillsonburg Street.

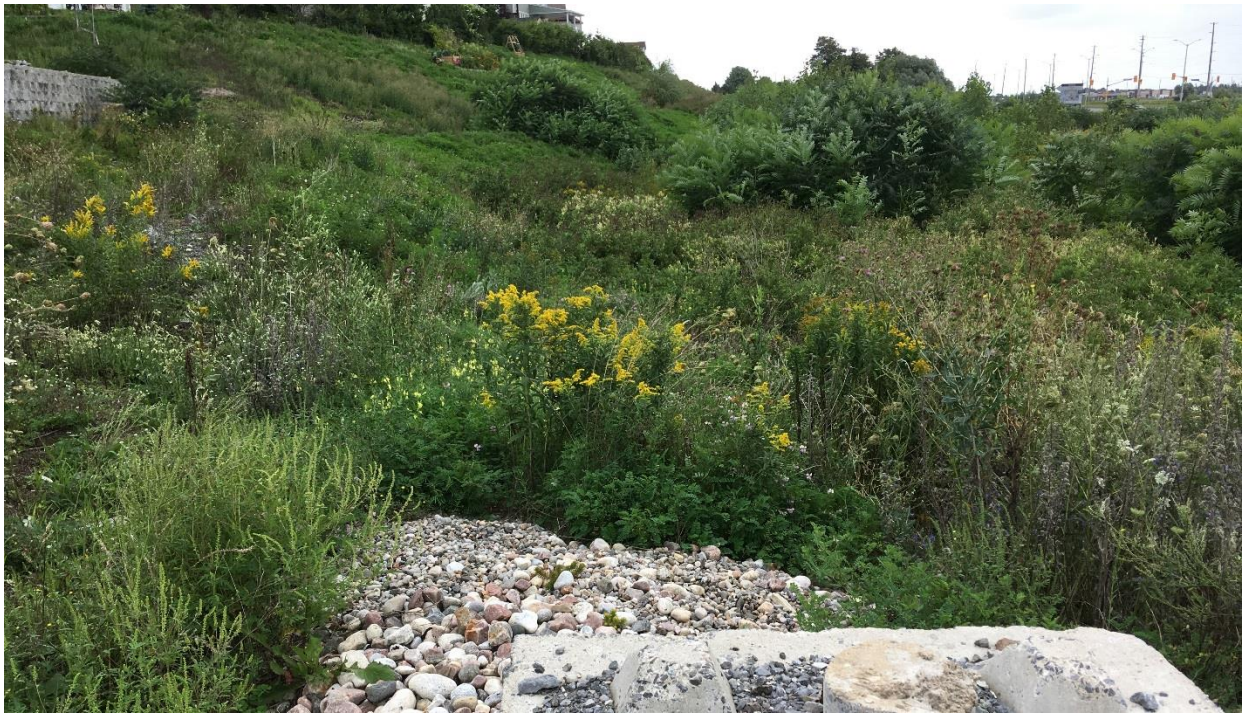
Photograph 2: View of north east side of the subject property, looking towards Kanata Avenue.

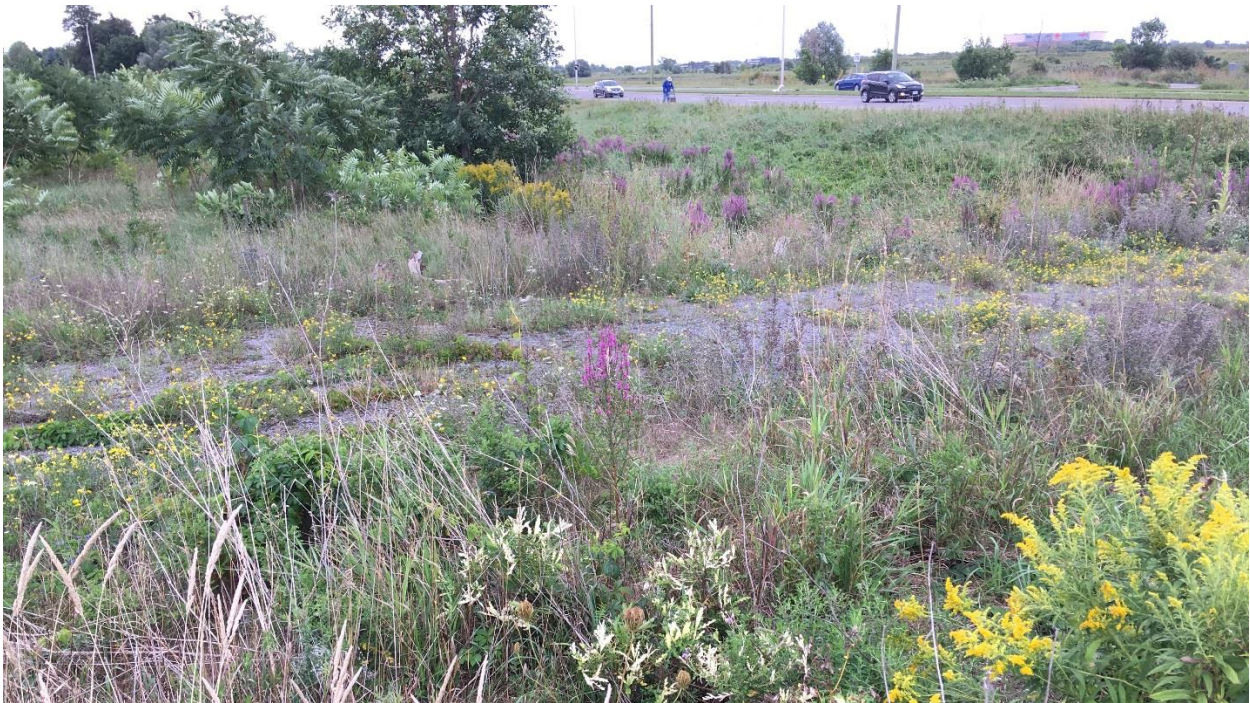
Photograph 3: View of central south west portion of the subject property, looking onto Terry Fox Drive.

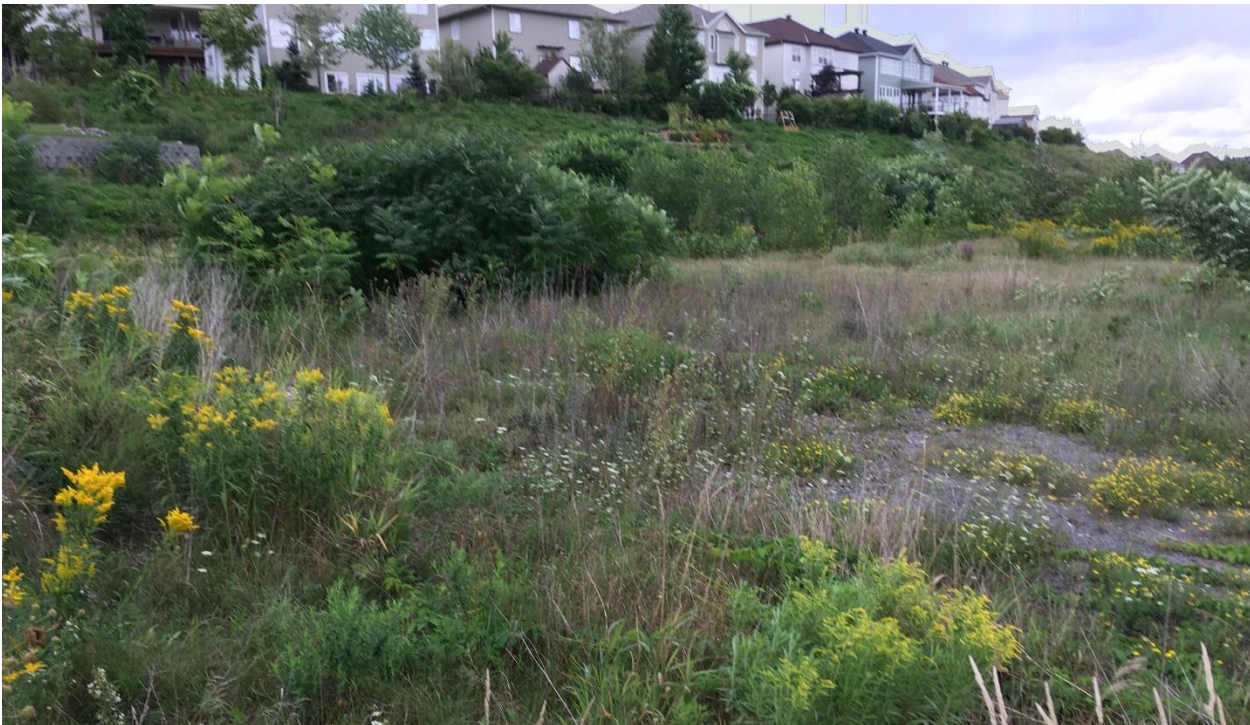
Photograph 4: View of the central north east portion of the subject property, taken from the northwest side of the site.
