Phase I Environmental Site Assessment

433 and 435 Churchill Avenue North
468 and 472 Byron Place
Ottawa, Ontario

December 17, 2018

Report: PE4453-1

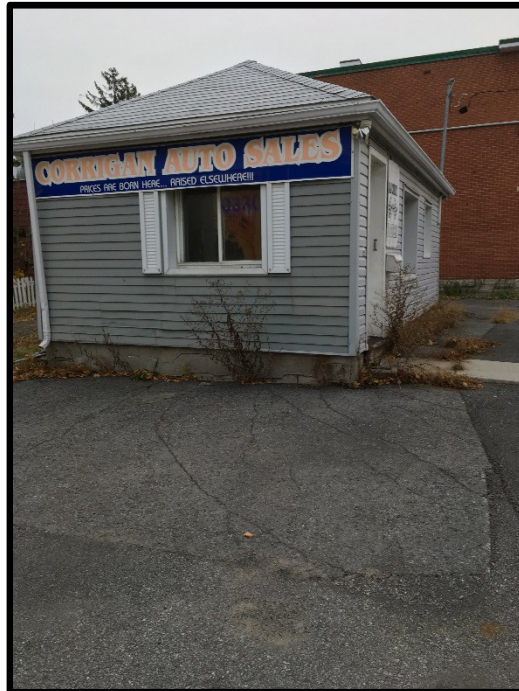
The northwestern portion of the Phase I Property is occupied by a one-storey commercial office building (433 Churchill Avenue North) and a private garage structure. The office is constructed with a poured concrete slab-on-grade foundation. The exterior of the building is constructed with vinyl siding over stucco and a sloped roof covered with asphaltic shingles. The garage is a wood-frame structure finished on the exterior with wood siding and a sloped roof with asphaltic shingles. The office is heated with electric baseboard heaters, while the garage is not heated.

Photograph 1: Photograph illustrates the commercial sales office (433 Churchill Avenue North) on the northwestern portion of the Phase I Property, facing southeast.

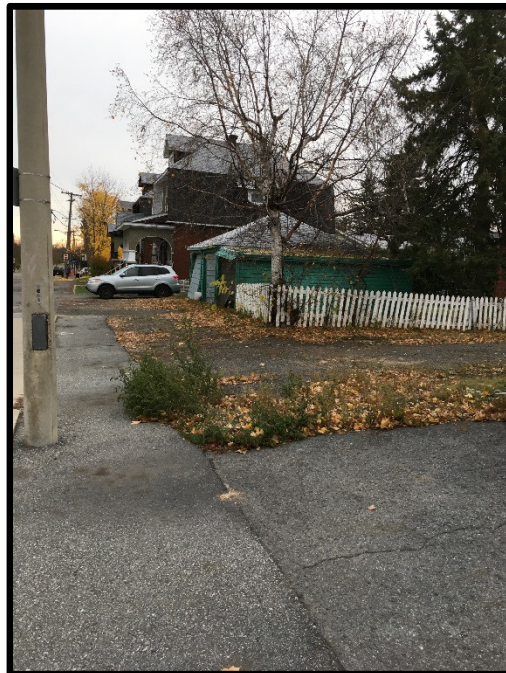
Photograph 2: Photograph illustrates north-central portion of the Phase I Property, facing east.

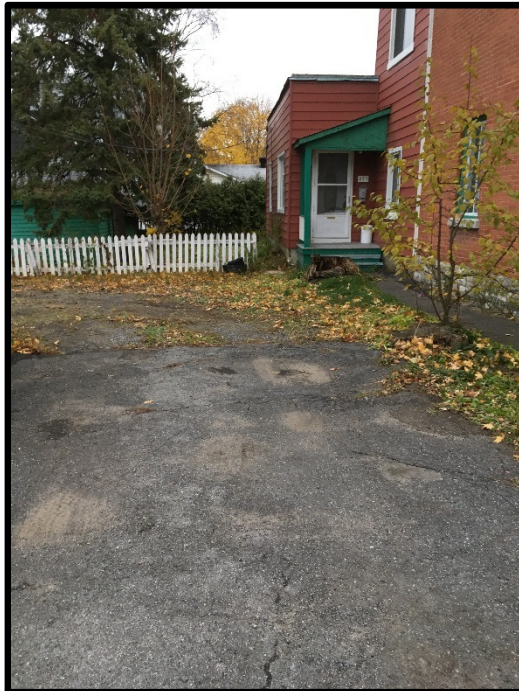
Photograph 3: View of west-central portion of the Phase I Property, facing east. Photo illustrates south portion of commercial lot and north portion of residential building at 435-437 Churchill Avenue North.

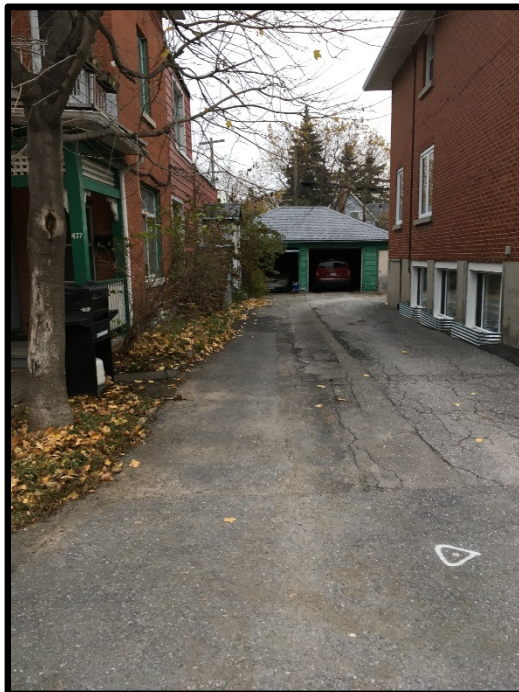
The southwestern portion of the Phase I property is occupied by a 2-storey residential apartment building with a basement level (435-437 Churchill Avenue North) and a private garage. The original portion of the building is constructed with a stone and mortar foundation and is finished on the exterior with brick and a flat, tar and gravel roof.

Photograph 4: View of southwestern portion of the Phase I Property, facing east. Photograph illustrates south face of 435-437 Churchill Avenue North, laneway and private garage shared with adjacent property to the south.

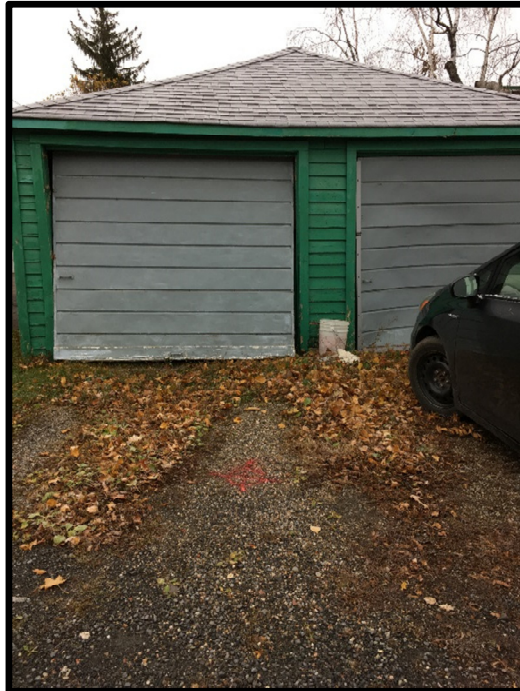
The associated private garage structures were unfinished on the interior and have never been heated. The garages were used for the storage of automobiles, lawn mowers and/or miscellaneous household items. No fuel or chemical storage was observed within the private garages.

Photograph 5: View of private garage on north-central portion of the Phase I Property (435-437 Churchill Avenue North), facing south.

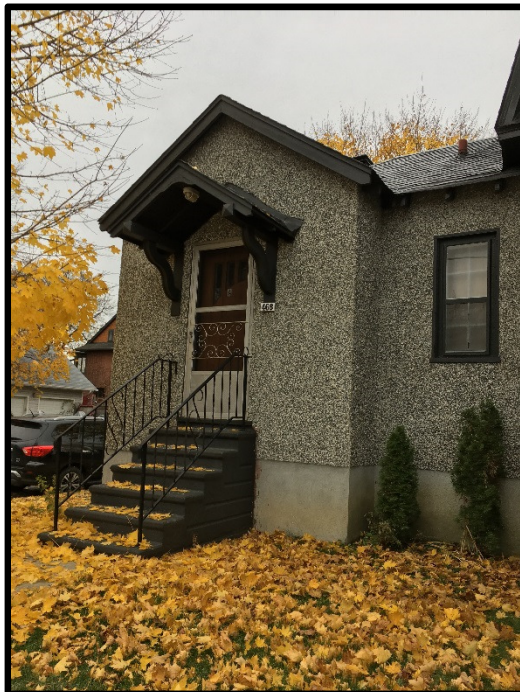
Two (2) residential dwellings and associated private garage structures occupy the eastern portion of the Phase I Property (468 and 472 Byron Place). The dwellings each have two-stories with a basement level and an attic. The original building structures are constructed with stone and mortar foundations and finished on the exterior with brick, stucco and asphaltic shingles (attic). Building additions are constructed with poured concrete foundations and are finished on the exterior with stucco and/or vinyl siding. The roofs are finished with asphaltic shingles. Private wood-frame garage structures are associated with each dwelling. The garages are finished on the exterior with wood siding and sloped roofs covered with asphaltic shingles. The dwellings are heated with natural gas-fired equipment.

Photograph 6: Photograph illustrates east addition of residential building addressed 468-470 Byron Place, on northeastern portion of the Phase I Property, facing southeast.

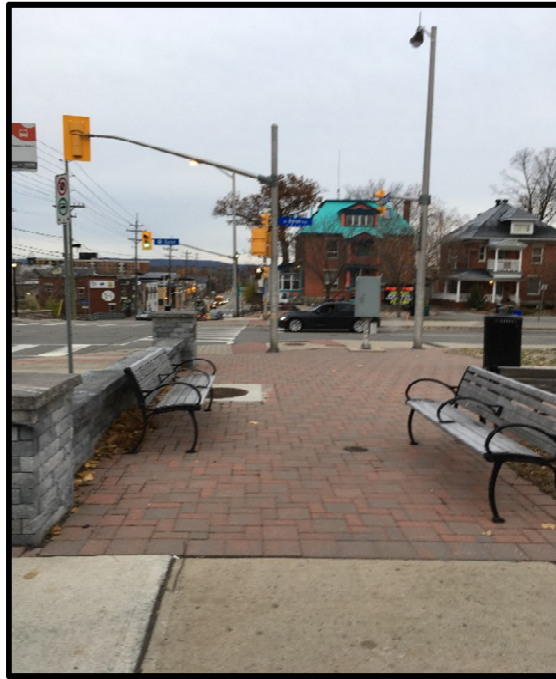
Photograph 7: Photograph illustrates Byron Place, followed by Byron Avenue and commercial businesses to the north of the Phase I Property, facing north.

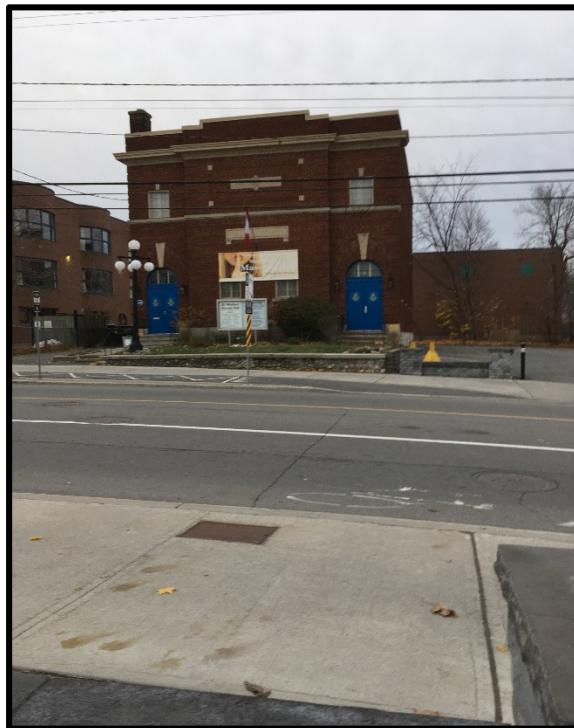
Photograph 8: Photograph illustrates Churchill Avenue North followed by Westboro Masonic Hall to the west of the Phase I Property.

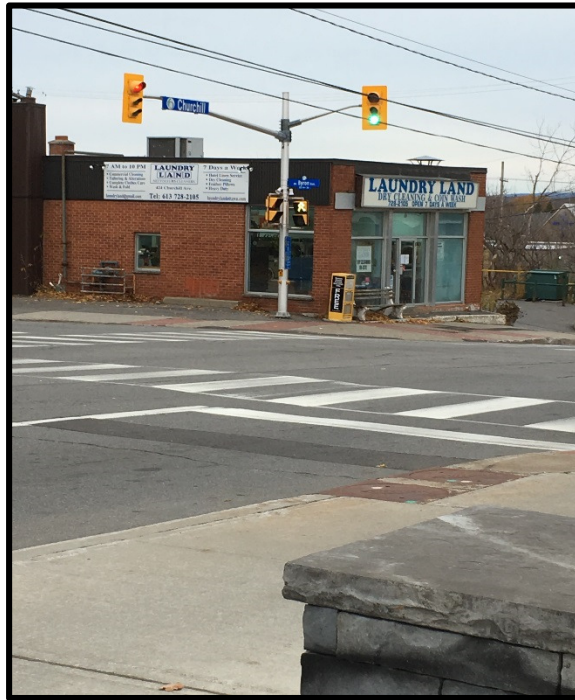
Off-site activities identified by the HLUI database include the historical jewellery manufacturer and existing dry cleaning facility at 424 Churchill Avenue North. As previously noted, based on the separation distance and orientation down-gradient with respect to the Phase I Property, in combination with information in our files, this property is not considered to represent an area of potential environmental (APEC) concern on the Phase I Property. The City response also indicates that the Phase I Property is within 500m of a former landfill site (Ur-19, McRae Avenue). Based on the separation distance of over 400m and its orientation downgradient in relation to the subject land, in combination with information in our files, the former landfill is not considered to represent an APEC on the Phase I Property.

It should also be noted that based on several Phase II ESAs conducted by Paterson, the groundwater flows to the northwest in the particular area of the drycleaner.

Photograph 9: Photograph illustrates existing drycleaner further to the northwest of the Phase I Property across Churchill Avenue North and Byron Avenue.

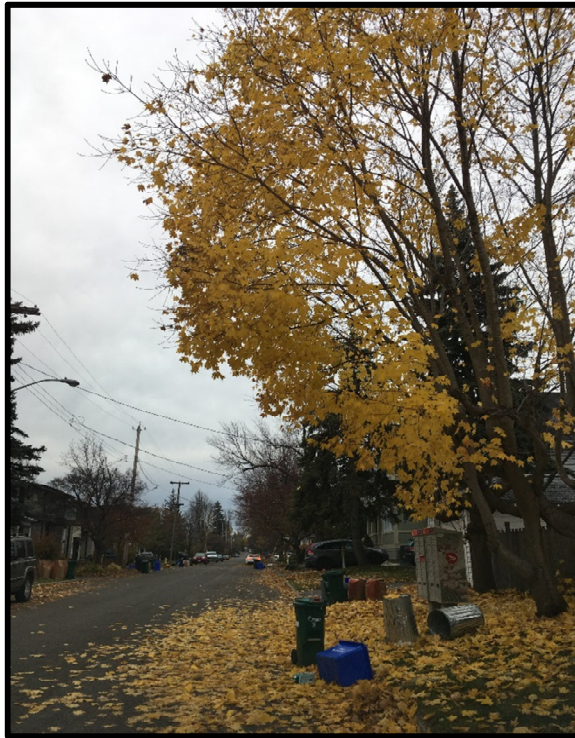
Photograph 10: Photograph illustrates Highcroft Avenue and residential dwellings east and south of the Phase I Property.
