**Phase One Environmental Site Assessment  
87 Stirling Avenue, Ottawa, Ontario**

**FINAL REPORT**

**April 2019**

**DST File No.: TS-SO-037342**

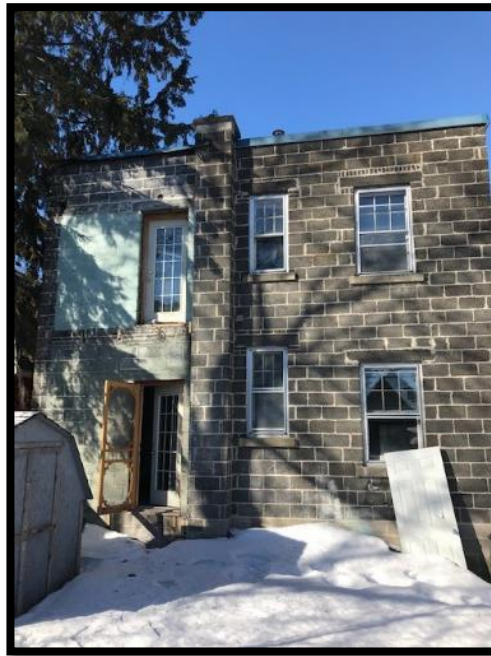
In addition to the Site building, there was a storage shed at the rear of the southeast corner of the Site building in the eastern portion of the Site. Various household chemicals and gasoline containers were stored within the shed (four containers were observed). There was no staining observed around the stored containers. There was a gravel driveway to the north of the Site building, a concrete walkway to the west of the Site building and grassed/vegetated areas to the east and west of the Site building. The Site was accessed from Stirling Avenue.

**Photograph 3:** View of the east side of the Site building facing west; note the shed on the lower left portion of the photograph (March 2019).

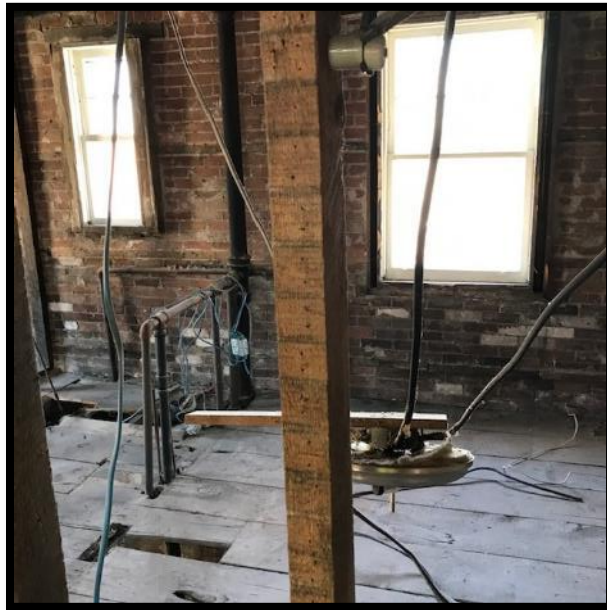
There were visible signs of water infiltration and staining observed at the Site, in the basement and on the 2<sup>nd</sup> floor in the extension to the original building. It was noted during the Site reconnaissance that there was heavy water damage on the 2<sup>nd</sup> floor in the extension over the vinyl floor tiles. Water was also observed to be trickling into the basement from ajar windows. No visual evidence of mould was present in the readily accessible areas of the Site building. It should be noted that the Site building was under extensive renovations at the time of the Site reconnaissance.

**Photograph 7:** View of a portion of the 2<sup>nd</sup> floor interior of the Site building (March 2019).

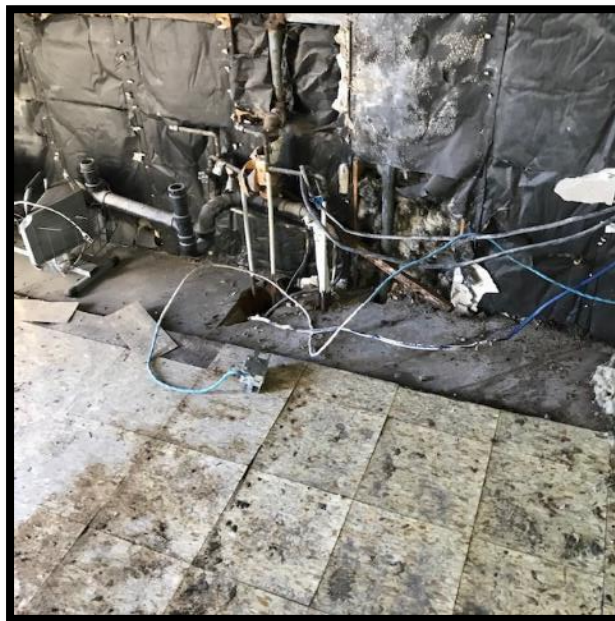
There was no staining observed in the exterior areas of the Site. There were vinyl floor tiles on the 2<sup>nd</sup> floor extension that were stained black. It is unknown what caused this staining; however, the 2<sup>nd</sup> floor was noted to be heavily water damaged at the time of the Site reconnaissance.

**Photograph 8:** View of the condition of the vinyl floor tiles over the 2<sup>nd</sup> floor in the Site building and the exposed wall (March 2019).

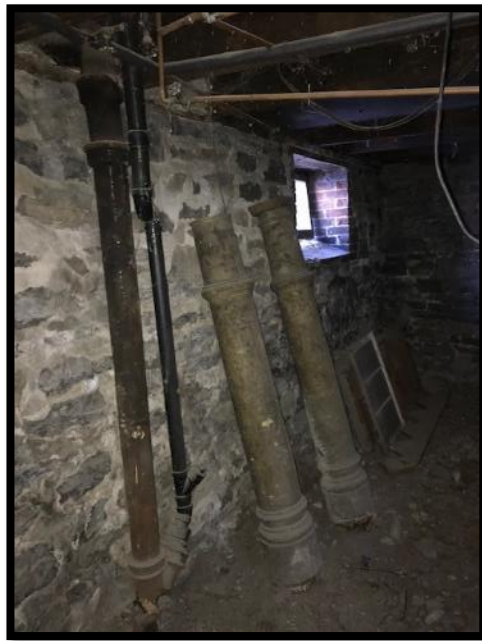
Due to the inferred construction date of the Site building (around 1920), lead-based paint and other lead-based materials may have been utilized in the Site building. Suspect lead piping was observed at the time of the Site reconnaissance. It should be noted that the Site building was under extensive renovations at the time of the Site reconnaissance with interior finishes removed.

**Photograph 9:** View of old piping laid against the north basement wall of the Site building (March 2019).

A project-specific designated substances survey (DSS) is recommended to assess the presence of lead-containing materials that may be disturbed during the renovation activities.

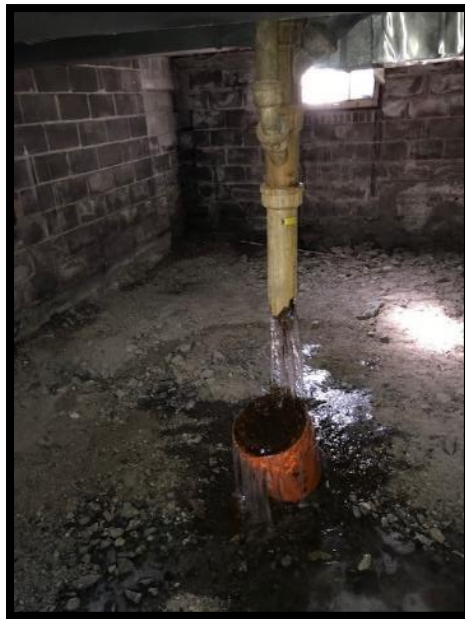
**Photograph 10:** View of broken water pipe in the southeast corner of the basement of the Site building (March 2019).

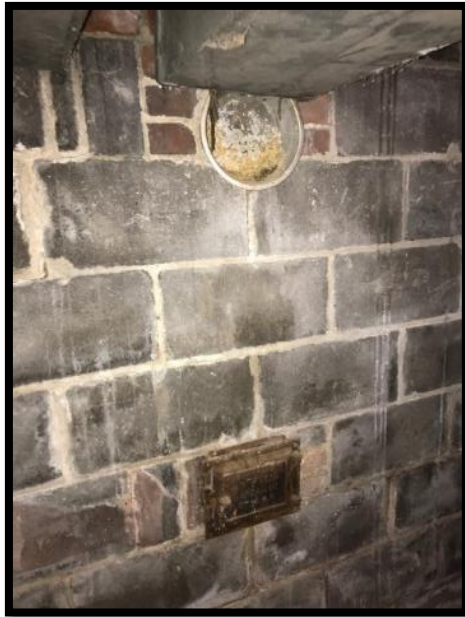
previously present at the Site; however, no visual or olfactory evidence of spills or staining associated with a potential former fuel oil AST was observed at the time of the Site reconnaissance.

**Photograph 11:** View of the location of the former furnace in the east wall of the basement of the Site building (March 2019).

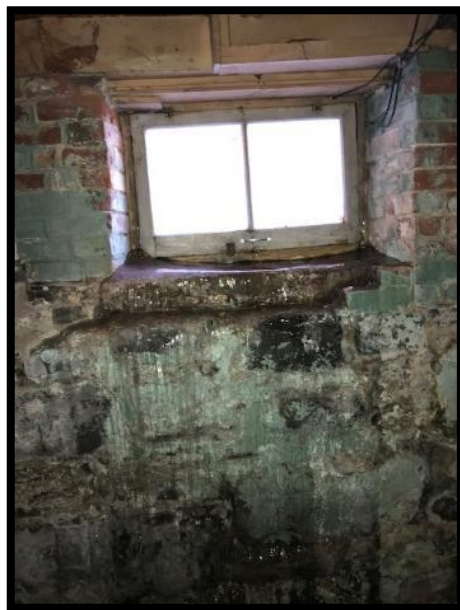
**Photograph 12:** View of the southwest basement window with water trickling into basement (March 2019).

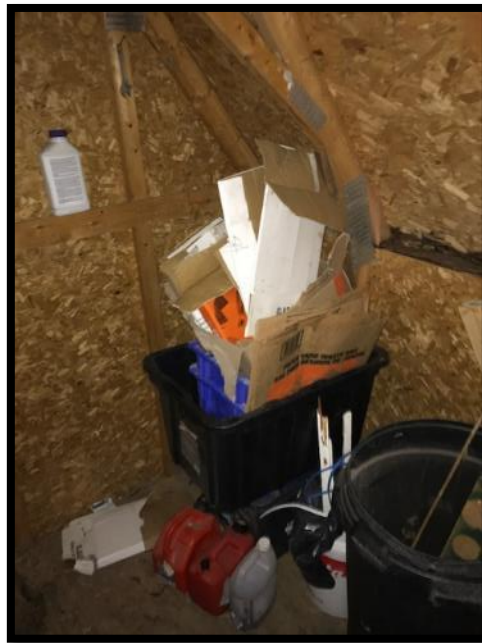
No containers of chemicals were observed on Site during the Site reconnaissance, with the exception of household chemicals and small gasoline containers (approximately 5 L) in the storage shed. No evidence of spills or stains were observed in the vicinity of any chemical storage areas.

**Photograph 13:** View of the interior of the storage shed to the southeast of the Site building. Note the stored containers of household chemicals and gasoline (March 2019).
