Phase I Environmental Site Assessment

Residential Properties
72-74 St. Andrew Street
and 73-77 Guigues Avenue
Ottawa, Ontario

September 29, 2017

Report: PE4116-1

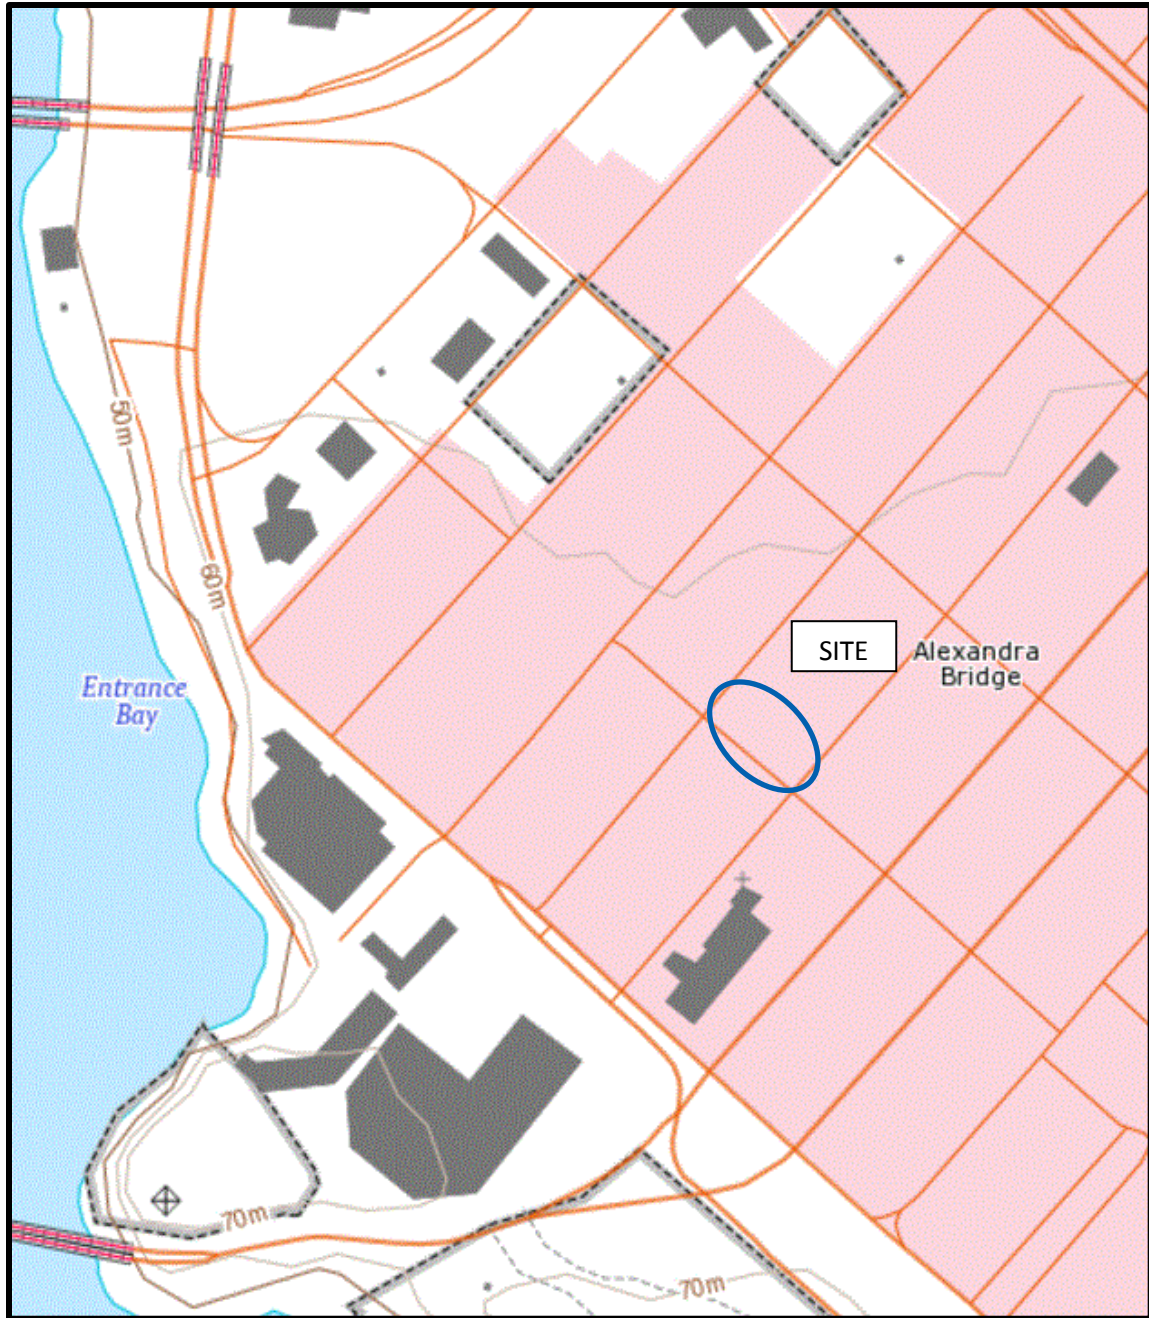
FIGURE 2
TOPOGRAPHIC MAP

Topographic information was obtained from Natural Resources Canada – The Atlas of Canada website. The topographic maps indicate that the elevation of the subject site is approximately 65 m ASL, and that the regional topography in the general area of the site slopes downward to the northwest, towards the Ottawa River. An illustration of the referenced topographic map is presented on Figure 2 – Topographic Map, appended to this report.

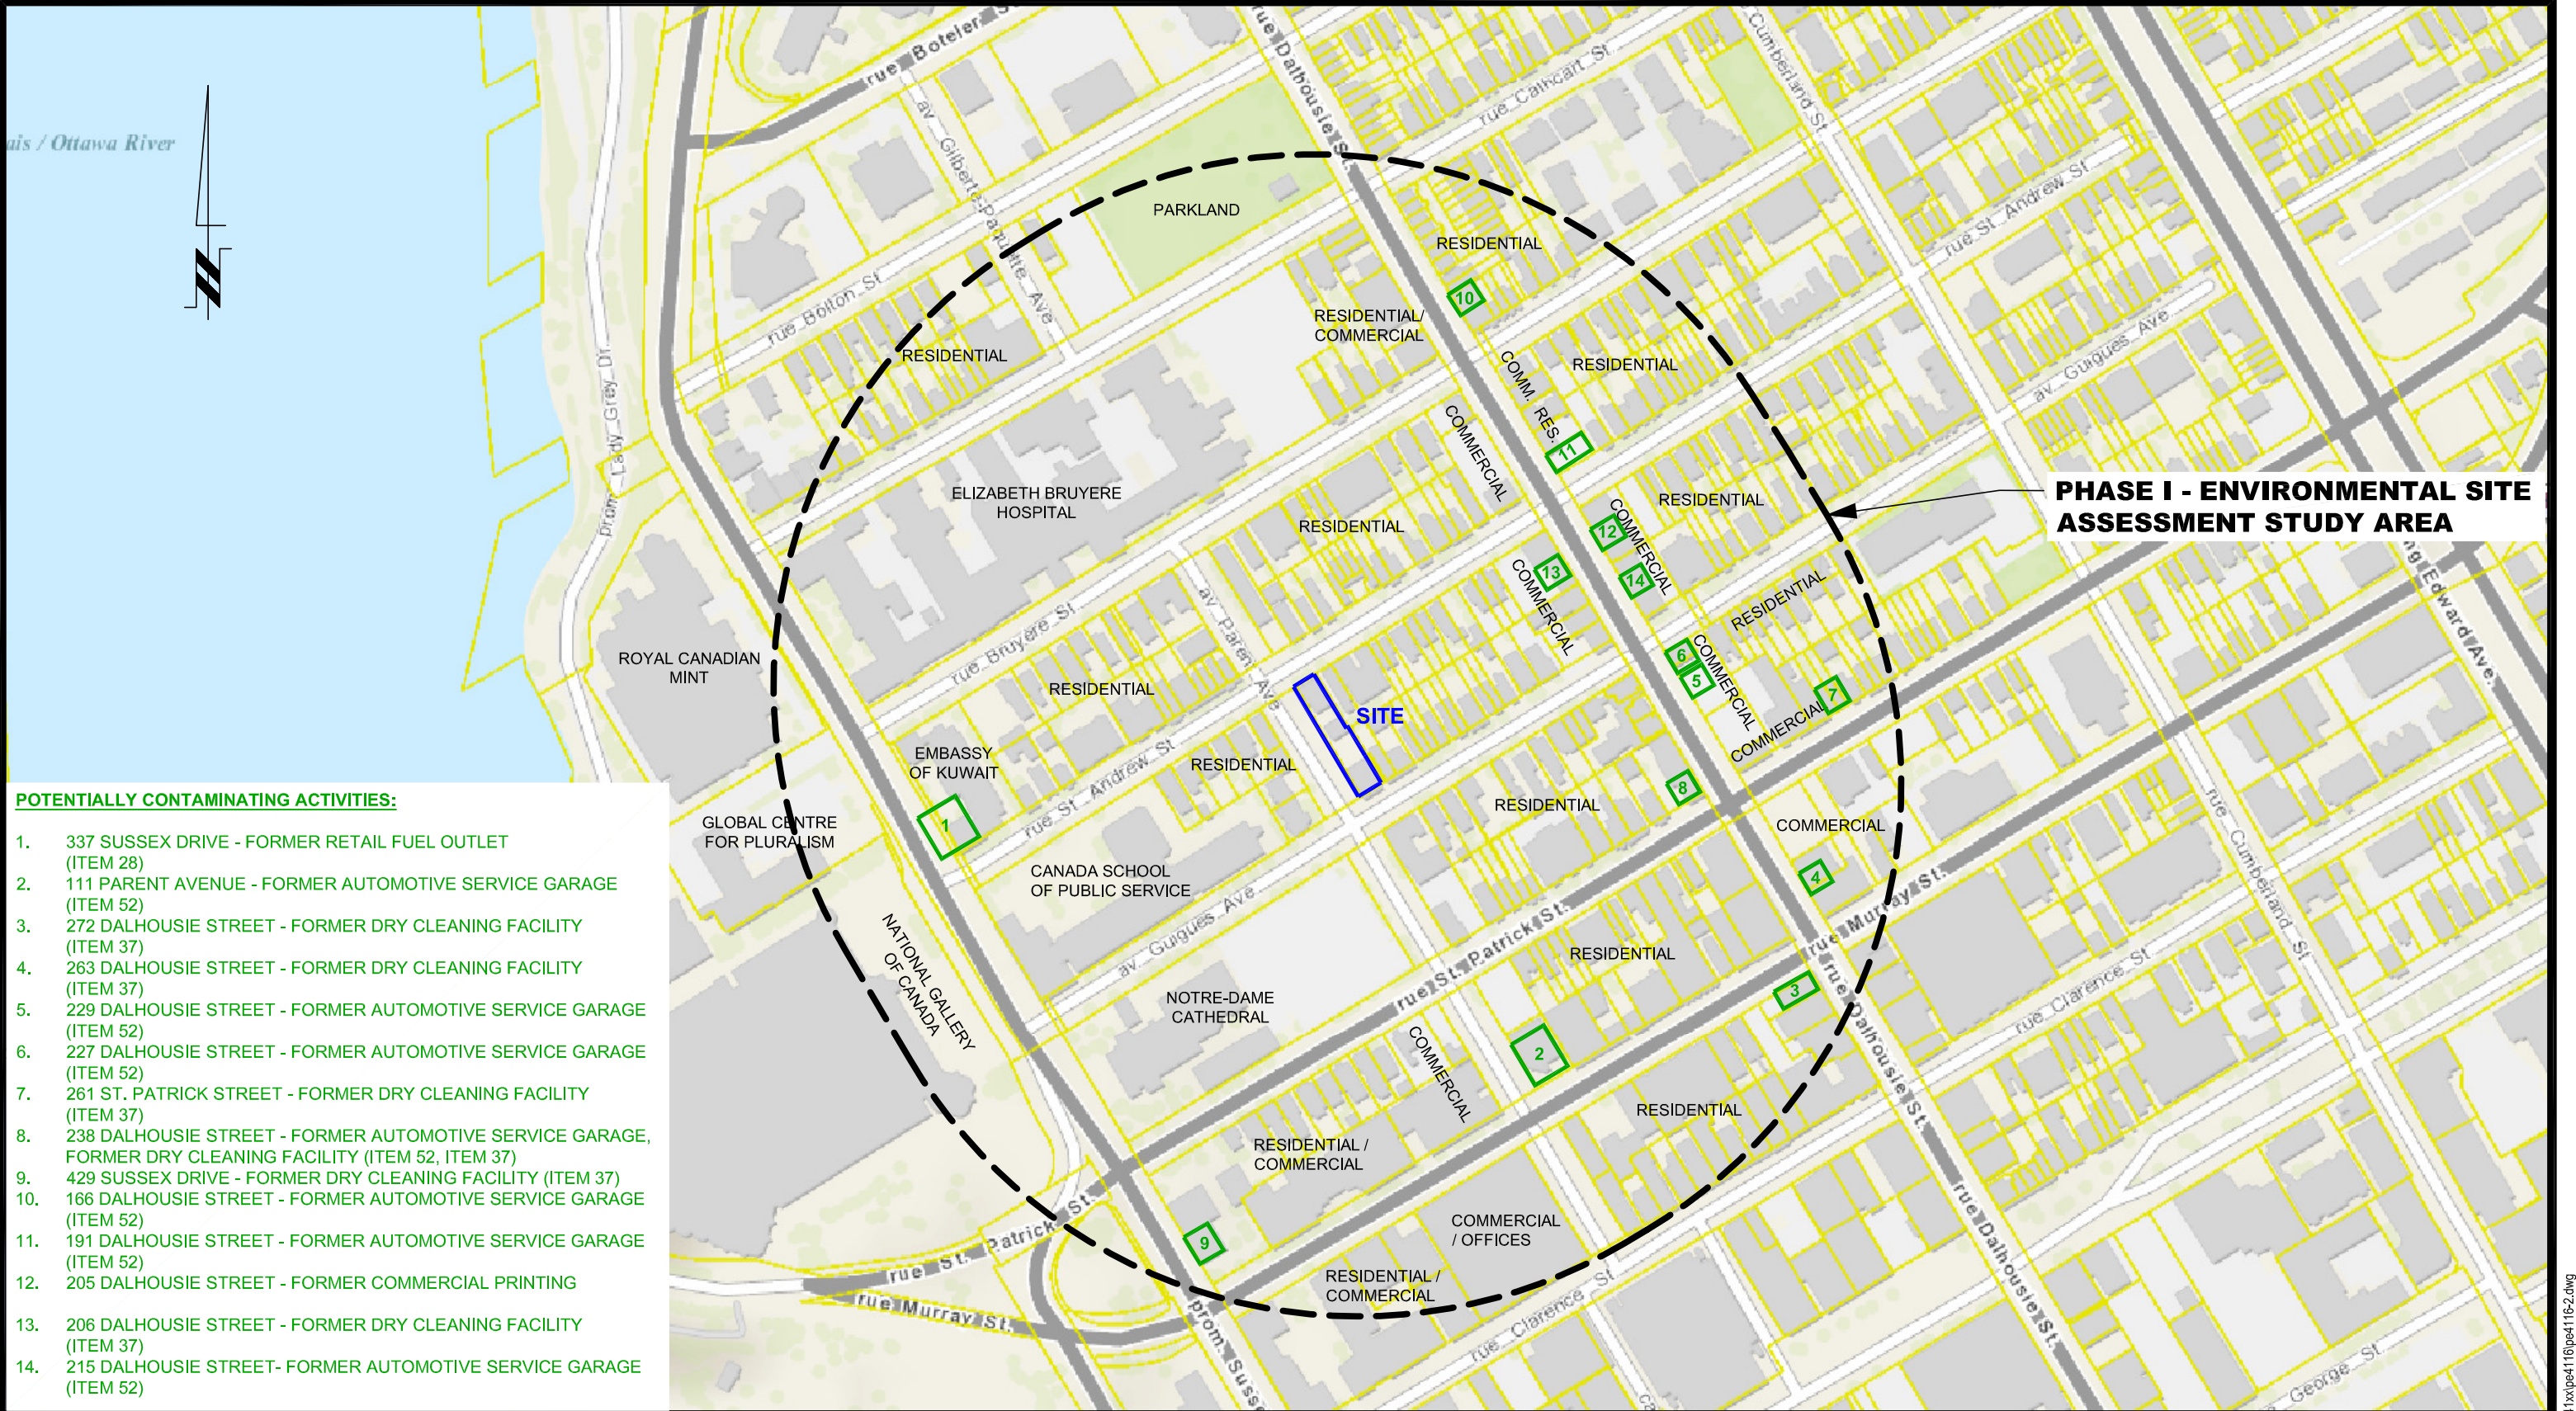
DRAWING PE4116-2 – SURROUNDING LAND USE PLAN

- POTENTIALLY CONTAMINATING ACTIVITIES:**
- 337 SUSSEX DRIVE - FORMER RETAIL FUEL OUTLET (ITEM 28)
 - 111 PARENT AVENUE - FORMER AUTOMOTIVE SERVICE GARAGE (ITEM 52)

- 272 DALHOUSIE STREET - FORMER DRY CLEANING FACILITY (ITEM 37)
 - 263 DALHOUSIE STREET - FORMER DRY CLEANING FACILITY (ITEM 37)
 - 229 DALHOUSIE STREET - FORMER AUTOMOTIVE SERVICE GARAGE (ITEM 52)

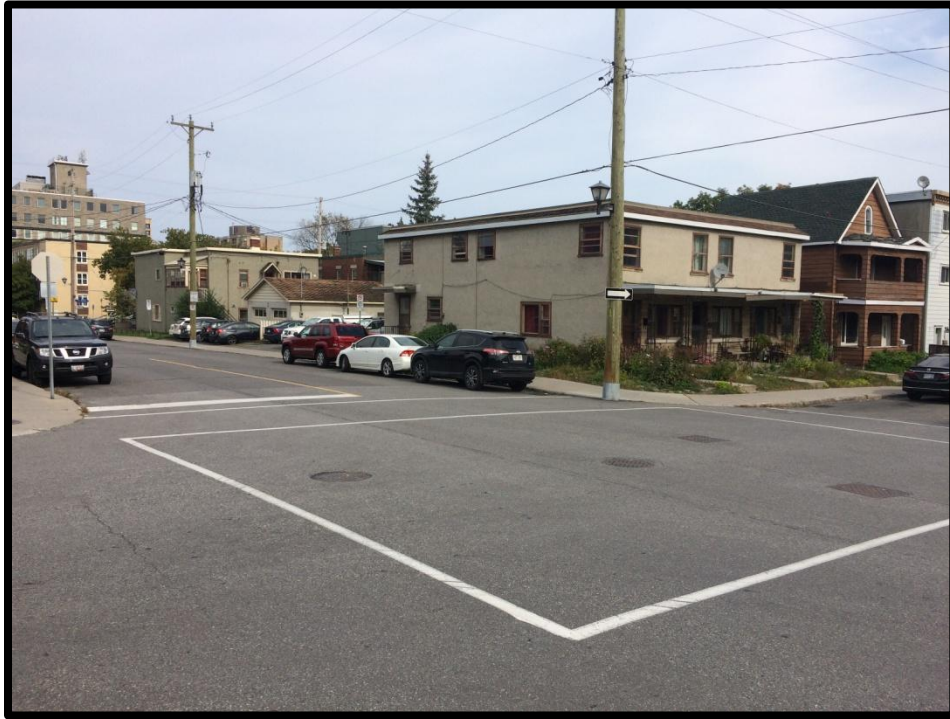
Photograph 1: View of the 73-77 Guigues Avenue, facing northeast. Photograph also depicts 72-74 St. Andrew Street on the left side.

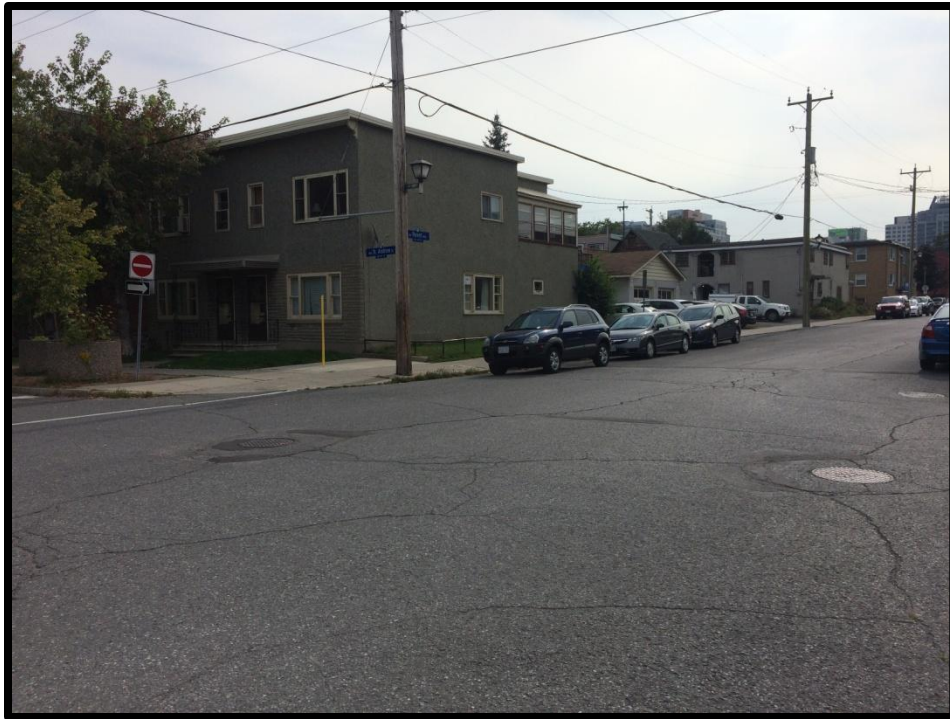
Photograph 2: View of 72-74 St. Andrew Street, facing southeast. Photograph also depicts 73-77 Guigues Avenue on the right side.

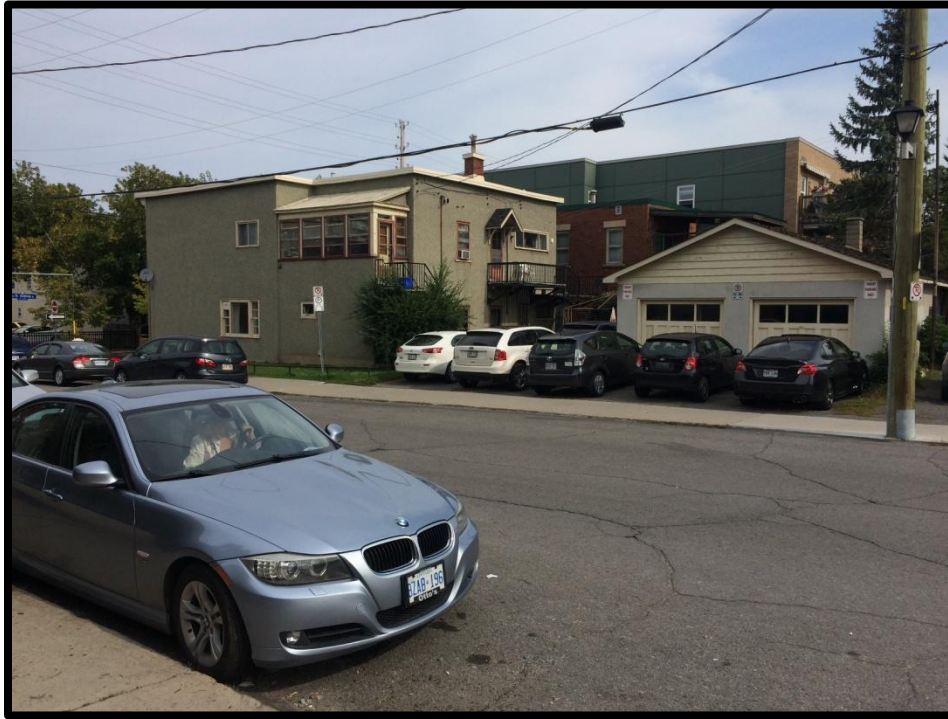
Photograph 3: View of back side of 72-74 St. Andrew Street and detached garage, facing east.

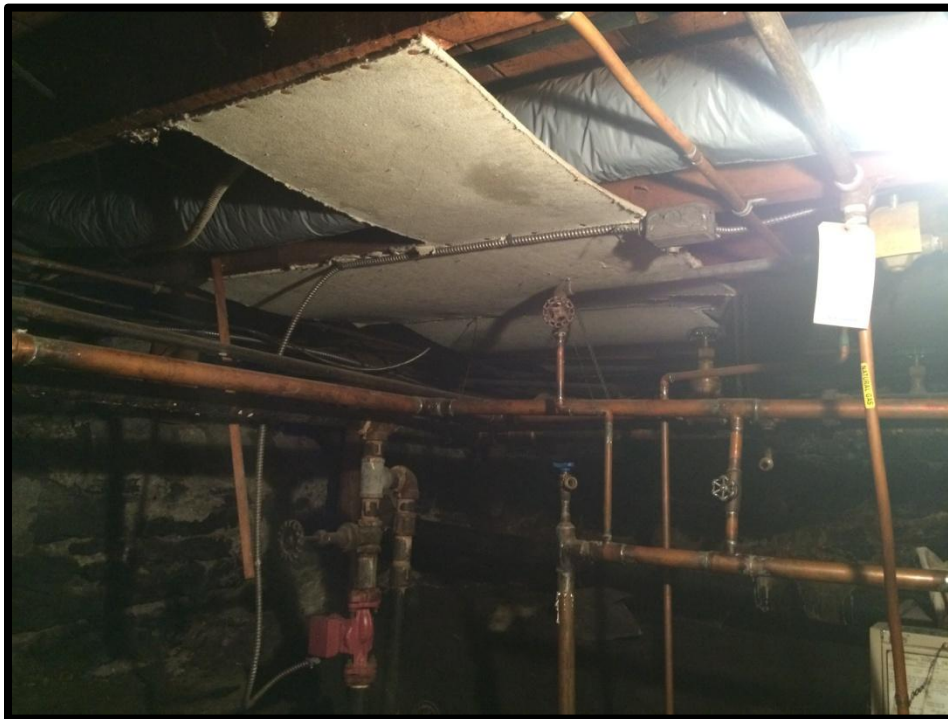
Potentially hazardous building materials were identified in both site buildings. Due to the age of the structures, asbestos containing materials (ACMs) are considered to potentially be present. Potential ACMs identified were exterior stucco finishes, plaster walls and ceilings, linoleum and vinyl tile flooring, and insulation board observed within the crawl space of 72-74 St. Andrew Street. Also considered to be potentially present is lead-based paint, mercury containing non-digital thermostats and light bulbs, and ozone depleting substances within refrigerators, freezers and window mount A/C units.

Photograph 4: View of suspected asbestos containing insulation board fastened to floor joists within the basement of 72-74 St. Andrew Street.

It is our understanding that demolition work is intended to take place on the subject site. Considering the potential presence of hazardous building materials within the subject buildings, it is recommended that a designated substance survey be conducted in accordance with Ontario Regulation 490/09, under the Occupational Health and Safety Act, if one has not already been completed.
