Phase Two Environmental Site Assessment 5938 Hazeldean Road, Ottawa, Ontario

Project Number: OTT-00250806-C0

Type of Document: Final

Date Submitted: June 27, 2019

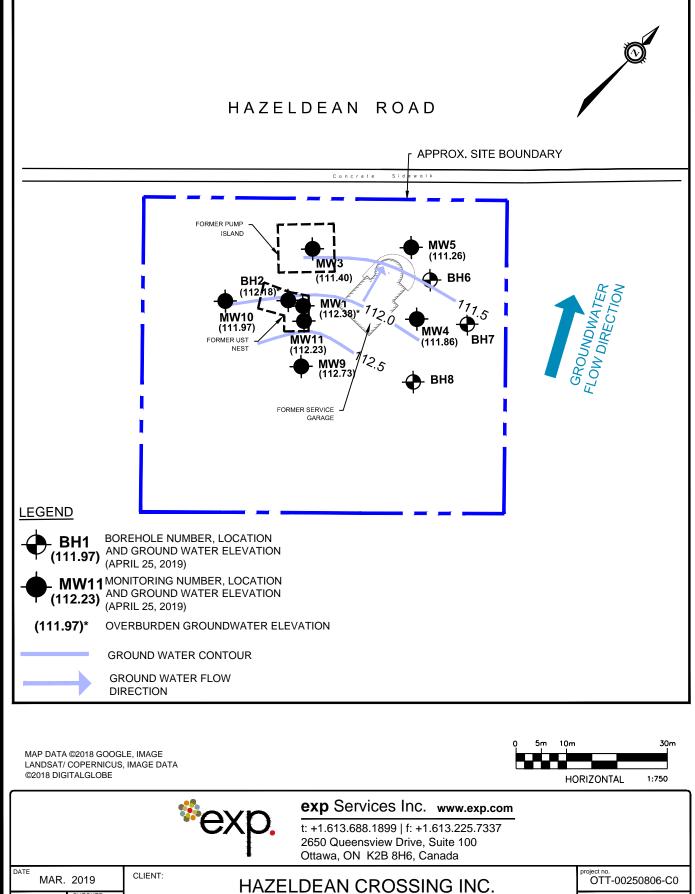
GROUNDWATER CONTOUR PLAN

Groundwater elevations and water levels were measured at the Phase Two property on January 26, March 18, and April 25, 2019. Groundwater was encountered within the limestone at a depth of 2.49 m bsg in MW19-9 to 3.42 m in MW19-4. No petroleum sheens were observed in the monitoring wells during either sampling event.

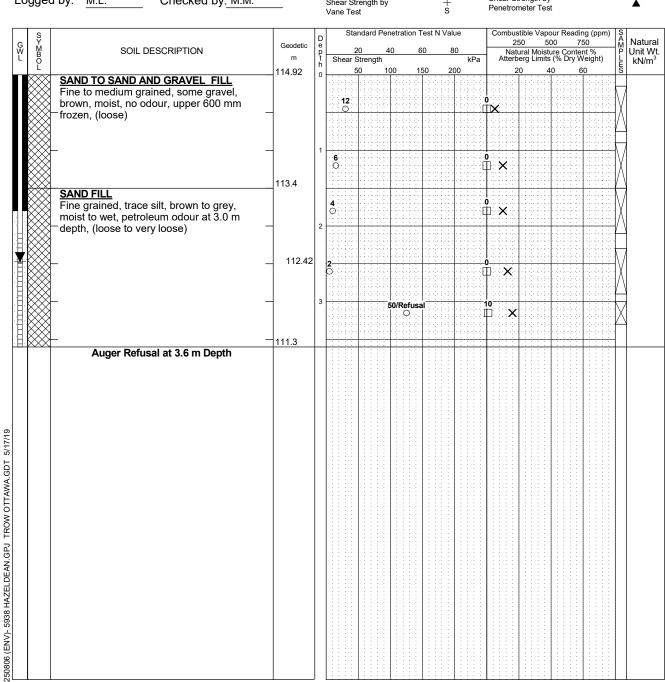
Log of Borehole MW19-01

- Borehole data requires interpretation by EXP before use by others
- A 32 mm diameter monitoring well installed upon completion
- 3. Field work supervised by an EXP representative.
- 4. See Notes on Sample Descriptions
- 5. Log to be read with EXP Report OTT-00250806-C0

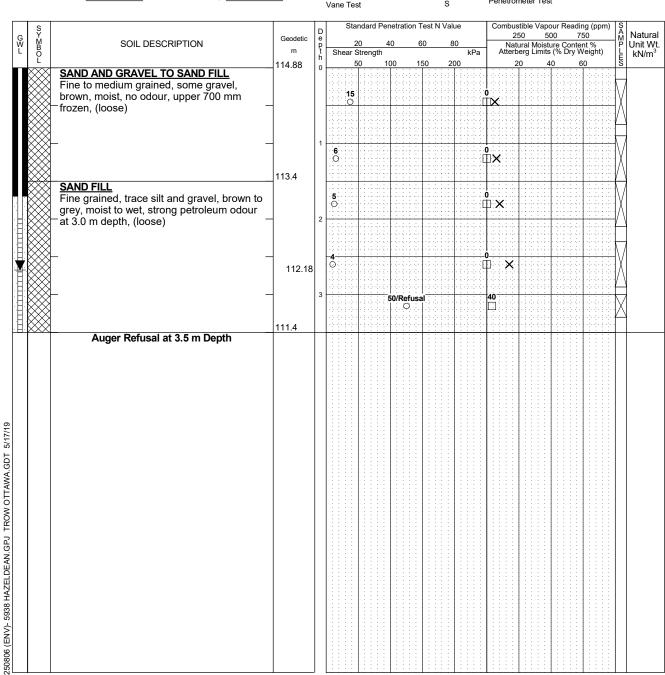
Log of Borehole MW19-02

- Borehole data requires interpretation by EXP before use by others
- 2. A 32 mm diameter monitoring well installed upon completion
- 3. Field work supervised by an EXP representative.
- 4. See Notes on Sample Descriptions
- 5.Log to be read with EXP Report OTT-00250806-C0

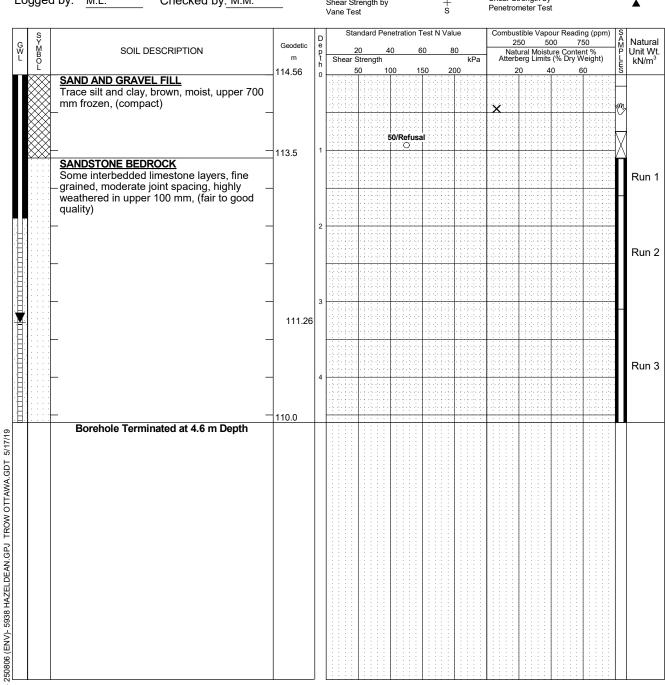
Log of Borehole MW19-05

WATER LEVEL RECORDS						
Elapsed Time	Water Level (m)	Hole Open To (m)				
Completion	-	-				
7 days	3.5	-				
31 days	3.9	-				
36 days	3.5	-				
94 days	3.3

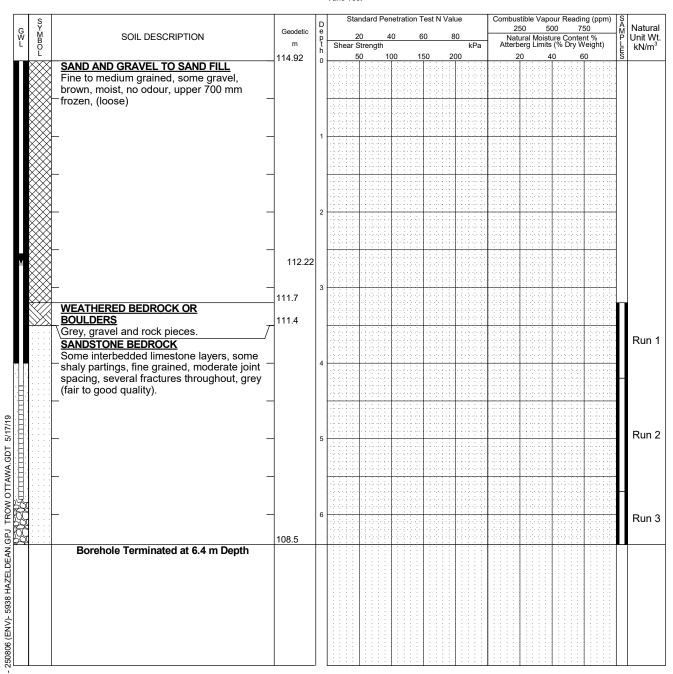
Log of Borehole MW19-11

No soil samples were collected from MW19-11 since the purpose of this monitoring well was to vertically delineate the groundwater impact found at MW19-1 and soil samples were previously collected from that location. MW19-11 was installed close to MW19-1.
