**RE: 1966 Roger Stevens Drive, North Gower, Proposed Warehouse
Tree Conservation Report and Environmental Impact Statement**

1966 ROGER STEVENS DRIVE, NORTH GOWER
TREE CONSERVATION REPORT and ENVIRONMENTAL IMPACT STATEMENT

ENVIRONMENTAL IMPACT STATEMENT/ TREE CONSERVATION REPORT

TREE CONSERVATION REPORT PROPOSED CONSERVED VEGETATION

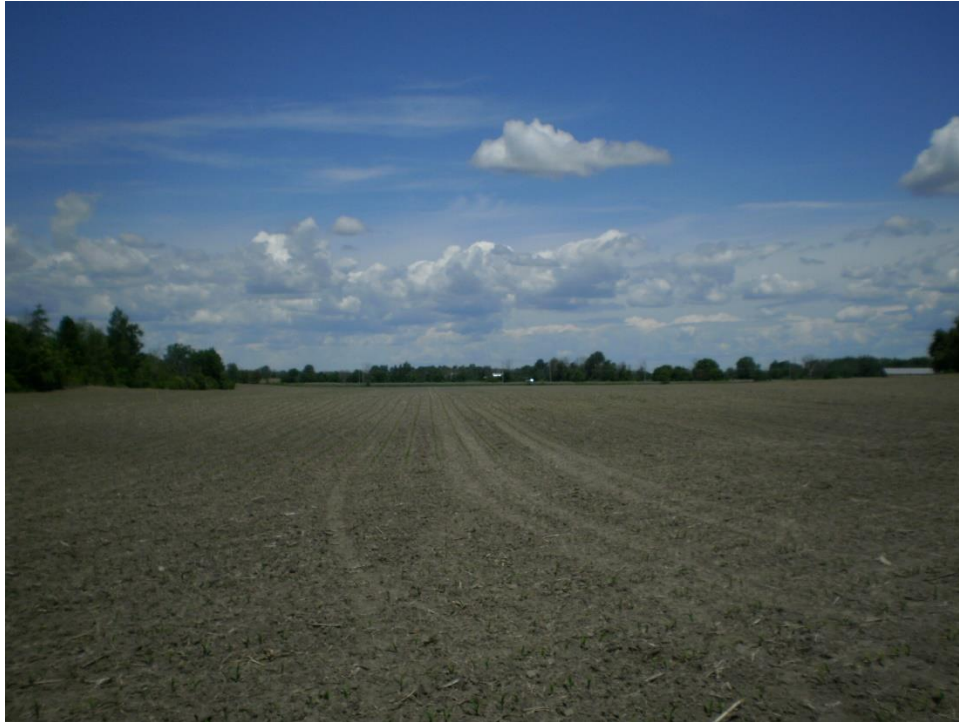
*Photo 1 – Cultivated field in the southwest portion of the site.
View looking north from the south site edge*

The site is dominated by cultivated fields, planed in soybeans or corn in 2018 and 2019 and shown as vegetation community 1 on Map 1 (Photos 1, 2 and 3). Cultural meadows are in the centre and south-central portions of the site (Photo 4). Common vegetation in the cultural meadows include orchard grass, bluegrass, reed canary grass, common brome grass, June meadow grass, timothy, common mullein, wild grape, common dandelion, chicory, evening primrose, wild carrot, wild parsnip, common milkweed, lesser stitchwort, red clover, white-sweet clover, stinging nettle, ground ivy, common burdock, New England aster, and Canada goldenrod. Slender willow, hawthorn, prickly ash, red raspberry, red-osier dogwood, blackberry, tartarian honeysuckle, and common buckthorn shrubs are common in the meadow habitat, along with

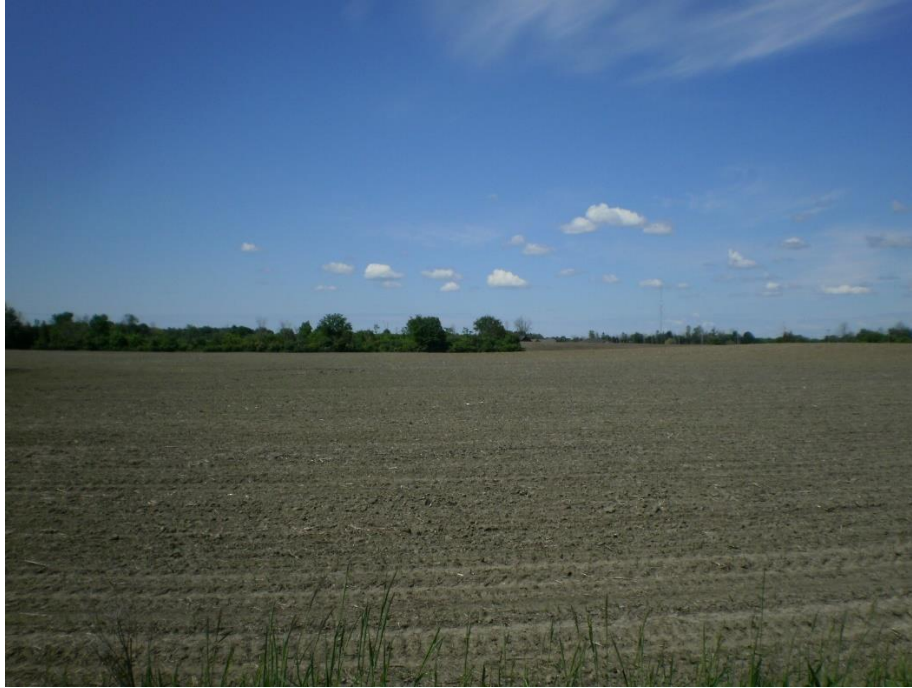
*Photo 2 – Cultivated field in the northwest portion of the site.
View looking west from the central laneway*

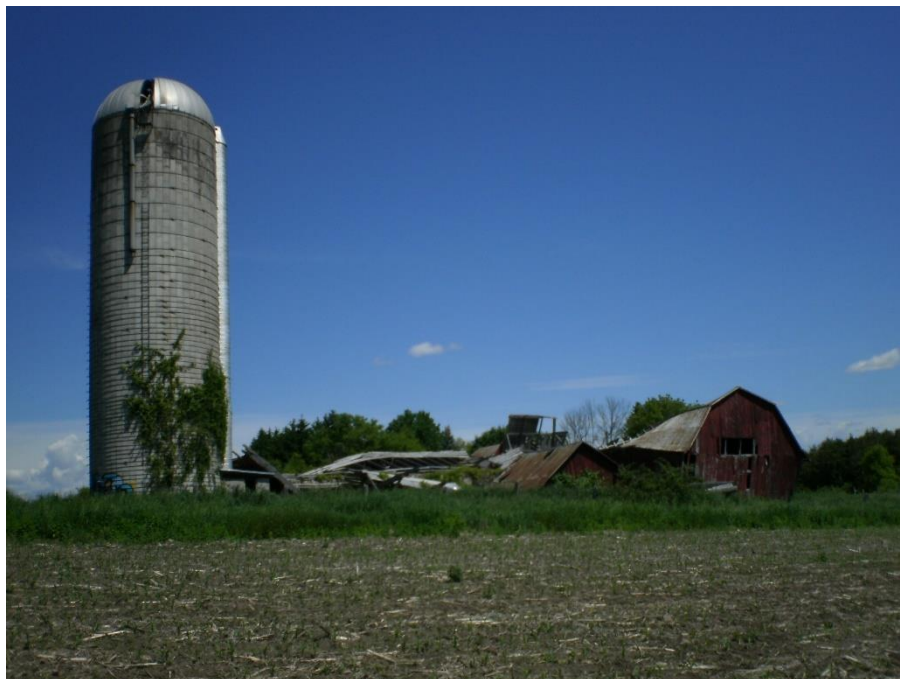
*Photo 3 –South cultivated field with view looking north to silo and other structures.
Barn swallows were observed nesting in the dilapidated barn on the far right*

The other Species at Risk breeding bird listed in the Ontario Breeding Bird Atlas for the 10 km square 18VQ49 was barn swallow. The decaying barn and other structures in the central portion of the site could be used for nesting by barn swallow and a pair of barn swallows were observed during each of three June surveys, with a nest noted in the southern barn (Photo 3). Other potential Species at Risk in the general area include bank swallow, which use the open face of sand banks; habitat not observed on or adjacent to the site. Chimney swift nests in larger brick chimneys without a metal liner. The farmhouse has been removed and no chimneys were on the site. Eastern whip-poor-will utilize rock or sand barrens with scattered trees, savannahs, old burns, or other disturbed sites in a state of early to mid-forest succession, or open conifer plantations. The understory of the deciduous forest in the southwest corner appeared suitable but the understory of the cedar coniferous forest to the south of the site was much denser. The total size of the maple forest onsite and extending a bit to the west is about 3.7 hectares, less than the required 9 hectares identified in the MNR 's general habitat description for eastern whip-poor-will. Also, eastern whip-poor-will was not reported in the breeding bird atlas for this area.

Removal of the barn currently used for nesting by barn swallow can also be compensated for using the on-line registration under the current process. The barn removal must occur outside of the May 1st to July 31st breeding window for barn swallow and will be compensated for with installation of a nesting structure in the southeast corner of the site adjacent to the south stormwater management facility. Changes to the above compensation measures may be implemented pending the details of the current 10-year Endangered Species Act review.

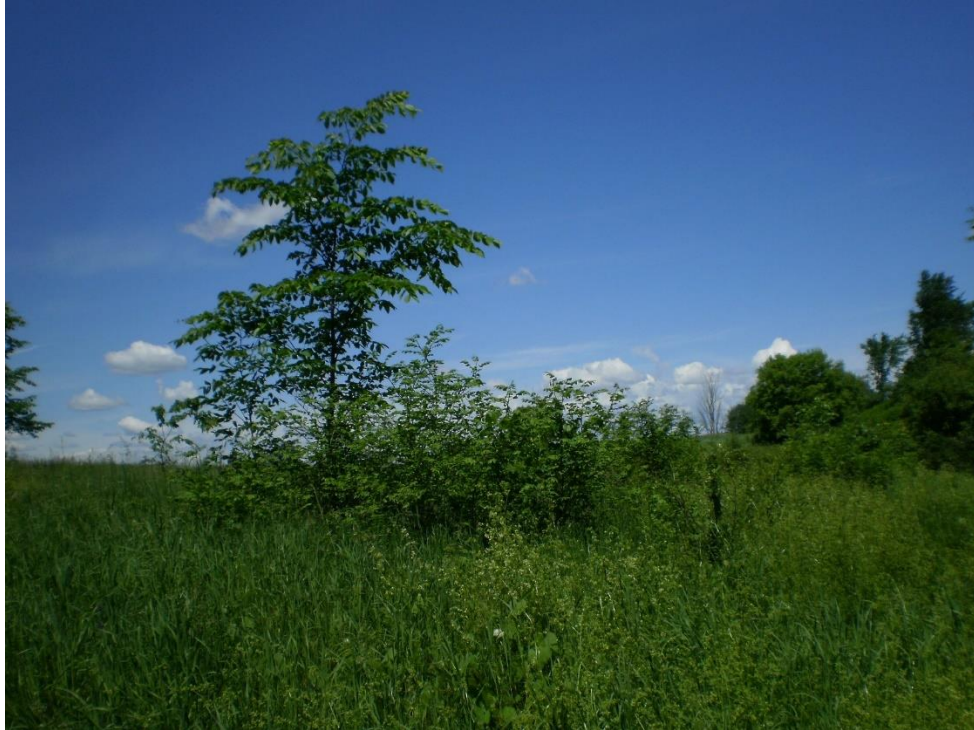
*Photo 4 – Cultural meadow in the south portion of the site.
View looking north*

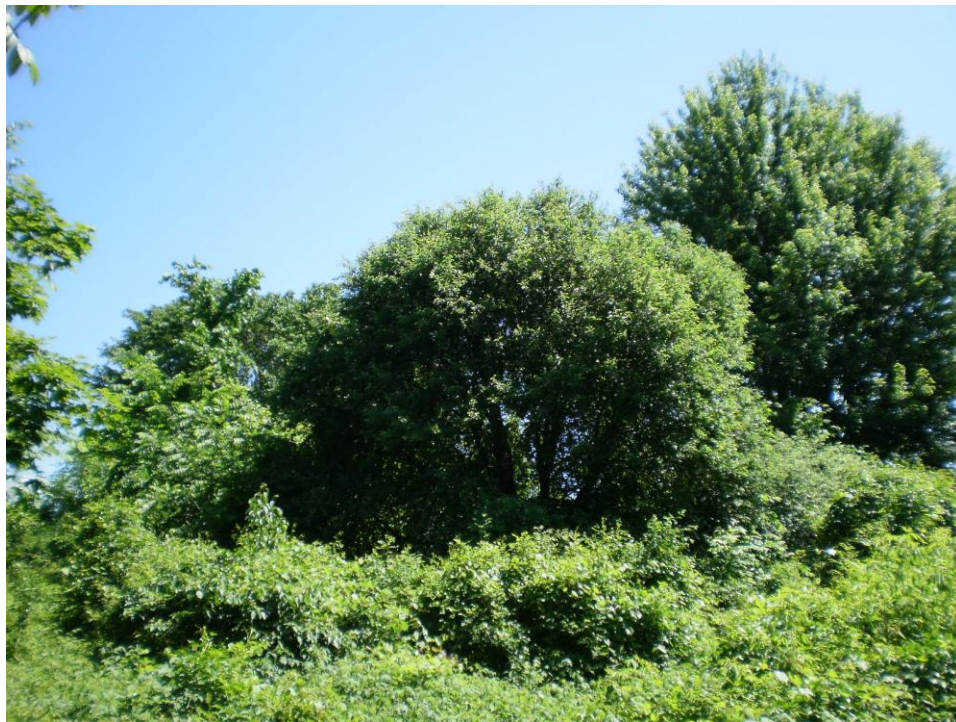
*Photo 5 – Cultivated woodland in the south-central portion of the site.
View looking northeast*

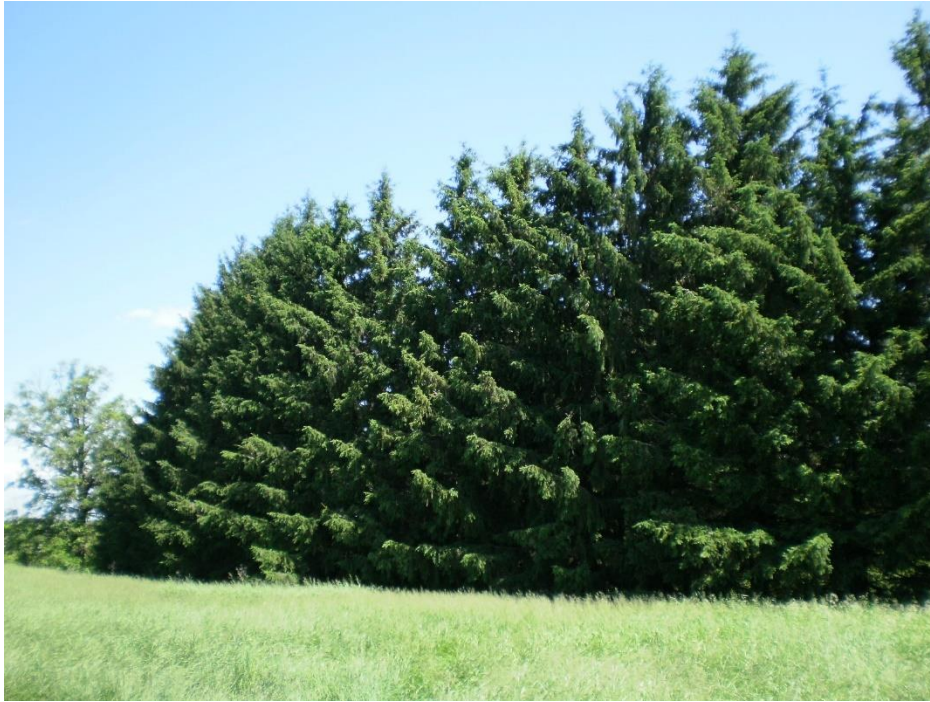
A north-south coniferous hedgerow dominated by white spruce is in the central portion of the site, on the west side of the laneway to the former farmhouse (Photo 6). The spruce were up to 55cm dbh and appeared to be in good condition. Deciduous hedgerows to the west of the coniferous hedgerow in the central portion of the site are dominated by sugar maple and white ash, with smaller white elm, basswood, and Manitoba maple. The largest maples are in the range of 75cm dbh. Cavities were present in some of the maples, along with dead smaller branches. Many of the white ash showed emerald ash borer damage while several of the white elm were dead with no functional bark. A smaller north-south coniferous hedgerow in the west part of the central area is dominated by smaller white cedar up to 26cm dbh.

*Photo 6 – North-south coniferous hedgerow of white spruce in the centre portion of the site.
View looking northeast*

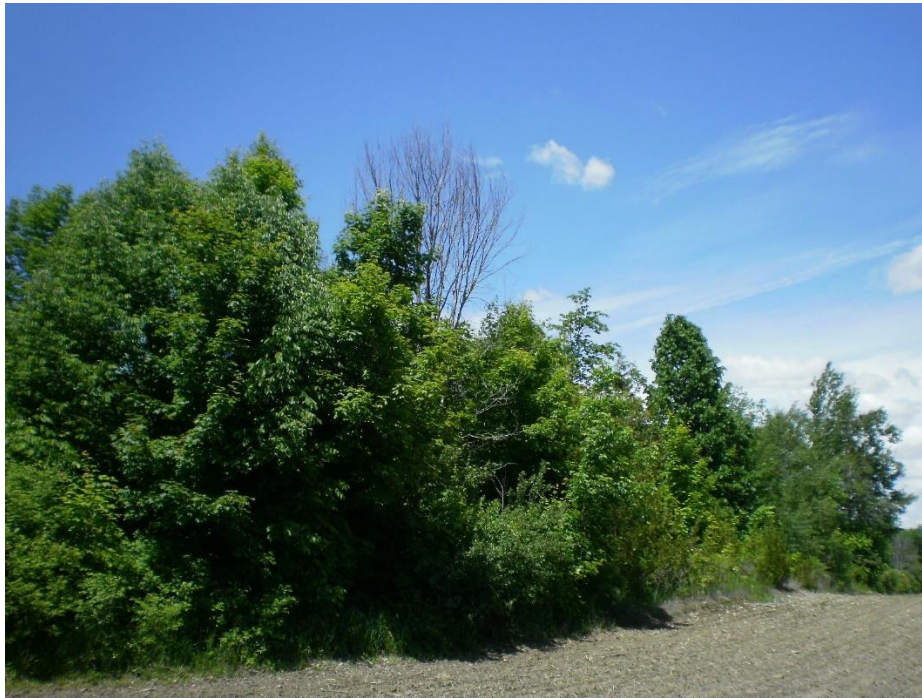
A north-south deciduous hedgerow along the east side of the northwest cultural thicket described above is dominant by white elm, with white cedar, bur oak, and white ash also present (Photo 7). The largest trees were elm and bur oak in the 40cm dbh range. Many of the elm were in very poor condition. White elms are also dominant in an intermittent north-south deciduous hedgerow in the south-central portion of the site.

Photo 7 – North-south deciduous hedgerow in the west portion of the site between cultivated field and cultural thicket. View looking northwest

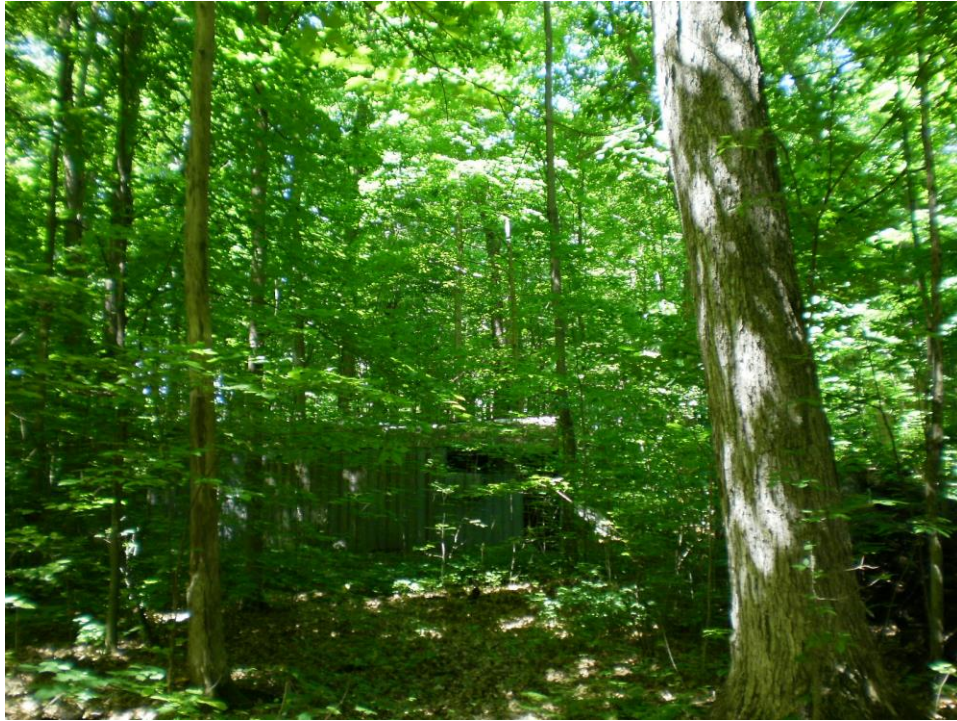
Sugar maple is dominant in the upland deciduous forest in the southwest portion of the site (shown as vegetation community 7 on Map 1, Photo 8). Many mature sugar maples up to 80cm dbh are in the forest, along with a few basswoods up to 75cm dbh. An old sugar shack in the central portion of the forest indicates the maples were formerly tapped. Stacks of firewood were also present. In addition to the dominant maple and some basswoods, ironwoods up to 20cm dbh are common, with a few white elm, American beech and white ash trees in the south portion of the deciduous forest. Several of the ash and beech are in poor condition, with extensive trunk decay on the beech and evidence of emerald ash borer damage on the ash. A few of the larger sugar maples have cavities (Photo 9), fungus and broken limbs, but the leaf-out was generally good. Regenerating maple stems were dominant in many areas of the forest, with young ironwood, bur oak, white cedar (in the south portion), and basswood also in the understory. A good amount of natural deadfall adds to the ecological functions of the forest. Ground flora was generally reflected of a rich forest, with blue cohosh dominant in several areas. Clintonia, white trillium, jack-in-the-pulpit, false Solomon-seal, sharp-lobed hepatica, thicket creeper, lady fern, ostrich fern, sensitive fern, thicket creeper, and evergreen woodfern. Rock and boulders were common at the surface in the forest. Chairs and windchimes indicate some social use of the forest.

*Photo 8 – Mature trees are common in the southwest upland maple forest.
View looking west to former sugar shack*

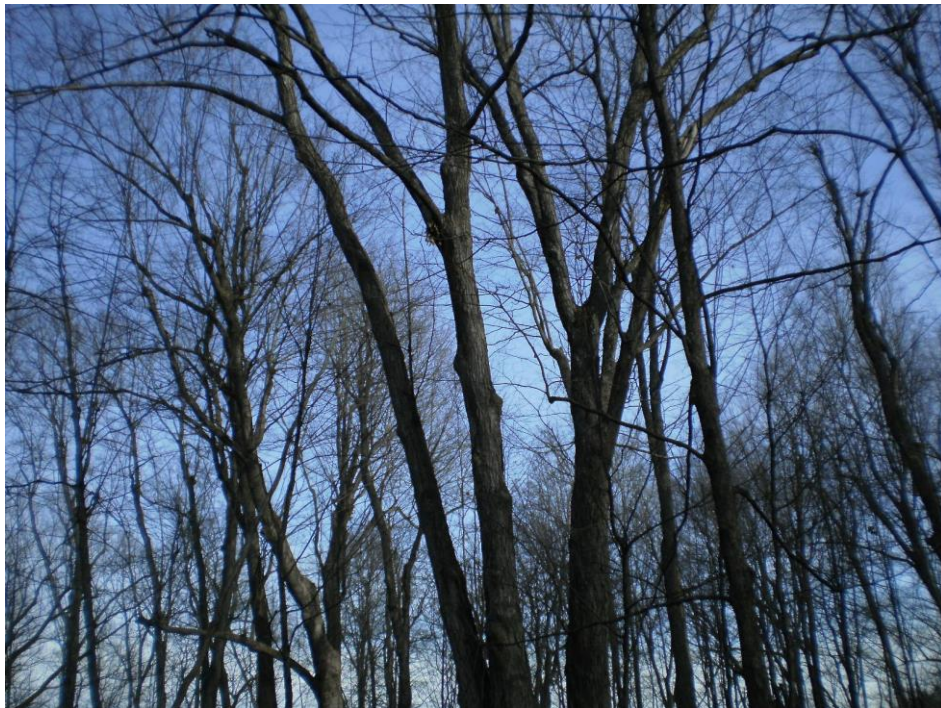
*Photo 9 – Upper portion of sugar maple in the southwest forest with a potential wildlife cavity.
View looking northeast*

4. The ideal time for removal of trees with potential wildlife cavities is between August 15th and October 15th to protect both breeding birds and overwintering wildlife in cavity trees. Depending on the year, April may also be a suitable time. If winter tree removal is anticipated, surveys should be undertaken ahead of time to determine no overwintering wildlife use in trees with suitable cavities;

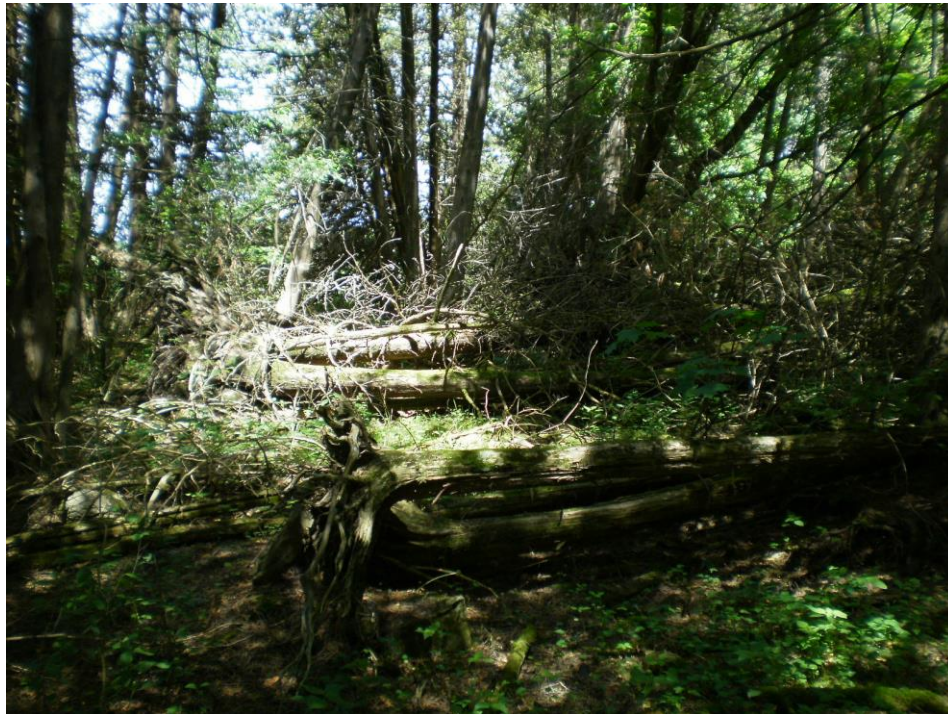
*Photo 10 – Windthrow was extensive in the upland cedar forest in the centre portion of the site.
View looking northeast*

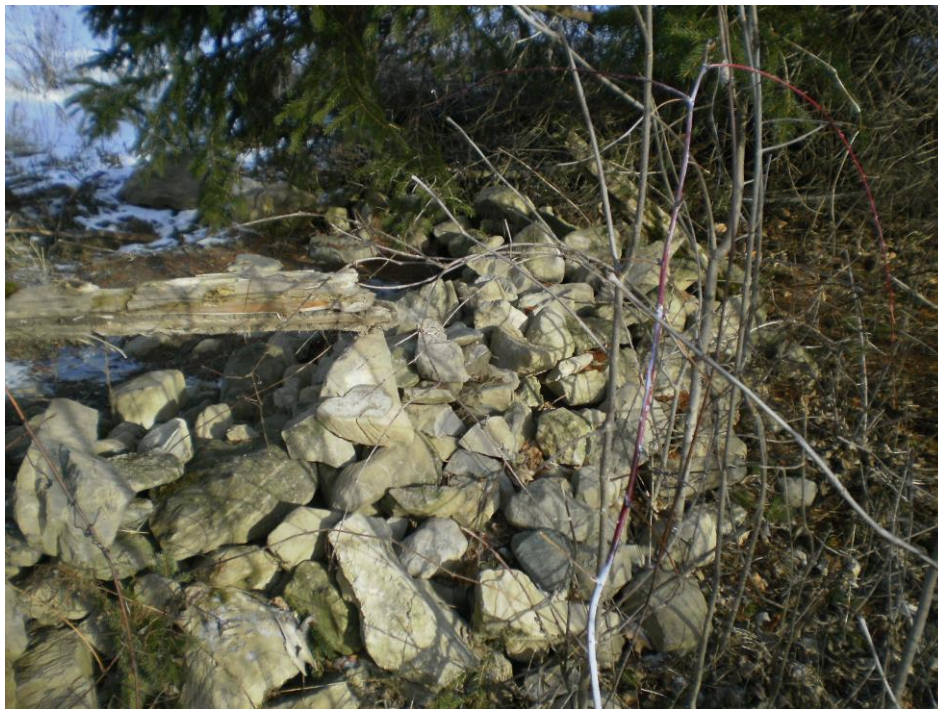
*Photo 11 – There are many stone piles on the site which could be used by overwinter wildlife.
This example is in the centre portion of the site. View looking northeast to spruce hedgerow*

The stone piles may represent significant wildlife habitat. Where removal is required, the mitigation measures below will ensure overwintering or nesting activity is not disturbed.

3. Stone piles were observed in several areas along the field edges. Where required, disturbances to stone piles are to occur outside of the winter and spring periods to protect wildlife, with the ideal time for removal in August and September. City of Ottawa (2015) contains mitigation measures for the removal of stone piles including retaining a biologist to inspect habitat for occupancy prior to removal during the more sensitive periods, and in cases where occupancy is uncertain, the stone piles are to be disassembled slowly (by hand where possible) to reduce potential impacts and allow wildlife time to relocate;

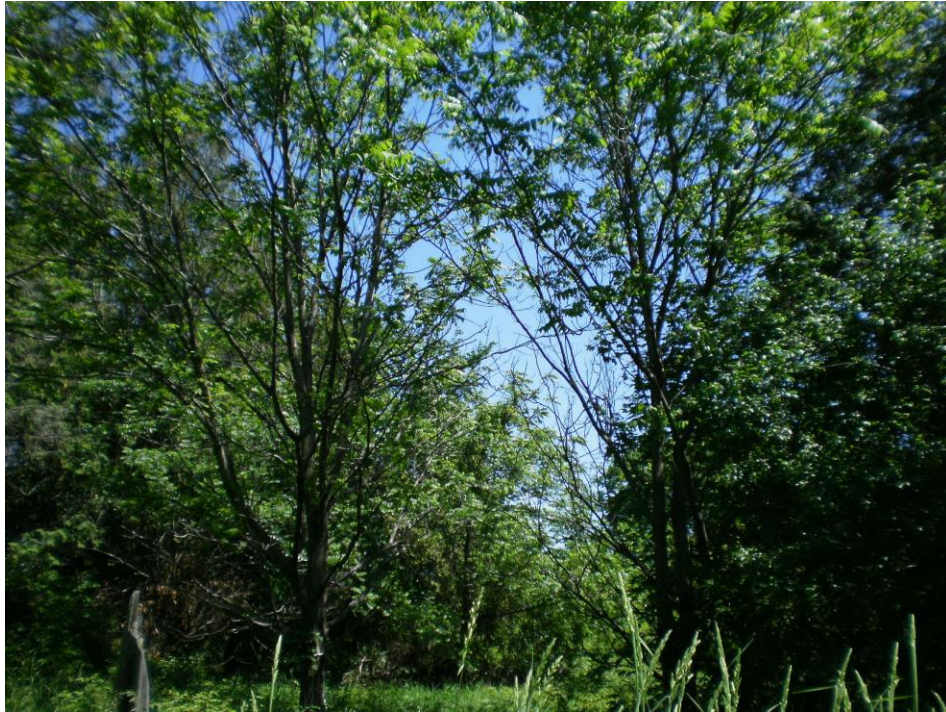
Butternut trees are found in a variety of habitats and 41 butternuts were identified on the site and adjacent lands (Map 3, Photo 12). Over half of these butternuts were assessed as unhealthy (24 Category 1 trees), with just over forty percent assessed as healthy (16 Category 2 trees and one Category 3 butternut). As described below, the stormwater management and parking areas were modified to avoid removing and the potential for harming the healthy butternuts as much as possible. A few cavity trees that could potentially be used as maternal summer colonies for bats were observed in the southwest forest, although the density appeared less than the 10 per hectare MNRF threshold and the forest will not be disturbed.

Photo 12 – Butternuts in the south-central cultural woodland. View looking northeast

The development footprint has been modified to retain as many butternuts as possible, including relocating the south stormwater management facility. It is anticipated four butternuts will require removal (#s 25, 26, 40, and 41 – each between 3cm and 14cm dbh) and three butternuts may be harmed (#s 27, 38, and 39 – also each between 3cm and 14cm dbh). Under the current process in place at the Ministry of Environment, Conservation and Parks, the removal and harm of these butternuts can be compensated for with an on-line registration for 29 plantings of pure butternut stems. The location of the compensation plantings will be finalized when the on-line registration is completed.

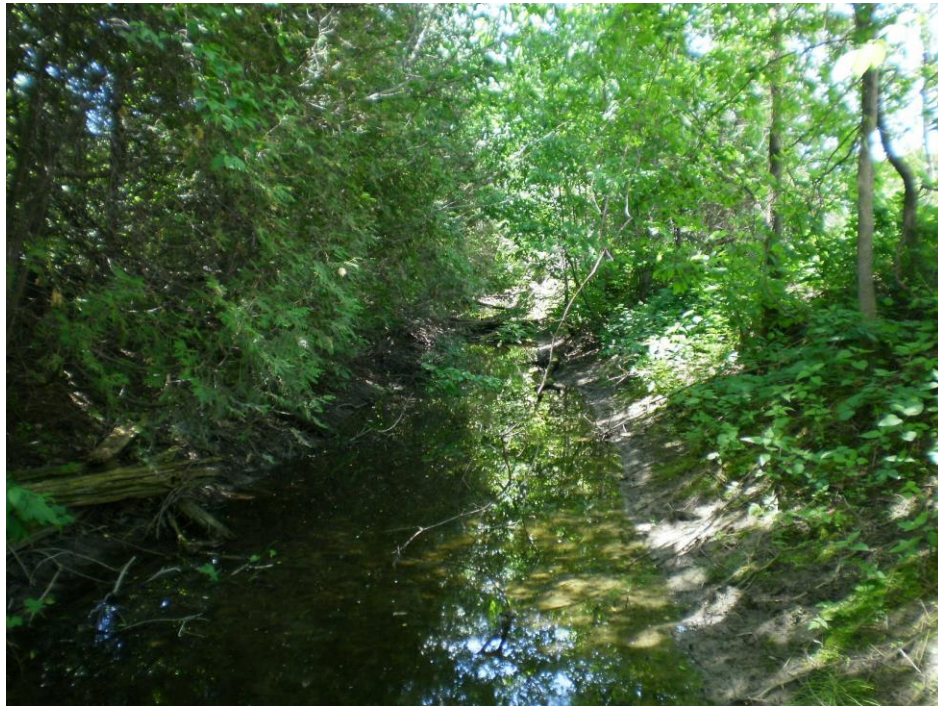
The Johnston Municipal Drain runs along the east portion of the south site boundary (Photo 13). The channel flows to the east and is a typical straight agricultural channel with a trapezoid cross-section. Good canopy cover was provided by a deciduous hedgerow and an upland mixed forest to the south. The exposed substrate was dominated by soft clay. In-stream structure was limited but included large woody debris and some vegetation. The banks were well vegetated with spotted touch-me-not, thicket creeper, Philadelphia fleabane, Canada goldenrod, June meadow grass, wild grape, field horsetail, and white snakeroot.

*Photo 13 – Johnston Municipal Drain along the east portion of the south site edge.
View looking east, downstream*

Other significant natural heritage features on and adjacent to the site include anticipated forage fish habitat in the Johnston Municipal Drain. To protect any fish habitat in this typical trapezoid drain shaped straight channel, no site alterations will occur within a 30 metre setback of the channel, as shown on Map 2. To provide an enhancement over the existing cultivated field, the portion of the 30 metre setback on the site will be allowed to naturalize. Another channel, the Dillon-Wallace Municipal Drain is to the north of the site, north of Rogers Stevens Drive. This Drain is more than 30 metres from the site, although the floodplain does extend onto the northwest portion of the site.
