Geotechnical Investigation

Proposed Warehouse Complex
1966 Roger Stevens Drive
Ottawa, Ontario

Report PG4870-1 Revision 1

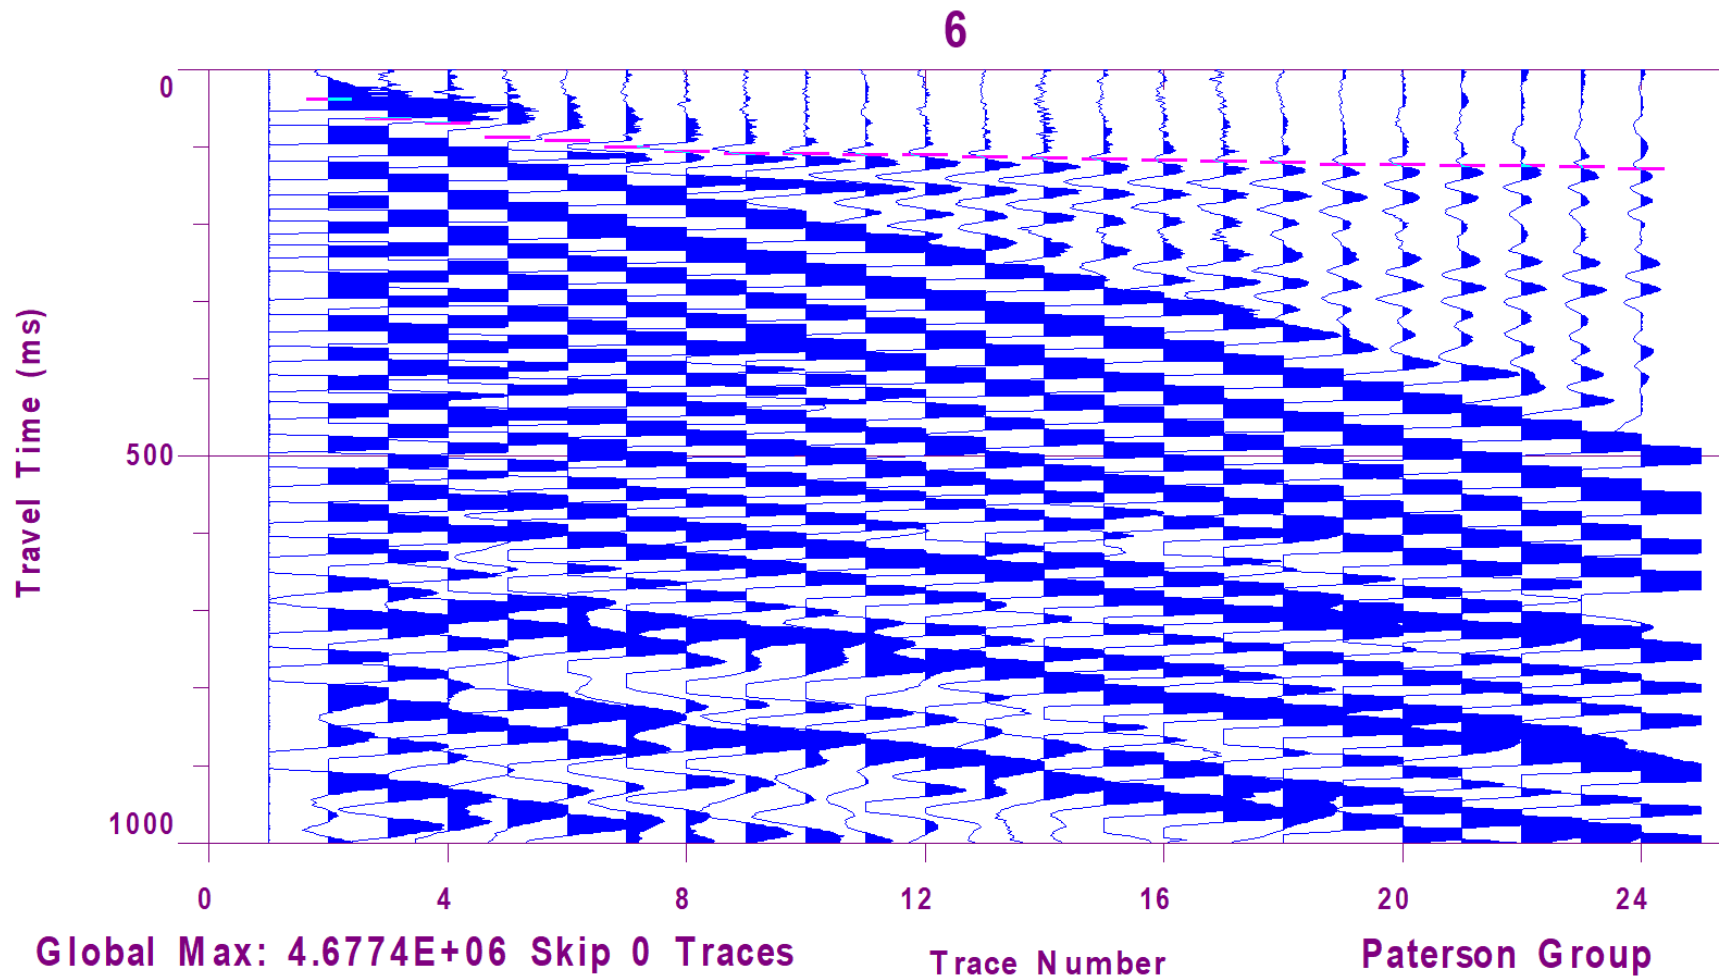
FIGURE 2 –Shear Wave Velocity Profile at Shot Location -4.5 m

Interpretation for the shear wave velocity results were completed by Paterson personnel. Shear wave velocity measurement was made using reflection/refraction methods. The interpretation is performed by recovering arrival times from direct and refracted waves. The interpretation is repeated at each shot location to provide an average shear wave velocity, V_{s30} , of the upper 30 m profile immediately below the building's foundation. The bedrock velocity was interpreted using the main refractor wave velocity, which is considered a conservative estimate of the bedrock velocity due to the increasing quality of the bedrock with depth. It should be noted that as bedrock quality increases, the bedrock shear wave velocity also increases.

Based on the results of the seismic testing, the average shear wave velocity, V_{s30} , for foundations placed on the overburden materials is 315 m/s. Therefore, a **Site Class D** is applicable for design of the proposed building, as per Table 4.1.8.4.A of the OBC 2012. The soils underlying the subject site are not susceptible to liquefaction.
