Combined Environmental Impact Statement &
Tree Conservation Report
Valecraft Kanata North Development
(1020 & 1070 March Road)

April 2019
Prepared for Valecraft Homes Ltd.

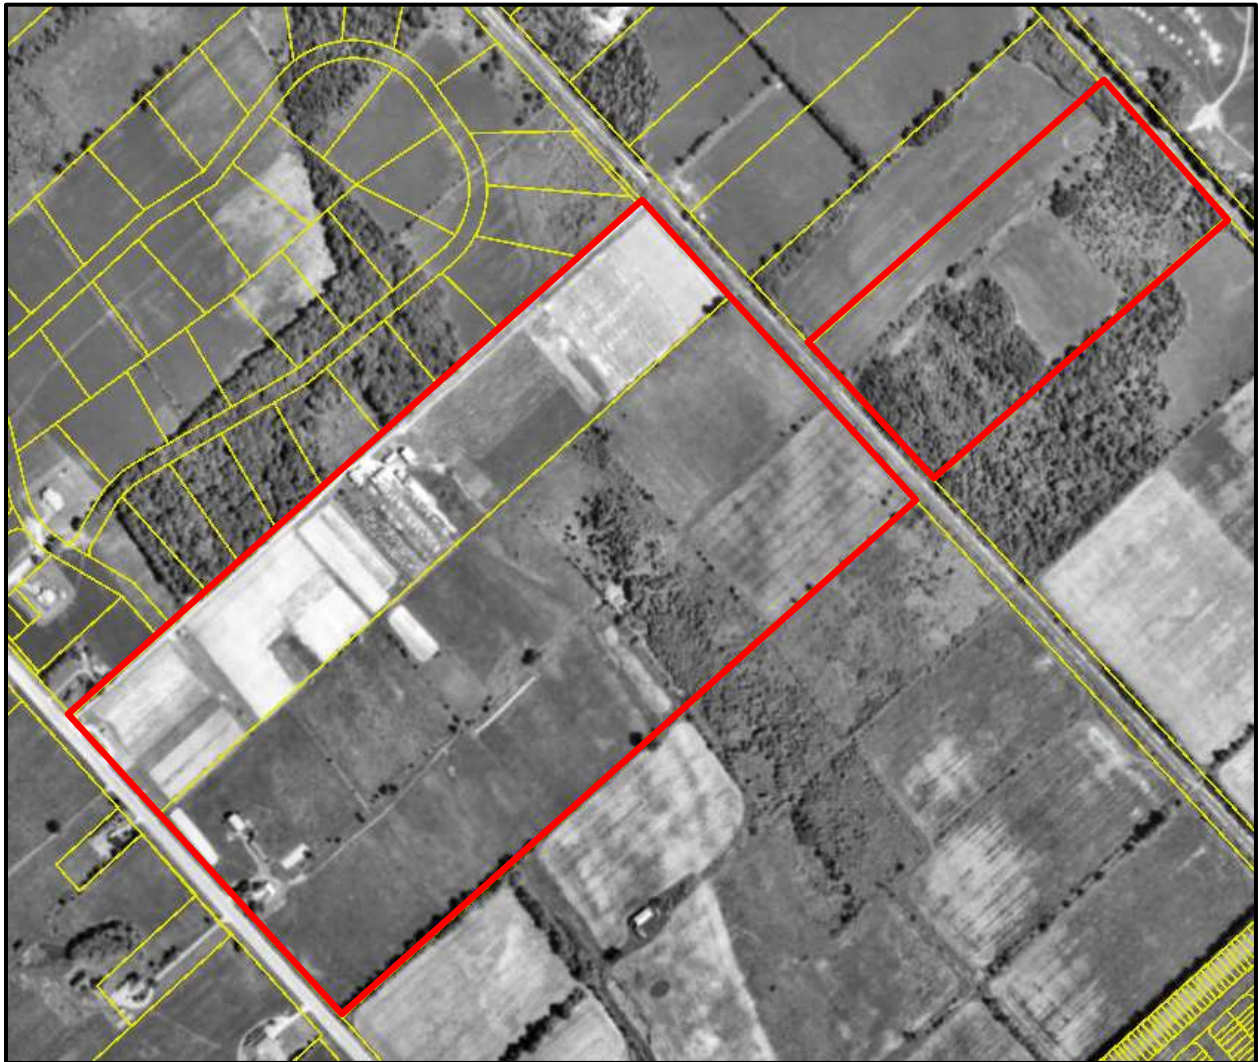
Historic Air Photograph 2: Historic Air Photo from 1991 (Site limits shown in red). Note that the overall composition of the Site was similar in 1991, with most of the Site intensively farmed. The western portion of Woodlot S-20, and both the western and eastern portions of Woodlot S-23 that occur within the Site appear to include mature tree cover in 1991. Deciduous Hedgerow B is also visible in 1991 (present along the southern Site boundary). The majority of the remaining Coniferous, Mixed, and Deciduous Hedgerows, and the eastern and northern portions of Woodlot S-20 do not appear to include significant mature tree cover in 1991 (Photos from City of Ottawa 2019).

Air photos from 1976, 1991 and 2005 are included below (Photos from City of Ottawa 2019). Recent air photos are included in the report figures. The oldest available air photo (from 1976) shows that the overall composition of the Site was similar in 1976, with most of the Site intensively farmed. The western portion of Woodlot S-20 is present in 1976, with mature tree cover evident. Within the portions of Woodlot S-23 that overlap the Site, very limited recent regrowth is visible in 1976. The eastern portion of Woodlot S-20, most of the Coniferous, Mixed, and Deciduous Hedgerows, and the portions of Woodlot S-23 that occur within the Site are all largely devoid of mature tree cover in 1976. The western portion of Woodlot S-20, and both the western and eastern portions of Woodlot S-23 that occur within the Site appear to include mature tree cover in 1991. Deciduous Hedgerow B is also visible in 1991 (present along the southern Site boundary). Most of the Coniferous, Mixed, and Deciduous Hedgerows are first visible in 2005. The Willow Shrub Thicket (Feature Q) does not appear to include mature tree or shrub cover in 2005. The historic air photos indicate that at the current time, trees within the western portion of Woodlot S-20 are greater than approximately 40 years of age, trees within Deciduous Hedgerow B and both the western and eastern portions of Woodlot S-23 that occur within the Site are approximately 20 to 30 years of age, and the northern/eastern portion of Woodlot S-20, the majority of the Coniferous, Mixed and Deciduous Hedgerows, and the Willow Shrub Thicket (Feature Q) are all likely to be less than approximately 20 years of age.

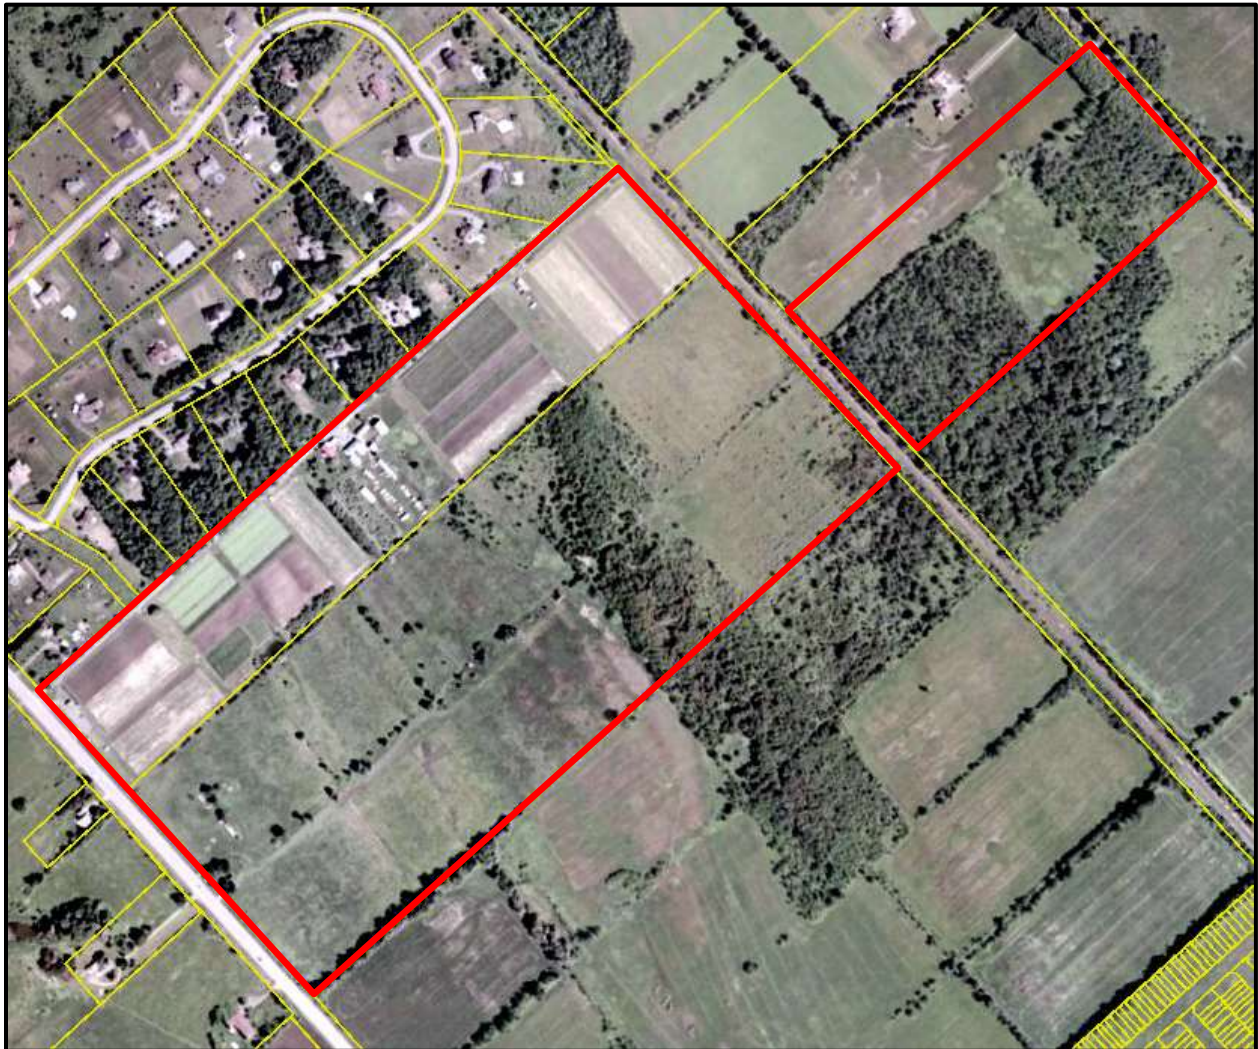
Historic Air Photograph 3: Historic Air Photo from 2005 (Site limits shown in red). Note that the overall composition of the Site was similar in 2005, with most of the Site intensively farmed. The western portion of Woodlot S-20, and both the western and eastern portions of Woodlot S-23 that occur within the Site appear to include mature tree cover in 2005. Most of the Coniferous, Mixed, and Deciduous Hedgerows are also visible in 2005. The Willow Shrub Thicket (Feature Q) does not appear to include mature tree or shrub cover in 2005 (Photos from City of Ottawa 2019).

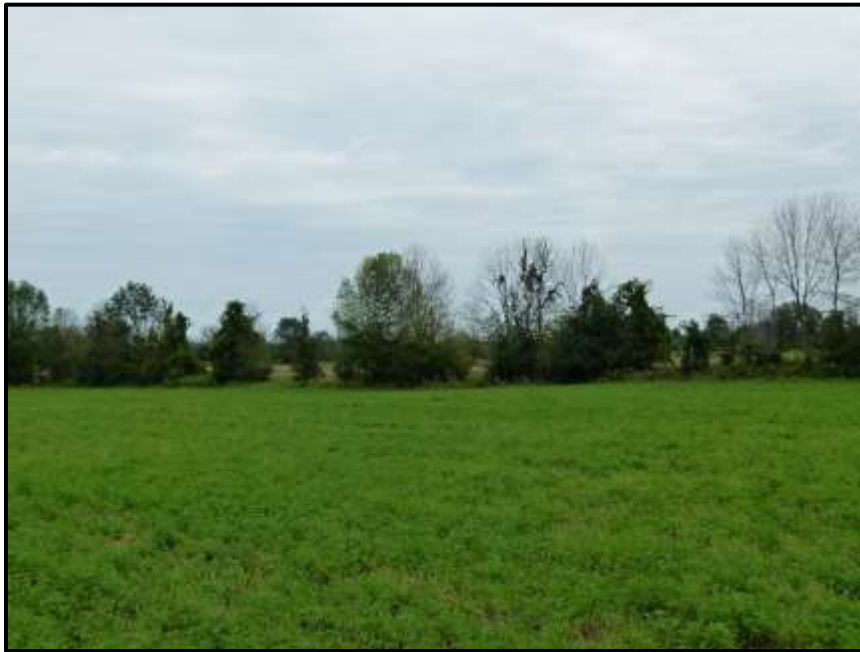
Photograph 1: Looking south at the Deciduous Hedgerow (Feature A) (September 4th, 2018).

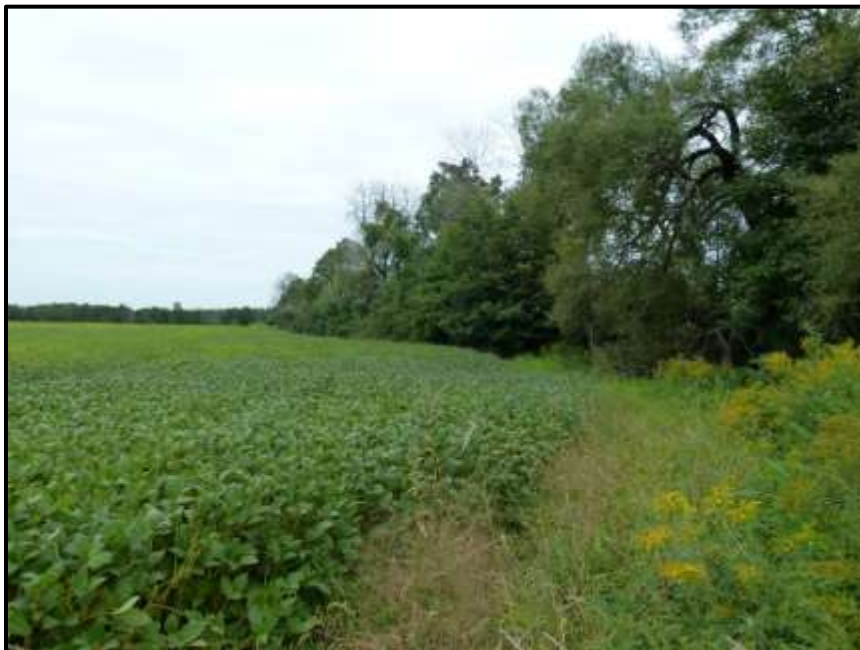
Photograph 2: Looking east at the Deciduous Hedgerow (Feature B) (September 4th, 2018).

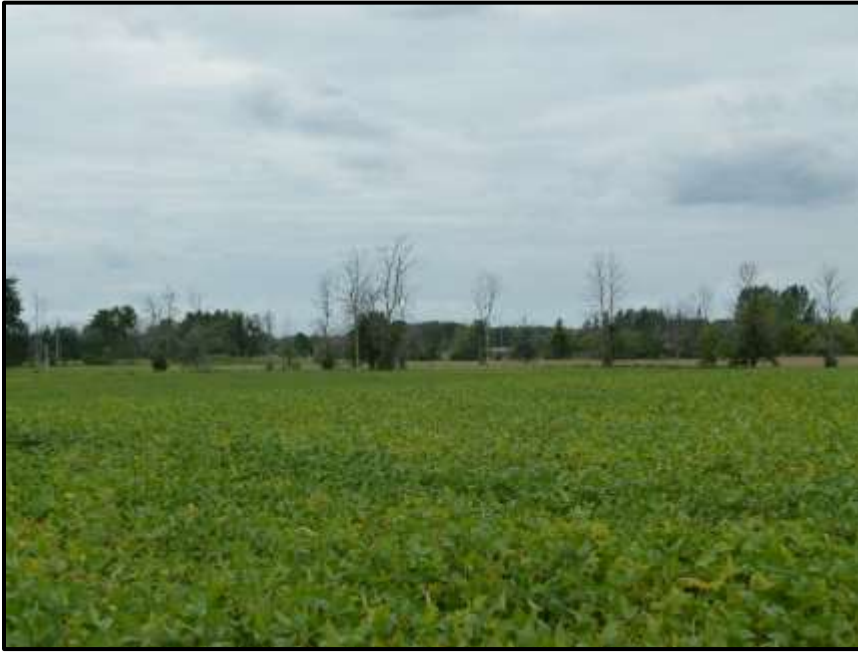
Photograph 3: Looking north at the Deciduous Hedgerow (Feature C) (September 4th, 2018).

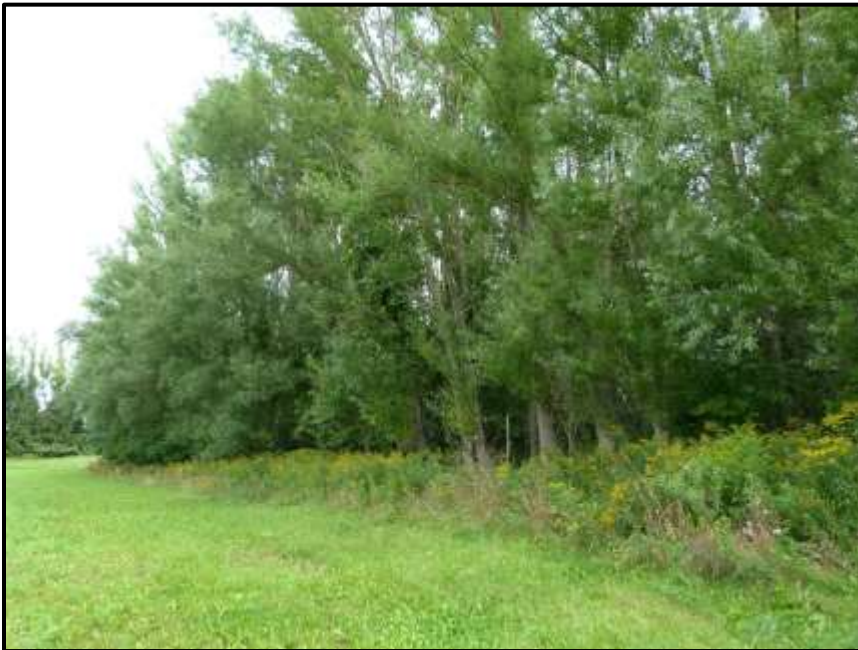
Photograph 4: Looking east at the Deciduous Hedgerow (Feature D) (September 4th, 2018).

- **Deciduous Hedgerow D:** Deciduous Hedgerow D is a planted stand of Crack Willow between approximately 10 cm and 40 cm dbh in size.
- **Deciduous Hedgerows E to G:** Deciduous Hedgerows E, F and G are all sparse features with Trembling Aspen, Manitoba Maple, American Elm, and dead/dying White/Green Ash between approximately 10 cm and 25 cm dbh in size. Staghorn Sumac and Slender Willow shrubs are also present.

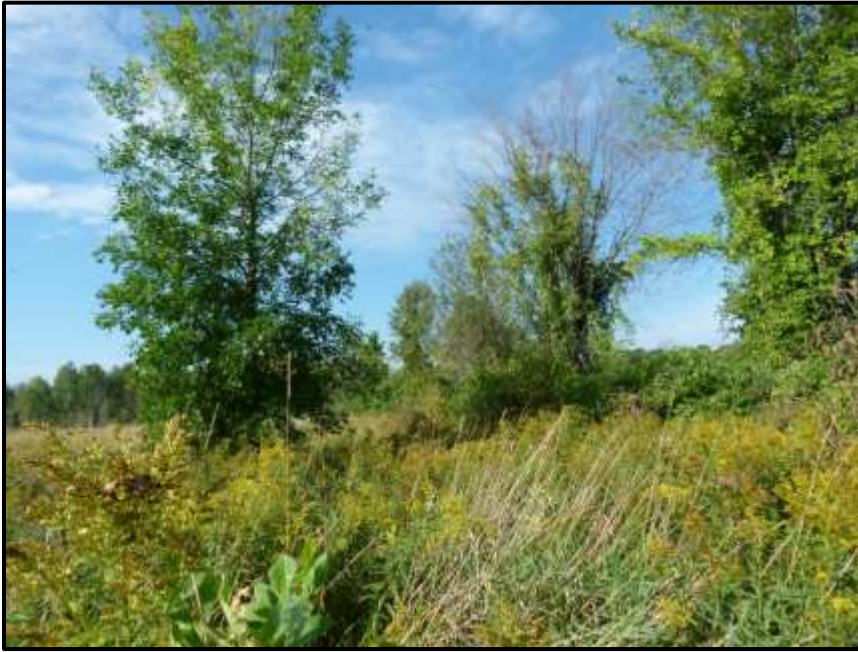
Photograph 5: Looking west at the Deciduous Hedgerow (Feature E) (September 4th, 2018).

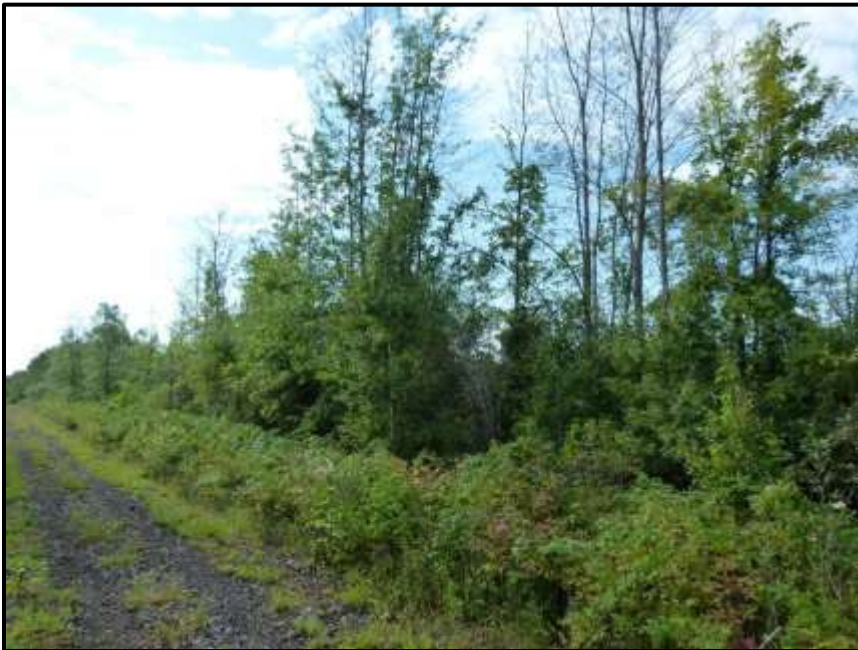
Photograph 6: Looking west at the Deciduous Hedgerow (Feature F) (September 4th, 2018).

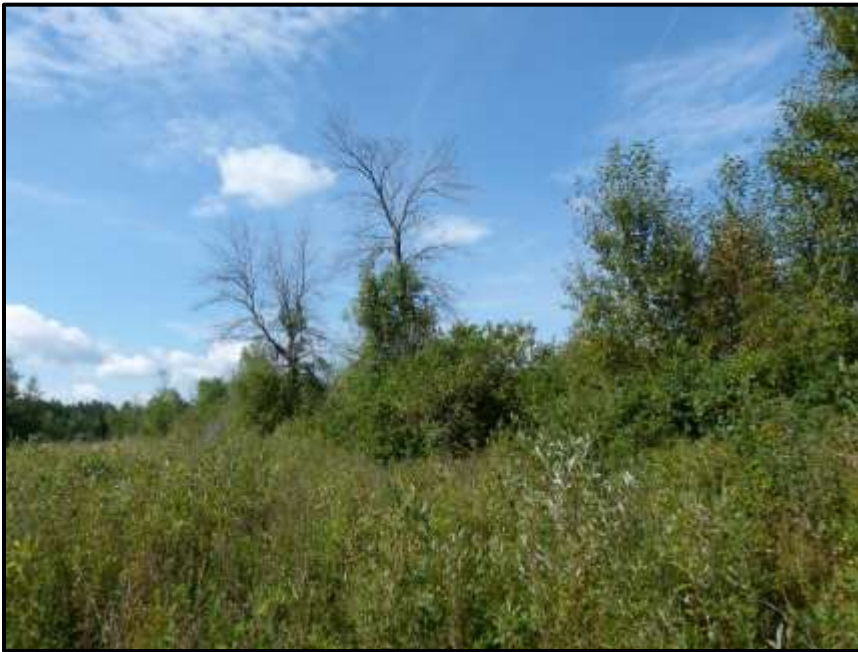
Photograph 7: Looking north at the Deciduous Hedgerow (Feature G) (September 4th, 2018).

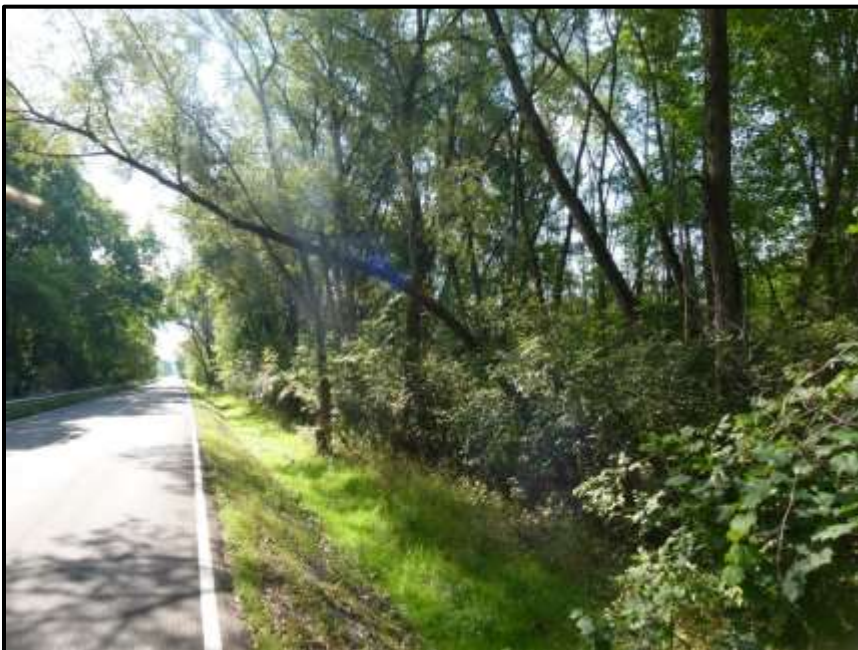
Photograph 8: Looking south along March Valley Road, with the Deciduous Hedgerow (Feature H) at the right (September 4th, 2018).

- **Deciduous Hedgerow H:** Deciduous Hedgerow H occurs along the west side of March Valley Road. The feature is dominated by Crack Willow that are between approximately 20 cm and 35 cm dbh in size. White/Green Ash, Sugar Maple, and Manitoba Maple between approximately 10 cm and 25 cm dbh in size are well represented. Shrub and groundcover differ from Deciduous Hedgerows A to G, likely due to moister soil conditions. Shrub cover is sparse and ground cover includes False Solomon's Seal, Poison Ivy, Sensitive Fern, Lady Fern, Spinulose Wood Fern, White Snakeroot, Common Blue Violet, Canada Anemone, Spotted Touch Me Not, Clearweed, and Common Nettle.

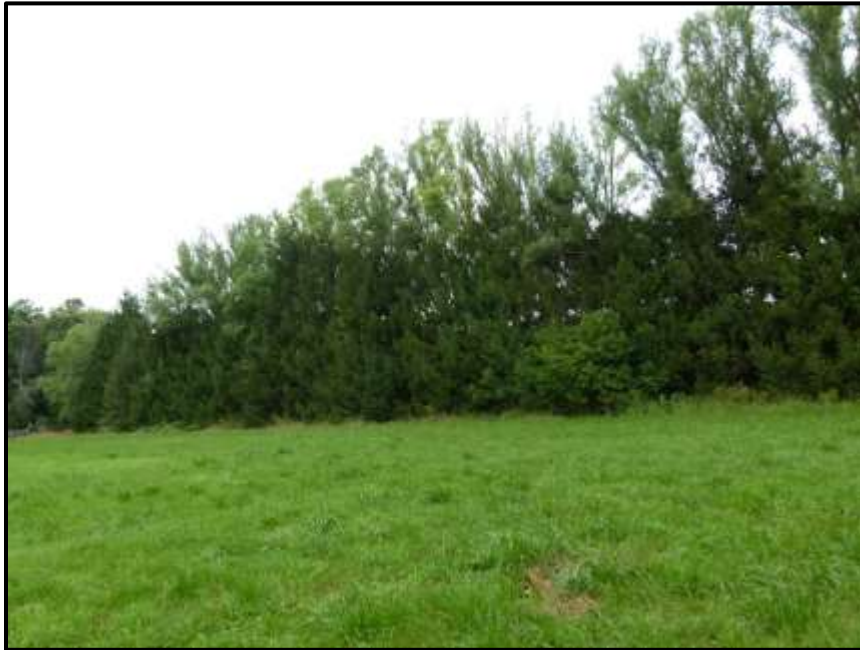
Photograph 9: Looking west at the Mixed Hedgerow (Feature I) (September 4th, 2018).

The western side of Mixed Hedgerow I is a planted line of Crack Willow between approximately 10 cm and 40 cm dbh in size. The eastern side of Mixed Hedgerow I is a planted line of White Spruce between approximately 20 cm and 40 cm dbh in size.

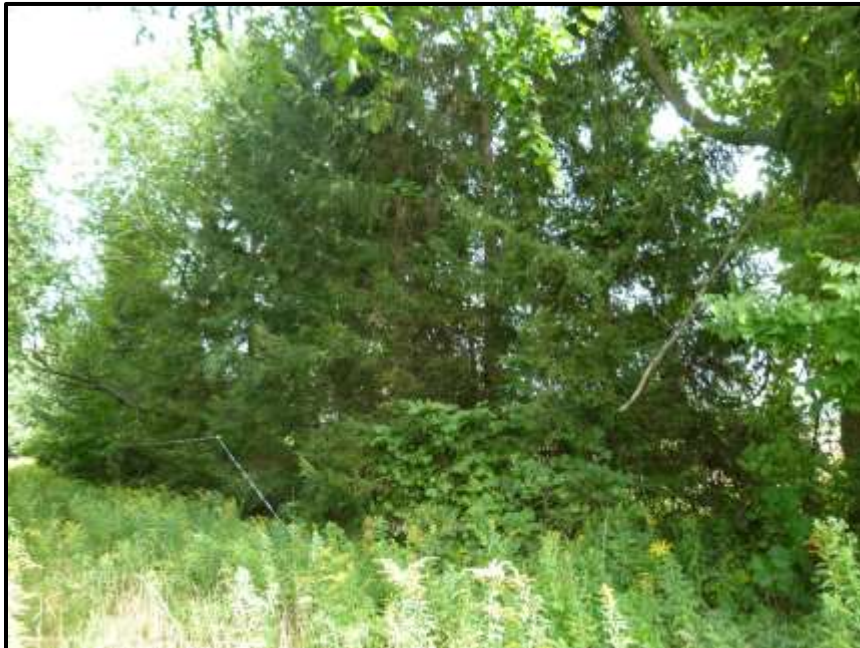
Photograph 10: Looking east at the Coniferous Hedgerow (Feature J) (September 4th, 2018).

- **Coniferous Hedgerow J:** Coniferous Hedgerow J consists of planted White Spruce between approximately 20 cm and 40 cm dbh in size.
- **Coniferous Hedgerow K:** Coniferous Hedgerow K consists of planted White Spruce between approximately 20 cm and 30 cm dbh in size.
- **Coniferous Hedgerow L:** Coniferous Hedgerow L consists of planted White Spruce between approximately 20 cm and 30 cm dbh in size. The feature is overgrown with Riverbank Grape and Wild Red Raspberry.

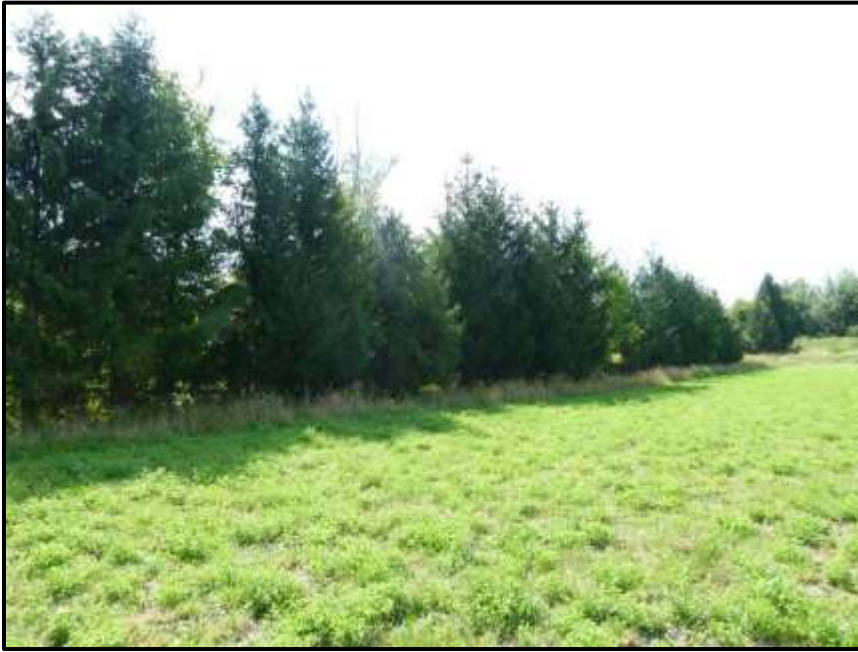
Photograph 11: Looking south at the Coniferous Hedgerow (Feature K) (September 4th, 2018).

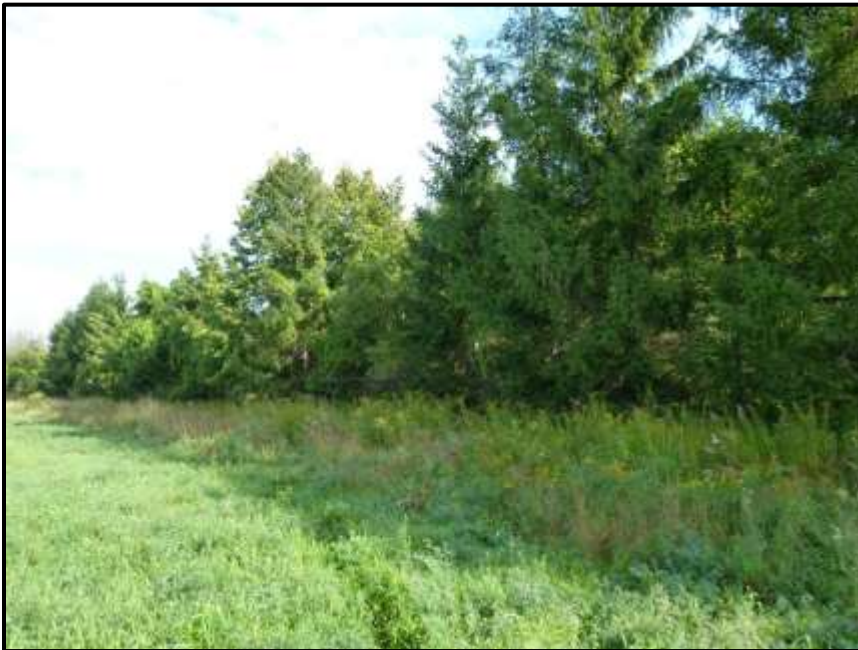
Photograph 12: Looking northeast at the Coniferous Hedgerow (Feature L) (September 4th, 2018).

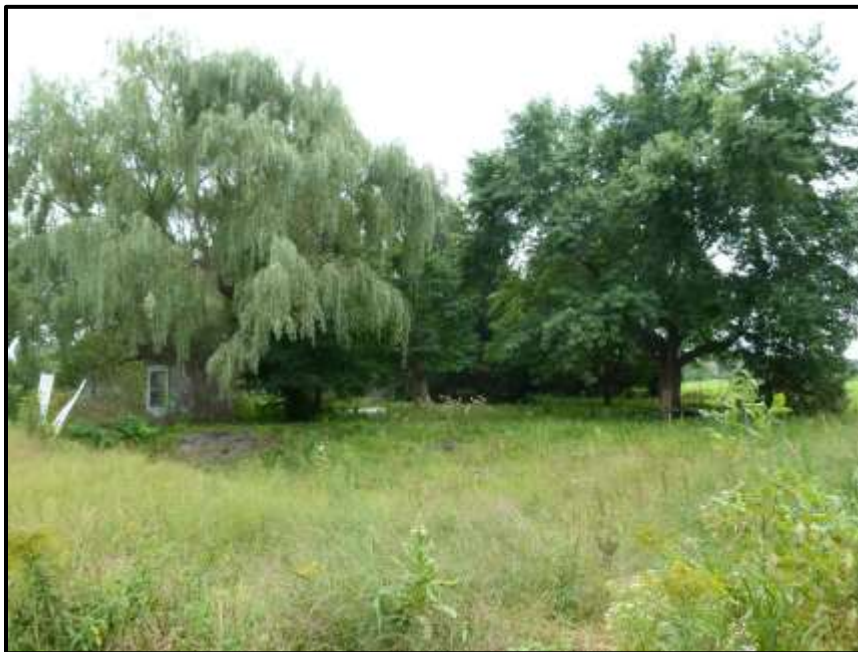
Photograph 13: Looking south at the Tree Stand (Feature M). Note the mature Silver Maple and Weeping Willow (September 4th, 2018).

- **Tree Stand M:** Tree Stand M consists of a small stand of trees which were planted around the farmhouse as landscaping features. Planted trees include White Spruce, White/Green Ash, Sugar Maple, and Trembling Aspen up to approximately 40 cm dbh in size. A planted Weeping Willow with a dbh of >1 m is also present, as is a 91 cm dbh Silver Maple.
- **Tree Stand N:** Tree Stand N is a small tree stand on the east side of March Road. The understory is sparse with very little shrub cover. Several mature Sugar Maples are present, as are younger White/Green Ash, American Elm, and White Cedar stems. The mature Sugar Maples include seven (7) trees measuring 71 cm, 47 cm, 56 cm, 53 cm, 84 cm, 64 cm, and 57 cm dbh. Shrub cover is sparse and includes Lilac.

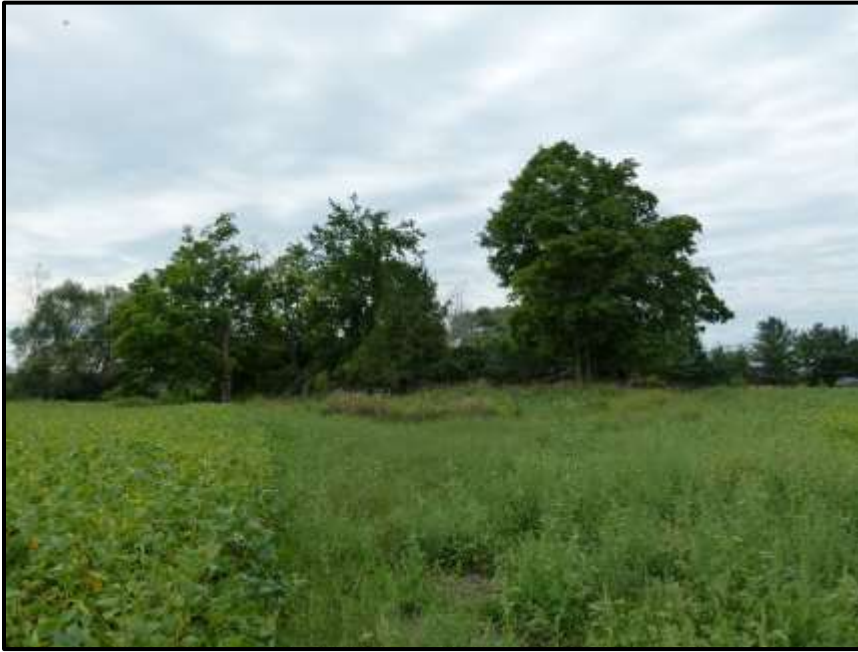
Photograph 14: Looking west at the Tree Stand (Feature N). Note the presence of several mature Sugar Maples (September 4th, 2018).

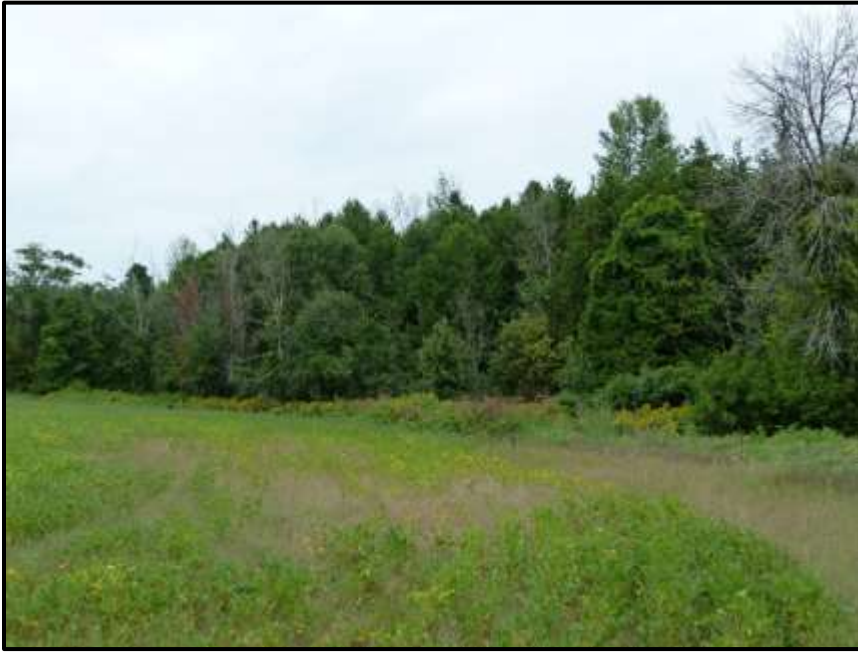
Photograph 15: Looking east at the western edge of the Fresh-Moist White Cedar Coniferous Forest (Feature O) (September 4th, 2018).

- **Fresh-Moist White Cedar Coniferous Forest (Feature O):** Feature O is a mature forest that is dominated by White Cedar, with White/Green Ash and American Elm well represented. Smaller numbers of Manitoba Maple and Butternut are also present, especially around the edges of the feature. The majority of White Cedar stems are relatively small (15 cm to 40 cm dbh), however, older White Cedar specimens are present within the western part of the feature. As described above in Section 3.2, the western part of Feature O represents the oldest part of Woodlot S-20, with the oldest trees exceeding approximately 40 years of age. MEP (2016) completed an inventory of large trees within Woodlot S-20 (see below), during which more than twenty (20) White Cedars, one (1) Red Maple, one (1) White Ash, and one (1) Bur Oak ≥ 50 cm dbh in size were identified (MEP 2016). Although several large trees are present, they represent the minority of stems. The measurements included below in Table B reflect the average tree sizes, which are much smaller than the largest specimens. Shrub cover is generally sparse but includes Hawthorn, Wild Red Raspberry, Red Elderberry, Prickly Gooseberry, Common Buckthorn, Tartarian Honeysuckle, Prickly Ash, and Red Osier Dogwood. Much of the groundcover is reflective of disturbed conditions with Blue Grass, Brome Grass, Virginia Creeper, Common Burdock, Riverbank Grape, Hog Peanut, Common Stinging Nettle, Bull Thistle, Canada Thistle, Field Horsetail, Poison Ivy, Common Mugwort, Wild Cucumber, Yellow Sorrel, Tall Buttercup, Dandelion and Tufted Vetch present. Wild Sarsaparilla, White Snakeroot, Jack in the Pulpit, Lady Fern, and White Trillium were also noted, particularly in areas with thick canopy cover.

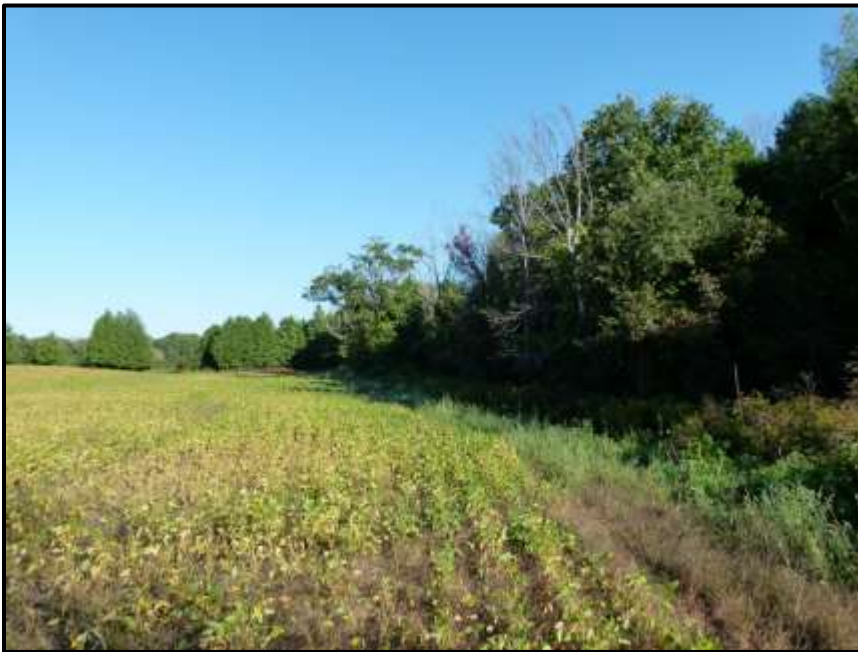
Photograph 16: Looking north at the western edge of the Fresh-Moist White Cedar Coniferous Forest (Feature O). The Deciduous Hedgerow (Feature C) is visible in the background (September 14th, 2018).

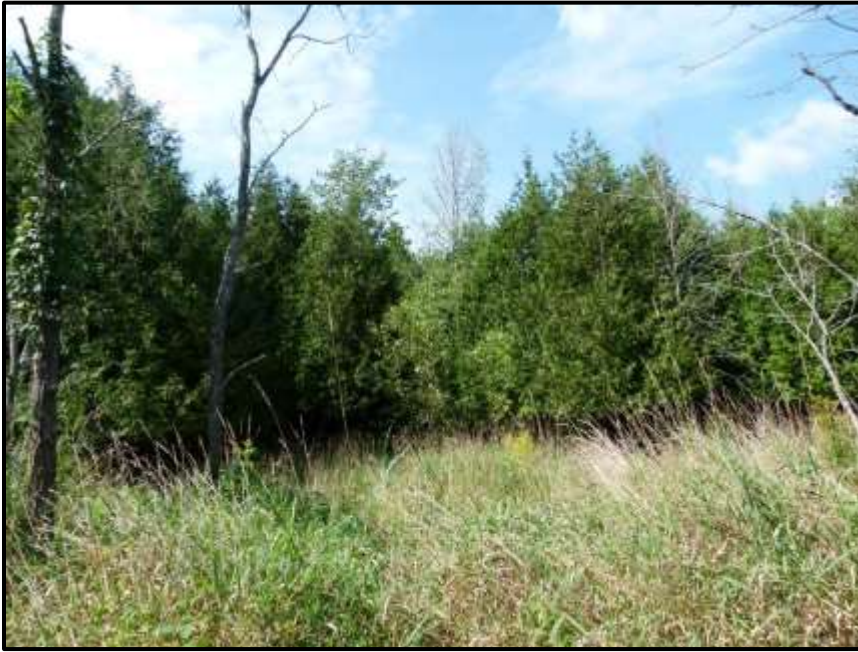
Photograph 17: Looking west at the eastern edge of the Fresh-Moist White Cedar Coniferous Forest (Feature O) (September 4th, 2018).

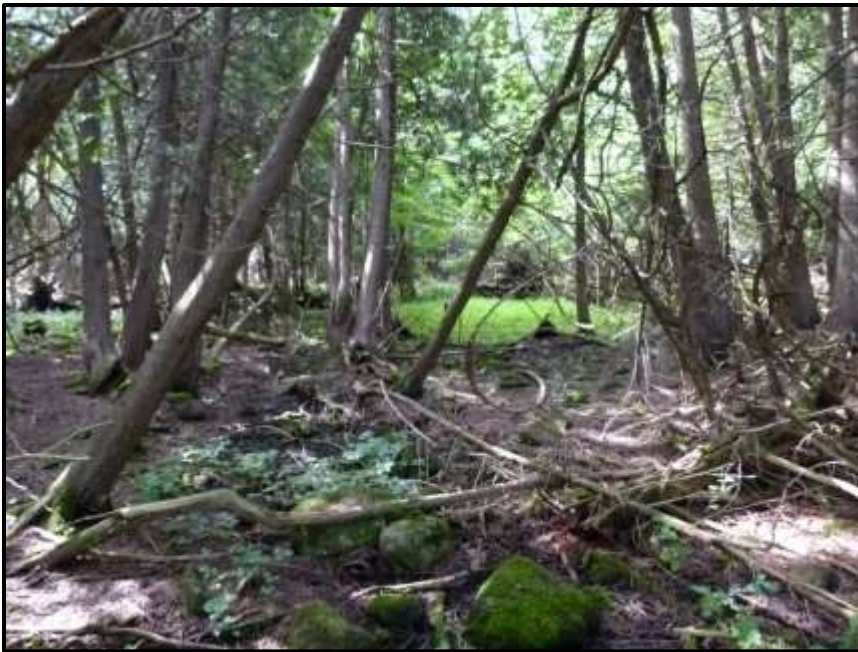
Photograph 18: Interior of the Fresh-Moist White Cedar Coniferous Forest (Feature O) (September 4th, 2018).

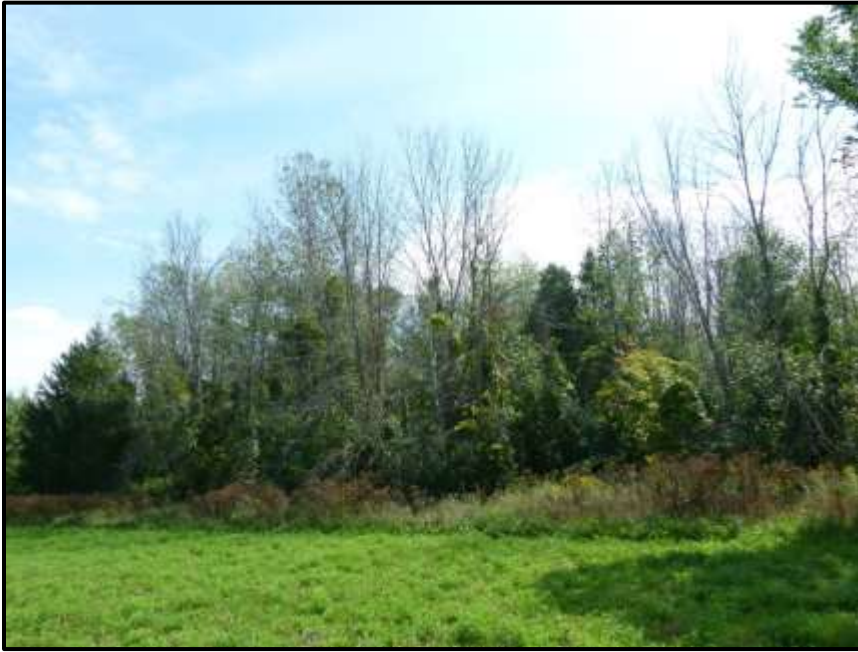
Photograph 19: Looking south at the edge of the Fresh-Moist Ash – Elm Deciduous Forest (West) (Feature P). Note the large number of dead ash stems (September 4th, 2018).

- **Fresh-Moist Ash – Elm Deciduous Forest (West) (Feature P):** The northern part of Woodlot S-20 consists of a relatively young recent regrowth forest. As discussed above in Section 3.2, the majority of tree cover within Feature P appears to be less than approximately 20 years of age. Feature P is dominated by White/Green Ash between approximately 10 cm and 20 cm dbh in size. American Elm and Trembling Aspen between 10 cm and 30 cm dbh in size, and White Cedar between 10 cm and 20 cm dbh in size, are also well represented. Shrub cover is very thick and includes Red Osier Dogwood, Wild Red Raspberry, Slender Willow, Common Buckthorn, Chokecherry, and young ash stems. Much of the groundcover is reflective of disturbed conditions with Meadow Grass, Tall Buttercup, Canada Goldenrod, Red Clover, Common Strawberry, Small White Aster, Doll's Eyes, Wild Cucumber, White Snakeroot, Sensitive Fern, Poison Ivy, Tufted Vetch, Yellow Sorrel, White Avens, Daisy Fleabane, Common Dandelion, and Virginia Creeper.

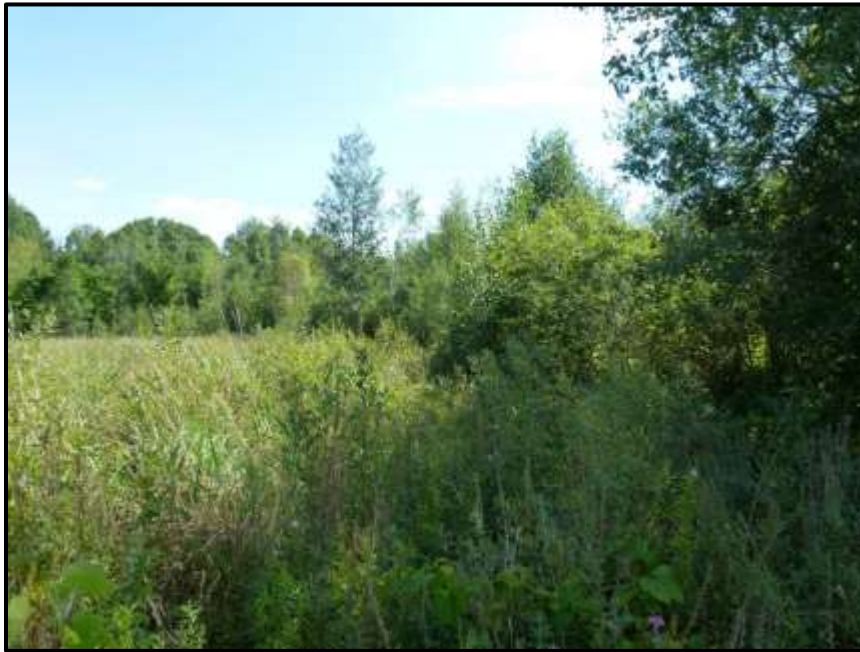
Photograph 20: Looking southeast at the edge of the Willow Shrub Thicket (Feature Q) (September 4th, 2018).

Feature Q is a Willow Shrub Thicket dominated by shrubs including Slender Willow, Bebb's Willow, Glossy Buckthorn, Wild Red Raspberry, and Red Osier Dogwood. Common Buckthorn, Chokecherry, and Prickly Ash are also present. Groundcover includes Reed Canary Grass, Purple Loosestrife, Blue Vervain, Spotted Joe Pye Weed, and White Gentian. Sparse Trembling Aspen, American Elm, and White/Green Ash stems between 10 cm to 25 cm dbh are present. Tree density increases in the southeast corner of the feature, where a stand of mature Trembling Aspen is present.

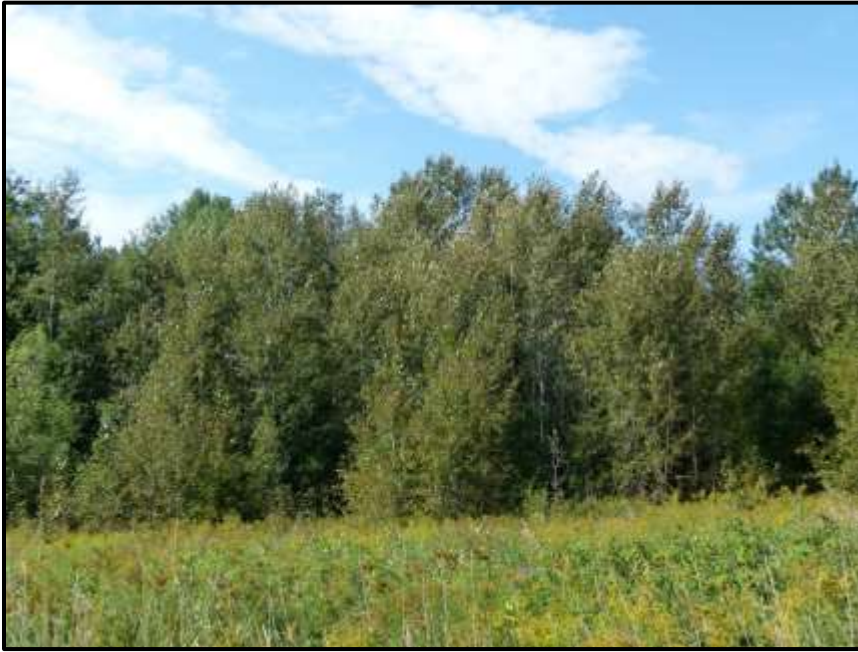
Photograph 21: Looking west at the edge of the Fresh-Moist Poplar Deciduous Forest (Feature R) (September 4th, 2018).

- **Fresh-Moist Poplar Deciduous Forest (Feature R):** The Fresh-Moist Poplar Deciduous Forest (Feature R) is dominated by Trembling Aspen that vary in size between approximately 15 cm to 45 cm dbh. American Elm and White/Green Ash are well represented and vary in size between approximately 10 cm and 30 cm dbh. Relatively young Sugar Maple, White Birch, Bur Oak, Red Maple and Butternut are also present. Red Osier Dogwood, Prickly Ash, Tartarian Honeysuckle, Wild Red Raspberry, and Common Buckthorn shrubs are common. The understory includes Sensitive Fern, White Snakeroot, Riverbank Grape, Virginia Creeper, Philadelphia Fleabane, Canada Goldenrod, White Trillium, Jack in the Pulpit and Common Horsetail.

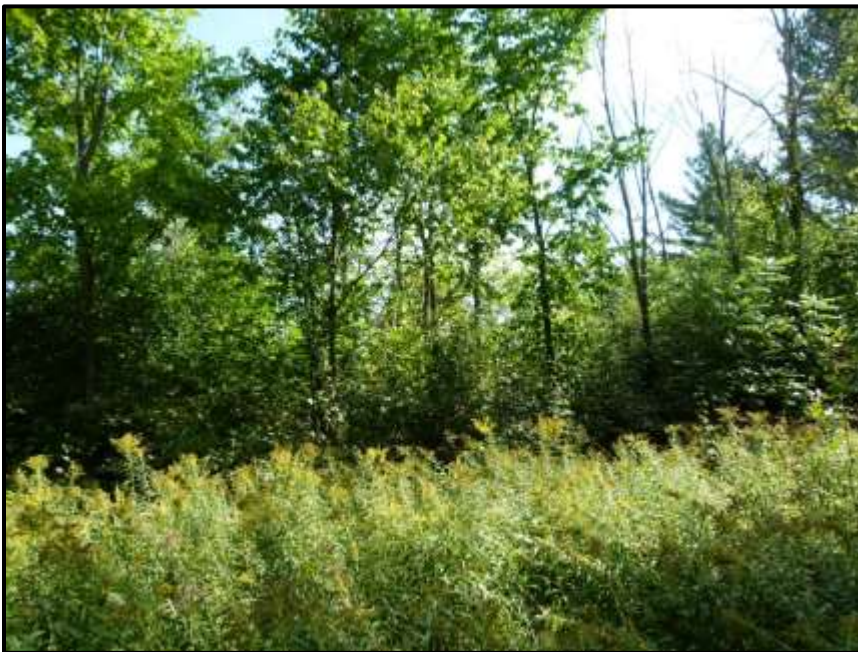
Photograph 22: Looking east at the edge of the Fresh-Moist Ash – Elm Deciduous Forest (Feature S) (September 4th, 2018).

- **Fresh-Moist Ash – Elm Deciduous Forest (East) (Feature S):** Feature S is dominated by White/Green Ash and American Elm between approximately 10 cm and 25 cm dbh in size. Manitoba Maple and Bur Oak between 10 cm and 20 cm dbh in size are also well represented. Stands of young Trembling Aspen are also present in some areas. Shrub cover is very thick and includes Red Osier Dogwood, Wild Red Raspberry, Prickly Ash, Common Buckthorn, Glossy Buckthorn, Hawthorn, Chokecherry, Domestic Apple, and young ash and Manitoba Maple stems. Much of the groundcover is reflective of disturbed conditions with Meadow Grass, Tall Buttercup, Canada Goldenrod, Red Clover, Common Strawberry, Small White Aster, Doll's Eyes, Wild Cucumber, White Snakeroot, Sensitive Fern, Poison Ivy, Tufted Vetch, Yellow Sorrel, White Avenas, Daisy Fleabane, Common Dandelion, Common Burdock, Common Milkweed, Hog Peanut, Wild Parsnip, Elecampane, Canada Anemone, Philadelphia Fleabane, Riverbank Grape, and Virginia Creeper.

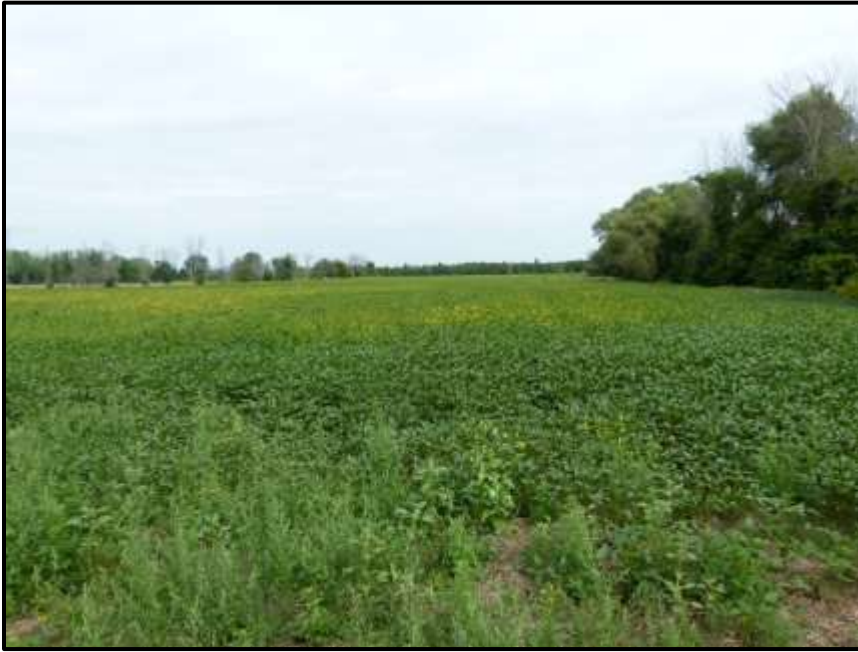
Photograph 23: Looking east from March Road at the Cultivated Field planted with soybeans (September 4th, 2018).

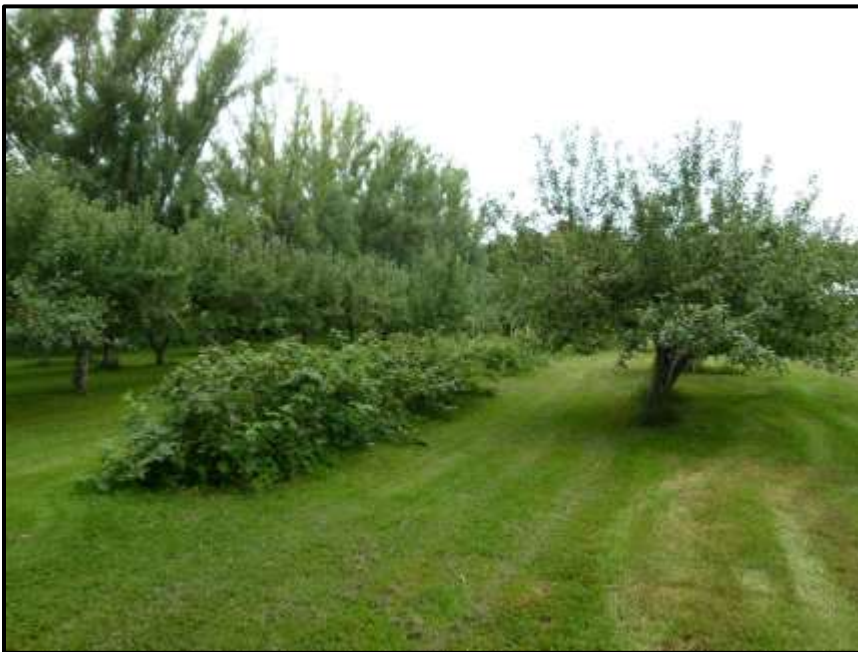
Photograph 24: Looking north at the small Apple Orchard (September 4th, 2018).

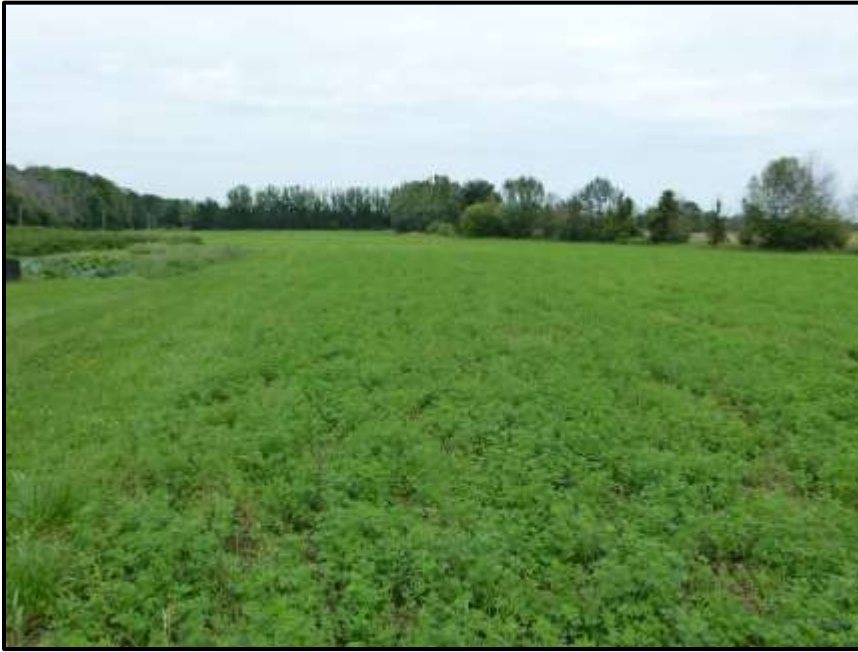
Photograph 25: Looking east from March Road at the Fallow Agricultural Field (Graminoid Meadow) in the northwest corner of the Site (September 4th, 2018).

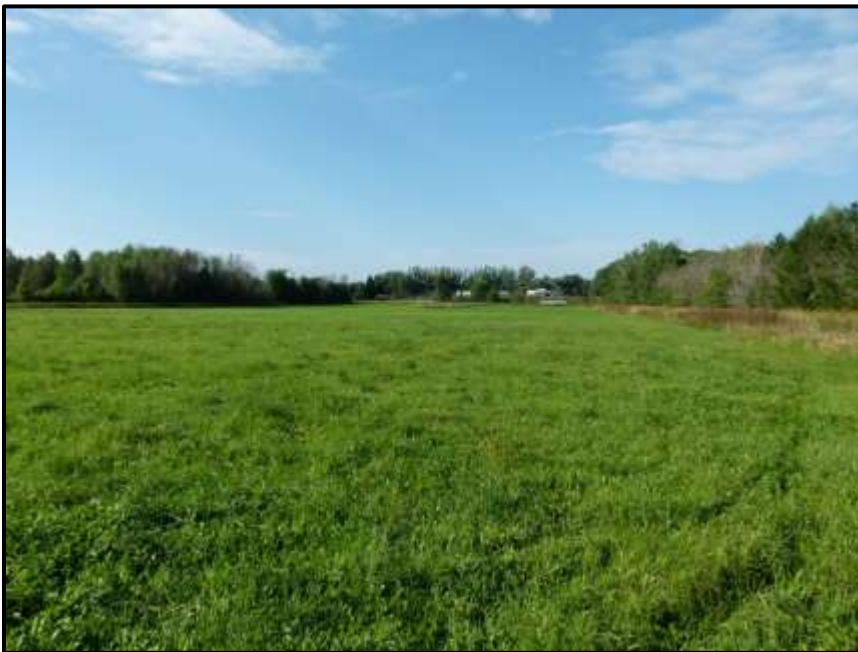
Photograph 26: Looking west from the Former CN Railway Corridor at the Fallow Agricultural Field (Graminoid Meadow) in the north-central part of the Site (September 4th, 2018).

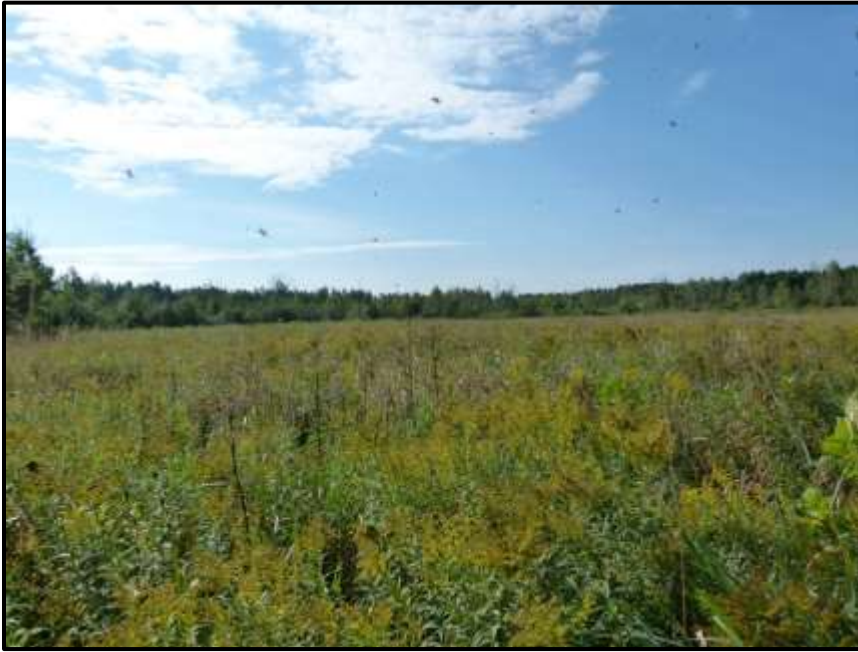
Photograph 27: Looking south at the Fallow Agricultural Field (Forb Meadow) located west of the Former CN Railway Corridor (September 4th, 2018).

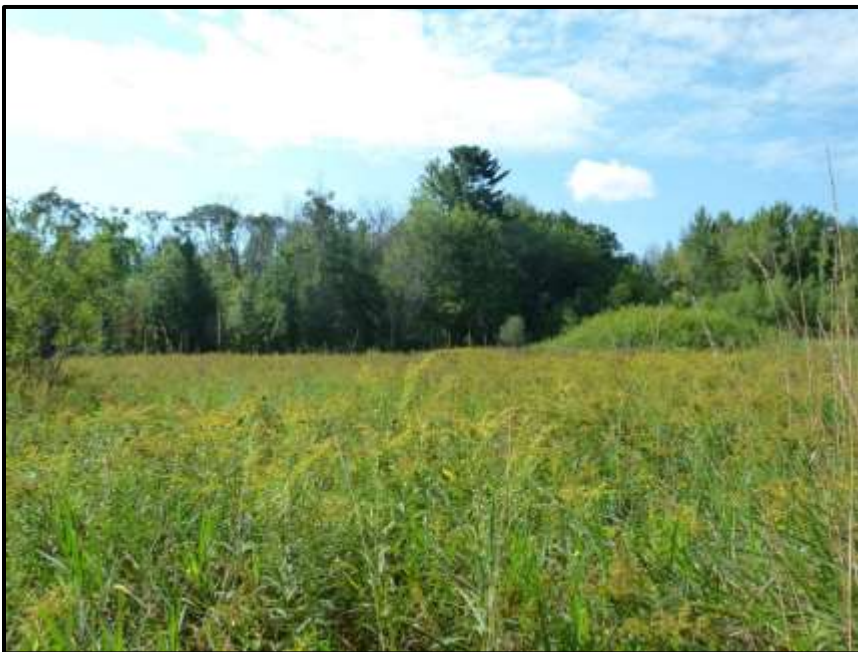
Photograph 28: Looking south at the Fallow Agricultural Field (Forb Meadow) located east of the Former CN Railway Corridor (September 4th, 2018).

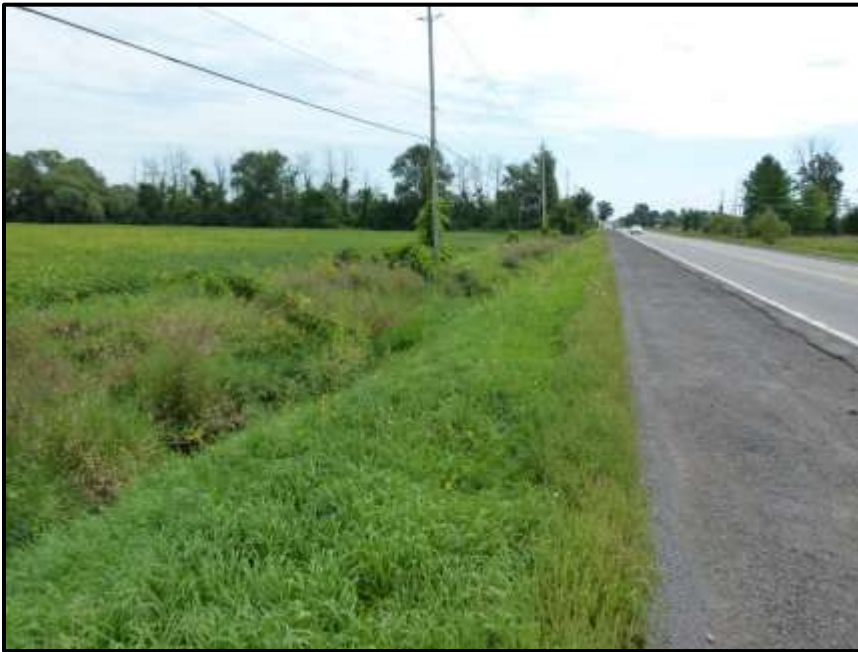
Photograph 29: Looking south at the North Tributary (Tributary #2) of Shirley's Brook where it passes through the eastern March Road ditch (September 4th, 2018).
