Combined Environmental Impact Statement &
Tree Conservation Report
Valecraft Kanata North Development
(1020 & 1070 March Road)

April 2019
Prepared for Valecraft Homes Ltd.

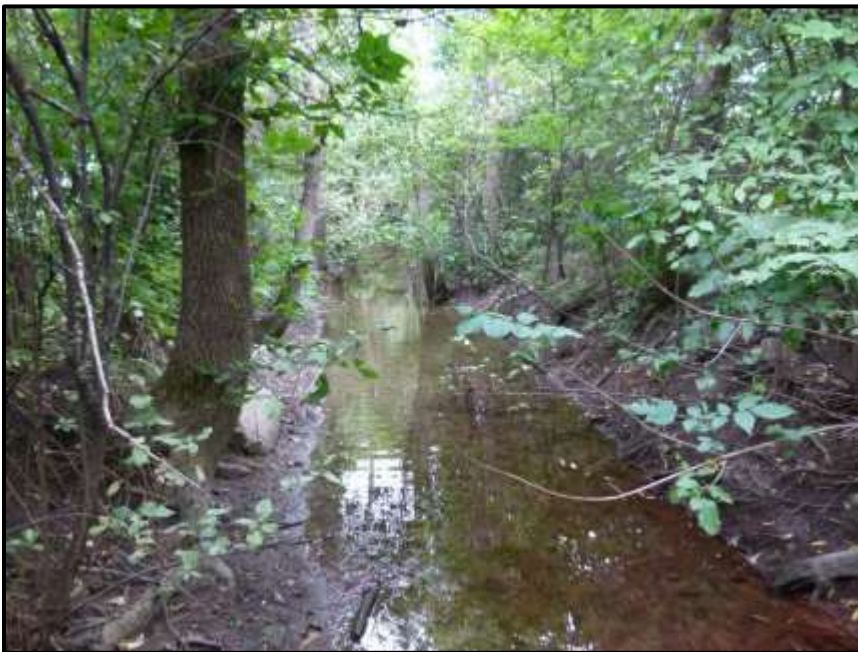
Photograph 30: Looking east at the North Tributary (Tributary #2) of Shirley's Brook where it passes through Deciduous Hedgerow B (parallel to the southern Site boundary) (September 4th, 2018).

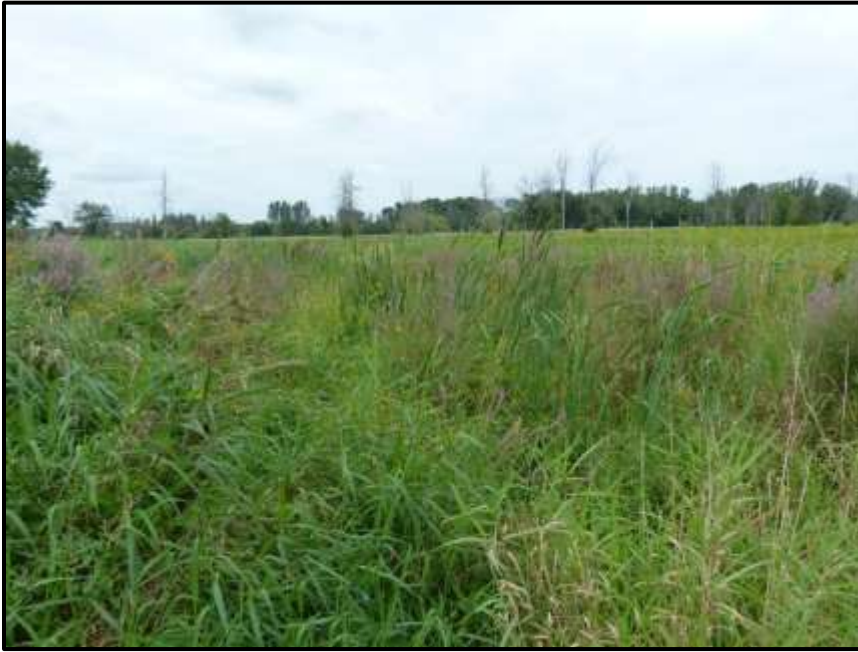
Photograph 31: Looking north at the Northern Field Drainage Channel (September 4th, 2018).

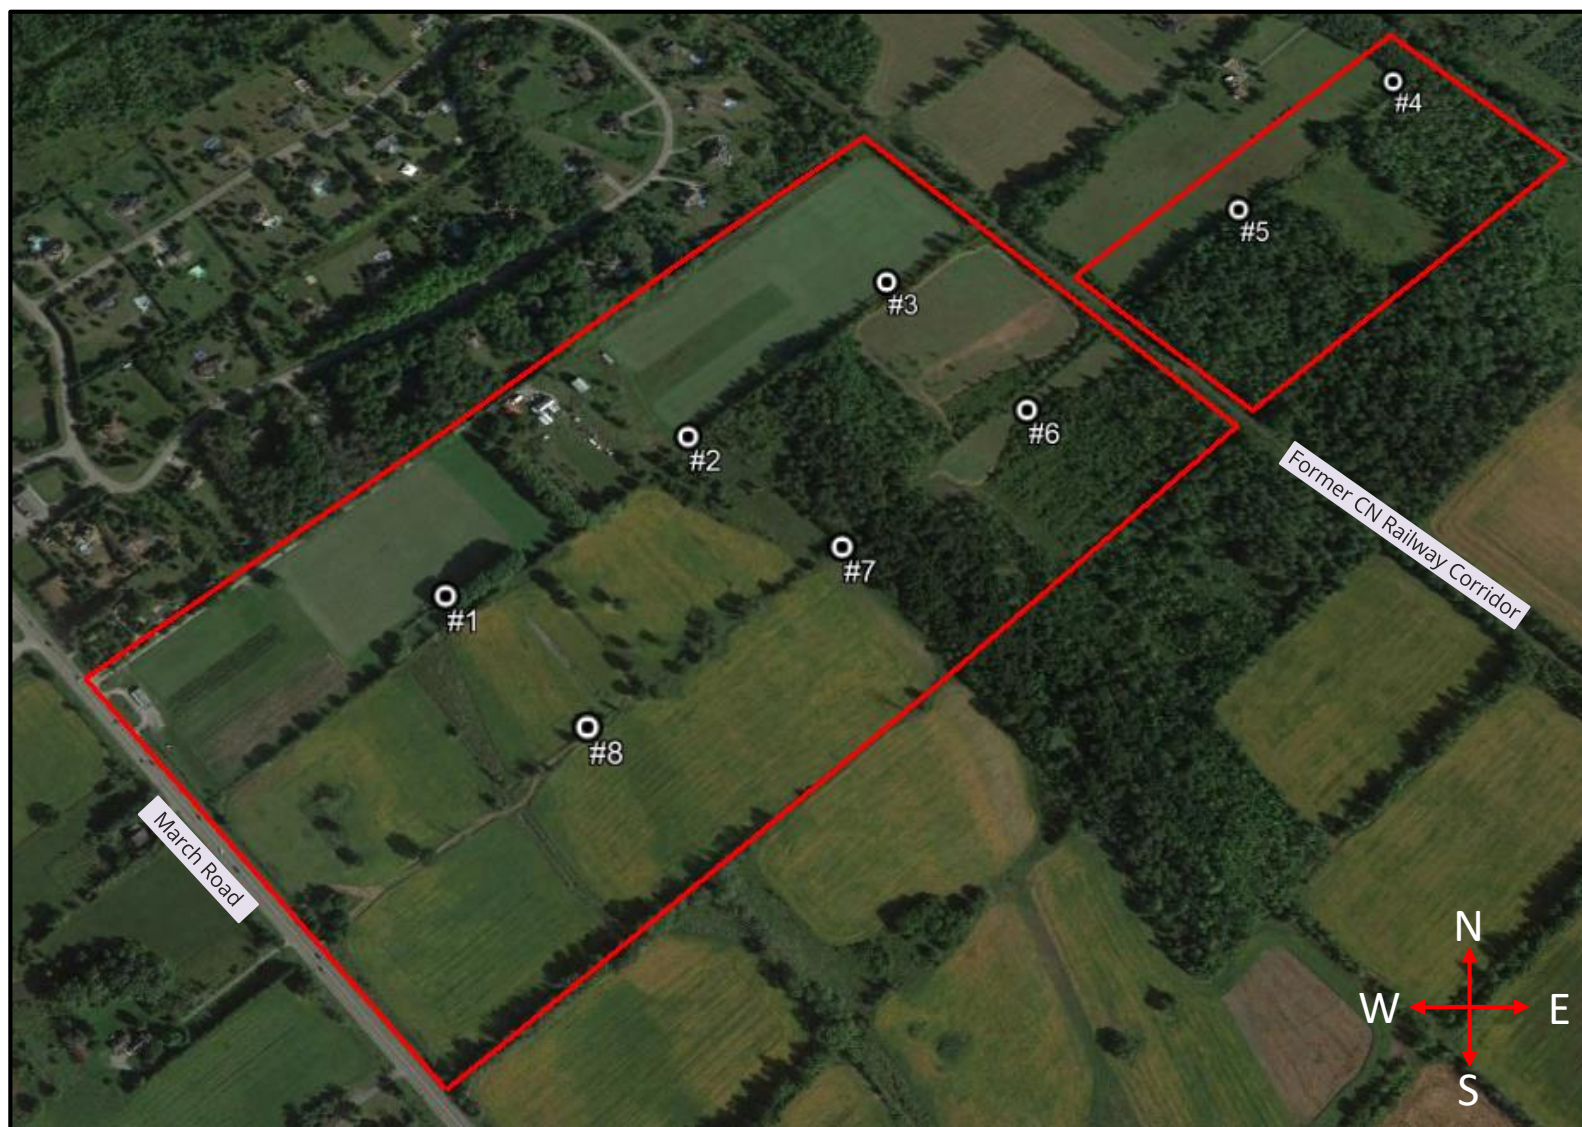
FIGURE 5: BIRD SURVEY POINTS

— Site Boundary ○ B2 - Bird Survey Points
