A CULTURAL HERITAGE IMPACT STATEMENT

58 Florence Street, Ottawa, Ontario

SUBMITTED TO: NOVATECH Engineers, Planners & Landscape Architects
PREPARED BY: COMMONWEALTH HISTORIC RESOURCE MANAGEMENT

Draft July 2019

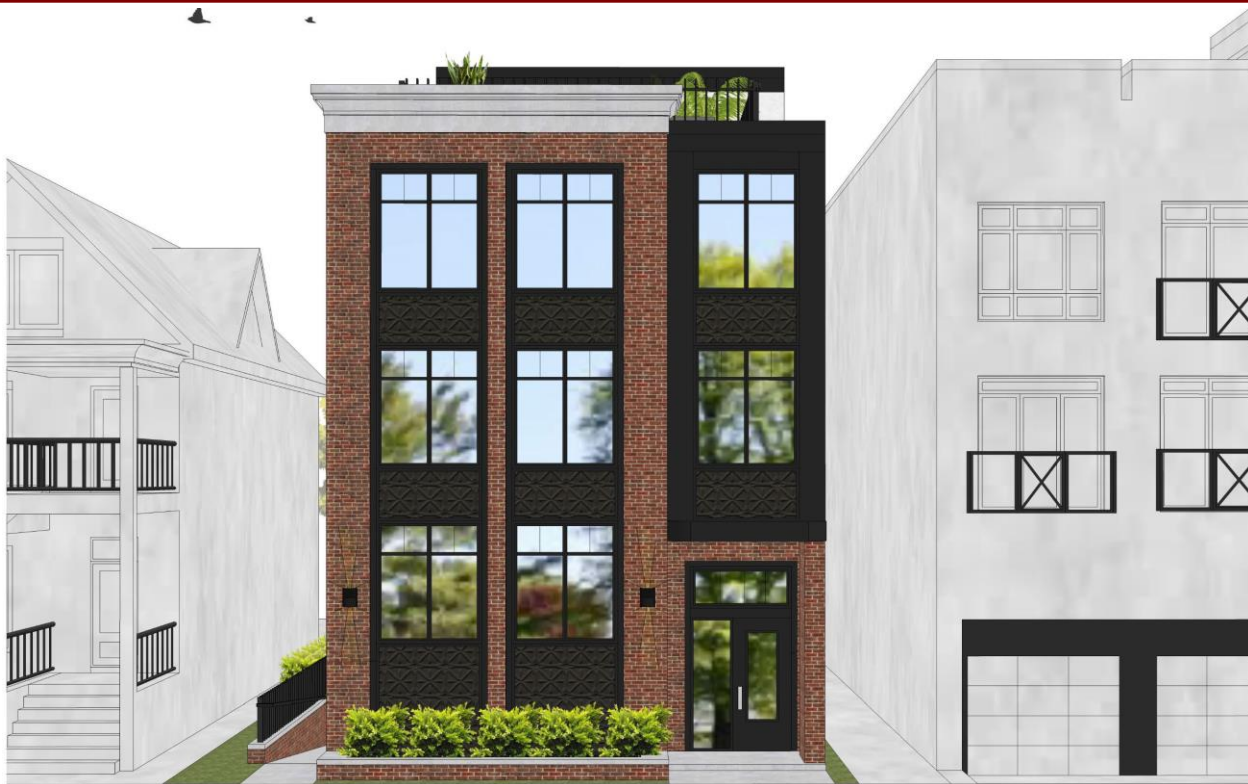
Cover Image: Rendered perspective view of the proposed development showing its relationship to the two adjacent properties. Note that some design changes have occurred subsequent to the development of this image. See drawings in Section 4. Source: Tanner Vine Interiors May 24, 2019.

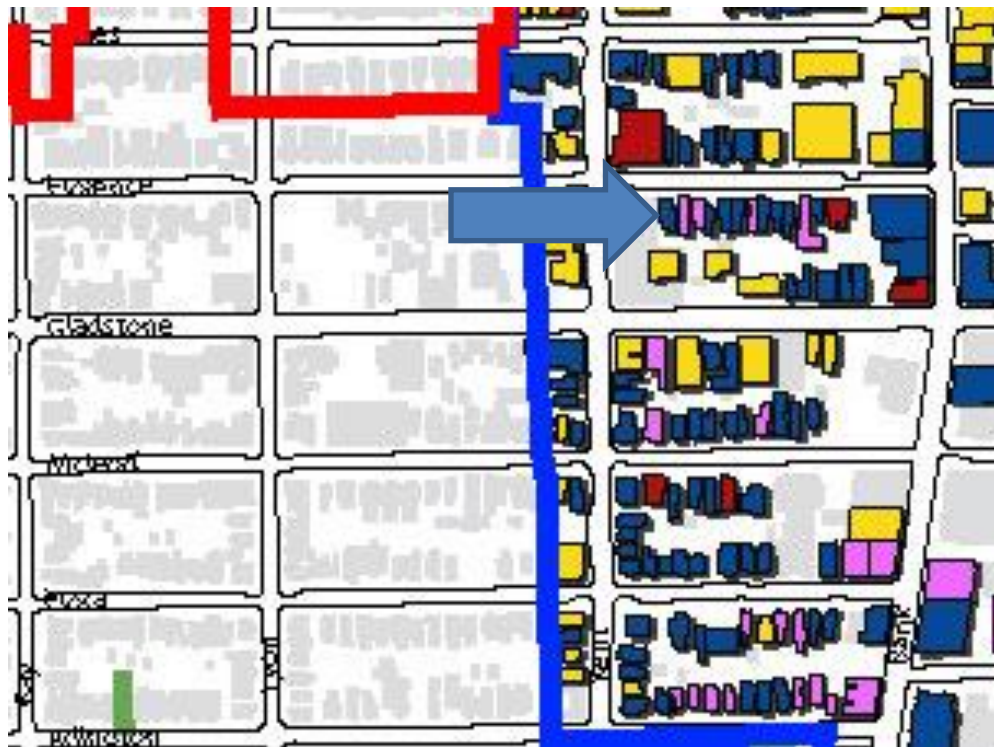
Figure 3: Centretown Heritage Conservation District ground plan detail. Development site arrowed. Source: Centretown Community Design Plan, City of Ottawa

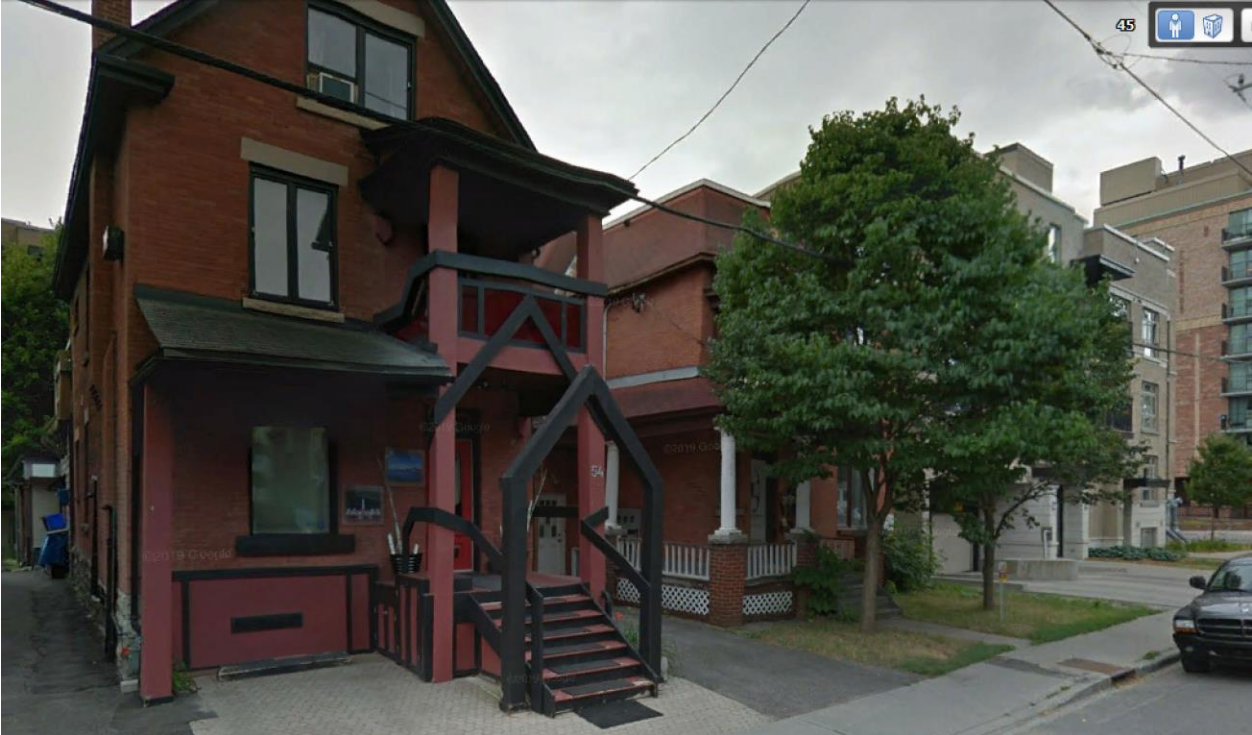
Figure 4: View of the development site 58 Florence to the right concealed behind the trees, and 54 Florence to the left.

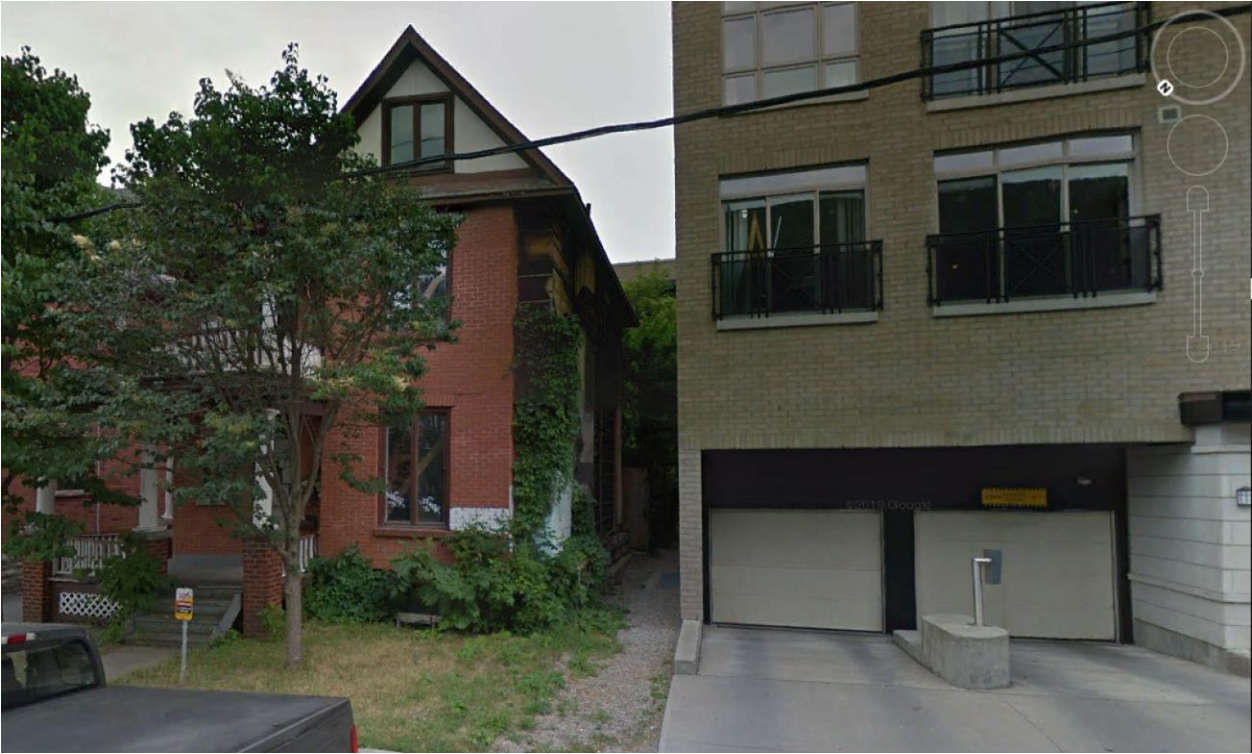
Figure 5: Context view of 58 Florence (left) and 429 Kent (right). Source: Google Earth.

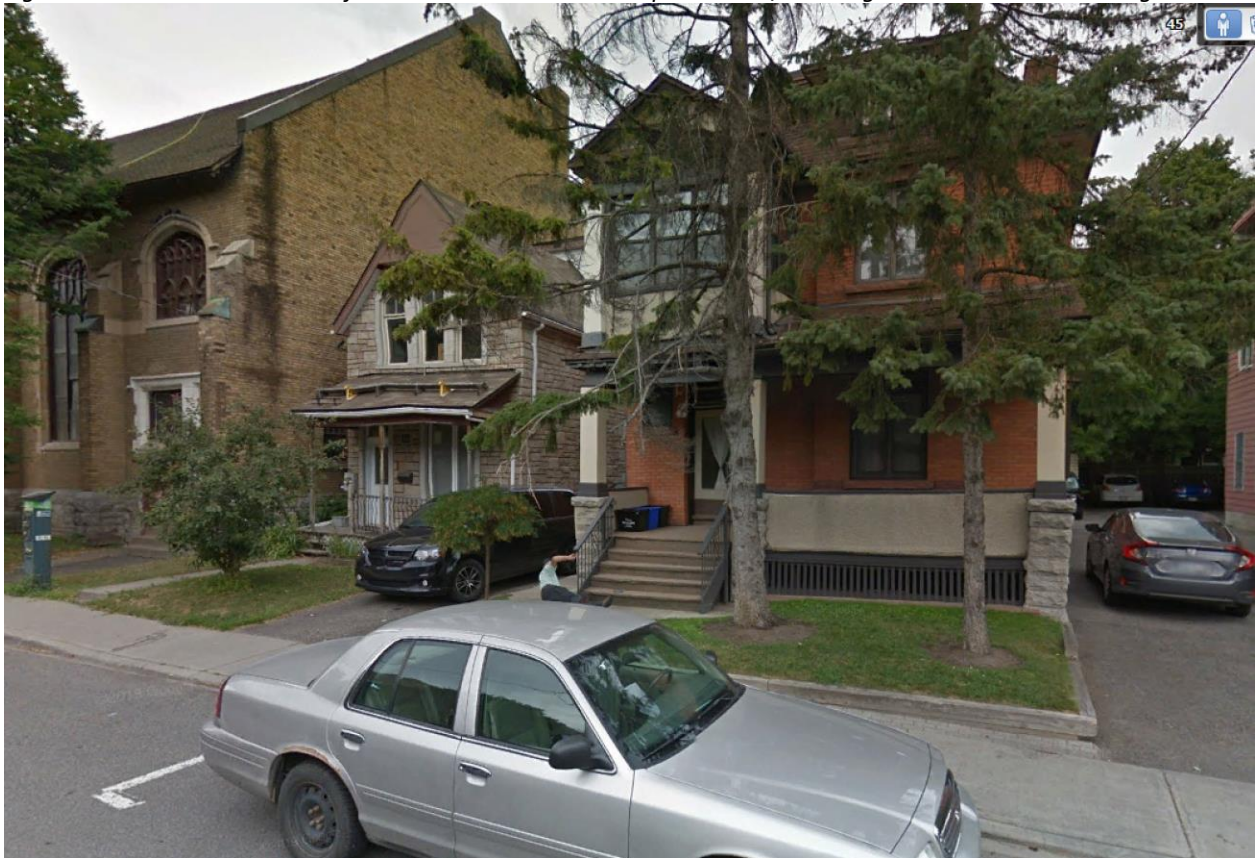
Figure 7: View of 45 (right) and 55 (left) Florence Street to the north of the development site. Note the landscaping treatment, lawns interspersed with shrubs and trees, with asphalt and concrete sidewalks and driveways. Source: Google Earth

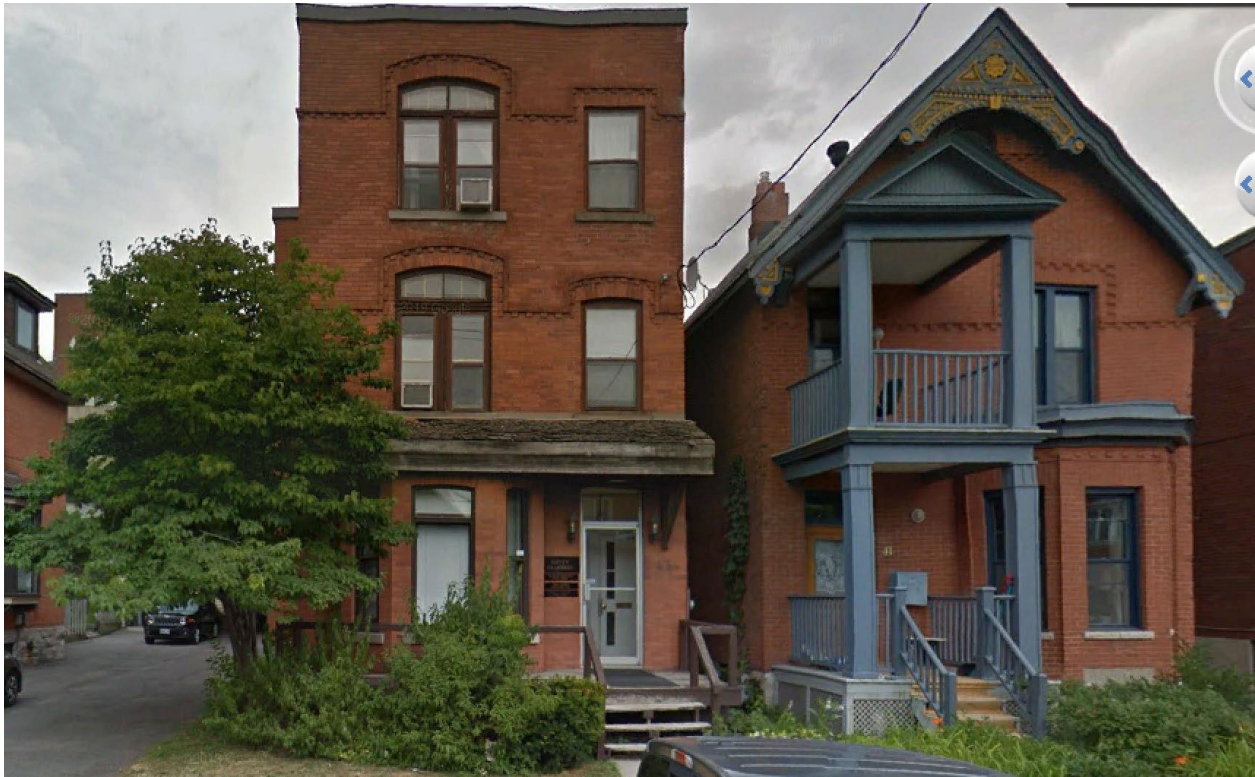
Figure 8: View of 41 (right) and 43 (left) Florence Street. Source: Google Earth

Discussion: The form of the proposed building – three storeys in height, with flat roof is consistent with the new development to the west, and the heritage building at 43 Florence (Figure 8) to the north and east of the development site. The front entrance is recessed back from the principal façade a

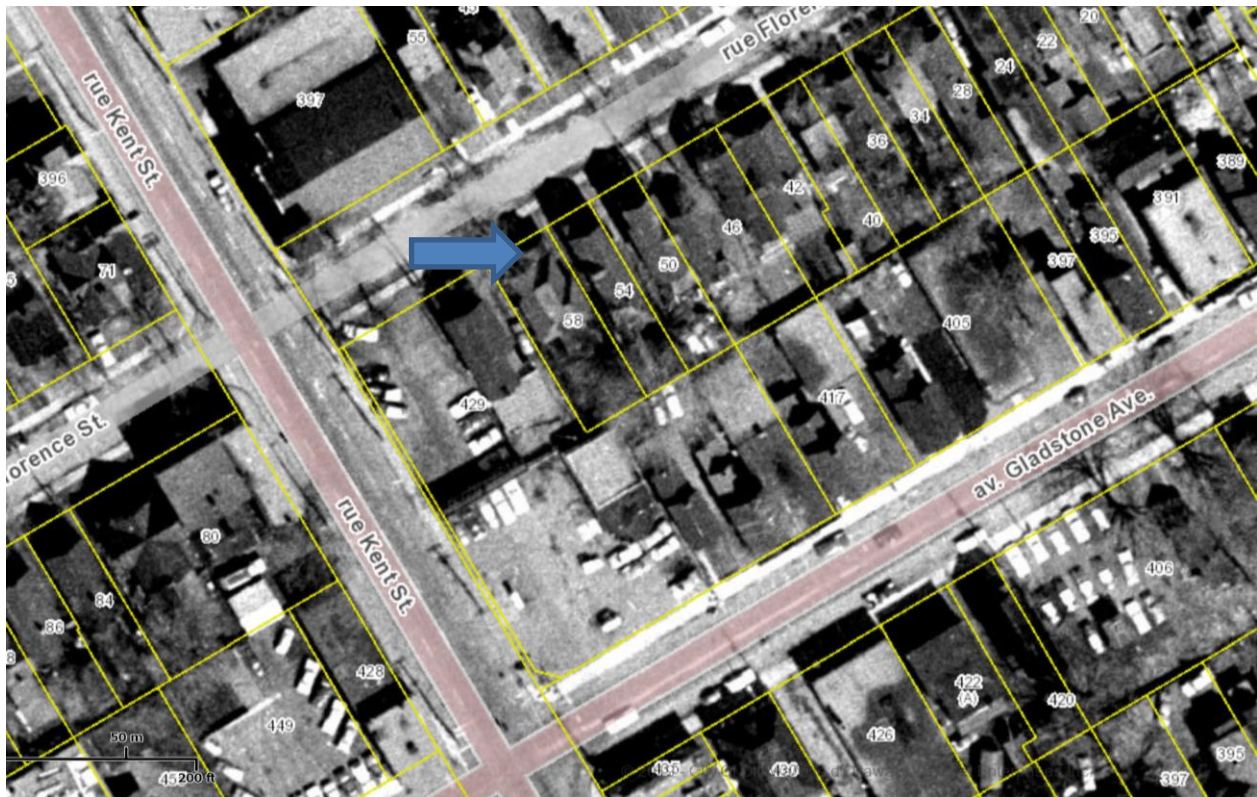
Figure 13: 1965 aerial view of the development site (arrowed). Note the demolition of the former residences fronting onto Kent and the development of surface parking lots. Source: Geottawa

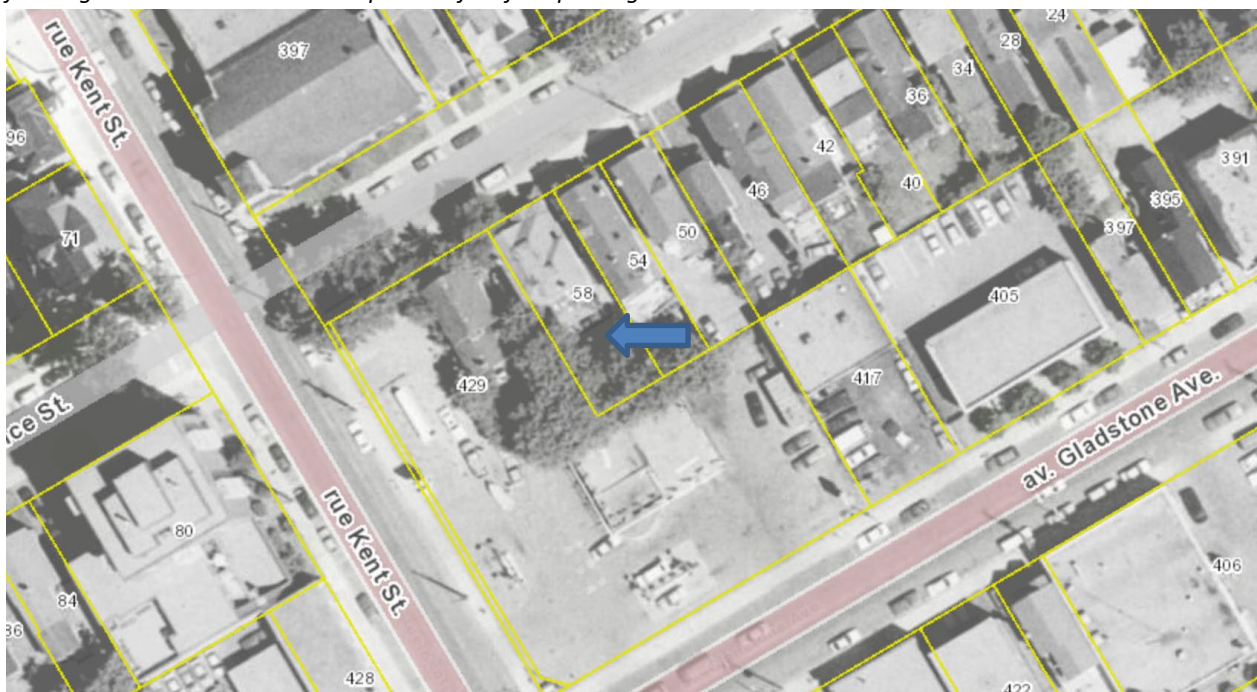
Figure 14: 1991 aerial view of the area. The building that was adjacent (west) of the development site 429 Kent was demolished sometime between 1991 and 1999 and the existing condominium completed. Development site arrowed. Source: Geottawa

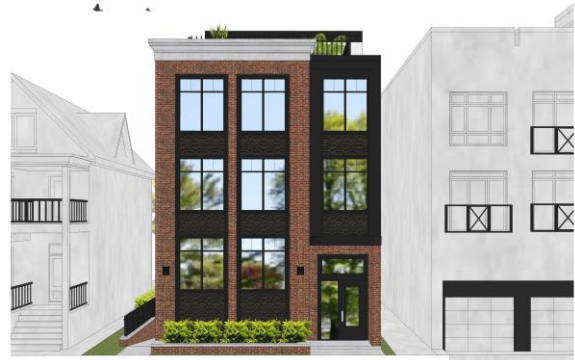
Figure 17: Rendered north elevation showing the relationship of the building to adjacent properties. Source: Tanner Vine May 21, 2019.

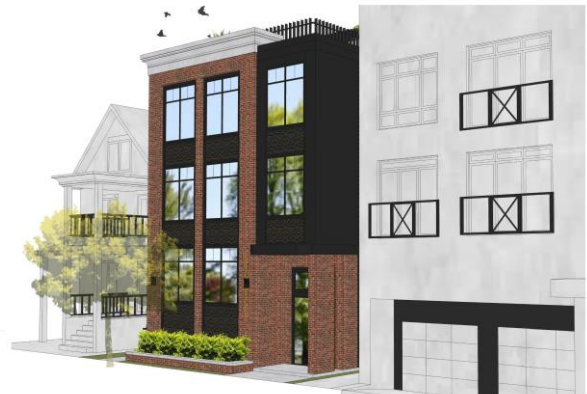
Figure 18: Oblique view of the development site from the west. Source: Tanner Vine May 21, 2019.

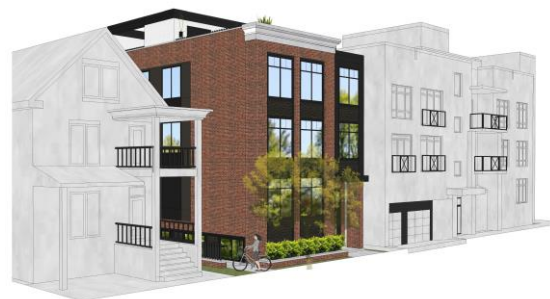
Figure 19: Oblique view of the development site from the east. Source: Tanner Vine May 21, 2019.

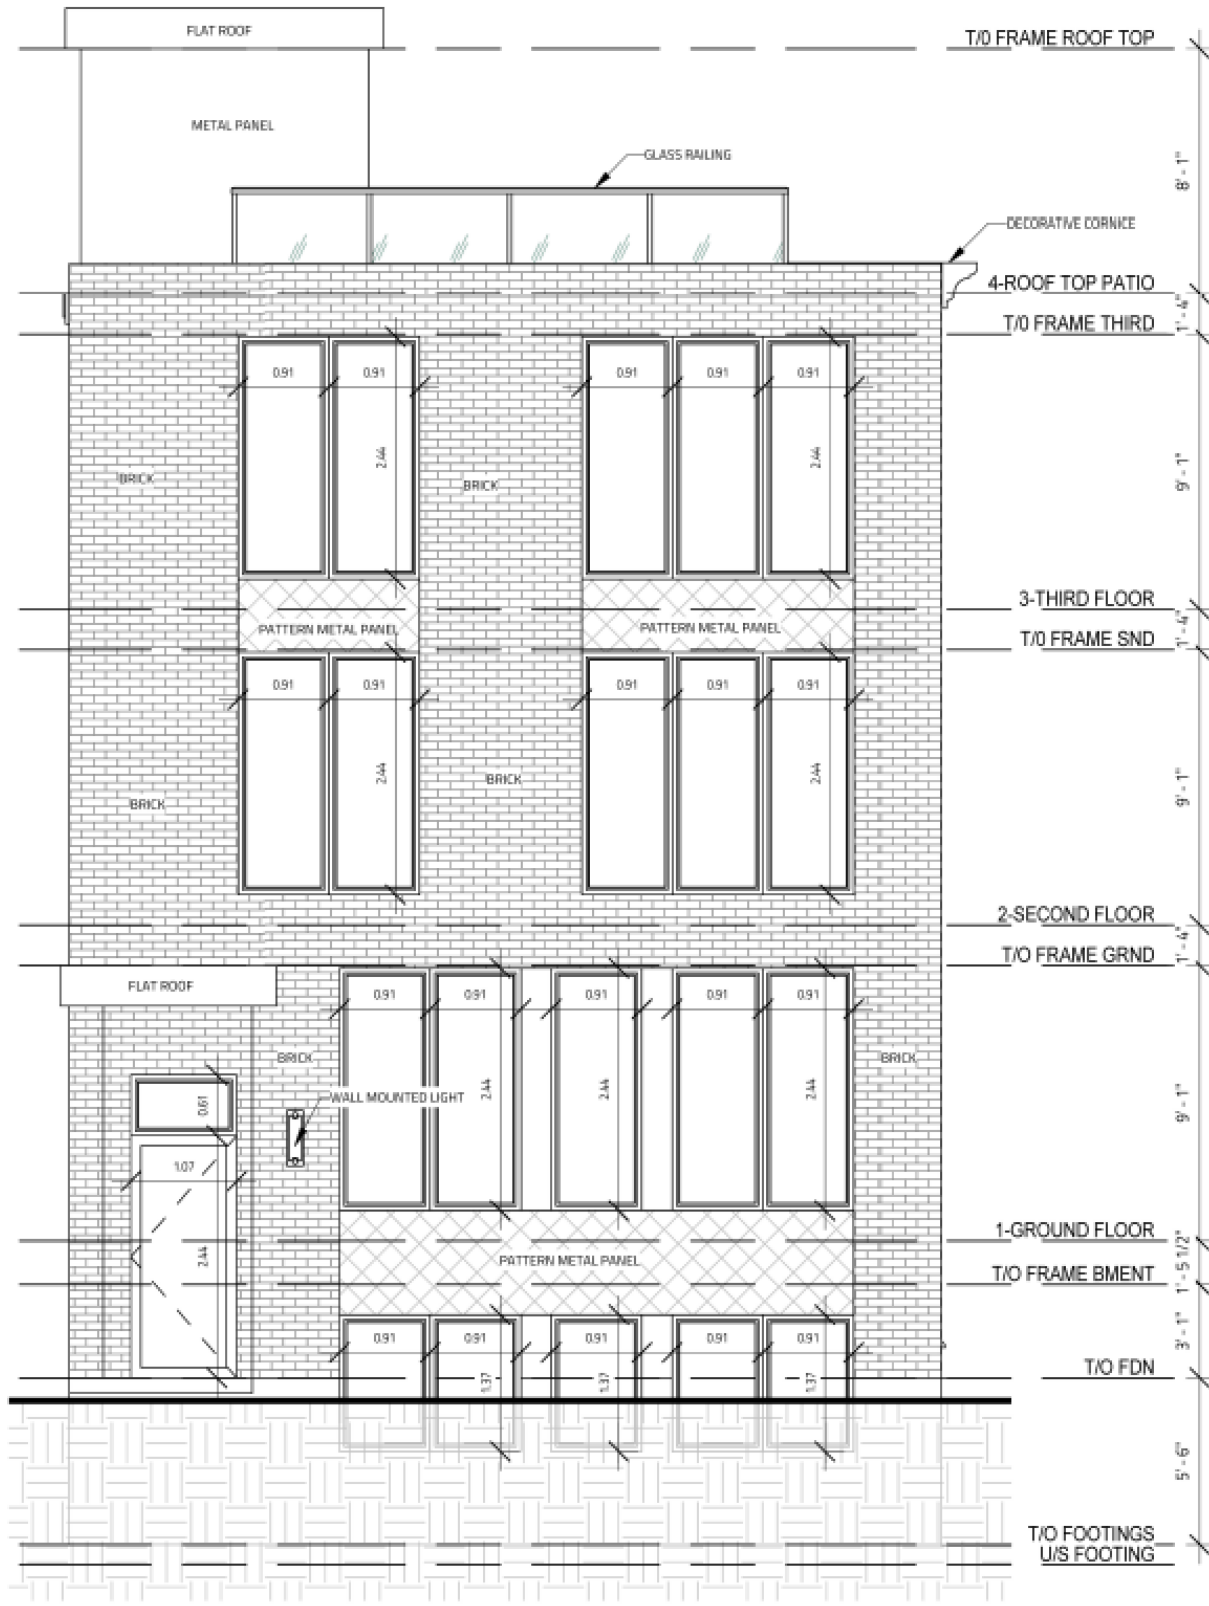
Figure 21: South elevation of the proposed development. Evolution Design July 5, 2019.

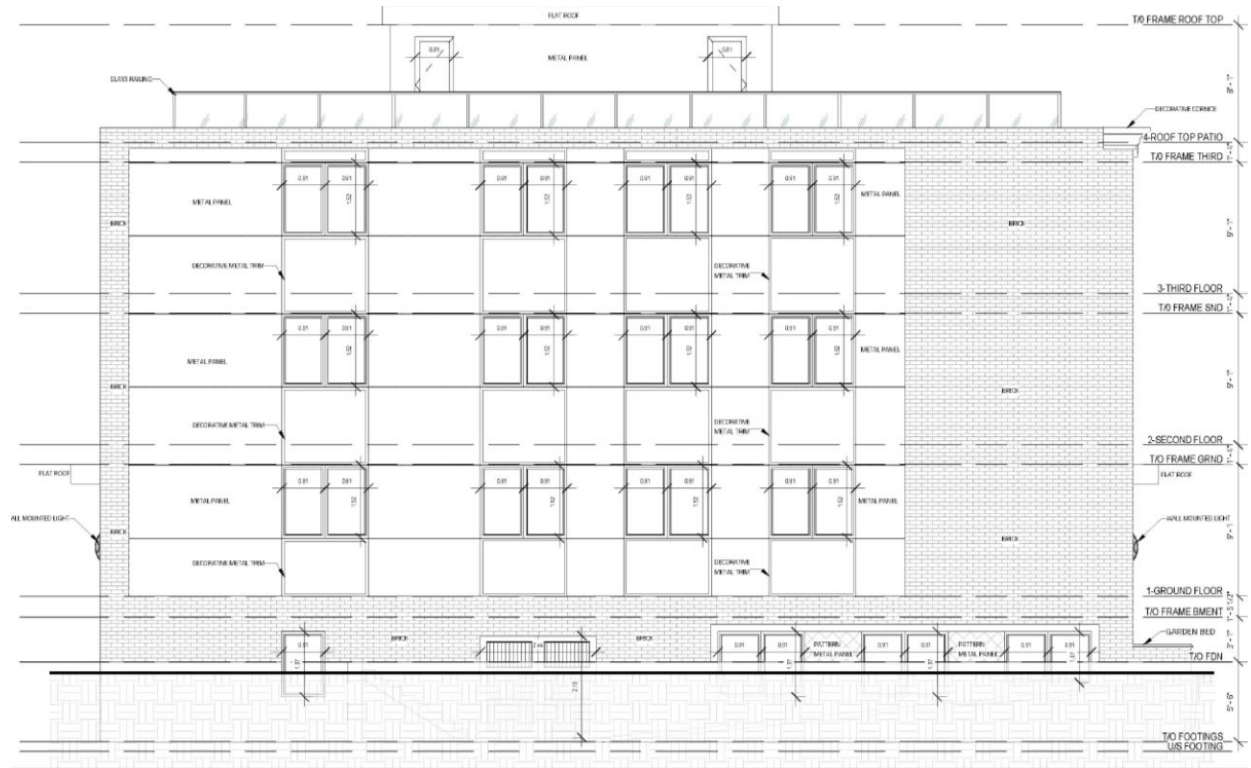
Figure 22: Side (east) elevation of the proposed development. Source: Evolution Design July 5, 2019.

Consider adding a window to the side or the east elevation. The windows would provide a view east along Florence Street and east light exposure;

Consider an alternate finish material other than brick for the foundation walls extending along the east elevation.

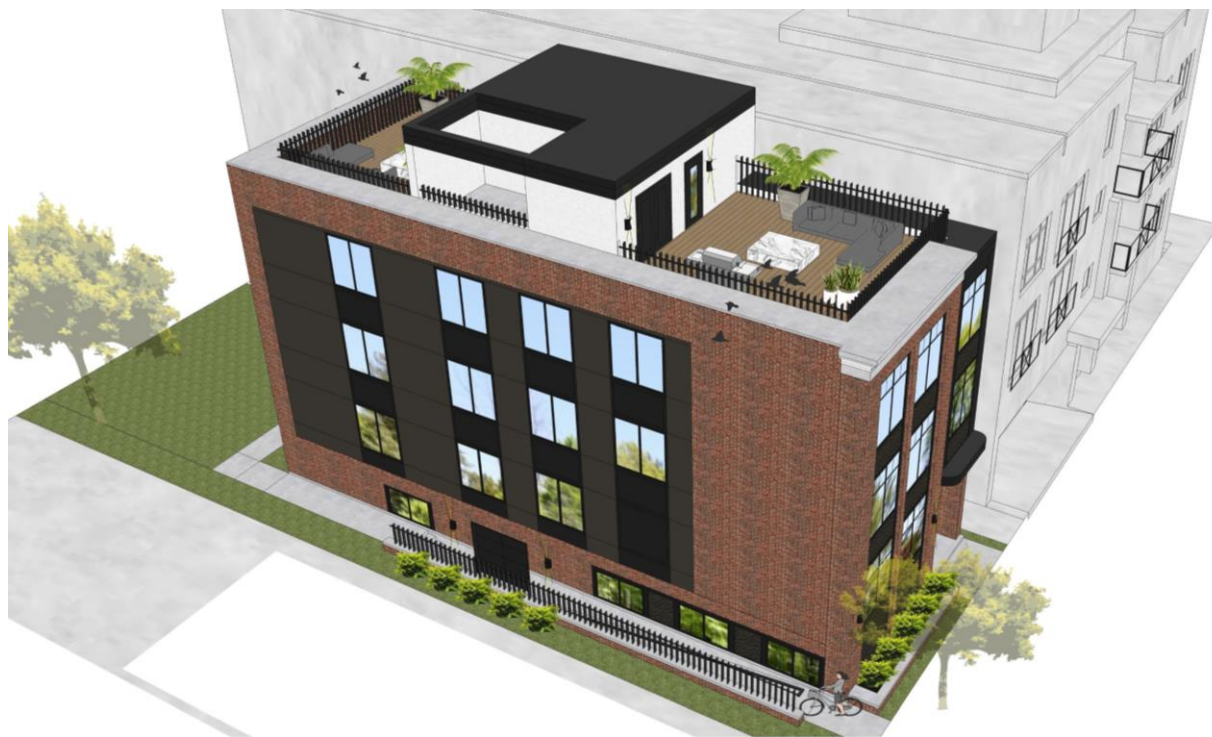
Figure 23: Rendered oblique view from the north-east showing the proposed roof top amenity area. Source: Tanner Vine Interiors. May 2019.

The roof top amenity space is not a traditional feature of the district where porches or balconies serving individual units on each floor level are more typical.

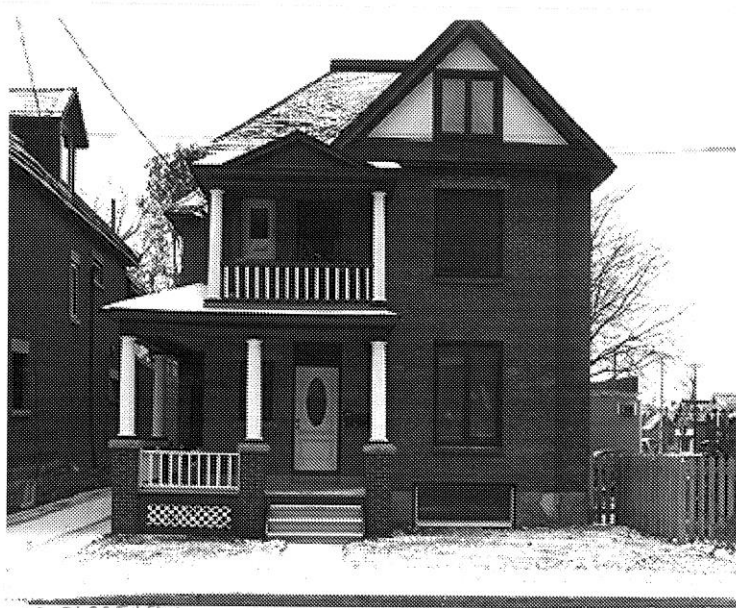
58 FLORENCE

PHOTO DATE: May 1995
VIEW: N
SOURCE: K. Deevey
NEGATIVE NUMBER: FB-15

Architectural Integrity (Alterations): Very good, porch replaced
