390-394 Bank Street Ottawa, ON

October, 2019

Cultural Heritage Impact Statement

Bray Heritage

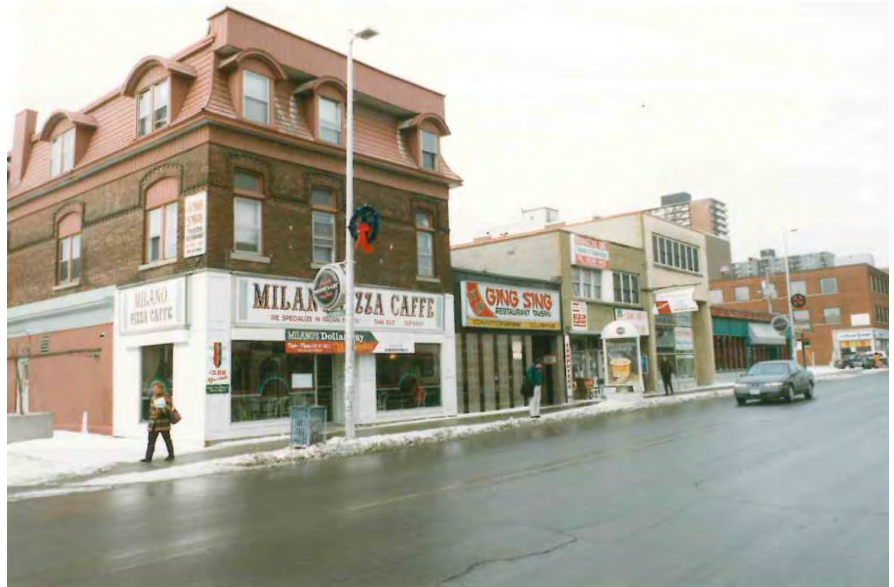
On the other end of the subject lands, the two abutting buildings further south (Nos. 406 and 408 Bank Street) appear in the City Directories beginning in 1910 and seem to have survived until the early 2000s. The evaluation from the 1996 HCD Study inventory shows a three-storey Second Empire style brick structure at No. 408 and a one-storey early-mid-20th century concrete block structure at No. 406. The building at No. 408, had commercial uses at grade and on the flanking elevation on Florence Street, with apartments above (fire insurance plans show it as the Clarendon Apartments with a garage attached behind).

*Nos. 408 and 406 Bank Street,
with Nos. 404-390 shown abutting*

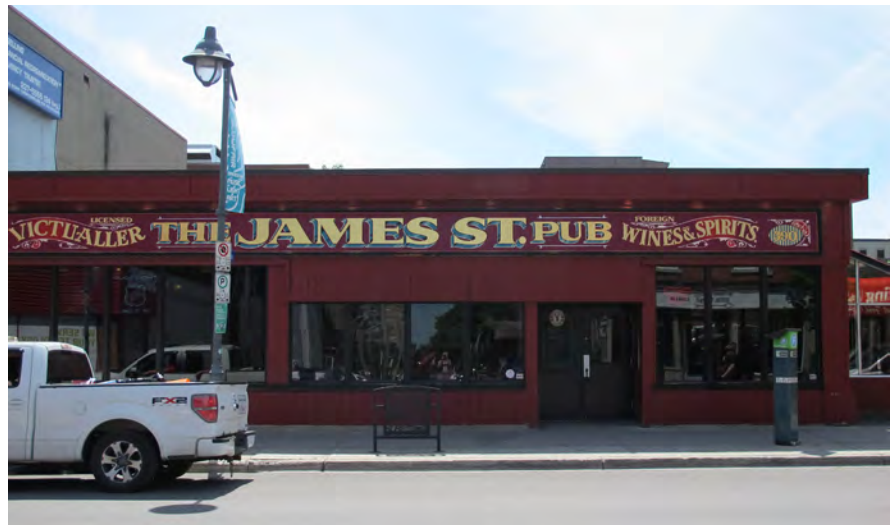
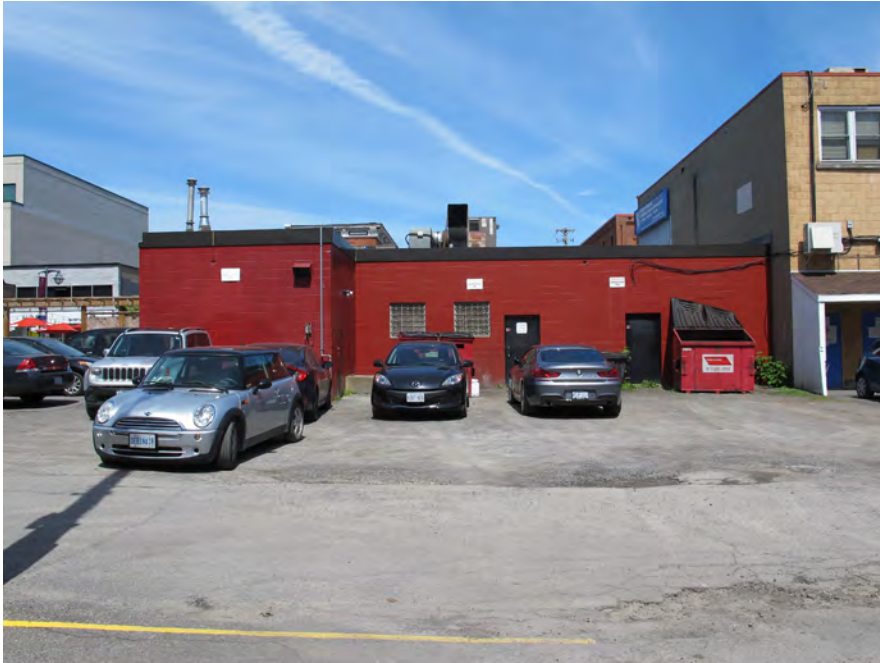
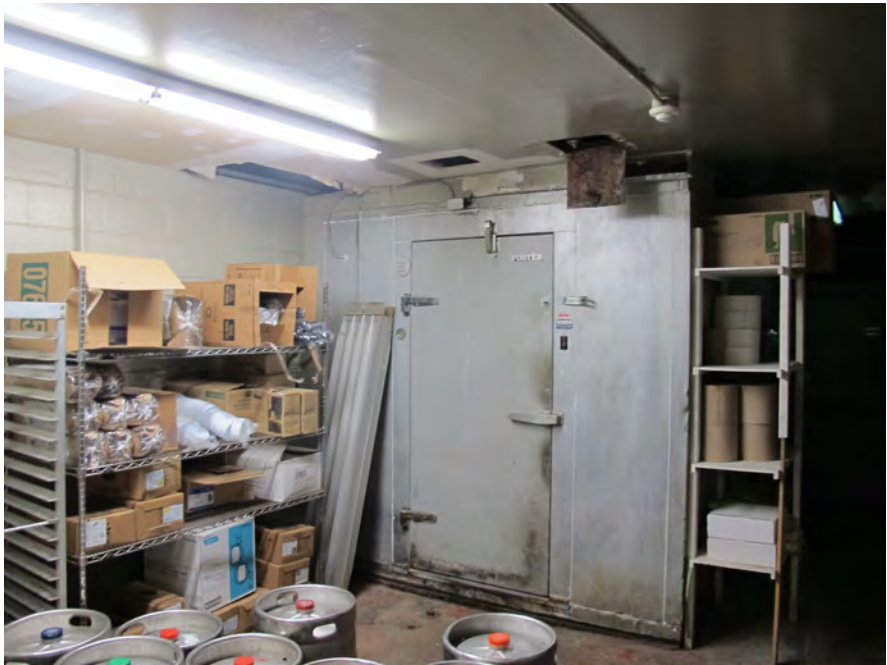
390 Bank (James Street pub)

- The interior appears to have been substantially altered over time, with changes in the interior layout and floor levels.
- Some dampness is evident in the basement.

- In general, the building appears to have been competently built and to have fair-good structural integrity

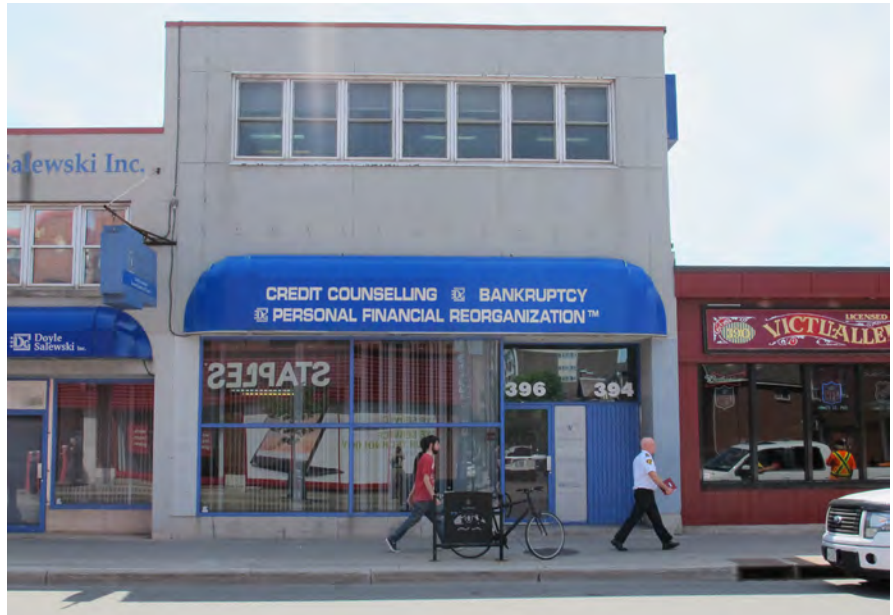
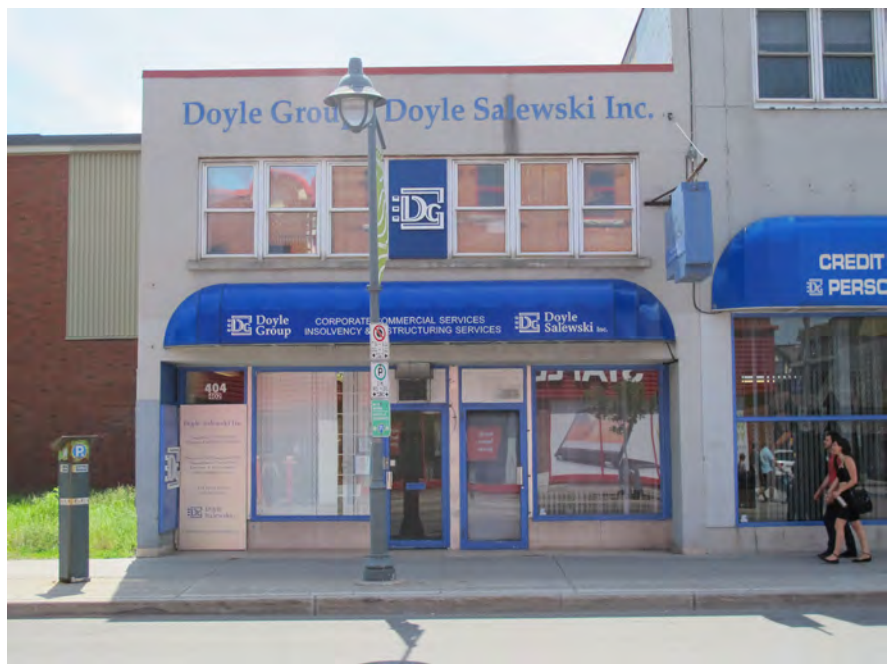
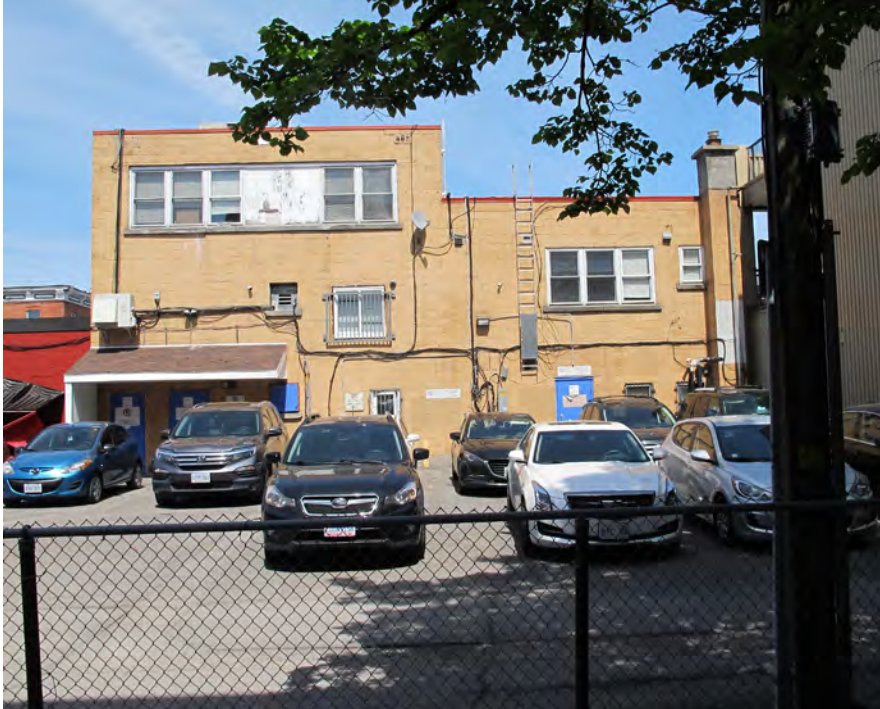
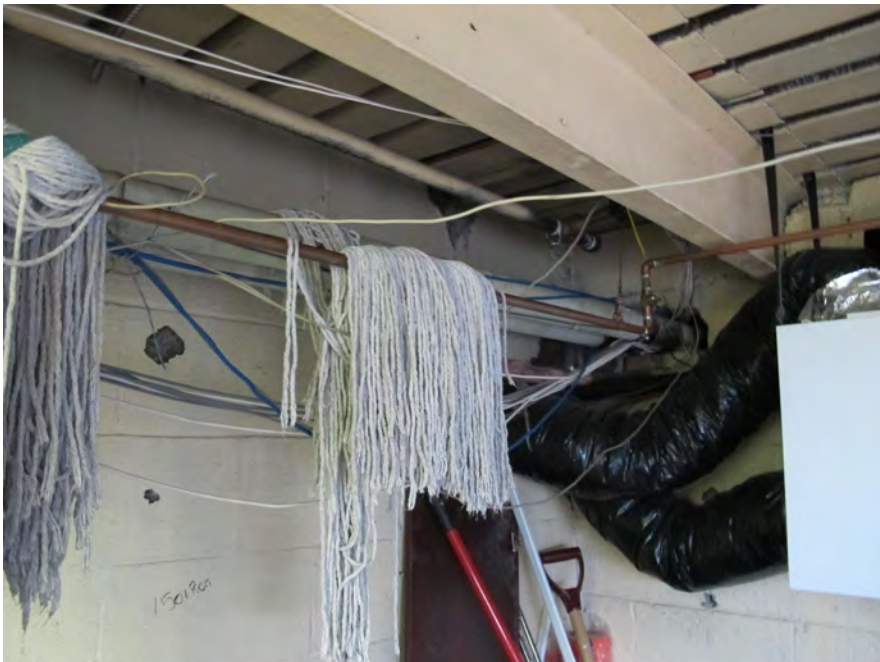
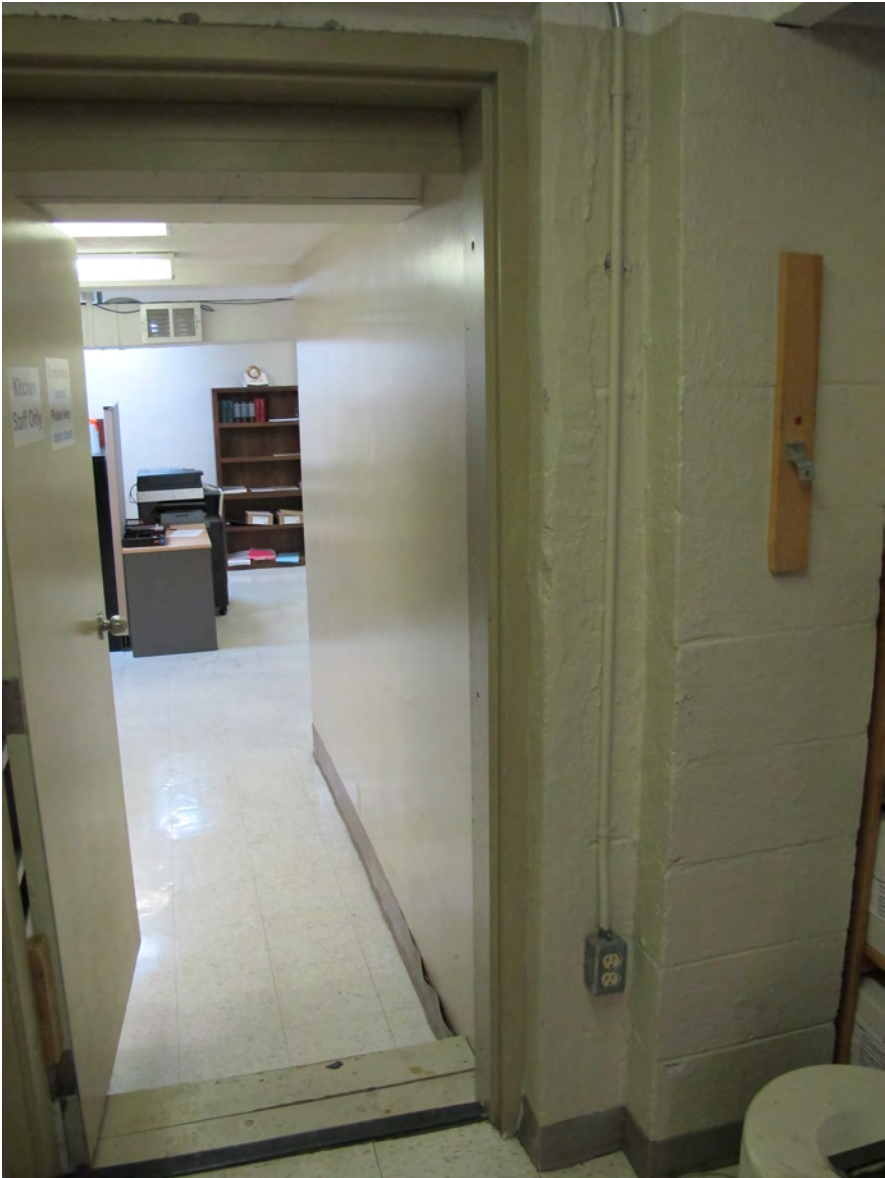
394-404 Bank Street

- Roof is a shallow monopitch (rooftop was not observed).
- Materials are panels (concrete?) over concrete block walls (façade) and painted on the north and west elevations.

CONDITION

- The interiors of the buildings have been extensively altered to permit conversion to a single office operation.
- No signs of damage or deterioration were evident.
- In general, the building appears to be competently built and in good condition.

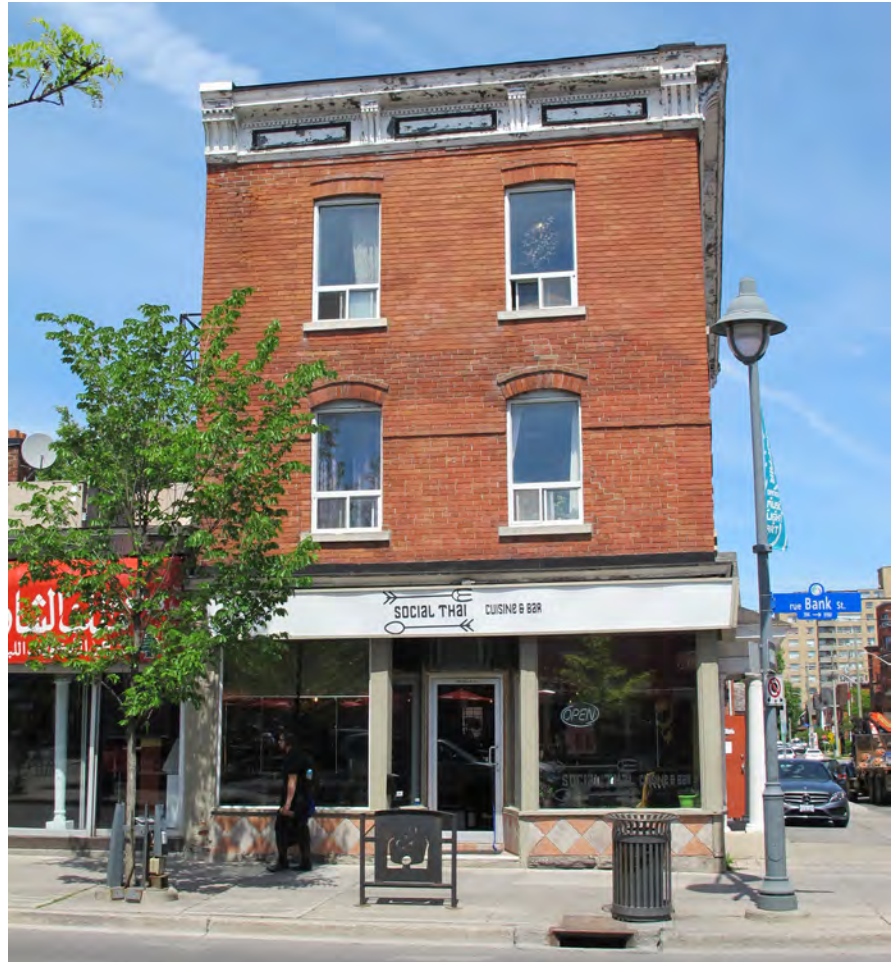
399 BANK

399 Bank Street

- 1879-1901
- Category 2, Edwardian Commercial style
- Good example of turn of the century commercial design
- Very compatible with heritage commercial environment
- Helps establish heritage commercial character of Bank Street corridor

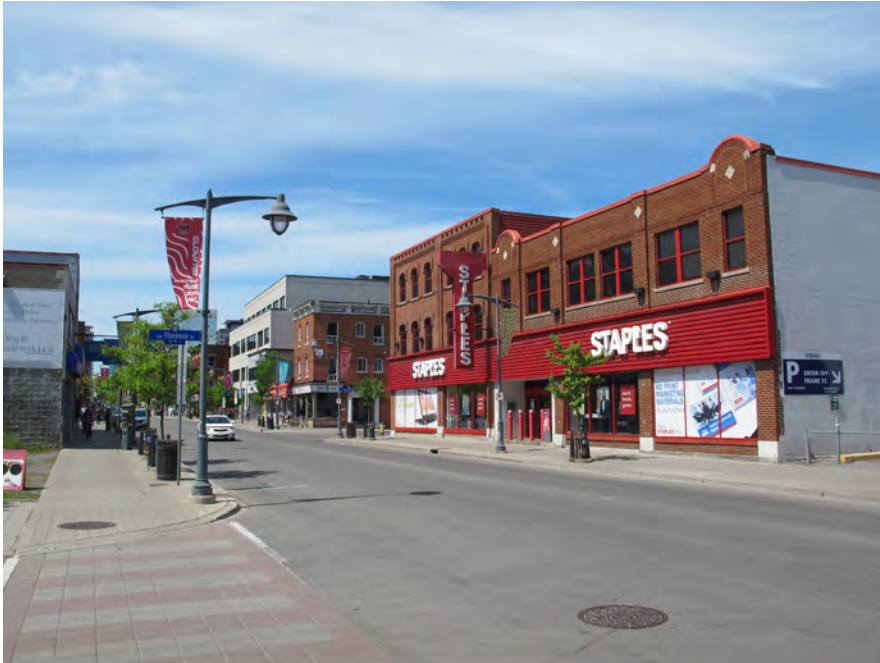
403 BANK

*403 Bank Street, with
399 Bank Street beyond*

- 1923-1948
- Category 2, vernacular Edwardian Commercial style
- Good example of turn of the century commercial design
- Very compatible with heritage commercial environment
- Helps establish heritage commercial character of Bank Street corridor

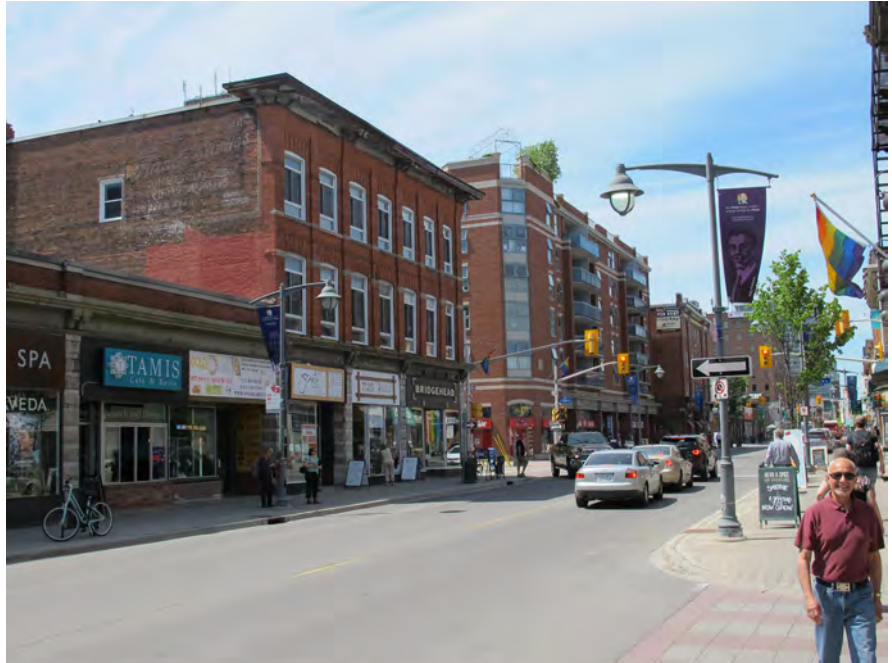
366-370 BANK

366-370 Bank Street

- 1879-1901
- Category 2, Edwardian Commercial style
- Very good example of turn of the century commercial design
- Very compatible with heritage commercial environment
- Reinforces heritage commercial character of Bank Street corridor

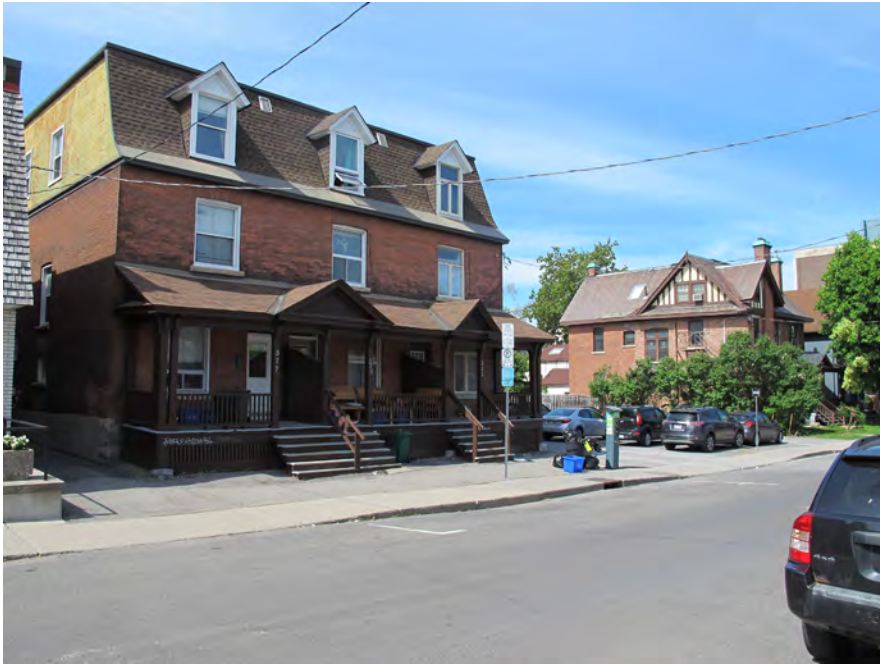
371-377 WAVERLEY

371-377 Waverley Street

- 1913-1922
- Category 2, vernacular Edwardian style
- Very compatible with mixed residential/commercial environment
- Reinforces heritage residential/commercial character

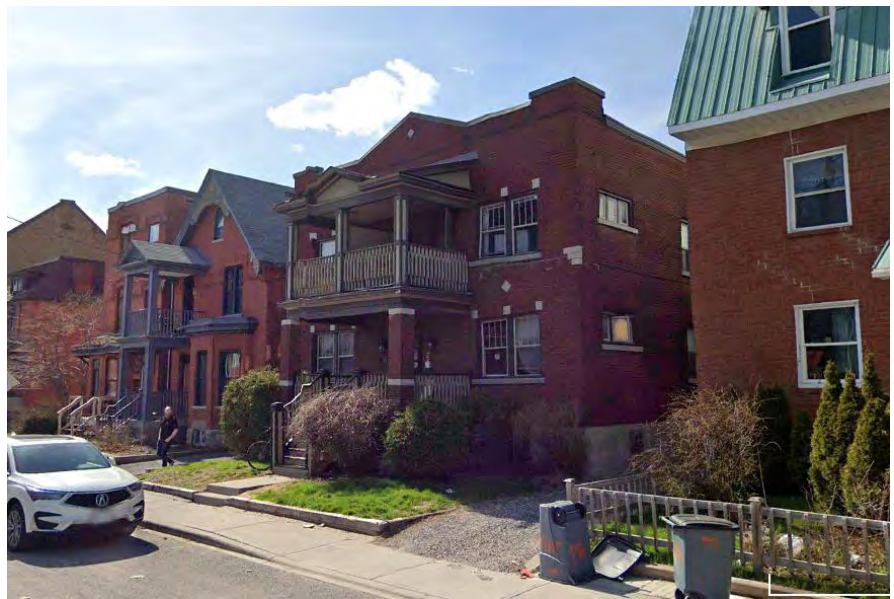
18 FLORENCE

*Florence Street, north side,
looking west from Bank Street.
Source: Google Earth*

- 1879-1901
- Category 1, vernacular Gothic Revival style
- Excellent example of turn of the century residential design
- Very compatible with heritage residential/commercial environment
- Reinforces heritage residential/commercial character

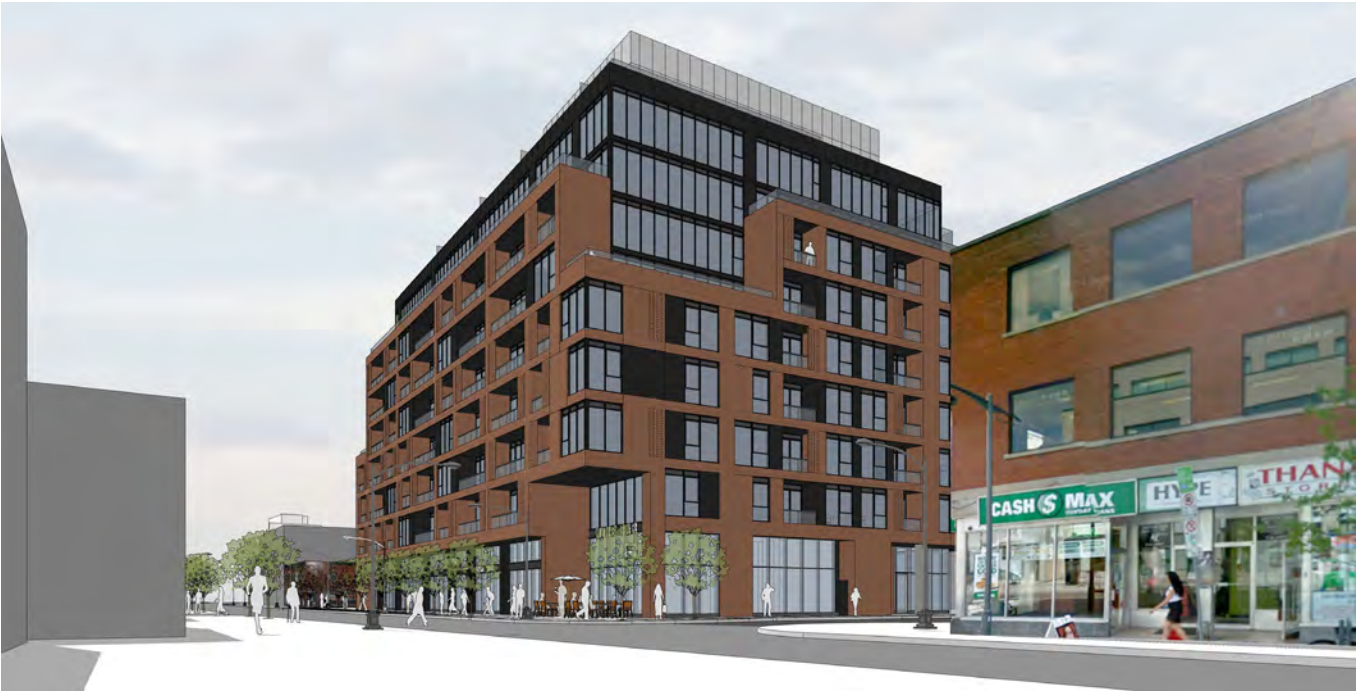
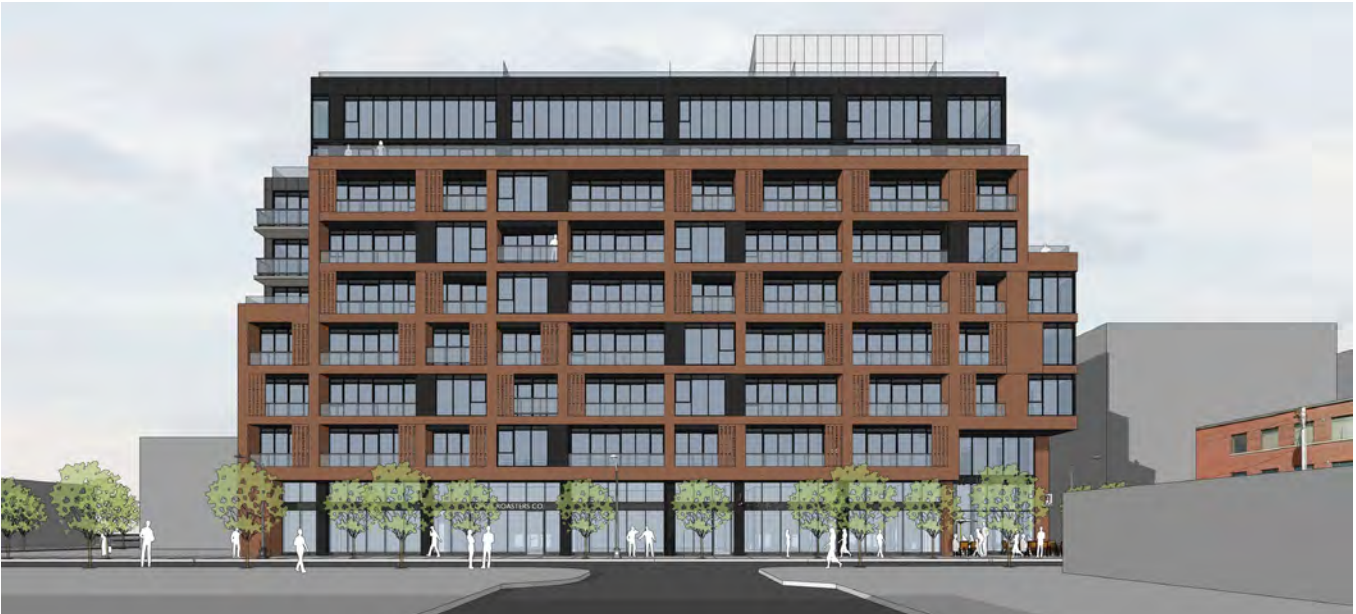
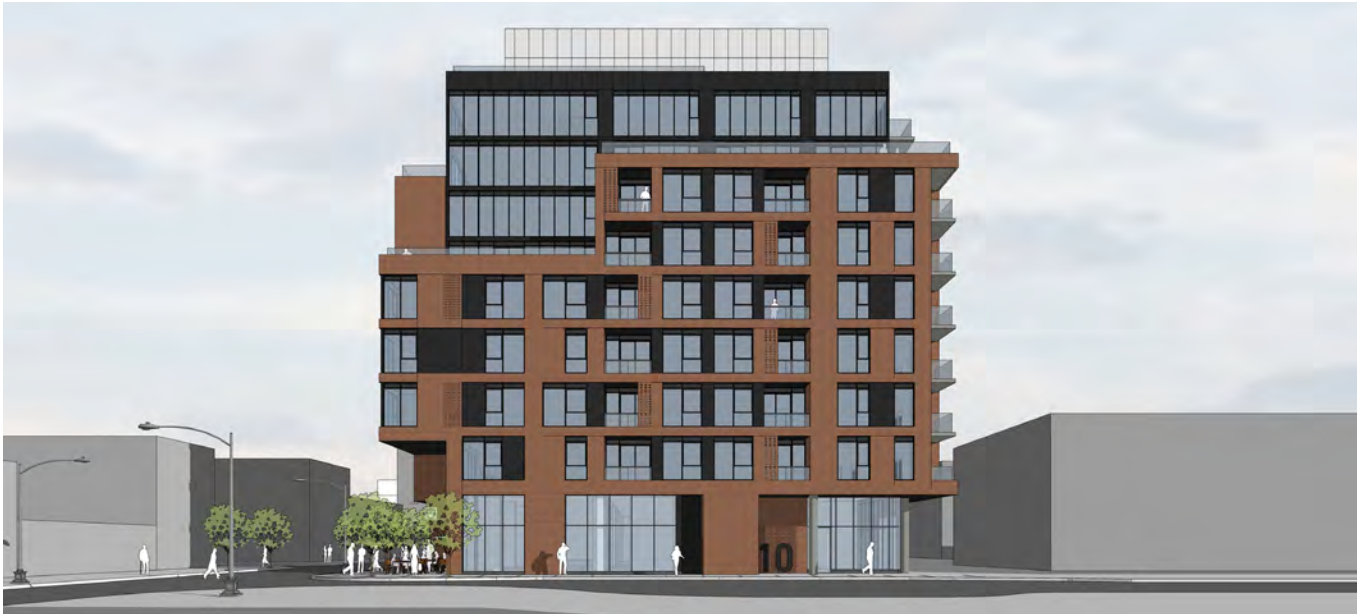
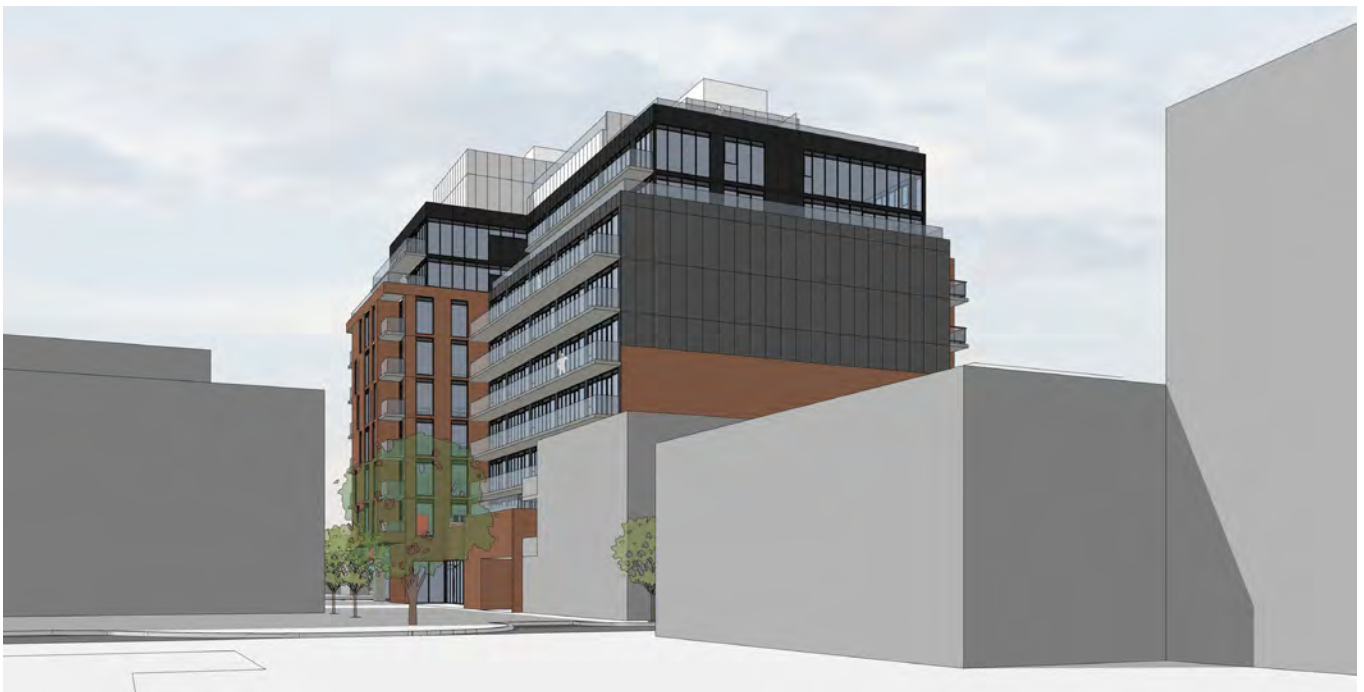
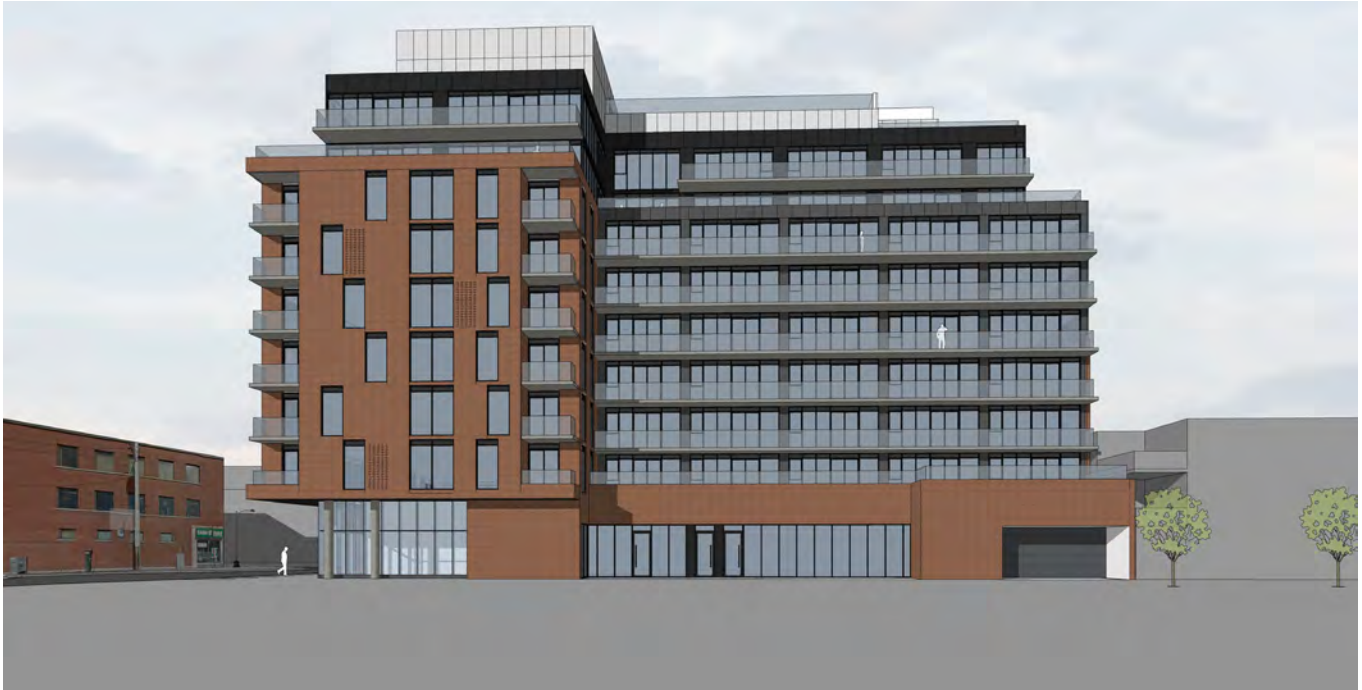
Exterior views

The fenestration pattern is asymmetrical with different window sizes and configurations: there are no clearly defined bays. The ground floor is continuously glazed with floor-ceiling units framed in black metal surrounds. Similar glazing is found in floors 7-9. The other floors have punched windows with black metal surrounds. Exterior materials glazing and black metal for the ground floor and floors 7-9, with red brick for floors 2-6. Brick cladding extends around the corner along James Street to include a projecting bay on the west elevation (the remainder of that elevation is glazed above the ground floor). The south elevation is brick-clad for floors 2-4 and metal-clad for floors 5-7, with no windows on these walls that abut the property line. Floors 8-9 are stepped back with extensive glazing with black metal surrounds.

Above the ground floor the building is rendered in a sympathetic and traditional red brick palette using a loose pattern of running bond and an open 'headered' coursing to create a gentle horizontal play across the façade. The grillage formed by the headered course allows light onto the balconies and provides them additional privacy but more importantly gives a depth and play of shadow to the façade. This brick pattern is interspersed with charcoal window framing and panels.

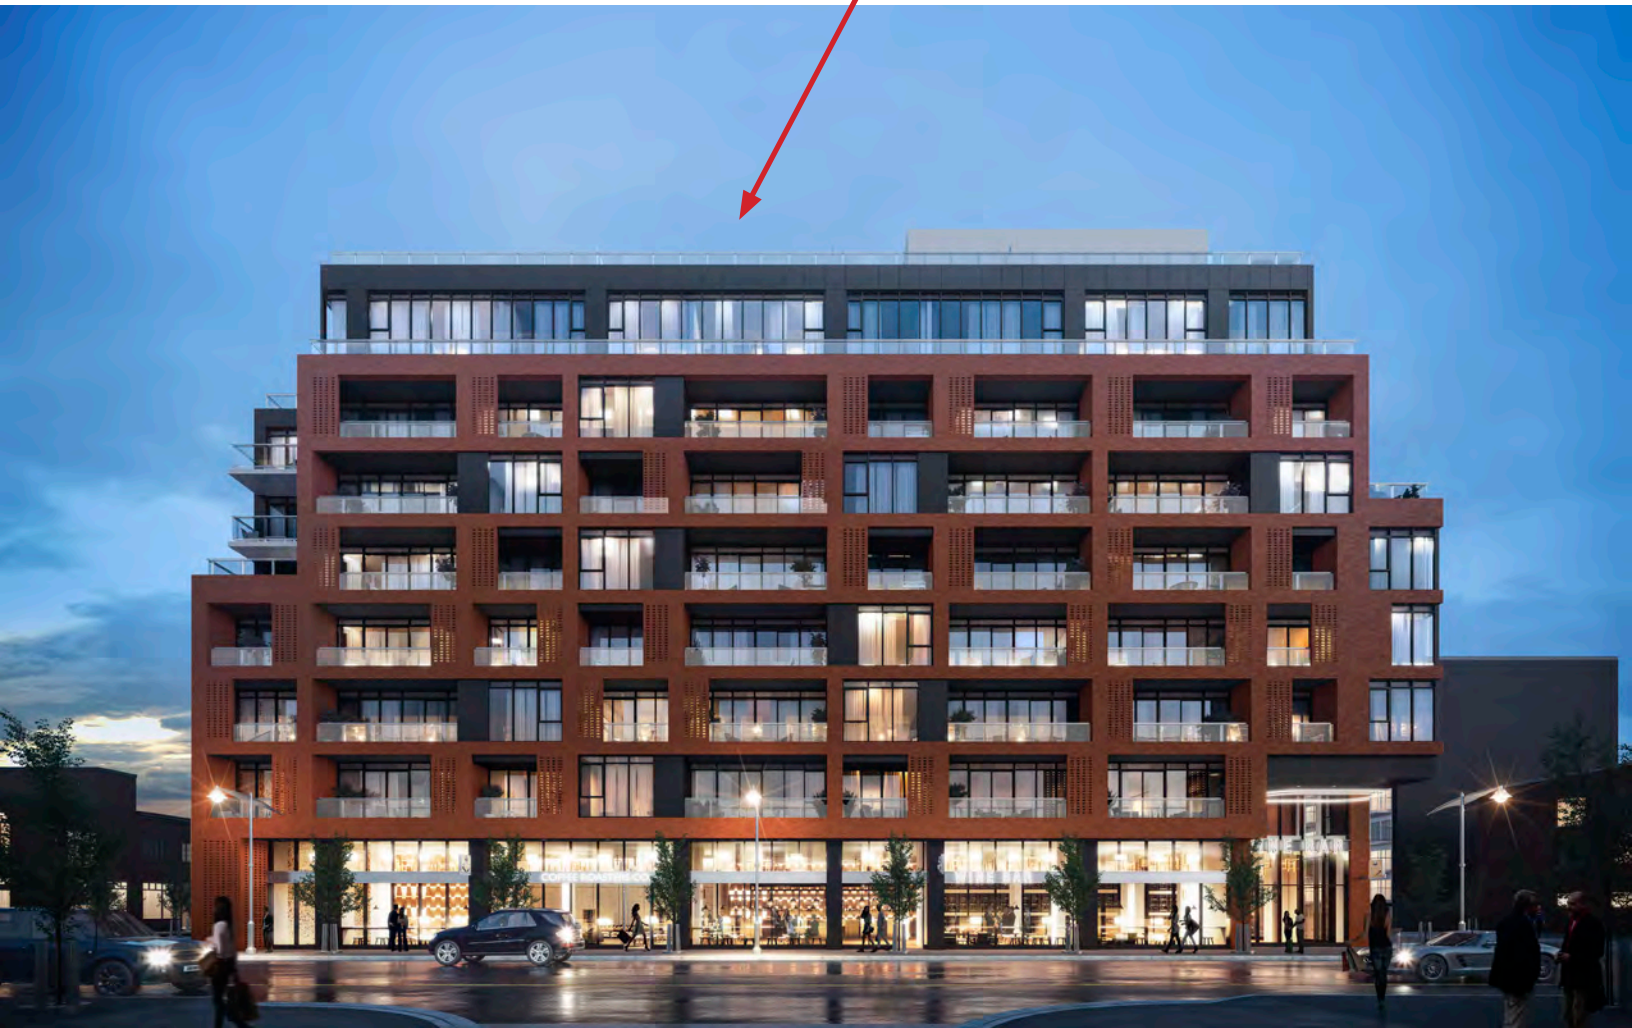
**1.0 DISTINGUISHABLE
CONTEMPORARY
DESIGN**

1.0 All infill should be of contemporary design, distinguishable as being of its own time. However, it must be sympathetic to the heritage character of the area, and designed to enhance these existing properties rather than calling attention to itself.

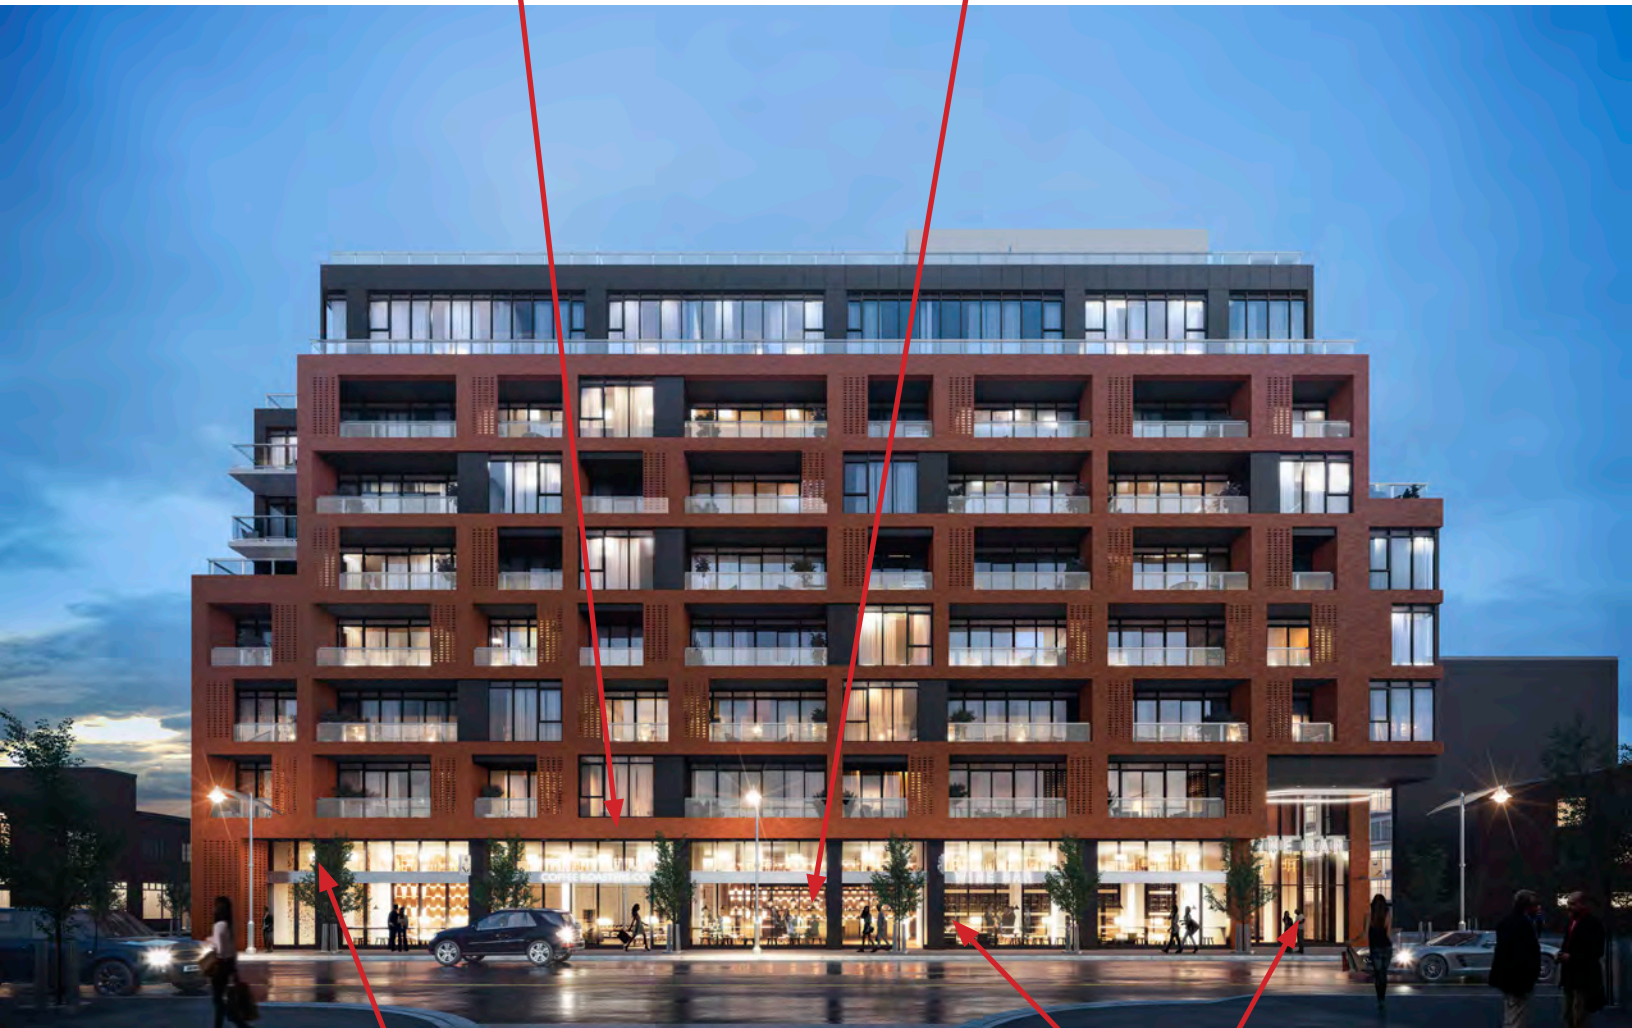
2019 Proposal
Rendered East Elevation (Bank St. view)

**2.2 GROUND
FLOOR FACADE
TRANSPARENT**

**2.2 MASONRY/STONE PIERS,
EMPHASIZE THE THREE-
DIMENSIONALITY OF THE
FACADE**

**2.2 RECESSED
ENTRANCE AND
TRANSOM**

2.2 Ground floor facades should be transparent and three-dimensional, with large glass areas, recessed entrances, and articulated transoms. Signage should maintain existing patterns of horizontal banding. Projecting cornices can be used to emphasize the separation between ground floor and upper floor.

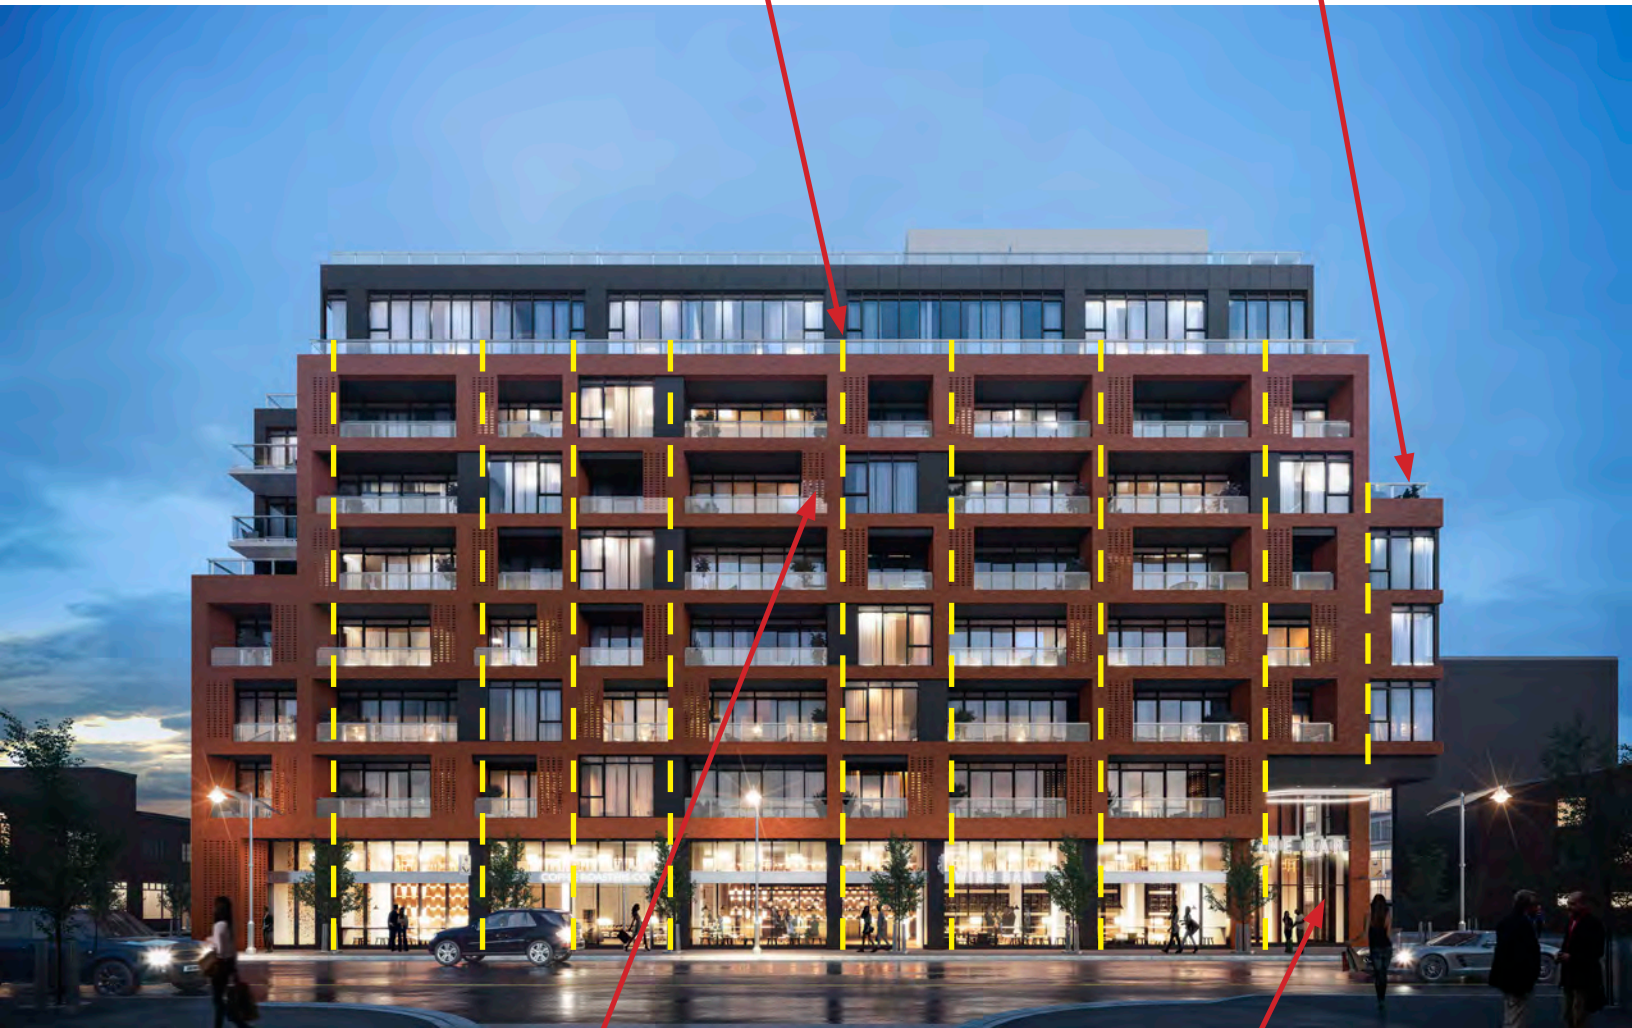
2019 Proposal
Rendered East Elevation (Bank St. view)

**2.3 SUBTLE VERTICAL RHYTHM
(INDICATED WITH DASHED YELLOW
LINES)**

**2.3 ACKNOWLEDGE
CORNER PRESENCE**

**2.3 UPPER FLOOR
FACADES MORE
OPAQUE**

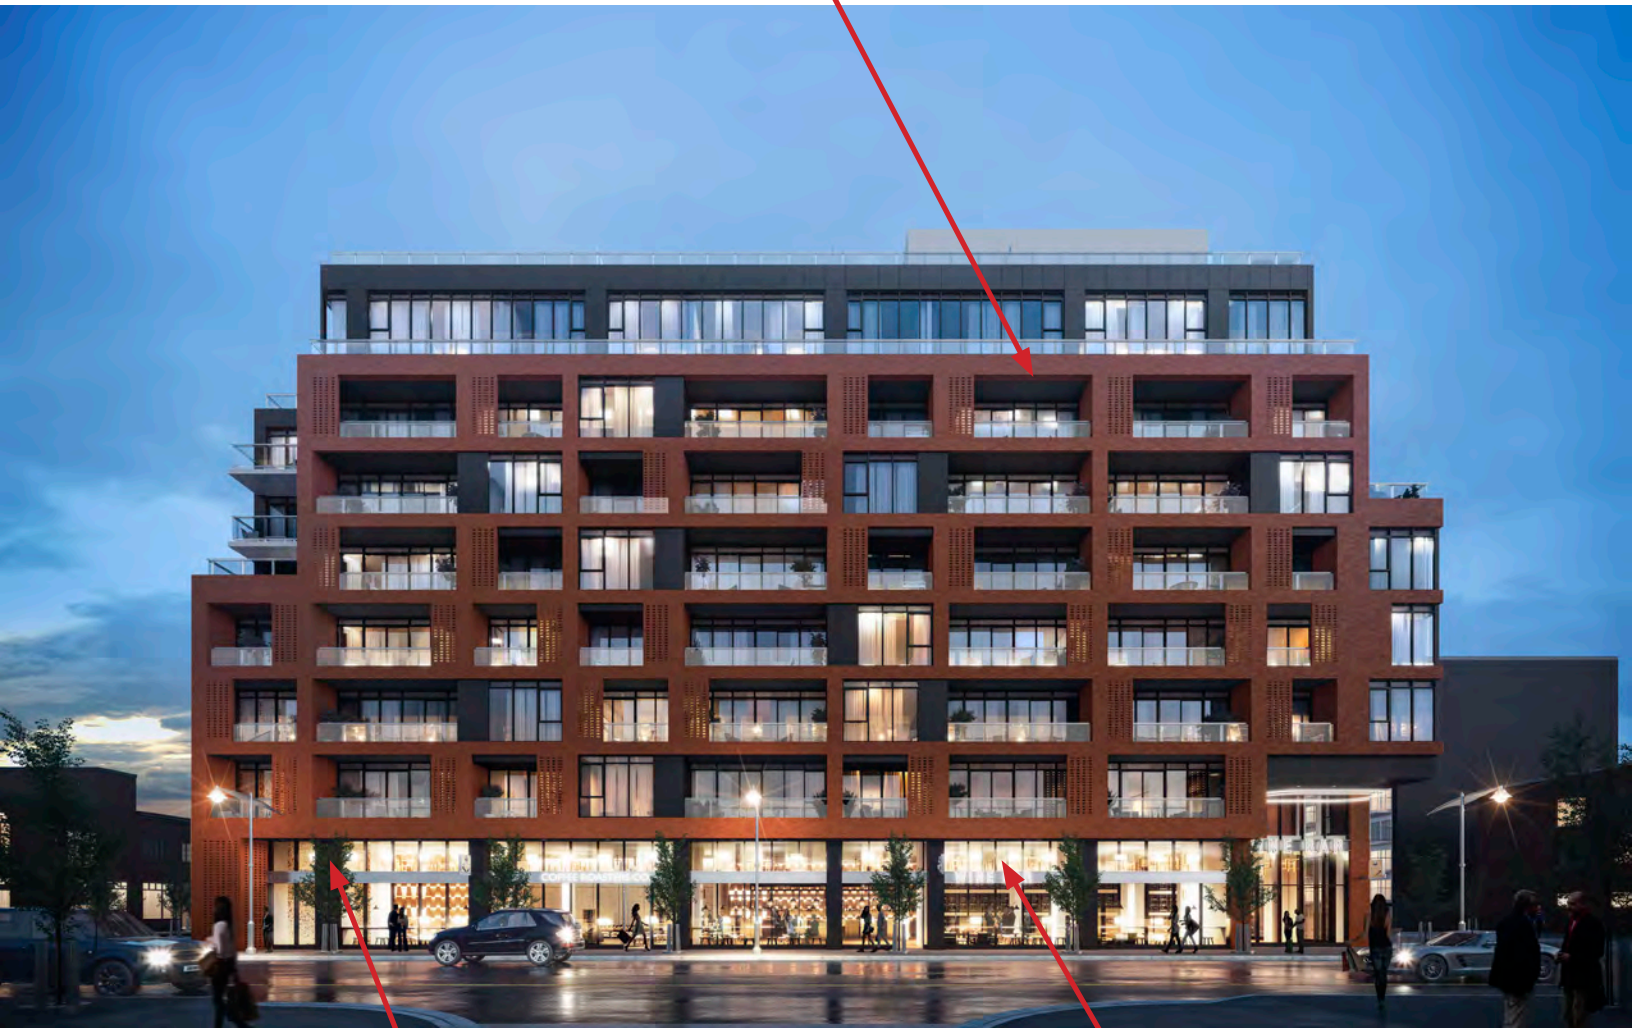
2.4 TRADITIONAL BRICK

2.4 MASONRY/STONE PIERS

2.4 VIBRANT BUT DISCREET LIGHTING
