# **Phase I-Environmental Site Assessment**

390 Bank Street Ottawa, Ontario

Urban Capital Property Group

Report: PE4650-1

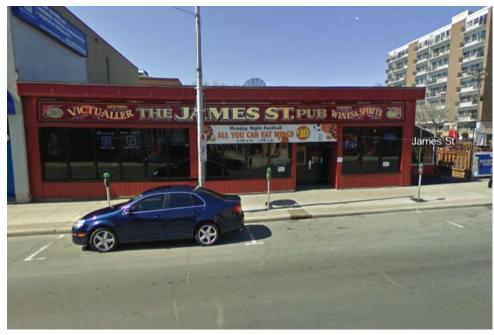
Photograph 1 (Google Street View): View of the site looking west. Photograph illustrates the commercial building on the site.

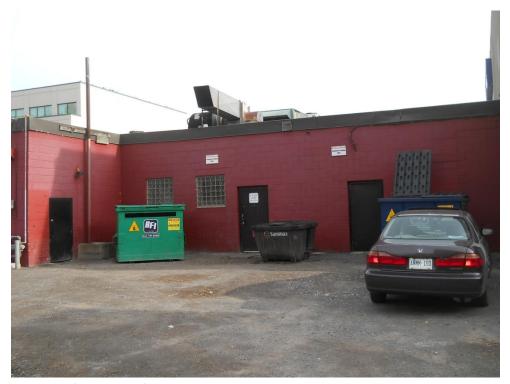
Photograph 2: View of the back of the subject building, looking east. Photograph illustrates waste storage locations, rear entrances, natural gas connection (far left) and a possible vent pipe encased in protective concrete.

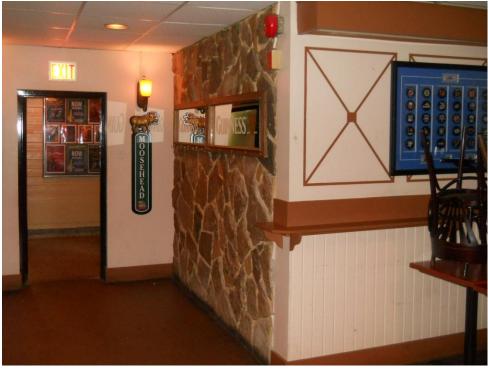
Photograph 3: View of the interior of the basement of the subject building.

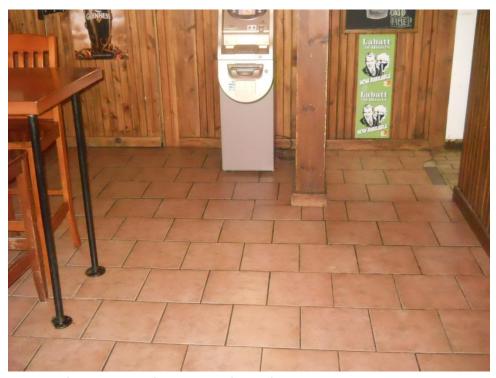
Photograph 4: View of the interior of the ground floor of the subject building. Photograph illustrates use of the building as a pub/restaurant.
