## **Phase I Environmental Site Assessment**

4837 Albion Road  
Ottawa, Ontario

**November 10, 2017**

Report: PE4149-1

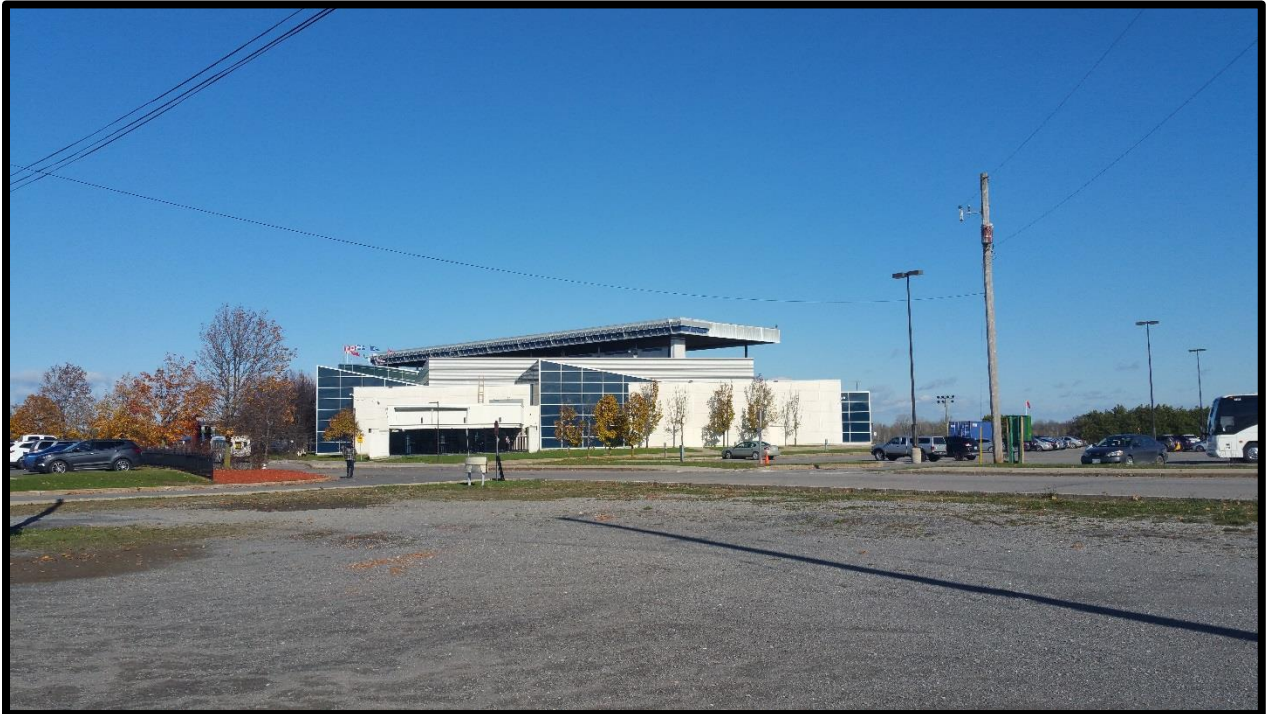
Photograph 1: View of the southern portion of the site, facing northeast. Photograph illustrates a gravel parking lot in the area of the residential dwelling and the Rideau Carleton Raceway building.

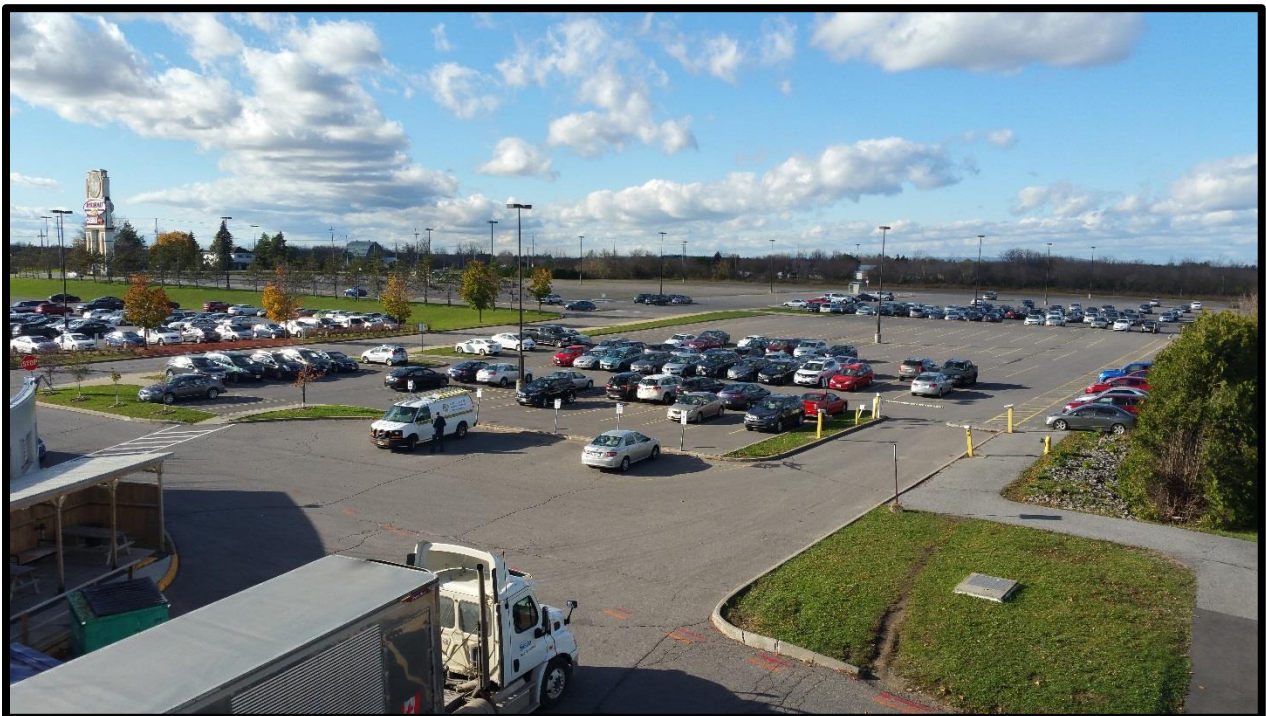
Photograph 2: View from the northern portion of the subject site, facing northwest. Photograph illustrates an asphaltic concrete parking lot.

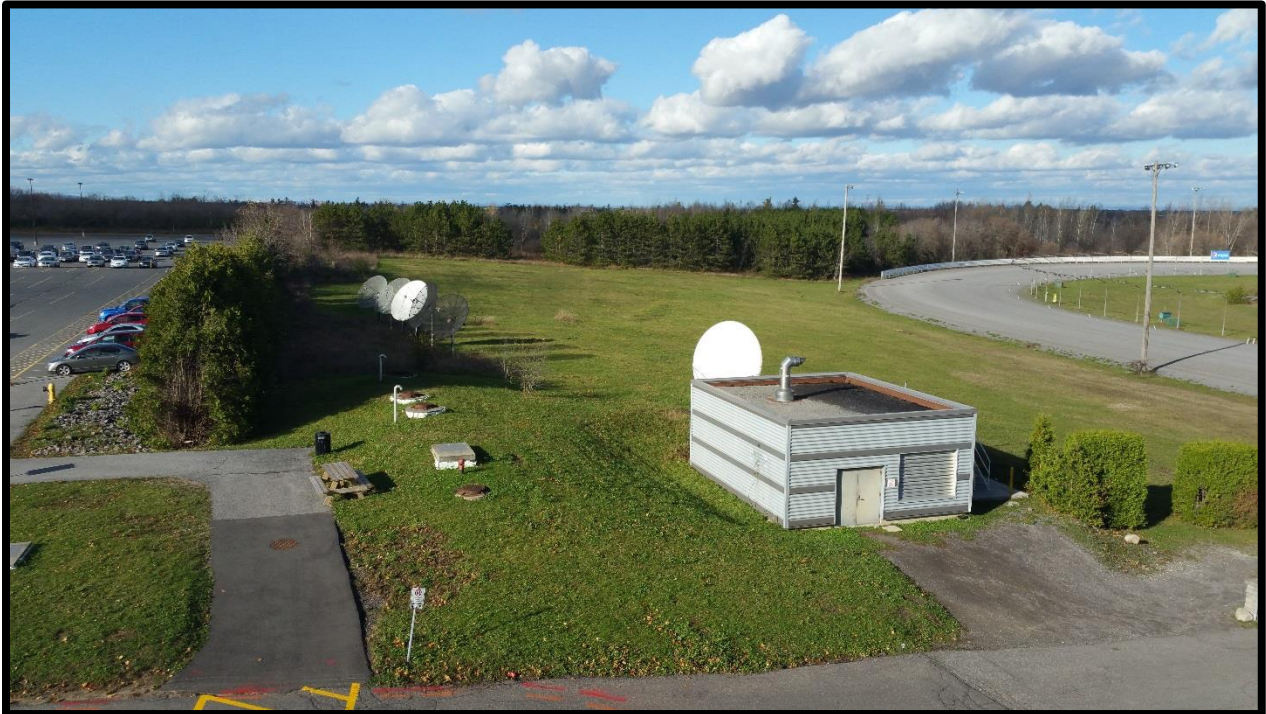
Photograph 3: View of the northern portion of the subject site, facing north. Photograph illustrates a grass field, the backup generator building and the location of the wastewater holding tank.

Two wastewater holding tanks were observed on the subject site. The primary tank is located west of the backup generator building and was installed in 1999. The primary tank discharges to the municipal sewer system. The secondary tank is located on the southern portion of the site (adjacent to the RCR track) and is used as overflow. The secondary tank also discharges to the municipal sewer system. No below ground structures, aside from utilities observed, were found at the time of the site visit.

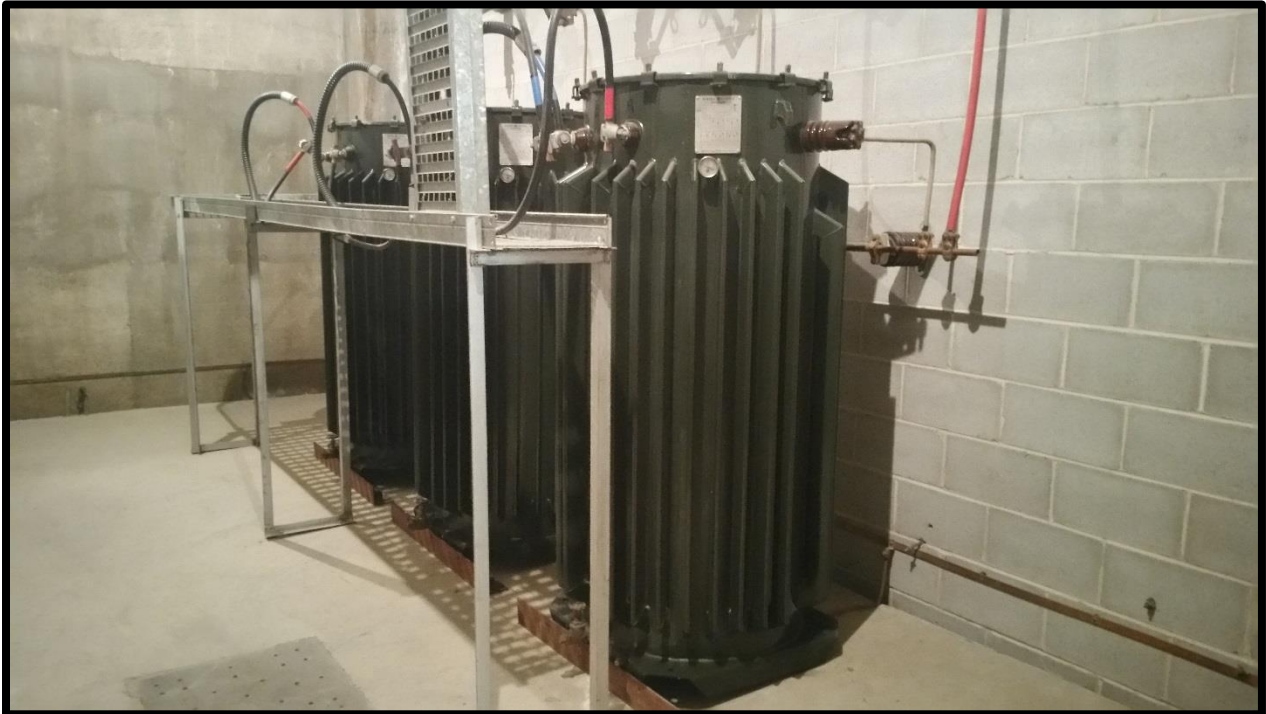
Several interior transformers were observed in an electrical room in the lower level of the RCR building. Based on conversations with the facility manager, PCBs are not present with the transformers. No stains or leaks were observed in the vicinity of the interior transformers. No concerns with respect to PCBs or transformer oil were identified on the subject property at the time of the site visit.

Photograph 5: Photograph of interior transformers in the electrical room on the lower level of the Rideau Carleton Raceway building.

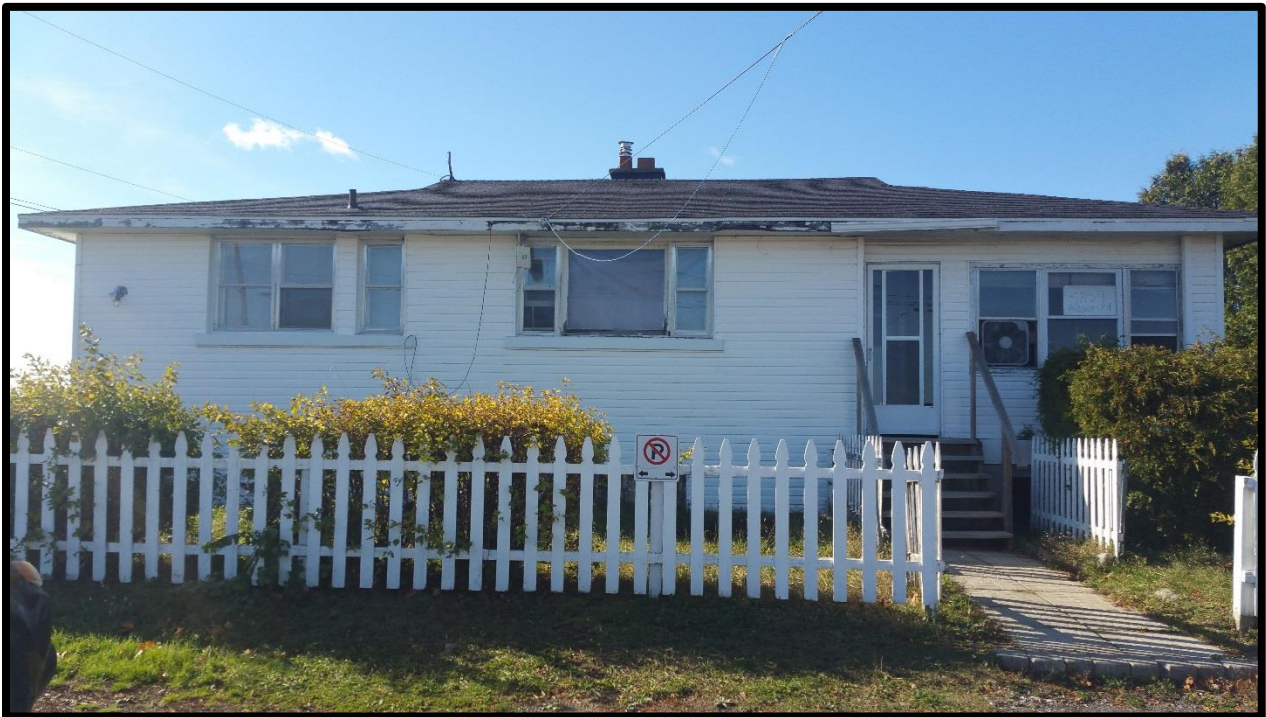
The one-storey residential dwelling has a sloped shingle roof, is clad with vinyl siding and has a concrete block foundation with a single basement level.

Photograph 6: Photograph of the one-story residential dwelling located on the subject site. Photograph is taken facing west.

Based on the age of the residential dwelling, lead-based paints may be present on painted surfaces. Painted surfaces were observed to be in good condition at the time of the site visit.

Based on the age of the residential dwelling (1962) ACM may be present within the building (suspended ceiling tiles). These materials were in good condition at the time of the site visit and do not pose an immediate environmental concern.
