Phase I - Environmental Site Assessment

367, 369 and 371 Preston Street
Ottawa, Ontario

June 7, 2018

Report: PE4276-1

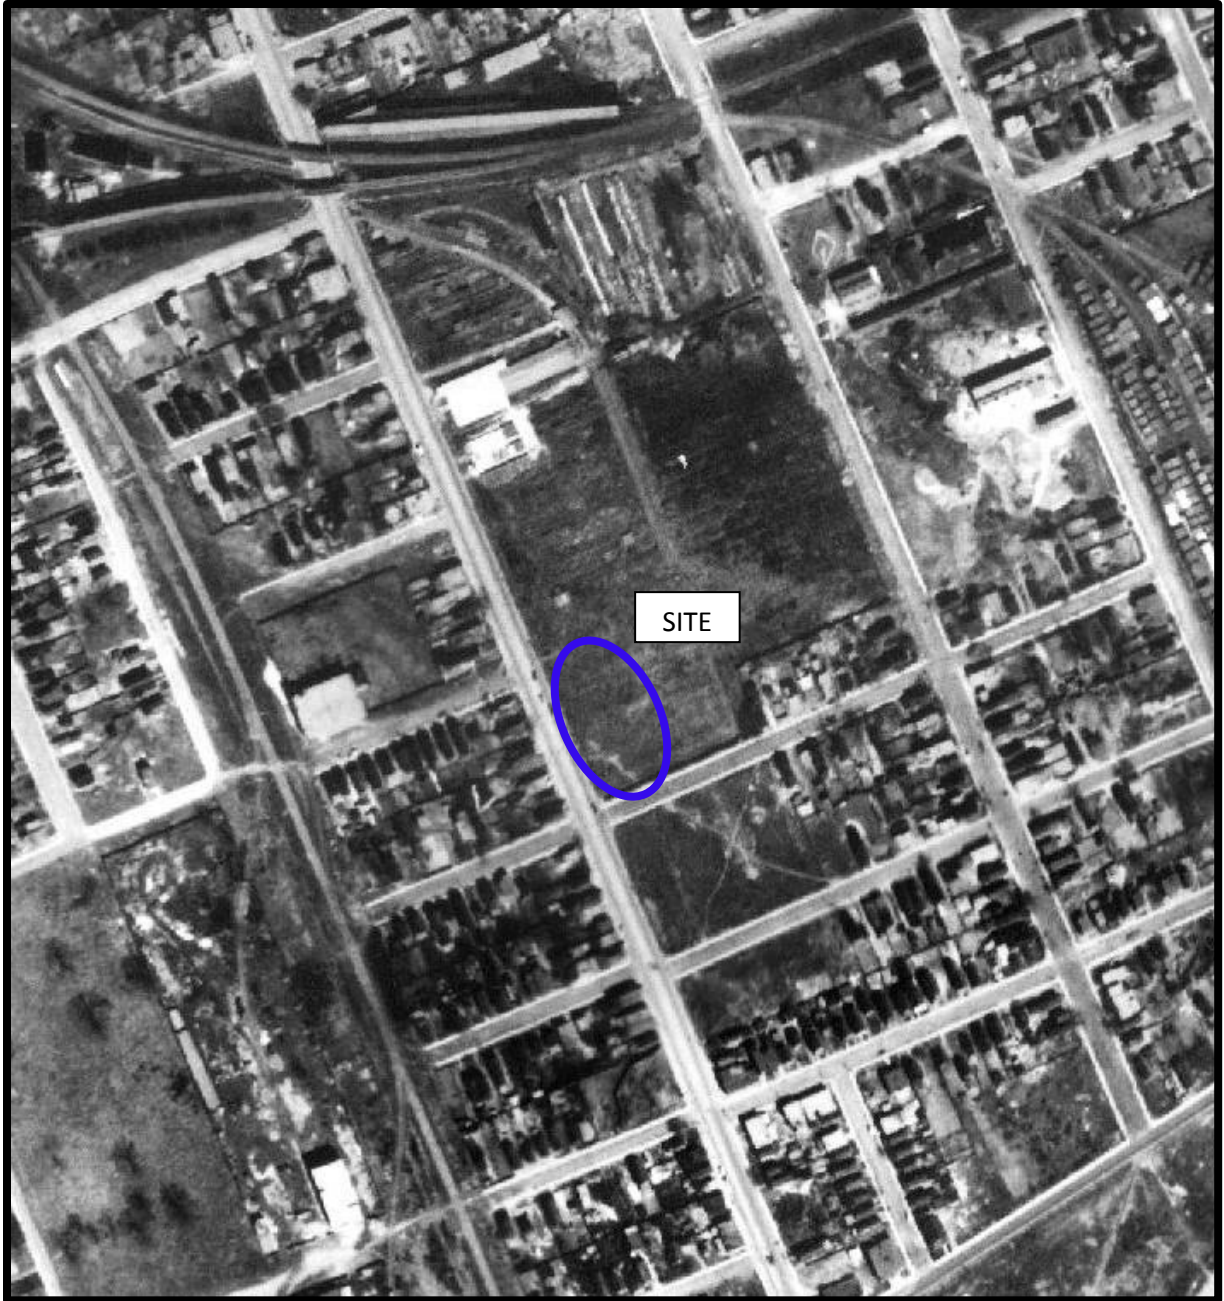
AERIAL PHOTOGRAPH
1928

| 1928 | (City of Ottawa Website) The subject site appears to be vacant land at this time. Neighbouring properties to the south, east and north are also vacant in this photograph. Properties to the west appear to be primarily residential. |

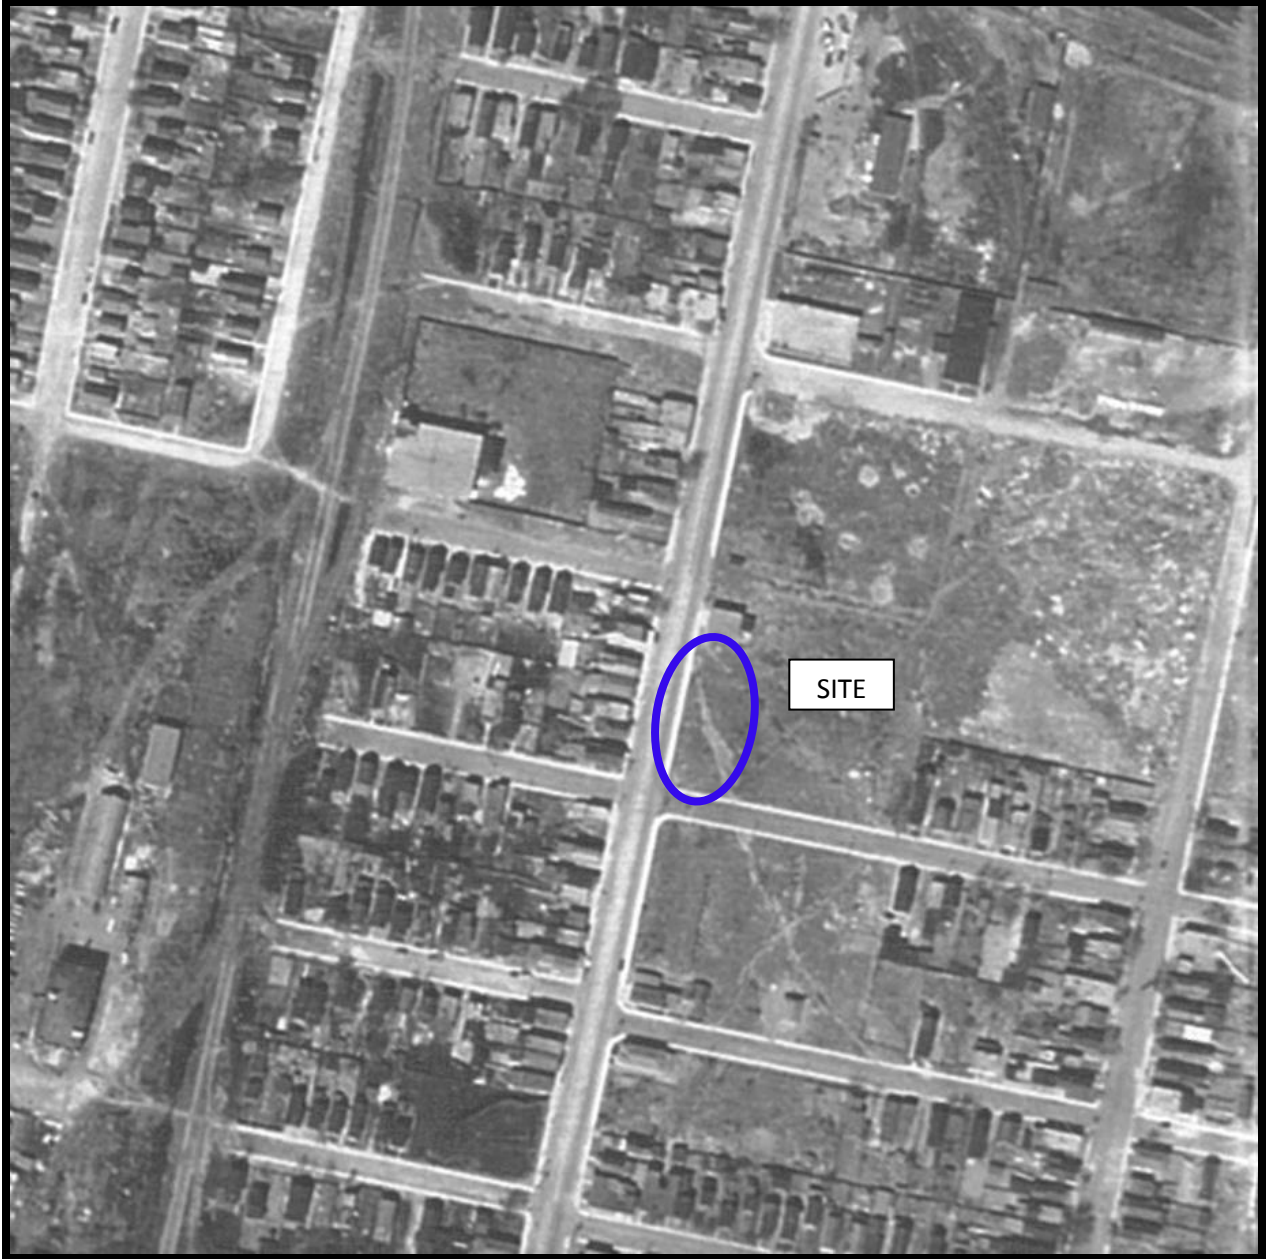
AERIAL PHOTOGRAPH
1933

| 1933 | No significant changes have been made to the subject or neighbouring properties with one exception. The adjacent property to the north has been developed with a residential dwelling. |

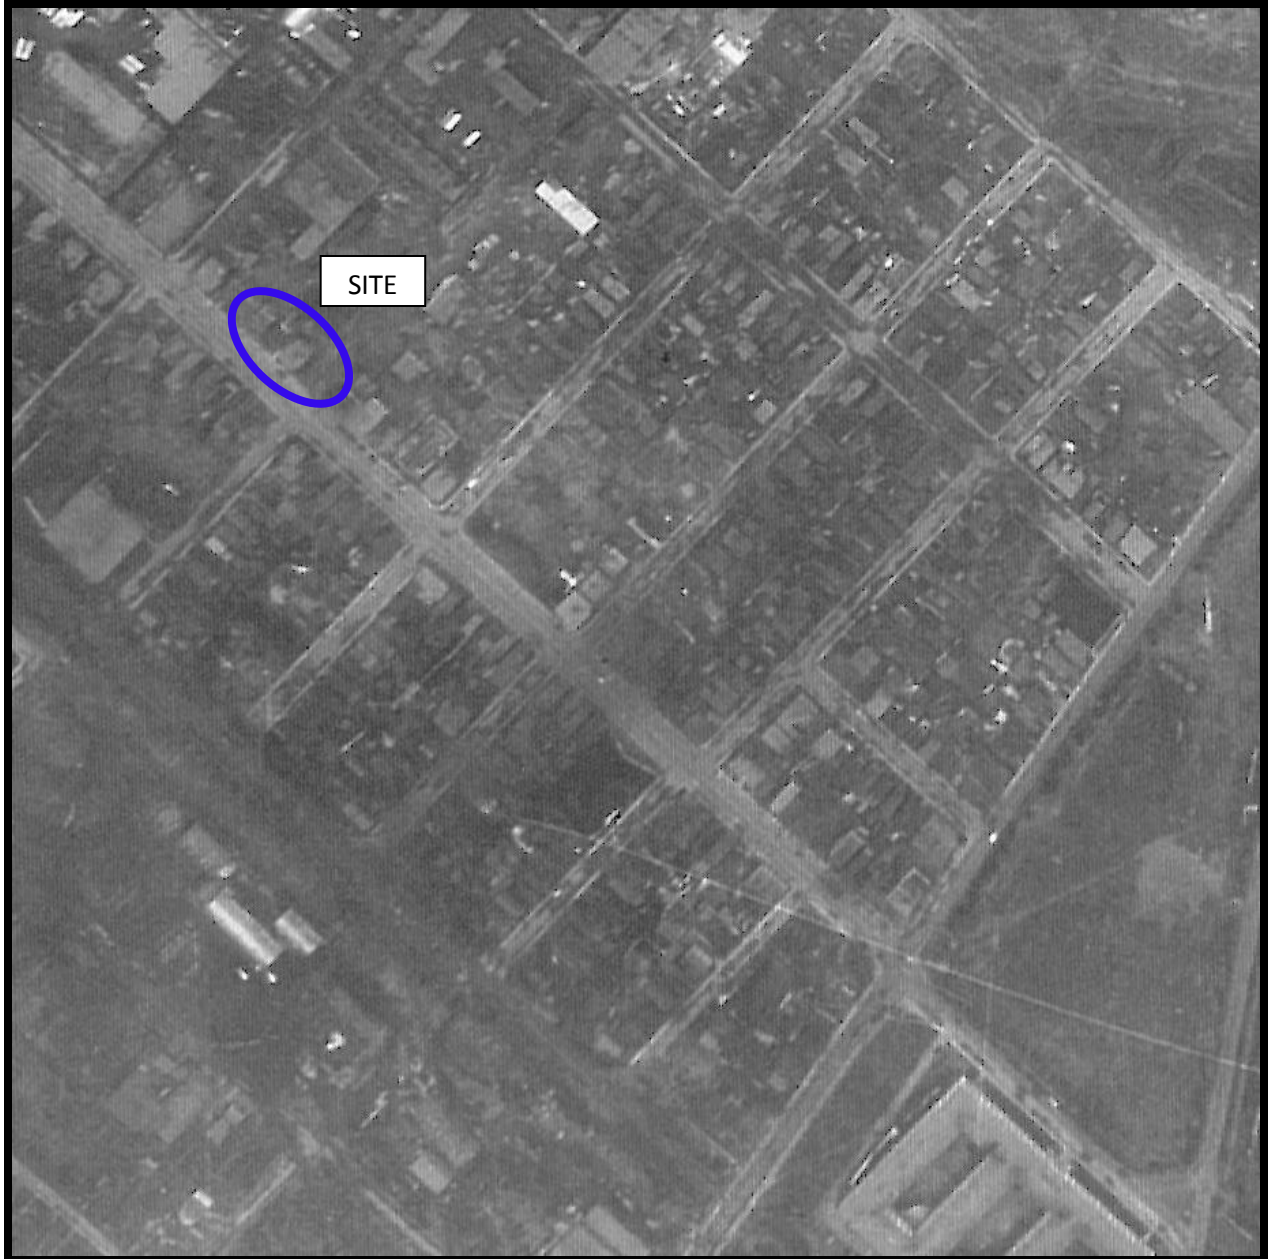
AERIAL PHOTOGRAPH
1947

| 1947 | The subject property appears to have been developed with the three (3) present-day buildings. Properties to the north have been developed with residential dwellings. Properties to the south appear to have been developed with a combination of commercial and residential buildings. The adjacent property to the east has been developed with a commercial/industrial building. |

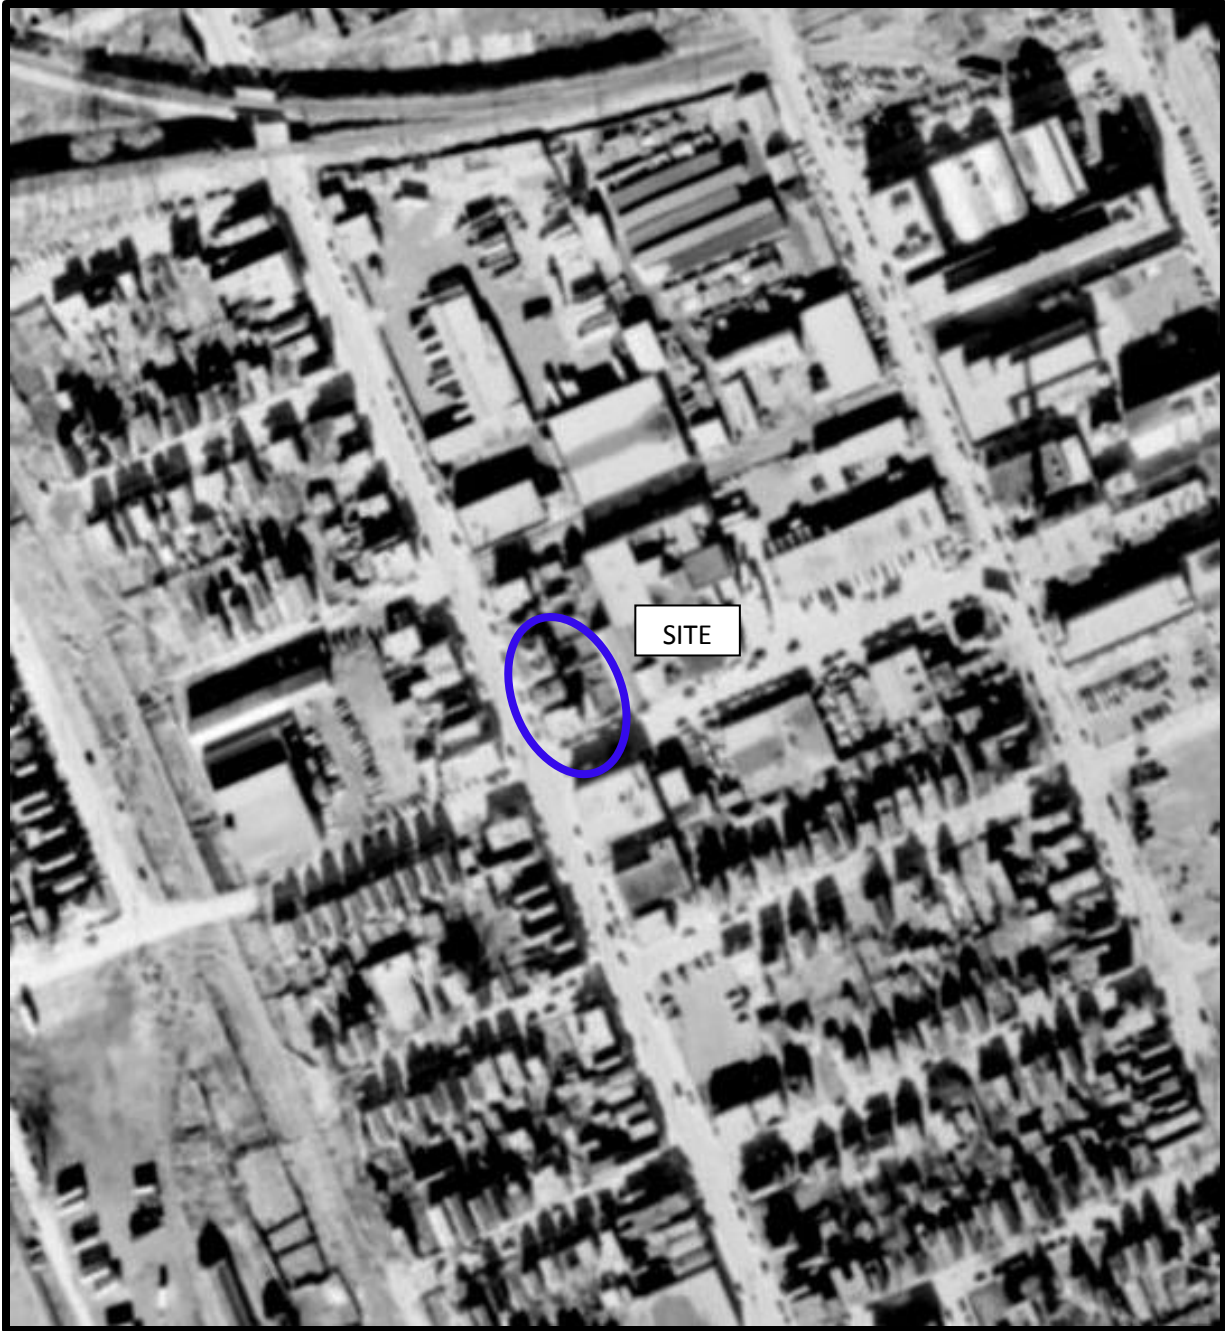
AERIAL PHOTOGRAPH
1958

| 1958 | (City of Ottawa Website) No significant changes have been made to the subject or adjacent properties. |

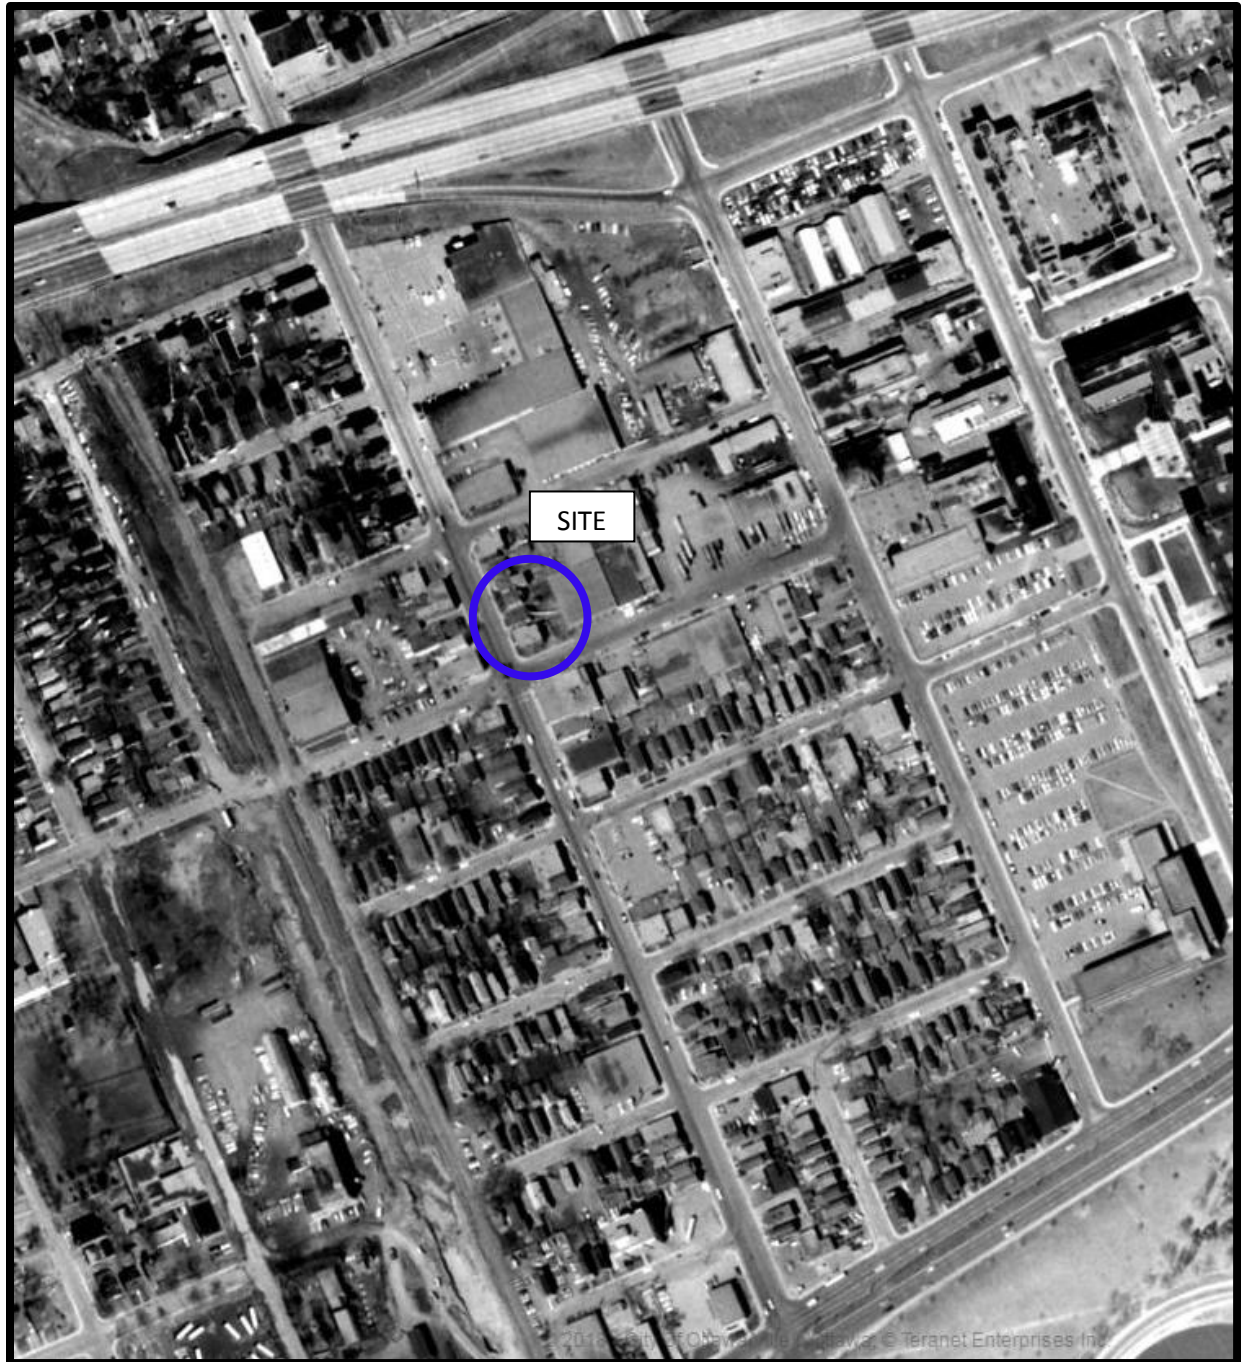
AERIAL PHOTOGRAPH
1965

| 1965 | (City of Ottawa Website) No significant changes have been made to the subject site. The adjacent building east of the subject site has been expanded. The building located at 60 Beech Street has been expanded to include 50 Beech Street. |

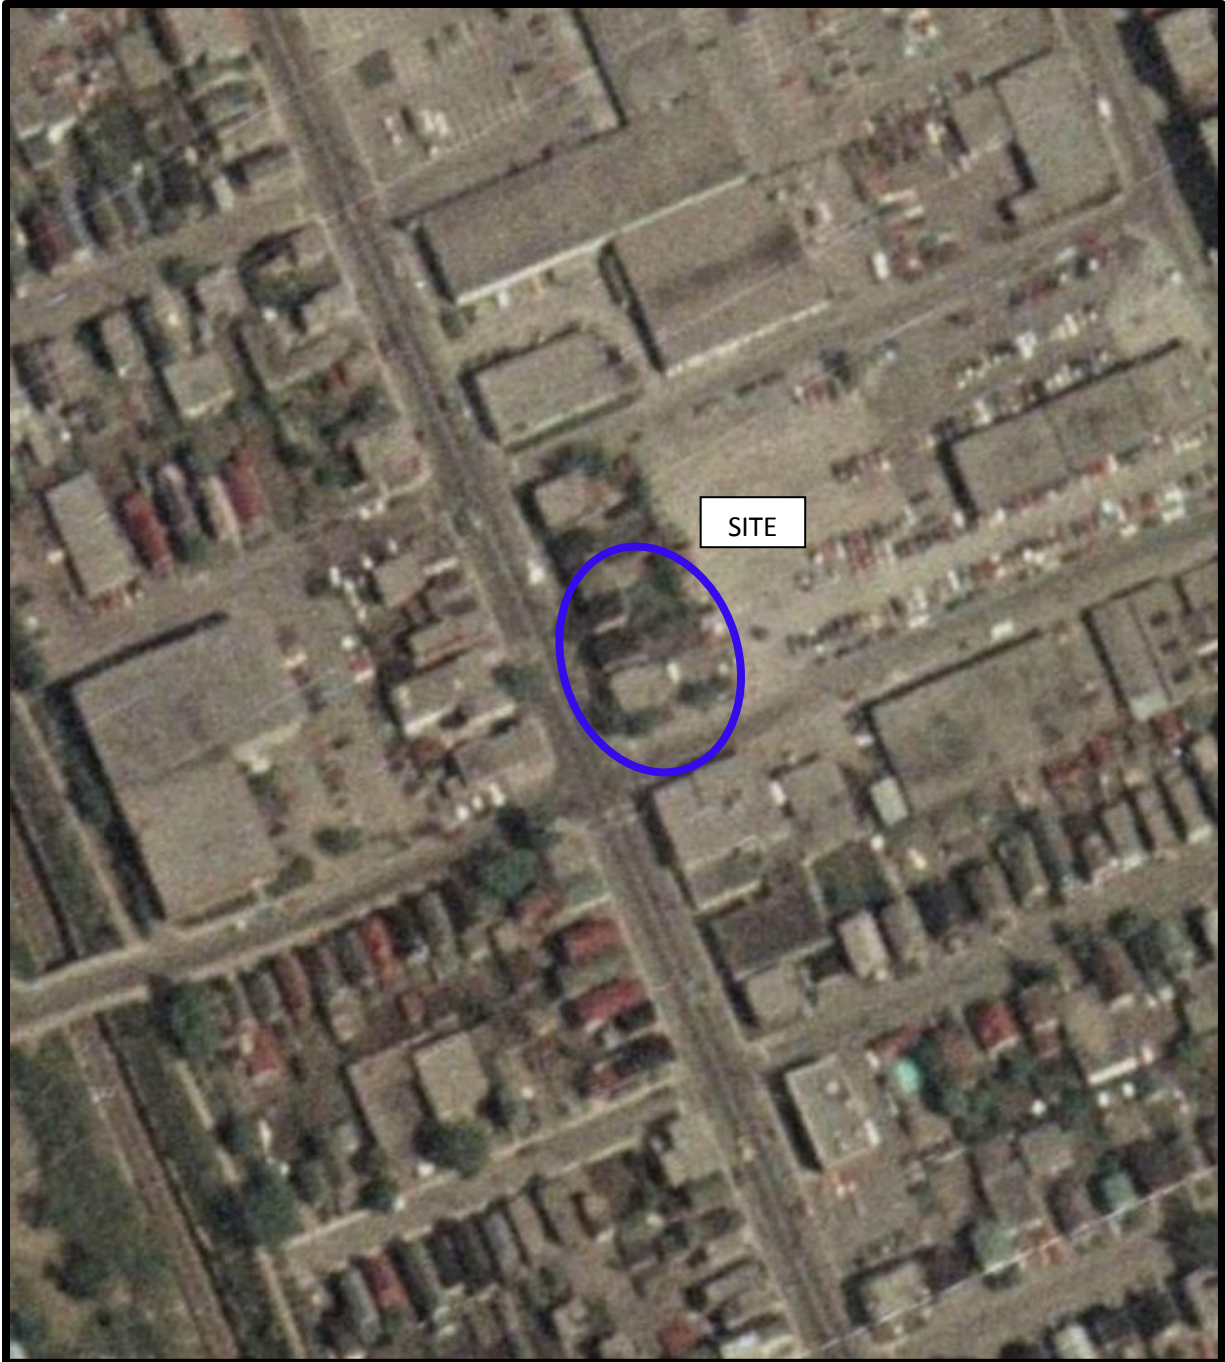
AERIAL PHOTOGRAPH
1976

| 1976 | (City of Ottawa Website) No significant changes have been made to the subject or neighbouring properties with one exception. The adjacent commercial/industrial building to the east has been demolished. This site has been re-developed as a parking lot. |

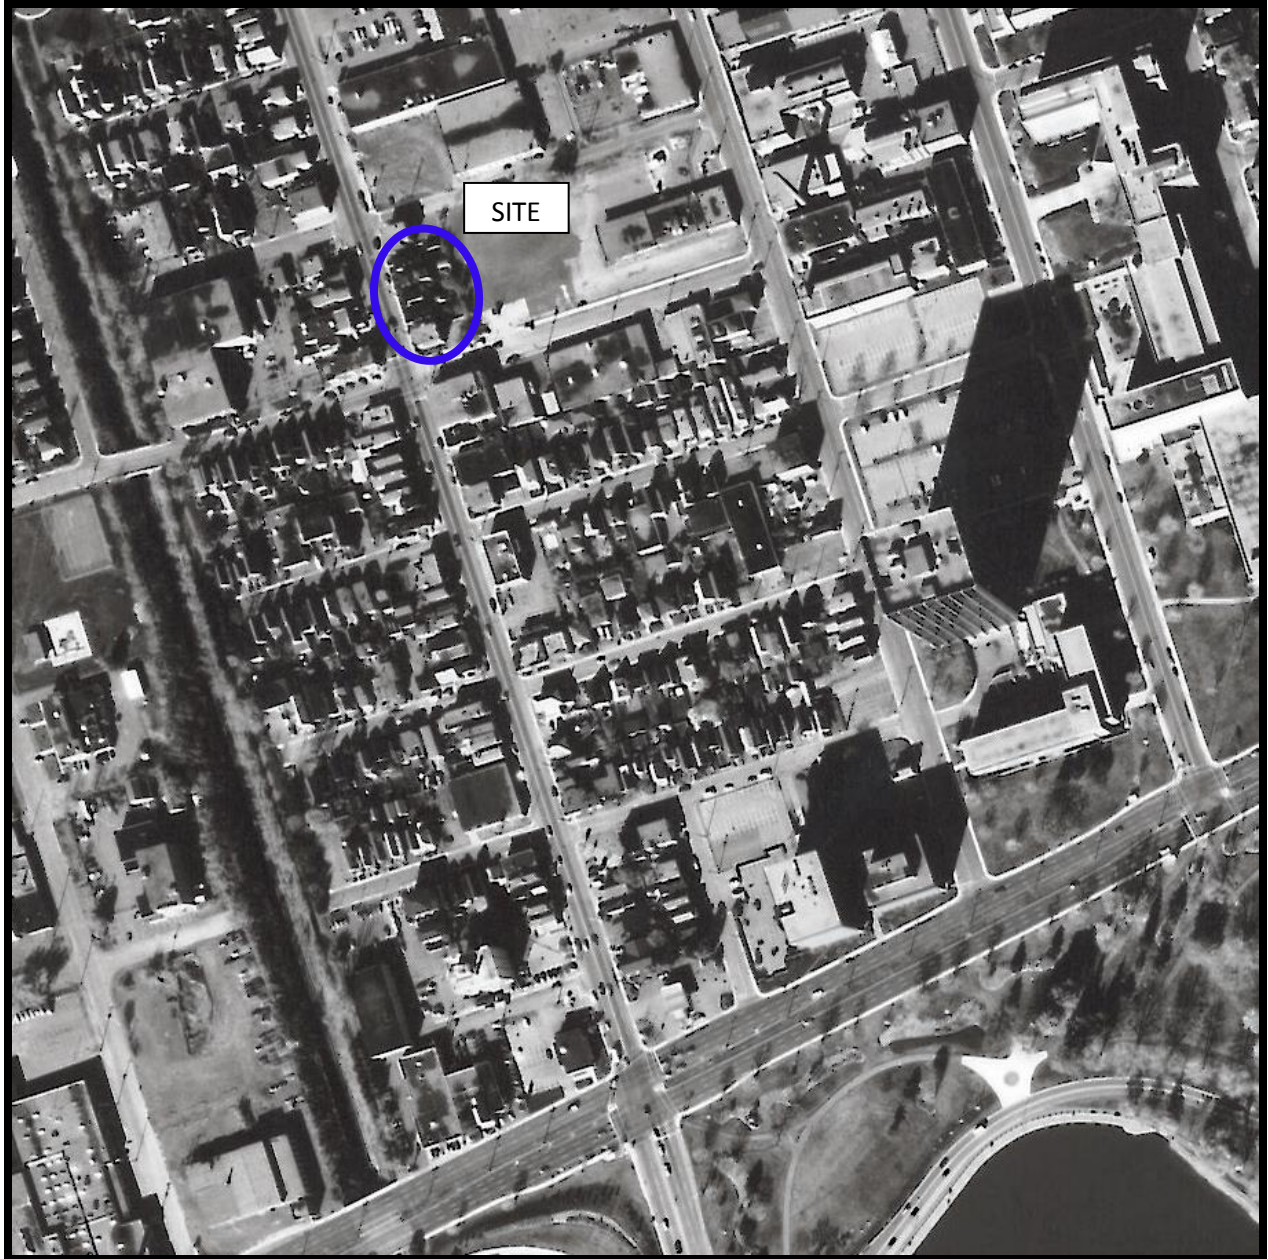
AERIAL PHOTOGRAPH
1987

| 1987 | No significant changes have been made to the subject site or surrounding properties since the previous photo. |

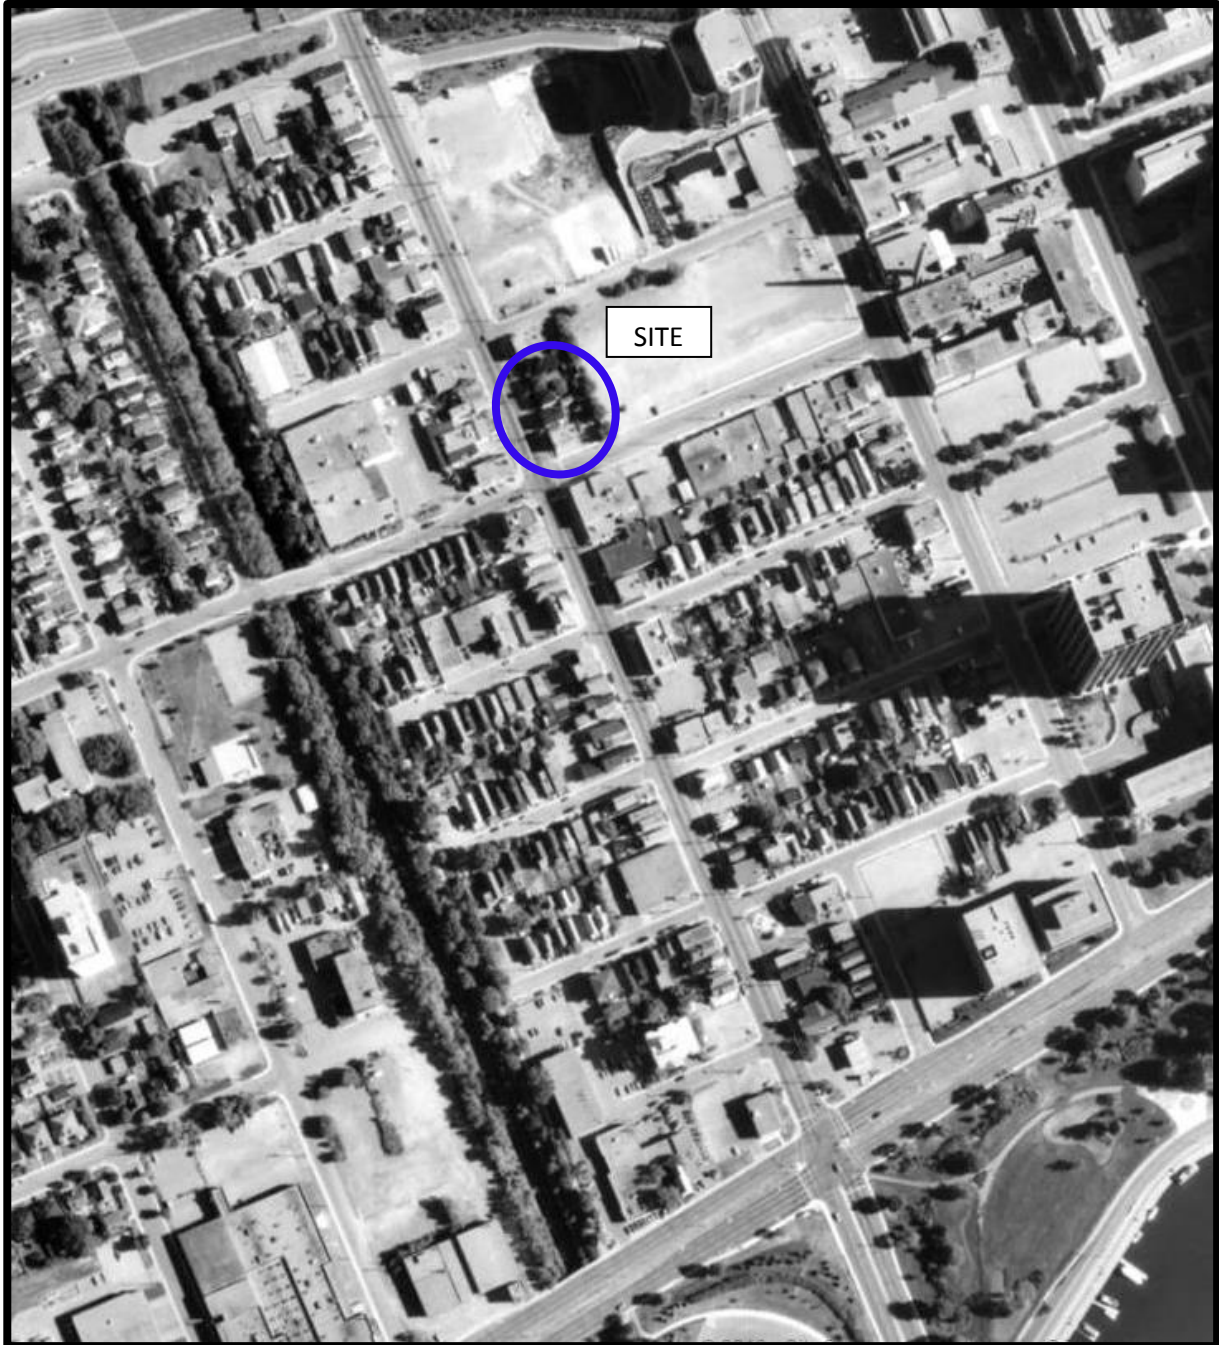
AERIAL PHOTOGRAPH
1991

- 1991 (City of Ottawa Website) No significant changes have been made to the subject site since the previous photo. Commercial/industrial buildings north of the site (333 Preston Street) and east of the site (450 Rochester Street) have been demolished at this time.
- 2005 (City of Ottawa Website) No significant changes have made to the subject or neighbouring properties.
- 2017 (City of Ottawa Website, geoOttawa) The subject site and surrounding properties are depicted as they appear today.

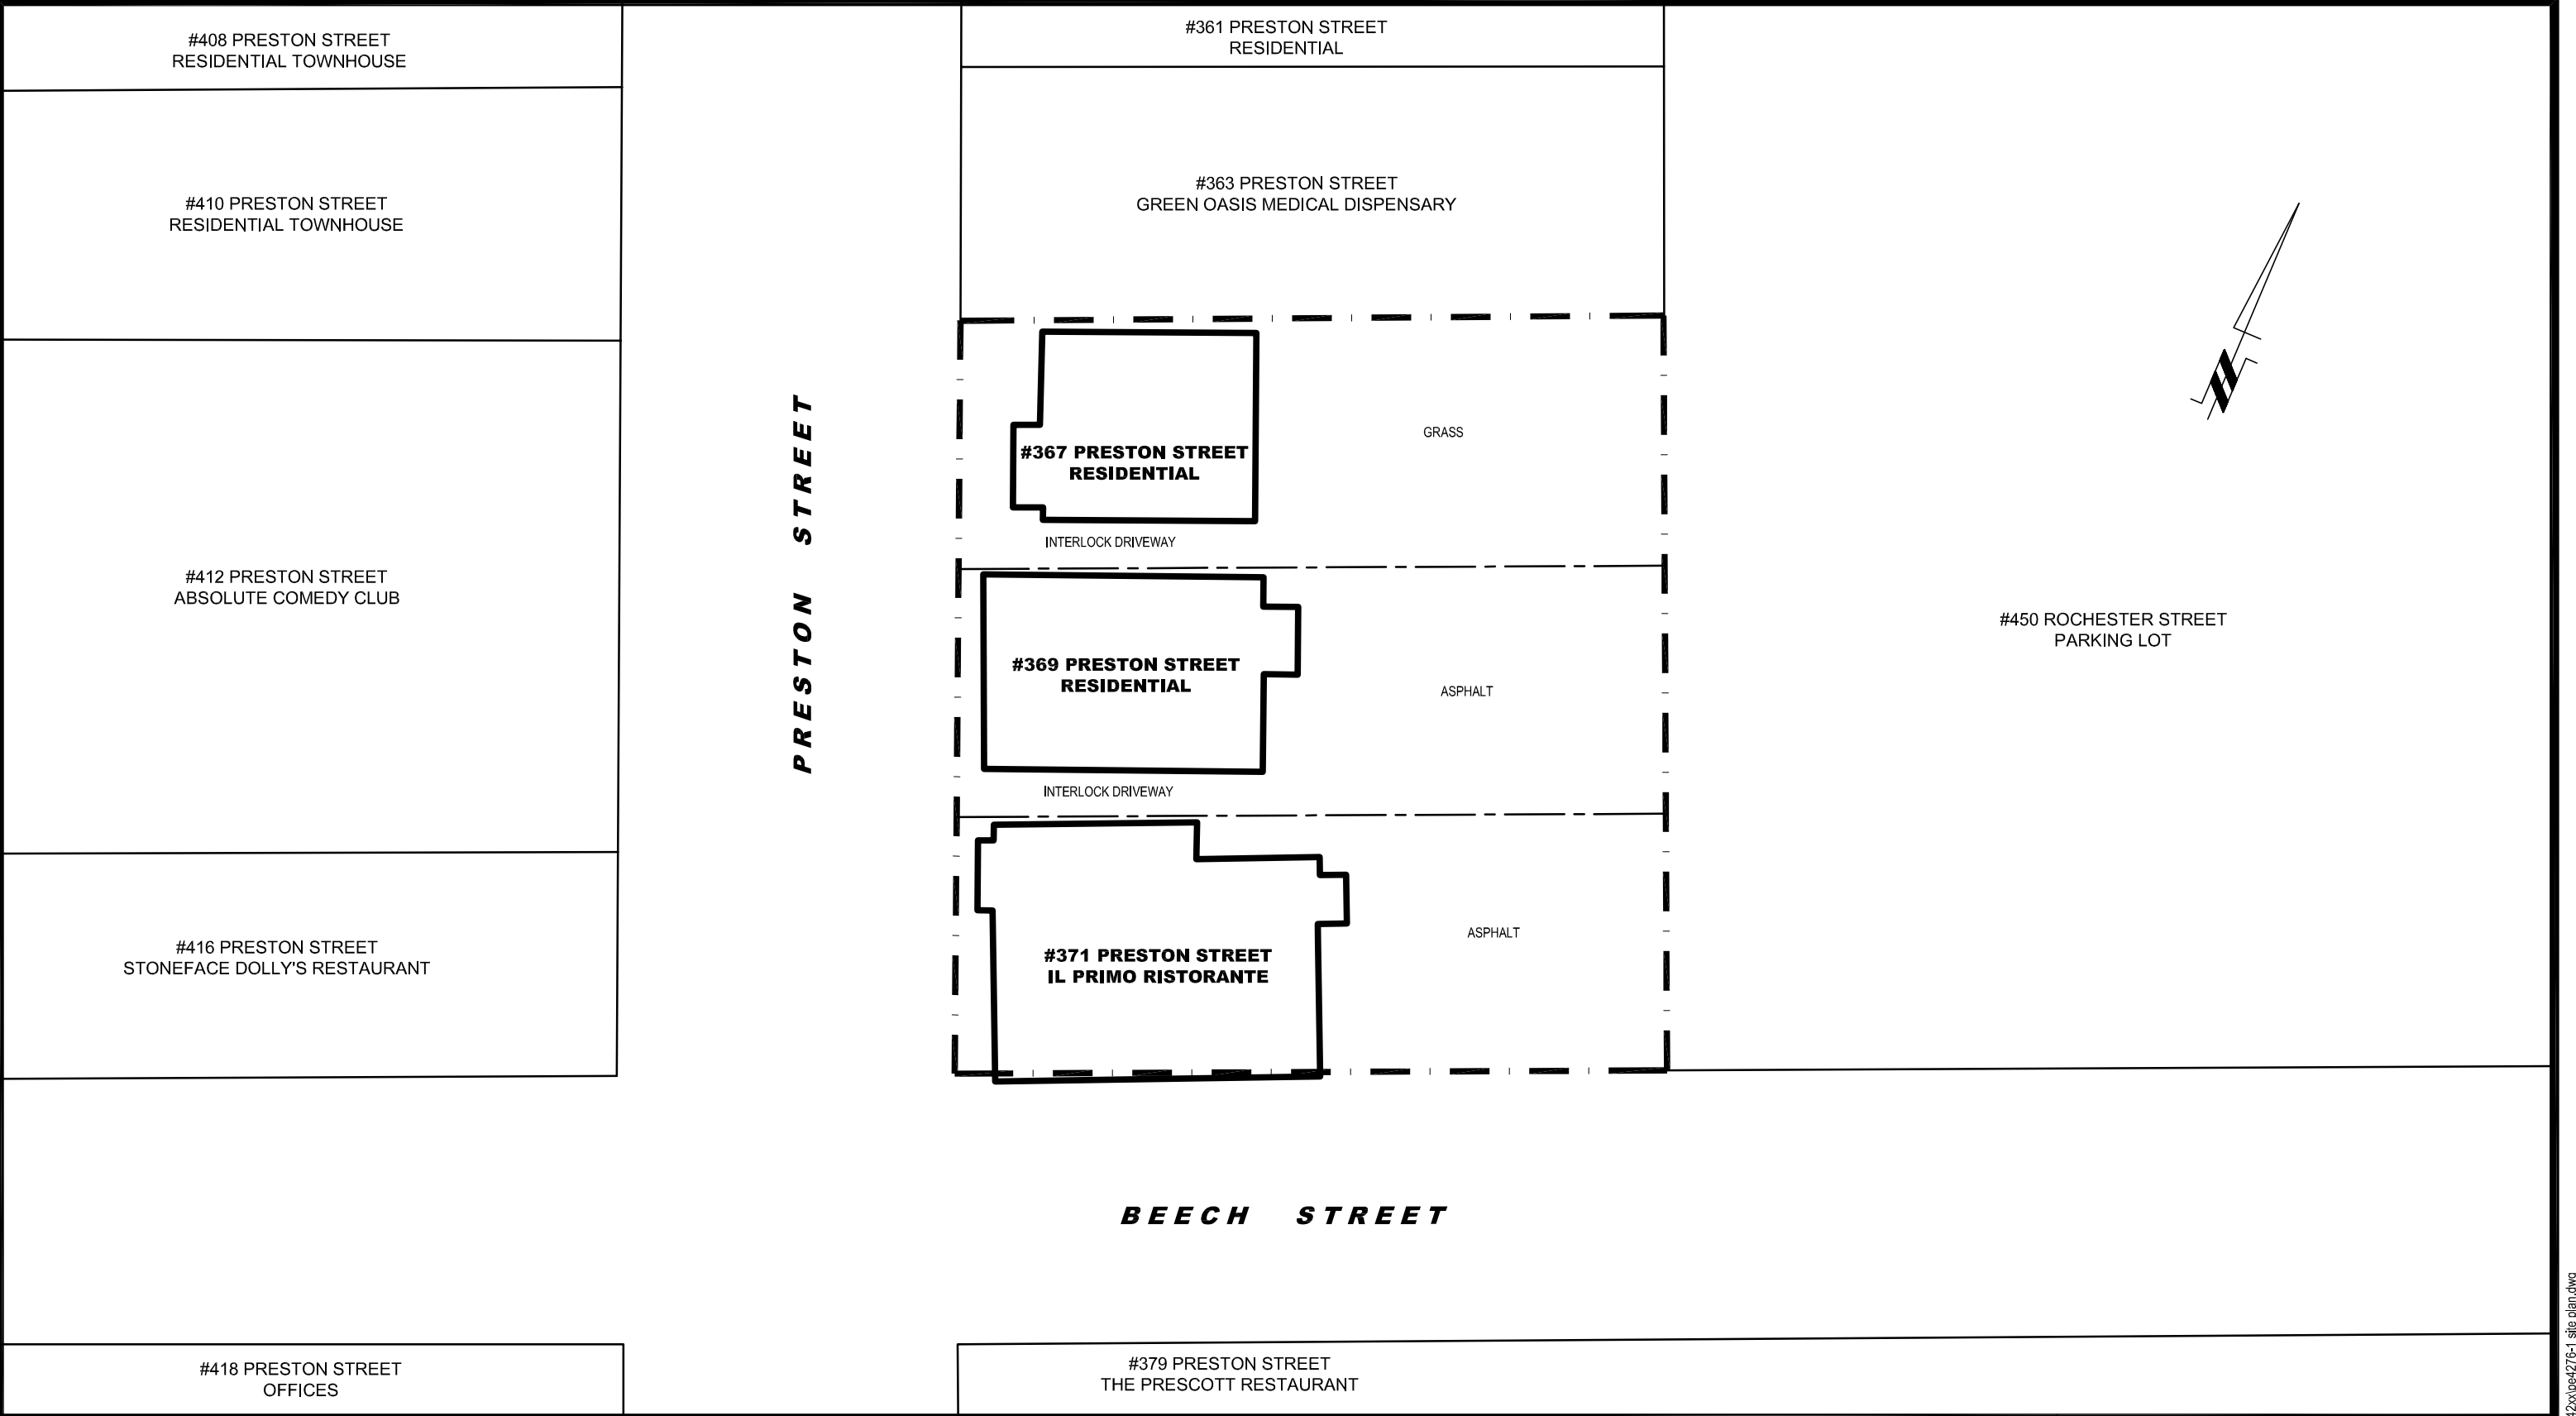
There were no concerns identified with the current use of the neighbouring properties. Land use adjacent to the subject site is illustrated on Drawing PE4276-1 – Site Plan in the Appendix.
