ST. MARY COPTIC ORTHODOX CHURCH

PHASE ONE ENVIRONMENTAL SITE ASSESSMENT

May 31, 2019

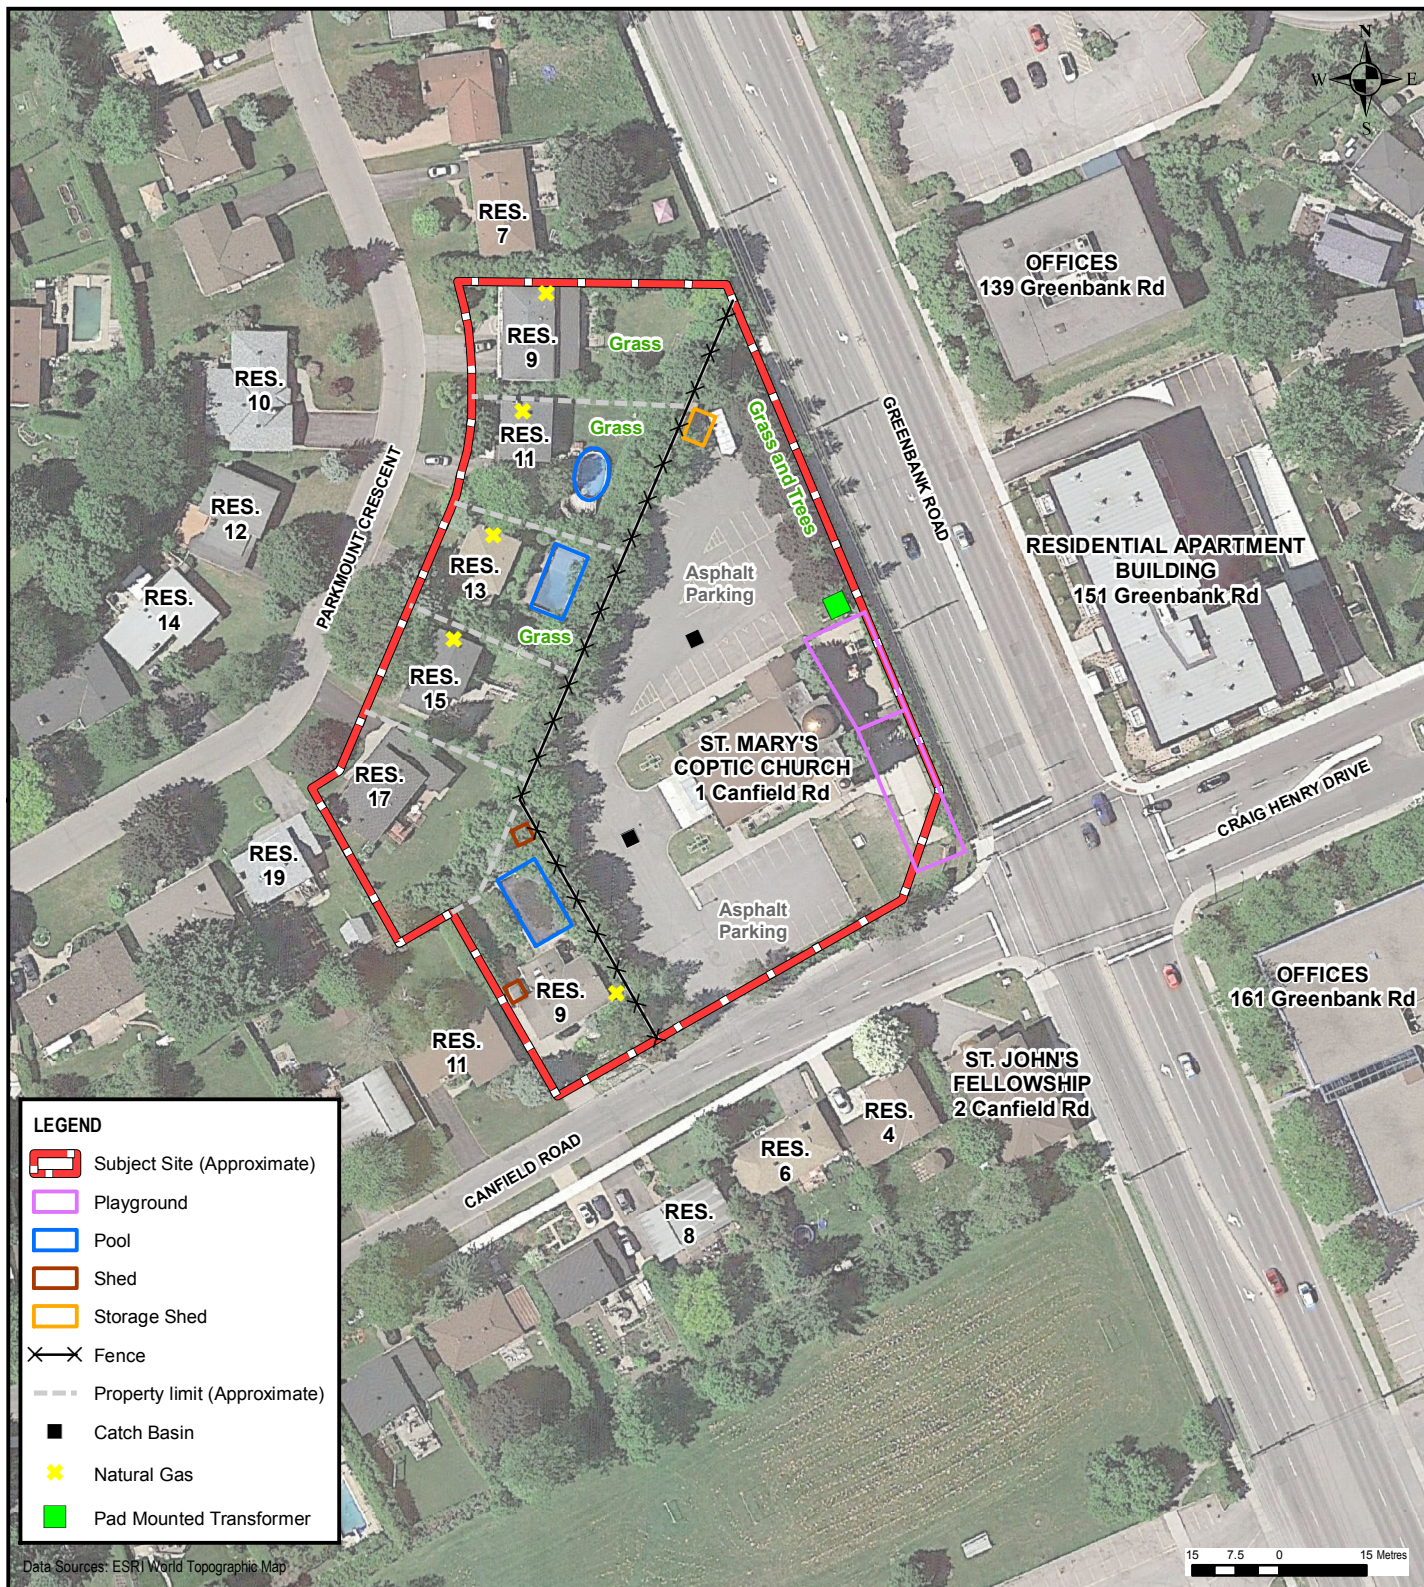
FIGURE 2 PHASE ONE CONCEPTUAL SITE MODEL

IDENTIFIABLE FEATURES	SPECIFIC OBSERVATIONS
IMMEDIATELY ADJACENT PROPERTIES	
Adjacent Land Uses	Adjacent land uses at the time of the Site reconnaissance are illustrated on Figure 2 and were noted as follows: <u>North:</u> Parkmount Crescent, followed by residential dwellings. <u>South:</u> Canfield Road, followed by St. John's Fellowship Centre. <u>East:</u> Greenbank Road followed by residential apartment building. <u>West:</u> Residential dwellings.
PHASE ONE STUDY AREA PROPERTIES	
Water Bodies	No surface water bodies were observed within the Phase One Study Area.
Areas of Natural Significance	No areas of natural significance were identified on the properties located within the Phase One Study Area.

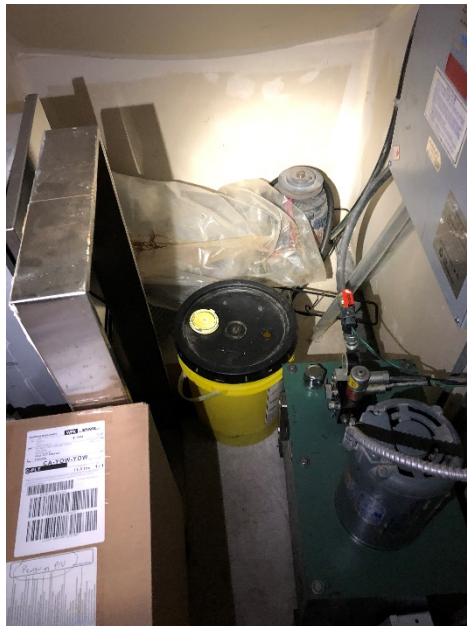
4. Photograph of the hydraulic elevator pump (bottom right) and pail of hydraulic oil (1/4 full)

iii. Above Ground Storage Tanks (AST)	<p>There were no above ground storage tanks (AST) observed during the Site reconnaissance, with the exception of the hydraulic oil tank used as part of the hydraulic elevator system.</p> <p>The volume of the hydraulic oil tank was not indicated. No concerns were noted with respect to the tank. No signs of leaks or spills were noted on the concrete floor below, and the floor appeared to be in good condition. A 20L pail of hydraulic fluid was located next to the tank. The pail was approximately one quarter full and was sealed with a tight lid. No concerns were noted with respect to the pail.</p>
iv. Potable and Non-Potable Water Sources	<p>Potable water is supplied by the municipality to the developed properties around the Site. There were no water wells observed on the Site.</p>

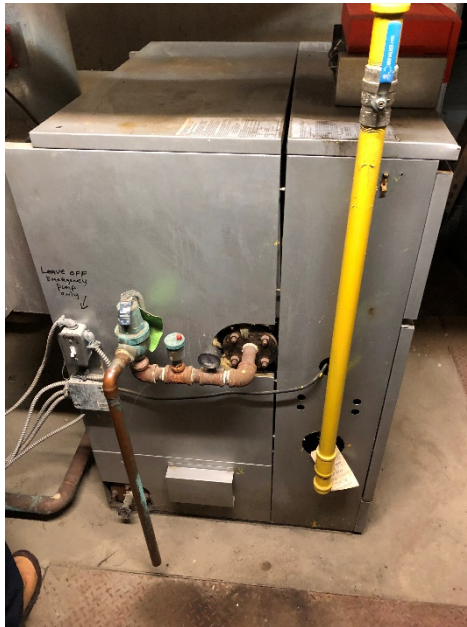
5. Natural gas boiler, located in basement of the church

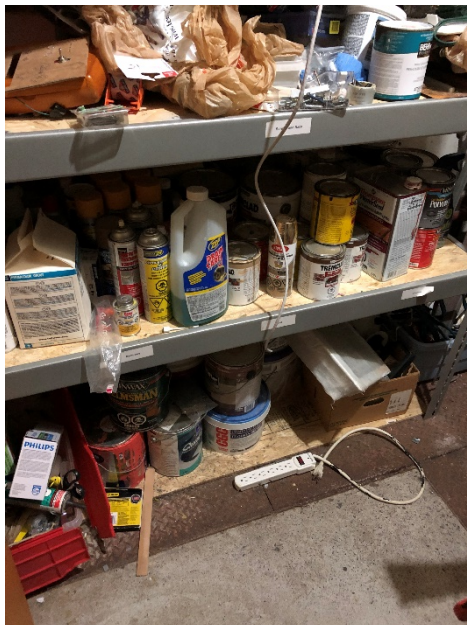
6. General use chemicals, stored in shelving unit, in maintenance room of the church

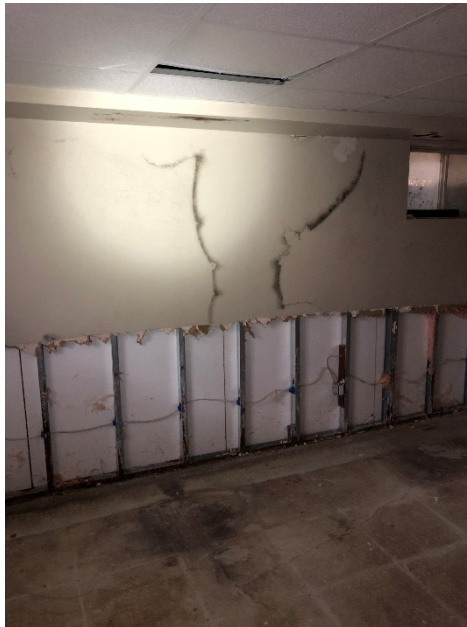
9. Basement of 9 Parkmount Crescent; visible signs of mould can be seen on some walls.

i. Entry and Exit Points	<p>The church is equipped with at least three entry and exit points, including the large main entrance way. The dwellings all have a main front entrance, and a rear patio entrance.</p>
ii. Heating & Cooling Systems	<p>The church is heated by a natural gas fired boiler system. The residences are heated by natural gas forced air furnaces, with the exception of the residence at 17 Parkmount Crescent, which is heated by electrical baseboards. Some residences are equipped with air conditioning units.</p>
iii. Drains, Pits, Sumps	<p>A sump pit was observed in the bakery room of the church. The lid could not be opened at the time of the site visit. The pump appears to discharge to the storm sewer located in the parking lot. No pits or sumps were noted in the residences.</p>
iv. Unidentified Substances	<p>No evidence of unidentified substances that could have an effect on the environmental conditions at the Site was observed.</p> <p>Note that mould was observed on some walls in the basement of the building at 9 Parkmount Crescent.</p>

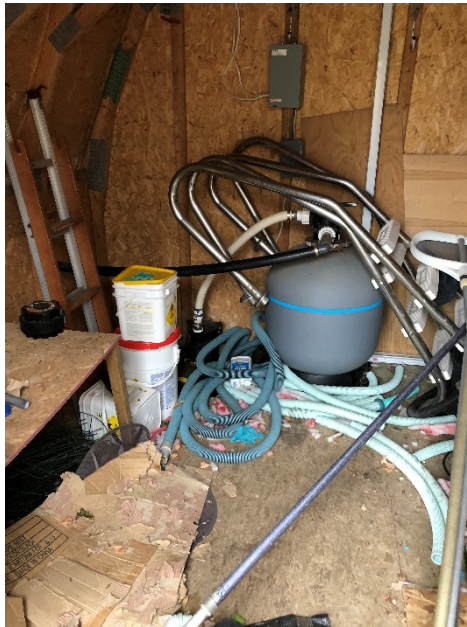
15. Interior of pool shed at 9 Canfield Road
