Phase I-Environmental Site Assessment

1050 and 1060 Bank Street Ottawa, Ontario

Tel: (613) 226-7381 Fax: (613) 226-6344 www.patersongroup.ca December 10, 2019

Report: PE4783-1

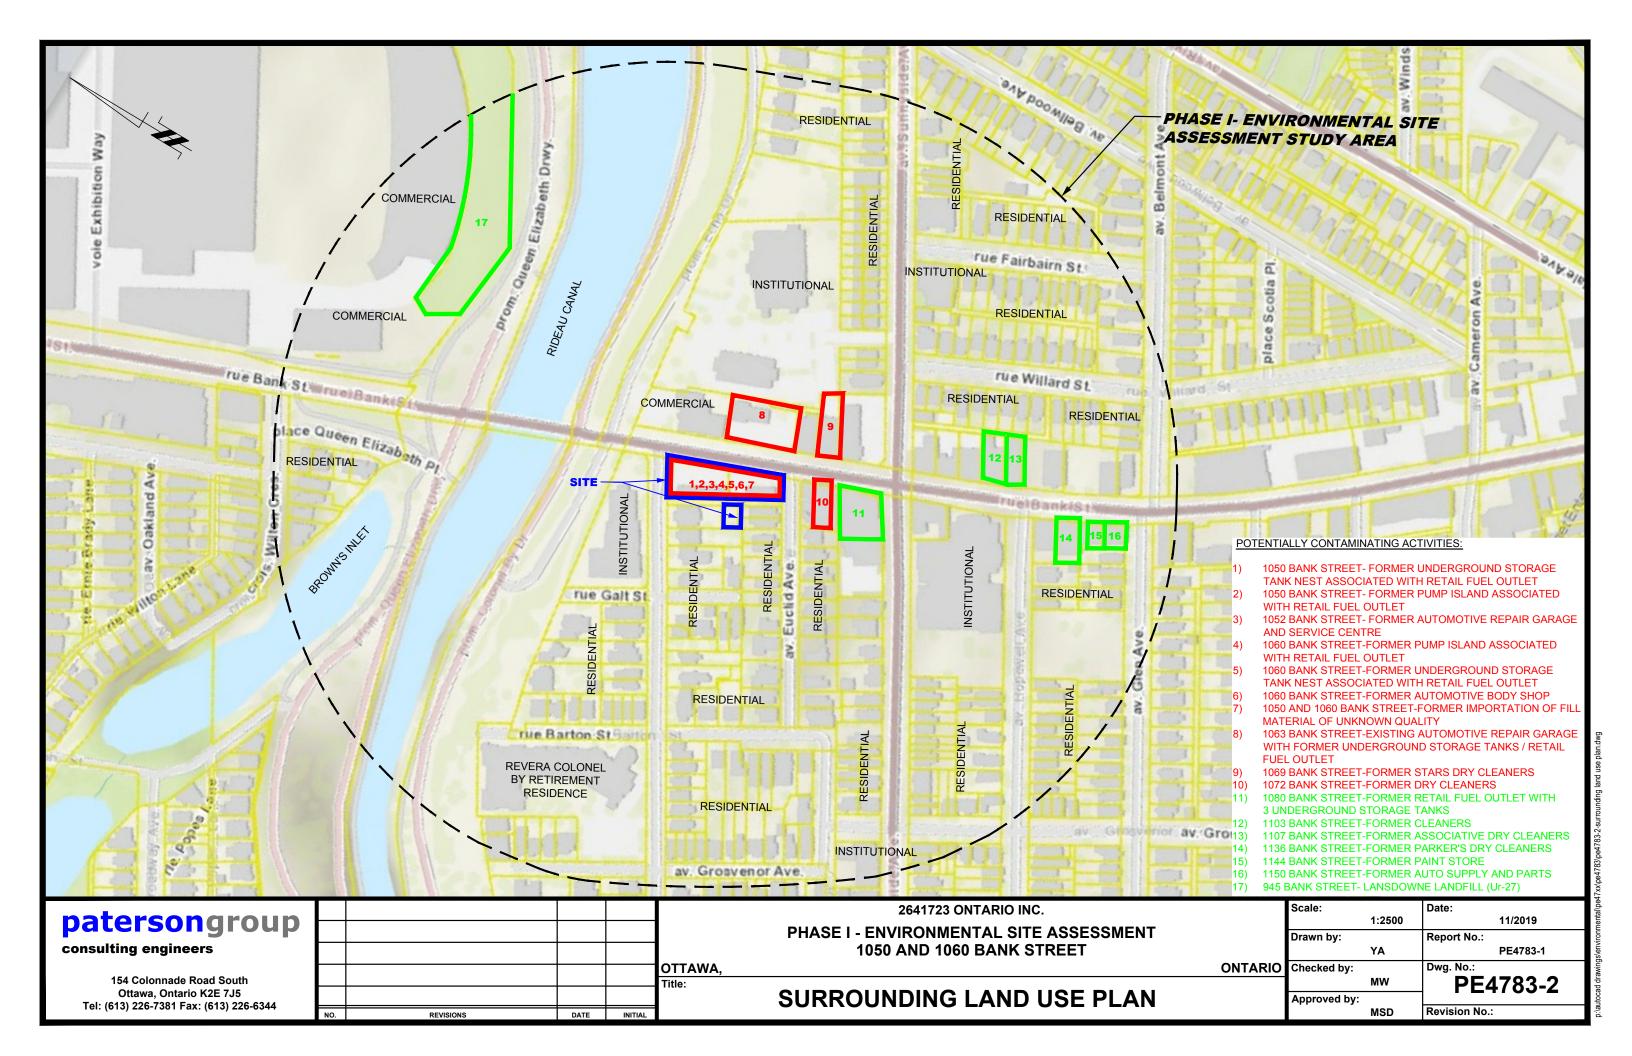
DRAWING PE4783-2 – SURROUNDING LAND USE PLAN

Remaining land use within the Phase I Study Area is primarily residential with commercial land use along Bank Street, and parkland along the Rideau Canal. A previously noted automotive service garage building remains present at 1063 Bank Street although it is no longer operational; this property is currently operated as a commercial parking lot. No existing off-site PCAs were identified at the time of the site visit. Surrounding land use within the Phase I Study Area is presented on Drawing PE4783-2 – Surrounding Land Use Plan.

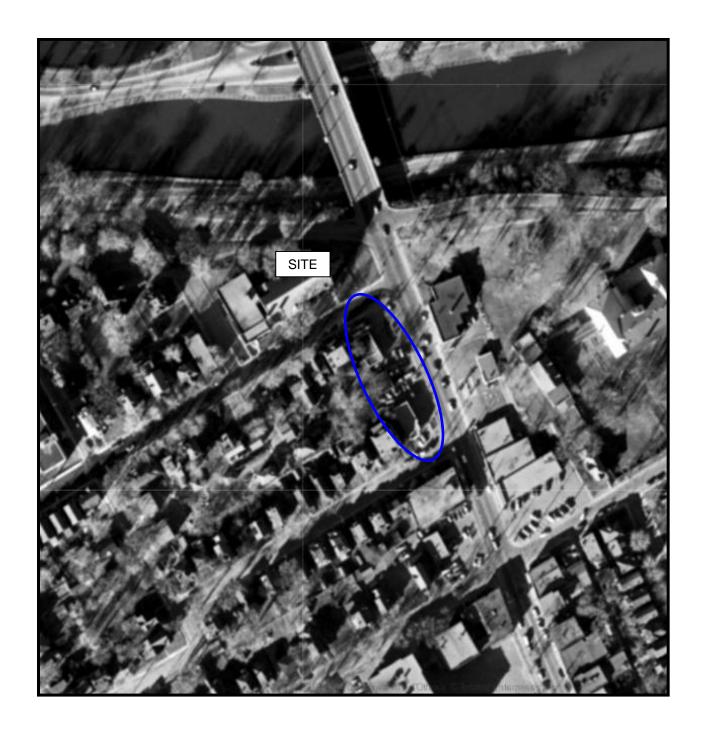
AERIAL PHOTOGRAPH 1958

1958	The Phase I Property appears to have been developed with by two (2) additional buildings, on the central portion and an existing building on the southern portion. Properties to the east of Bank Street have been developed for commercial purposes. A retail fuel outlet can be seen on the adjacent property to the east across Bank Street. Neighbouring lands along Bank Street appear to be occupied by commercial buildings and residential buildings on the adjacent streets. A retail fuel outlet can be seen two properties south of the Phase I Property. Lands to the west remain unchanged from the previous photograph.
1965	One of the former on-site buildings, specifically the middle building appears to have been demolished and replaced by expanding the

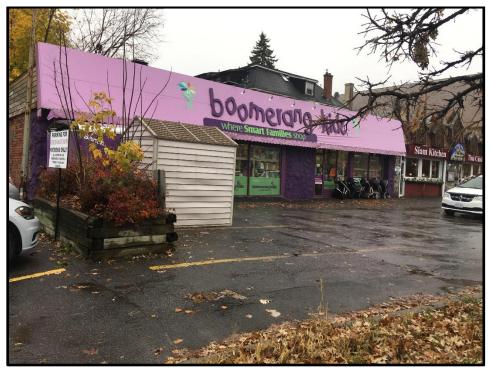
Photograph 1: Northwestern view of the Phase I Property (1050 Bank Street) from Bank Street looking northwest.

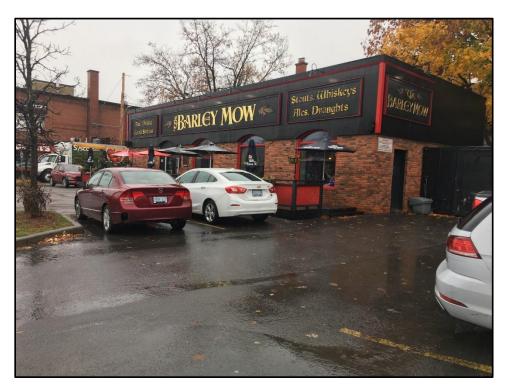
Photograph 2: Southwestern view of the Phase I Property (1060 Bank Street) from Bank Street, looking southwest.

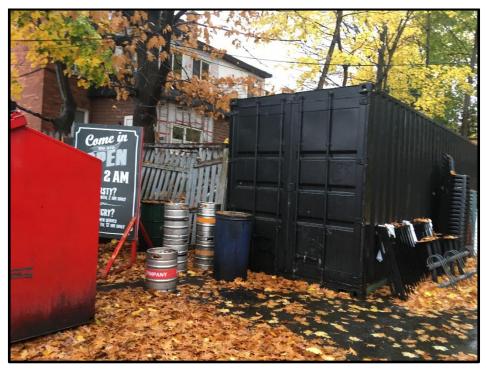
Photograph 3: Storage area behind Barley Mow, looking southwest. Photograph illustrates residential property adjacent to the west of 1060 Bank Street, across the easement.

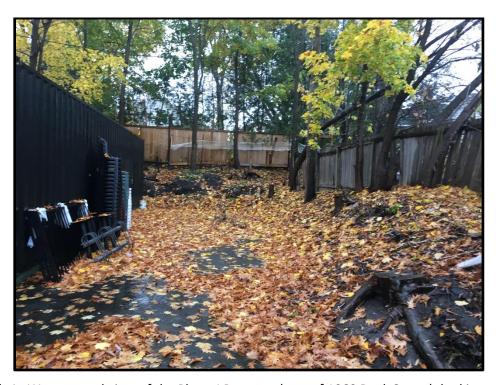
Photograph 4: West-central view of the Phase I Property (part of 1060 Bank Street), looking west.

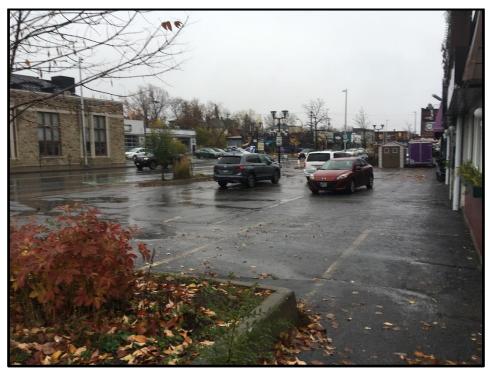
Photograph 5: View of the northern portion of the Phase I Property, looking southeast. Photograph illustrates commercial properties to the adjacent east, across Bank Street.

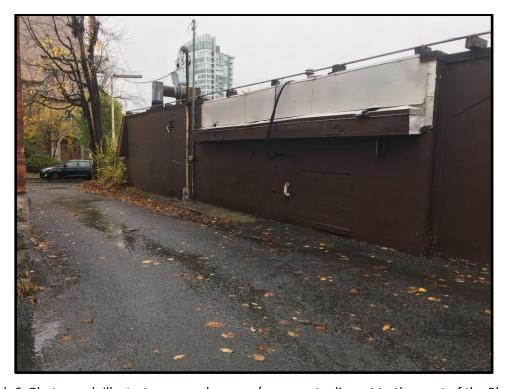
Photograph 6: Photograph illustrates access laneway/easement adjacent to the west of the Phase I property, facing north.
