March 12, 2020 File: PE4897-LET.01

Subject: Phase I - Environmental Site Assessment Update 1380 Upper Canada Street (Block 2 of Registered Plan 4M-1627) Ottawa, Ontario

Further to your request, Paterson Group (Paterson) conducted a Phase I - Environmental Site Assessment (ESA) Update for the aforementioned property. This report updates a Phase I ESA entitled "Phase I-Environmental Site Assessment, Vacant and Agricultural Property, 405- 425 Huntmar Drive and 3001 Palladium Drive, Ottawa, Ontario" prepared by Paterson, dated January 8, 2014 (Report: PE3146-1).

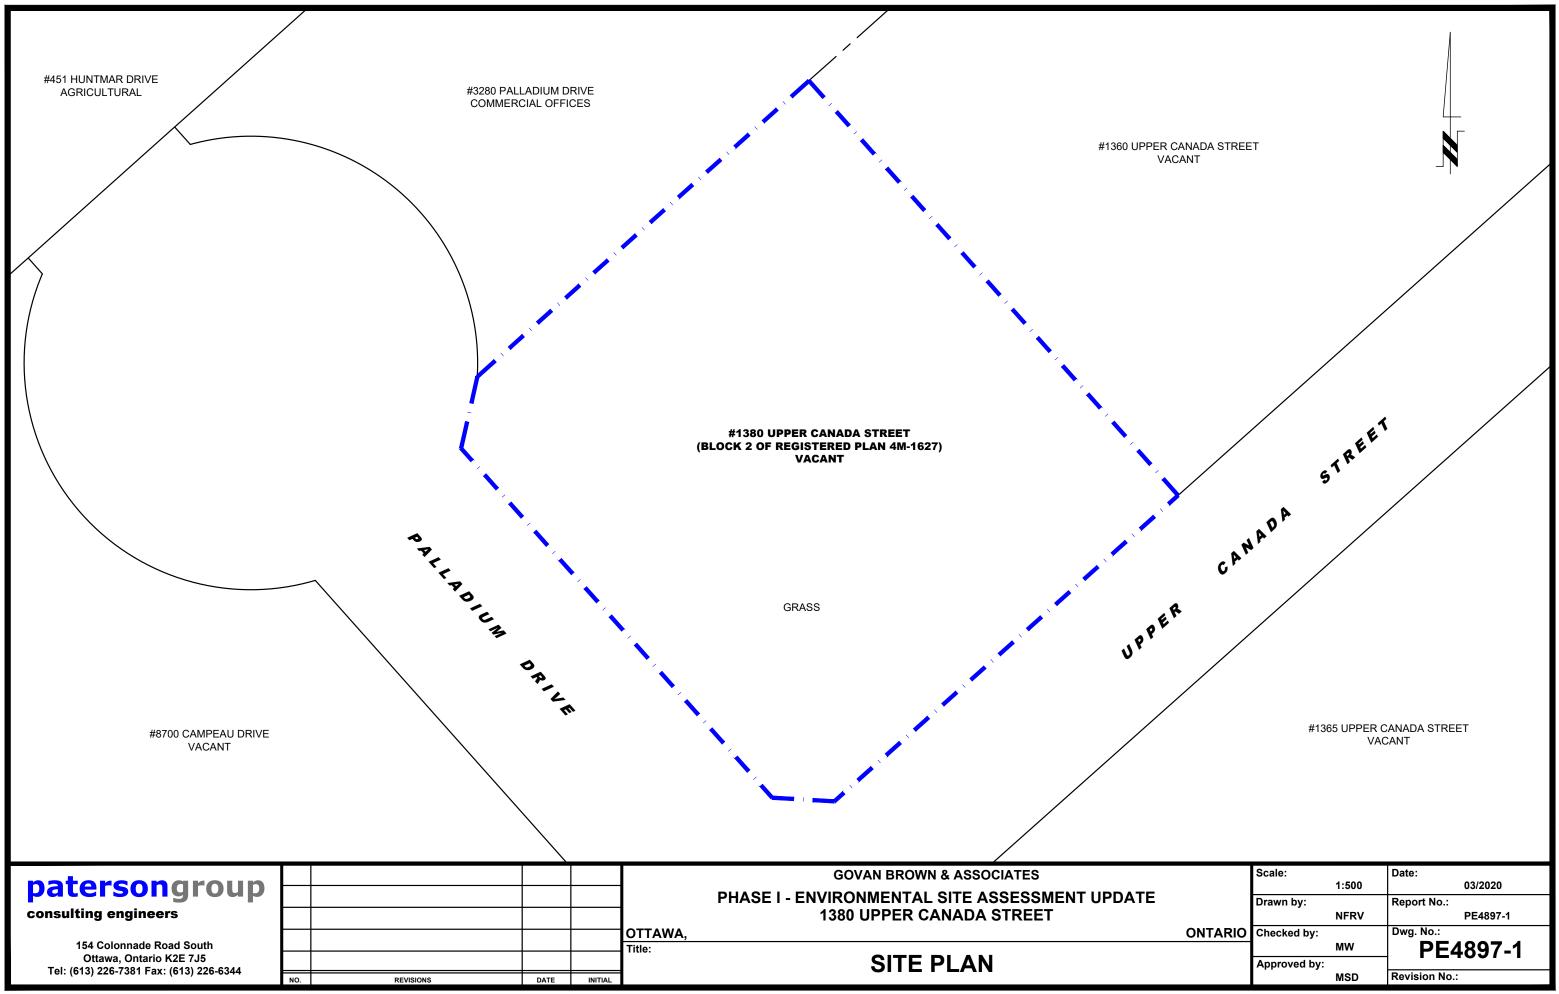
Scale:		Date:
		1:500	03/2020
	Drawn by:		Report No.:
		NFRV	PE4897-1
ONTARIO	Checked by:		Dwg. No.:
		MW	PE4897-1
	Approved by:		
		MSD	Revision No.:

The current configuration of the subject site has changed since the 2014 Phase I ESA, which is shown on Drawing PE4897-1 – Site Plan, attached to this report.
