## **Phase II Environmental Site Assessment Update 112 Montreal Road, Ottawa, Ontario**

OTT-00214936-B0

January 14, 2014

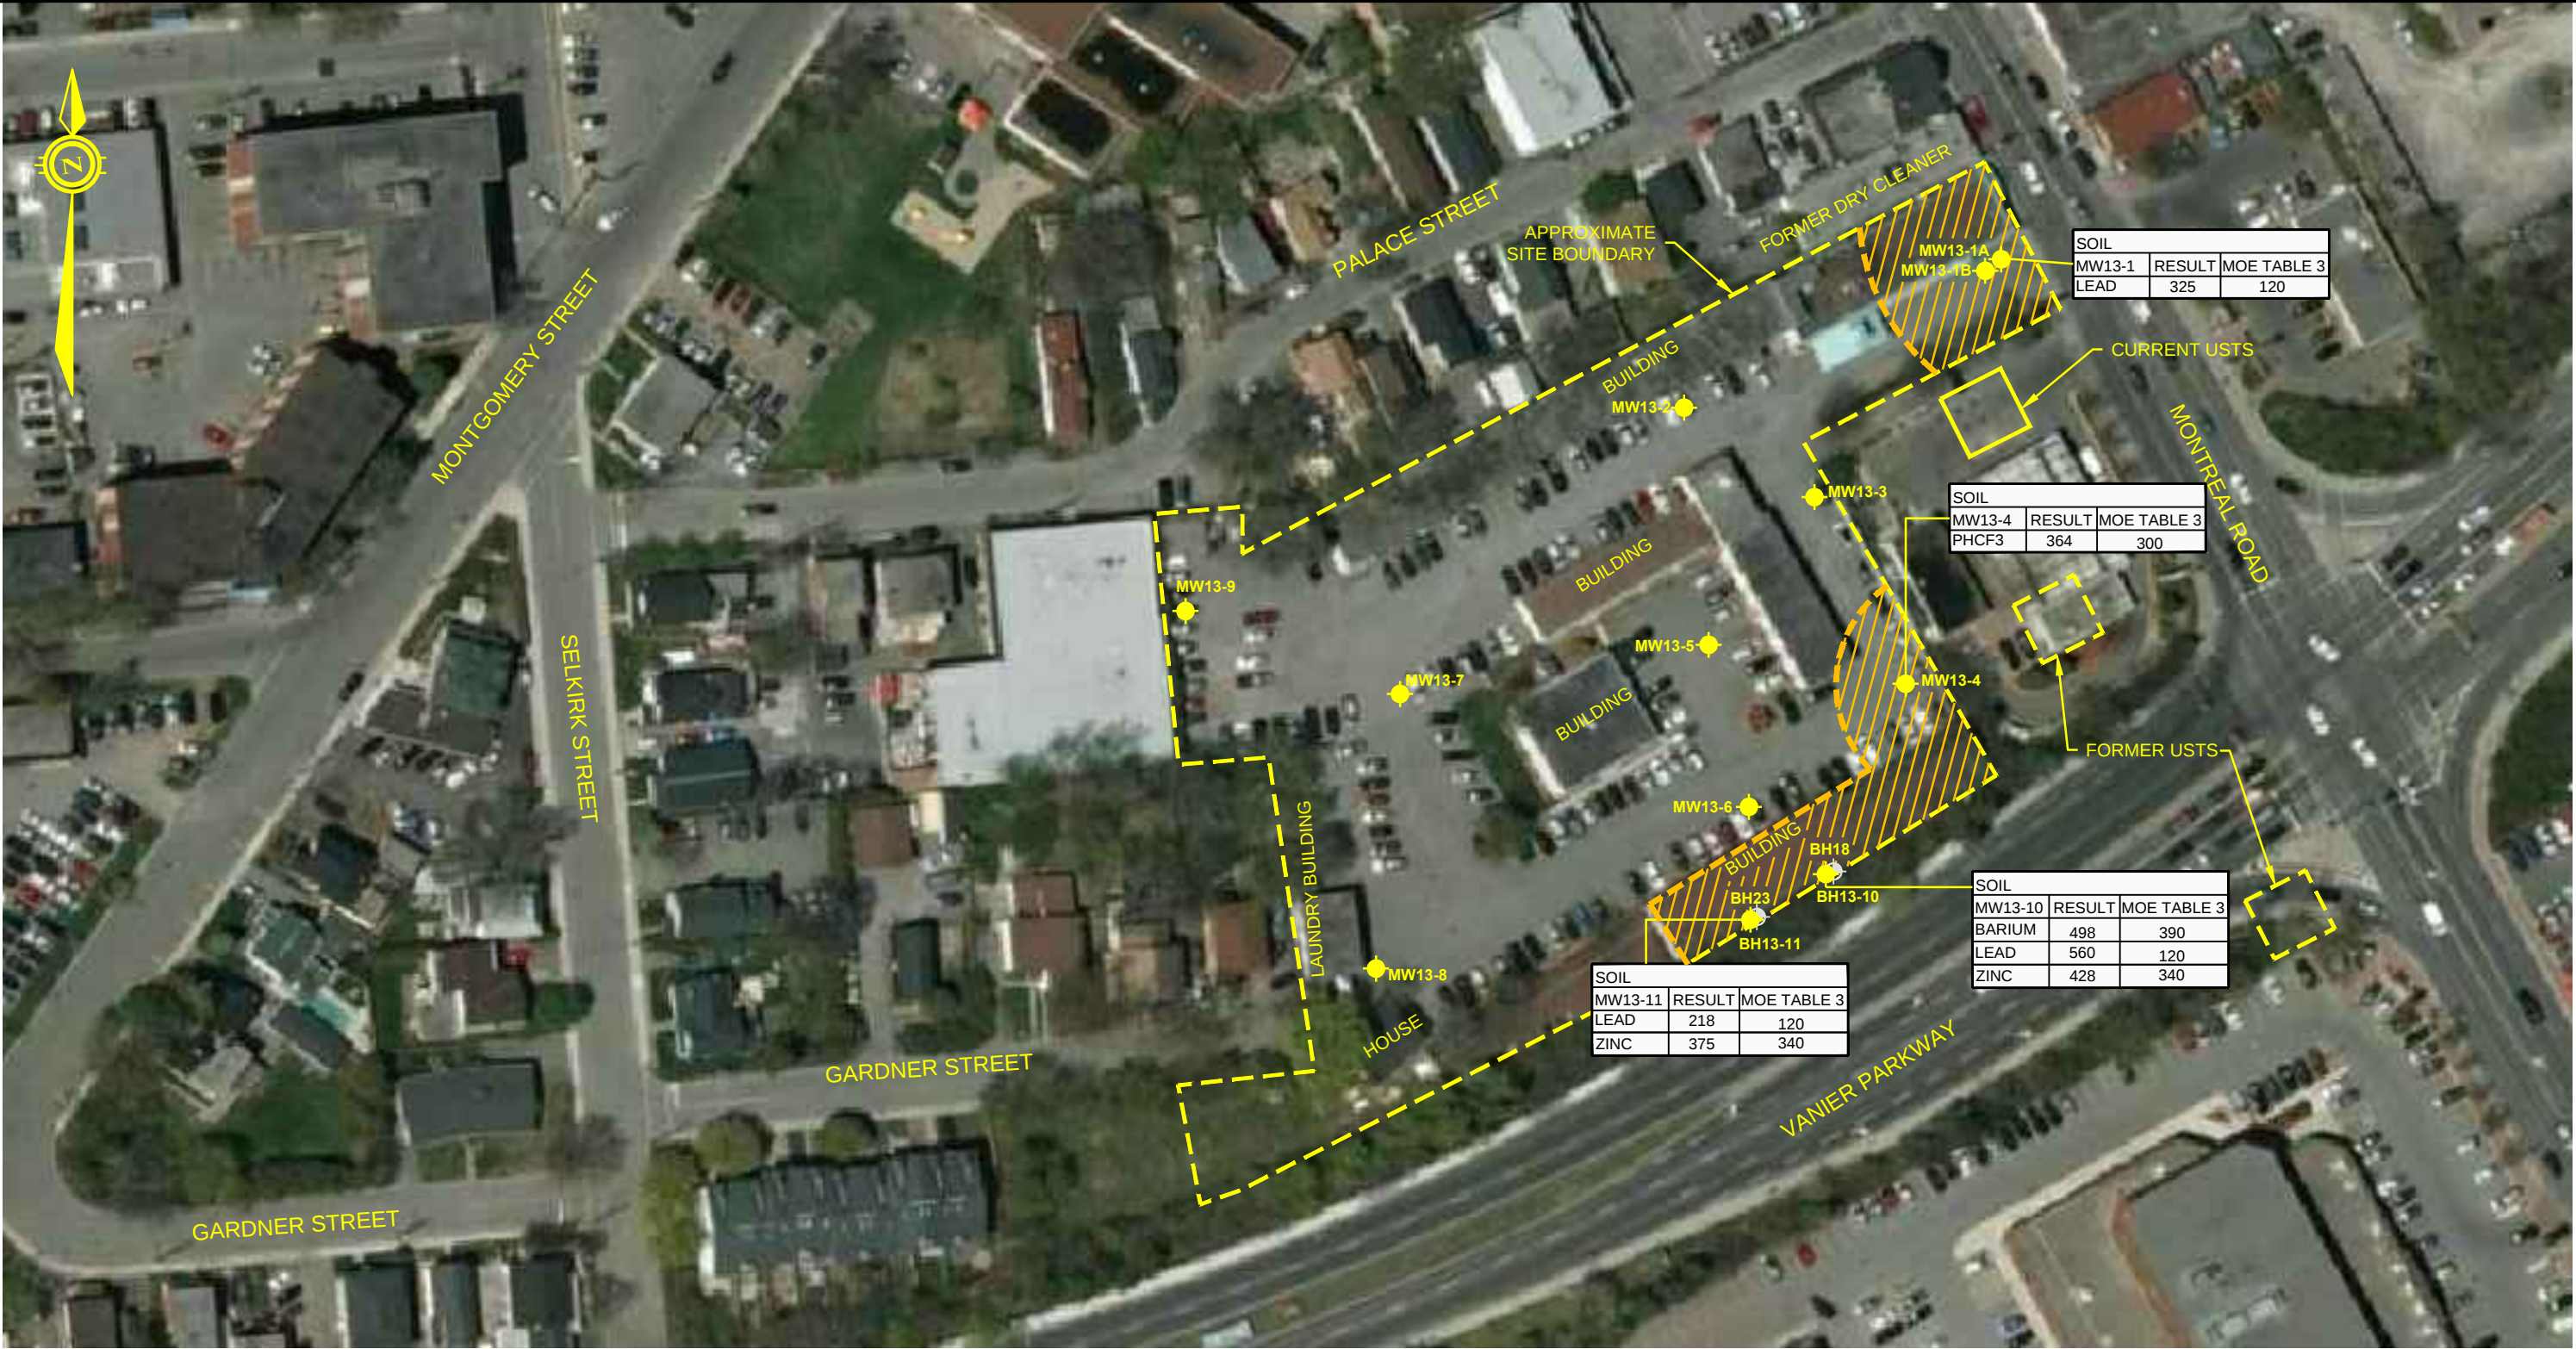
PHC impacted soil is found in the northeast part of the site at the site and is likely limited in extent, since the nearest boreholes have non-detectable concentrations of PHC F3. Because the PHC-impacted soil is present above the water table, it would not have been transported by groundwater. It is likely the result of

**MW13-8** MONITORING WELL LOCATION & NUMBER
- MOE TABLE 3** FULL DEPTH GENERIC SITE CONDITION STANDARDS (2011)  
IN A NON-POTABLE GROUNDWATER CONDITION
- PHC** PETROLEUM HYDROCARBONS  
(CONCENTRATIONS IN ug/g)
