PHASE ONE ENVIRONMENTAL SITE ASSESSMENT

1830 Trim Road, Ottawa, Ontario

1 August 2019

PHASE ONE ENVIRONMENTAL SITE ASSESSMENT - FINAL

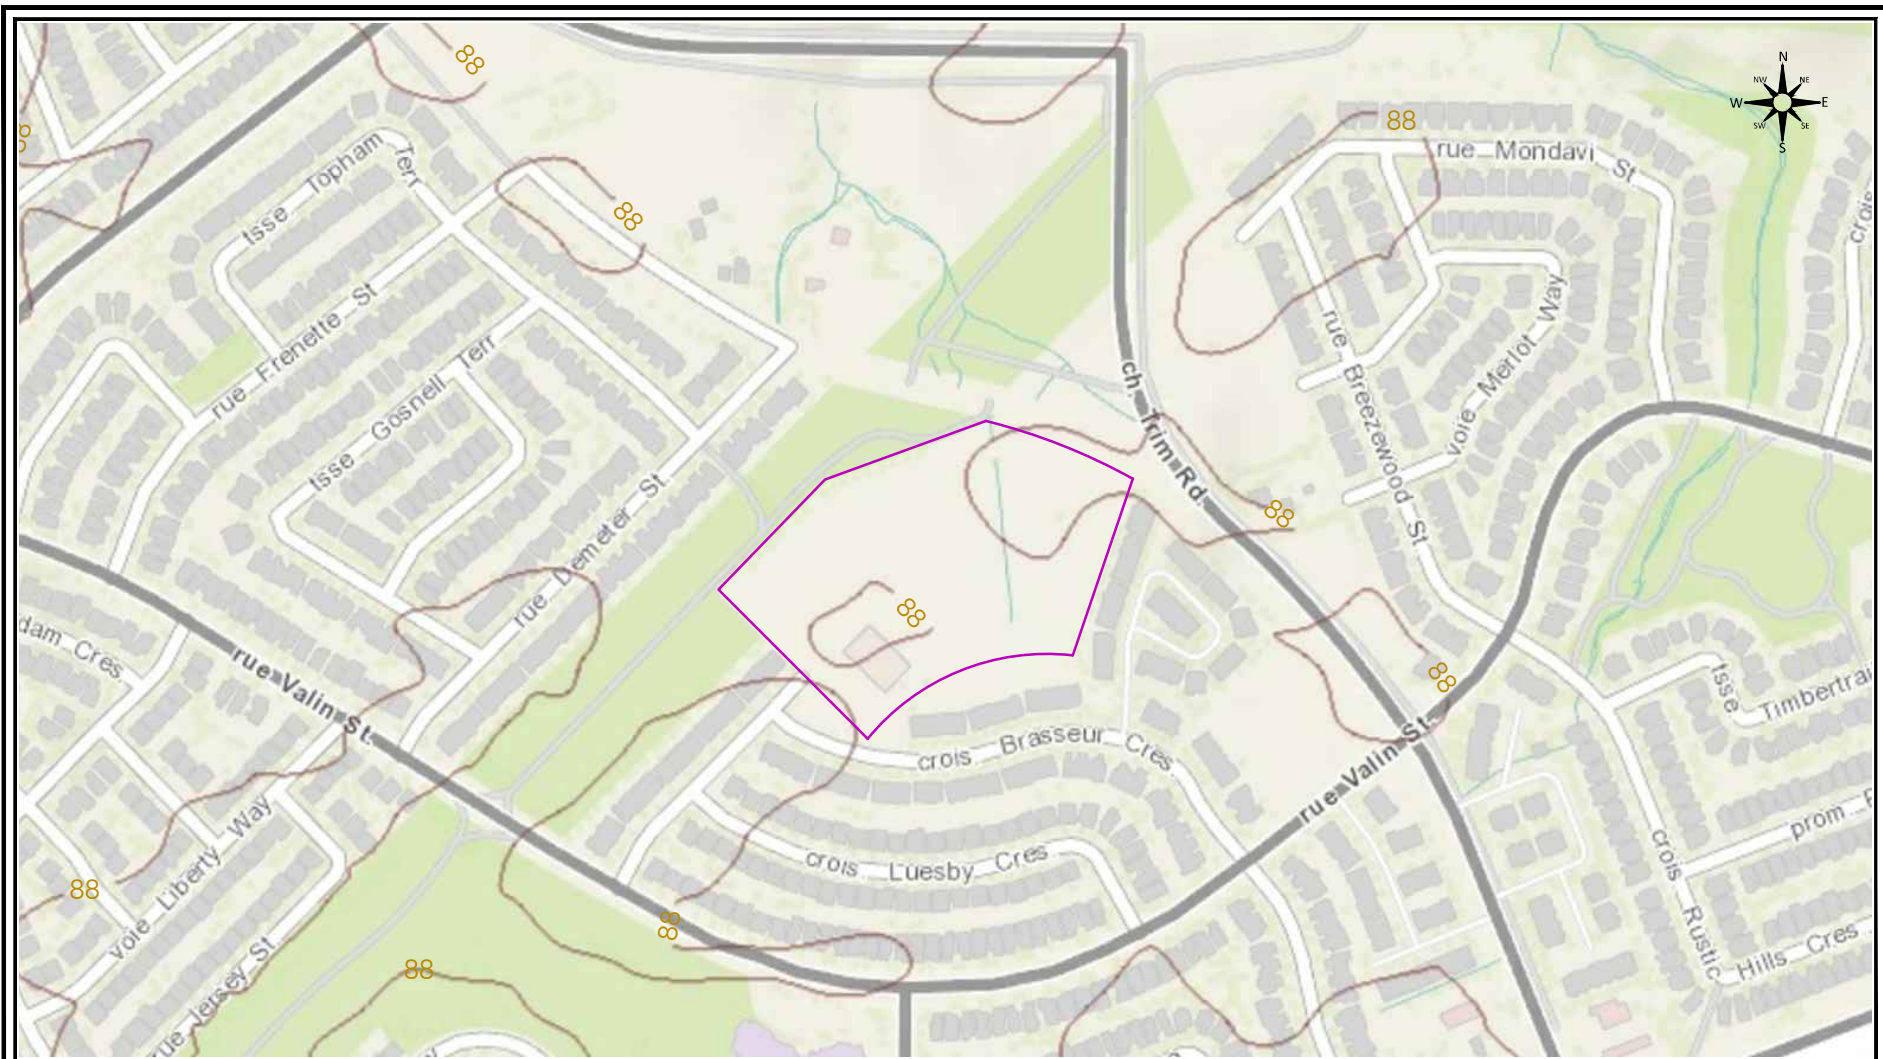
Title: TOPOGRAPHY PLAN	
<div style="display: flex; align-items: center;"> <div> <p>ARCADIS</p> </div> </div>	Project: PHASE I ENVIRONMENTAL SITE ASSESSMENT 1830 TRIM ROAD, OTTAWA, ONTARIO
Date: OCTOBER 2017	Client: FirstGroup
<div style="display: flex; justify-content: space-between; align-items: center;"> <div style="text-align: center;"> <p>75 0 75 150</p> <p>Metres</p> <p>1:5500</p> </div> <div style="border: 1px solid black; padding: 5px; flex-grow: 1;"> <p style="text-align: center; margin: 0;">FIGURE 3</p> </div> </div>

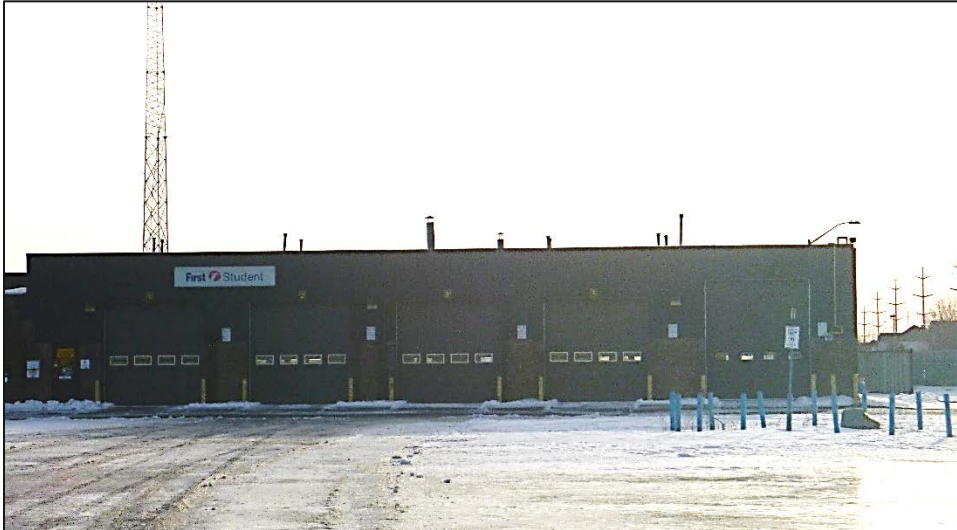
Photo: 1

Description:
Front of the school bus maintenance facility

Location:
Centre of property facing southwest

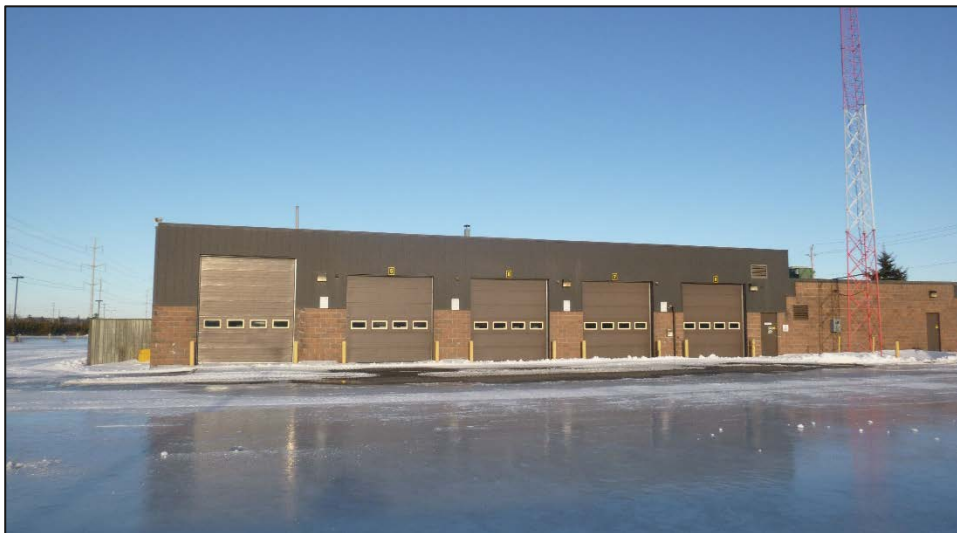
Photo: 2

Description:
Back of the school bus maintenance facility

Location:
Southwest side of property facing northeast

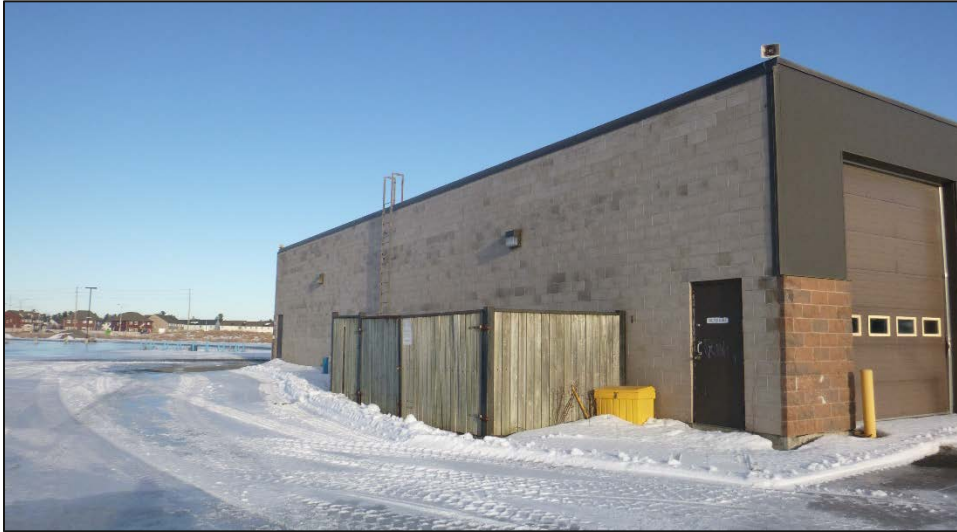
Photo: 4

Description:
North side of the school
bus maintenance facility

Location:
North side of facility facing
southeast

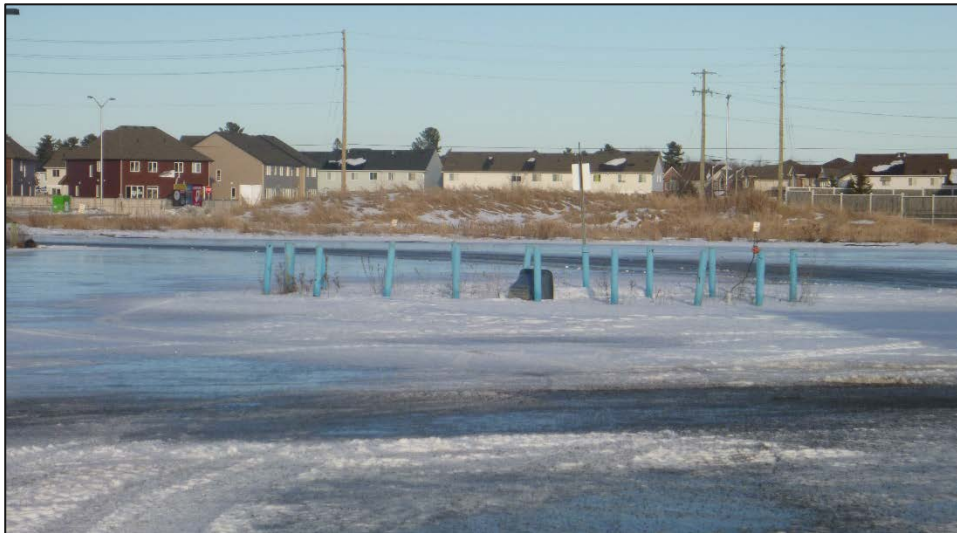
Photo: 5

Description:
Former location of
aboveground propane tank
(foreground) and vegetated
berm (background)

Location:
North side of facility facing
northeast

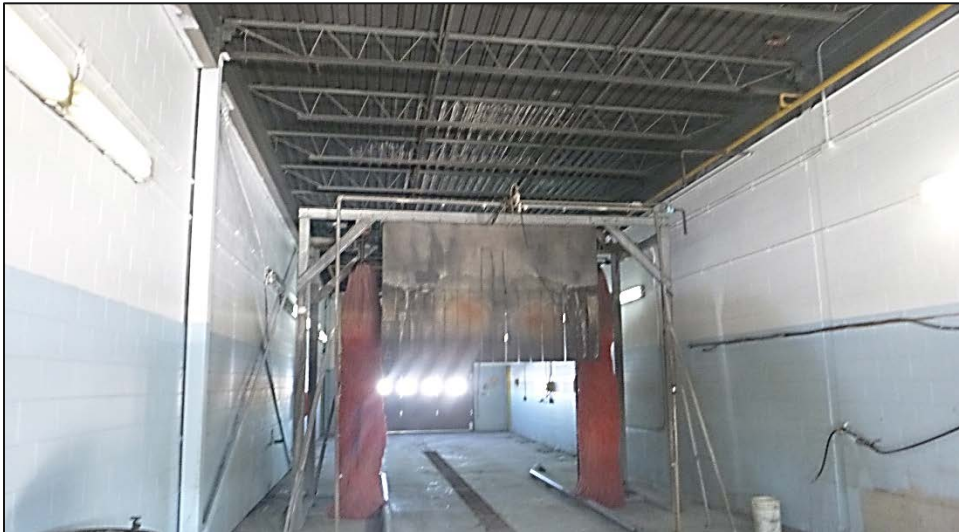
Photo: 7

Description:
Bus wash bay

Location:
Back side of wash bay
facing northeast

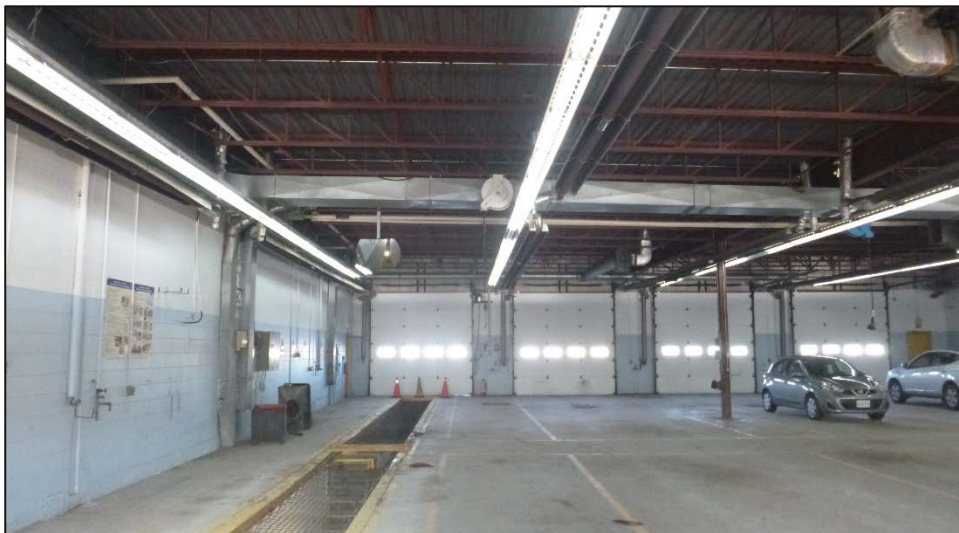
Photo: 8

Description:
School bus maintenance pit
in garage

Location:
Back side of garage facing
northeast

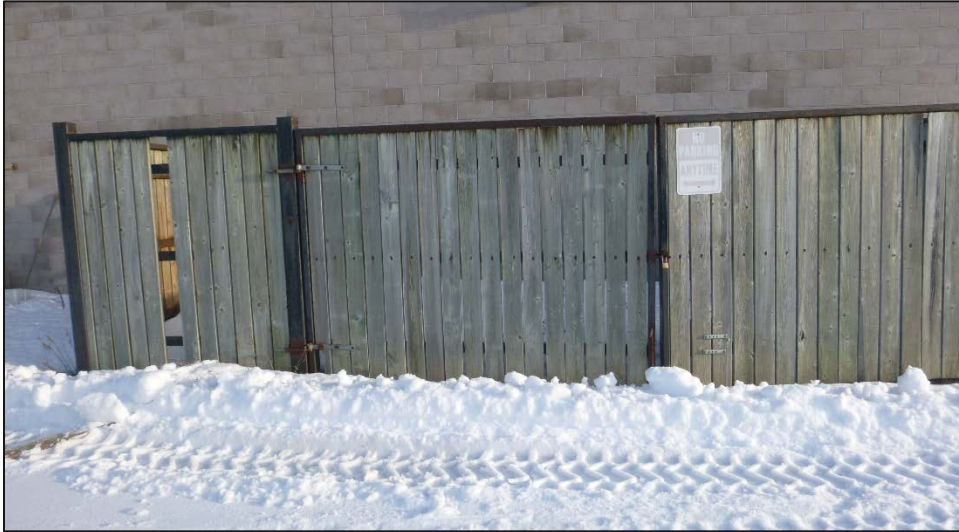
Photo: 13

Description:
Waste storage area

Location:
Wash bay side of facility

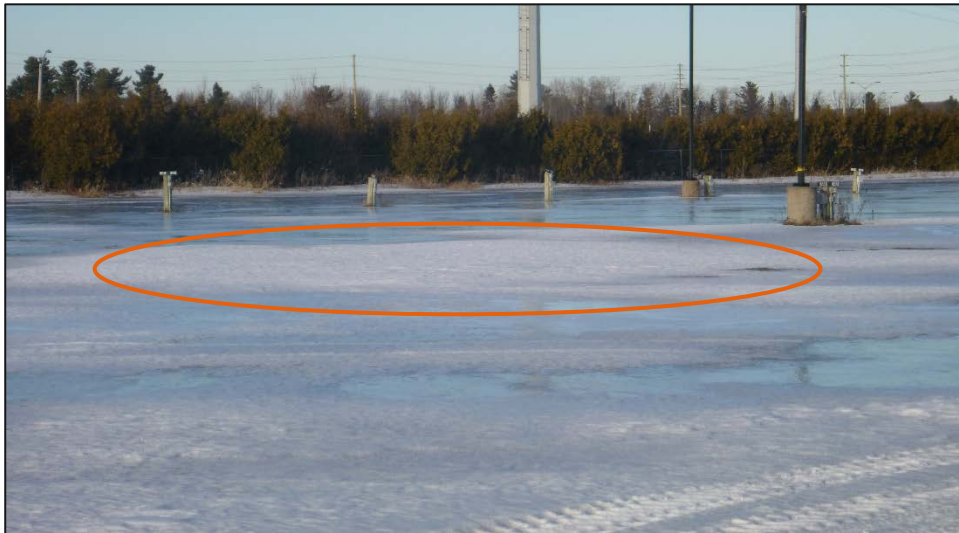
Photo: 14

Description:
Former 25,000 L UST area

Location:
Parking Lot

Two storage tanks were identified within both the Fuel Storage Tank and Historical Fuel Storage Tank Databases searches, and both results are related to the subject property. The tanks are listed as two steel single-walled 25,000 L USTs installed in 1989 for the purpose of storing diesel and gasoline fuel. Corrosion protection is listed to comprise a sacrificial anode on both tanks. The existence of these tanks on the subject property is considered a PCA.

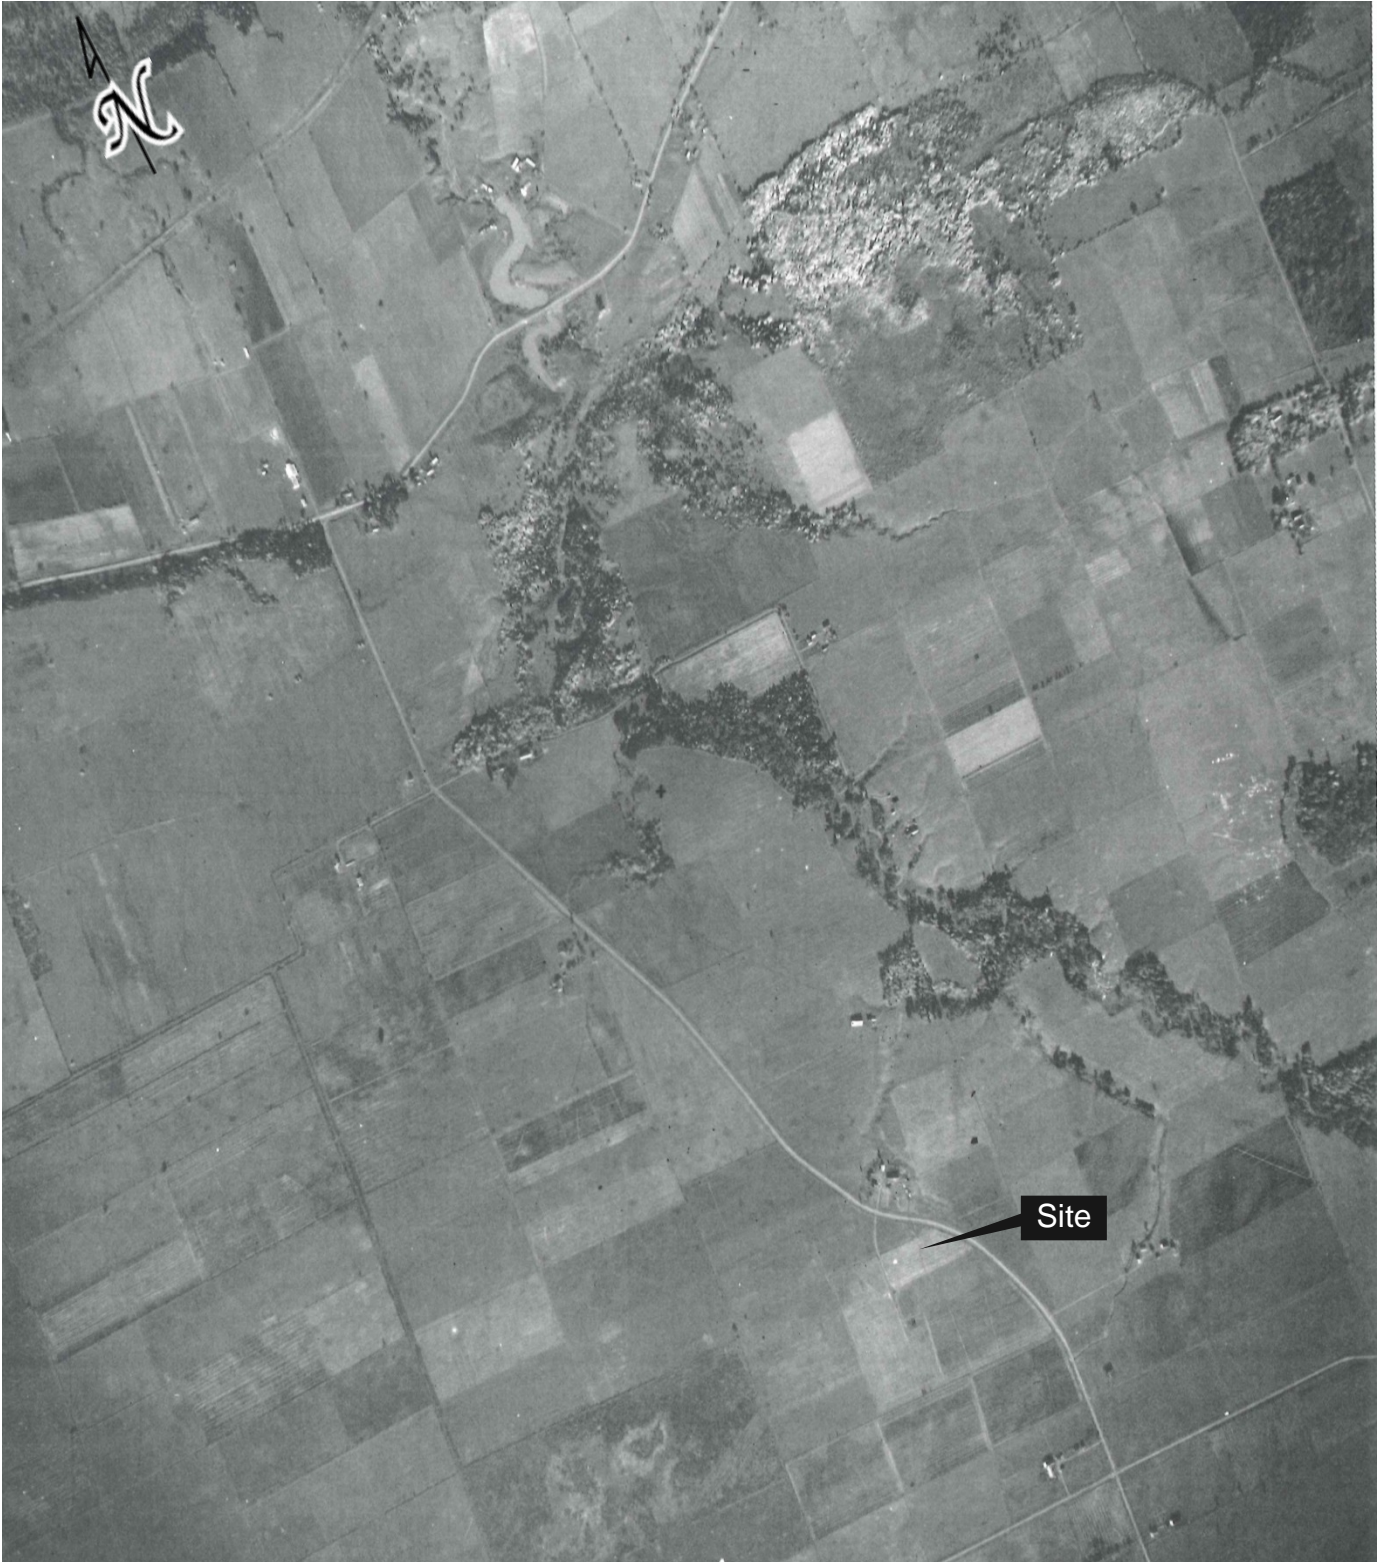
Year: 1945

Source: National Air Photo Library , Photo: A9551-106 (Approx. Scale: 1:15,000)

Year	Description
1945 A9551-106 (1:15,000)	<ul style="list-style-type: none">- The subject property is vacant at the time of this photograph- The subject property and surrounding lands north, east, south and west appear to comprise mainly farmed land.- Two buildings and a few other small structures are visible to the northeast of 1830 Trim Road, one larger possible farm house as well as several smaller structures.
1960	<ul style="list-style-type: none">- No significant changes were observed from the previous (1945) photograph.

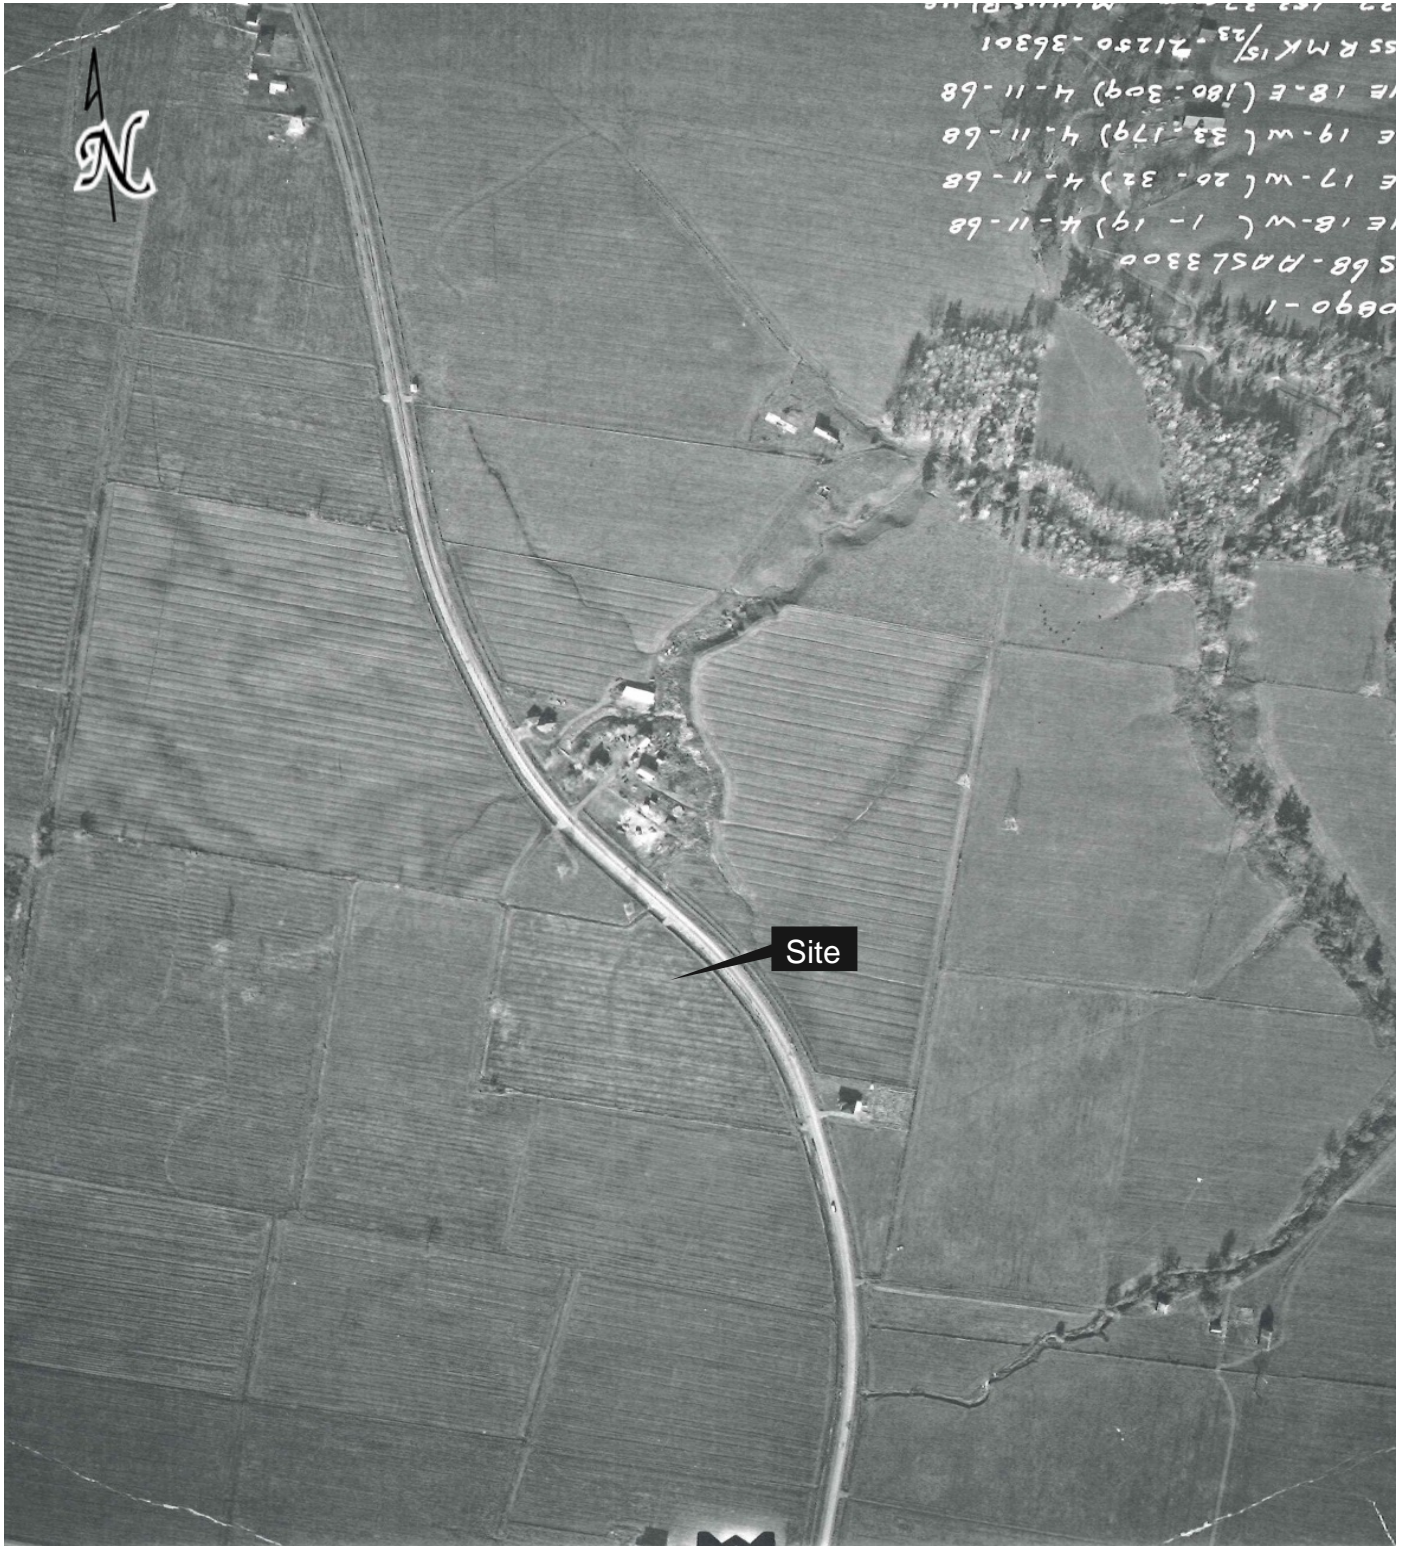
Year: 1968

Source: National Air Photo Library , Photo: A20890-1 (Approx. Scale: 1:7,000)

Year	Description
A17262-134 (1:25,000)	
1968 A20890-1 (1:7,000)	<ul style="list-style-type: none"> No changes appear to the subject property as it remains vacant agricultural land. A larger cleared area is present as well as an increased number of smaller buildings visible on the property to the northeast of the subject property.
1978 A31190-50 (1:15,000)	<ul style="list-style-type: none"> No significant changes to the subject property or surrounding properties were observed from the previous (1968) photograph
1983 A26246-148 (1:7,000)	<ul style="list-style-type: none"> No significant changes were observed to the subject property or surrounding properties from the previous (1978) photograph.
1990 A27643-108 (1:6,000)	<ul style="list-style-type: none"> A cleared/paved area now appears on the subject property. The large garage which remains on the site to current date is visible; many large vehicles/buses are also observed. The surrounding properties are observed to be relatively unchanged from previous photographs.

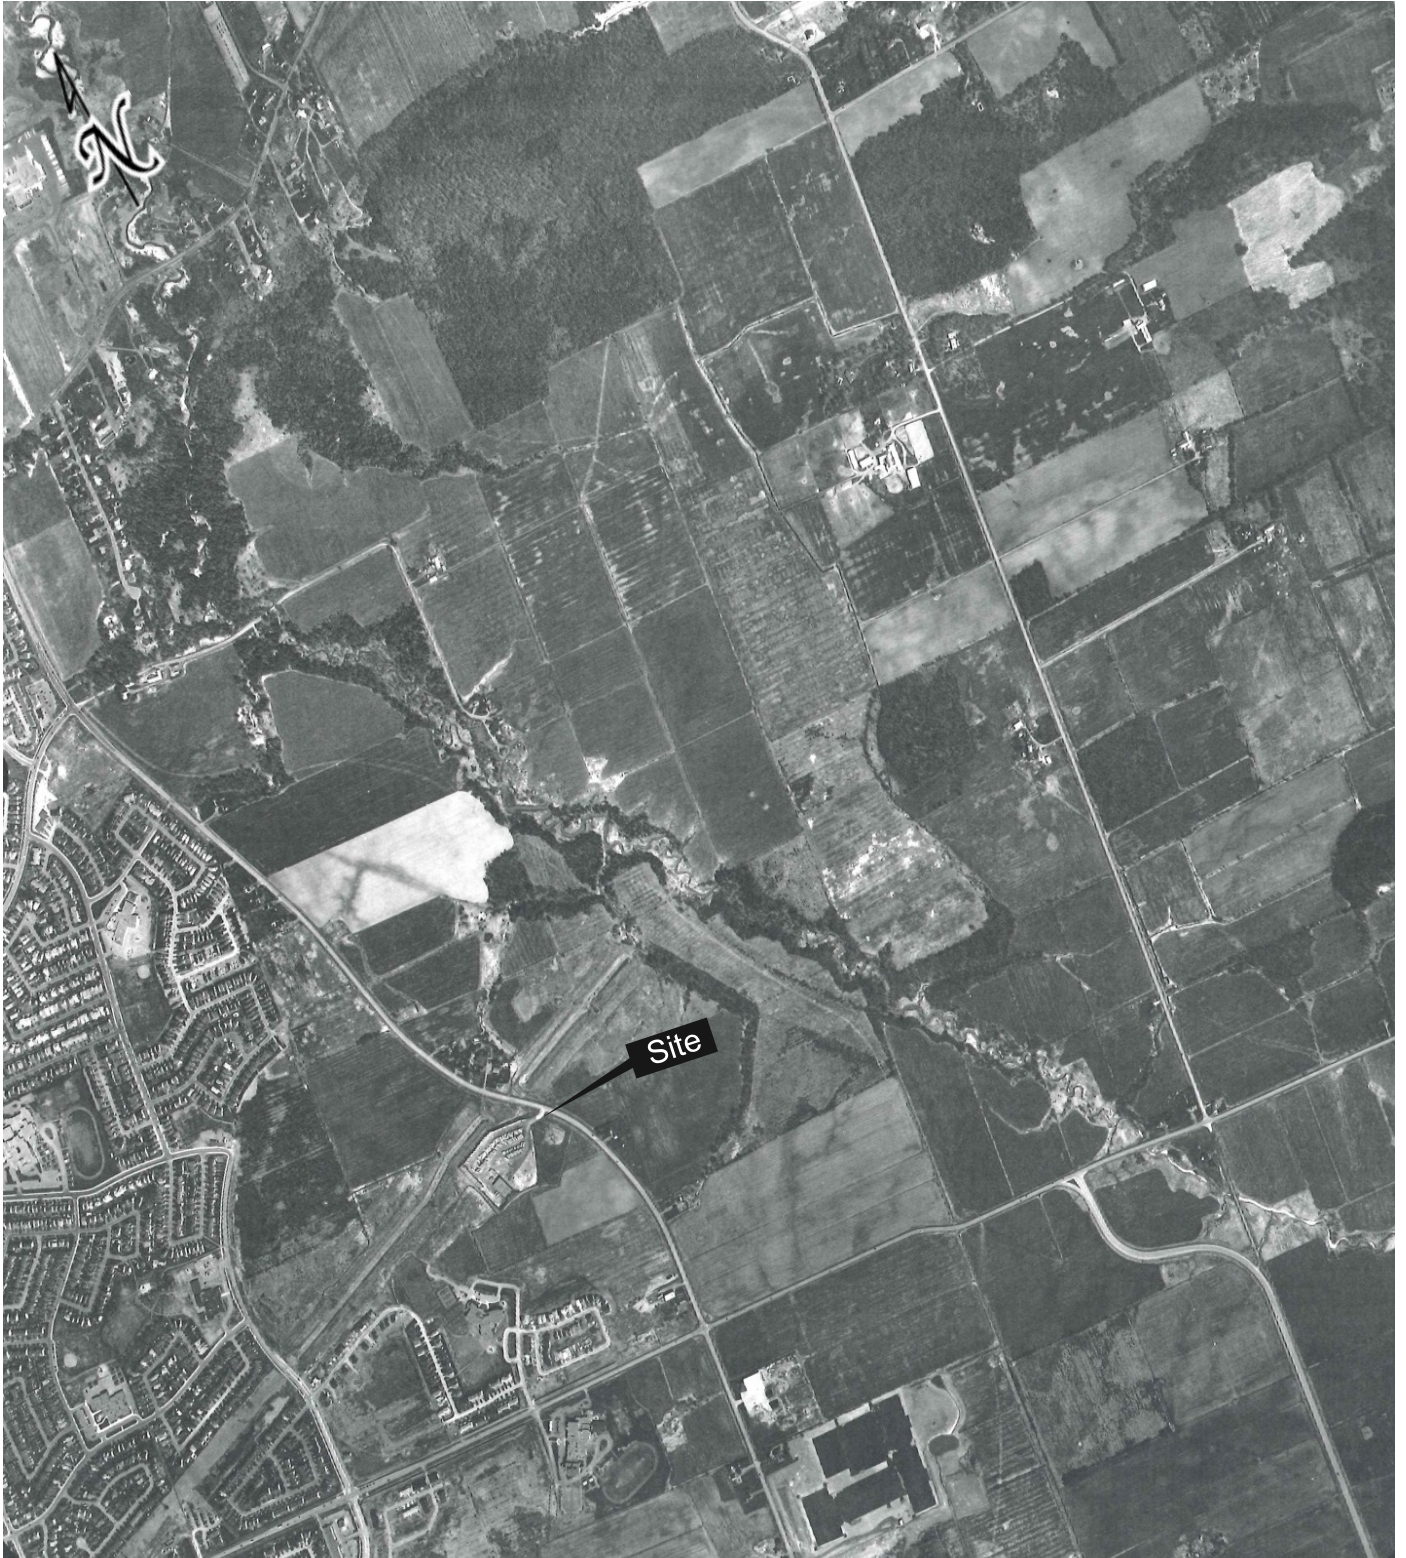
Year: 2001

Source: National Air Photo Library , Photo: A28466-37 (Approx. Scale: 1:20,000)

2001 28466-37 (1:20,000)	<ul style="list-style-type: none"> The subject property appears similar to present conditions. A fill pile on the east of the subject property is visible in this photograph. Portions of the northern part of the property, as well as the lands to the immediate north are disturbed. The hydro corridor is visible adjacent to the north. The corridor appears to be under construction at the time of the taking of this photograph. More residential development is observed on the surrounding properties than in previous years' photographs Surrounding lands to east and south east appear mixed agricultural and residential in usage.
