Phase I - Environmental Site Assessment

1995 Carling Avenue
Ottawa, Ontario

Claridge Homes

Report: PE4833-1

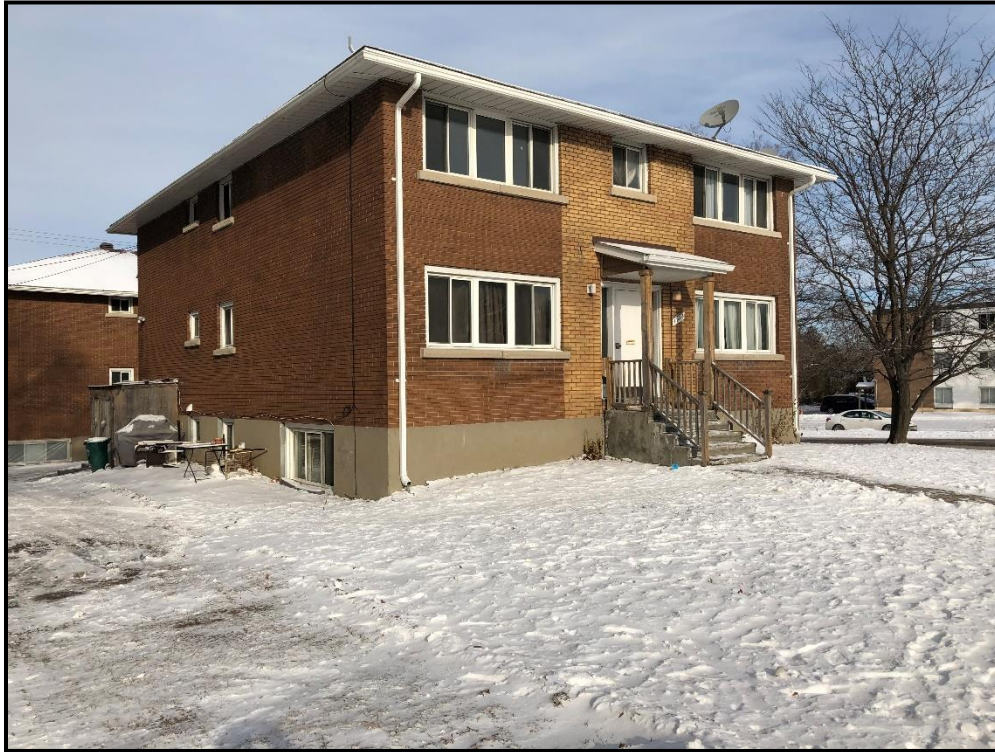
Photograph 1: View of the Phase I Property, facing north from Carling Avenue.

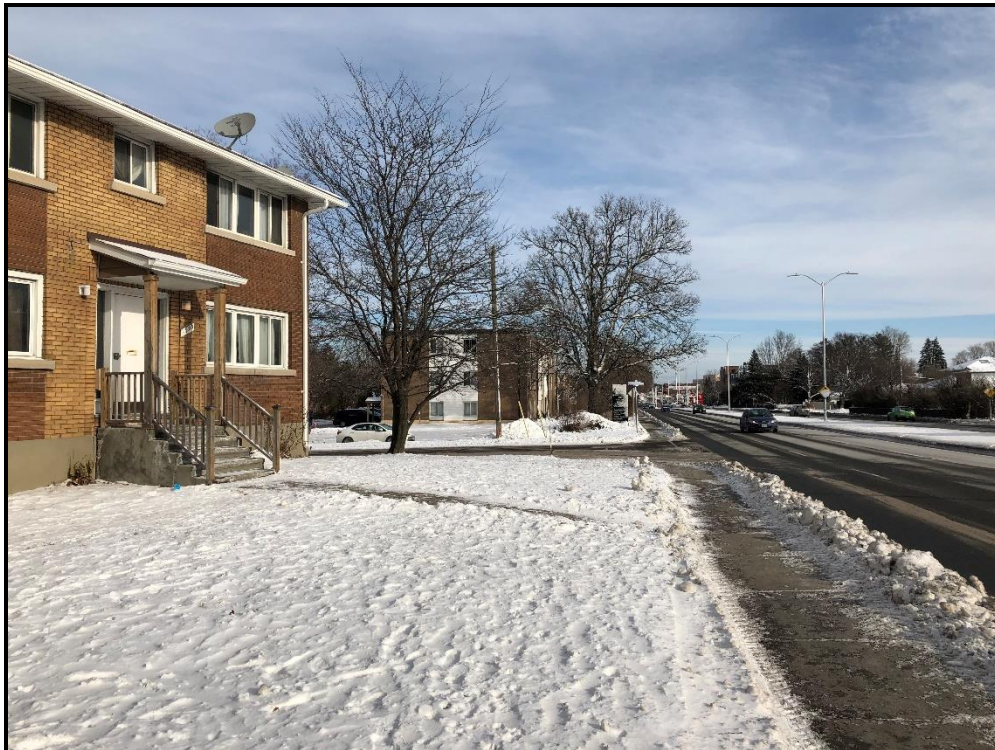
Photograph 2: View of Phase I Property, facing east. Photograph also depicts residential dwellings east of Bromley Road.

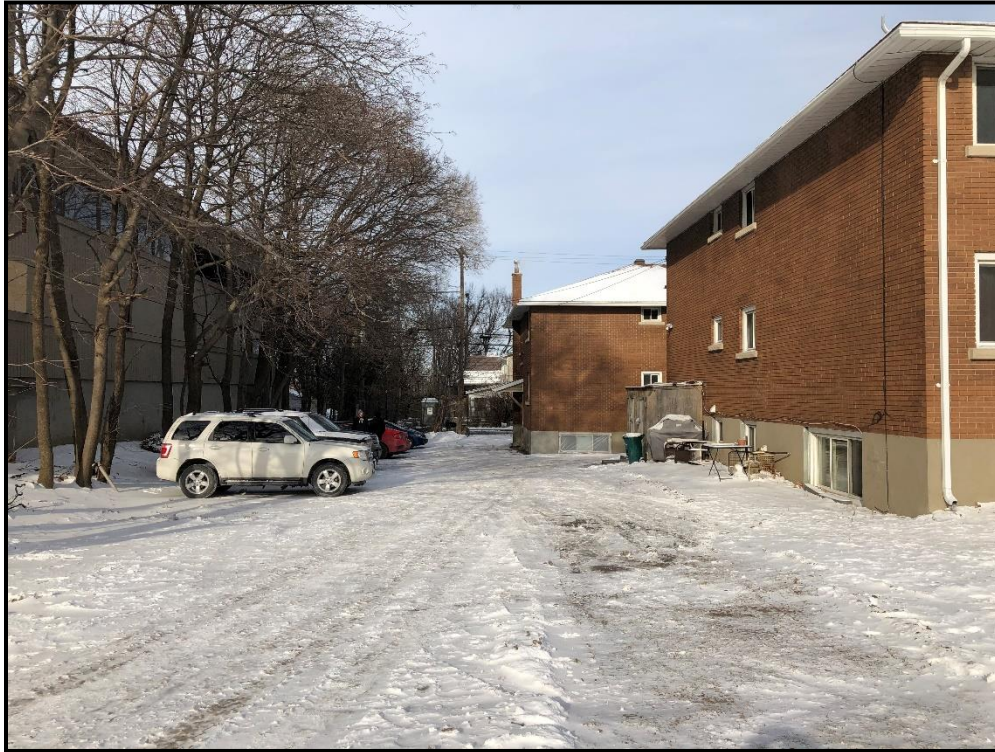
Photograph 3: View of the adjacent parking lot at the rear of the two structures, facing north. The photograph also depicts the second residential structure on the north side of the property.

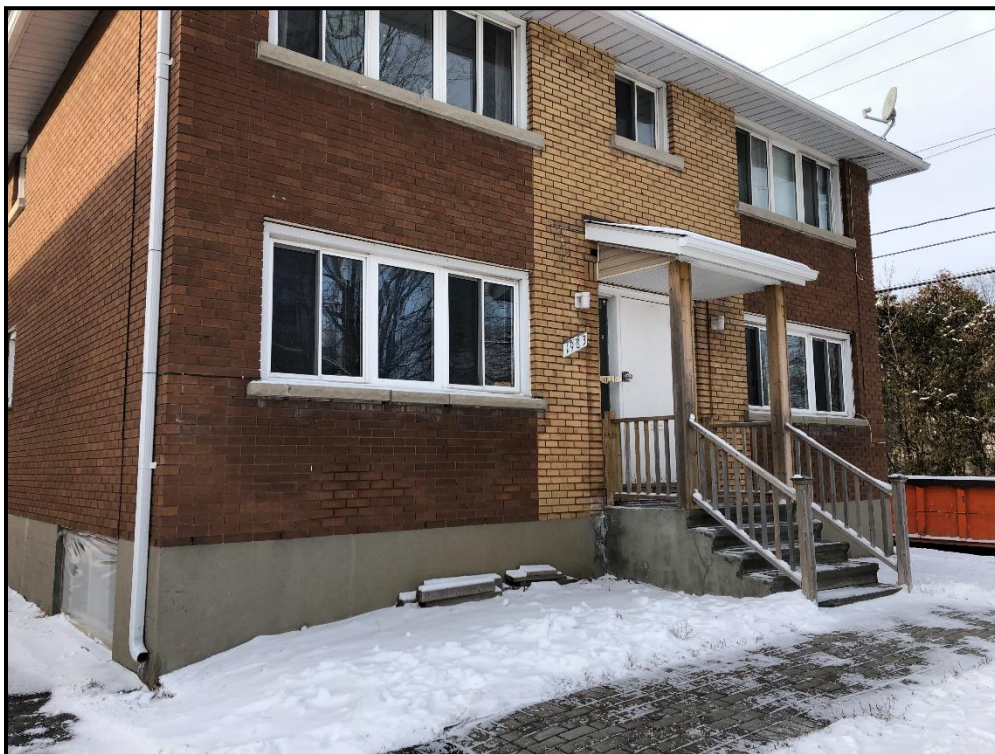
The two (2) residential structures on the subject property are two (2) storey structures with full-basement levels. Both structures were estimated to be constructed sometime in or around 1960. Both structures are constructed with a block wall and poured concrete foundation and are finished on the exterior with brick and a sloped shingled roof.

Photograph 4: View of the eastern face of the northern structure, facing northwest from Bromley Road.

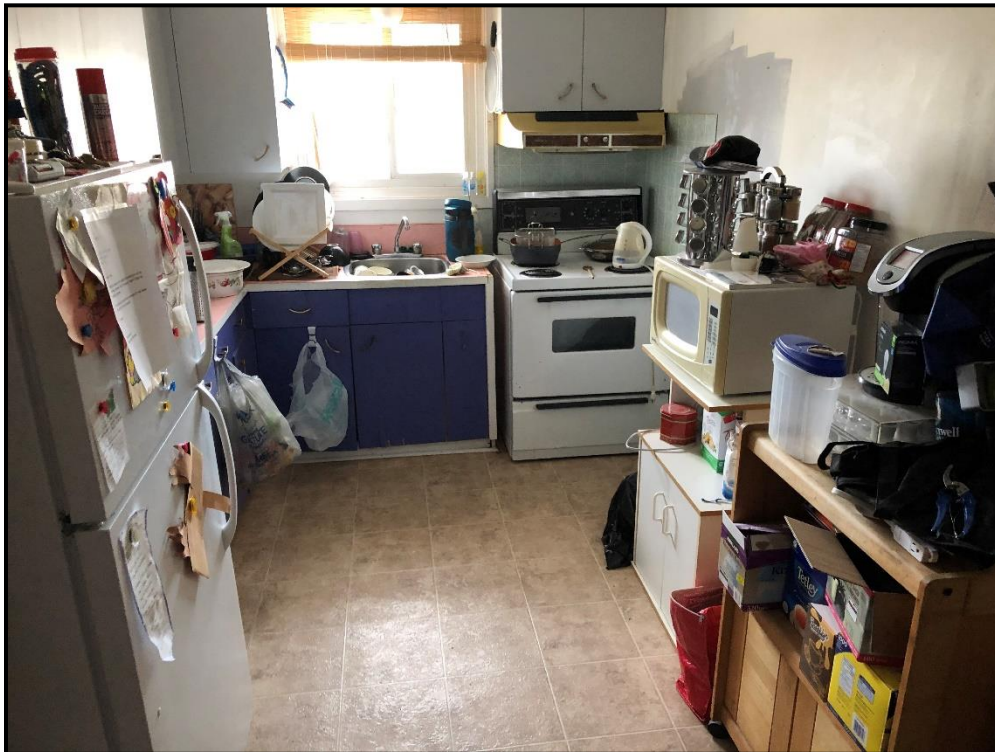
Photograph 6: Typical interior layout of kitchen areas of the apartments within the Phase I buildings.
