## **Phase I Environmental Site Assessment**

1705 Carling Avenue  
Ottawa, Ontario

**December 29, 2017**

Report: PE4192-1R

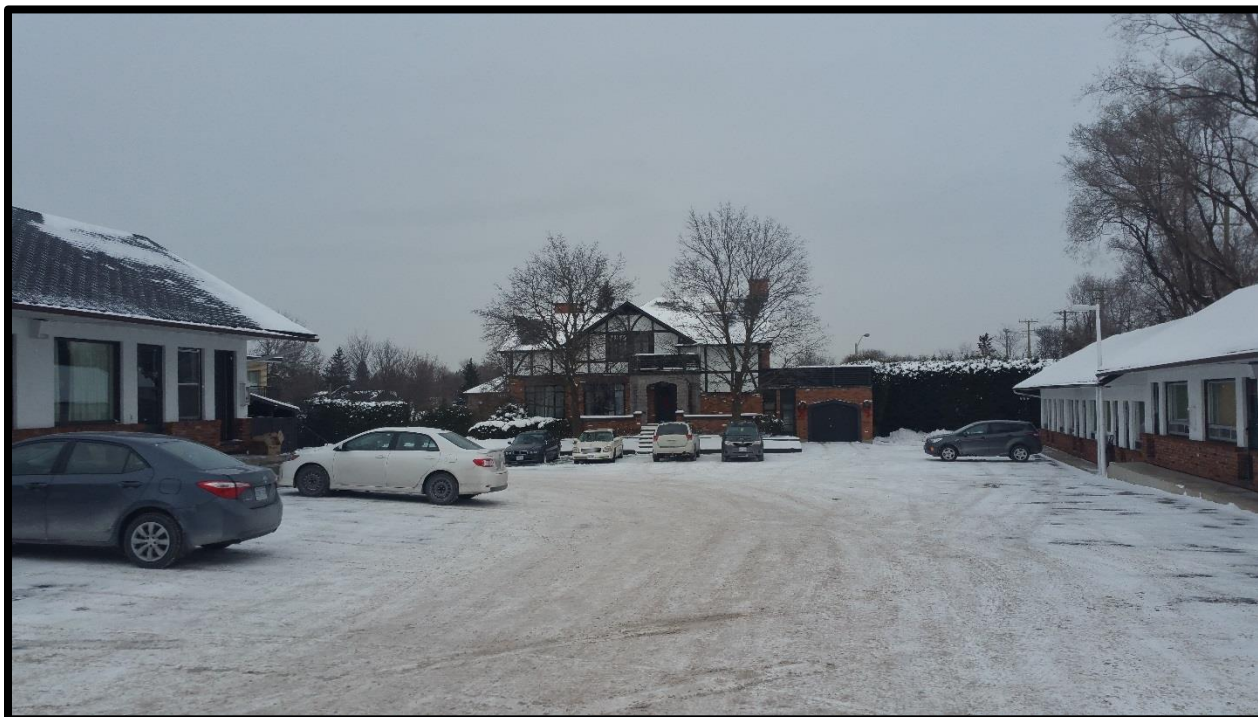
Photograph 1: View of the eastern portion of the site, facing north. Photograph illustrates a snow-covered parking area, two motel structures and a residential dwelling.

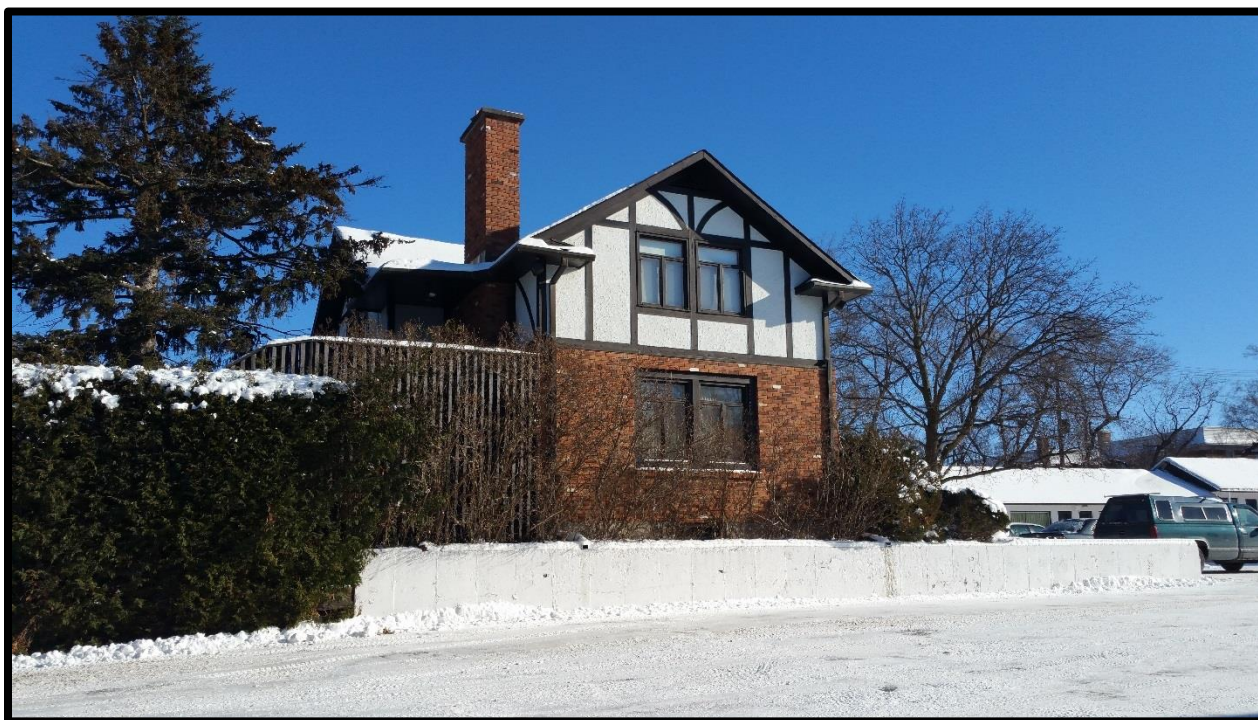
Photograph 2: View of the western side of the residential dwelling. Photograph illustrates an asphaltic concrete parking lot and landscaped areas surrounding the residential dwelling.

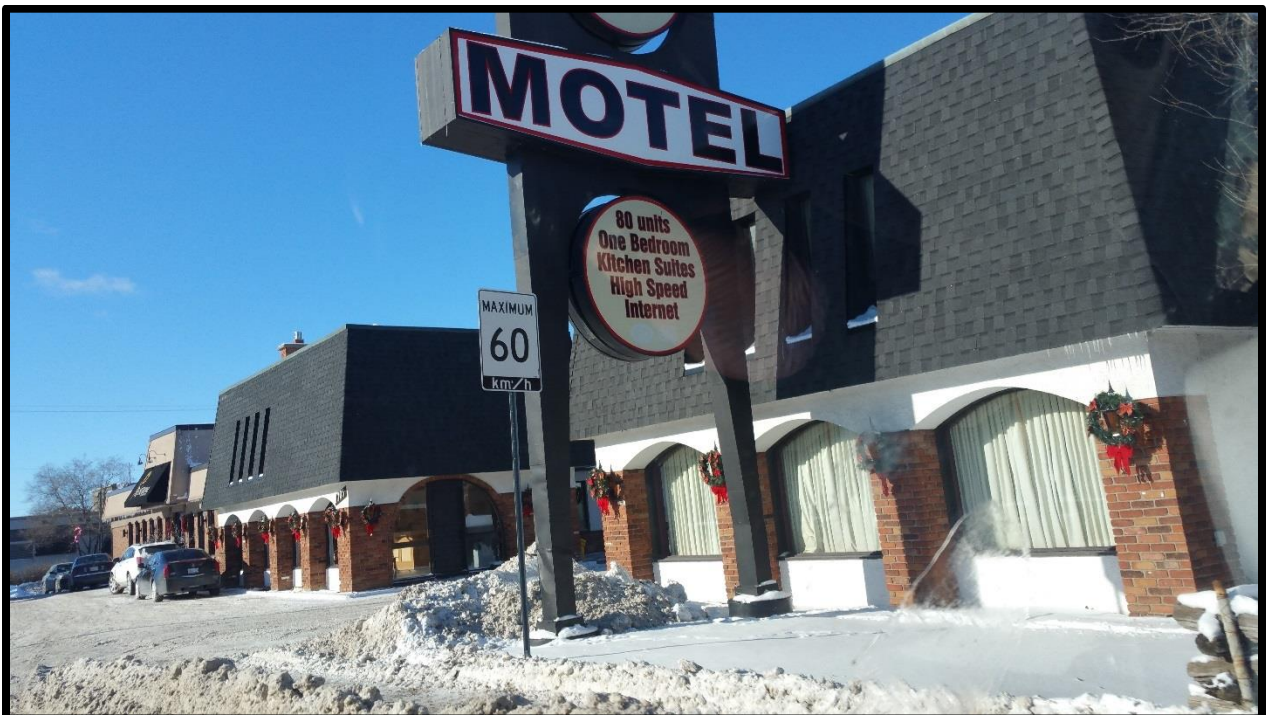
Photograph 4: View of the southern portion of the subject site, facing northwest. Photograph illustrates the front sides of the central and eastern motel structures.

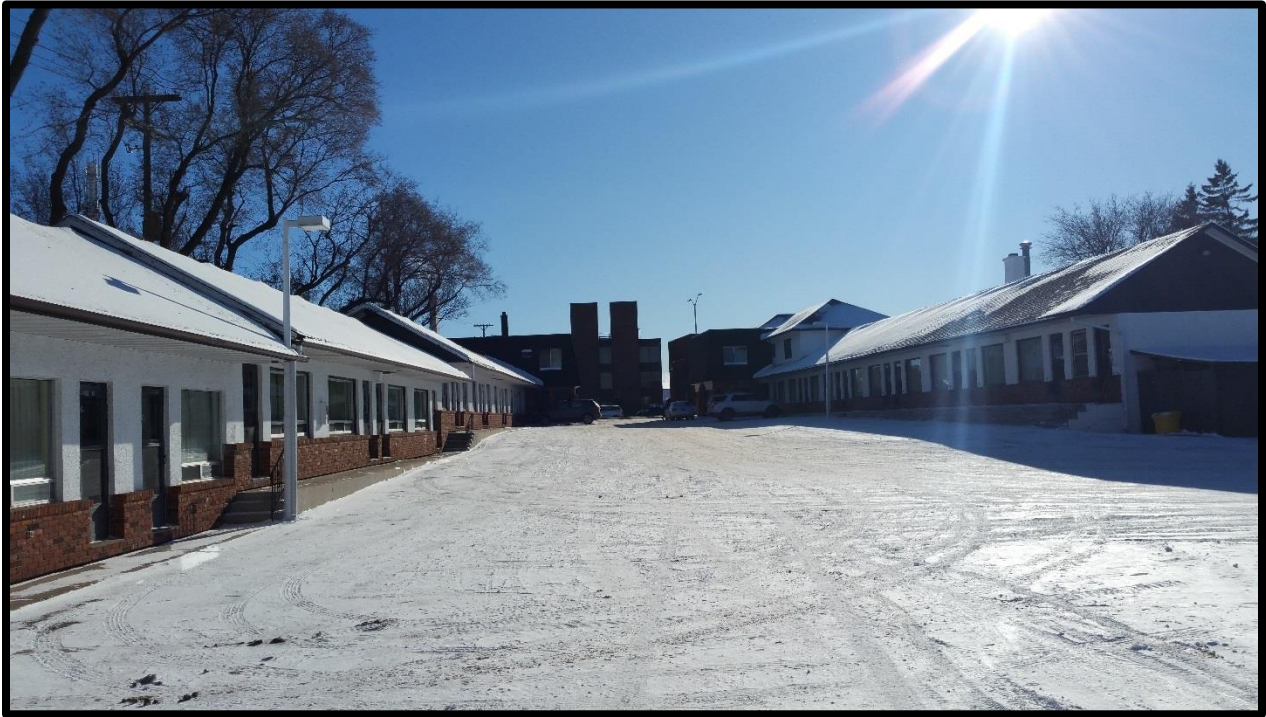
Photograph 5: View of the eastern portion of the subject site, facing south. Photograph illustrates an asphaltic concrete parking lot and the eastern (left) and central (right) motel structures.

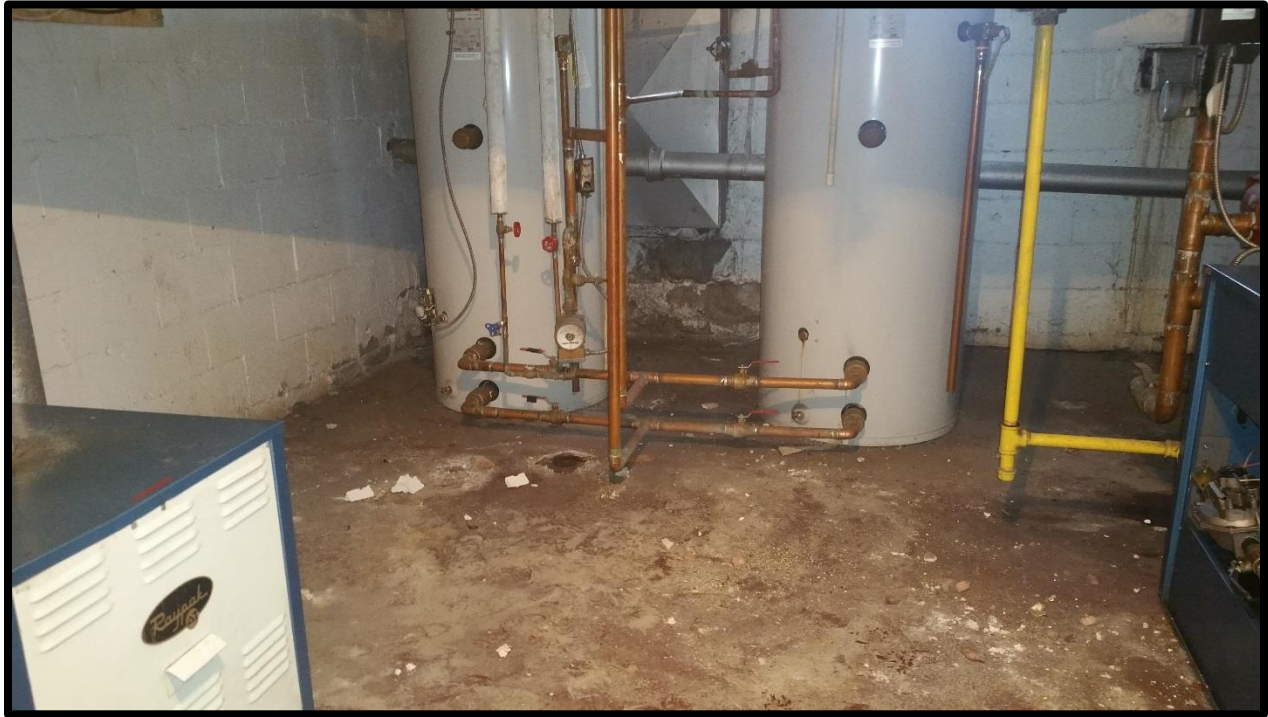
Photograph 7: View of the natural gas fired hot water tanks and boilers within the utility room located in the basement of the eastern motel structure.

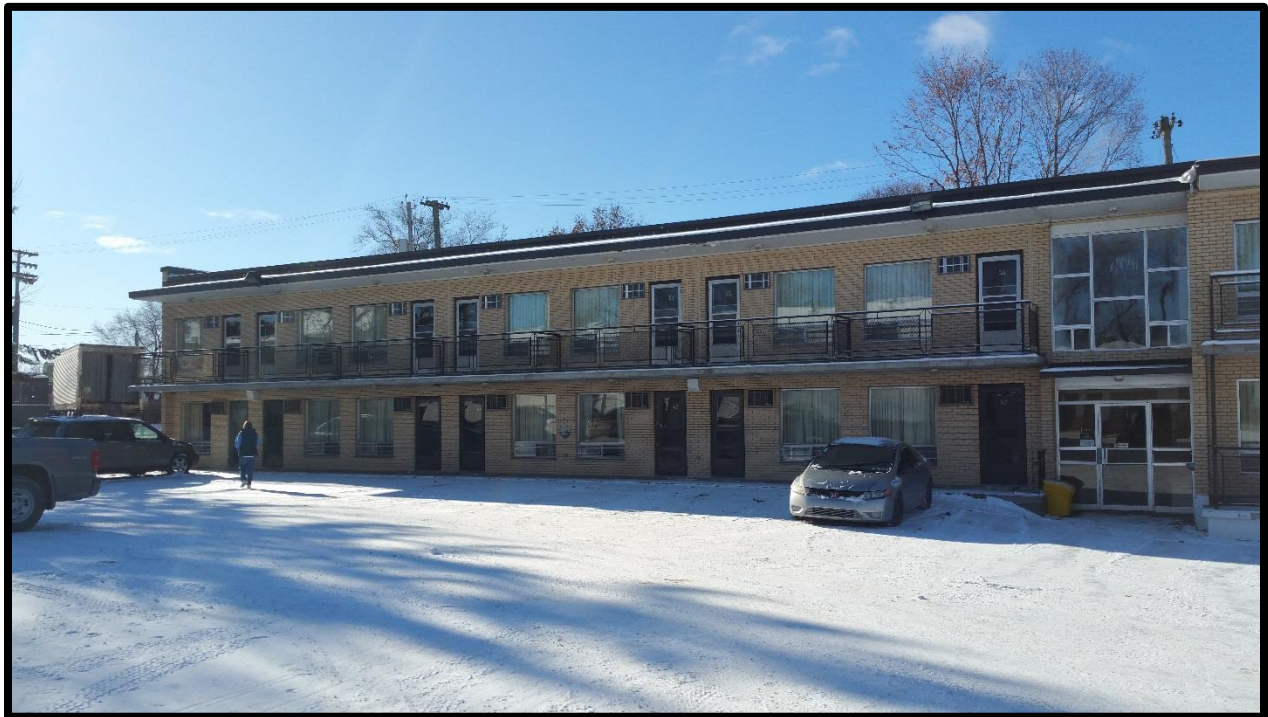
Photograph 8: View of the western portion of the subject site, facing southwest. Photograph illustrates an asphaltic concrete parking lot and the two-story western motel structure.

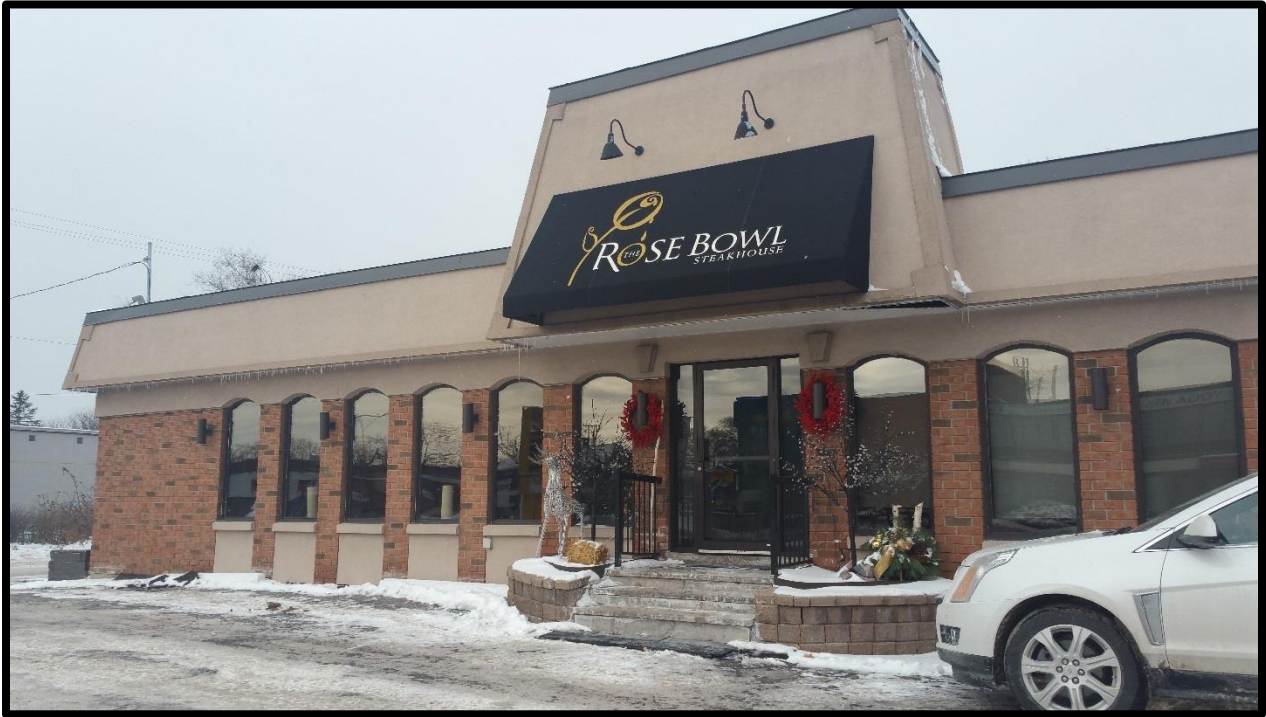
Photograph 11: View of southwestern portion of the subject site. Illustrates the front of the restaurant and an asphaltic concrete parking lot. Photograph taken facing northwest.

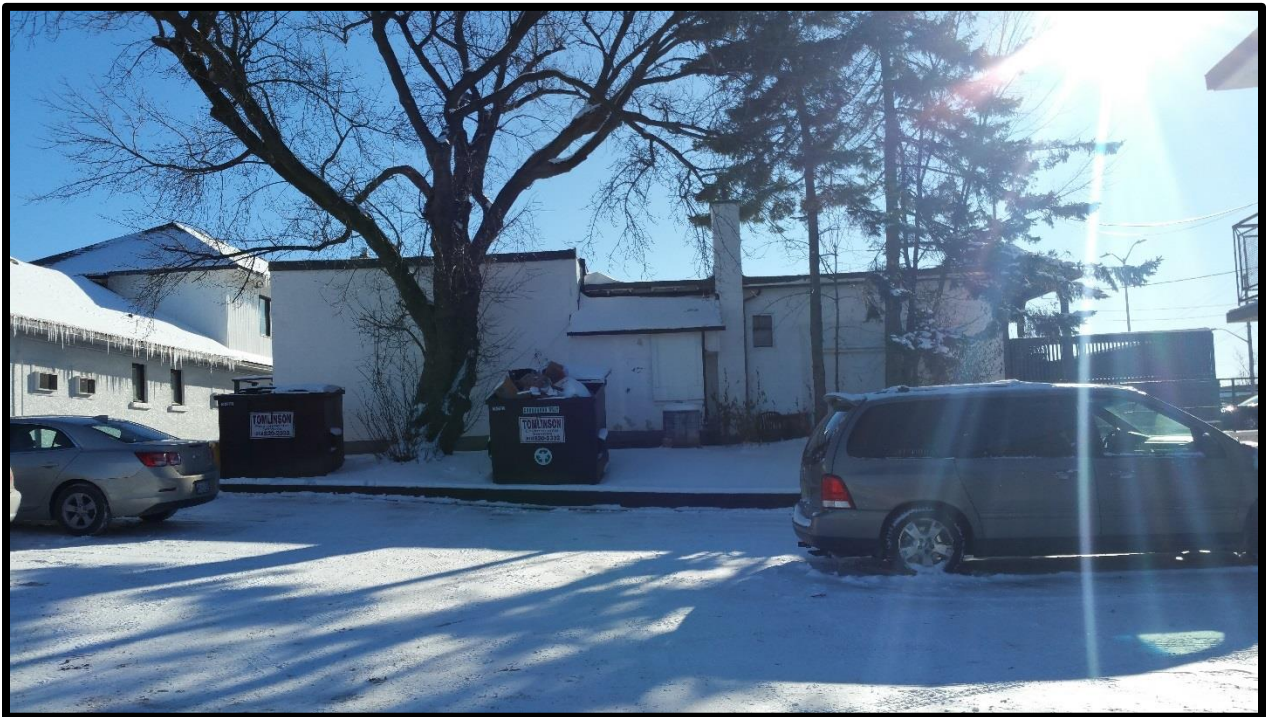
Photograph 12: View of the central portion of the subject site, facing south. Photograph depicts an asphaltic concrete parking lot, the back of the restaurant and the waste storage location on site.
