Phase I-Environmental Site Assessment

2046 and 2050 Scott Street
295, 297, 299 and 301 Ashton Avenue
Ottawa, Ontario

April 24, 2020

Report: PE4892-1R

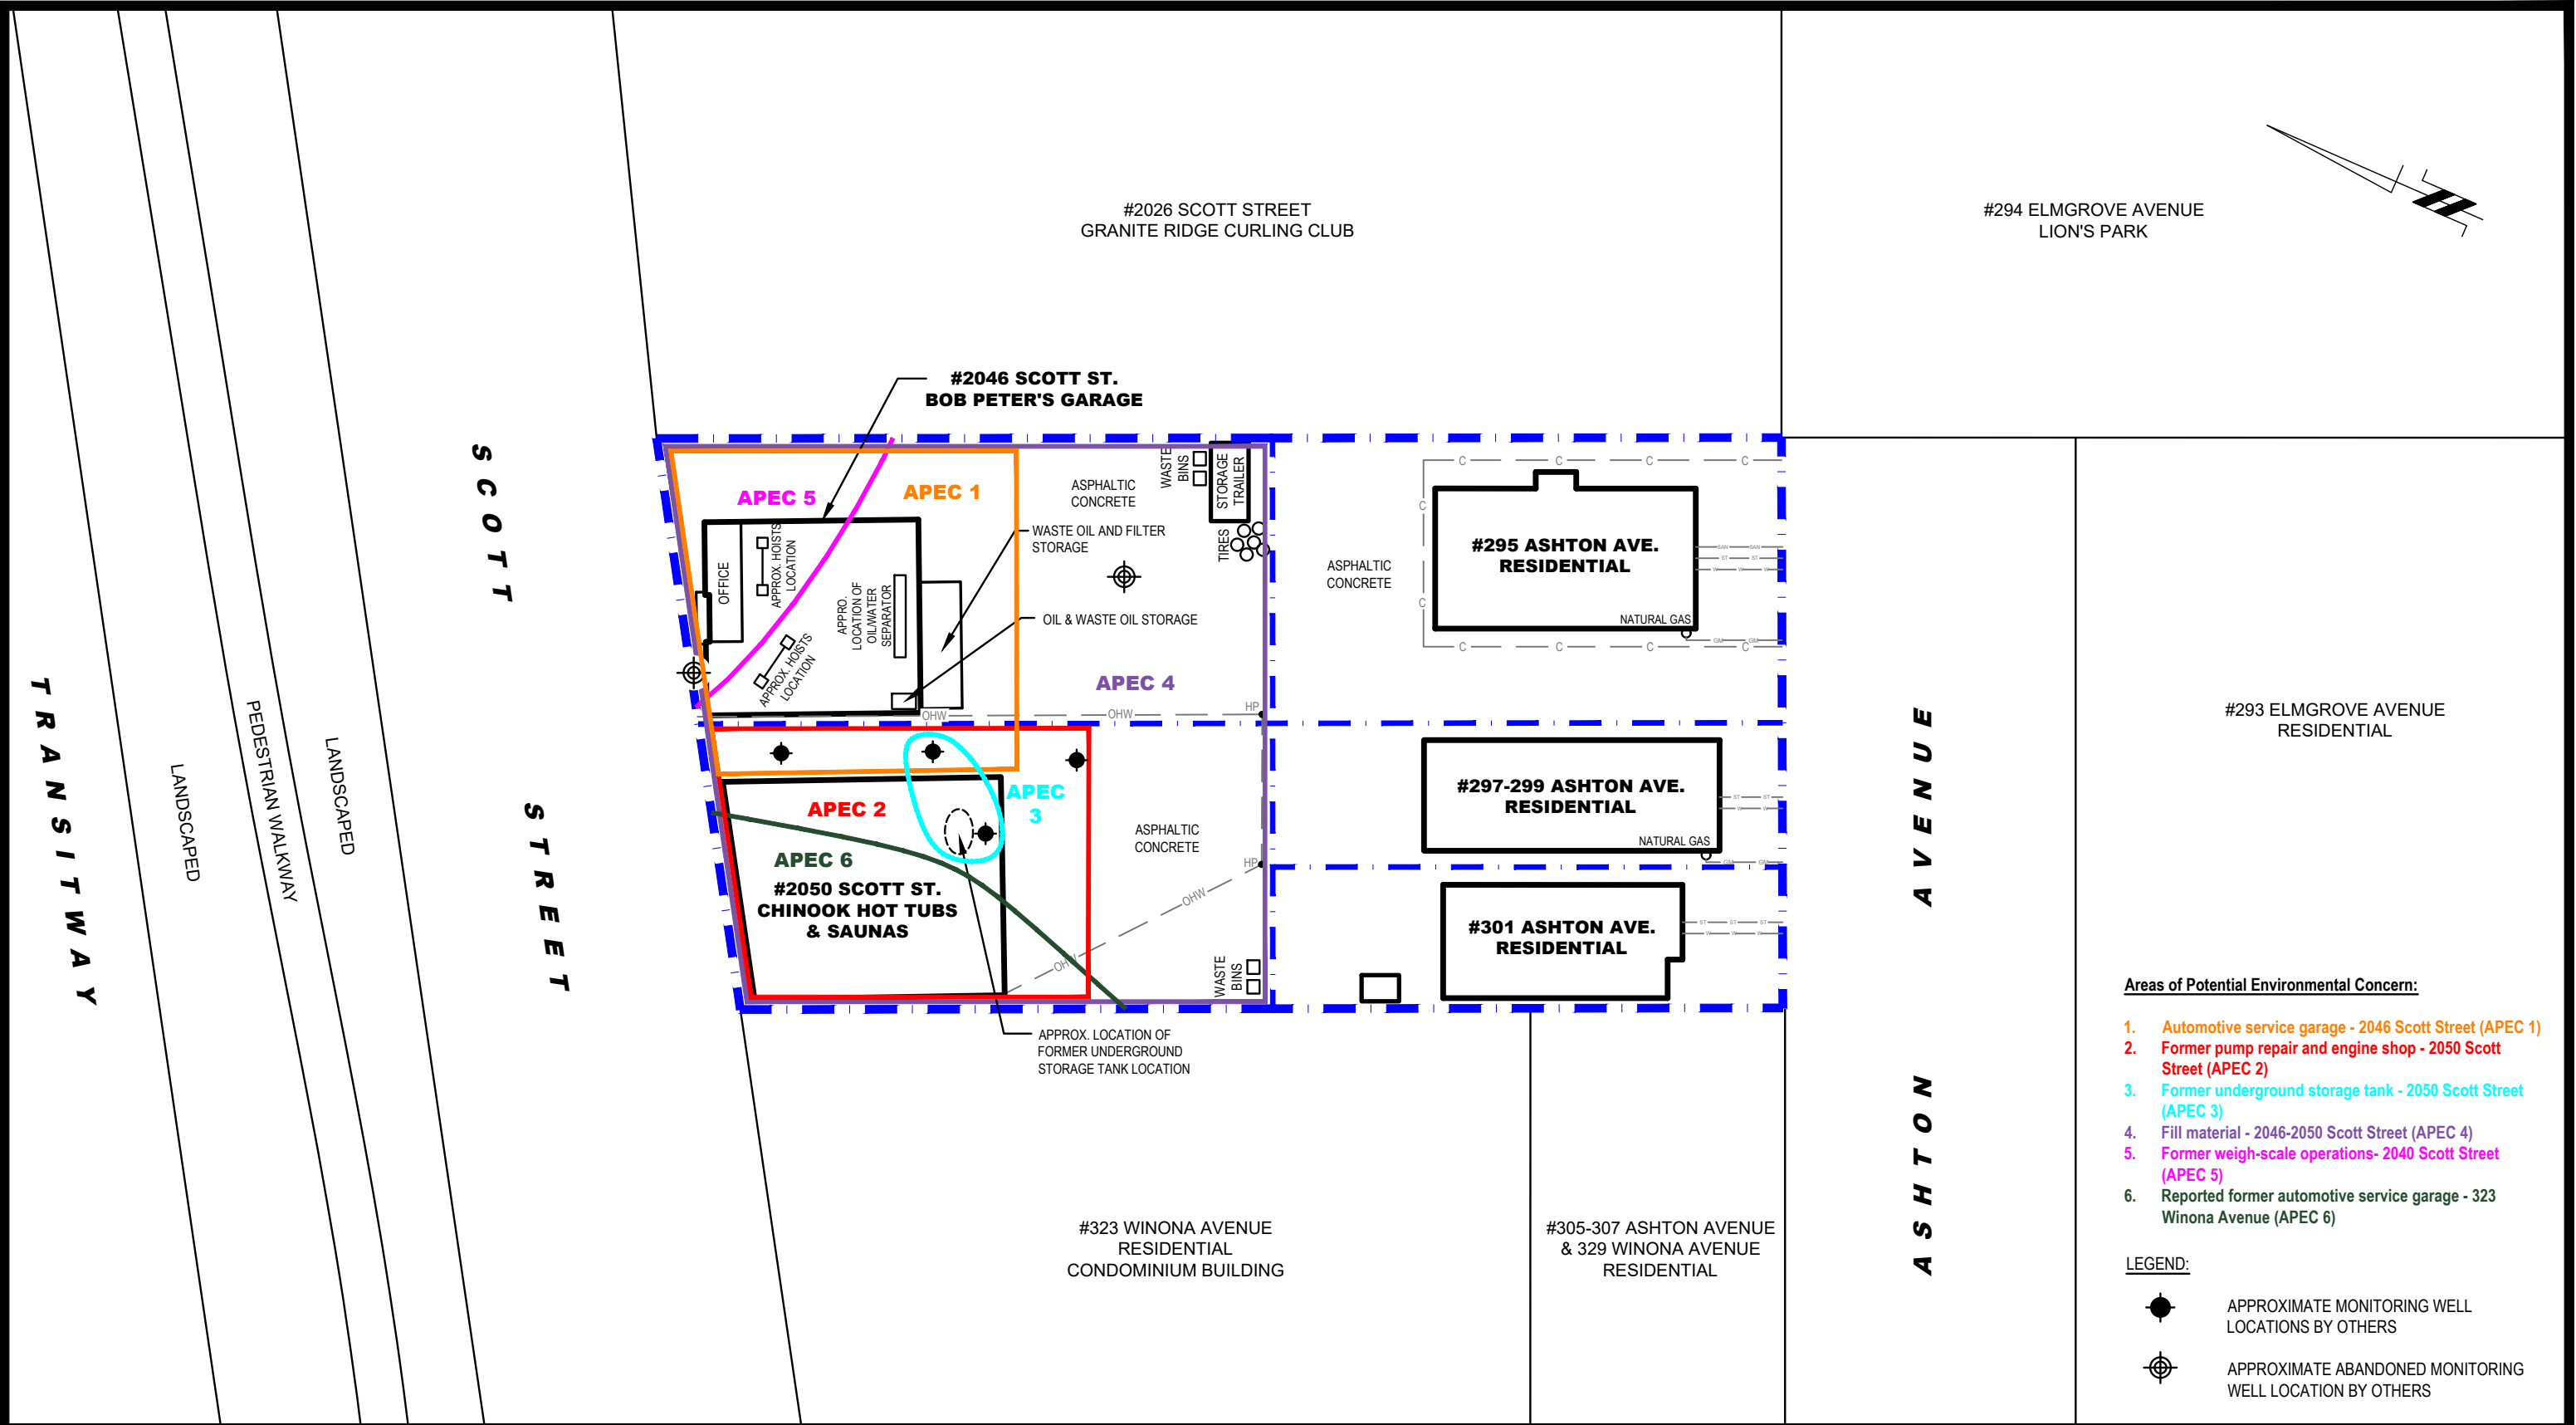
DRAWING PE4892-1 – SITE PLAN

No signs of stressed vegetation, surficial staining or evidence of fill material were noted on the Phase I Property. It should be noted that the site was partially snow-covered at the time of the site visits. Site features are presented on Drawing PE4892-1 – Site Plan, provided in the Figures section following the text.

- Areas of Potential Environmental Concern:
- 1. Automotive service garage - 2046 Scott Street (APEC 1)
 - 2. Former pump repair and engine shop - 2050 Scott Street (APEC 2)
 - 3. Former underground storage tank - 2050 Scott Street (APEC 3)
 - 4. Fill material - 2046-2050 Scott Street (APEC 4)
 - 5. Former weigh-scale operations- 2040 Scott Street (APEC 5)
 - 6. Reported former automotive service garage - 323 Winona Avenue (APEC 6)

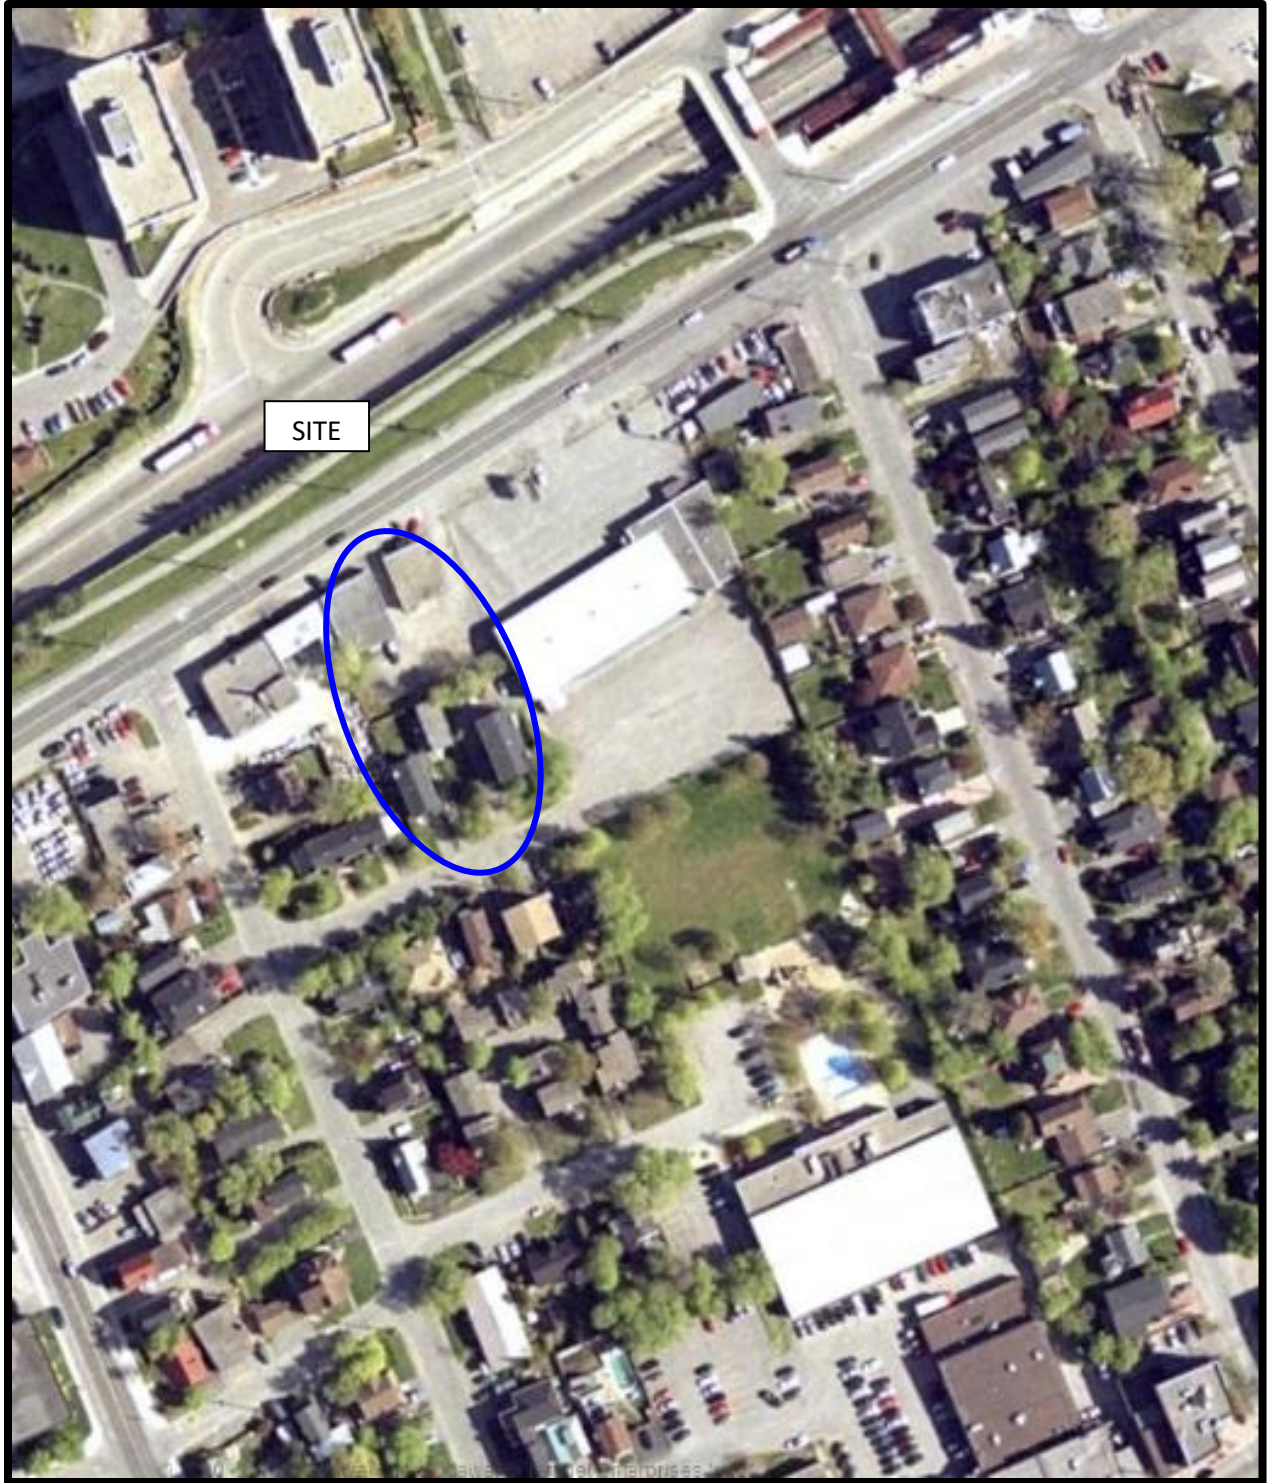
AERIAL PHOTOGRAPH
2002

- 2002 The Phase I Property and neighbouring lands remain unchanged from the previous photograph.
- 2011 The Phase I Property appears to remain unchanged from the previous photograph. The adjacent property to the west, at the southeast corner of the intersection of Scott Street and Winona Avenue, has been redeveloped with a residential building. No other changes appear to have been made to the neighbouring lands.

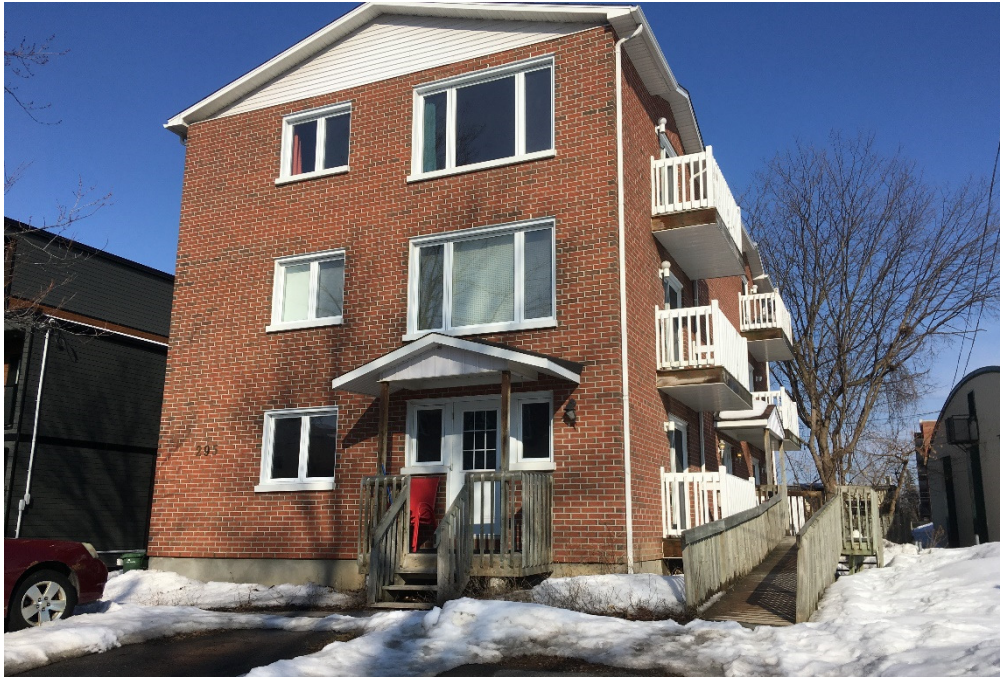
Photograph 1: View of south face of 295 Ashton Avenue, looking northwest.

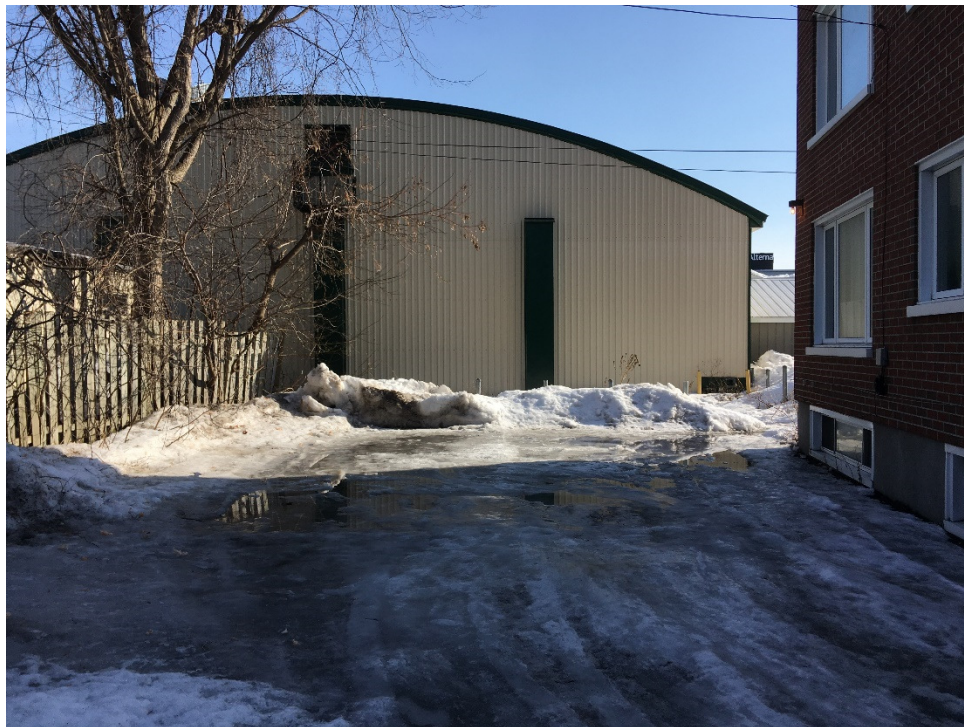
Photograph 2: View of northern portion of 295 Ashton Avenue, looking east. Photograph illustrates the Granite Curling Club to the east.

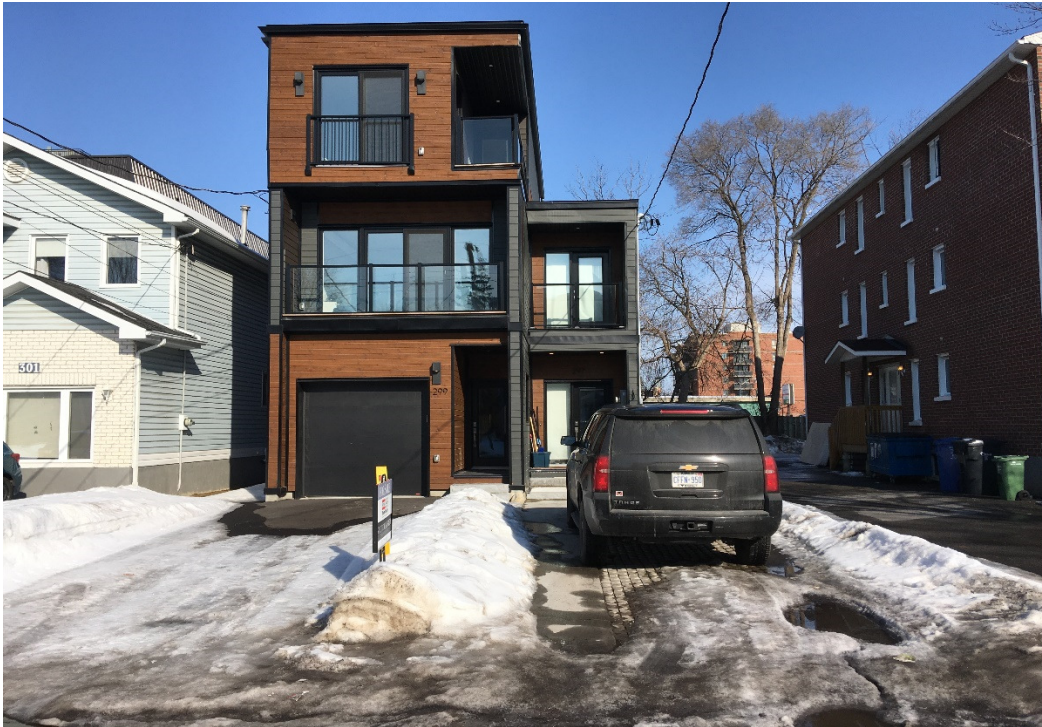
Photograph 3: View of southern portion of Phase I Property, looking north. Photograph illustrates south faces of the three residential subject buildings fronting onto Ashton Avenue.

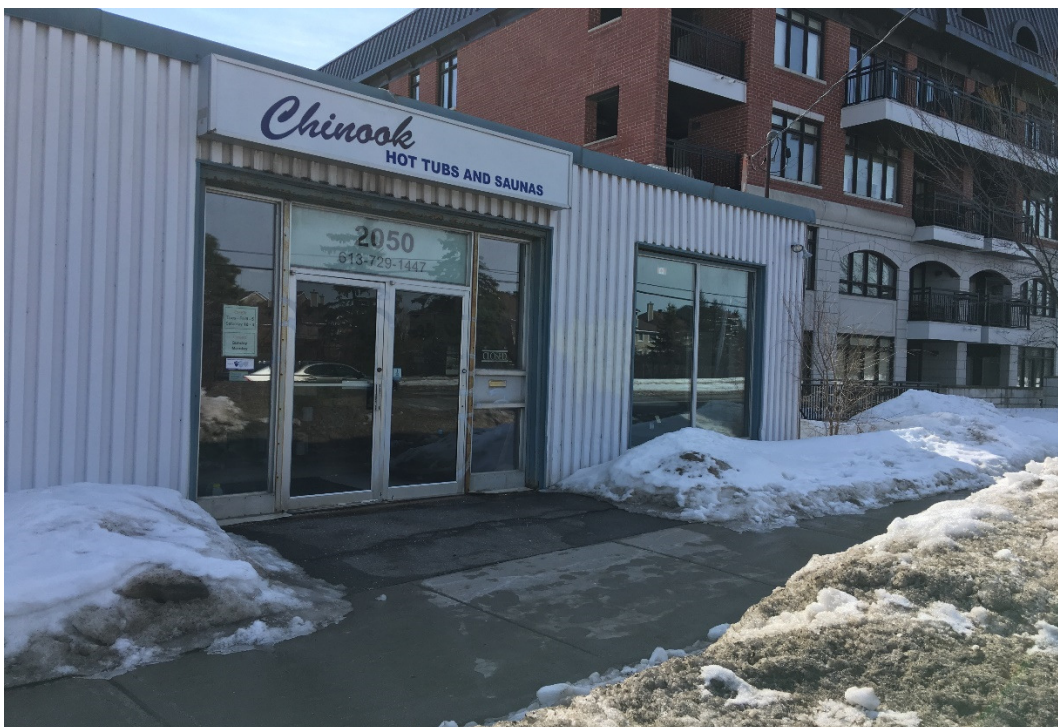
Photograph 4: View of commercial building occupying northwestern portion of Phase I Property.

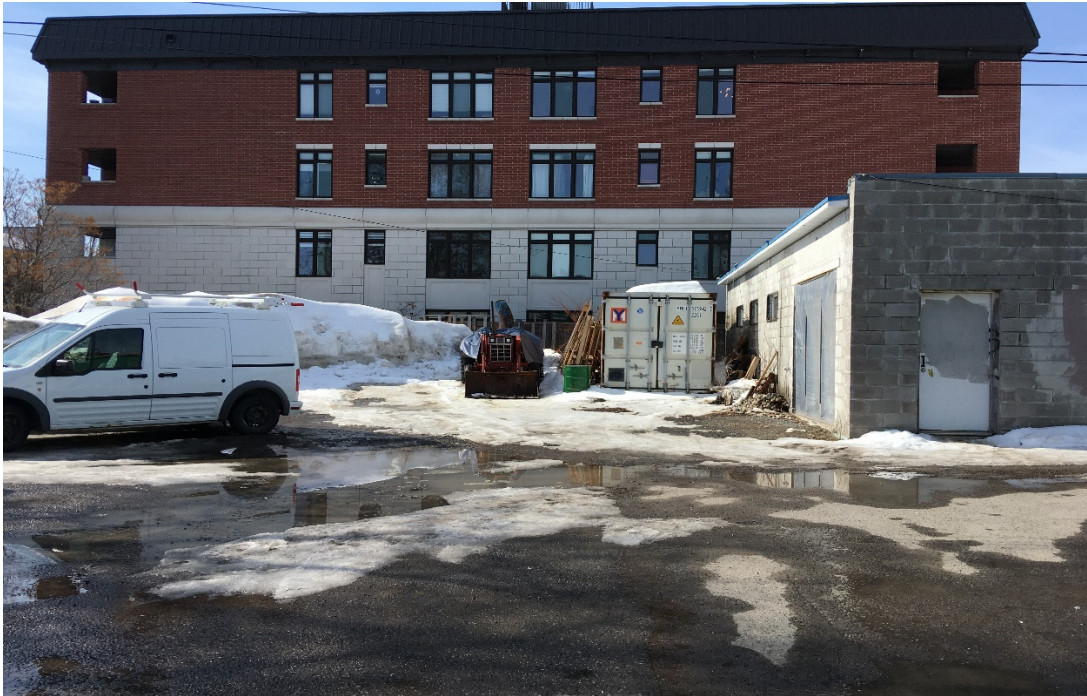
Photograph 5: View of northwestern portion of the Phase I Property (2050 Scott Street), facing west. Photograph illustrates residential condominium on the adjacent property to the west.

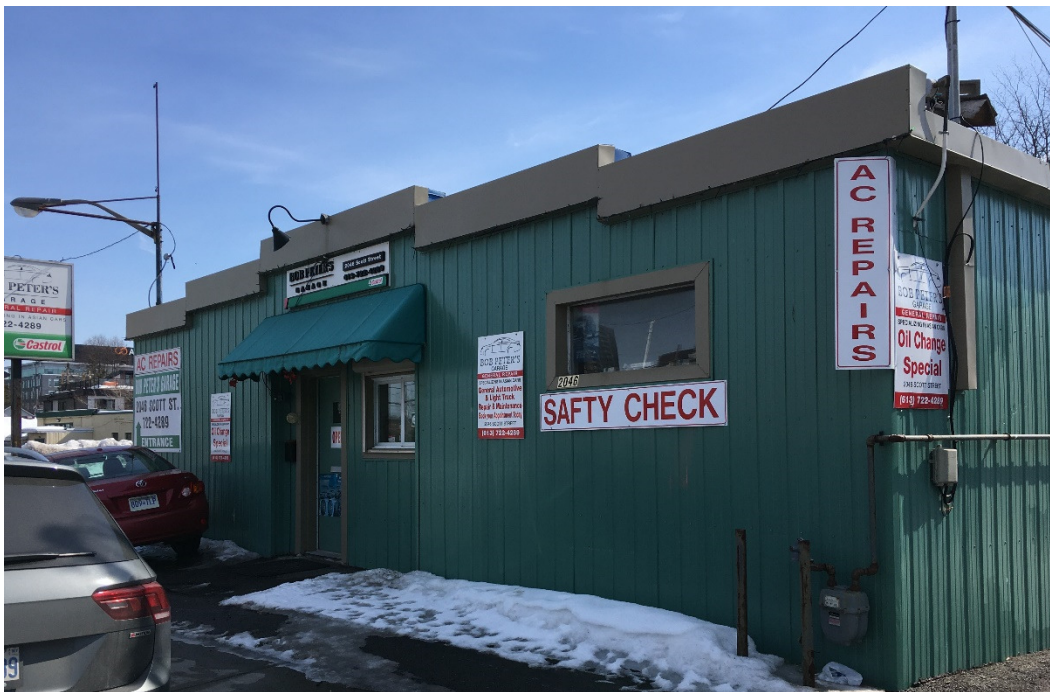
Photograph 6: View of northeastern portion of the Phase I Property, facing southeast. Photograph illustrates the north face of the automotive service garage at 2046 Scott Street.

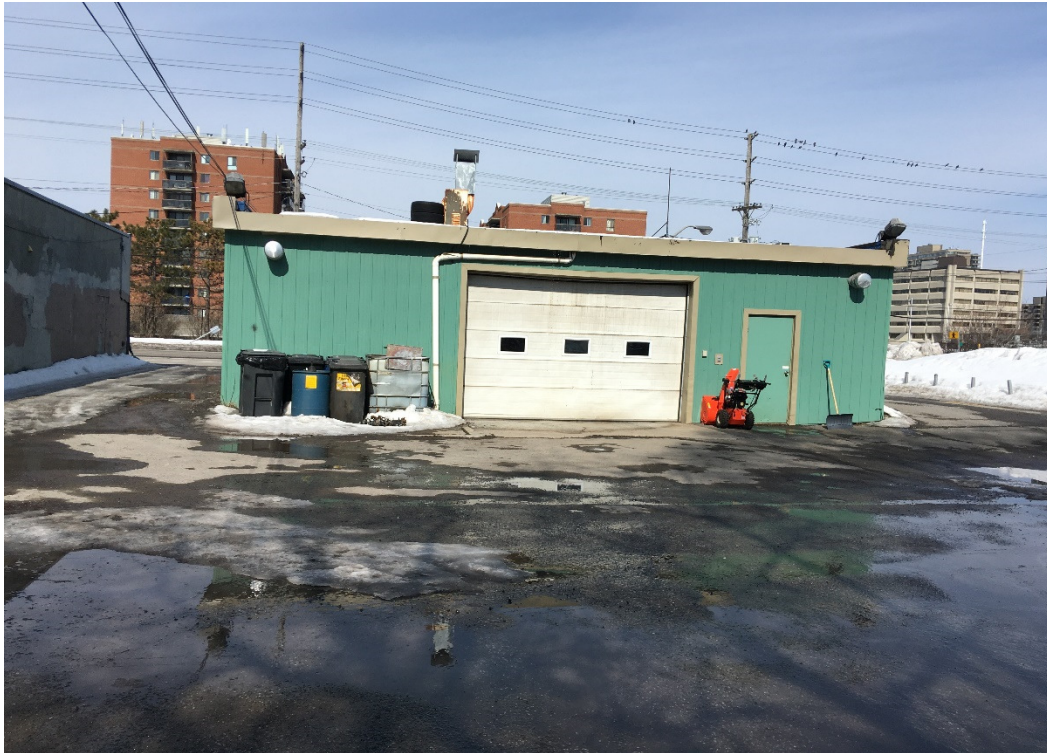
A 200L drum and 950L tote containing waste motor oil were observed on the exterior of this property, situated on a concrete slab. No obvious signs of staining were observed on the exterior of the property around the waste oil storage area; it should be noted that this portion of the property was partially covered with snow and ice at the time of the site visit. The waste oil is reportedly collected and disposed off-site by a licenced contractor as needed.

Photograph 7: View of northeastern portion of the Phase I Property, facing north. Photograph illustrates the south face of 2046 Scott Street and the exterior storage of waste oil and filters.

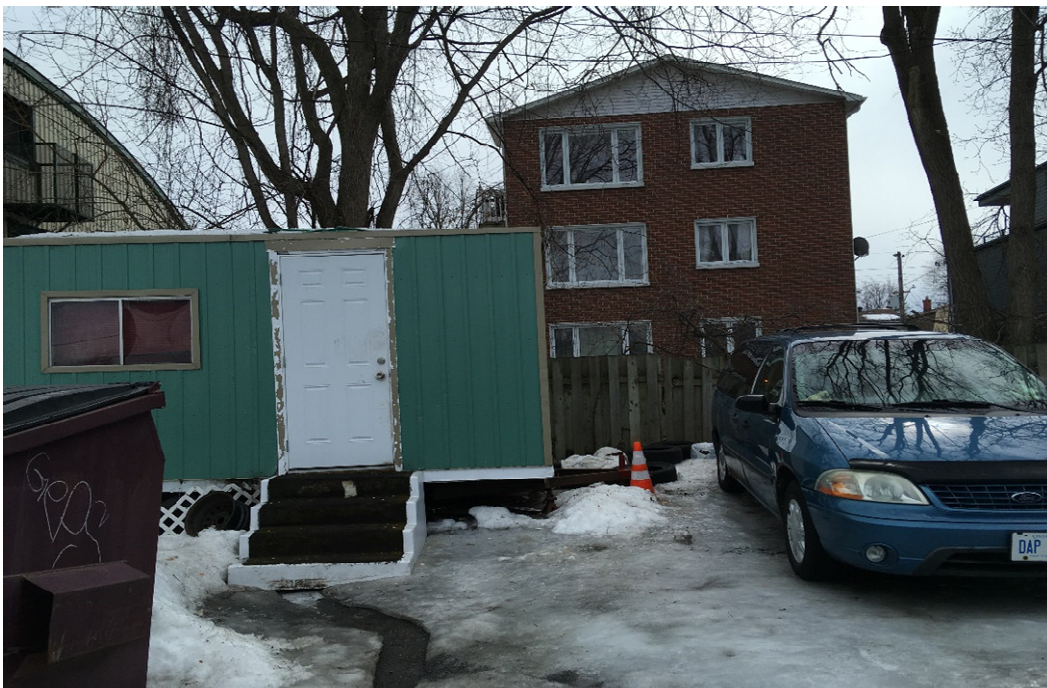
Photograph 8: View of east-central portion of the Phase I Property (2046 Scott Street), facing south.

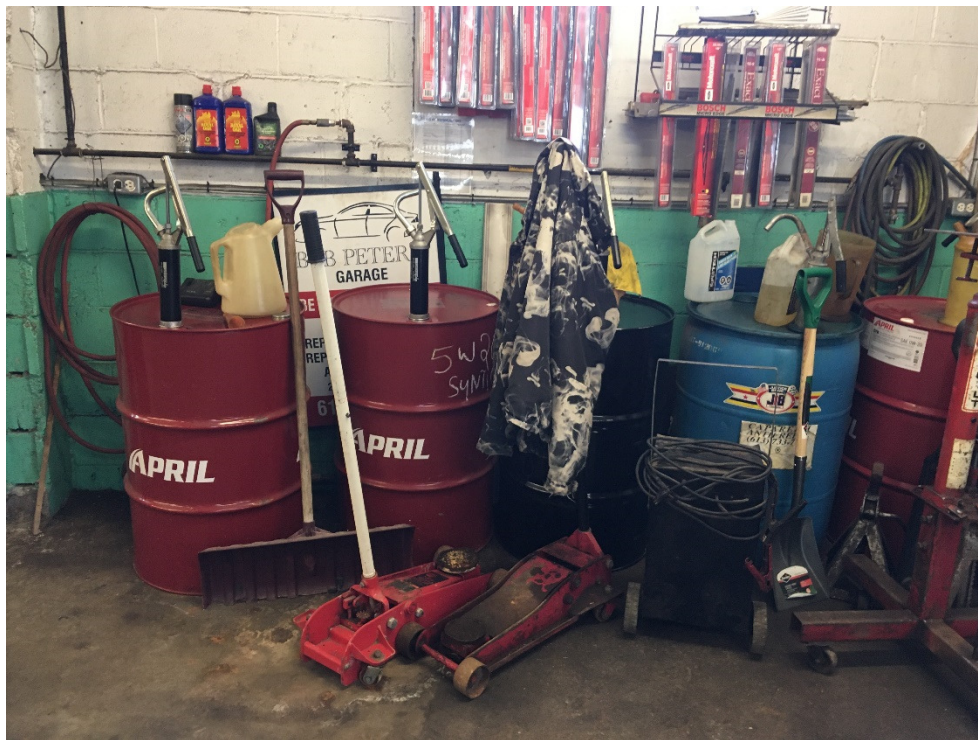
No aboveground storage tanks (ASTs) or were observed on the interior of the garage. Five (5) 200L drums containing new or waste oil were observed on the interior of the garage, in addition to multiple containers (less than 10L) of motor oil, windshield waster fluid, brake fluid and transmission fluid in sealed containers properly stored on shelves. It should be noted that areas of staining were observed on the concrete floor throughout the garage. The concrete floor was in fair condition at the time of the site assessment, with some cracks and pitting observed.

A 200L drum containing waste oil was observed on the interior of the property. Staining as observed on the concrete floor in the vicinity of the waste oil and new oil storage area. A 200L drum and 950L tote containing waste motor oil were observed on the exterior of this property, situated on a concrete slab. No obvious signs of staining were observed on the exterior of the property around the waste oil storage area; it should be noted that this portion of the property was partially covered with snow and ice at the time of the site visit. The waste oil is reportedly collected and disposed off-site by a licenced contractor as needed.

Photograph 9: View of interior of automotive service garage at 2046 Scott Street, facing west. Photograph illustrates storage of new oil and waste oil.

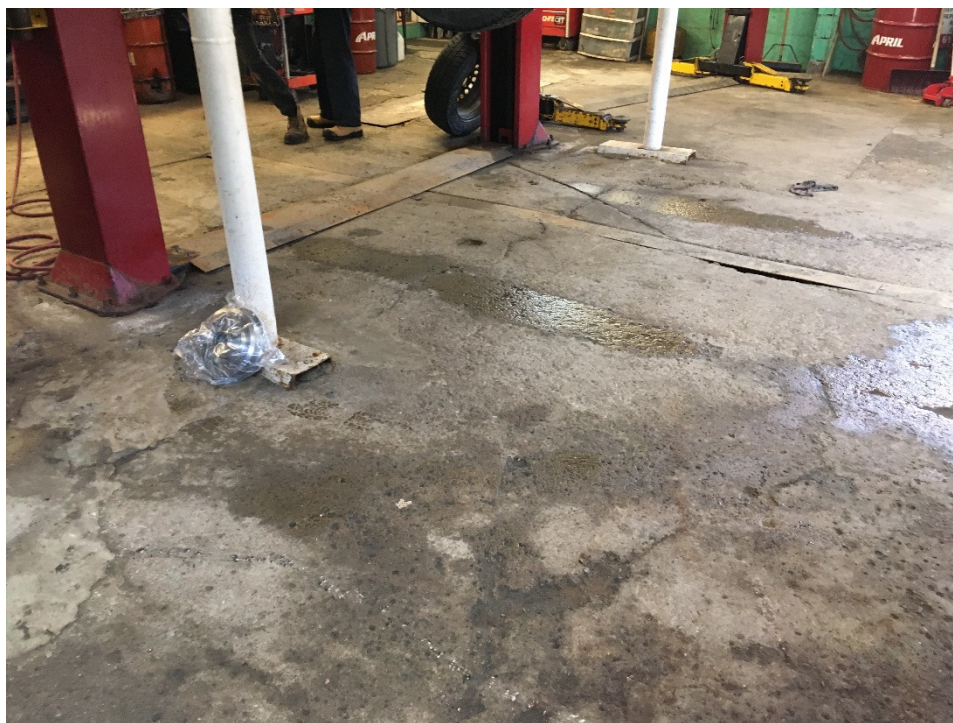
The garage consists of two (2) bays, both equipped with electrical hoists. Two (2) floor drains leading to an oil-water separator were observed in the garage. The drains were observed to be dry at the time of the site visit. As previously noted, Mr. Park indicated that automotive service repairs carried out on-site are limited to oil changes, transmission and brake flushes, tire replacement and wheel alignments.

Photograph 10: View electric hoist and floor drains on the interior of 2046 Scott Street.
