Phase I-Environmental Site Assessment

1330 Carling Avenue and 815 Archibald Street
Ottawa, Ontario

February 28, 2020

Report: PE4789-1

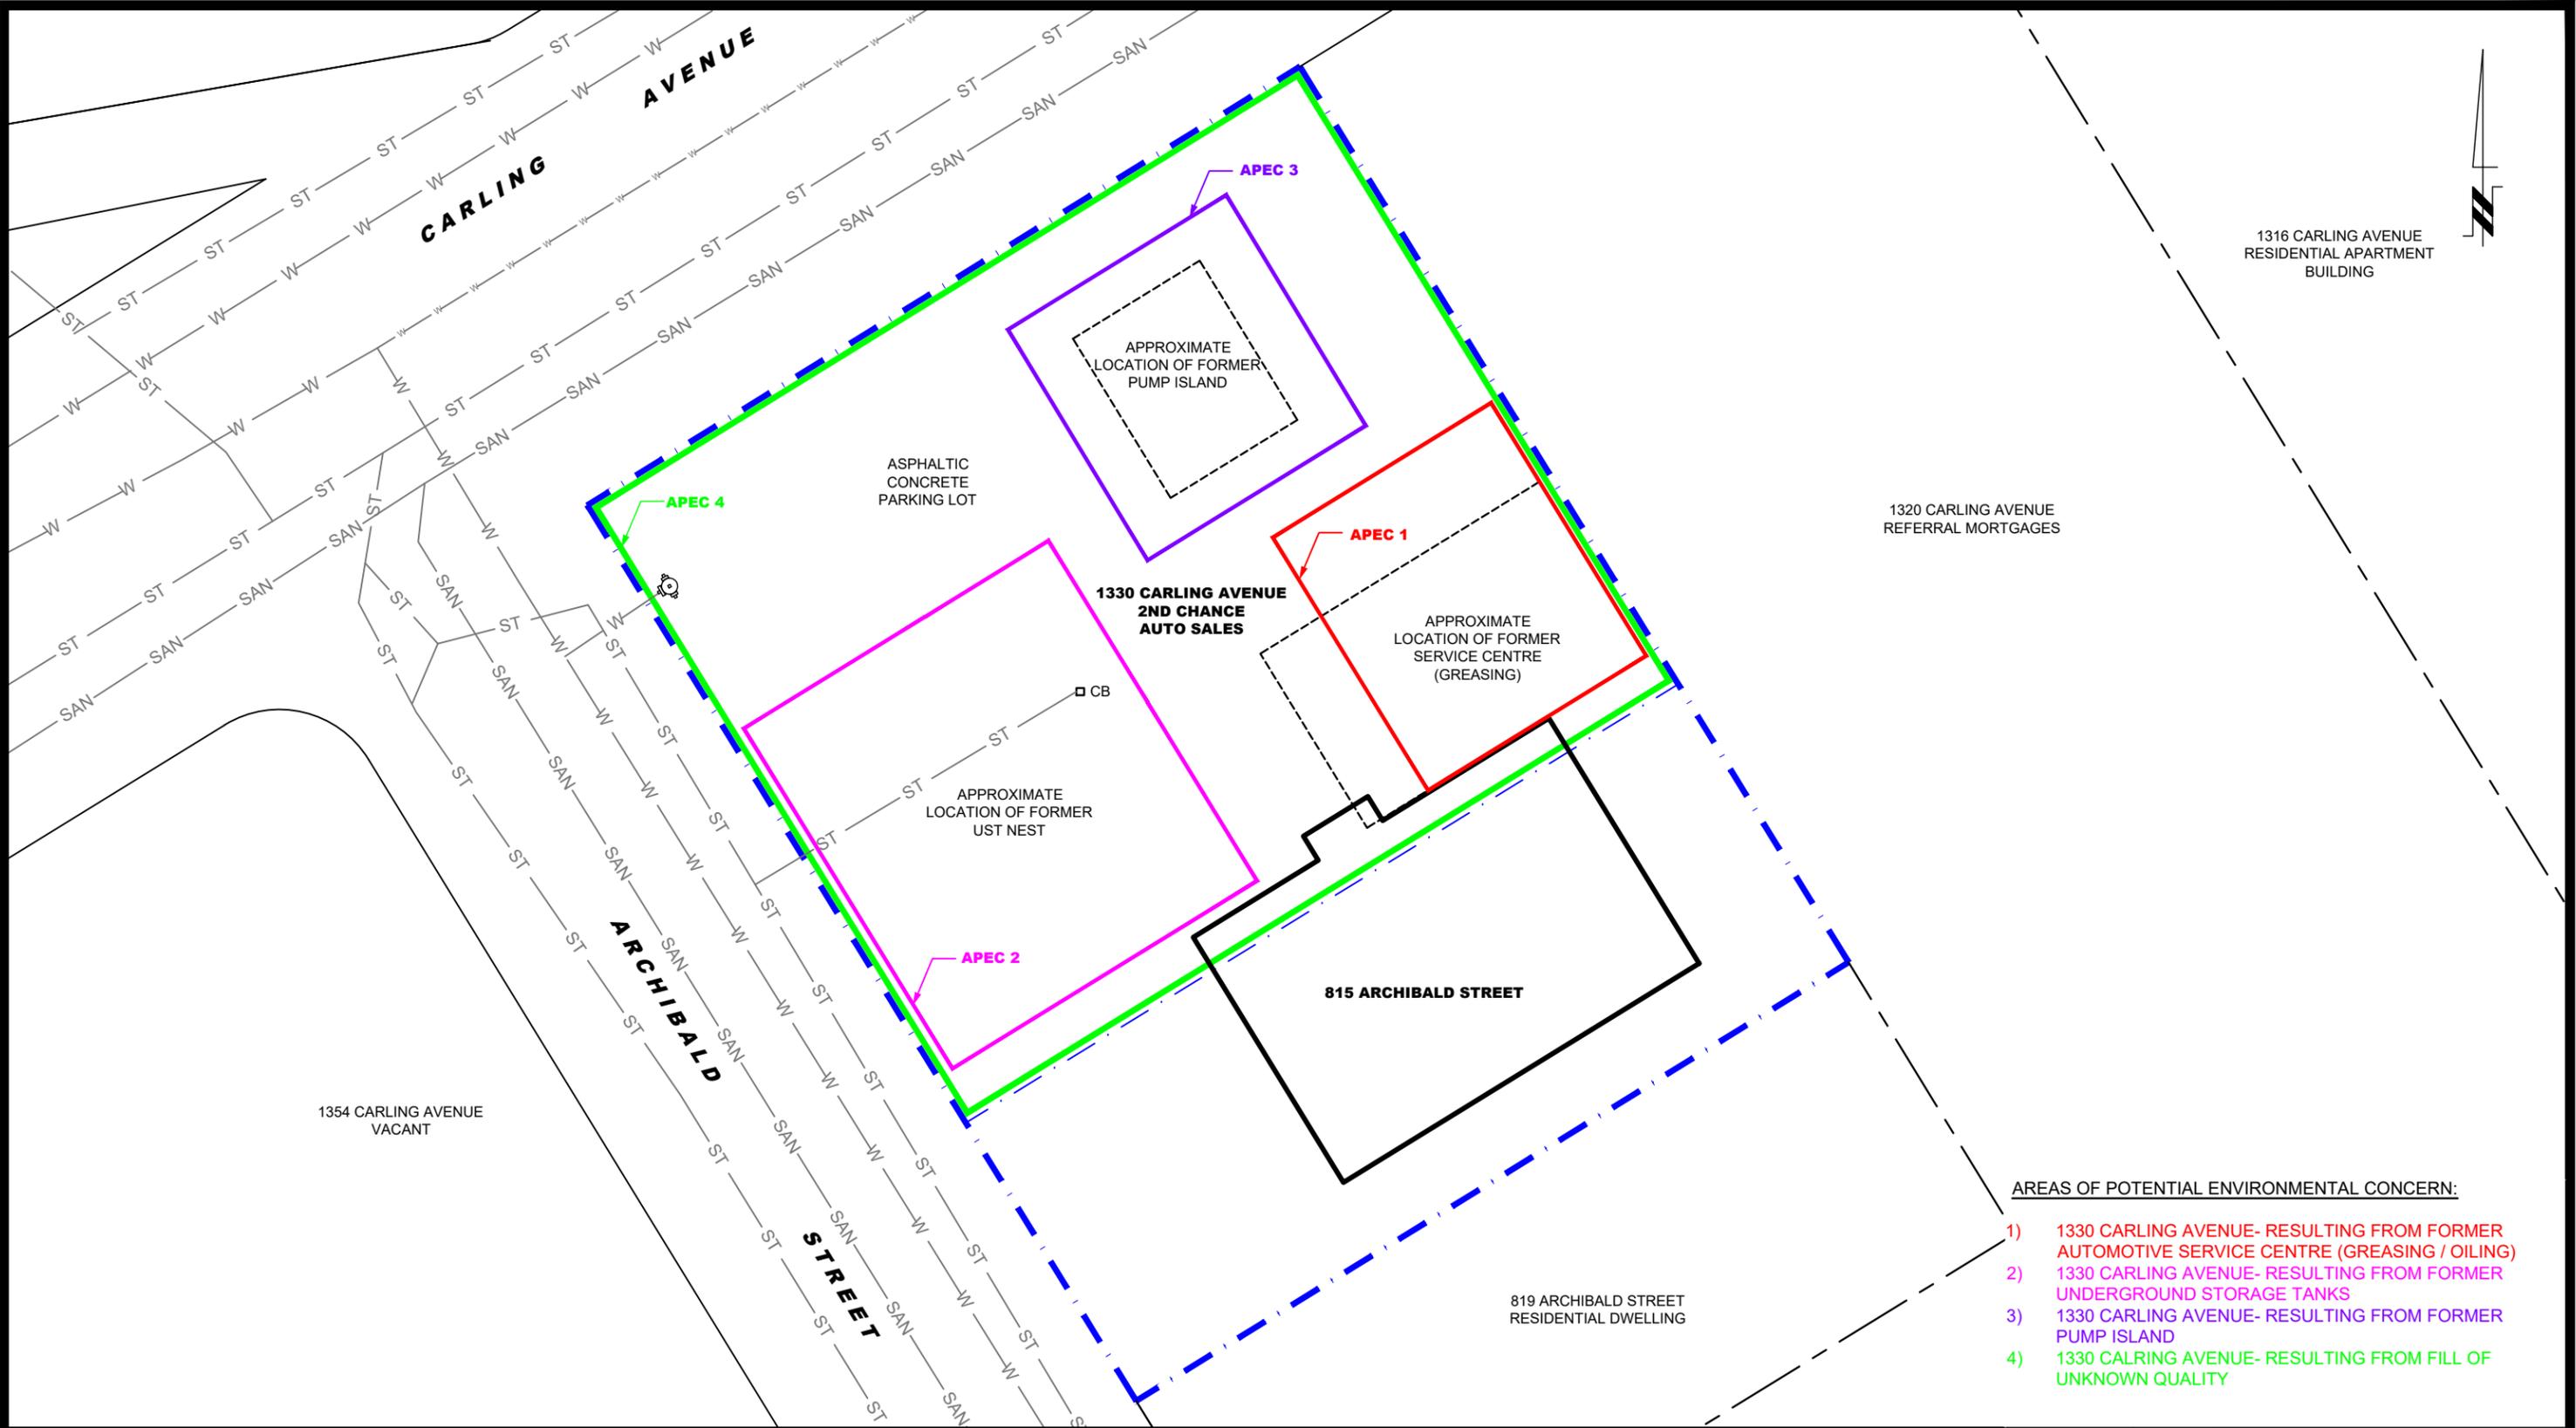
DRAWING PE4789-1 – SITE PLAN

- AREAS OF POTENTIAL ENVIRONMENTAL CONCERN:**
- 1) 1330 CARLING AVENUE- RESULTING FROM FORMER AUTOMOTIVE SERVICE CENTRE (GREASING / OILING)
 - 2) 1330 CARLING AVENUE- RESULTING FROM FORMER UNDERGROUND STORAGE TANKS
 - 3) 1330 CARLING AVENUE- RESULTING FROM FORMER PUMP ISLAND
 - 4) 1330 CALRING AVENUE- RESULTING FROM FILL OF UNKNOWN QUALITY

1343678 ONTARIO LTD.
PHASE I - ENVIRONMENTAL SITE ASSESSMENT
1330 CARLING AVENUE AND 815 ARCHIBALD STREET
OTTAWA, ONTARIO
Title: **SITE PLAN**

The PCAs that generated APECs on the Phase I Property are shown on Drawing PE4789-1-Site Plan, and the locations of the aforementioned PCAs relative to the Phase I Property are shown on Drawing PE4789-2 - Surrounding Land Use Plan. It should be noted that documented addresses on the FIPs are not the same as reported in the directories.

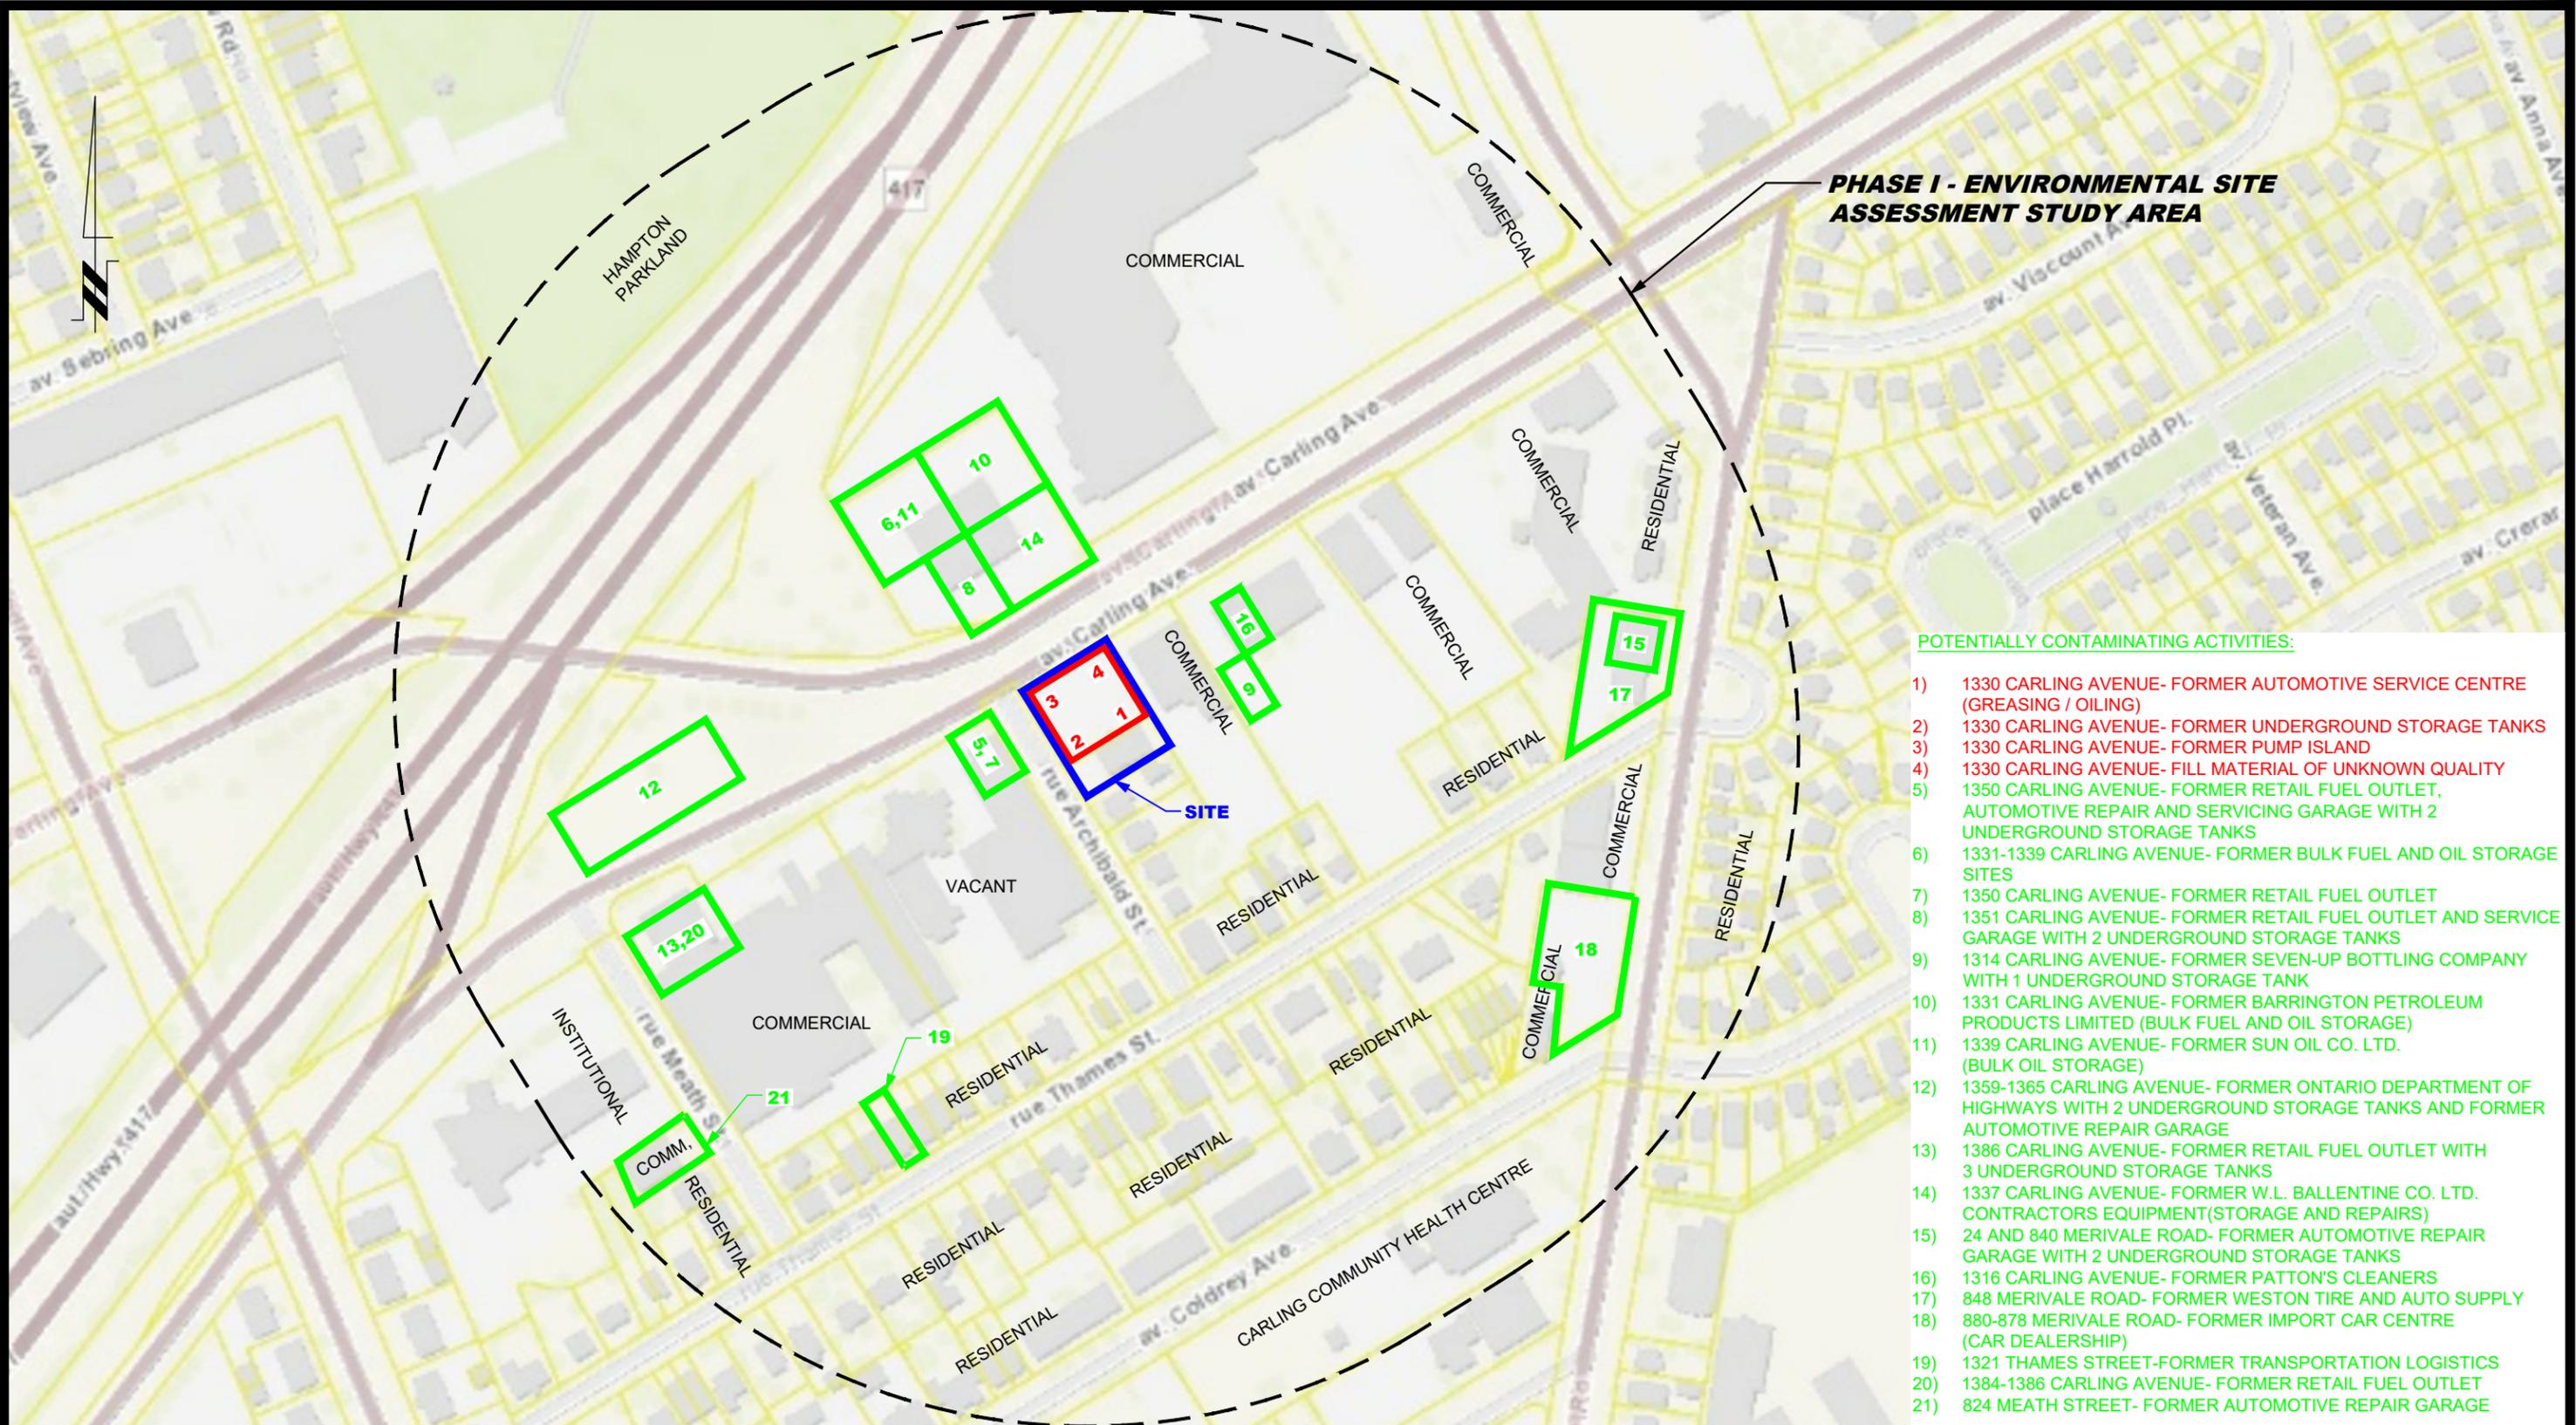
DRAWING PE4789-2 – SURROUNDING LAND USE PLAN

PHASE I - ENVIRONMENTAL SITE ASSESSMENT STUDY AREA

- POTENTIALLY CONTAMINATING ACTIVITIES:**
- 1) 1330 CARLING AVENUE- FORMER AUTOMOTIVE SERVICE CENTRE (GREASING / OILING)
 - 2) 1330 CARLING AVENUE- FORMER UNDERGROUND STORAGE TANKS

The HLUI search results from the HLUI2005 database found one activity associated with the Phase I Property (Activity ID: 6225). The activity (Activity ID: 6225) was identified as an RFO under Len Desforge Service Station and Gus and John Service Station Ltd. from 1957 to 1980. Thirty-seven (37) activities associated with properties within the study area were identified, of which, 10 were considered PCAs that were formerly identified during the FIP and City Directory review. A summary of the PCAs identified during the HLUI review is provided in Table 3 and their locations relative to the Phase I Property are shown on Drawing PE4789-2 – Surrounding Land Use Plan.

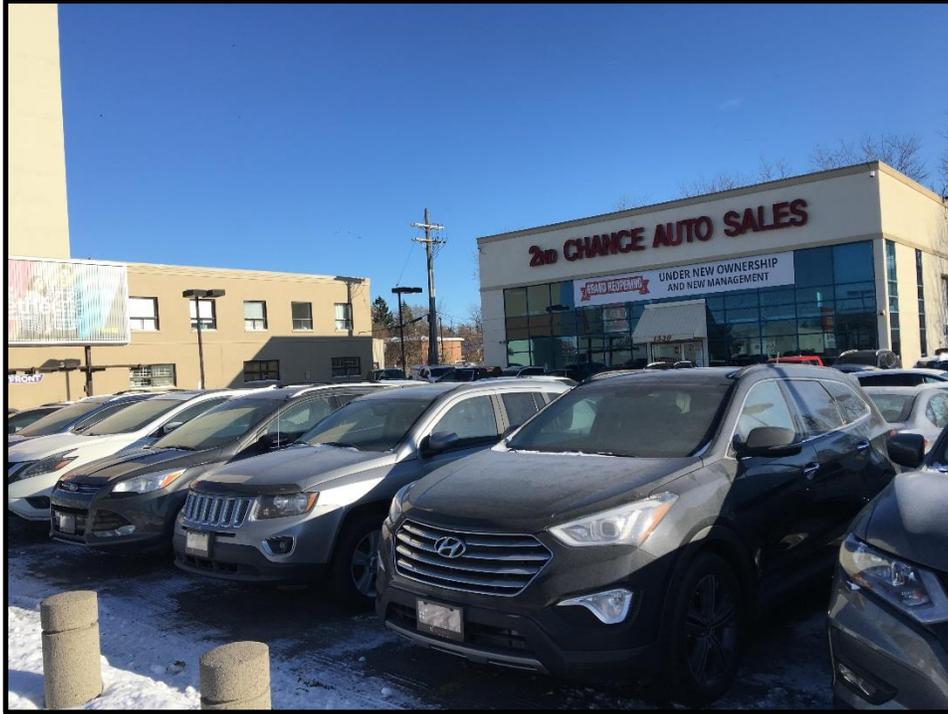
Photograph 1: View of the Phase I Property, taken from the Carling Avenue and Archibald intersection, looking southeast.

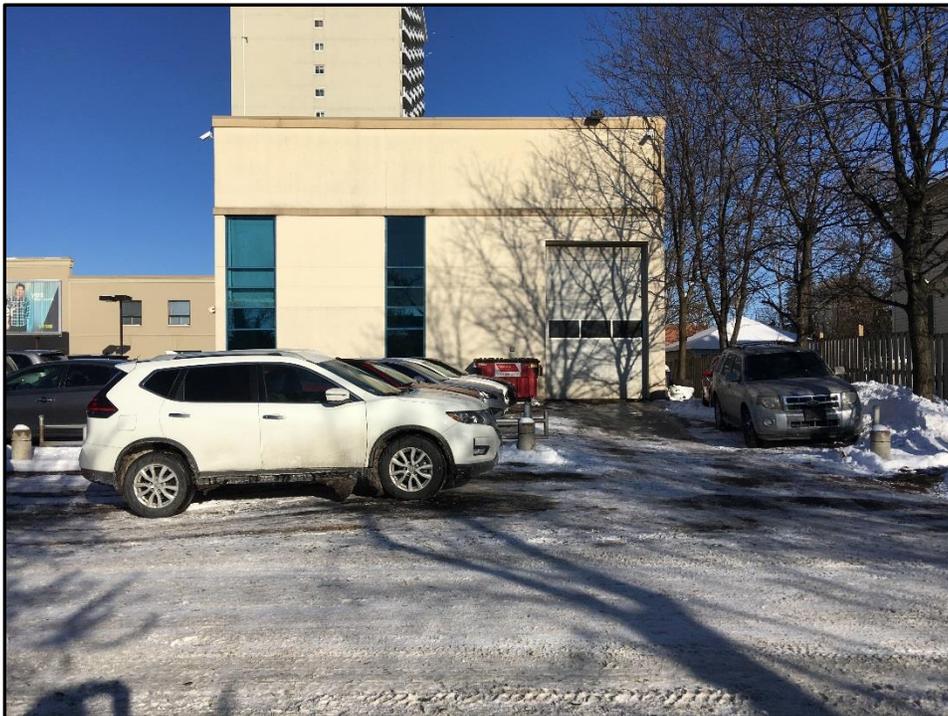
Photograph 2: Southern view of the Phase I Property and subject building, taken from Archibald Street, looking east.

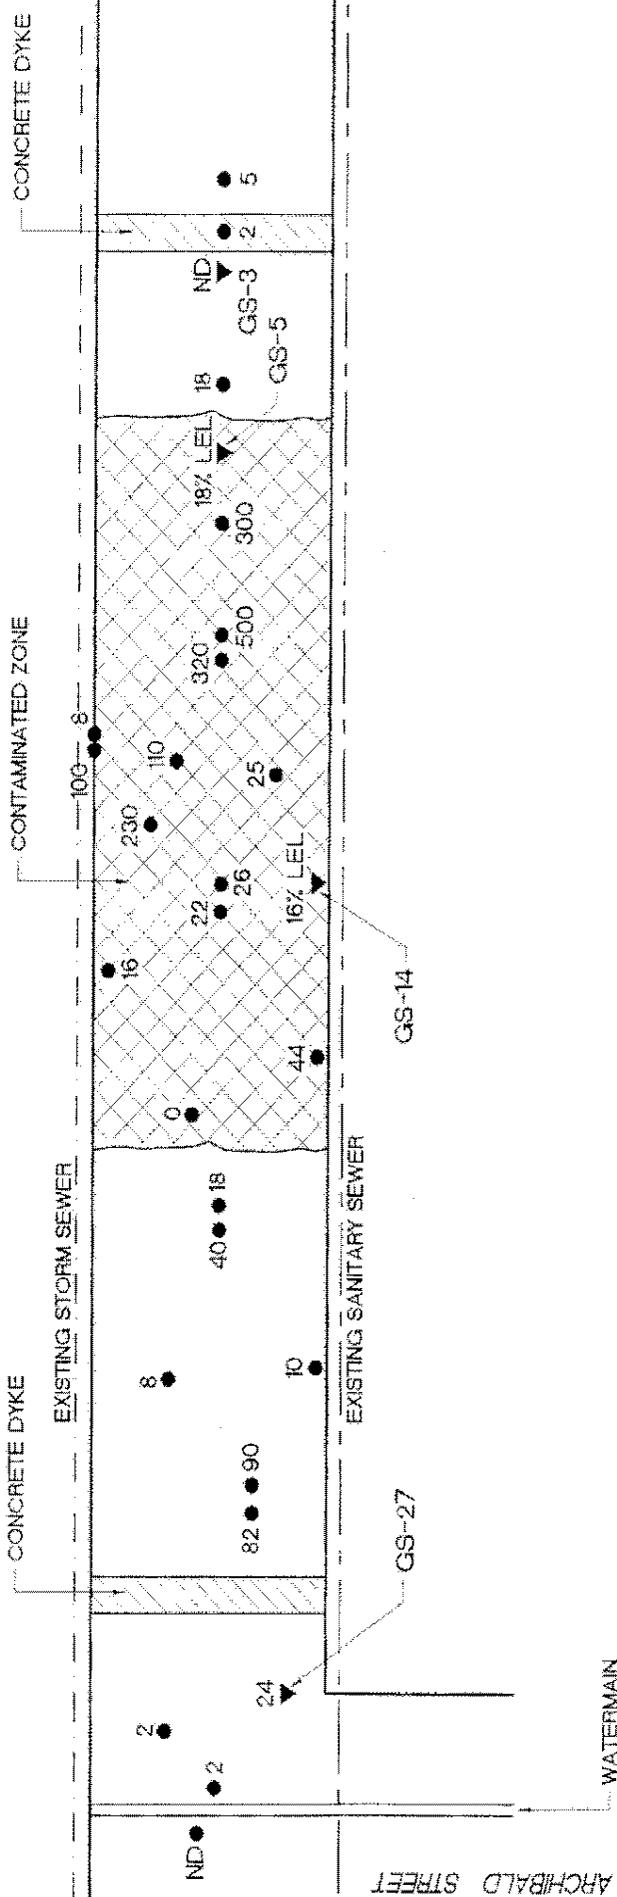
- PETROLEUM HYDROCARBON VAPOUR CONCENTRATIONS IN PPM UNLESS OTHERWISE NOTED IN %LEL
- ▼ SOIL SAMPLE SUBMITTED FOR LABORATORY ANALYSIS
- ND NON DETECTABLE

AINLEY GRAHAM AND ASSOCIATES		Scale : 1 : 200	Figure No: 30494-3
ENVIRONMENTAL MONITORING - SEWER TRENCH EXCAVATION		Date: 95/06/28	Dwn. By: GBB
1330 CARLING AVENUE - SAMPLE LOCATION PLAN		App'd: <i>[Signature]</i>	
OTTAWA, ONTARIO		Jacques Whitford

A sewer excavation adjacent to the Shell site along the north edge of the sidewalk on the south side of Carling Avenue, approximately 4 m north to an existing cast-in-place concrete sewer was conducted. Contaminated soil from 1.5 to 3 m depth and approximate length of 10 m was excavated. Soil at either end of this zone showed no evidence of hydrocarbon contamination. No free product was detected and no hydrocarbon sheen on groundwater entering the excavation was observed. Approximately 222 tonnes of soil were excavated and disposed of at the Carp Landfill site.

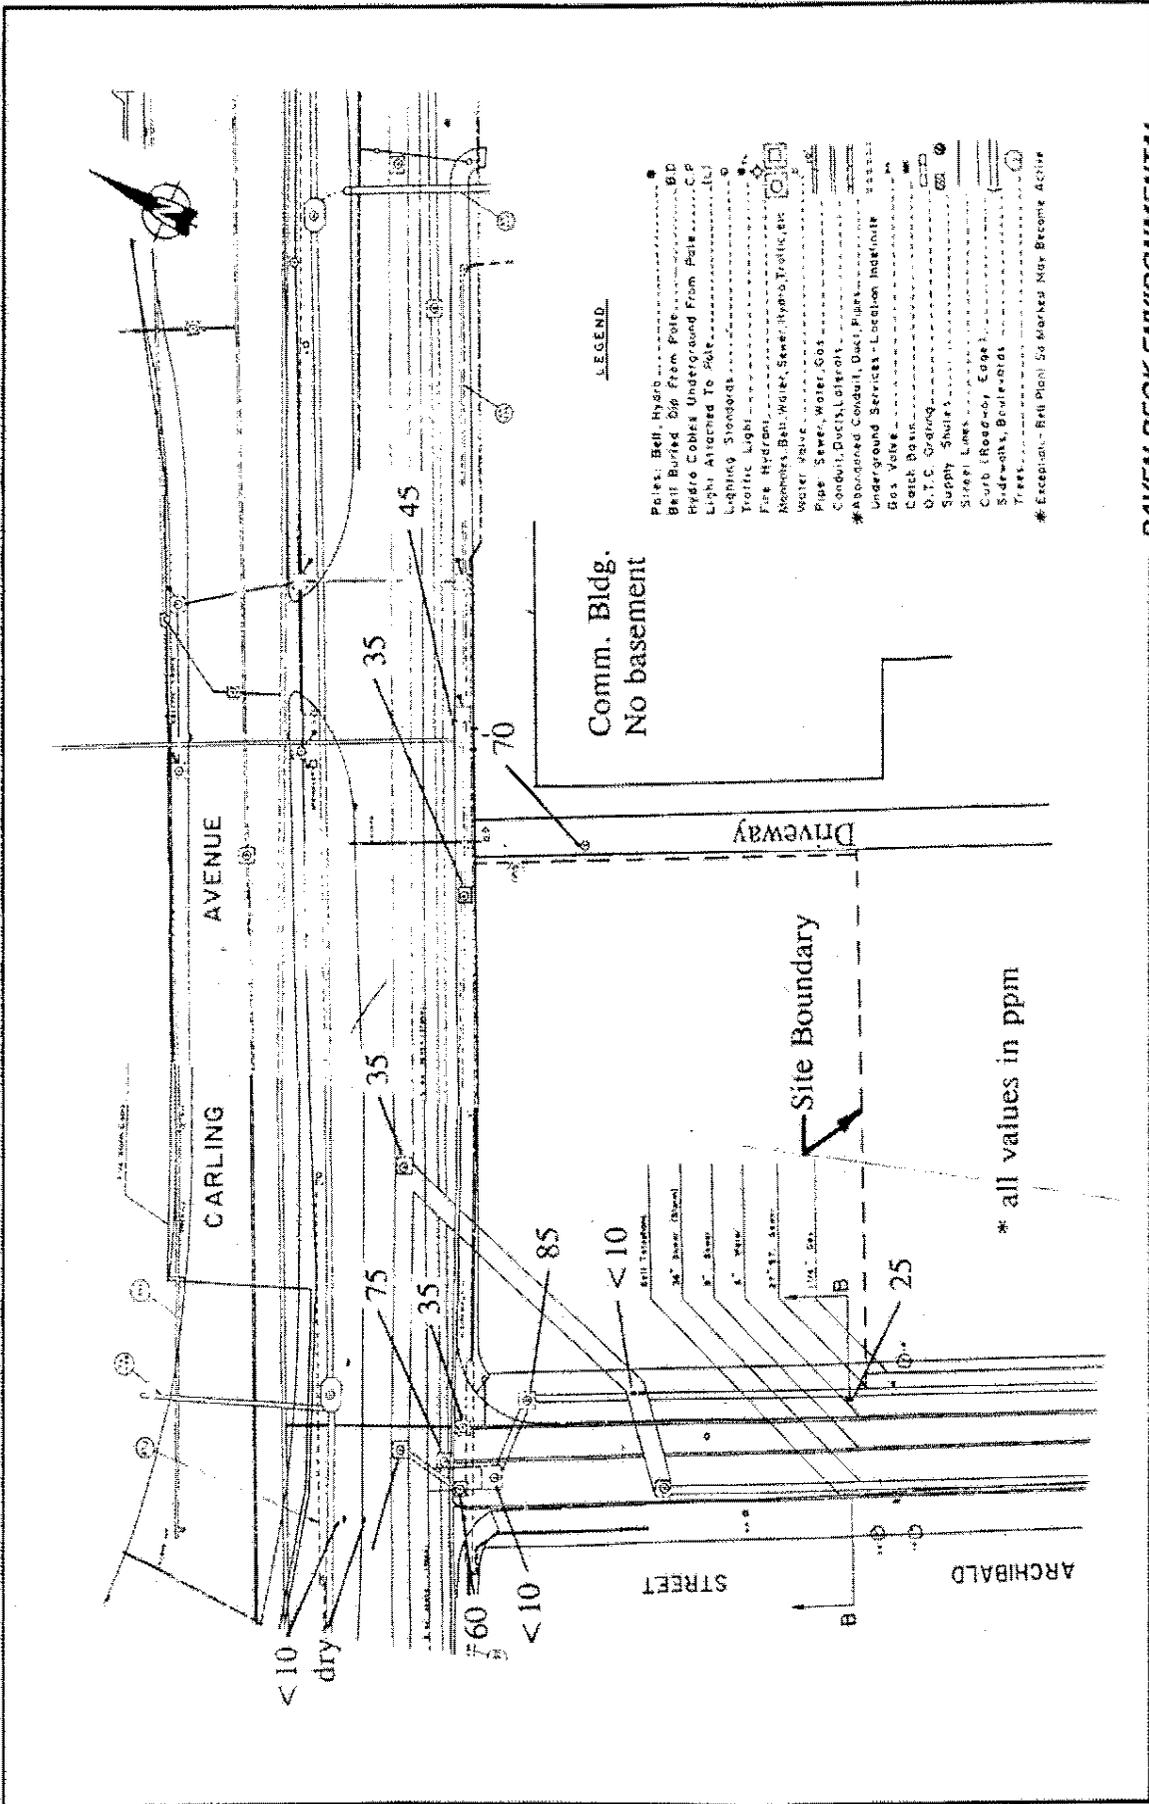
Figure 3 Utilities plan showing vapour survey results
