Phase I Environmental Site Assessment

78, 84, 86, 90 Beechwood Avenue
& 77, 83, 85, 89, 93 Barrette Street
Ottawa, Ontario

Minto Communities

Report: PE4614-1

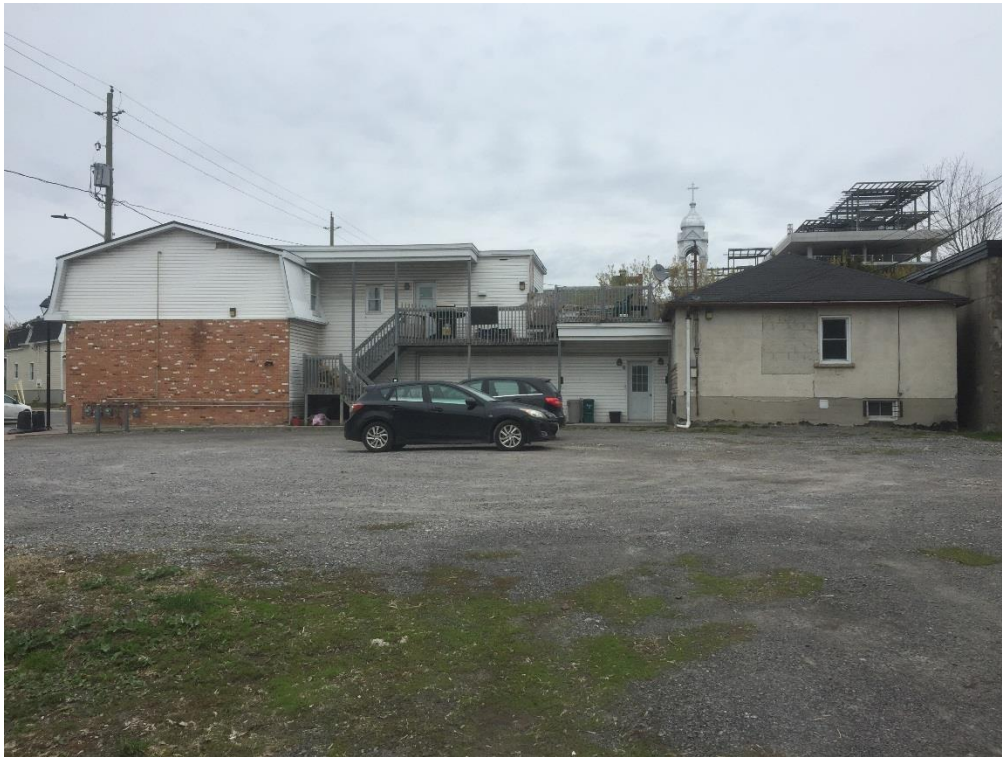
Photograph 1: Northeast part of the site.

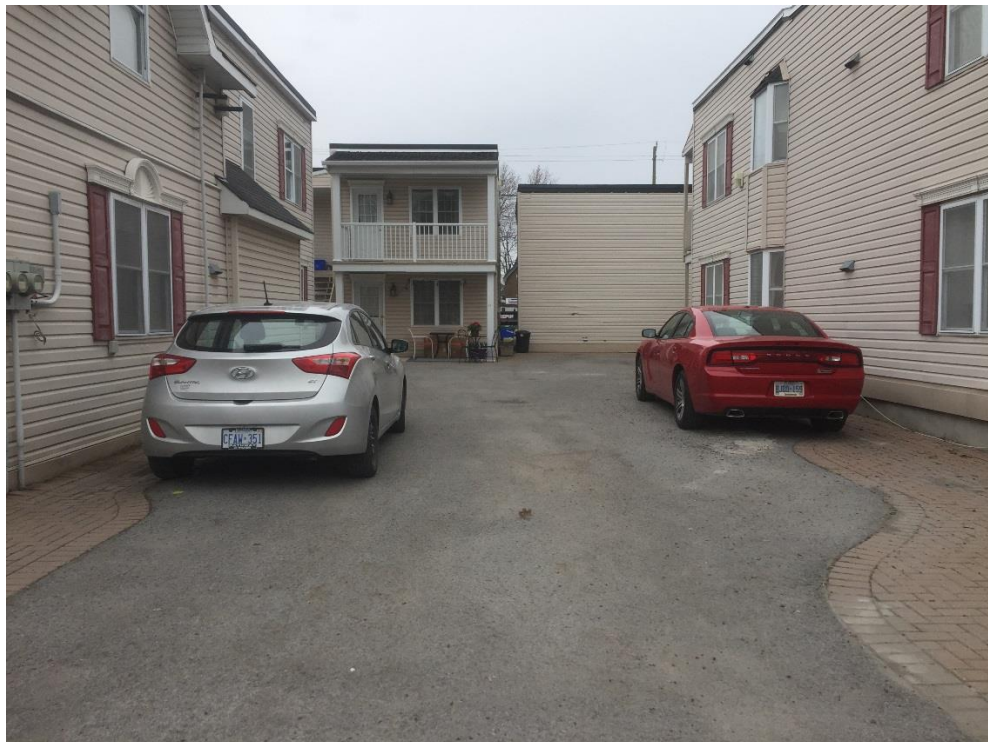
Photograph 2: Southern part of the site.

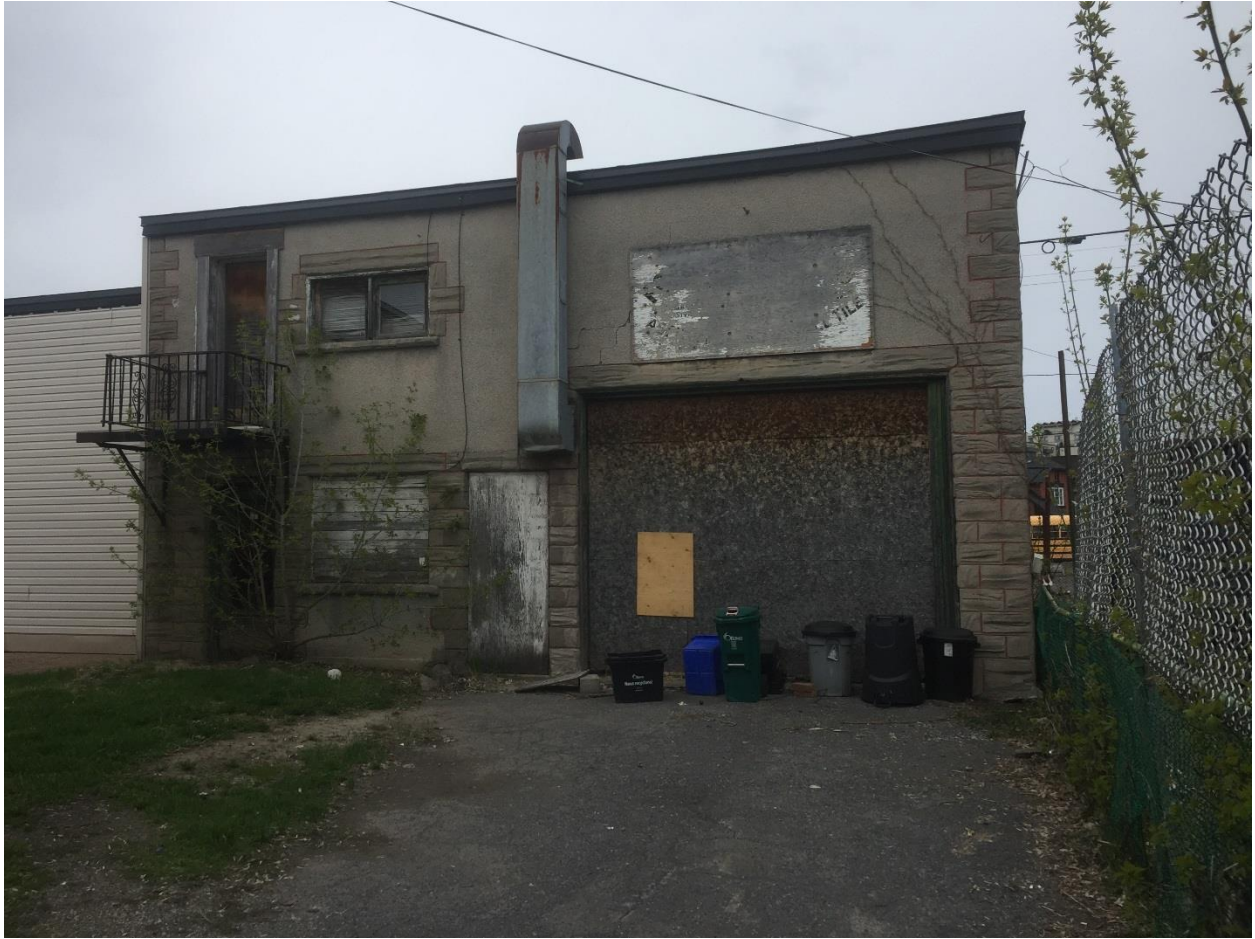
Photograph 3: Former Bob and Jerry's Body Shop and Auto Repair, north of 89 Barrette Street.

The historical use of 89 Barrette Street for Auto Repairs is considered an on-site PCA resulting in an APEC.
