## **Phase II Environmental Site Assessment**

335 Roosevelt Avenue  
Ottawa, Ontario

**August 4, 2020**

Report: PE2144-3

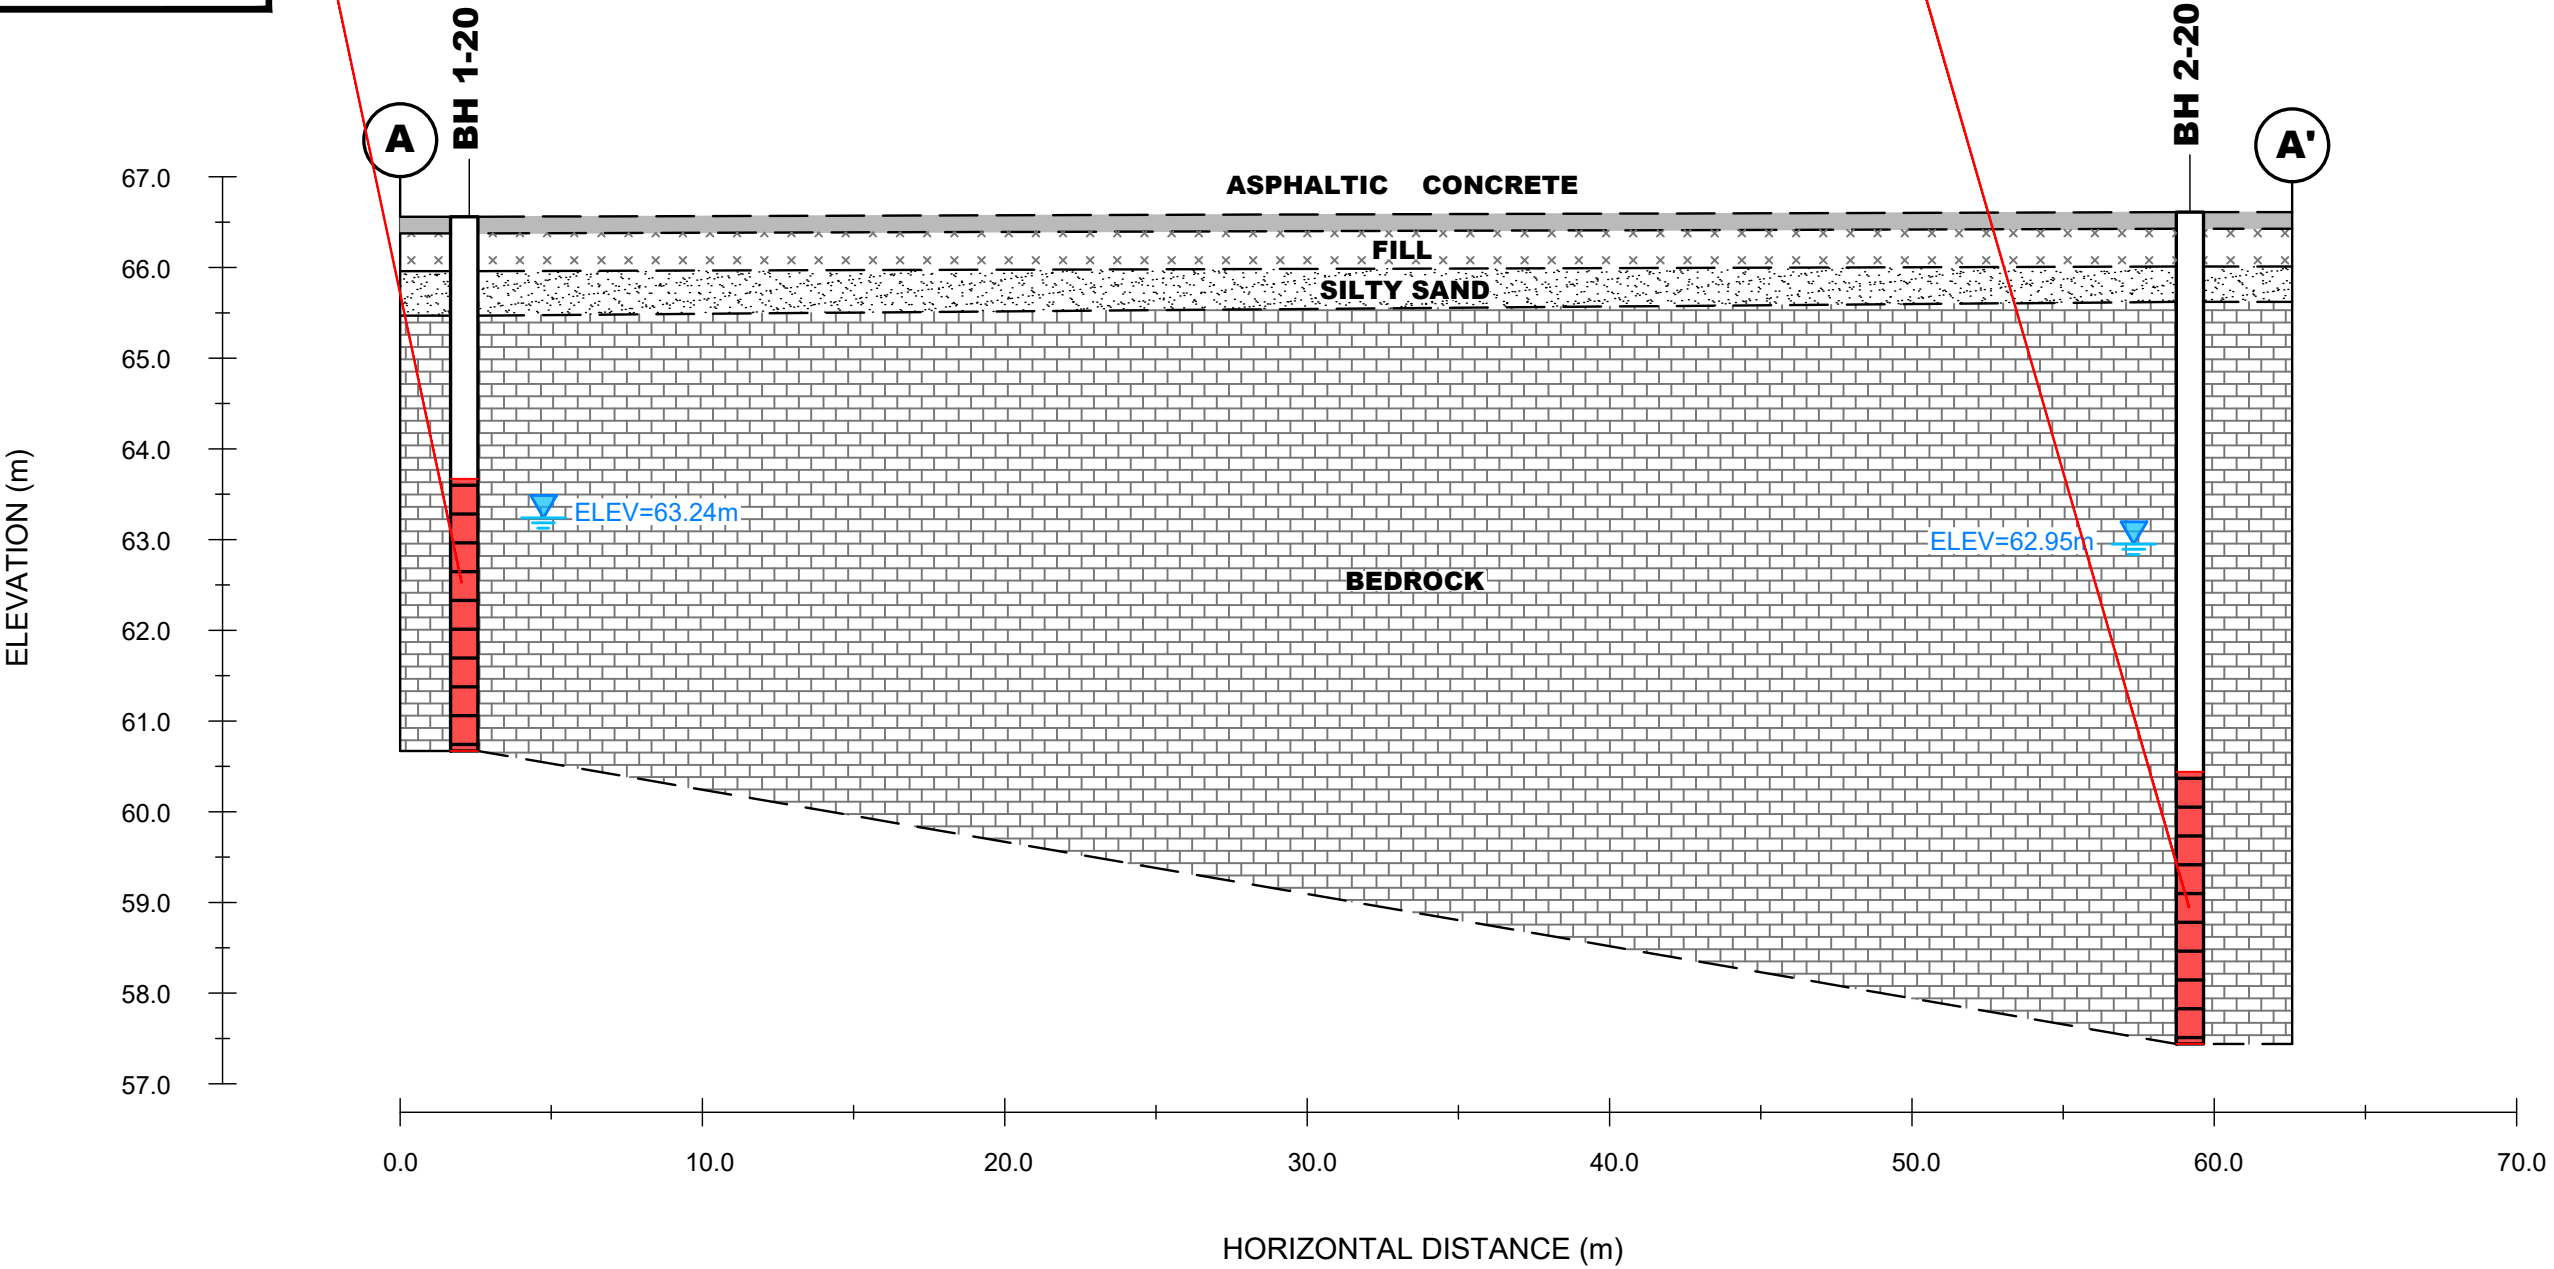
GROUNDWATER RESULT COMPLIES WITH MECP TABLE 7 STANDARDS

GROUNDWATER RESULT EXCEEDS MECP TABLE 7 STANDARDS

<div><b>pater</b>songroup</div> <div>consulting engineers</div> <div>154 Colonnade Road South Ottawa, Ontario K2E 7J5 Tel: (613) 226-7381 Fax: (613) 226-6344</div>					UNIFORM DEVELOPMENTS  SUPPLEMENTAL PHASE II - ENVIRONMENTAL SITE ASSESSMENT 335 ROOSEVELT AVENUE  OTTAWA, ONTARIO	Scale: AS SHOWN	Date: 07/2020
						Drawn by: MPG	Report No.: PE2144-3
						Checked by: MW	Dwg. No.: <b>PE2144-8</b>
						Approved by: MSD	
					Title: CROSS SECTION A-A' - GROUNDWATER		Revision No.:
		NO.	REVISIONS	DATE	INITIAL

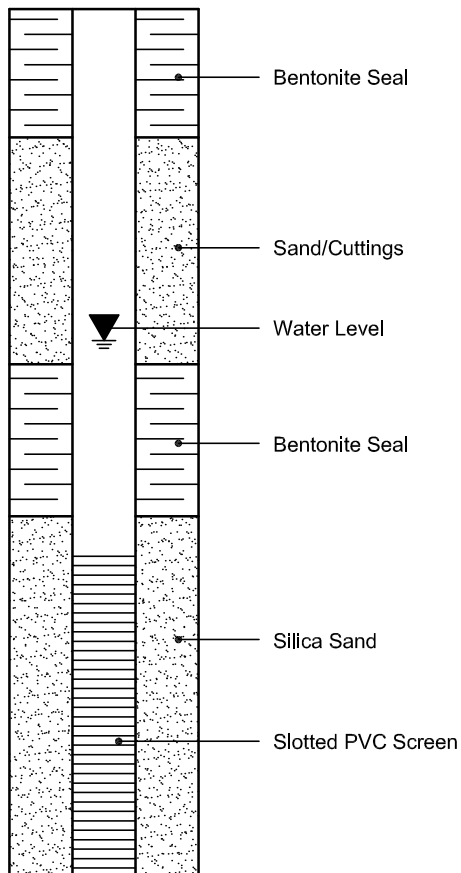
#### MONITORING WELL CONSTRUCTION

### MONITORING WELL AND PIEZOMETER CONSTRUCTION
