Combined Environmental Impact Statement &  
Tree Conservation Report  
54 Springbrook Drive, Ottawa, Ontario

June 2020

Prepared for the Amberwood Village Recreation Association

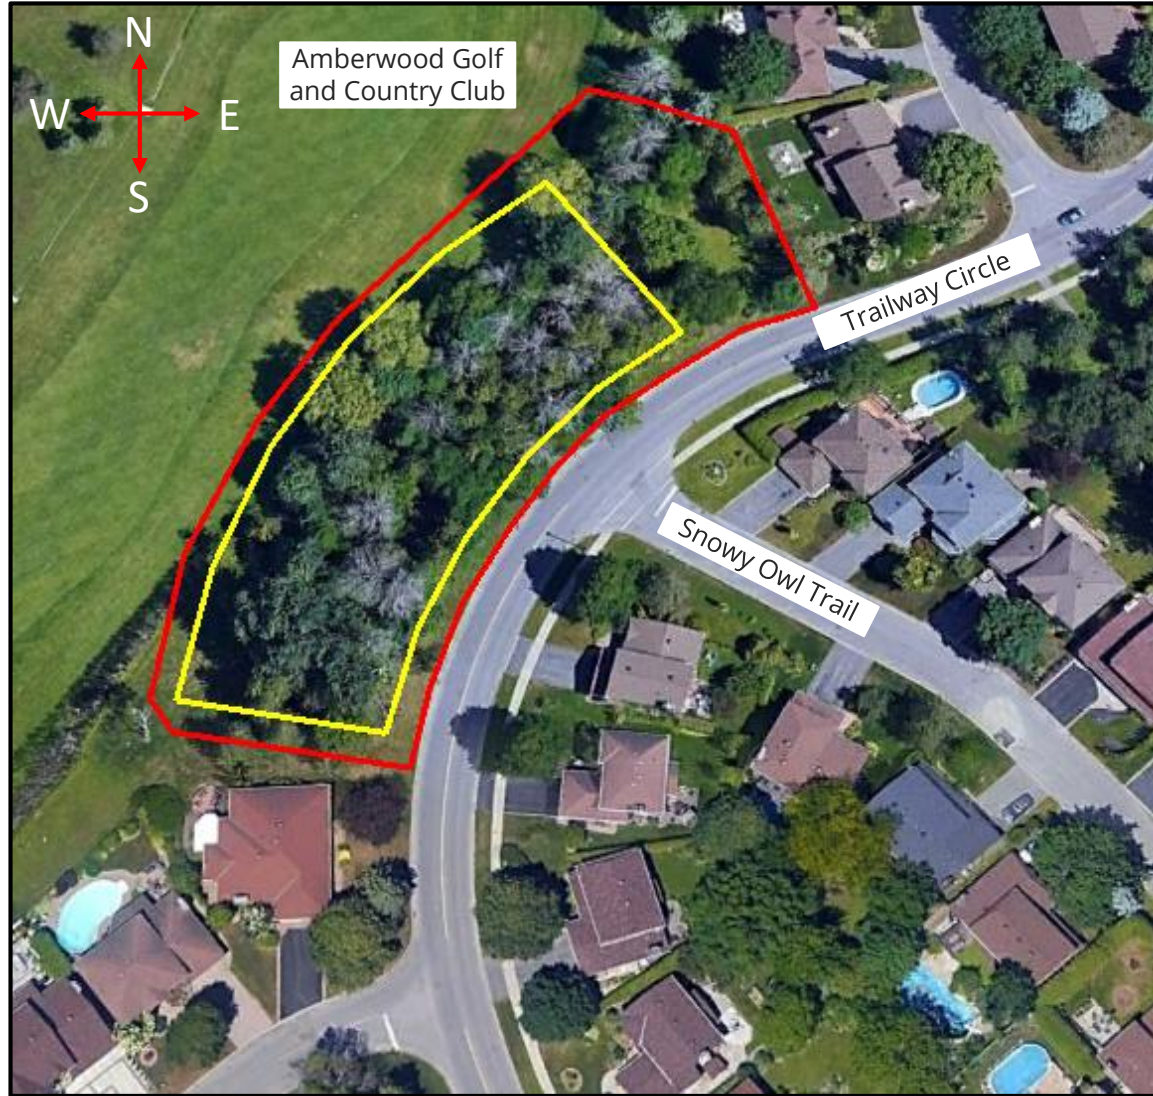
# FIGURE 1: SITE OVERVIEW

— - Tree Survey Area    — - Approximate Development Limits

Please Note:  
This is not a  
legal land  
survey. All  
dimensions  
and locations  
are shown as  
approximate.

The Site includes an approximately 0.28 ha development area, which is located within the southeastern portion of the Amberwood Golf and Country Club (54 Springbrook Drive, Ottawa (Ontario)) (Figure 1). As shown in Figure 1, the Site consists of a small Cultural Woodlot which is located between the golf course playing area and Trailway Circle. Several residential homes also border the Site. The Site is surrounded by the golf course playing area and existing development on all sides, and does not directly interface with any adjacent significant natural heritage features. As discussed below in Section 3.4, the Stittsville Wetland Complex is located approximately 182 m west of the Site, and several Stormwater Management Ponds are located northwest of the Site within the Amberwood Golf and Country Club.

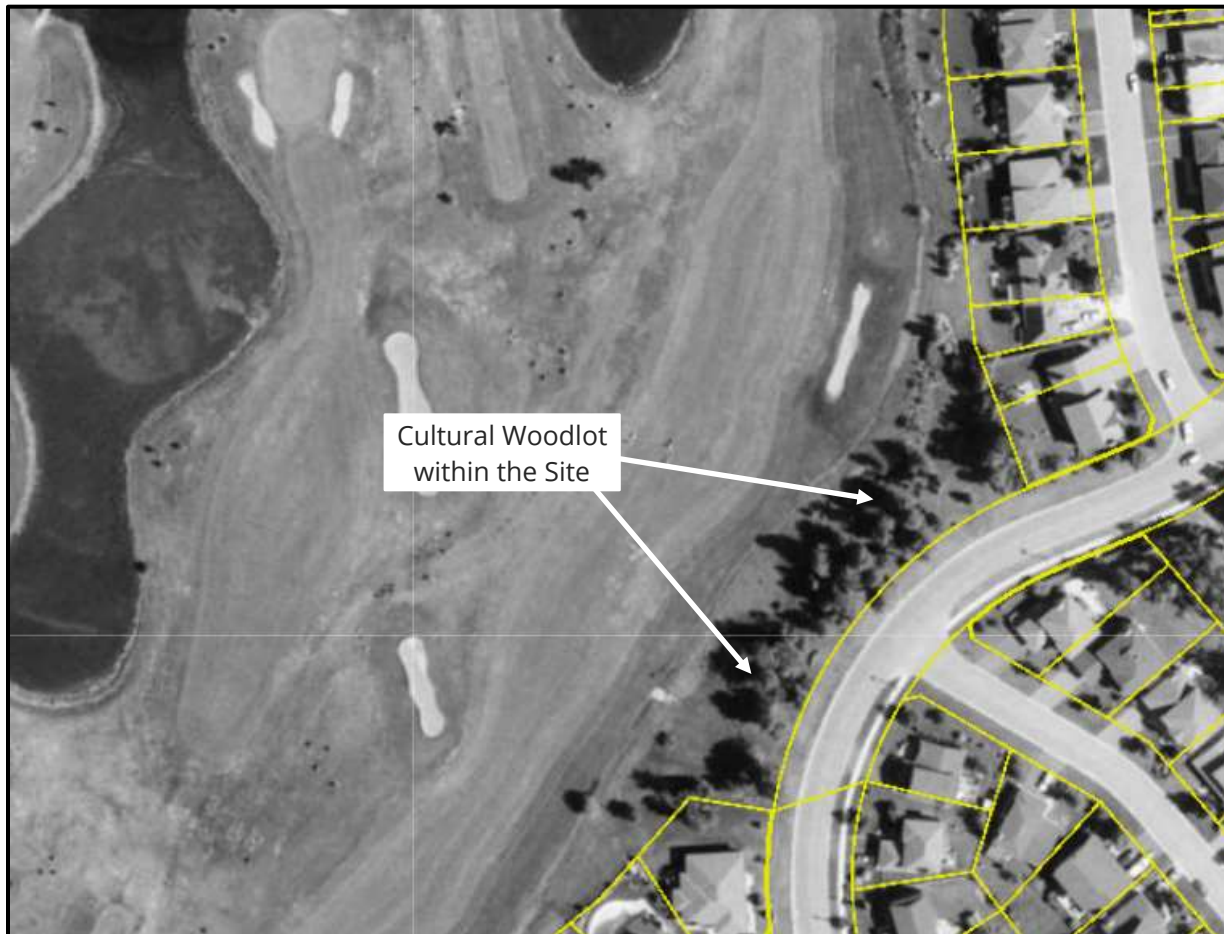
**Historic Air Photograph 1:** Historic Air Photo from 1991. As shown in the 1991 air photo, the Site was forested at that time. This suggests that trees found within the Site currently may be at least thirty (30) years of age (Photo from City of Ottawa 2020).

Air photos from 1976 are available on Geo-Ottawa, however, they re-date the development of the Amberwood Golf and Country Club, as well as the surrounding houses and roads. As such, the 1976 air photos do not provide a useful reference, as they pre-date development of the region surrounding the Site. An air photo from 1991 is included below. As shown in the 1991 air photo, the Site was forested at that time. This suggests that trees found within the Site currently may be at least thirty (30) years of age.

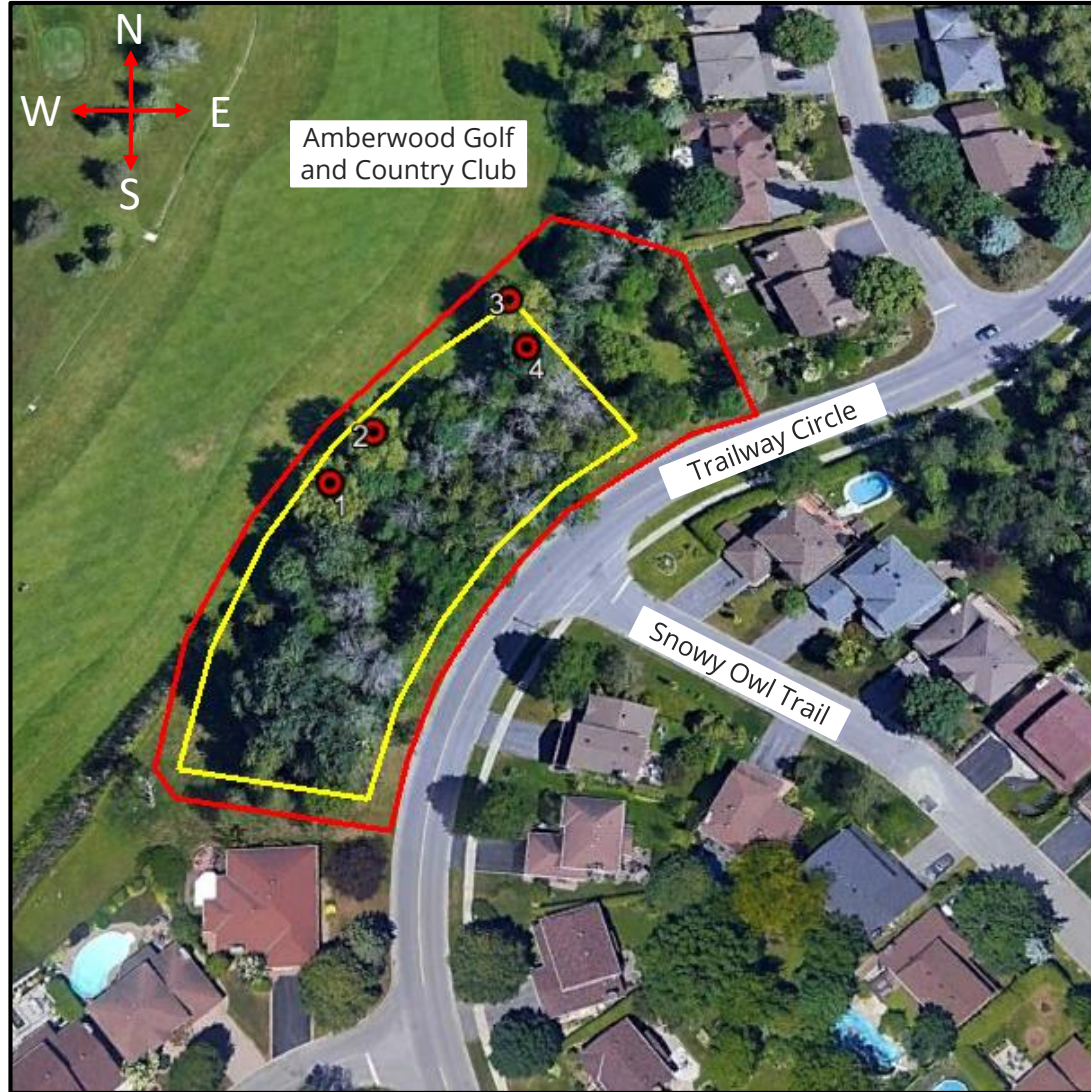
# FIGURE 2: LARGE TREE LOCATIONS

Please Note:  
This is not a legal land survey. All dimensions and locations are shown as approximate. DBH = Diameter at Breast Height.

- **Tree Removal Permit:** The City of Ottawa has noted that a Distinctive Tree Permit will be required to remove any tree >50 cm diameter at breast height (dbh) in size. As described below in Section 4.1, development of the Site will result in the removal of four (4) trees which are >50 cm dbh in size.

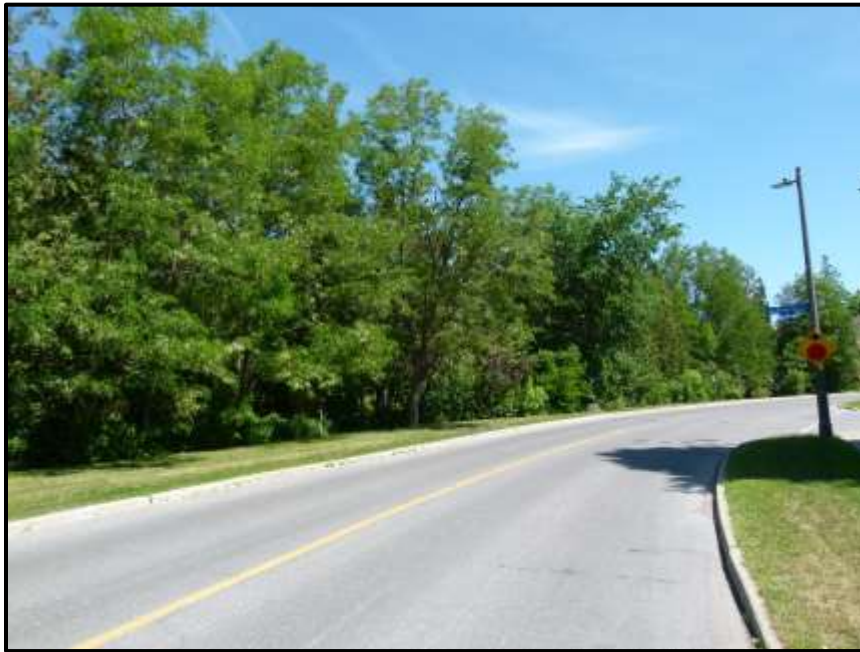
**Photograph 1:** Looking north at the Cultural Woodlot from Trailway Circle (June 19<sup>th</sup>, 2020).

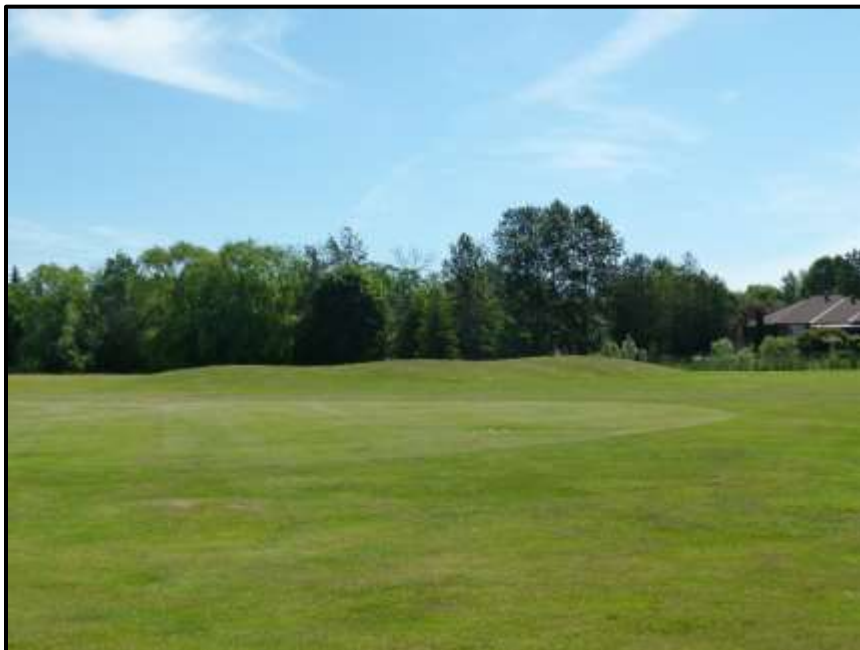
**Photograph 2:** Looking east at the Cultural Woodlot from the Amberwood Golf and Country Club (June 19<sup>th</sup>, 2020).

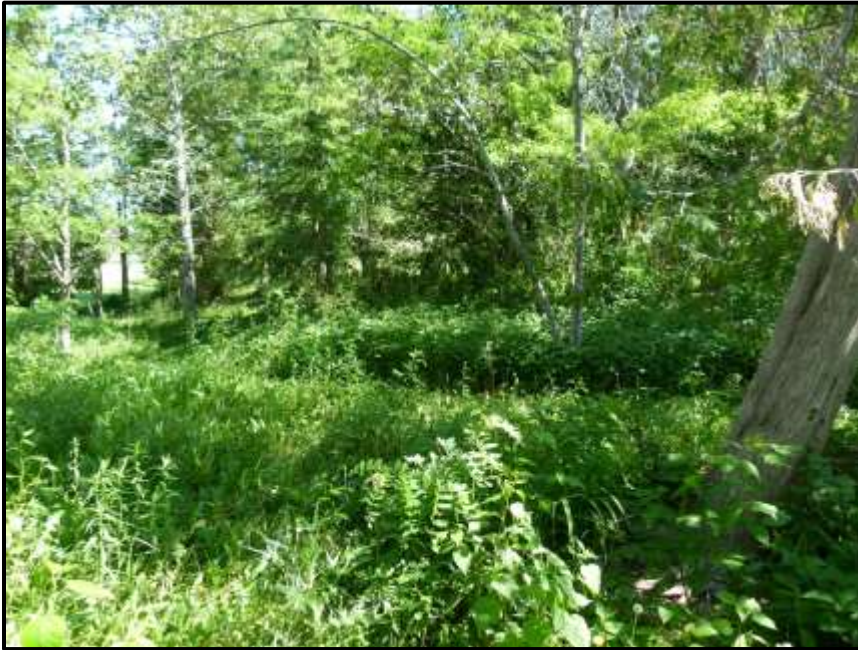
Photograph 3: Interior of the Cultural Woodlot (June 19<sup>th</sup>, 2020).

The majority of the Site is occupied by a disturbed Cultural Woodlot. The Cultural Woodlot includes a mixture of native and non-native species, including trees which appear to have been planted as landscaping features, as well as natural regeneration. The number of stems and tree sizes are summarized below in Table A. Refer to Appendix A for a list of plants found within the Site. White Cedar is the most common tree species within the Cultural Woodlot, followed by Trembling Aspen, White Ash, Honey Locust, and White Birch. A few Sugar Maple, White Spruce, Red Pine, Weeping Willow, American Elm, Manitoba Maple, Bur Oak, Balsam Fir, and a single Domestic Apple are also present. It should be noted that virtually all of the White Ash trees are either dead or in very poor condition, as a result of the impacts of the invasive Emerald Ash Borer. Shrub and groundcover within the Cultural Woodlot reflects the generally disturbed condition of the feature. Shrub cover varies between sparse and moderately dense, and includes Common Buckthorn, Tartarian Honeysuckle, Lilac, Wild Red Raspberry, and Riverbank Grape. The groundcover is dominated by patches of Day Lily and Common Stinging Nettle. Canada Thistle, Bull Thistle, Prickly Lettuce, Canada Goldenrod, grasses, Dandelion, Red Clover, White Clover, Canada Violet, Common Blue Violet, and Virginia Creeper are also present. Escaped and/or intentionally planted garden plants are also present within the woodlot, including various cultivated flowers and hostas.

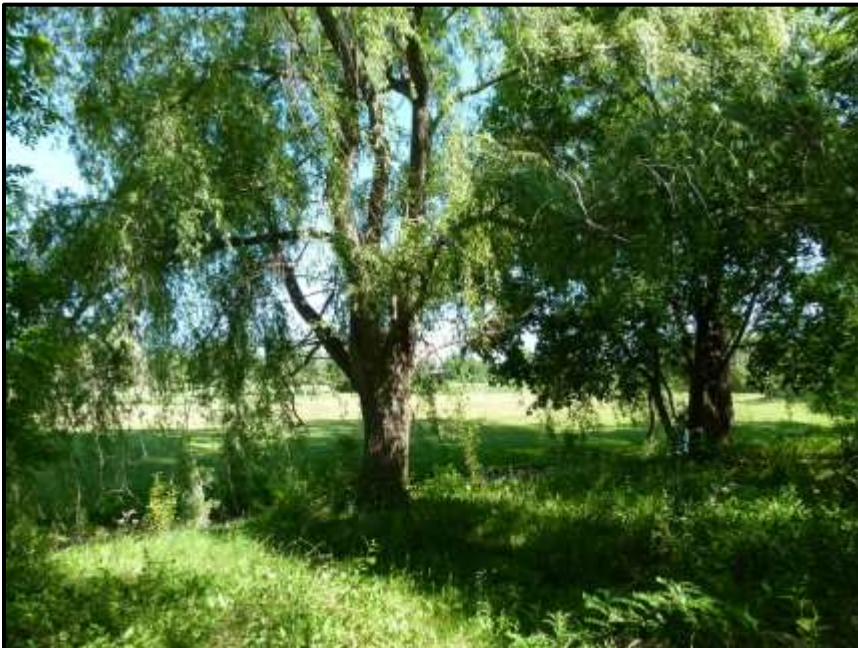
Photograph 4: Large Tree #1 (82 cm dbh Weeping Willow) (June 19<sup>th</sup>, 2020).

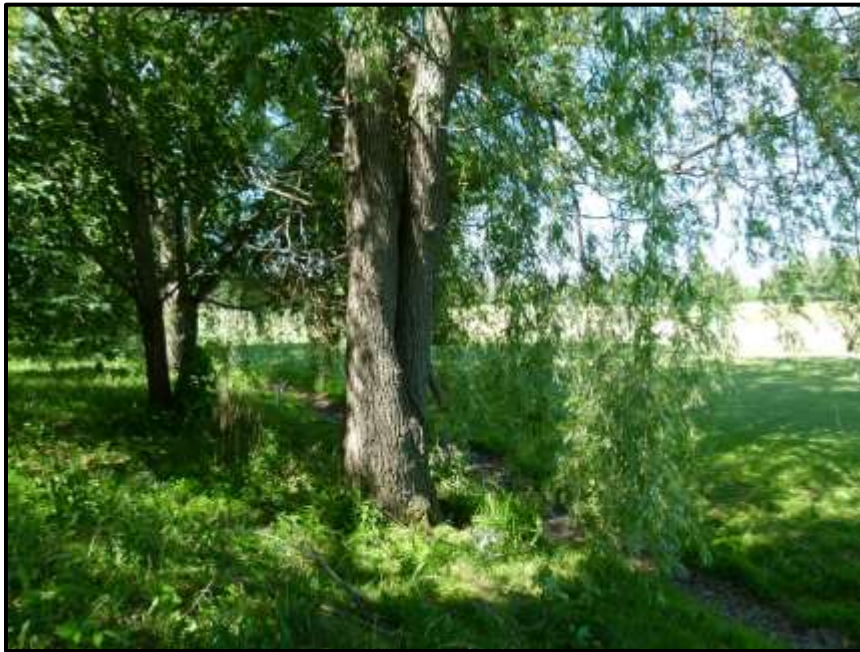
Photograph 5: Large Tree #2 (88 cm dbh Weeping Willow) (June 19<sup>th</sup>, 2020).

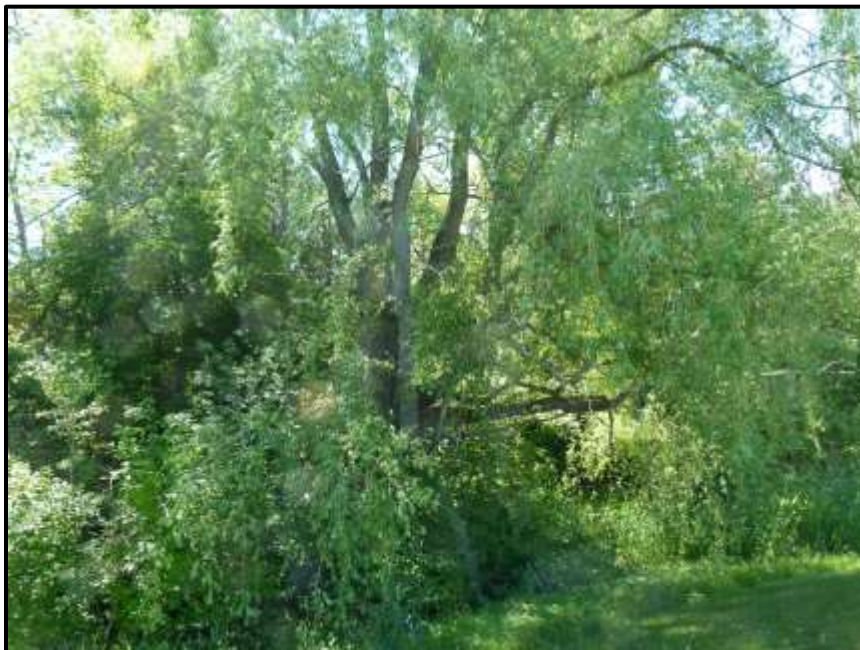
Photograph 6: Large Tree #3 (>1 m dbh Weeping Willow) (June 19<sup>th</sup>, 2020).

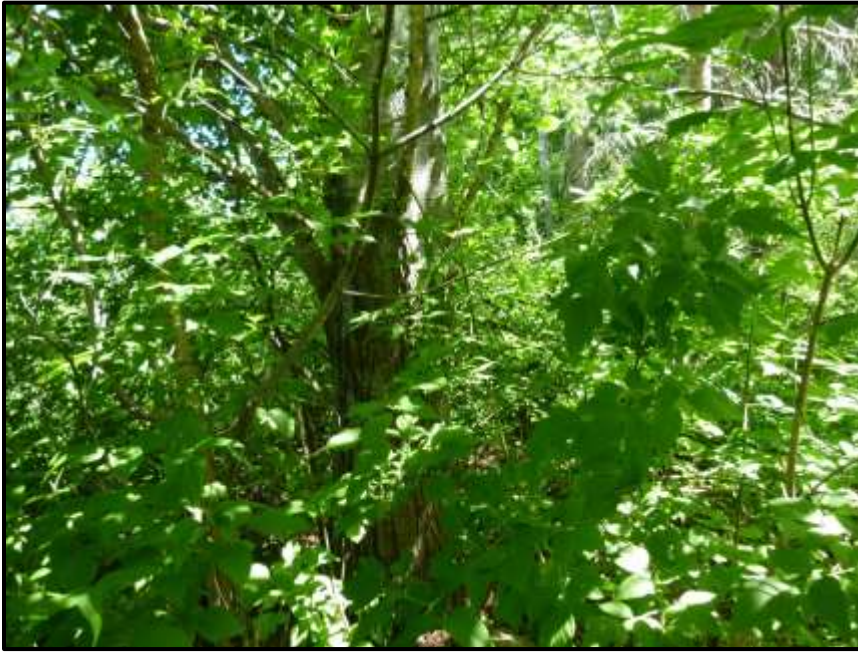
Photograph 7: Large Tree #4 (58 cm dbh Trembling Aspen) (June 19<sup>th</sup>, 2020).

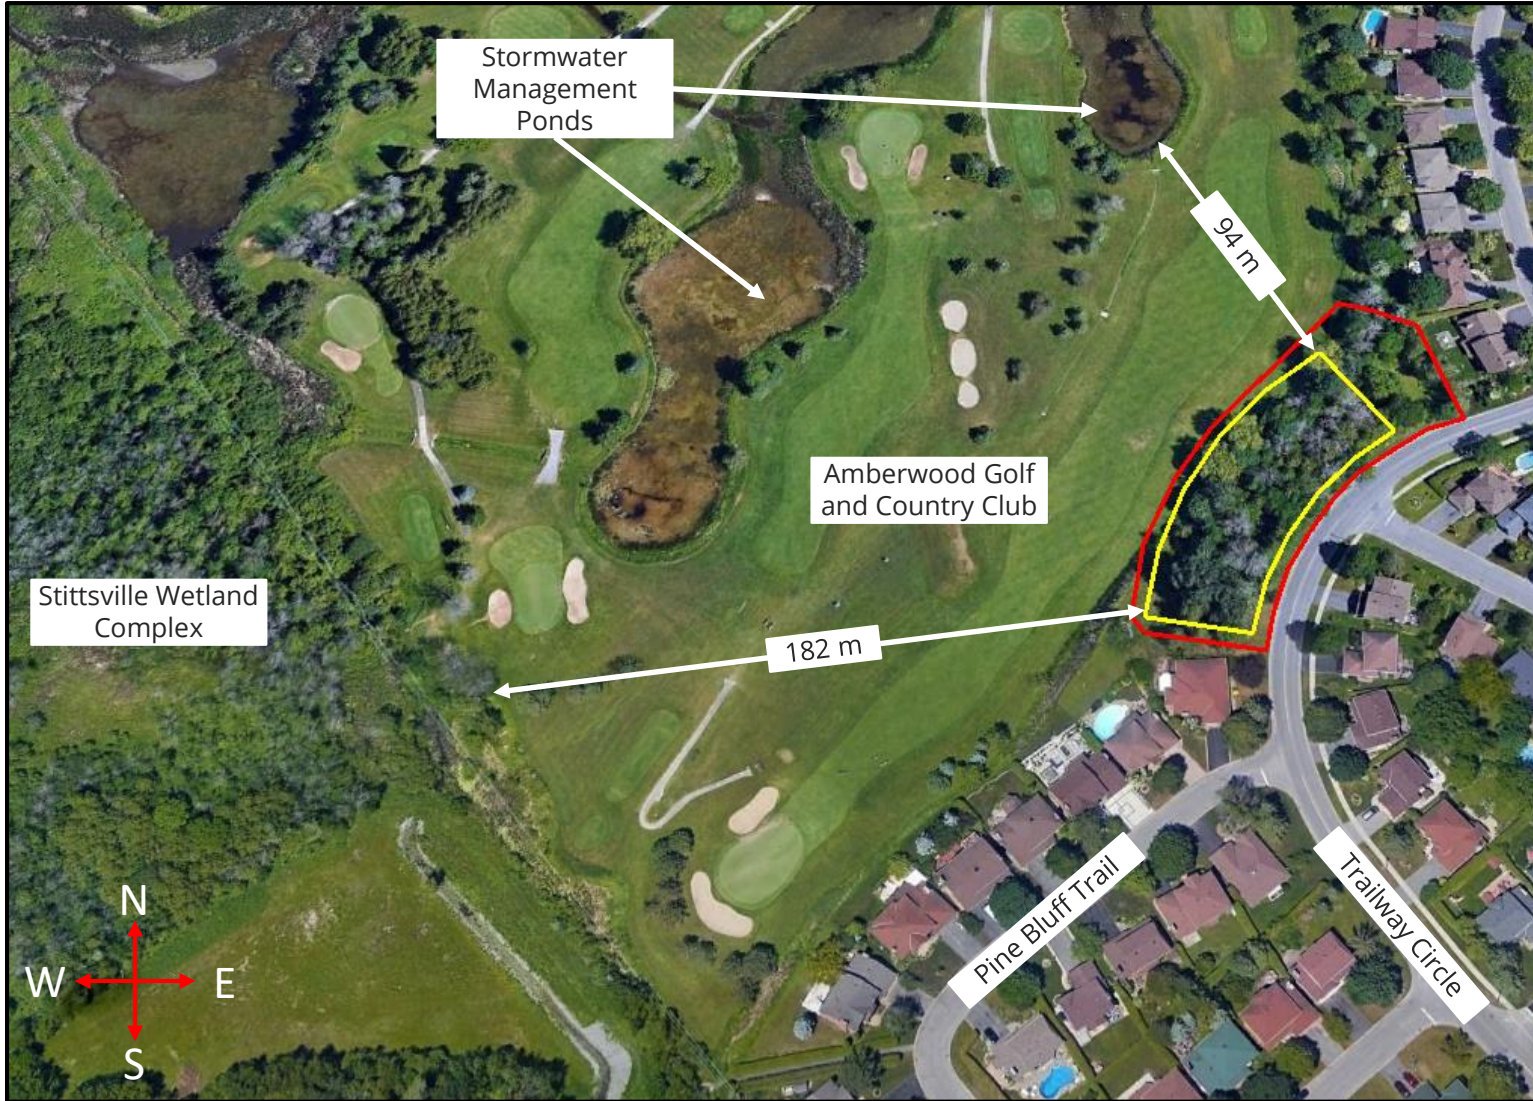
# FIGURE 3: ADJACENT FEATURES

— - Tree Survey Area    — - Approximate Development Limits

Please Note:  
This is not a  
legal land  
survey. All  
dimensions  
and locations  
are shown as  
approximate.

The Site is well drained and does not include any wetlands or watercourses. No evidence of water pooling was noted within the Site. As shown below in Figure 3, the Site occurs approximately 94 m from the nearest part of the adjacent Stormwater Management Ponds (located within the Amberwood Golf and Country Club) and approximately 182 m from the nearest part of the Stittsville Wetland Complex. As such, the Site is sufficiently separated from the existing Stormwater Management Ponds and the Stittsville Wetland Complex so that no significant impacts to those features are likely to occur as a result of the proposed development. Due to the distance between the Stormwater Management Ponds/Stittsville Wetland Complex and the Site, the Stormwater Management Ponds/Stittsville Wetland Complex were not investigated in detail as part of the current assessment. The portion of the Stormwater Management Ponds that is closest to the Site was observed to include a shallow pond and naturalized marsh habitat. The nearest portion of the Stittsville Wetland Complex was observed to include a Cattail Marsh at its edge, beyond which is a treed swamp.

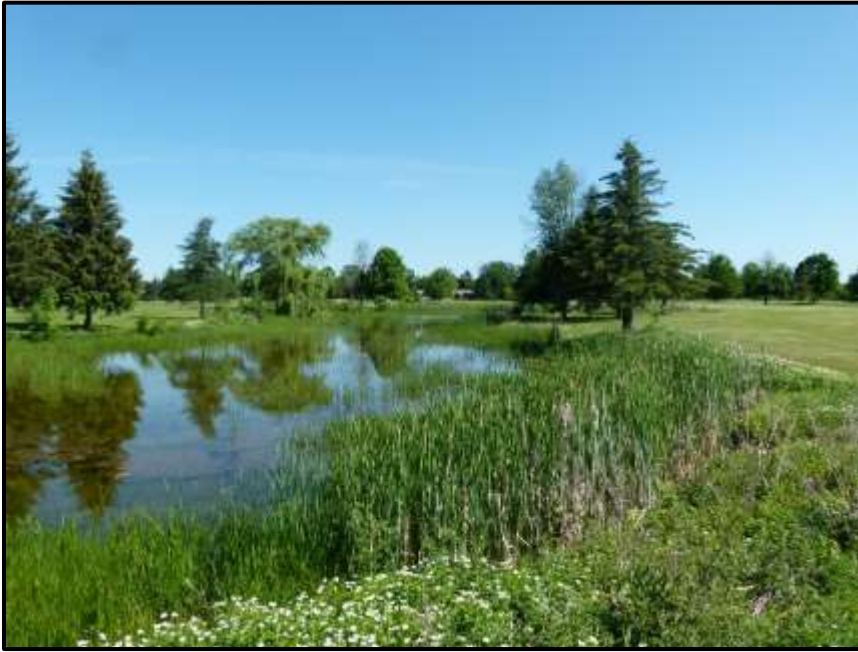
**Photograph 8:** Looking north at the Stormwater Management Pond within the Amberwood Golf and Country Club (June 19<sup>th</sup>, 2020).

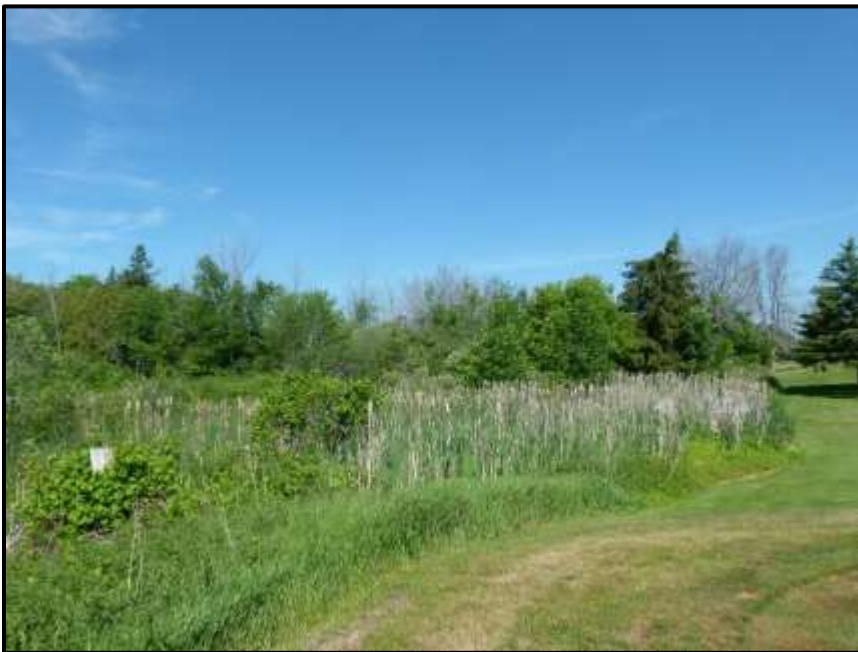
**Photograph 9:** Looking northwest at the edge of the Stittsville Wetland Complex (June 19<sup>th</sup>, 2020).
