Phase I-Environmental Site Assessment

Southern Portion of 1009 Trim Road
Ottawa, Ontario

August 17, 2020

Report: PE4886-1

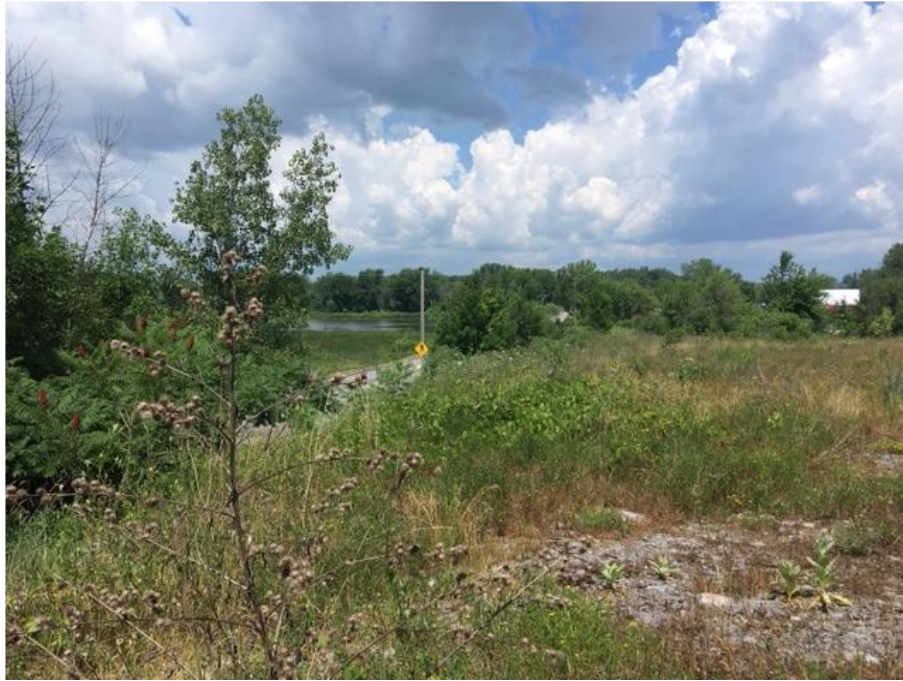
Photograph 1: Eastern view of the Phase I Property, taken from the central west side of the property, looking towards the Ottawa River.

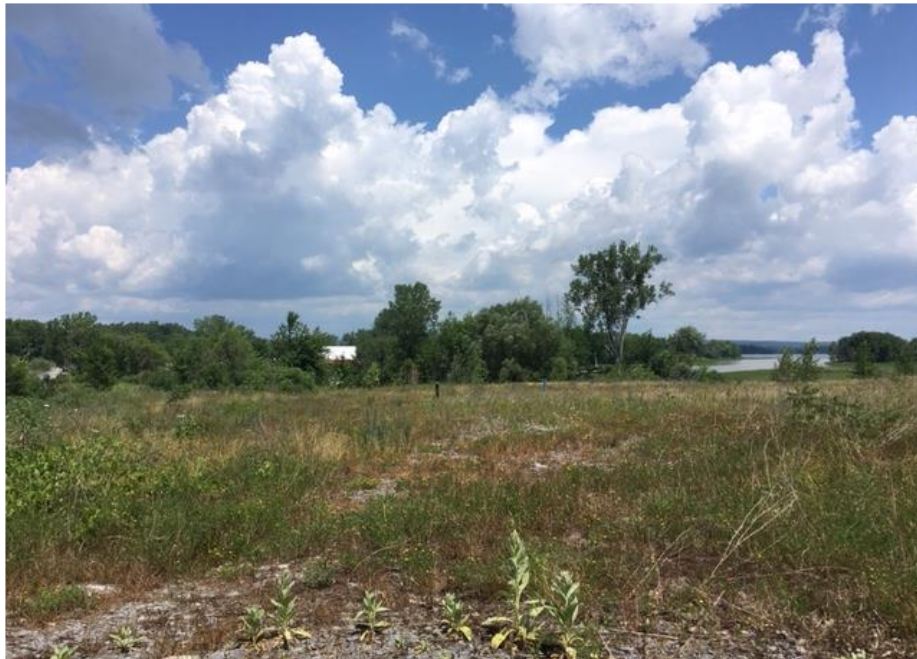
Photograph 2: Central view of the Phase I Property, taken from the southern tree line, looking north towards the Ottawa River.
