**Slope Stability Review and
Landslide Risk Assessment**

Proposed Multi-Storey Building Complex
1009 Trim Road - Ottawa

Report: PG3556-LET.01, Revision 2

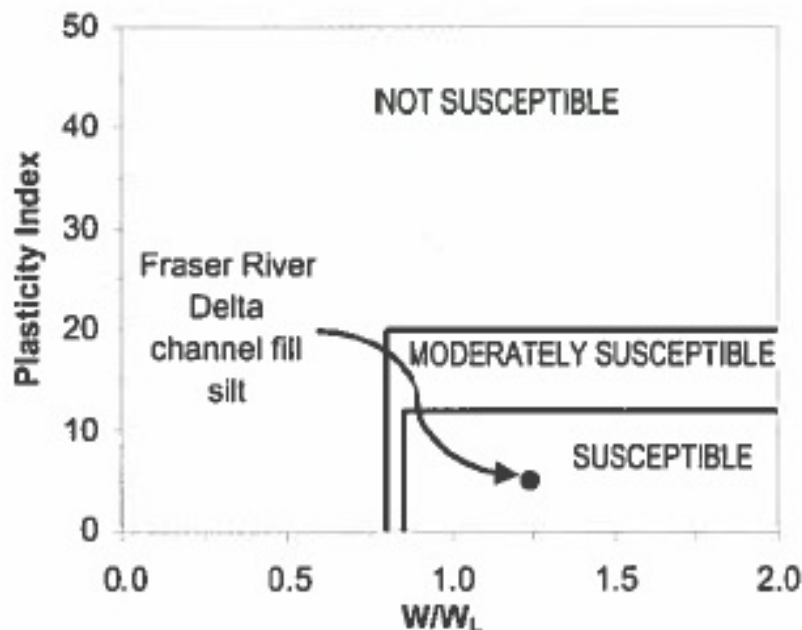
Figure 2 - Bray et al. (2004) criteria for liquefaction assessment of fine-grained soils

Further to the above, it should be noted that liquefaction potential is assessed as part of the seismic design considerations. The silty clay deposit encountered at the subject site has been encountered during numerous geotechnical investigations completed by Paterson across the greater Ottawa area. Based on our experience, and supported by multiple laboratory testing results, this material would typically be considered highly plastic with a plasticity index (PI) greater than 20. Figure 6.15 of the Canadian Foundation Manual (2006) provides criteria for liquefaction assessment of fine-grained soils from Bray et al. (2004) as shown in Figure 2 below.

Based on the Atterberg Limits testing results conducted on the representative soils samples at the subject site resulting in Plasticity Index (PI) above 20 in conjunction with the site specific shear wave velocity test results, the underlying soils at the subject site not considered susceptible to liquefaction or subsequent 'earth flows' from a geotechnical perspective.

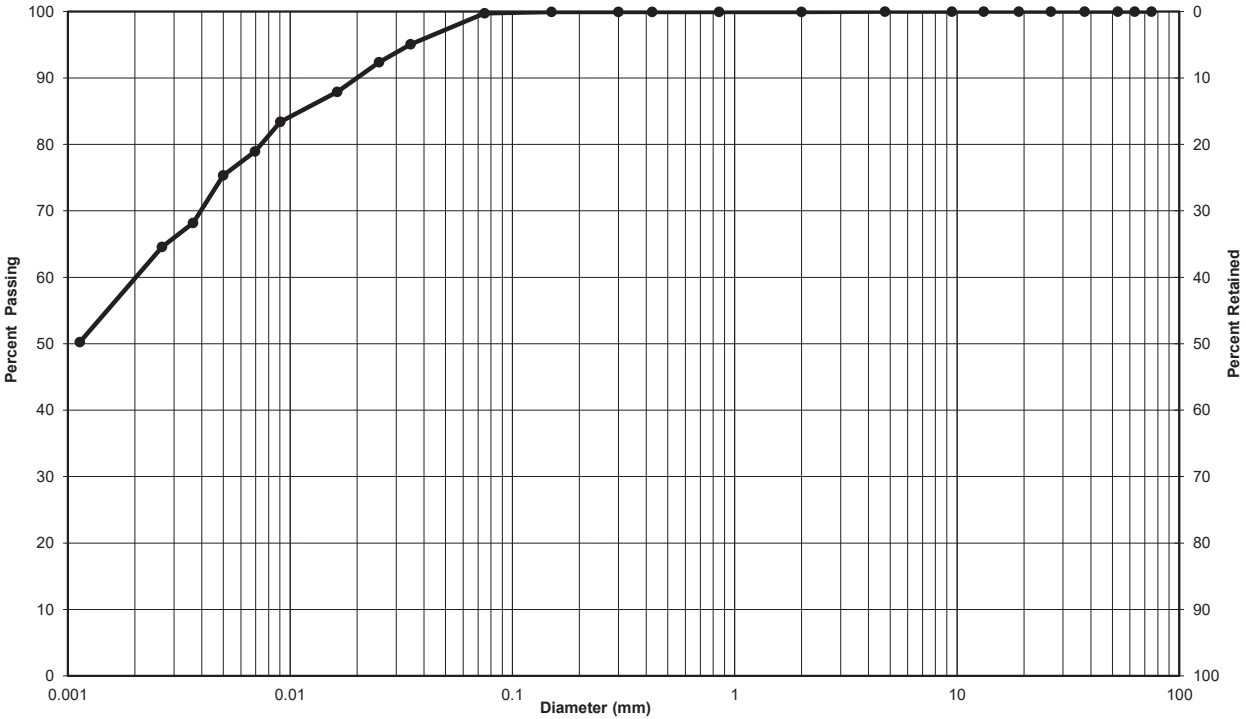
Borehole no.: 16-1	Sample no.: SS11
Depth: 7.6-8.2m	Location: -

Percent Retained	Gravel	Sand	Clay & Silt	Silt	Clay
	0	0	100	40	60

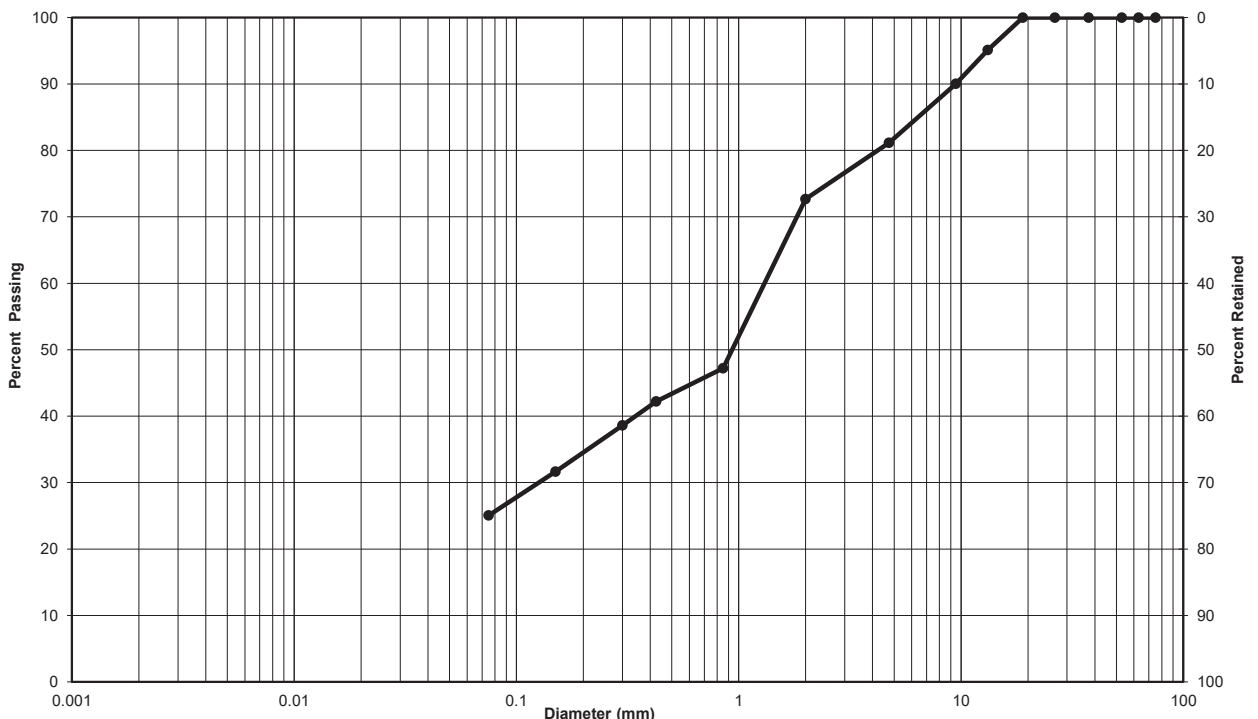
Borehole no.: 16-1	Sample no.: SS4B
Depth: 2.3-2.9m	Location: -

Percent Retained	Gravel	Sand	Clay & Silt	Silt	Clay
	19	56	25	-	-

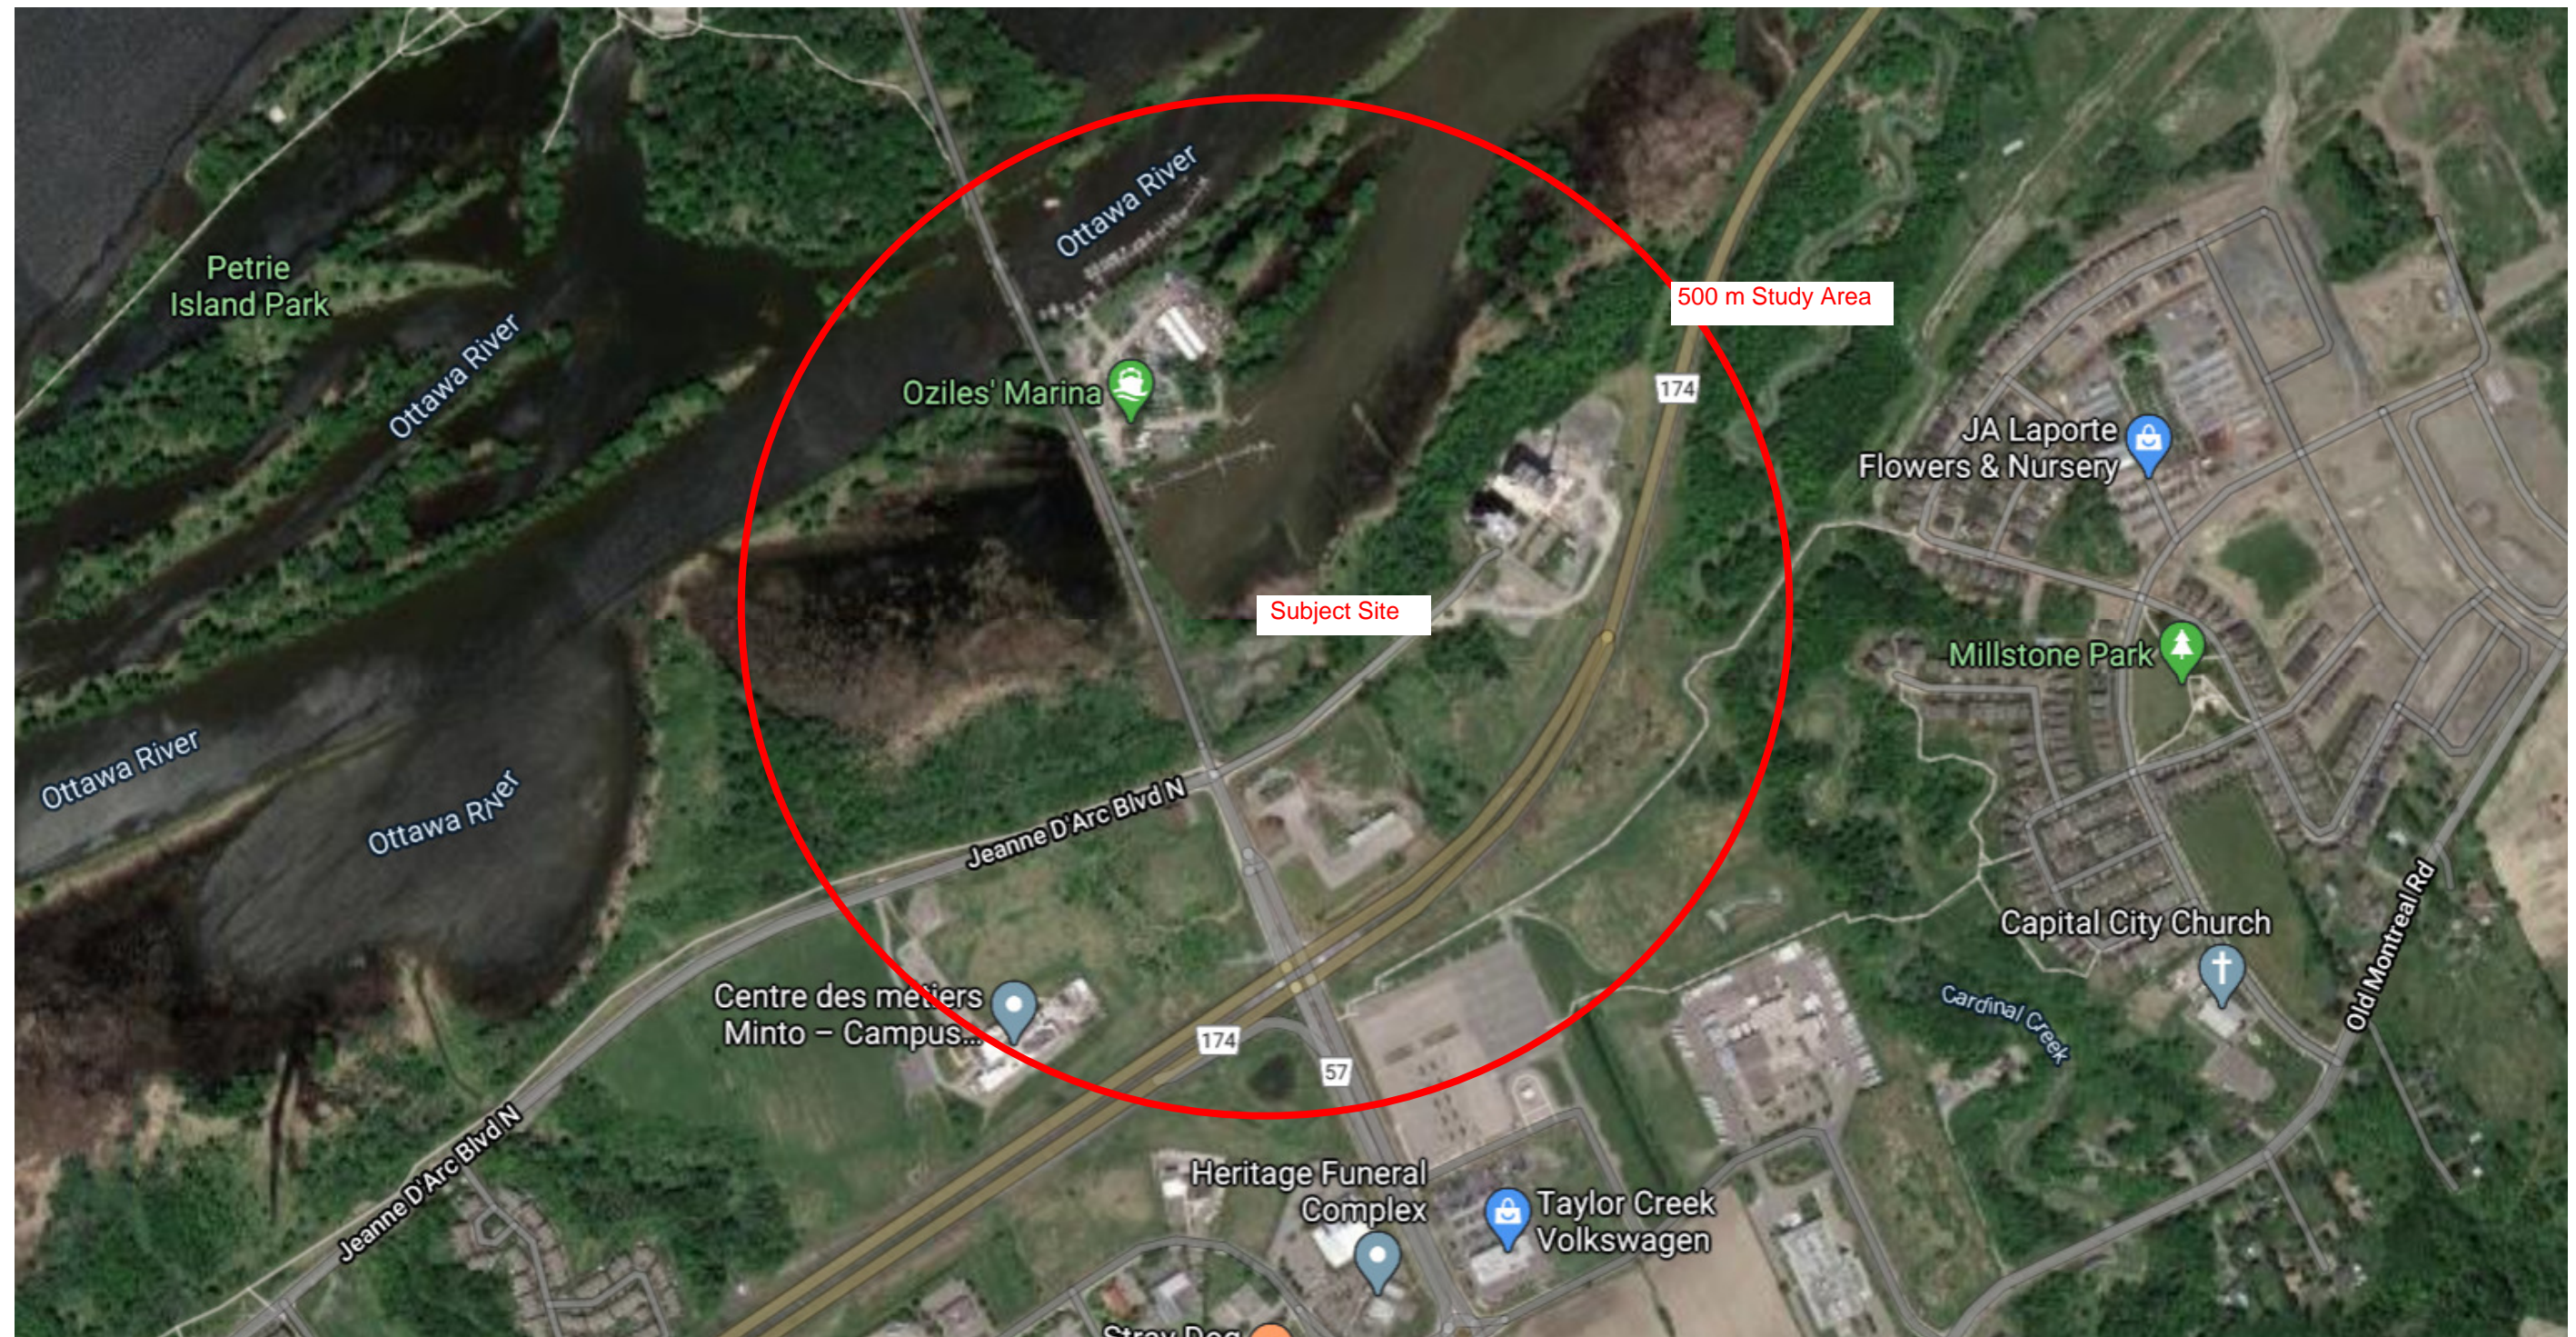
FIGURE 3 - 500 m Study Area

- ❑ Low lying wetlands to the north which has created table lands to the south.
- ❑ Wetland channel along the Ottawa River between Petrie Islands and the shoreline.
- ❑ Causeway restricting water flow along the eastern portion of the channel.
- ❑ 4H:1V or flatter slope located within the south portion of the site which is heavily treed.
- ❑ Highway 174 and the future LRT station at Trim Road.
- ❑ Multi-storey building complex located to the east.
- ❑ The meandering Cardinal Creek valley and table lands to the south east.
- ❑ The residential development of Cardinal Creek Village southeast of the subject site.

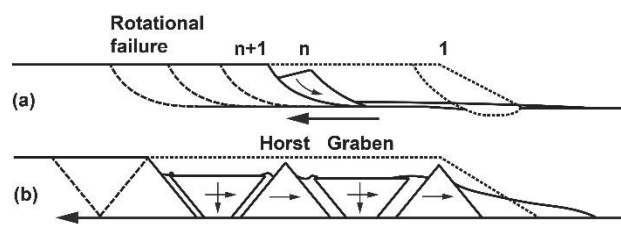
Figure 1. Conceptual sketch of the mode of failure (a) for a flow with successive rotational slides propagating rearward, and (b) for a spread involving the dislocation of the soil mass into horsts and grabens. Large arrows indicate the propagation direction of the failures. Small arrows indicate the main components of soil movement.

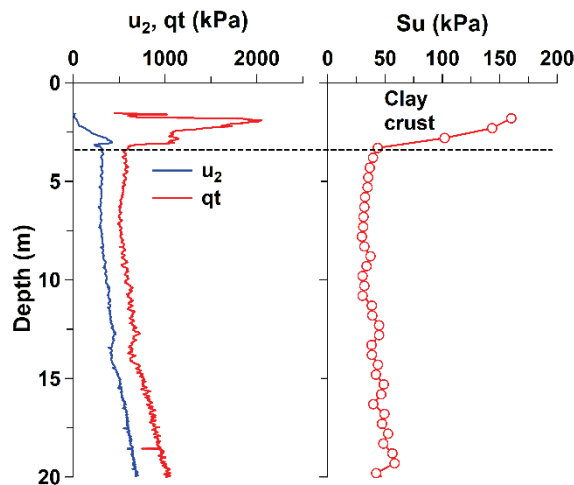
Figure 2. Piezocone and field vane tests profiles in a sensitive clay deposit overlain by a stiffer clay crust (case #32, Table 1). A hole was drilled to a depth of 1.5 m before beginning the piezocone test to avoid the desaturation of the porous element; u_2 is the pore pressure generated by cone penetration and qt is the cone tip resistance. S_u is the soil shear strength determined from the field vane test.

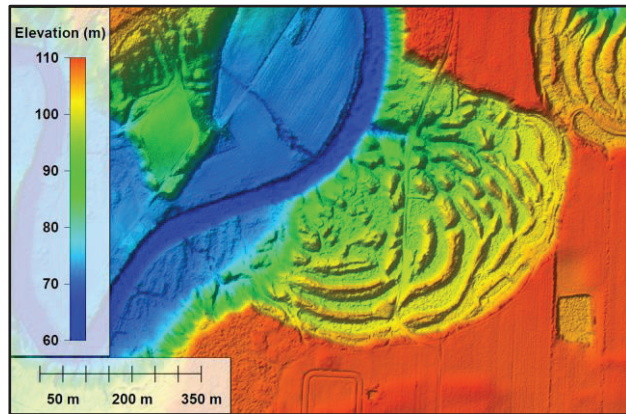
Figure 5. Lidar DEM of a landslide spread (case # 16, Table 1) showing a typical ribbed pattern with alternating horsts (protruding prisms) and grabens (sunken wedges). Part of another spread is visible in the upper right corner of the figure.
