FINAL REPORT

Phase One Environmental Site Assessment

4639 Bank Street, Ottawa, Ontario

19128449

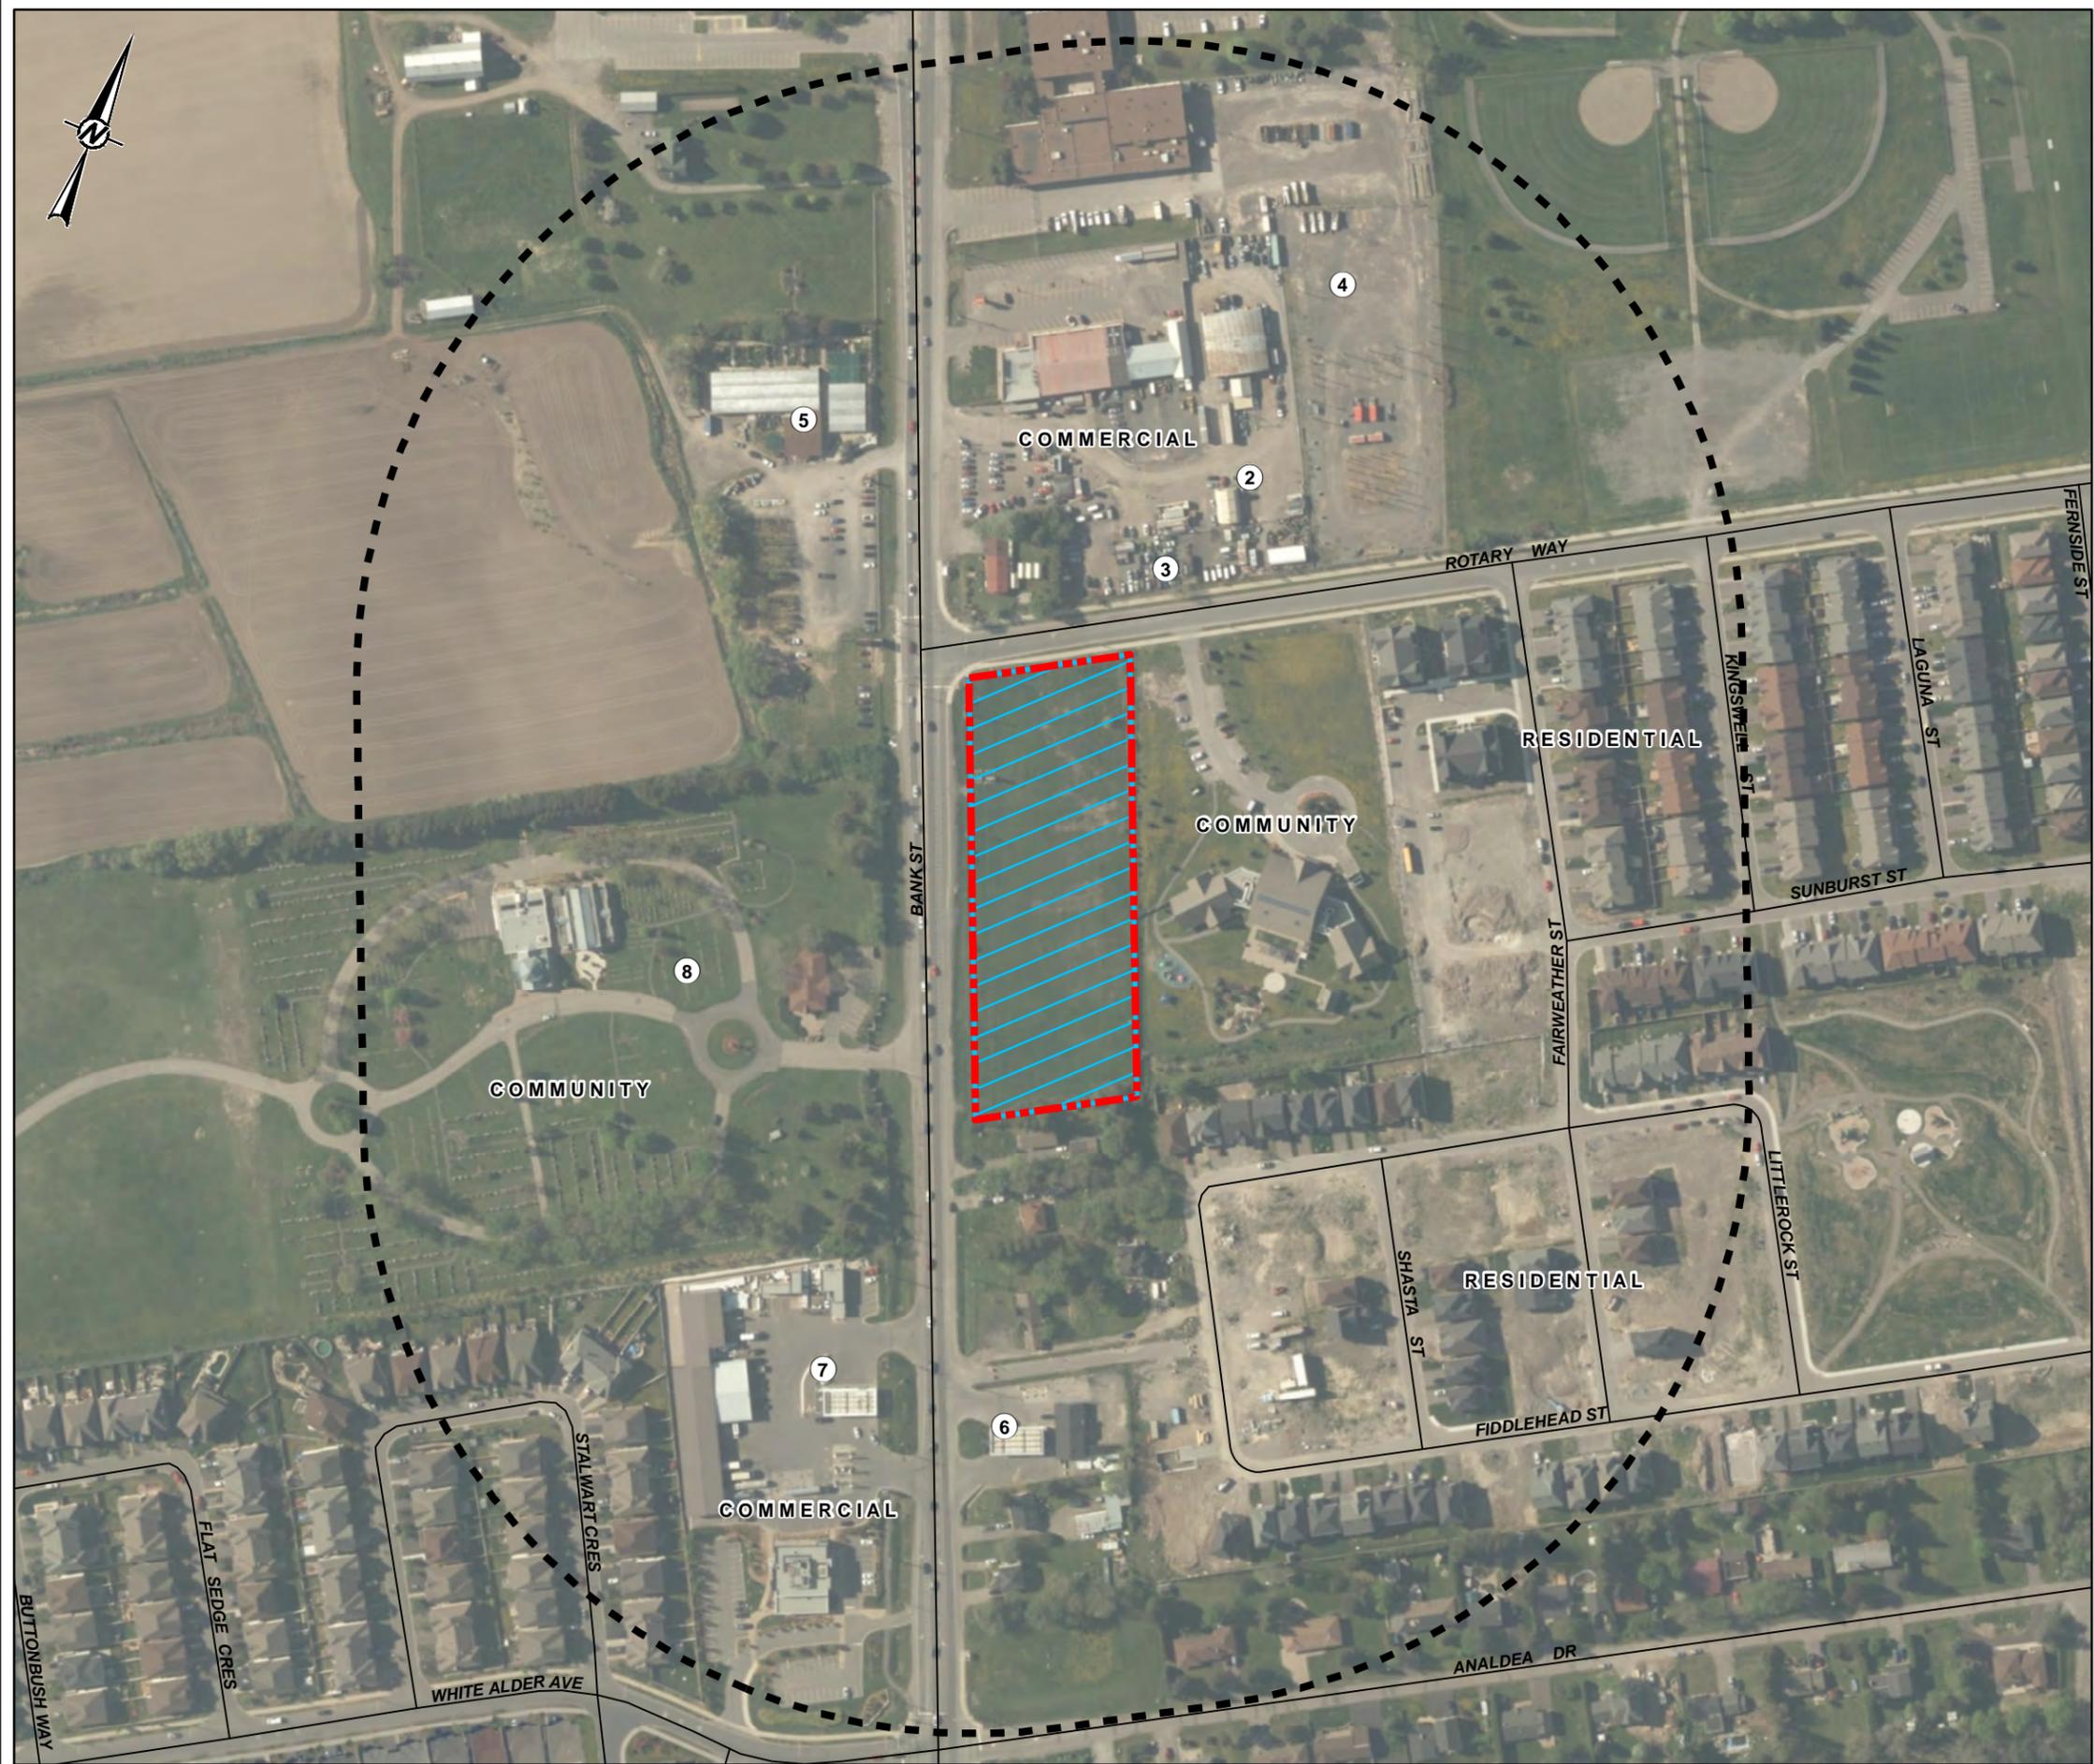
ROADWAY (solid line)
 PHASE ONE SITE (red dashed line)
 PHASE ONE STUDY AREA (black dashed line)
 PCA 1 (blue hatched area)

| Potentially Contaminating Activities (PCAs) | | |
|---|---|---|
| 1 | Importation of Fill Material of Unknown Quality or Origin – Fill material was found to be present across the Site up to depths of 0.75 and 1.90 mbgs during the current geotechnical investigation at the Site. Fill material was used to fill in the former creek that intersected the northeast corner of the Site. No signs of contaminated were observed in the fill. | 30 |

| Location | Potentially Contaminating Activity | Information Source | Rationale for Potential Contribution of the PCA to an APEC |
|---|---|---|---|
| Phase One Property | 30. Importation of Fill Material of Unknown Quality or Origin – Fill material was found to be present across the Site up to depths of 0.75 and 1.90 mbgs during the current geotechnical investigation at the Site. Fill material was used to fill in the former creek that intersected the northeast corner of the Site. | Aerial Photographs and | Although this PCA is located on the Phase One Property, there was no evidence of contamination (staining, odour or debris) found in the fill with the exception of one piece of concrete found in the fill at one location and therefore, it is not expected to be of poor quality. Additionally, future development of the Site is likely to include the removal of the fill. Therefore, this PCA is not considered to represent an APEC on the Site. |

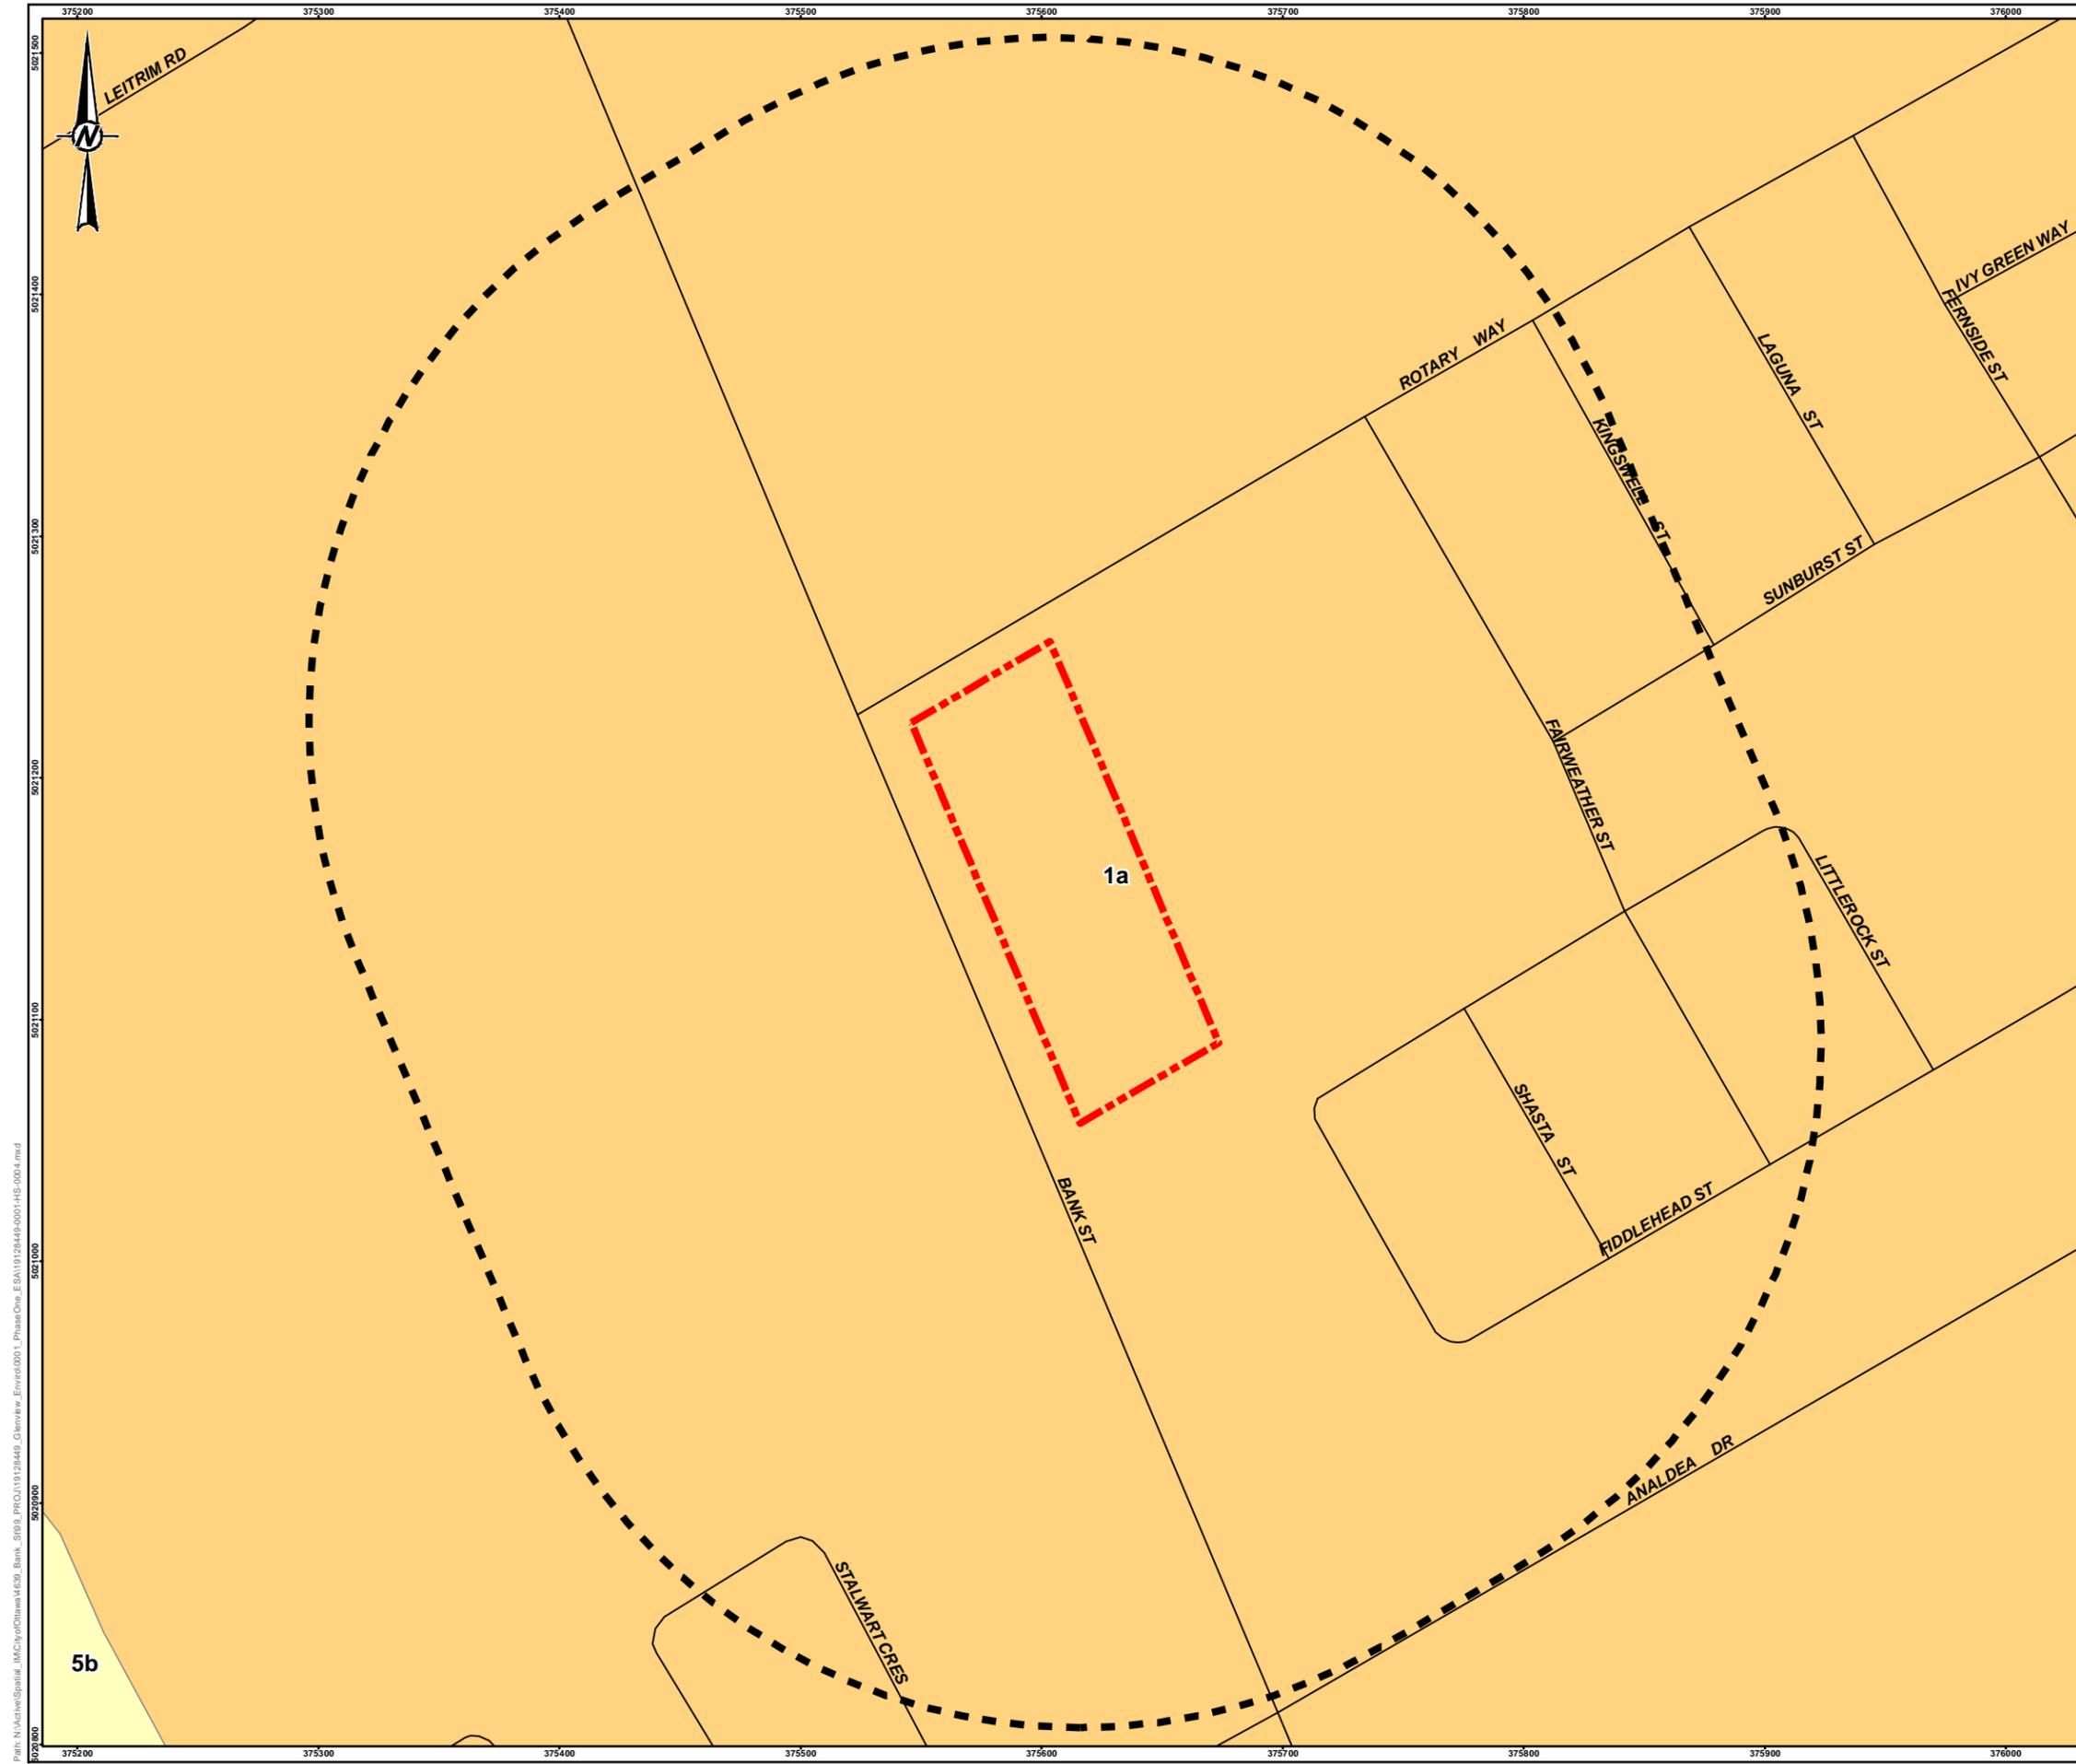
- ROADWAY
- PHASE ONE SITE
- PHASE ONE STUDY AREA
- 5b: NEARSHORE SEDIMENTS: FINE TO MEDIUM GRAINED SAND
- 1a: TILL, PLAIN WITH LOCAL RELIEF <5 m

- The geological mapping indicates that the subsurface conditions at the Site are till, plain with local relief <5 m and that the bedrock at the Site of the Lindsay Formation (limestone, nodular to black laminated). Based on the geotechnical test pit investigation that was completed for the Site in September 2019, the overburden soils at the Site generally consisted of topsoil over fill material below which was native silt over silty sand glacial till.

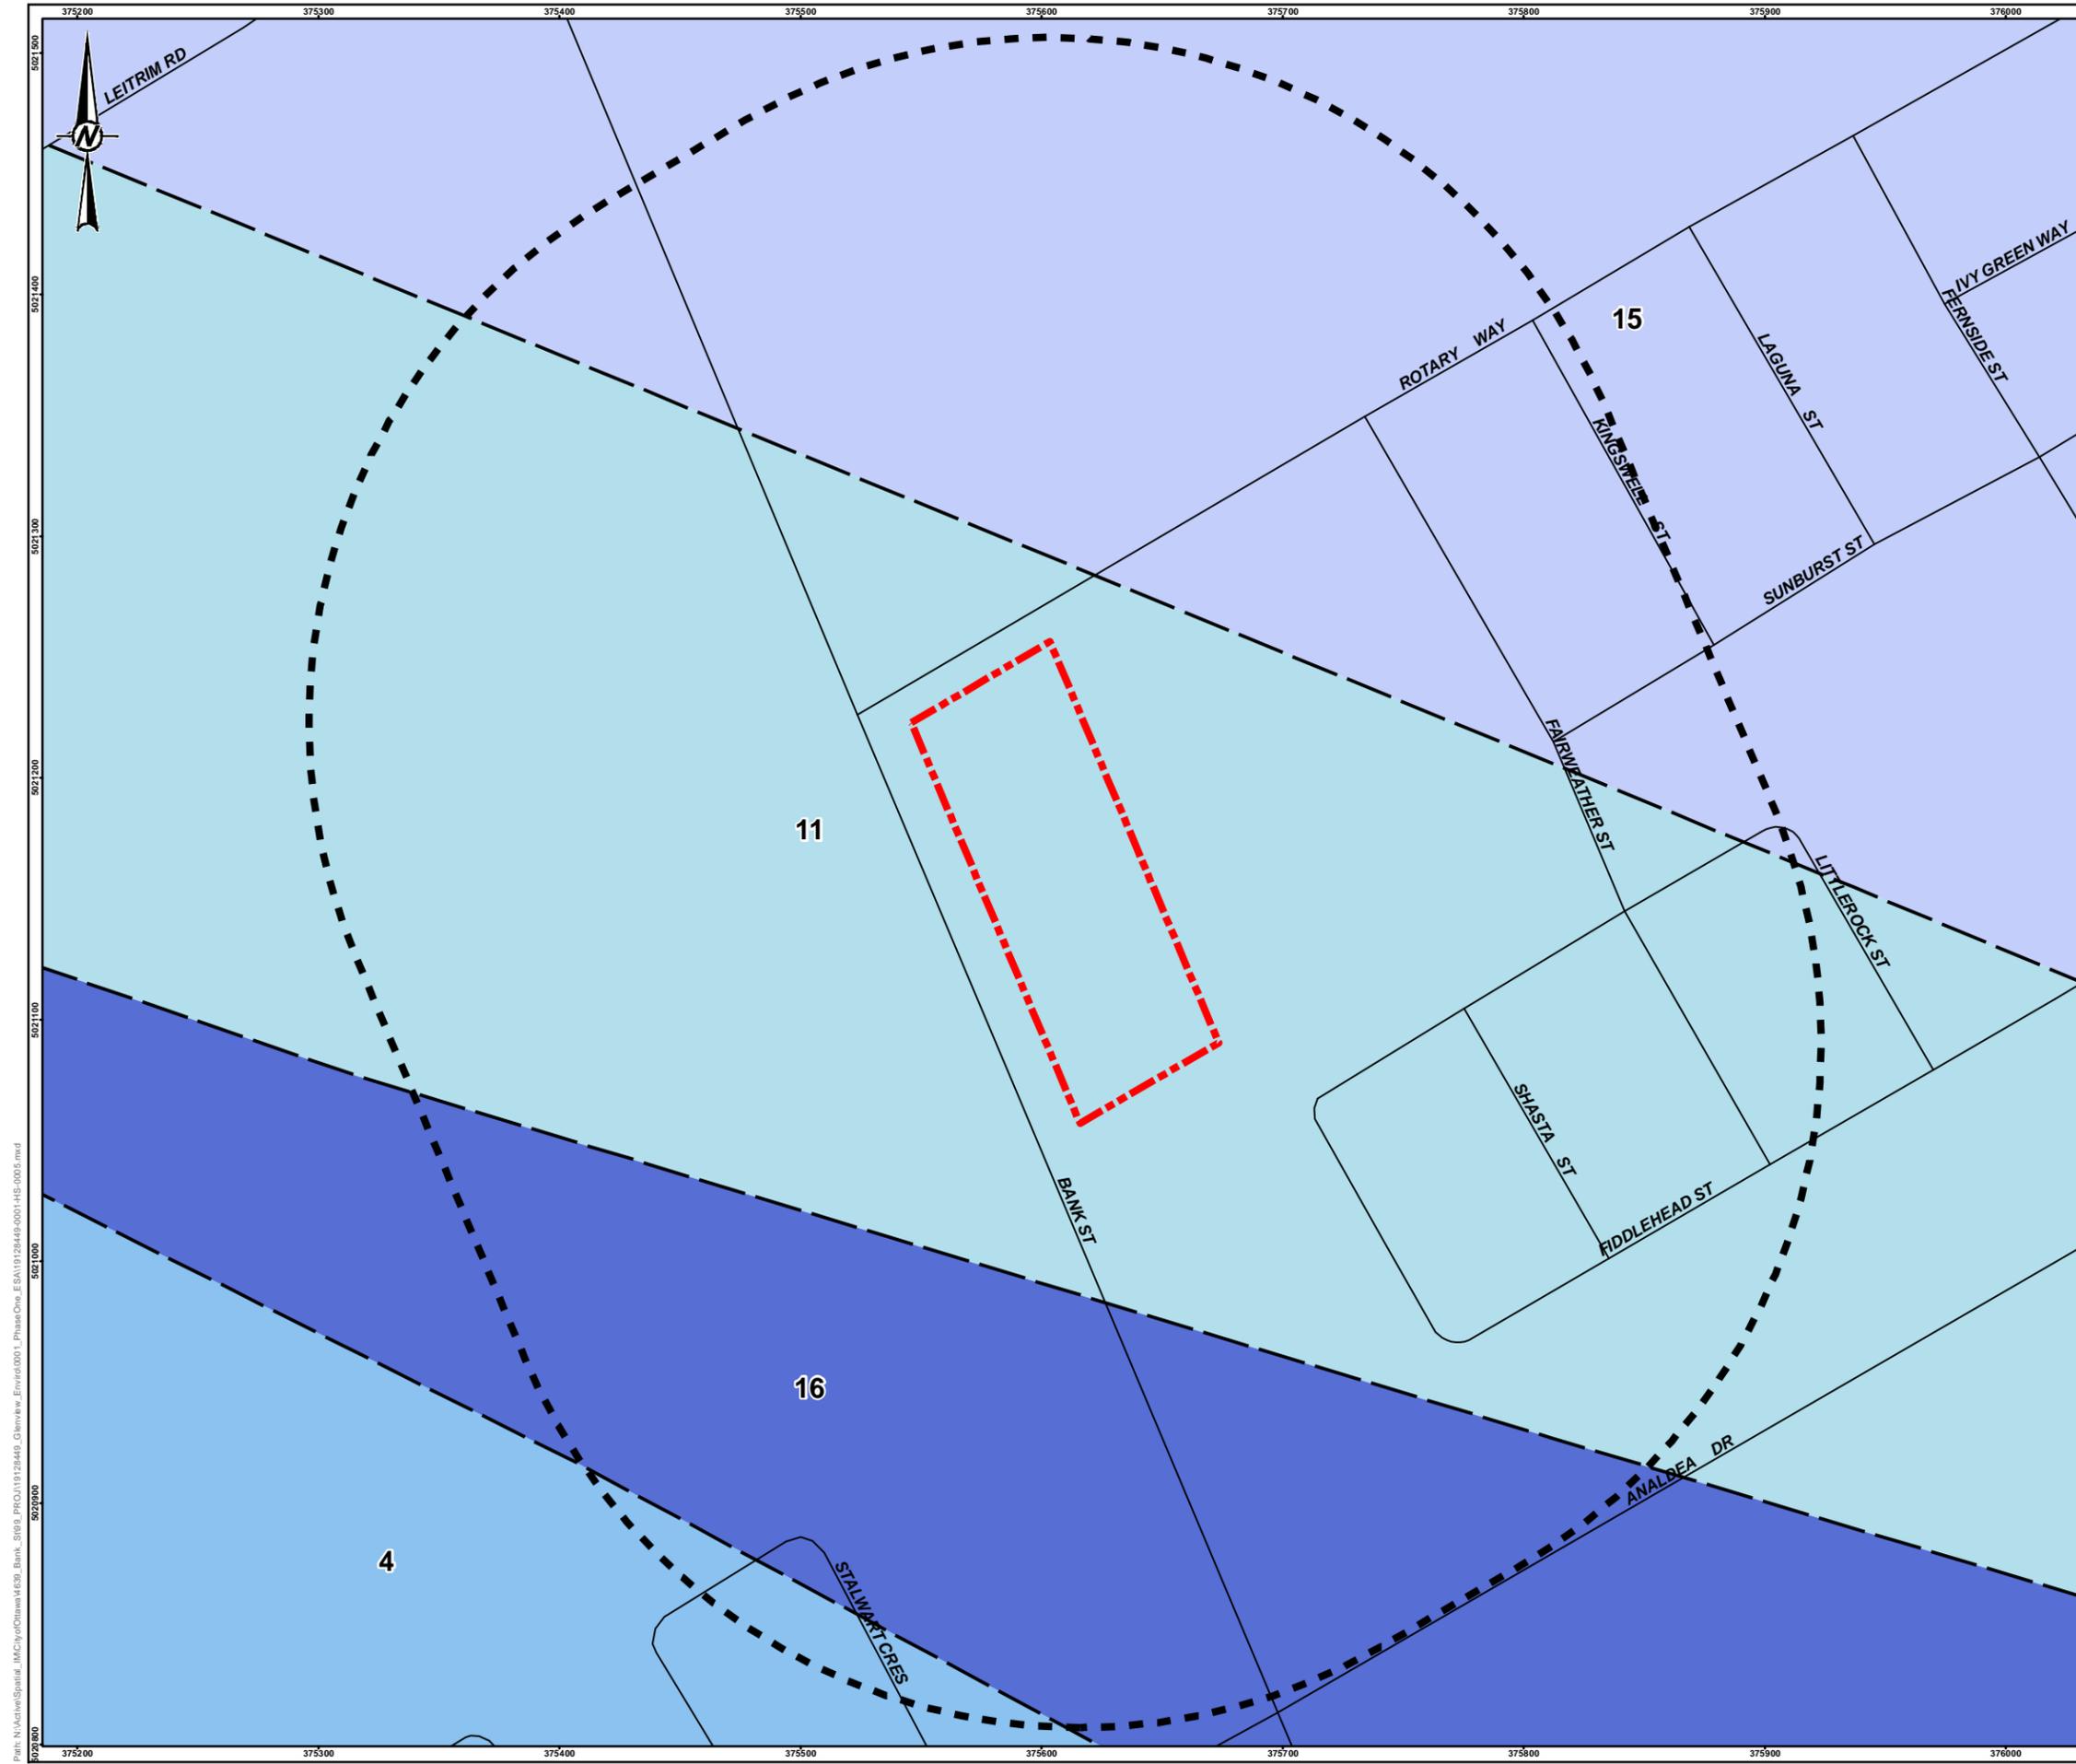
- ROADWAY
- PHASE ONE SITE
- PHASE ONE STUDY AREA
- 16: QUEENSTON FORMATION - SHALE, SILTSTONE, MINOR LIMESTONE AND SANDSTONE
- 15: CARLSBAD FORMATION - SHALE AND LIMESTONE
- 11: LINDSAY FORMATION - LIMESTONE; NODULAR TO BLACK LAMINATED
- 4: MARCH FORMATION - SANDSTONE, DOLOMITIC SANDSTONE, DOLOSTONE

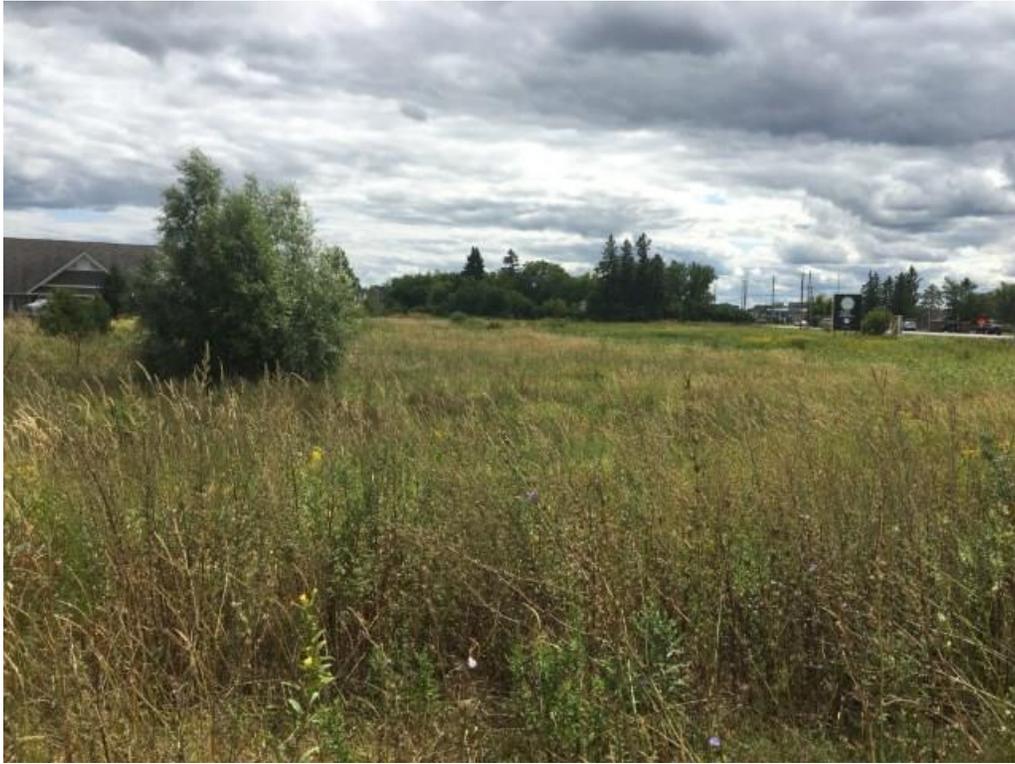
Photo 1: Looking southwest at the Site.

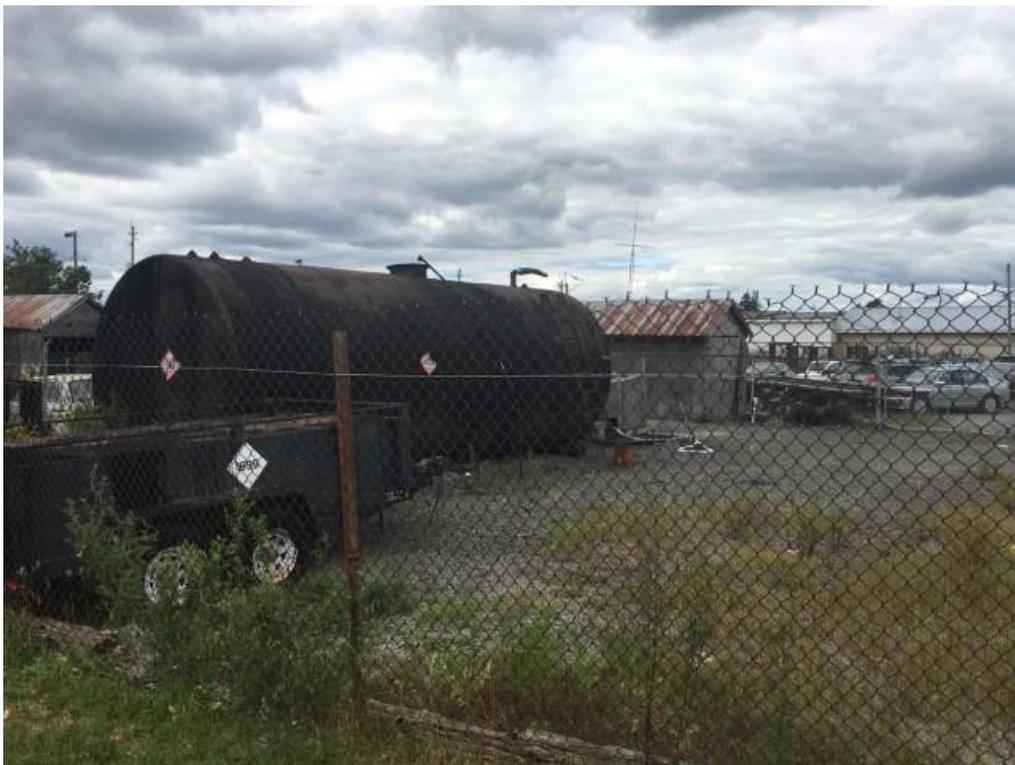
Photo 4: Photo of the tar or asphalt AST on the former asphalt company property north of the Site at 4603 Bank Street.

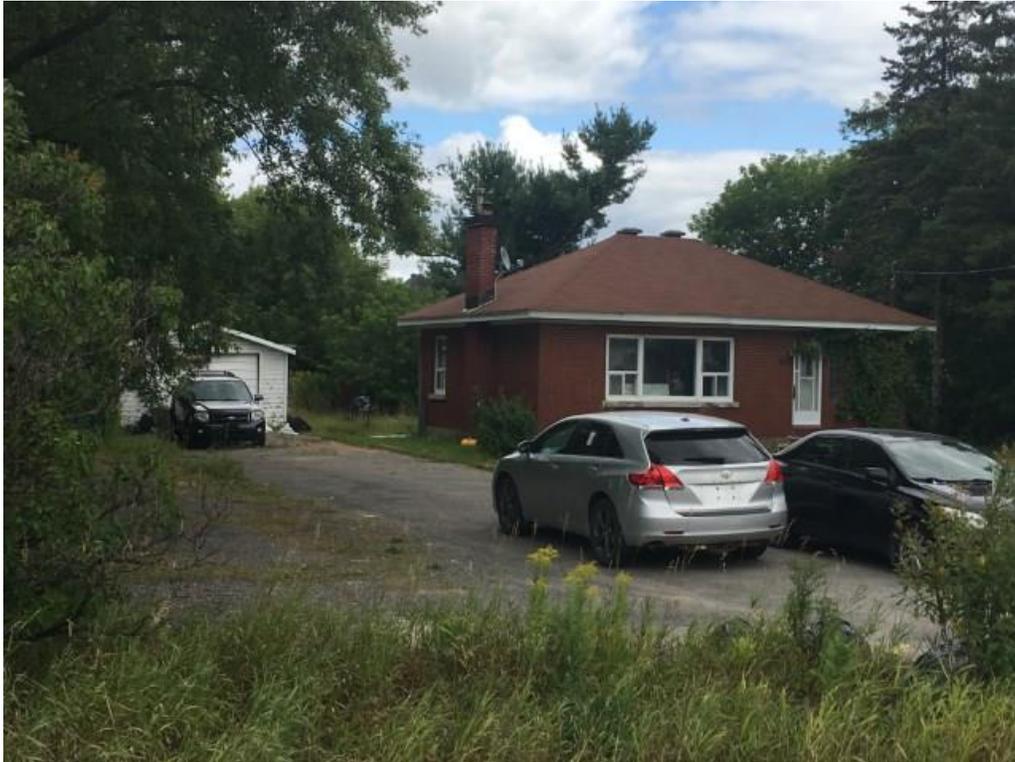
Photo 7: Photo of the fill and vent pipes observed on a residential house south of the Site at 4695 Bank Street.

- The TSSA Incidents (INC) database has records of TSSA incidents within the Phase One Study Area. Both records were for fuel oil spills that occurred at a private residence at 4695 Bank Street, approximately 25 m south of the Site. One spill occurred in 2009 and the other occurred in 2011. Although no other information was provided, it is likely that the 2009 spill was the 454 L fuel oil spill to basement that was noted in the Ontario Spills database mentioned above and that the 2011 fuel oil spill was also from a fuel AST in the basement.
