**Phase One Environmental
Site Assessment
6171 Hazeldean Road
Ottawa, Ontario**

OTT-00258780-C0

April 7, 2020

Phase One Environmental Site Assessment 6171 Hazeldean Road, Ottawa, Ontario

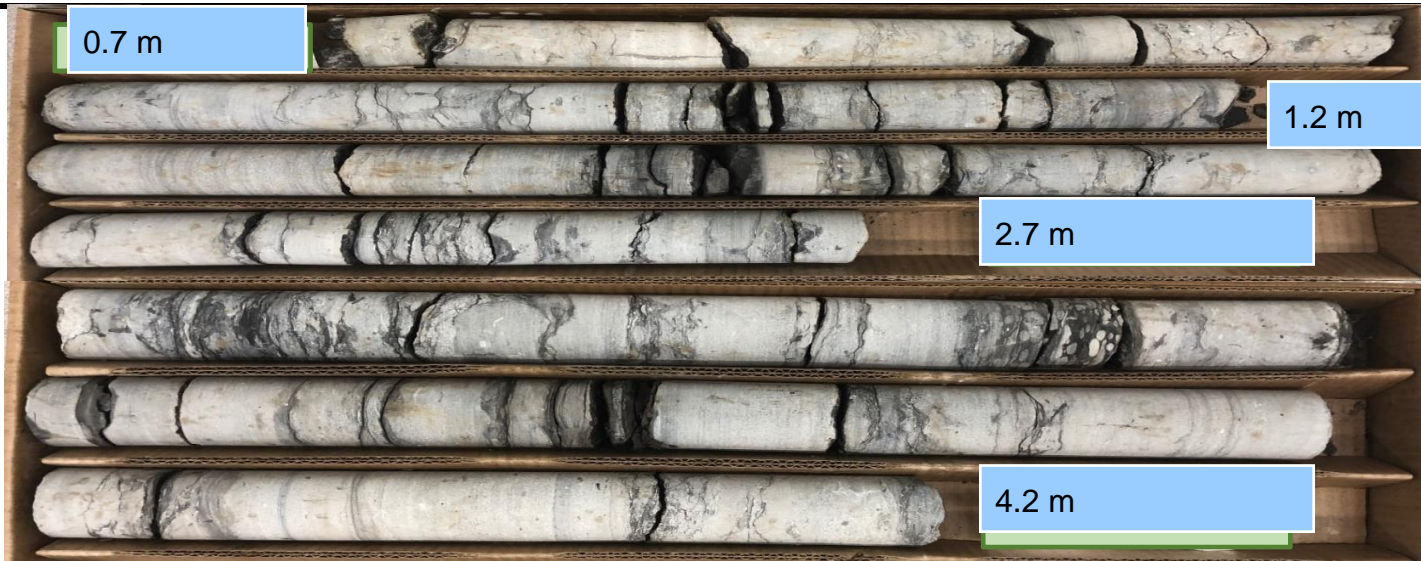
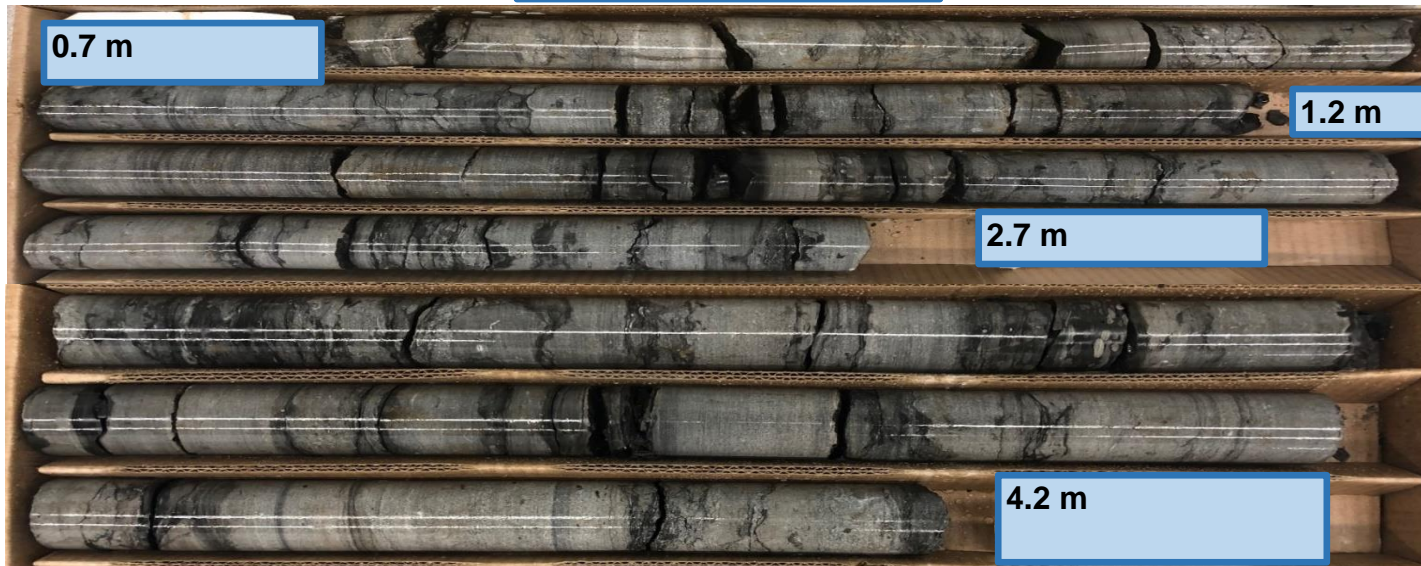
DRY BEDROCK CORES

WET BEDROCK CORES

Borehole No. BH-1	Core Runs Run 1: 0.7 - 1.2 m Run 2: 1.2 - 2.7 m Run 3: 2.7 - 4.2 m	Project Name: Propsoed Residential Development. 6171 Hazeldean Road, Ottawa, ON	Project No: OTT-000258780-B0
		ROCK CORE PHOTOGRAPHS
